breach of contract and misrepresentation Claim against the Suburban Land Agency in relation to Block 7 Section 12 Throsby

GEOTECHNICAL ASSESSMENT OF FOUNDATION

PROPOSED RESIDENCE – BLOCK 7, SECTION 12, THROSBY

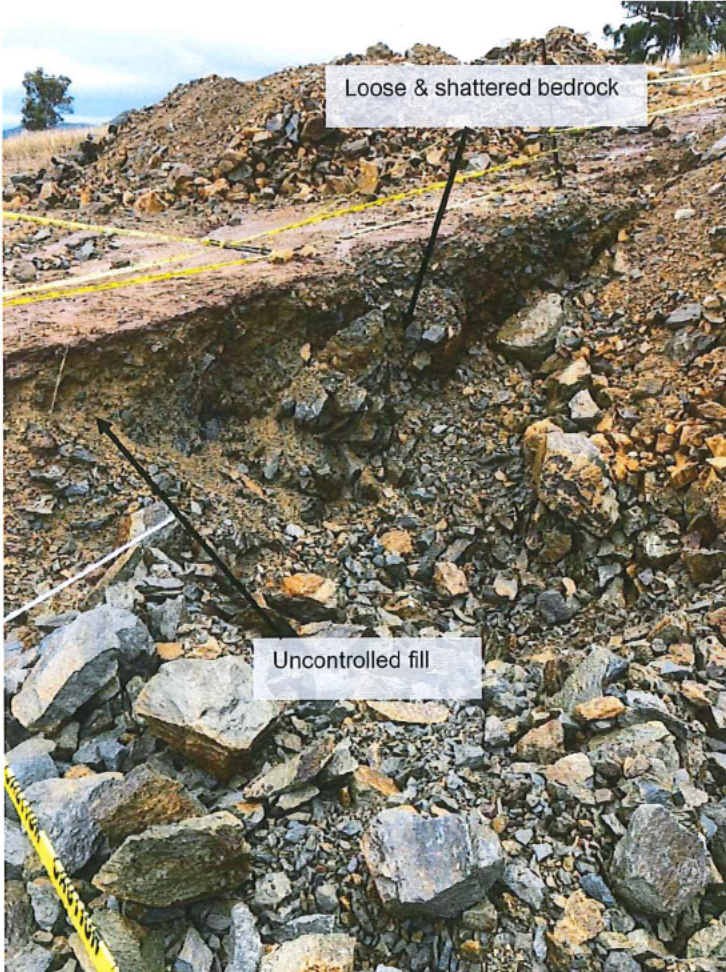
The subsurface profile exposed on the western corner of the block was markedly different to the rest of the site, and does not match the conditions indicated in the Douglas Partners site classification report.

This area includes loose, shattered bedrock that extends to >2.8m depth. The loose and shattered nature of the bedrock appears to be from previous blasting activities in the area. It has been indicated that during the subdivision development works, some excavation works required the use of pre-blasting to break the rock up, prior to bulk excavation. The pre-blasting has shattered and loosened the bedrock to at least 2.8m depth below groundsurface level in this area of the site.

Photo 1 (left) – 26/2/2018 – View of the site cut in the western corner of the site, showing the loose, shattered bedrock extending to >2.8m depth.

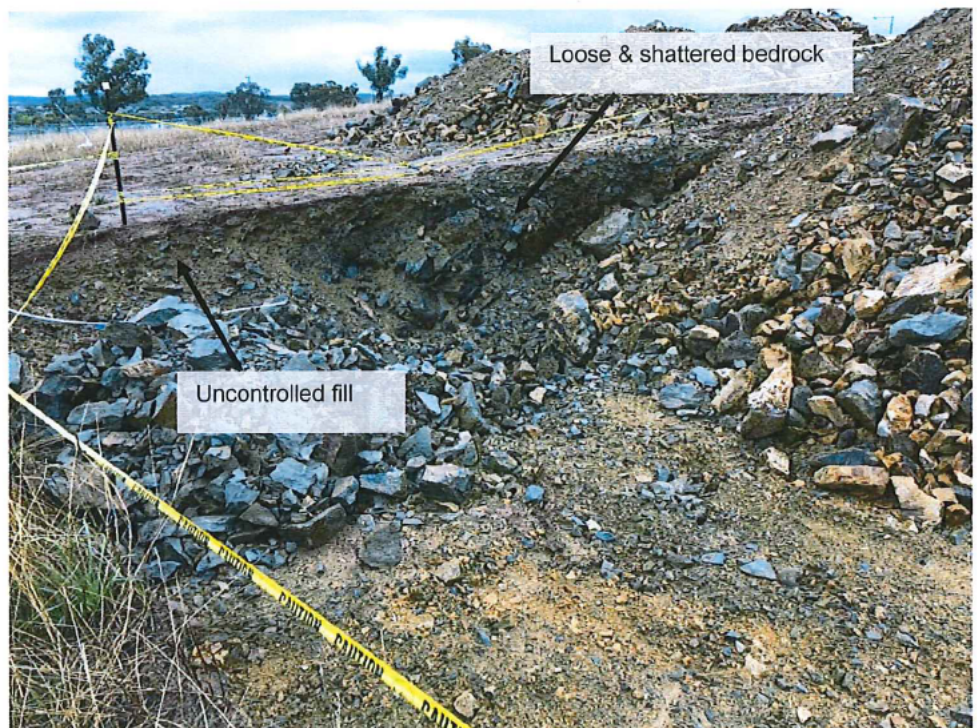
Photo 2 (right) – 26/2/2018 – View of the site cut in the western corner of the site, showing the loose, shattered bedrock extending to >2.8m depth.

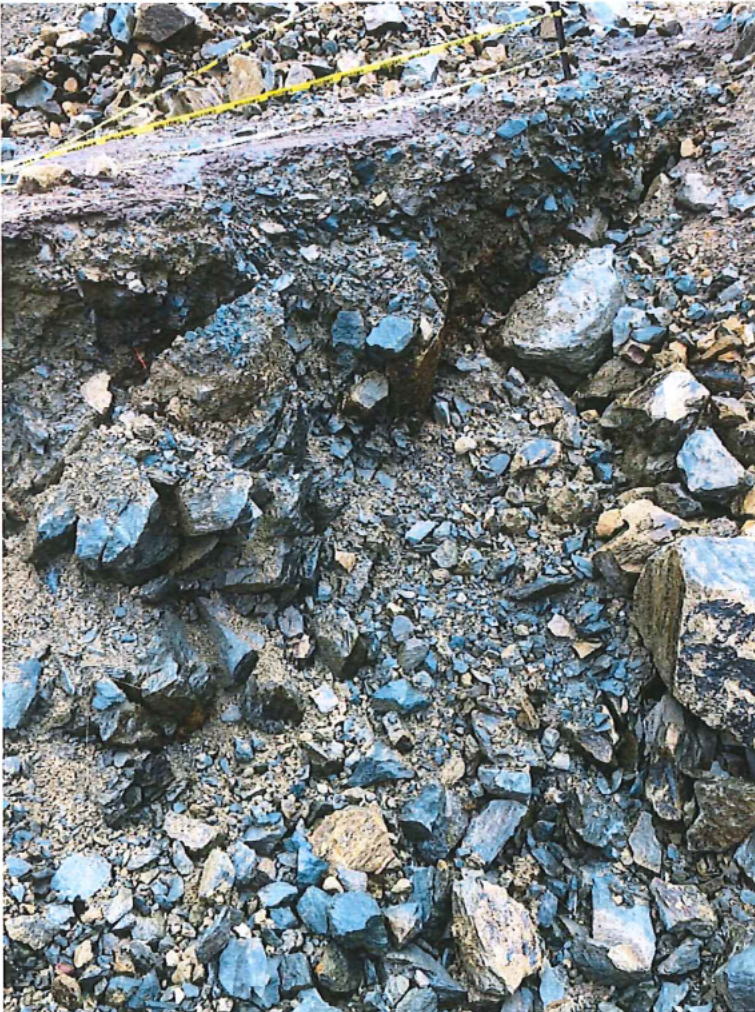
Photo 3 (above) – 26/2/2018 – Close up view of the loose & shattered bedrock.

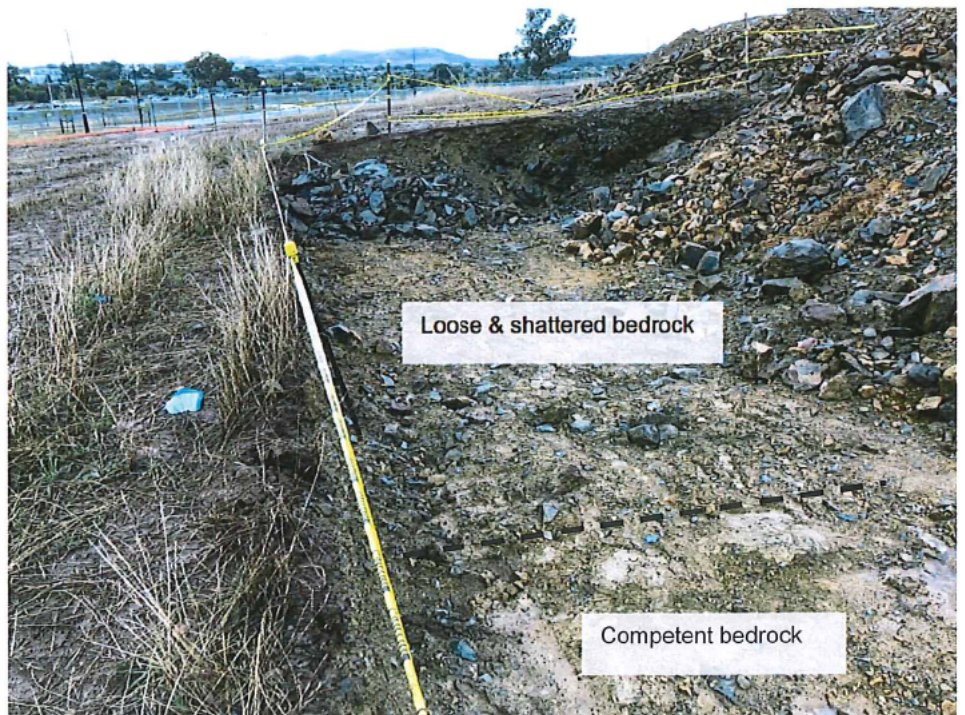
Photo 4 (right) – 26/2/2018 – View of the site cut in the western corner of the site, showing the loose, shattered bedrock extending to >2.8m depth. The transition between the competent bedrock, and loose, shattered bedrock can be seen in the foreground.

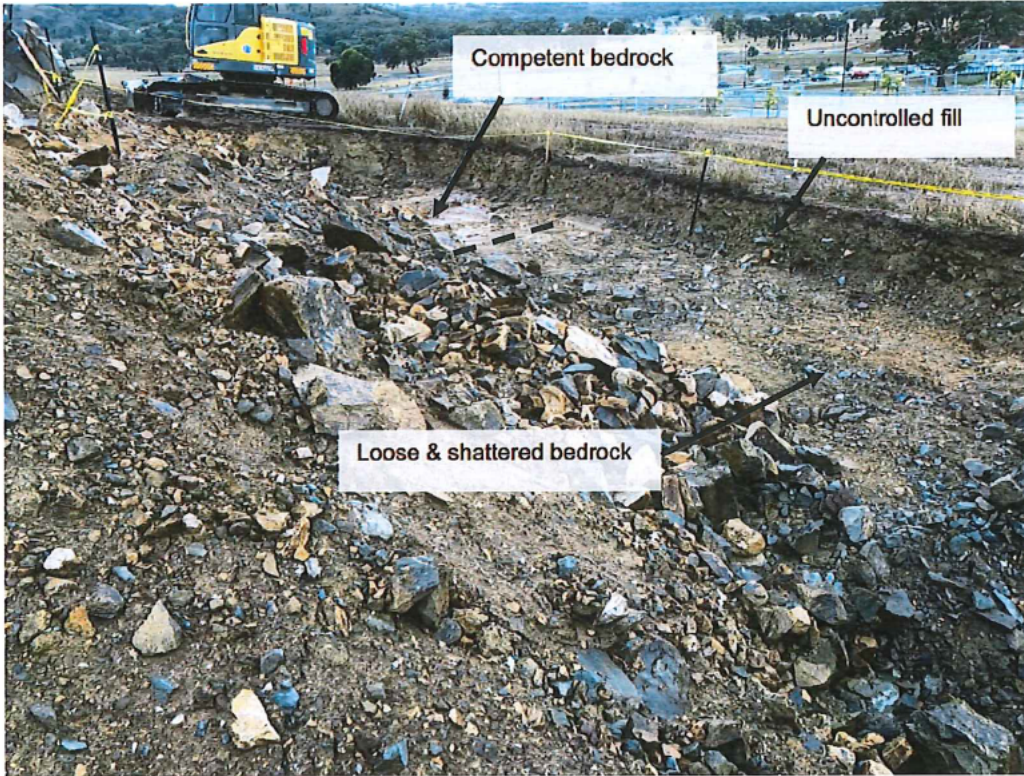
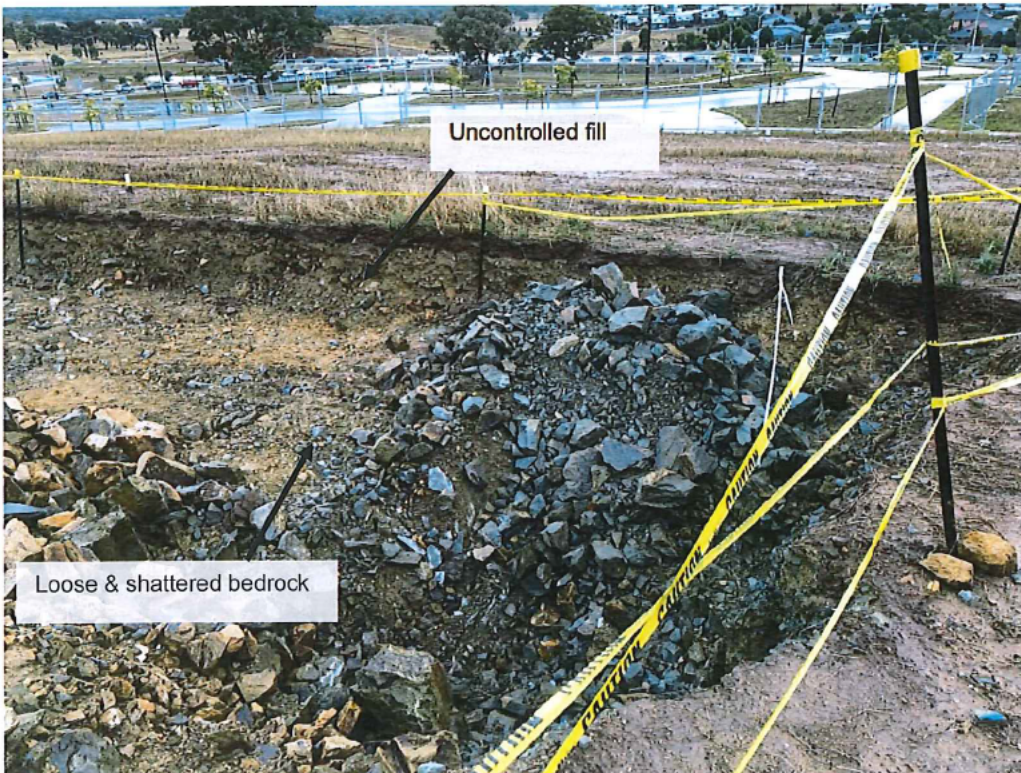
Photos 5 & 6 (above and below) – 26/2/2018 – View of the site cut in the western corner of the site, showing the loose, shattered bedrock extending to >2.8m depth. The transition between the competent bedrock, and loose, shattered bedrock can be seen in the rearground.
