13th November 2018

RECOMMENDATIONS FOR MOVEMENT AND STORAGE OF WANIASSA SCAR TREE.

Conservation Works Pty Ltd was asked to inspect the scar tree at Wanniasa and advise on its safe movement to a storage location. Recommendations in this report are to safeguard the tree trunk and stump only. We have made no comments about safe work procedures. This is the responsibility of the parties involved in the physical work.

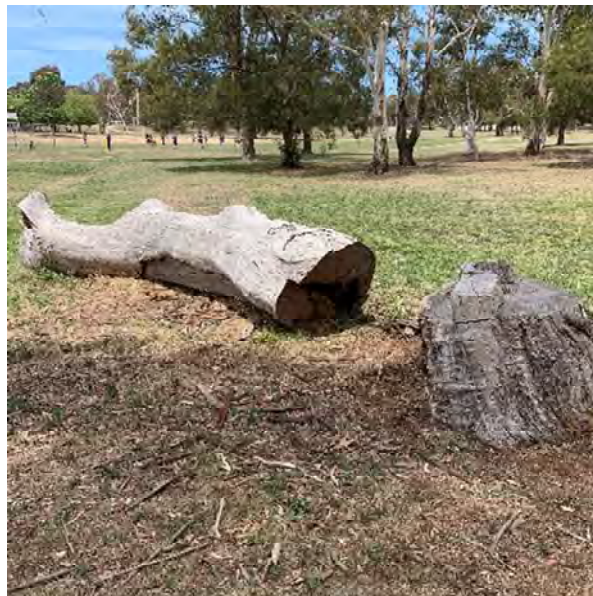
Image one Trunk and stump Nov 2018.

The tree trunk at Wanniasa is in robust condition. The tree has been cut down for a period of a least one year. There is no bark remaining on the tree, indicating it may have been dead prior to being felled.

It is believed to be a yellow box. The long trunk section is approximately 4 metres in length. Yellow box has a dry density of about 1100kg/m². We estimate the volume of the tree to be about two cubic metres giving a likely mass of around 2200kg

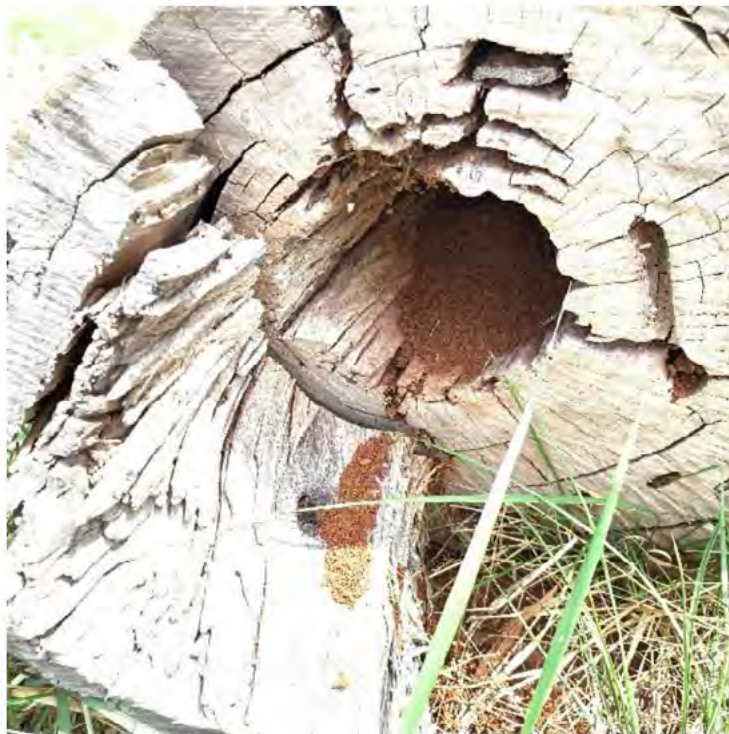
There is evidence of termite activity inside the trunk. This may or may not be active.

Image two: evidence of termite activity

- Both pieces should be blocked up clear of the ground on treated pine sleepers or similar. They should be off the ground on a termite proof material. Breaking the ground connection will protect the pieces from further termite activity.
- The ground below the pieces should be cleared of leaf litter to reduce the risk of burning in a grass fire.
- Ideally a tent structure should be erected over the pieces to avoid rain saturation. Care should be taken that the tarpaulin cover does not touch the surface of the timber or abrasive damage from the wind blowing the fabric could occur. Additionally, the tent should not be constructed so tightly around the timber as to reduce air flow.

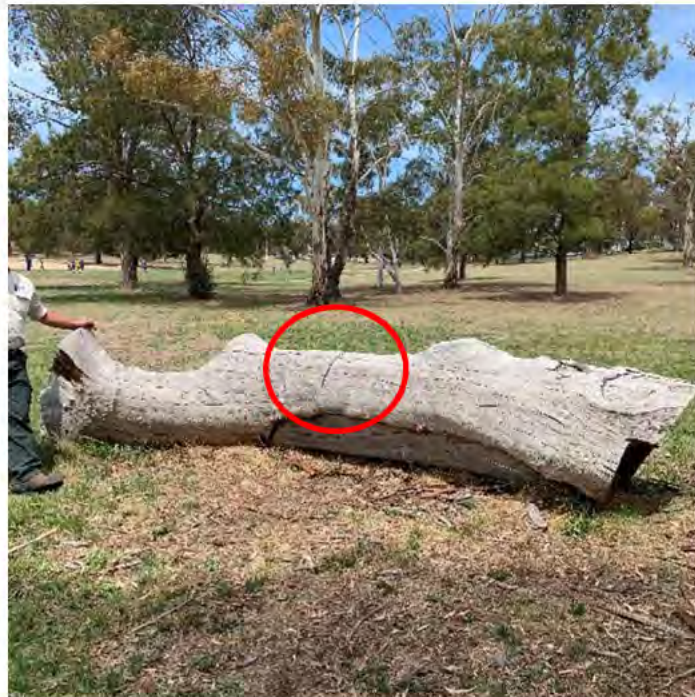
The tree was felled by someone inexperienced with a chainsaw. As well as the felling cuts there is a cut across the top of the log, estimated to be about 1/3 of the depth of the trunk.

Image Three: note cut across the top of the log

- The position of the straps on the trunk should be cushioned with foam to try and eliminate polish/scuff marks from the straps. Firm foam yoga mats cut into strips are good for this.
- The cut on the top third of the trunk should be packed with plywood. It is possible that the trunk could bend around this cut. Packing the gap will minimise the risk of the trunk folding at this point. Plywood strips cut to the width of the sawcut should be inserted radially, leaving a reasonable length protruding to allow for removal in the future.

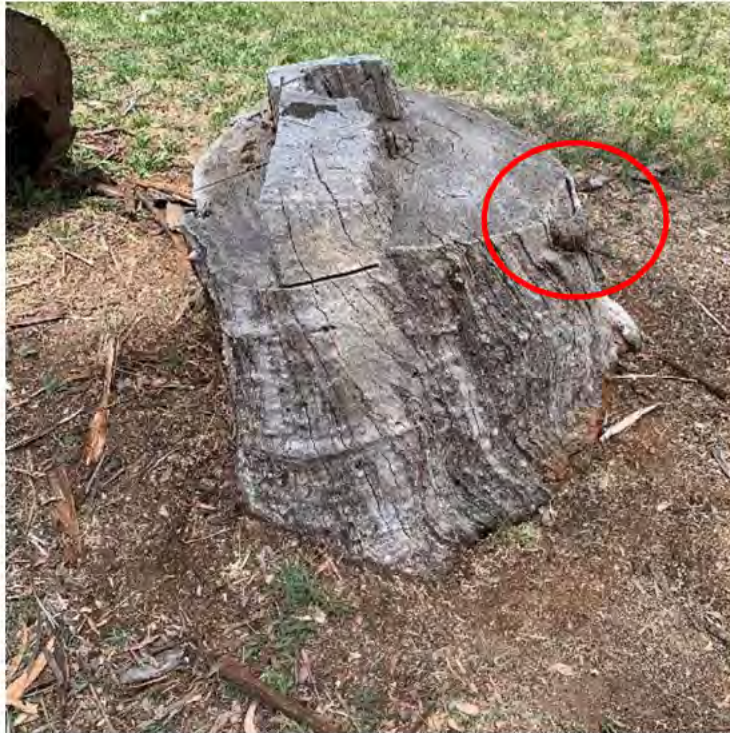
The stump, which remains in the ground has the lowest portion of the cultural scar on it.

Image Four: cultural scar on stump

- Where possible roots should be cut rather than snapped/torn.
 - The crew doing the excavation should be made aware of the scar location and take extra care not to damage this portion. A heavy tarp/blanket should be placed over this area during excavation.
