1 Feltus Place KAMBAH Coversheet

Asbestos Survey of

1 Feltus Pl Kambah ACT

Title: Loose-fill Asbestos Insulation (“Mr. Fluffy”) Contaminated Property Pre-demolition Survey
1 Feltus Place
Block 14 Section 102 Kambah
ACT 2902

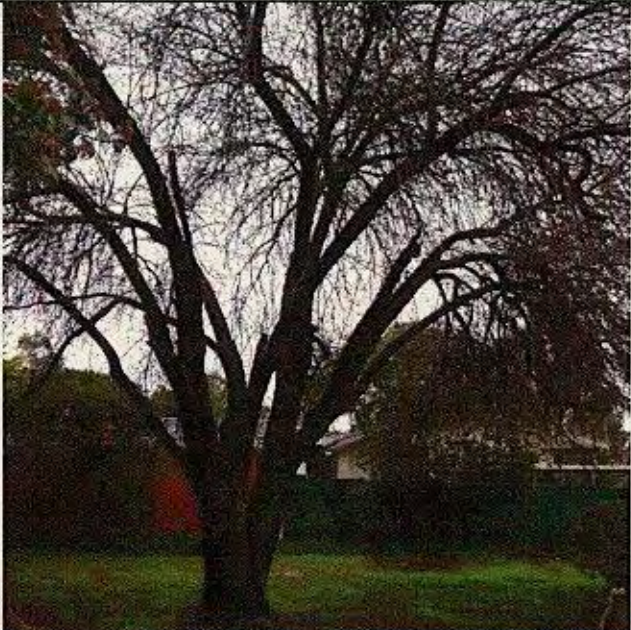
1

Retain trees.
---	--	---------------

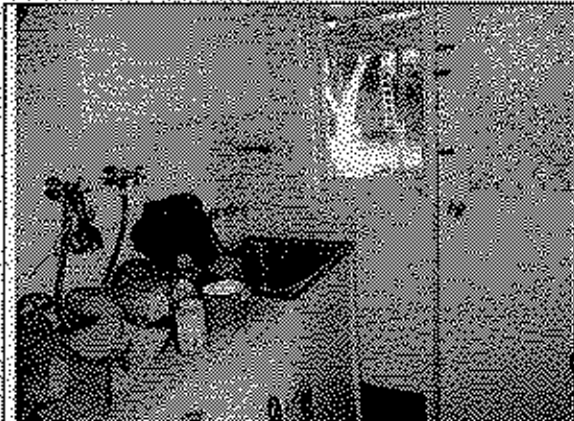
VA2	Sheet	Laundry walls	ACM
VA3	Sheet	Toilet walls	ACM

Laundry walls	Toilet walls

All bonded ACM is in good condition may remain in situ but it must be managed to ensure it remains in good condition.

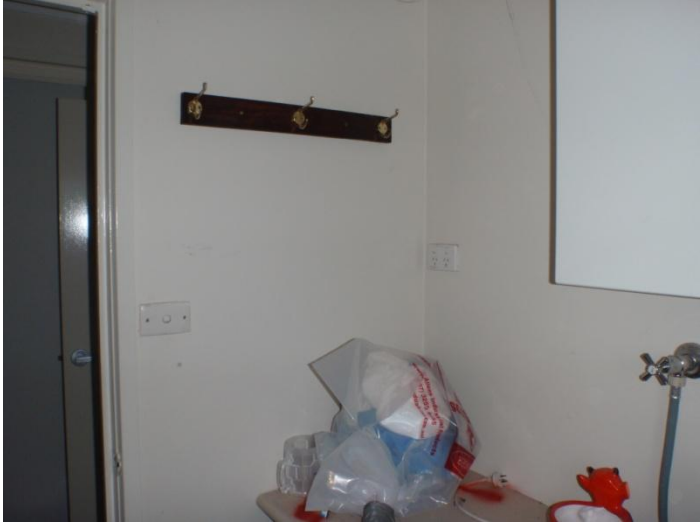
Item Number	Location Description	Material	Photograph
1	Laundry walls	Sheet

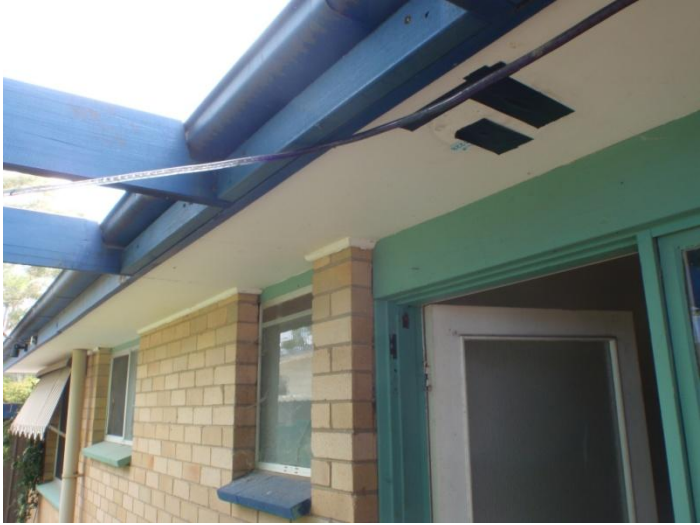
2	Eaves – original	Sheet

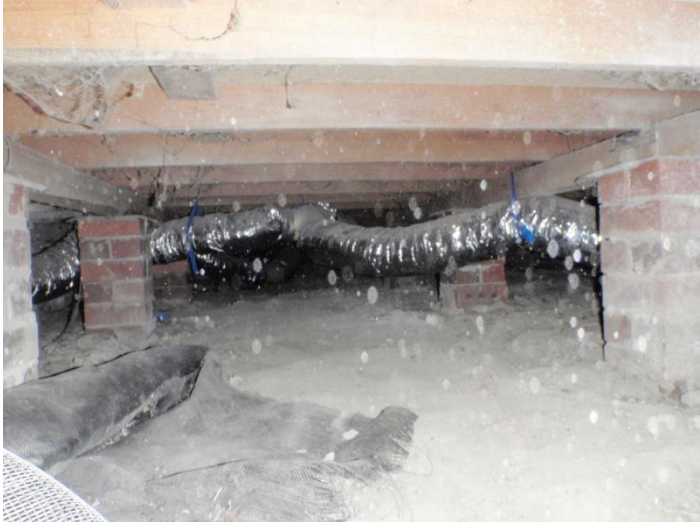
Flexible ducting is present in the sub-floor area. A substantial amount of Geofabric was also observed in the sub-floor. No packers were observed to piers, however they should be assumed to be present concealed beneath metal capping until shown otherwise.

3	Sub-floor	Flexible ducting

At a minimum the sub-floor should be exposed to the cavity walls of all living areas to the property 500-750mm (approximately) to allow these areas to be sufficiently cleaned of any asbestos loose-fill insulation contamination prior to demolition.

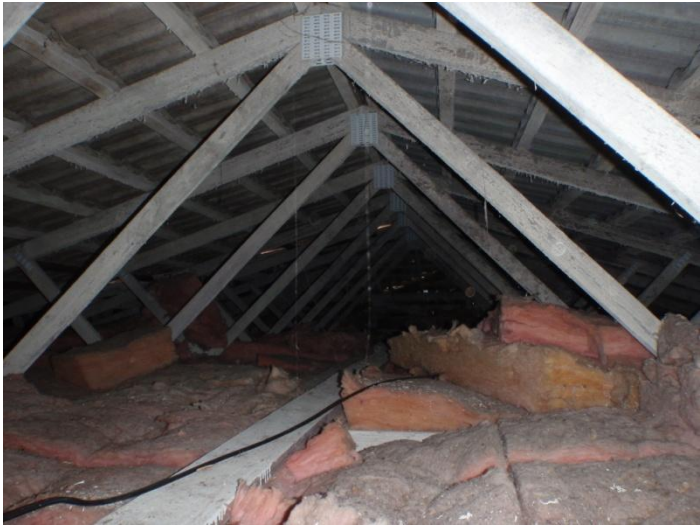
Synthetic Mineral Fibre (SMF) batt insulation was identified in the roof space of the property. This insulation has been installed post any loose fill asbestos remediation work at this property and may therefore be removed as asbestos impacted waste as long as it is removed prior to any inaccessible or concealed areas where visible amounts of loose fill asbestos may be present.

Item Number	Location Description	Material	Photograph
4	Sub-floor – packers to piers	Sheet	NO PHOTOGRAPH
5	Roof space	Batts

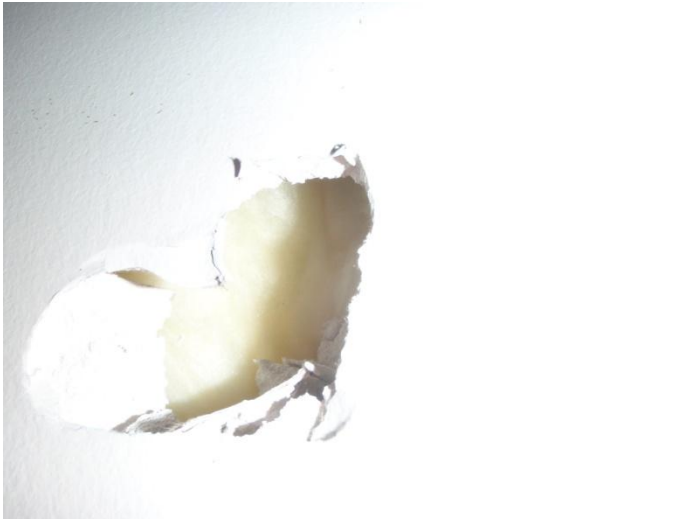
6	Wall spaces of extension	Batts
