Combustible façade cladding – preliminary fire safety assessment

ACT Health Procurement and Capital Works
Centenary Hospital for Women and Children,
Garran, ACT

CA170095

Revision FSA1.1 | 3 August 2017

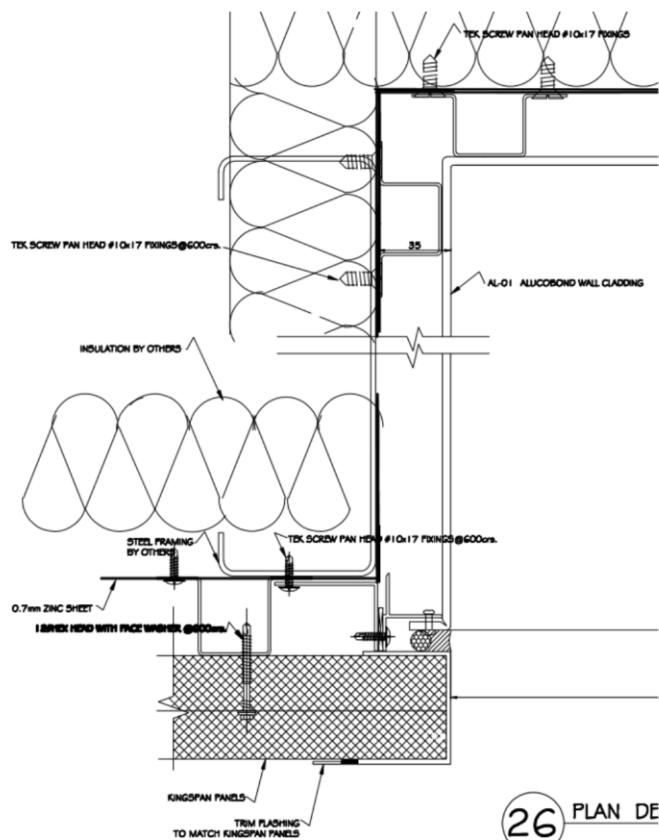
Figure 3. Typical ALUCOBOND Attachment Detail. Note Zinc Sheet and backing channels / purlins (EB-G-XX-2026)

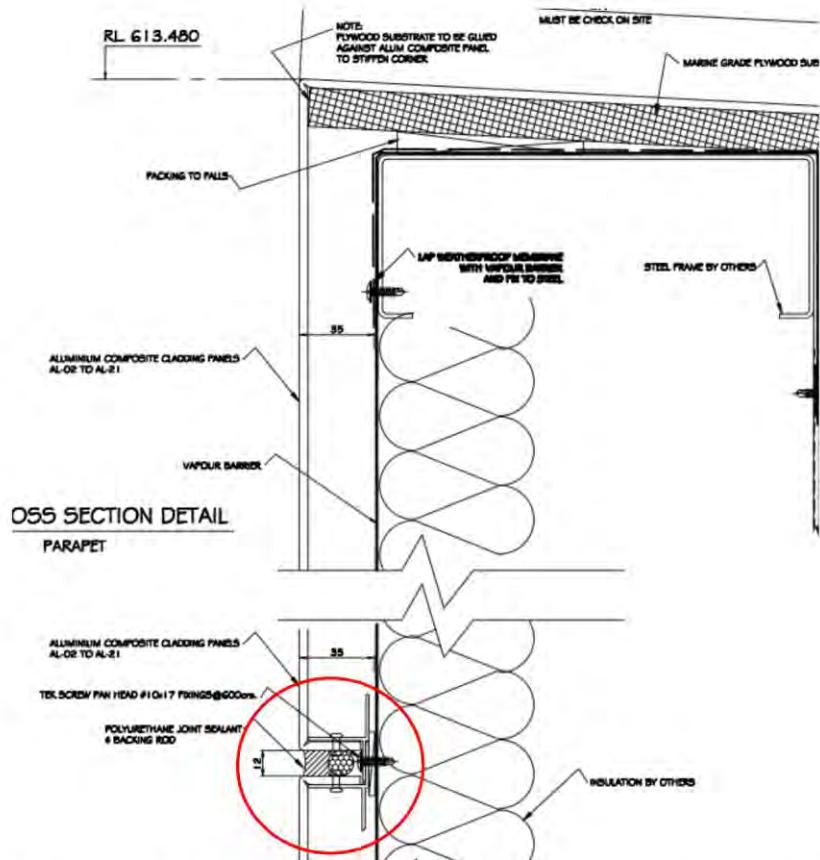
Figure 4. Typical ALUCOBOND Attachment Detail. Note Zinc Sheet and backing channels / purlins (EB-G-XX-2014)

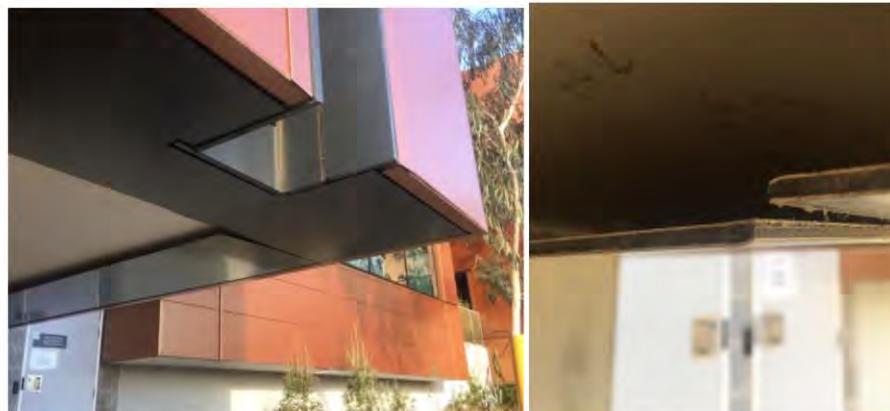
Figure 5. ALUCOBOND being used as a soffit sheeting. Note the black core material.

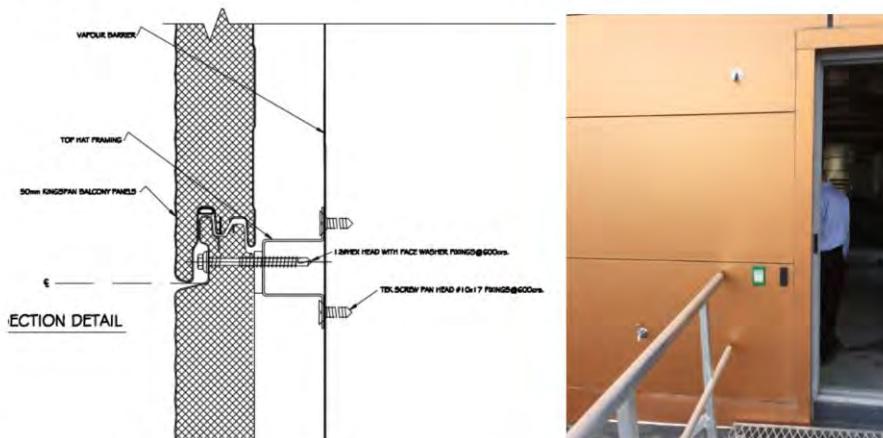
Figure 6. Suspected KINGSPAN fixing strategy for closely spaced panels (EB-G-XX-2019)

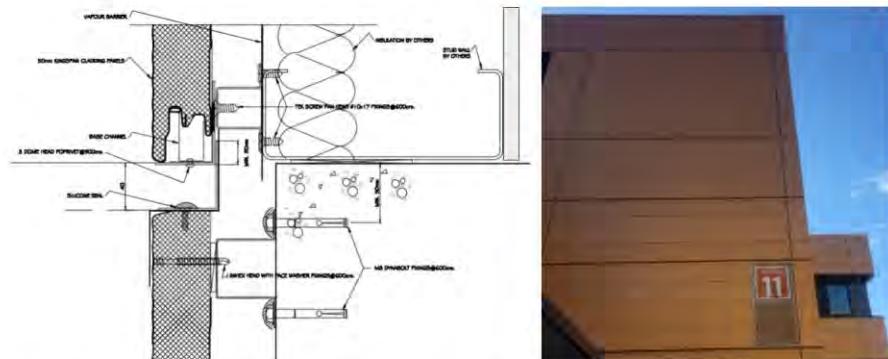
Figure 7. Suspected KINGSPAN fixing strategy where a gap is required (EB-G-XX-2020)

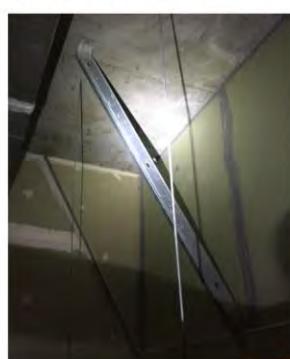
Figure 12. Typical connection detail between floor slab and façade support frame. The frame appears to be suspended from galvanised purlins bolted to the underside of the floor slab. The purlin-frame connection is hidden behind the fibre cement sheeting.

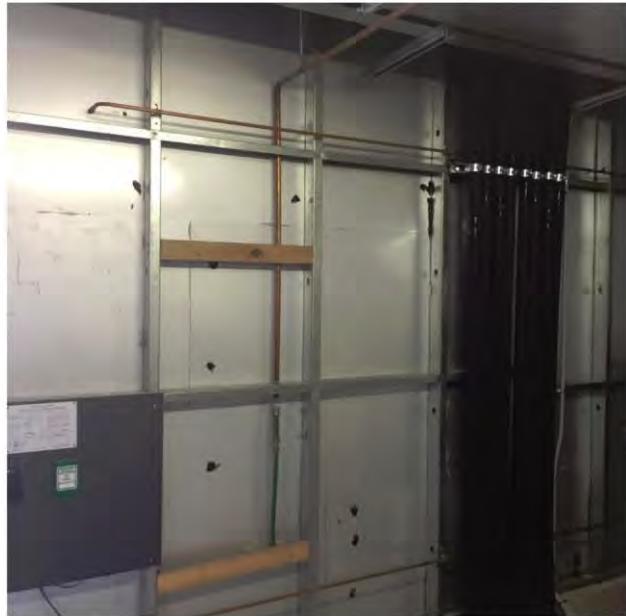
Figure 13. Typical façade support consisting of galvanised channelling. Note the presence of the 'zinc sheet' behind the framework and separating the framework from the exterior panels. The screws attaching the panels appear to go through both the zinc sheeting and the galvanized channels (support frame). The zinc sheet appears to be acting as a membrane. Normally the entire configuration is hidden behind fibre cement (removed here) which acts as the *interior* cladding.

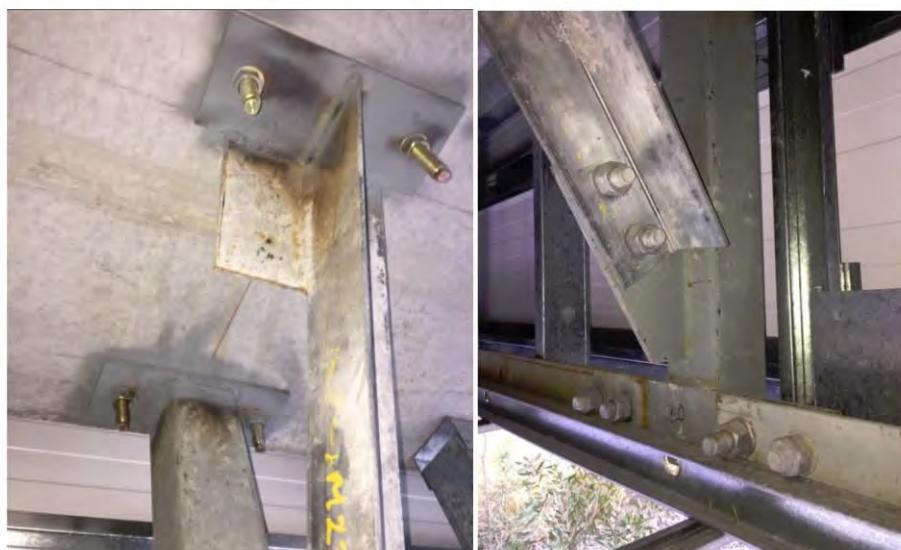
Figure 16. Connection between the ground floor slab and façade frame via bolted steel angle iron. The heavier iron is possibly employed as the support frame is held up, rather than suspended from the floor slabs.
