Asset 18: Medhurst Crescent Swale

General information

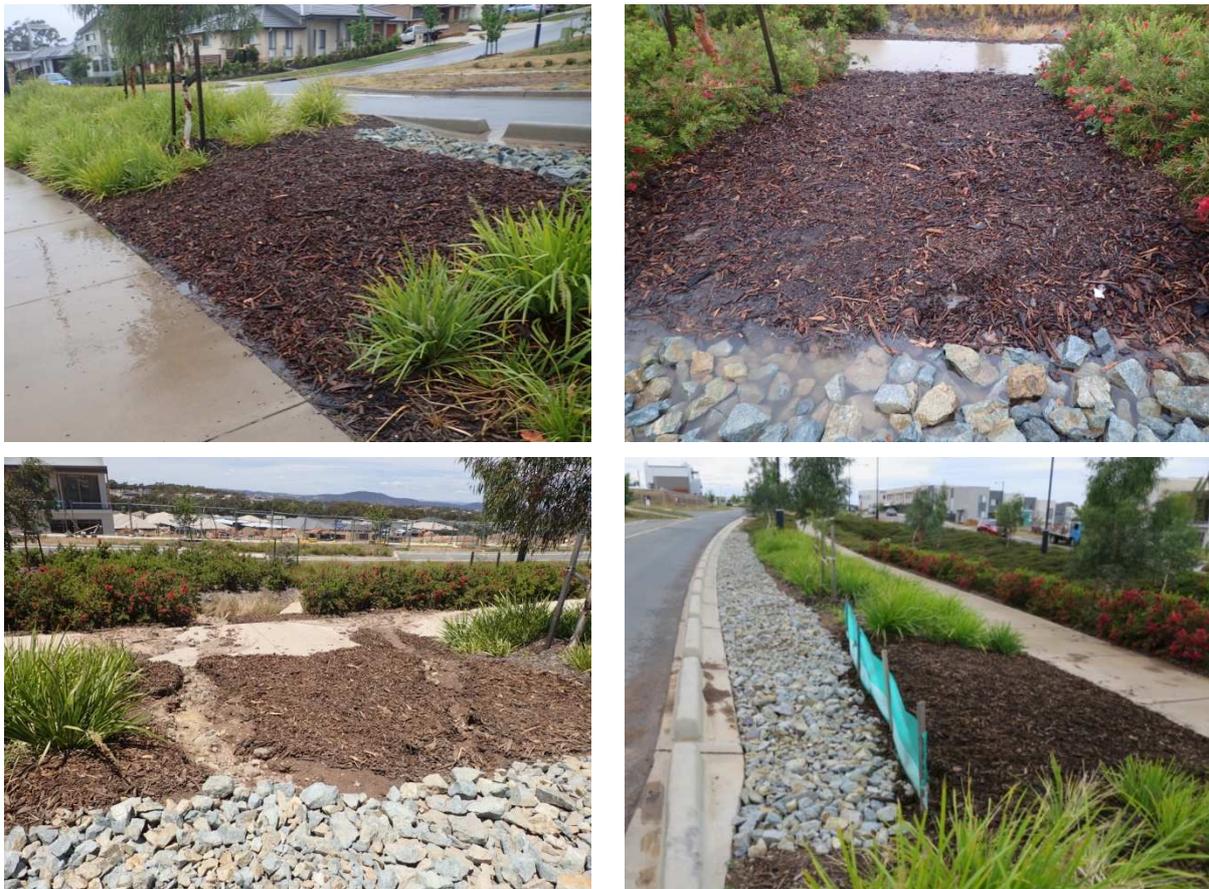
Figure 1: Location of stormwater flow from kerb edge to swale invert. Top: at commencement of rain event - 16 November 2014; Bottom left: scoured bark mulch following rain event - 17 November 2014; Bottom right: after reinstating mulch and installation of sediment fence to slow flows – 24 November

The key locations where there are ongoing stability issues are the locations where stormwater drops from the drainage channel just below road level down to the invert of the swale. On 16 November, these sections had been constructed in unconsolidated soil topped with loose mulch, which was grossly inadequate to cope with the flows from the drainage channel, which would have descended the steep slope with significant velocity.

A second issue is that most flows must pass across a footpath in order to reach the swale. This may have been acceptable if flows were well-distributed along the length of the swale, however the way it has been constructed, flows cross the footpath at a few key locations where there is significant flow across the path. This is visible in Figure 1.

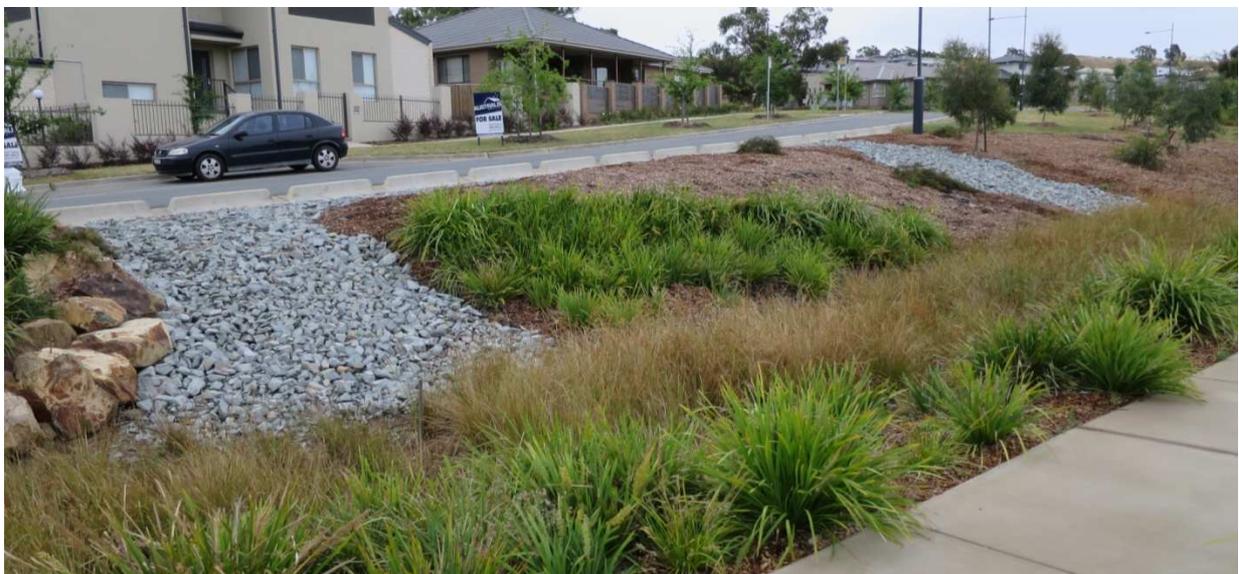
Figure 2: A large amount of rock is required for scour protection on steep banks

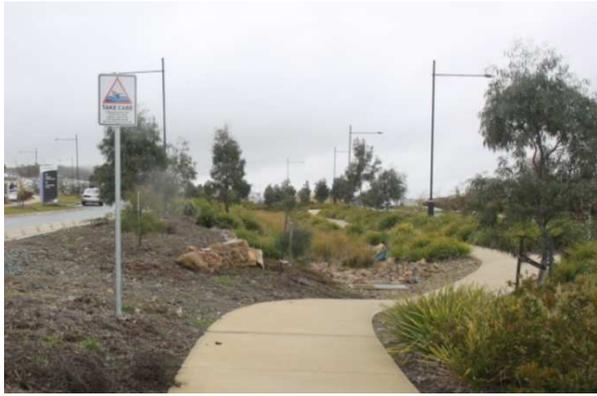
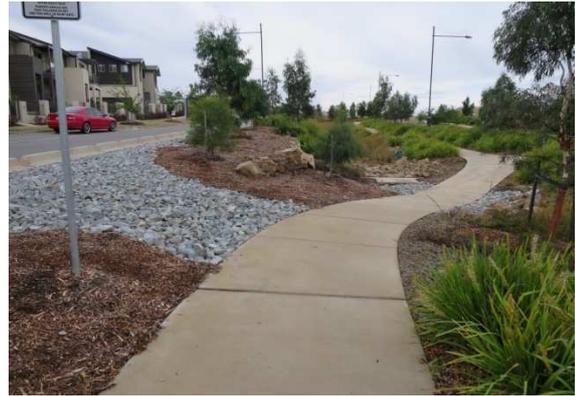
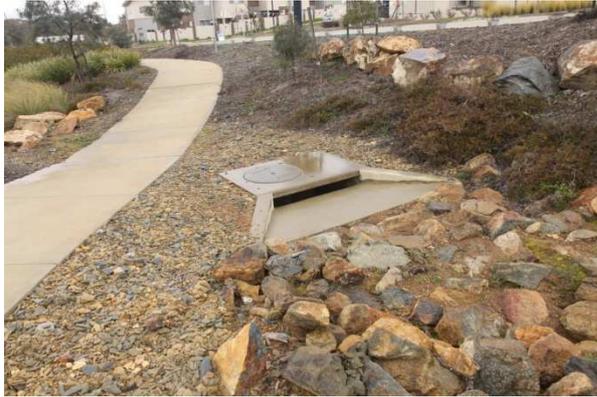
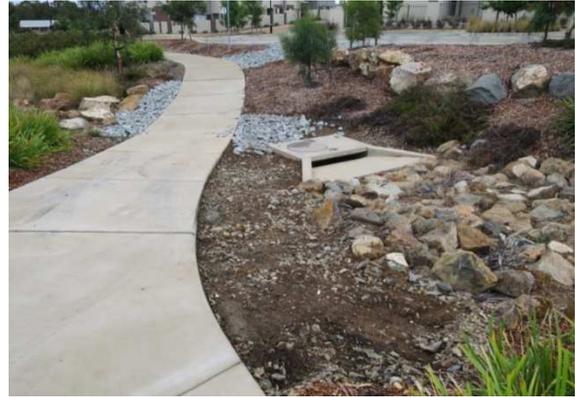
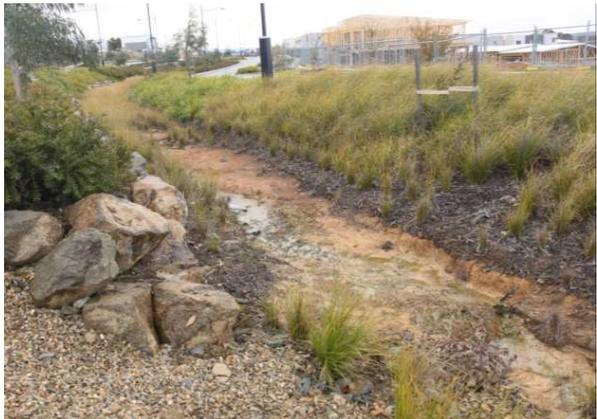
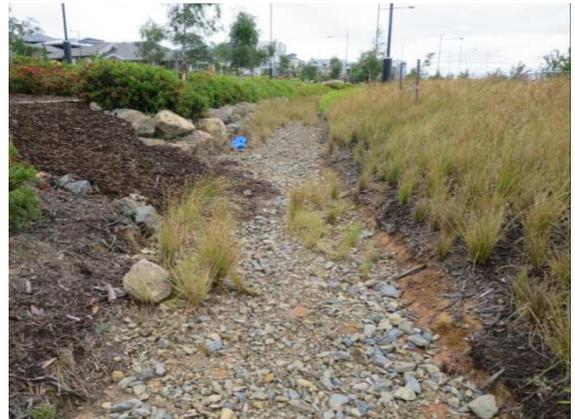
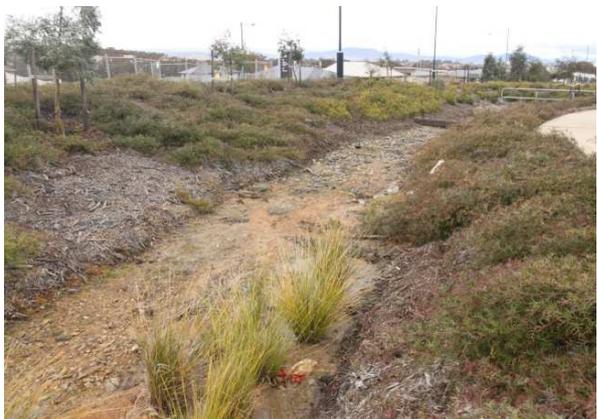
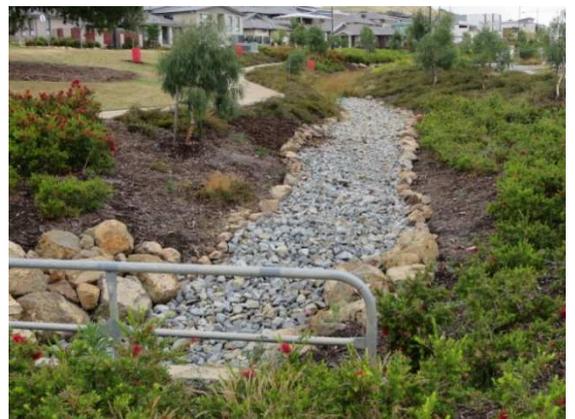
Figure 3: Swale earlier condition – 12 July 2014 (L) and after placement of additional scour protection – 24 November (R) at a number of different locations along the swale

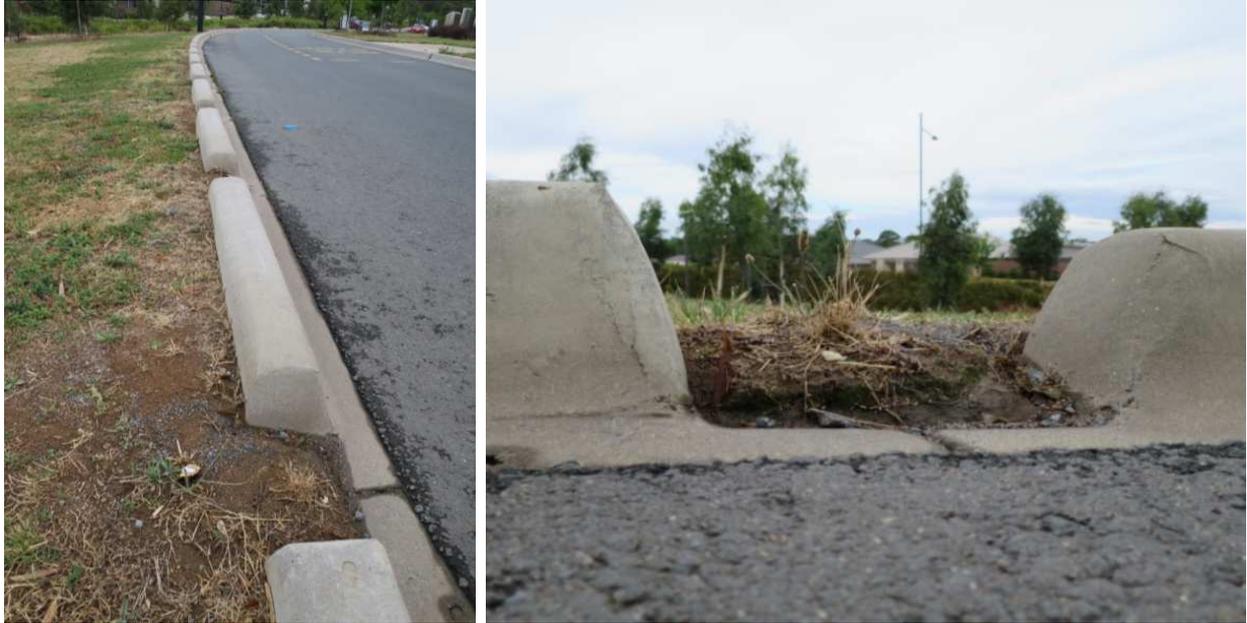
The castellated gutter is generally functioning well, with enough fall provided within the gaps to ensure that stormwater passes through. A dropdown has also generally been provided at the back of the kerb such that a small amount of sediment will not block the gap. Whilst there is generally adequate fall across the castellated gutter to avoid sediment build up, in some sections of the swale minor blockage of the castellated gutter has been observed (Figure 4). This could potentially become an increasing issue over time, as stormwater will bypass the blocked gaps and pass through in one location where scour will be more likely.

Figure 4: Blocked castellated kerb

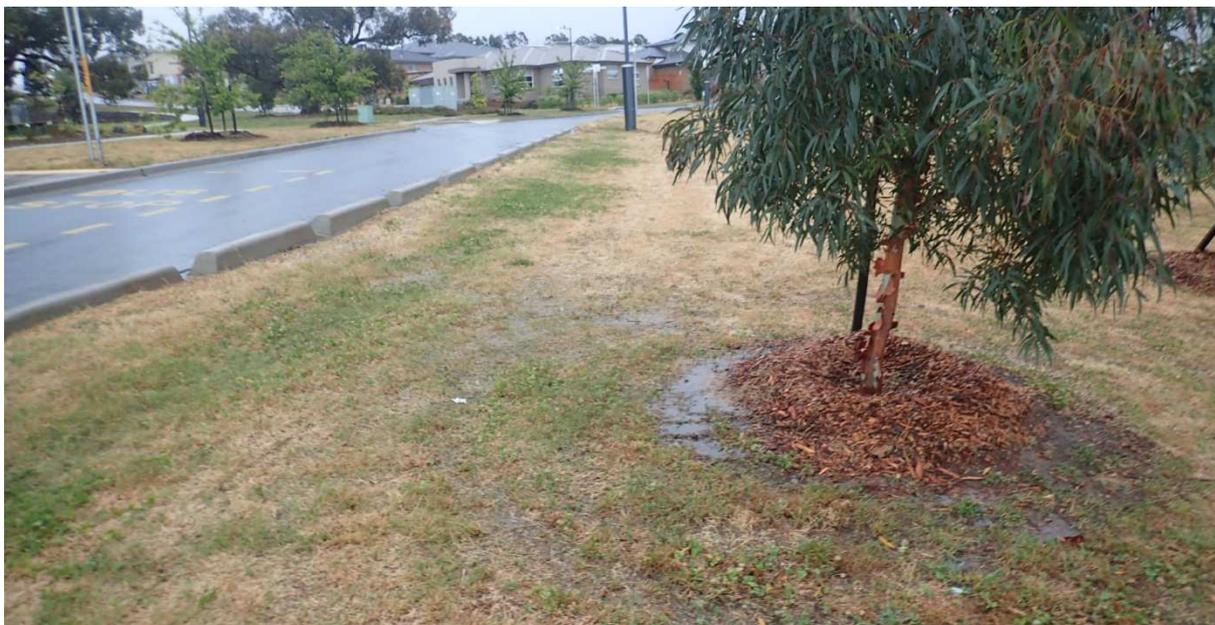
In some areas the castellated gutter backs onto a large turfed area (Figure 5). Where the flows can pass through the gutter easily the turf acts as an effective buffer treatment system. In many low intensity rainfall events much of the runoff would be absorbed by the turfed area without any flows reaching the swale invert.

Figure 5: Wide turf areas between the castellated gutter and swale invert

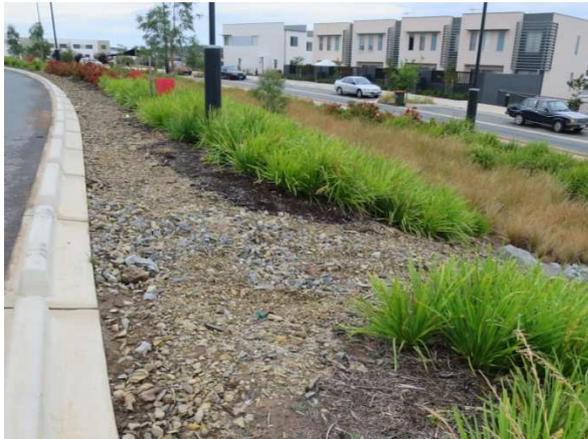
Figure 6: Earlier kerb with shale based scour protection

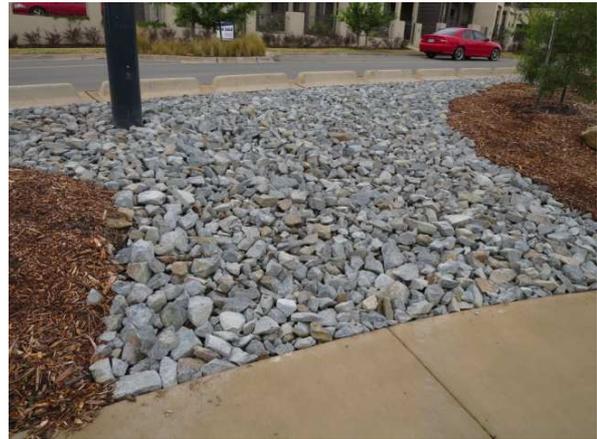
Figure 7: Recent kerb to swale transition with basalt based scour protection

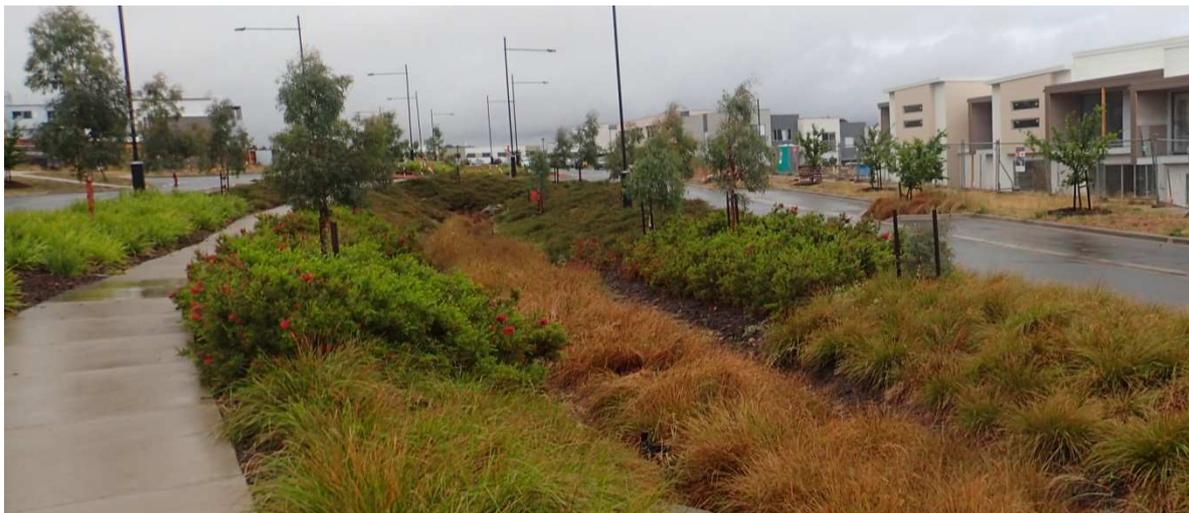
In general the vegetation is performing well (refer Figure 8), but there are some locations at the upstream end of the swale where it has not established well (Figure 9).

Figure 8: Good vegetation cover in the upper section of Plimsoll Drive swale, also showing flow of stormwater from the roadway across the path (November 2014)

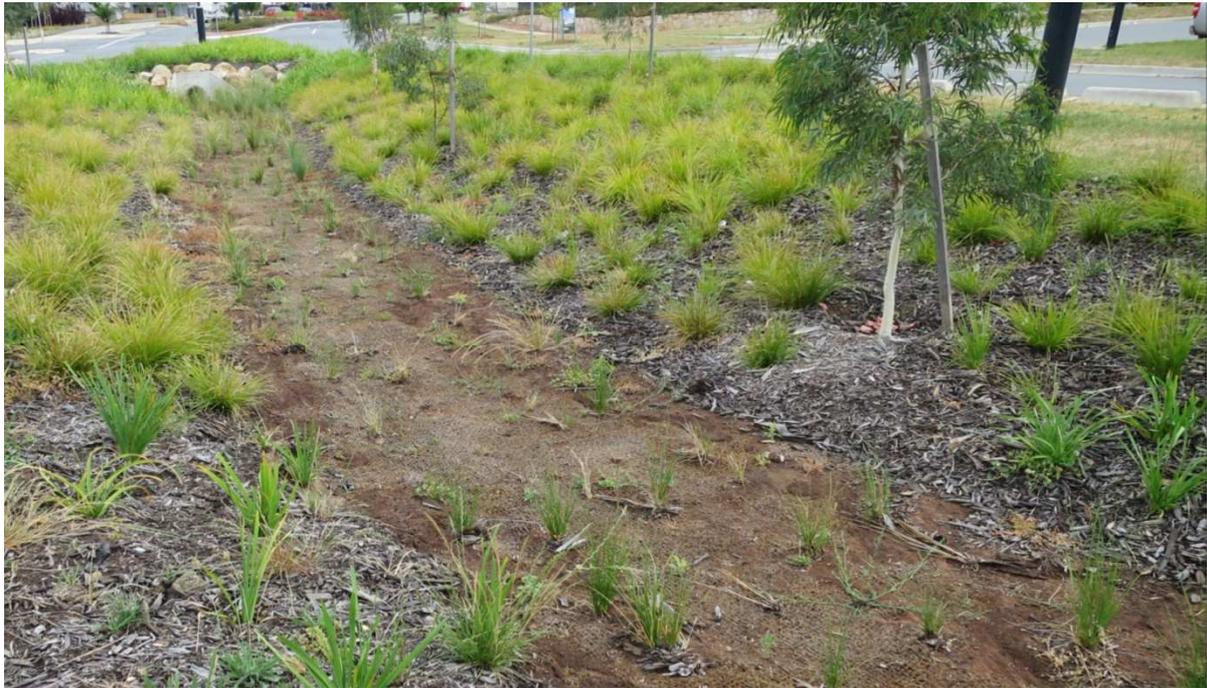
Figure 9: Poorly established plants to the swale base in the upper length of swale

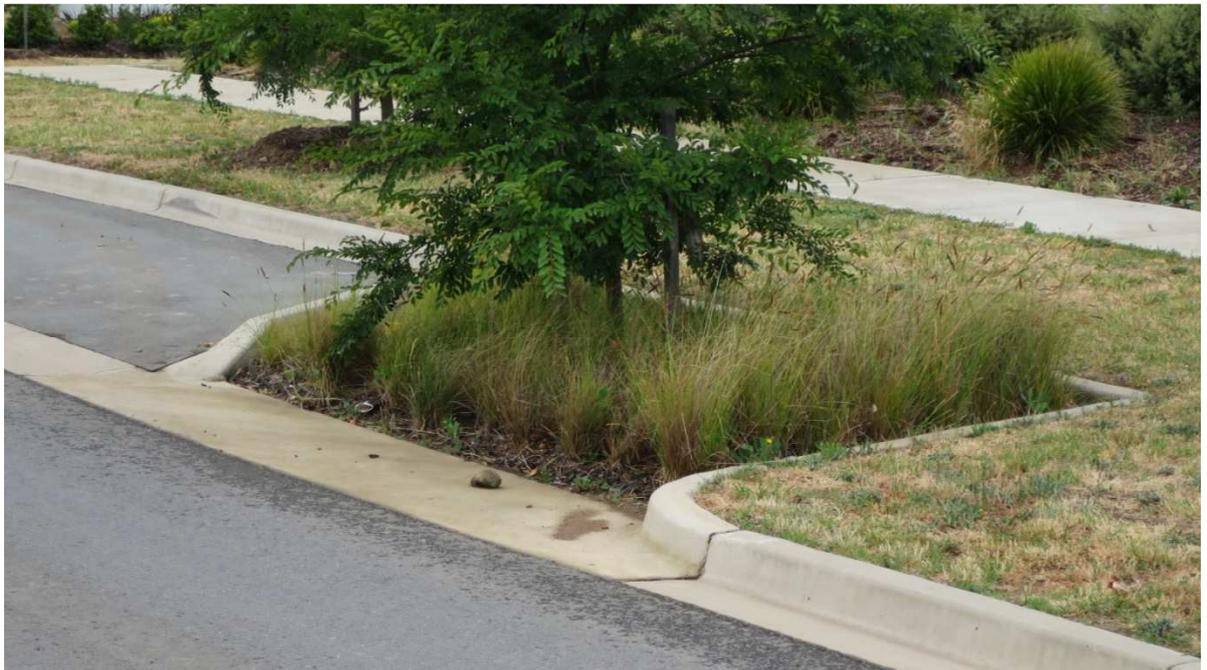
Figure 10: Ineffective tree rain gardens to eastern side of Plimsoll Drive – stormwater would bypass

The Plimsoll Drive swale only collects runoff from the western (northbound) roadway of Plimsoll Avenue. The eastern (southbound) roadway is intended to drain to a number of street tree rain gardens in some locations however these are not functional as noted above.

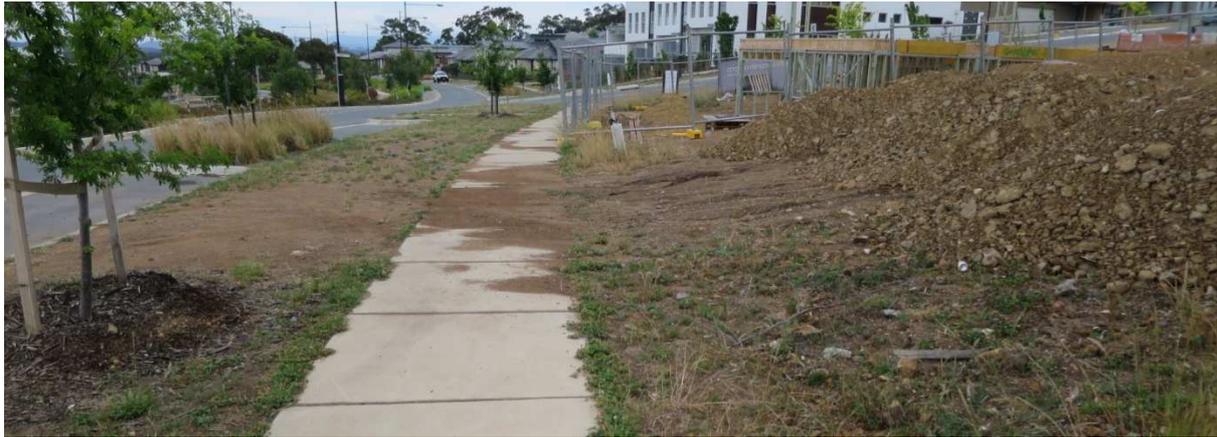
In addition to the erosion issues, TAMS has also reported that the swale has been impacted by significant sediment loads from construction in the catchment. Being a new development area obviously a significant amount of construction activity has taken place. This means that the treatment systems and downstream receiving waters are likely to be subject to a much higher load of sediment than during their normal operating conditions. A number of construction sites were observed with no sediment control systems in place (Figure 11).

Figure 11: Stockpile with no sediment controls contributing sediment to the swale

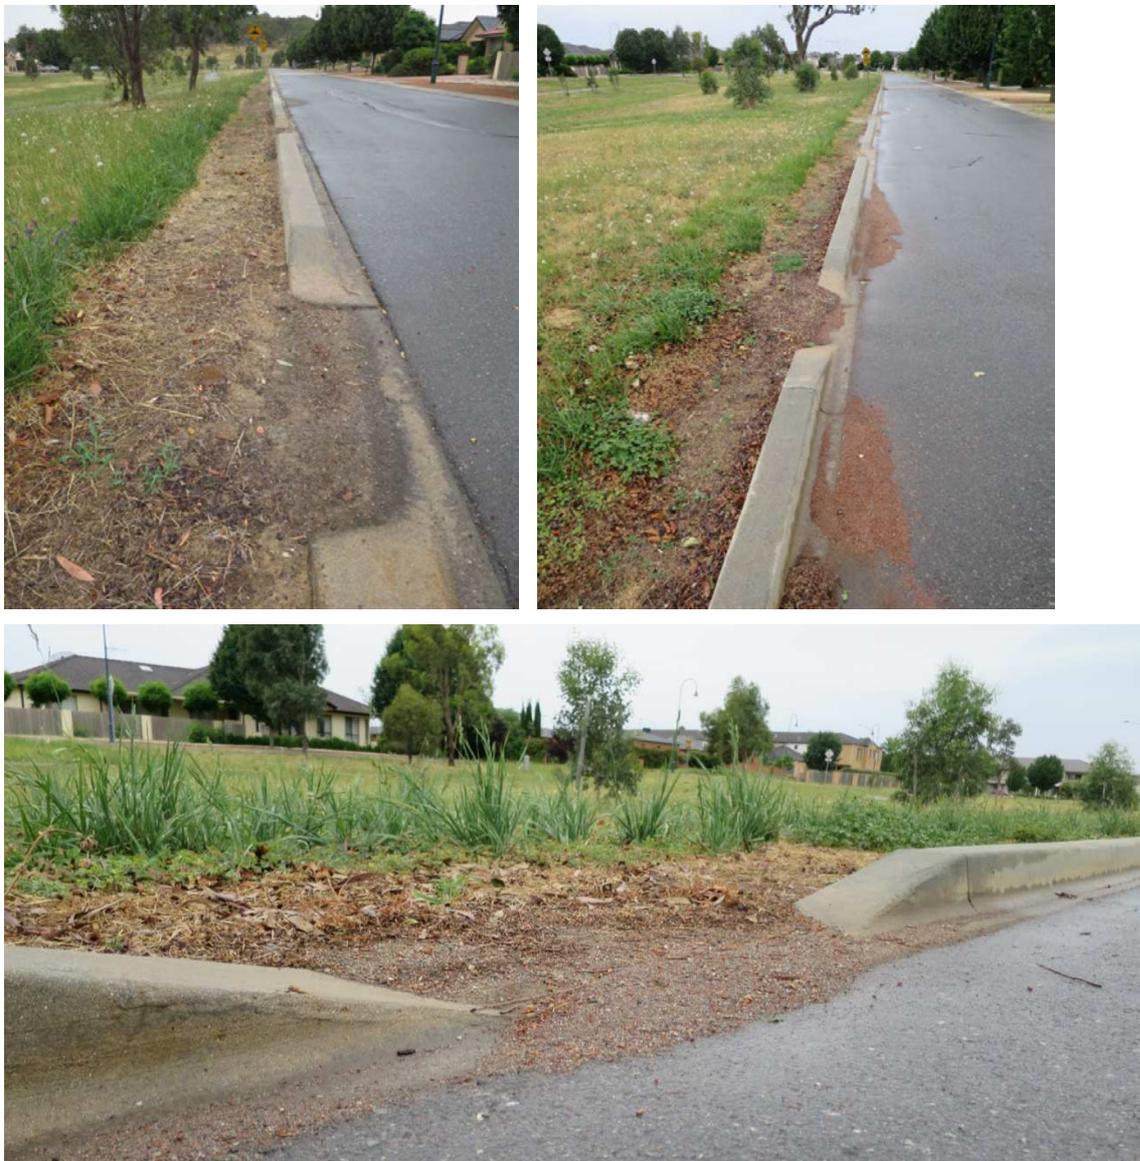
The main performance issue found in the Tsoulias St swale is the inability of stormwater to flow freely from the roadway into the swale due to minor blockage of the kerb gaps as shown in Figure 2. During a small rainfall event on 24 November we observed minor ponding on the roadway due to the inability of stormwater to drain away through the gaps. Sediment from the adjacent roadways is trapped immediately behind the castellated kerb and within the kerb gaps.

Figure 2: Image showing the castellated kerb on both sides of the swale and a close up of the accumulated sediment within one of the kerb gaps

The minor ponding that occurs at the blocked kerb gaps is also caused by the relatively flat grade of the road, which prevents stormwater from moving along the gutter to the downstream gap.

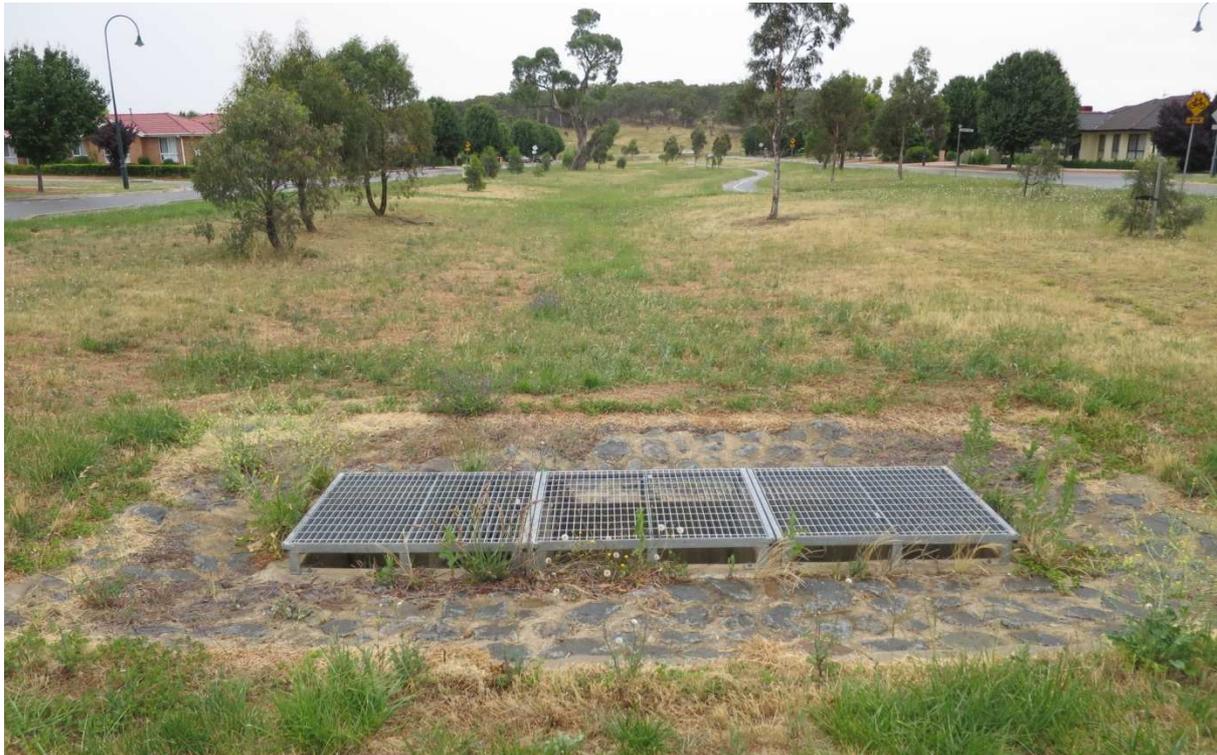
The swale also conveys high flows in excess of the low flow drainage pipe that surcharge from the upstream surcharge pit shown in Figure 3. The surcharge pit has four incoming pipes (300 mm, 450 mm and two 900 mm diameters) and a single 600 mm diameter outlet pipe. The surcharge pit was not observed in operation and there was no evidence that water has surcharged from here recently.

Figure 3: Surcharge pit at the upstream end of the swale

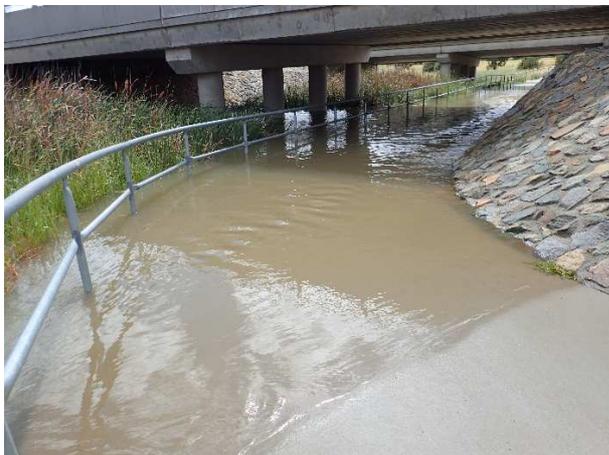
Figure 1: Inundation of the underpass beneath Flemington Road

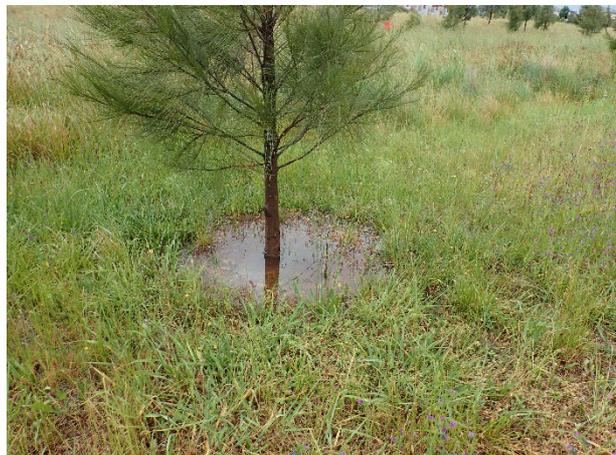
Figure 3: Ponded water around a tree on the edge of the waterway

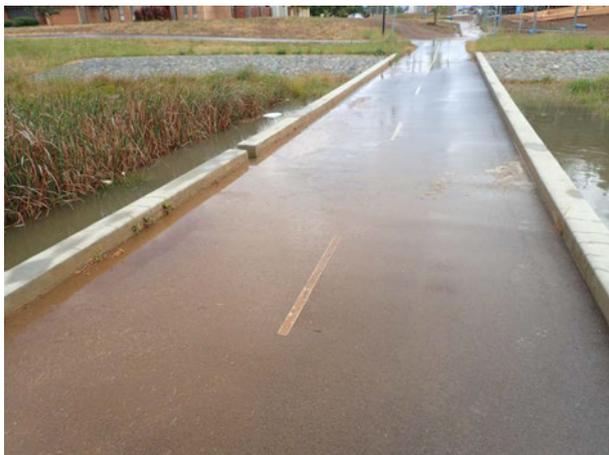
Figure 2: Sedimentation on the bike path crossing between Henry Kendall Street and Clare Burton Crescent

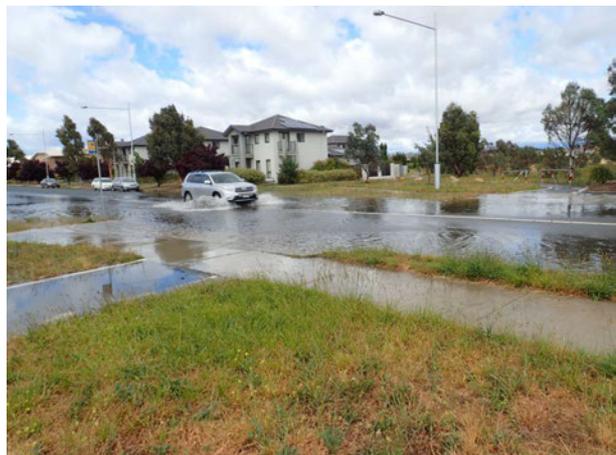
Figure 4: Ponded water on Hoskins Street

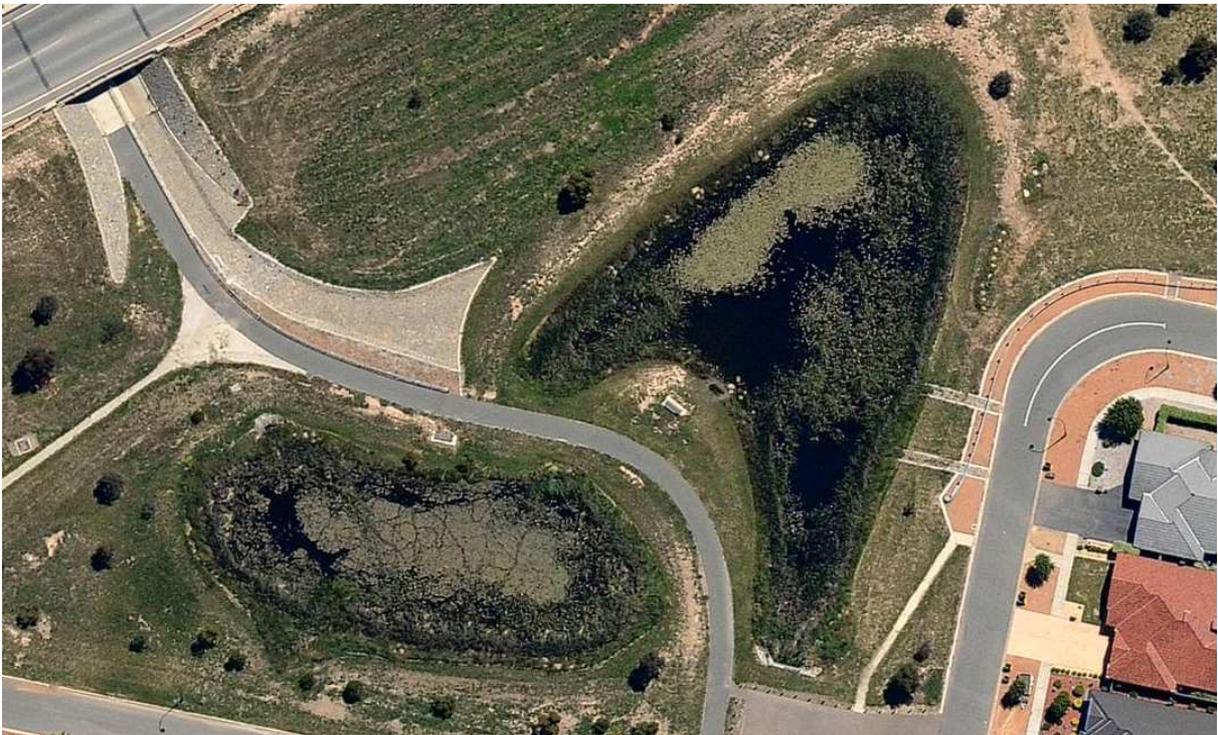
Figure 2: Floating weed cover in November 2010 (NearMap)

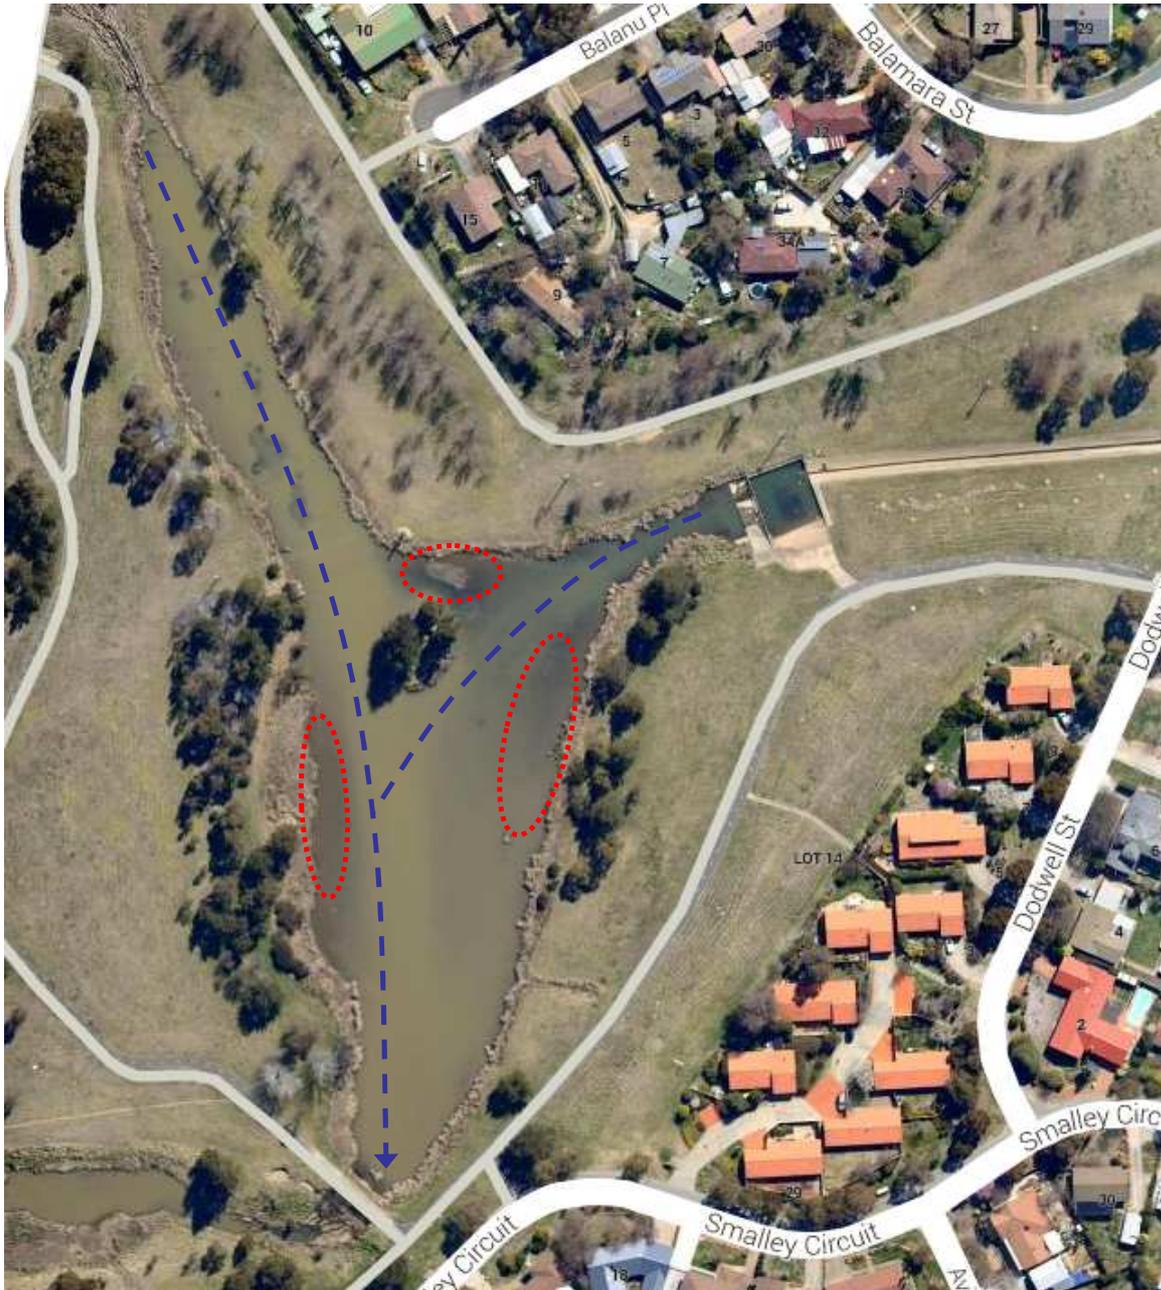
These zones can also be seen to have shallower water both as observed in the field and in aerial photos of the pond (refer Figure 2). With the sediment large amounts of organics are also accumulating in the pond. This material has a high oxygen demand as it breaks down. During periods of dry weather when oxygen is not replenished in the pond from the upstream creeks, the dissolved oxygen level in the pond are substantially reduced. This can cause fish kills in the pond as the low oxygen places stress on aquatic fauna in the pond. The lowered oxygen levels can also create issues as the decaying organic matter in an anaerobic environment produces gases such as hydrogen sulphide (rotten egg gas) which has an unpleasant odour.

Figure 1: Flow paths (blue line) and sediment build up (red areas) in Giralang Pond (base image from Sep 2012, Nearmap)

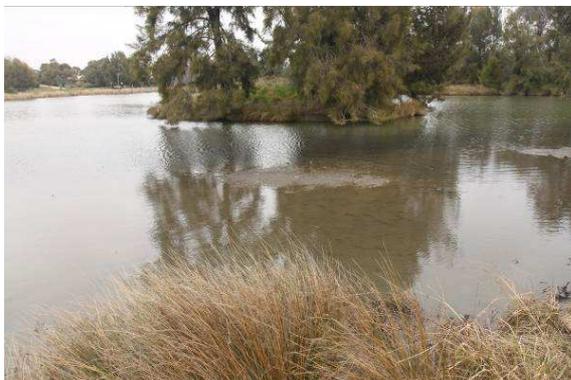
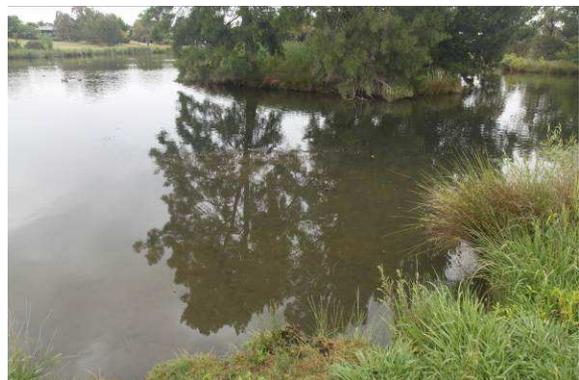
Figure 2: Sediment accumulation in dead zones

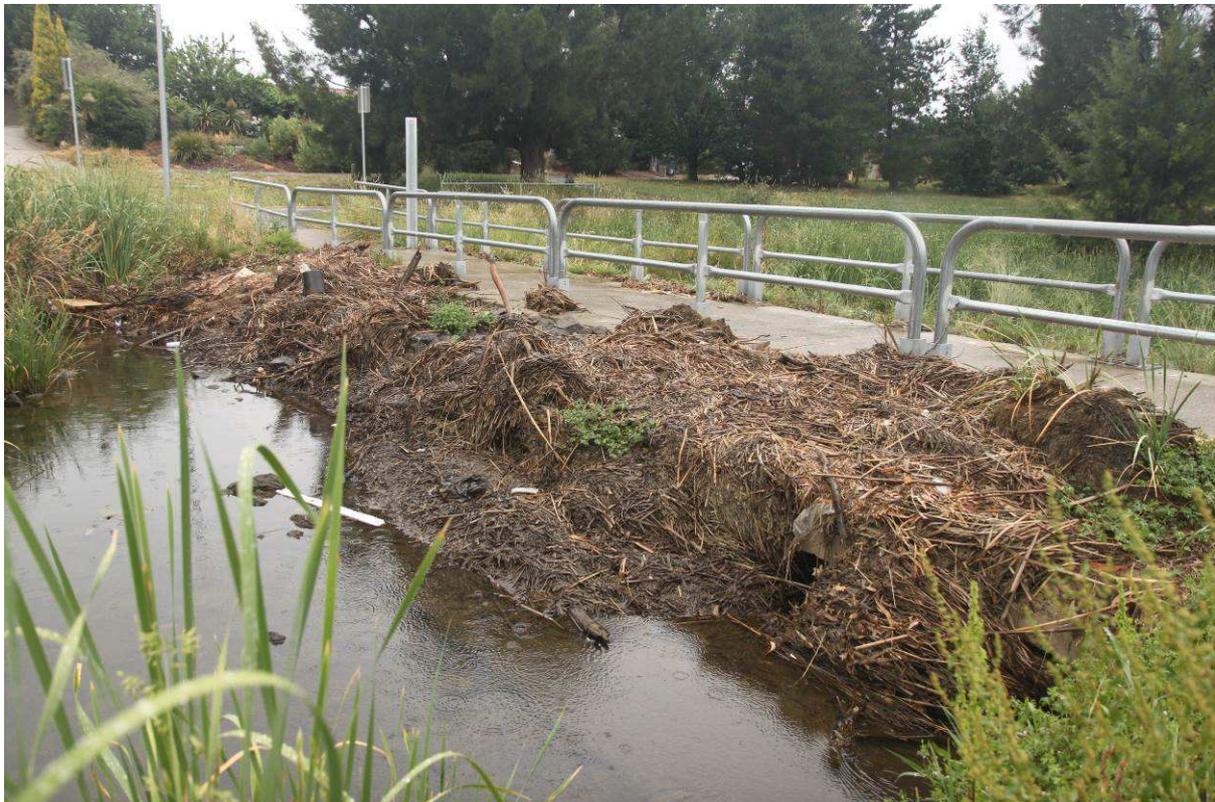
A second major performance issues at present is the failure of the main outlet from Giralang Pond. The outlet consists of approximately 14 low box culverts. These culverts are easily blocked by organic debris such as large leaf litter, branches, etc. Figure 3 shows the culverts after a relatively small rain event. The culverts are almost completely blocked and water is therefore flowing over the spillway which is also a pedestrian and cycle path.

Figure 3: Outlet structure showing blocked culverts and debris trapped by railing on the bridge indicating that in water is flowing over the bridge in relatively minor rain events

The blockage of the culverts is caused by the use of the multiple shallow small culverts which are easily blocked by relatively small debris. This blockage of the small culverts is contributing to the erosion scour hole at the outlet.

In terms of more routine improvement options a key recommendation is to upgrade the existing outlet which is causing erosion and a safety hazard. This would require reconfiguring the outlet to a structure which is less likely to block and which reduces the risk to safety of pedestrians and cyclists. This could take the form of a simple overflow weir.

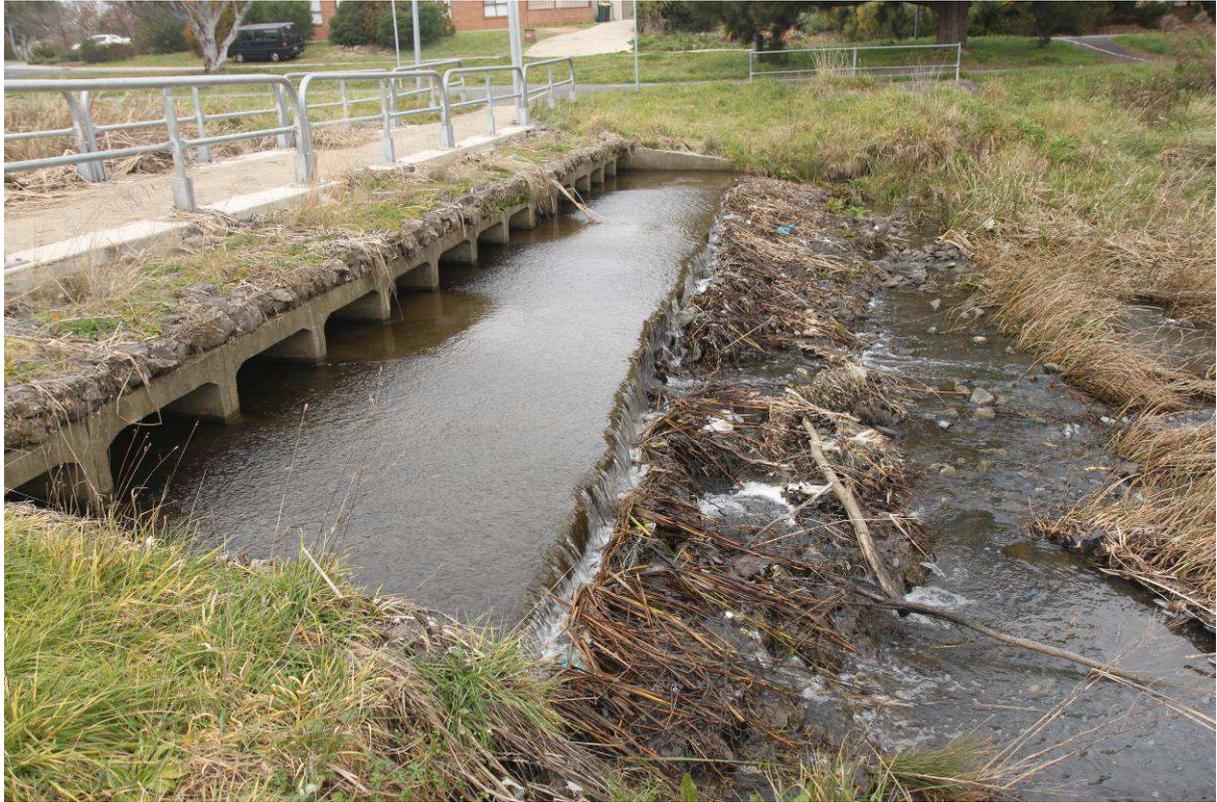
The outlet downstream of the spillway/bridge is also eroding and requires structural repairs. At the end of the concrete apron from the spillway there is a reno mattress which has substantially failed. This is shown in Figure 4. Also at the outlet there is a scour hole which has become approximately 1 m deep. Based on analysis from Nearmap imagery, this scour hole appears to have substantially worsened since 2010. The scour hole is likely to have been formed by water flowing over the spillway and in large events outflanking the spillway and flowing down the grass embankment and back into the creekline. Due to the concentrated flows over a relatively steep grade it has eroded in this location.

Figure 4: Outlet structure downstream showing failed reno mattress. Rocks from the mattress are visible on the stream bed.

The erosion downstream of the pond outlet at the apron is caused by the high velocities of water flowing over the concrete apron without any energy dissipation. The energy of the flows is dissipating on the reno mattress and this has failed over time. Water is now cascading off the end of the concrete apron into the creek bed and is causing scour of the bed of the creek. This issue is unrelated to the blocked culverts – even if the culverts always flowed freely, the failure of the reno mattress would not be rectified.

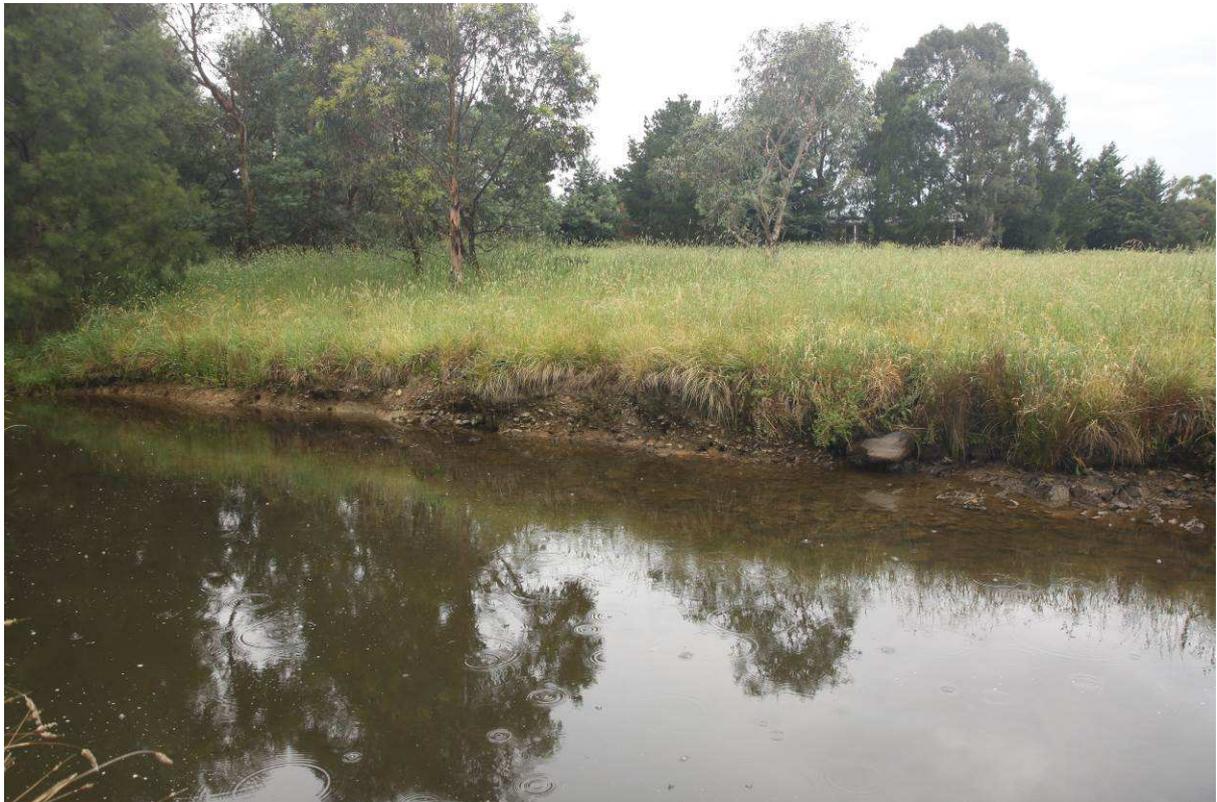
Also the downstream section of Ginninderra Creek is suffering from minor erosion of its banks immediately downstream of the outlet of Giralang Pond. The creek in this location has a 90 degree bend to the right. The outside bank at this bend is undercut and eroding as shown in Figure 1. This is highly likely to continue eroding into the future without stabilisation works.

Figure 5: Eroded creek bank at outlet of Giralang Pond

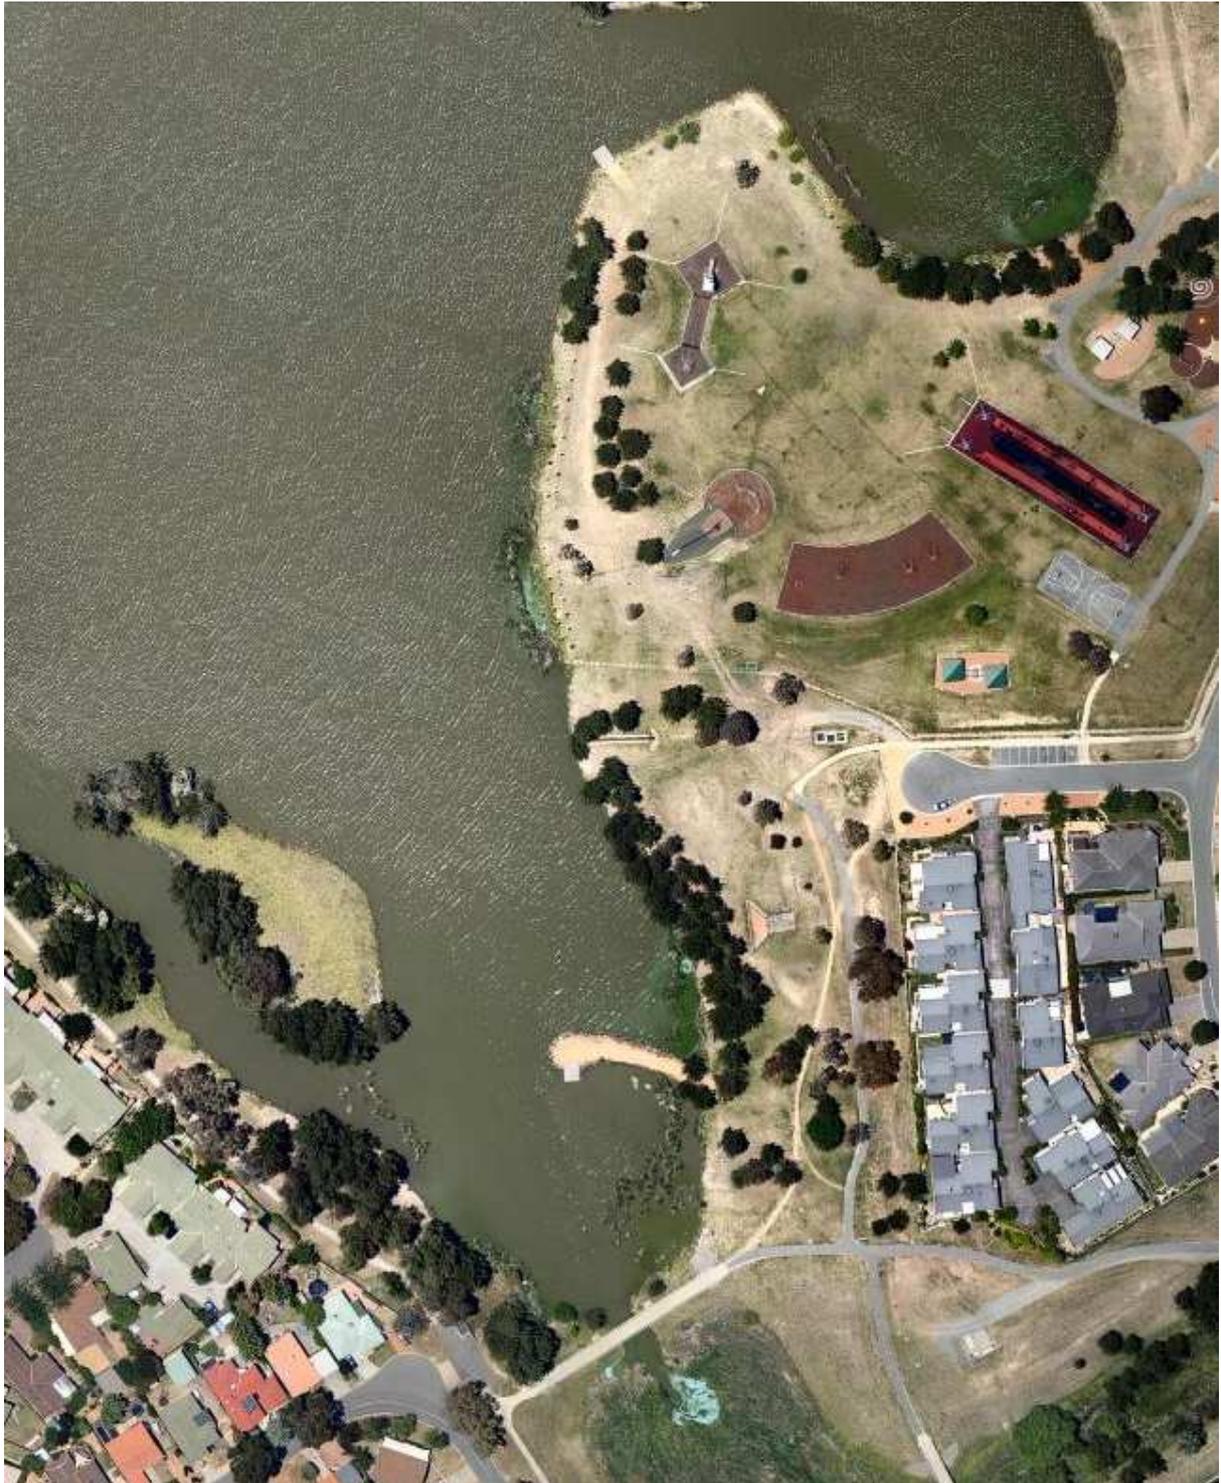
Figure 1: Algal bloom around the edges of Point Hut Pond, 12 December 2013 (Nearmap)
