Asset 18: Medhurst Crescent Swale

General information

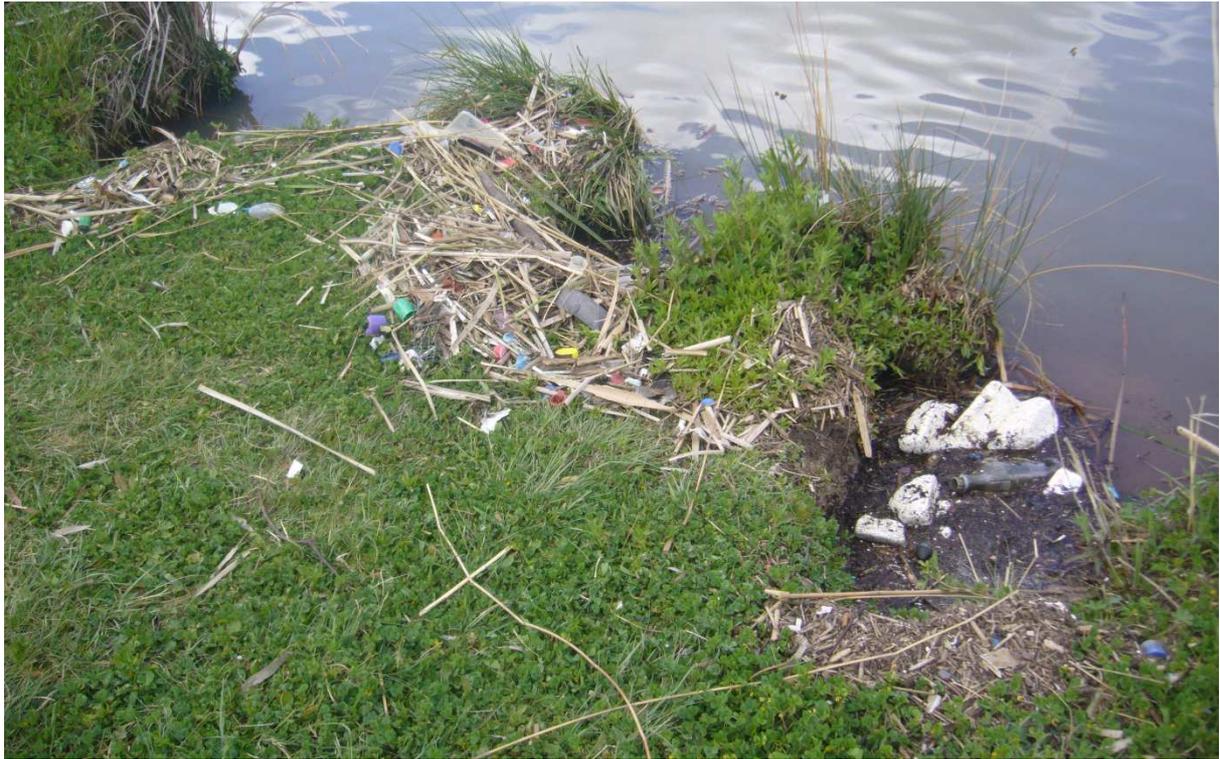
During our site inspections we did not observe large quantities of litter in the pond or at its edges, but noted that it has accumulated in significant quantities at certain locations. An example is shown in Figure 2. We noted bank erosion at the north-west corner, in the same location where the Carers have noted that illegal vehicle access occurs. This is shown in Figure 3. We also noted that there is a large population of water birds feeding the birds appears to be a common practice.

Figure 2: Accumulated litter on the edge of Point Hut Pond

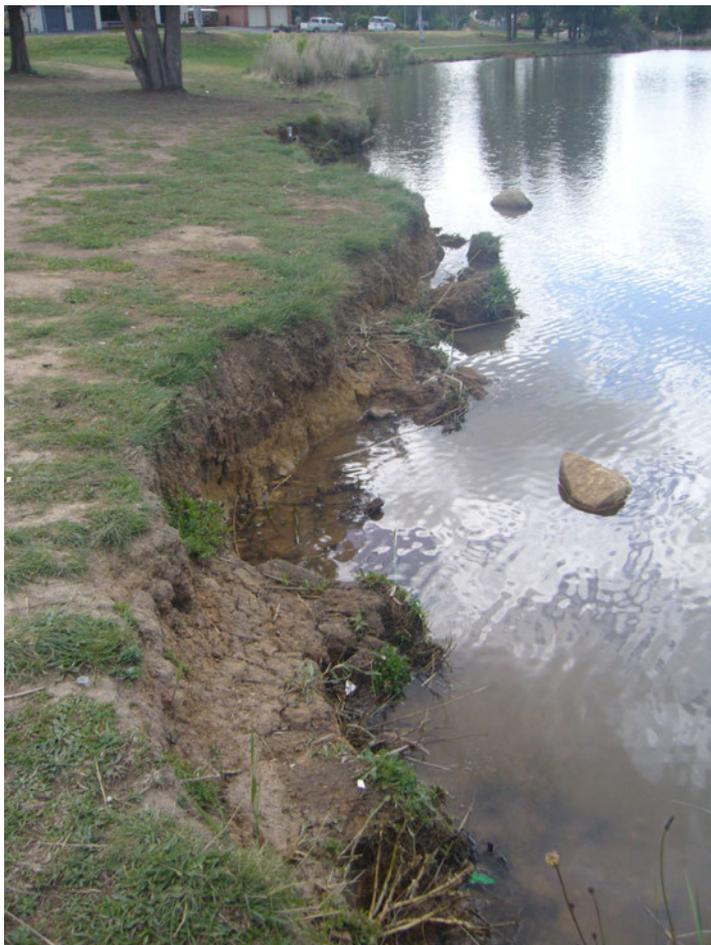
Figure 3: Erosion of the north-western bank of Point Hut Pond – near Lawton Place

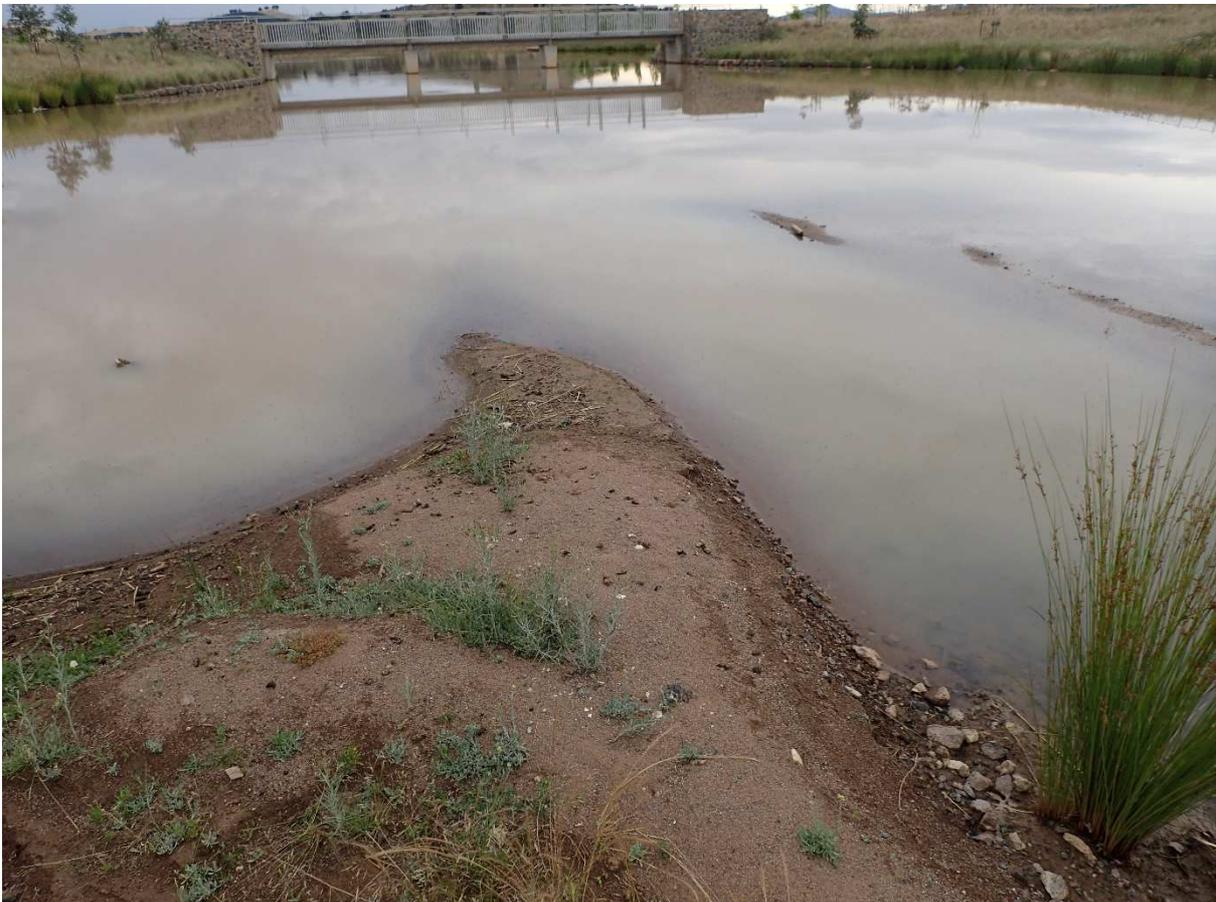
Figure 1 shows the sediment accumulating at the main inlet into Pond A.

Figure 1: Sediment accumulation in front of the main inlet to Pond A

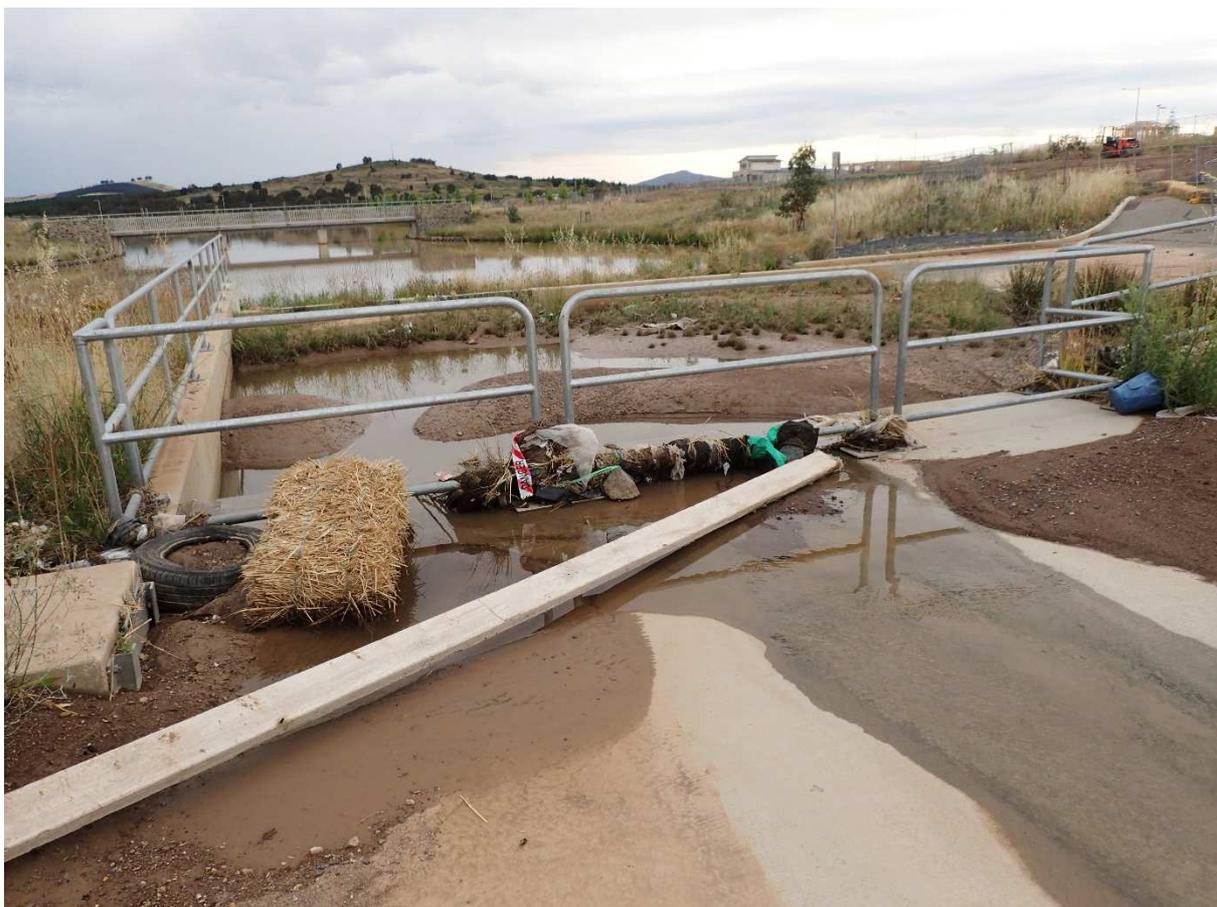
TAMS have also noted that the hand rails on top of the GPT are of a solid construction, so if a large item comes down the stormwater channel then these will have to be replaced. Figure 3 shows material accumulating against the hand rails of the GPT.

Figure 3: Material accumulating against the hand rails of the GPT at Coombs Pond A

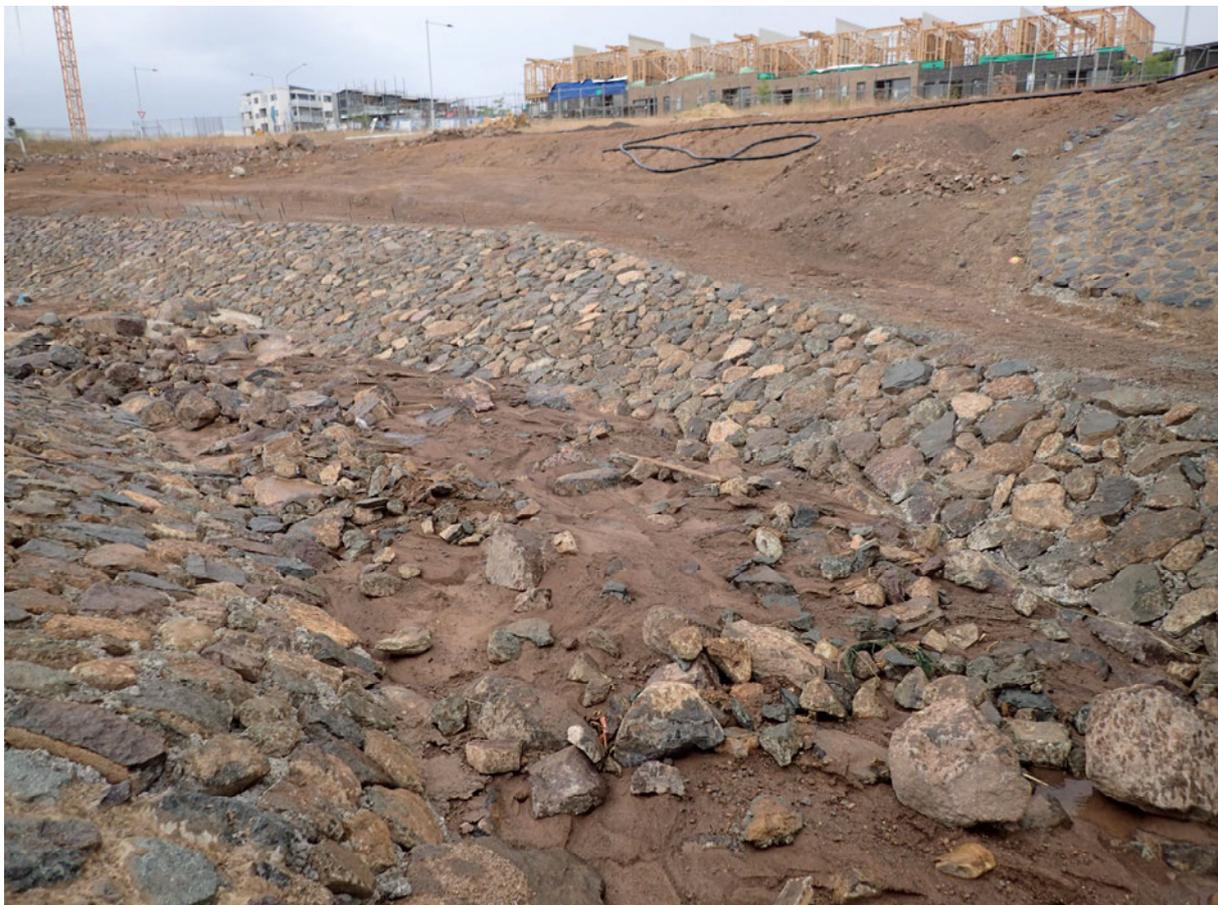
When we visited the site in late 2014 there were fewer major erosion and sediment control issues, however some of the issues raised by TAMS remained, and house building was underway so that stormwater runoff was still sediment-laden from uncontrolled building sites. Figure 4 shows the main stormwater channel upstream of Pond A, which has exposed soils on steep batters with no erosion controls in place. It is also possible to see significant sediment accumulation within the channel itself, which is gradually being washed down into the pond in each rain event. Our observations in wet weather were that where significant sediment had accumulated in the system (e.g. in the channel shown in Figure 4 and in the GPT immediately upstream of the pond), this was resuspended during the rain event.

Figure 4: Uncontrolled erosion on a steep batter slope and accumulated sediment in the channel bed upstream of Coombs Pond A

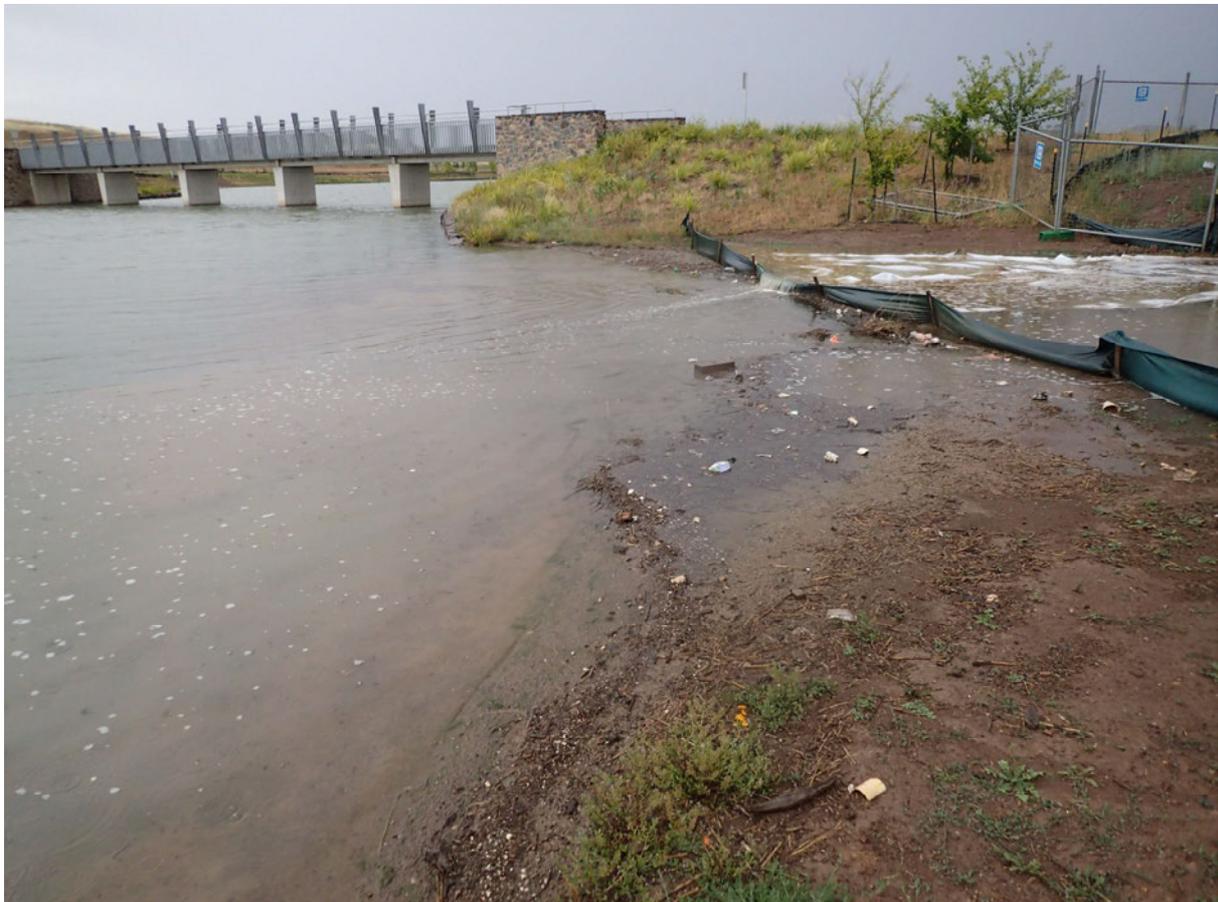
Figure 1 shows the sediment accumulating at an inlet on the southern side of Pond B.

Figure 1: Sediment accumulation in front of an inlet on the southern side of Pond B

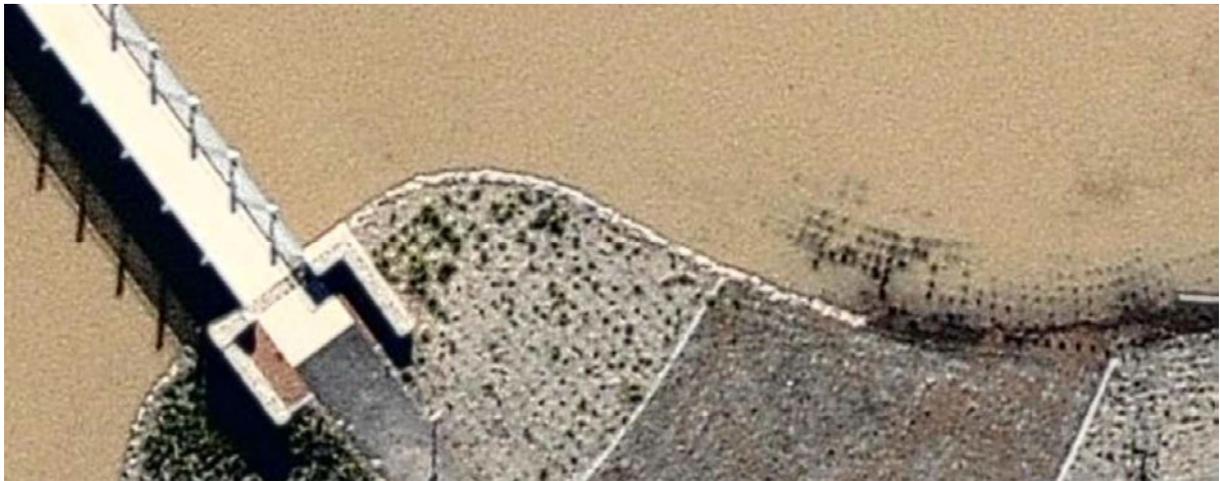
Figure 4: Snapshot of the same location four months later, showing macrophytes completely inundated before many of them have grown large enough for the water depth (Nearmap 24 July 2013)

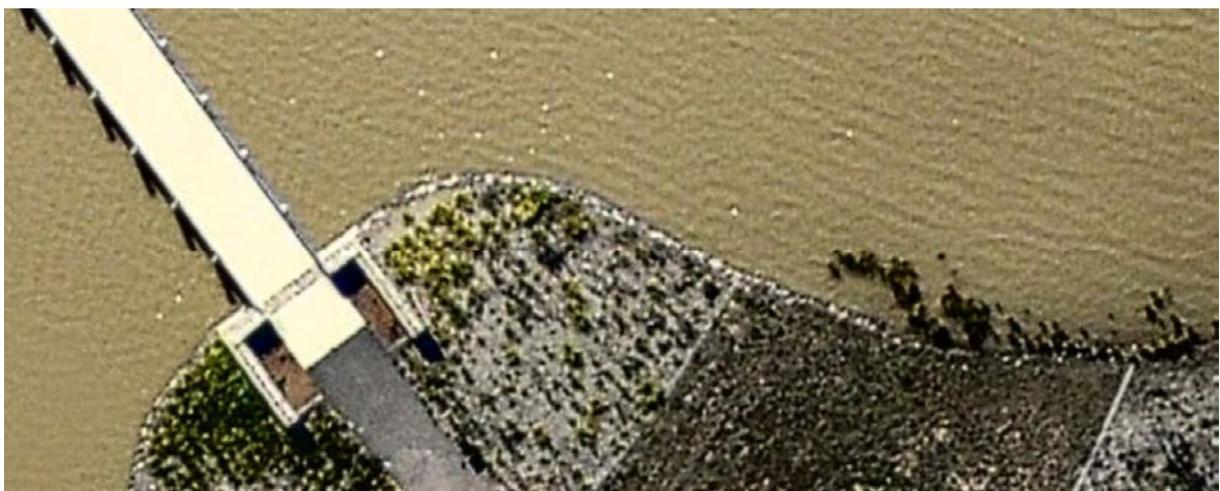
Figure 5: Snapshot of the same location one year on, showing that only a few macrophytes have survived, in the shallowest water near the edge of the pond (Nearmap 31 August 2014)

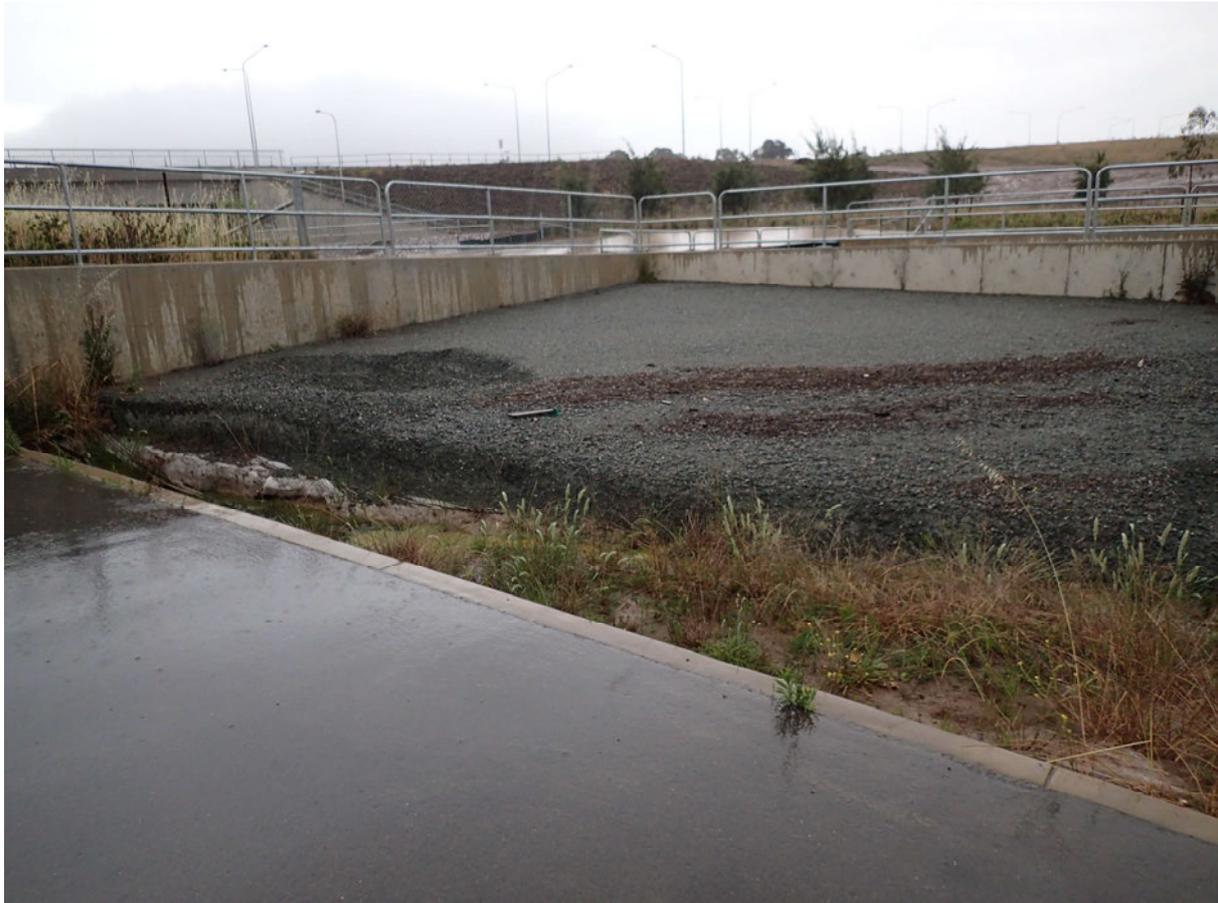
Figure 6: Damaged drying pad at Coombs Pond B
