Asset 3: Ultimo St rain gardens (Crace)

Asset 4: Digby Circuit rain gardens (Crace)

Asset 5: Langtree Crescent rain gardens (Crace)

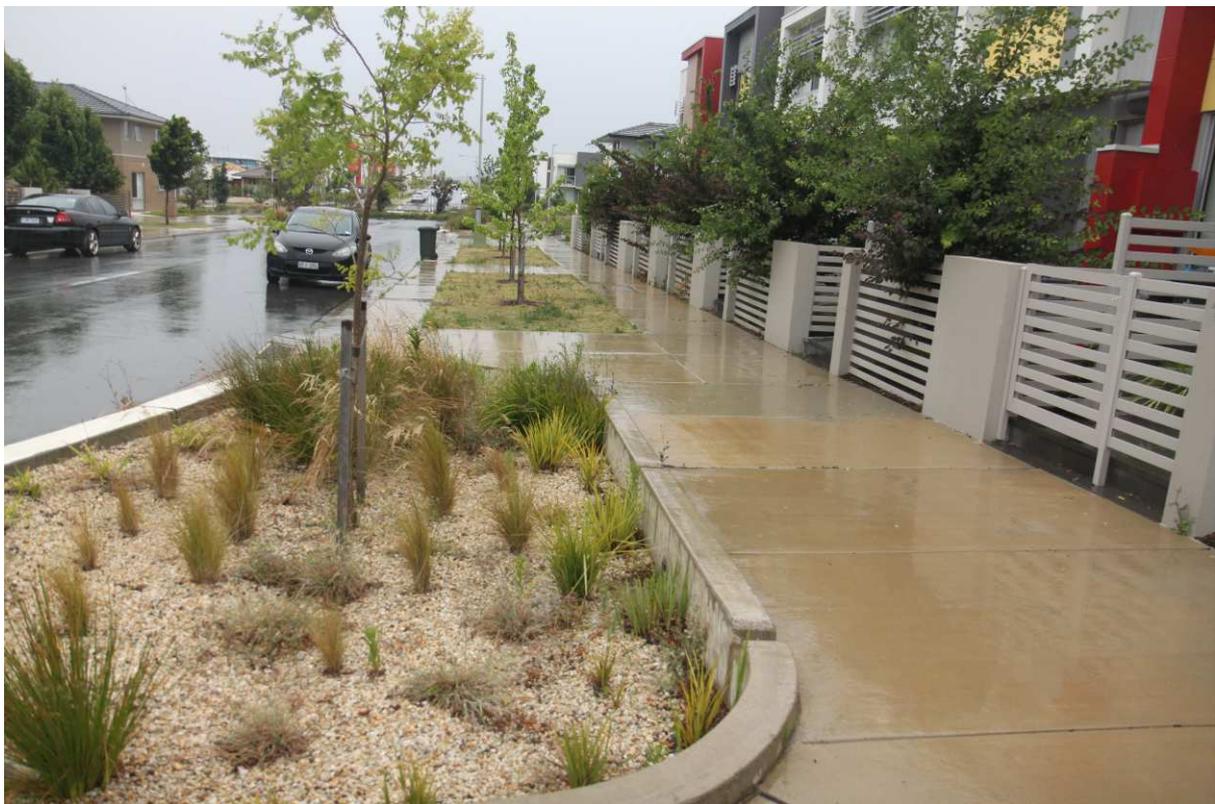
At Ultimo St, construction activity including house-building has been entirely completed and the systems are no longer affected by construction sediment. The rain gardens are also considered to be in the establishment phase with vegetation coverage increasing but still not providing significant coverage of the filter media as shown in Figure 1.

Figure 1: Rain garden on Ultimo St, showing vegetation establishment. Large areas of the filter surface are still visible

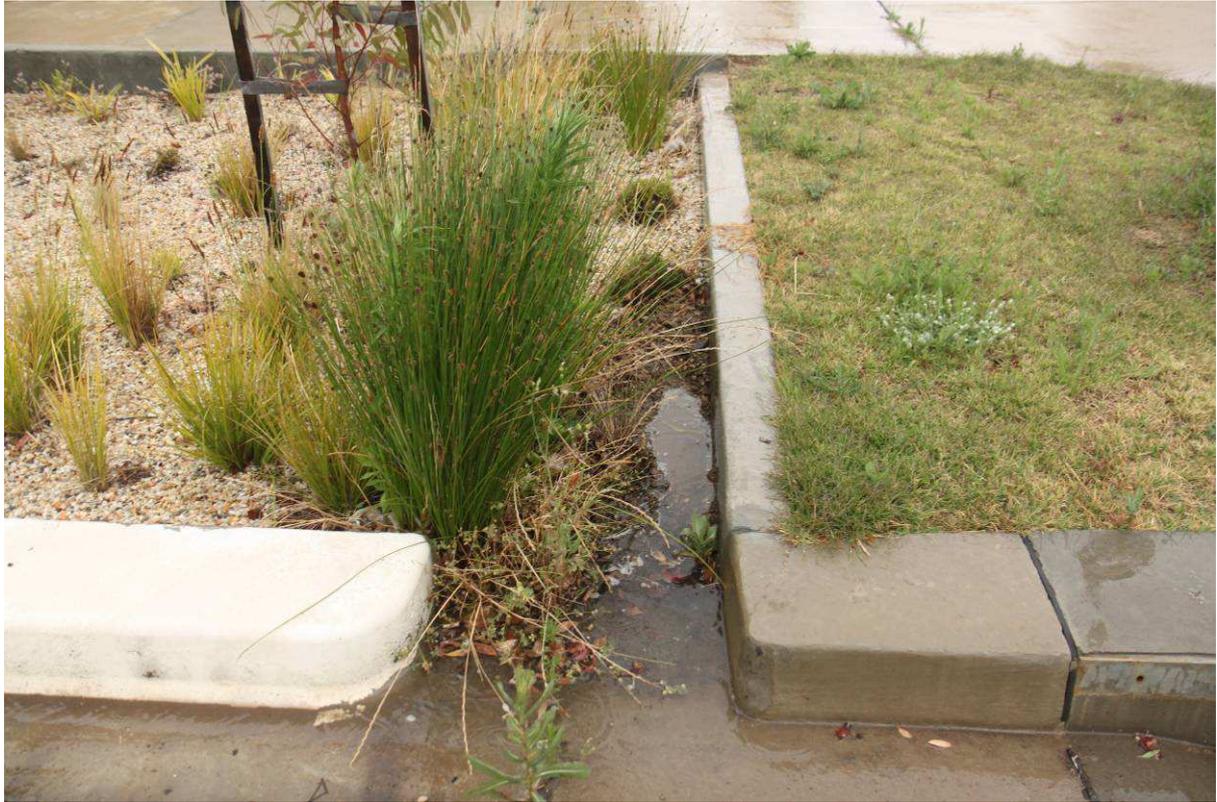
- In most cases a slight build up of debris including sediment and organics has caused blockage (refer Figure 2). In many cases after partially removing the sediment and debris and some of the mulch manually (to simulate maintenance activity), the majority of stormwater was still bypassing the systems

Figure 2: Rain garden on Ultimo St, with blocked inlet caused by poor levels and a small amount of debris

As the rain gardens have not been constructed with a sufficient drop from the inlet to the filter surface, flows are generally not entering the rain gardens and hence are unable to pond on the surface and appear to have limited extended detention. The lack of a drop between the kerb inlet and the filter surface level is the major factor driving the failure of the system.

- Lowering of the filter surface level to allow water to enter the rain garden and to provide more extended detention in the system. At best this lowering may potentially be required only at the inlet, but it may possibly be required across the whole rain garden to function effectively. This needs to be further resolved with site survey or similar.
- Reconfiguration of the inlet, to reflect the change in levels and to promote water entering into the basin and potentially also to increase the size of the inlet to reduce the risk of blockage due to single large pieces of litter and debris

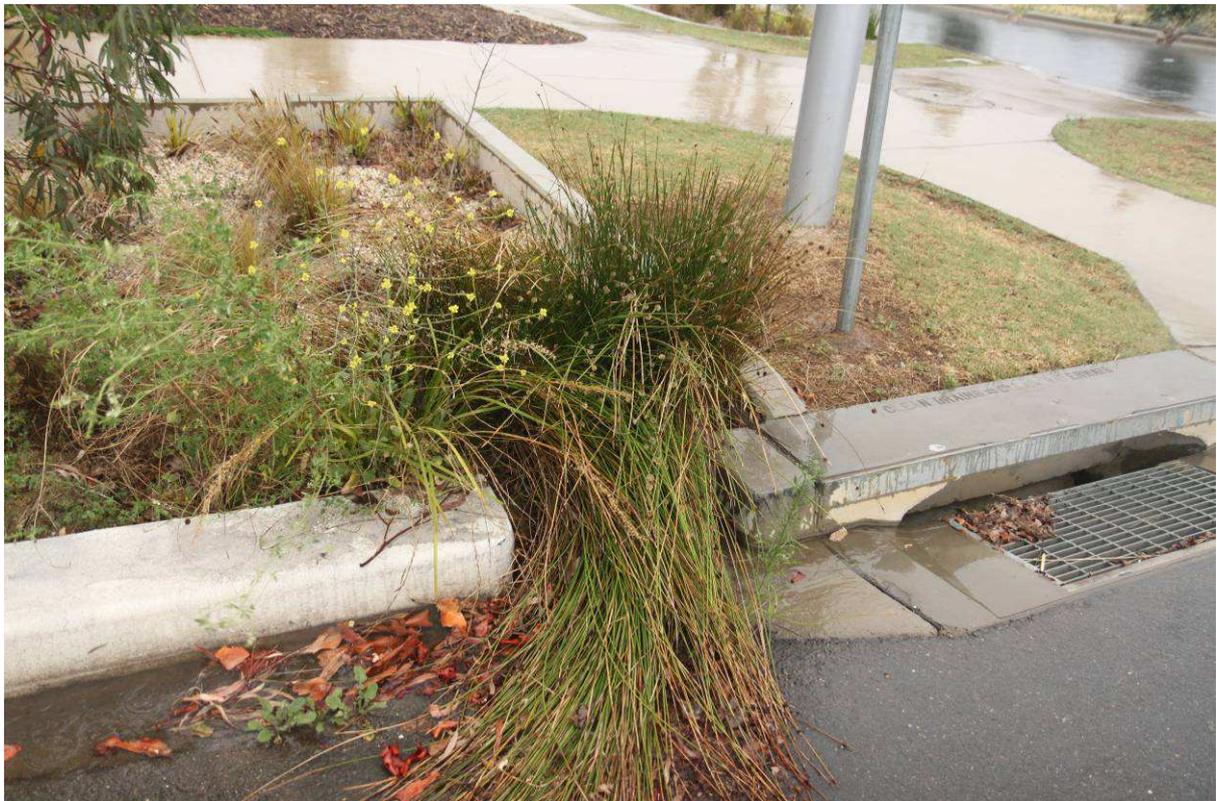
- In a few cases significant vegetation establishment right at the inlet is preventing water from entering the rain garden (refer Figure 3)
- Inlets from the lots are working well, with a slight area of scouring at the inlet although this is not considered a significant issue (refer Figure 4)

Figure 3: Rain garden on Ultimo St, with significant vegetation at the inlet, and flows can be seen bypassing the inlet (flowing from left to right) directly into the stormwater drainage pit

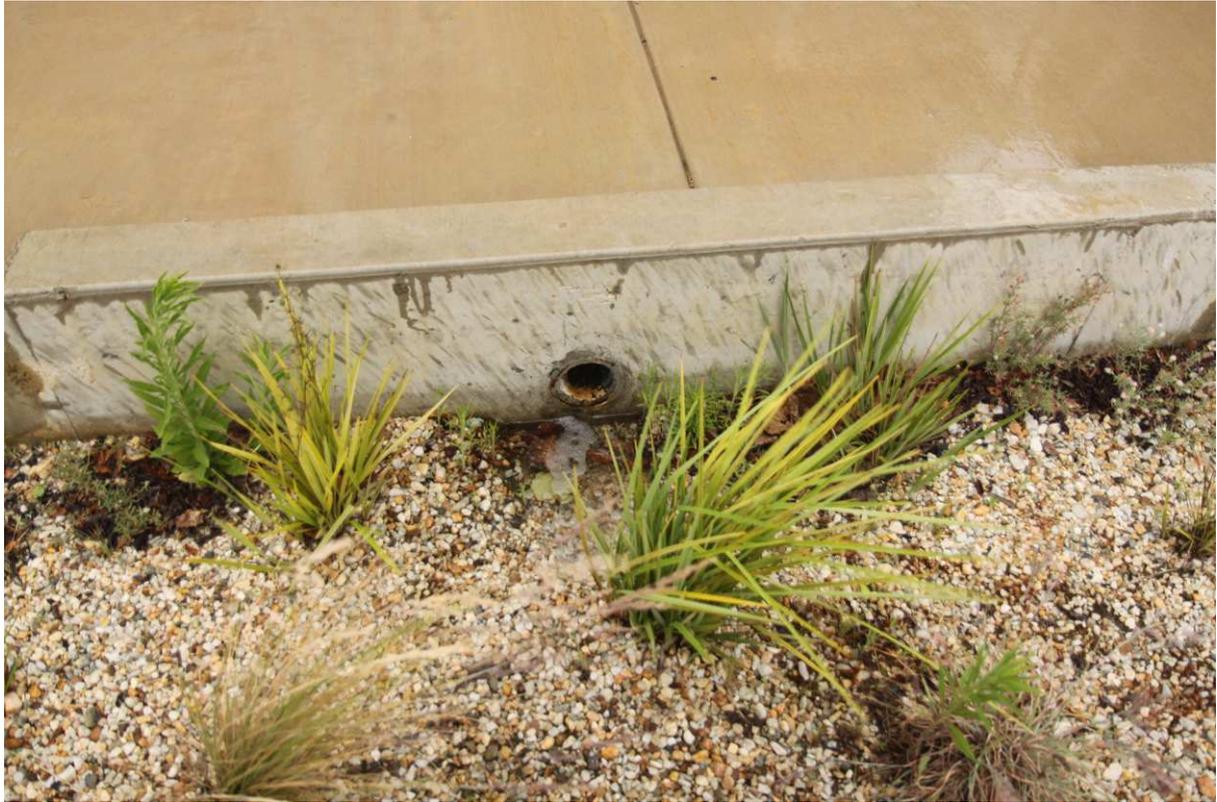
Figure 4: Example of a rain garden with an inlet from the adjacent lot

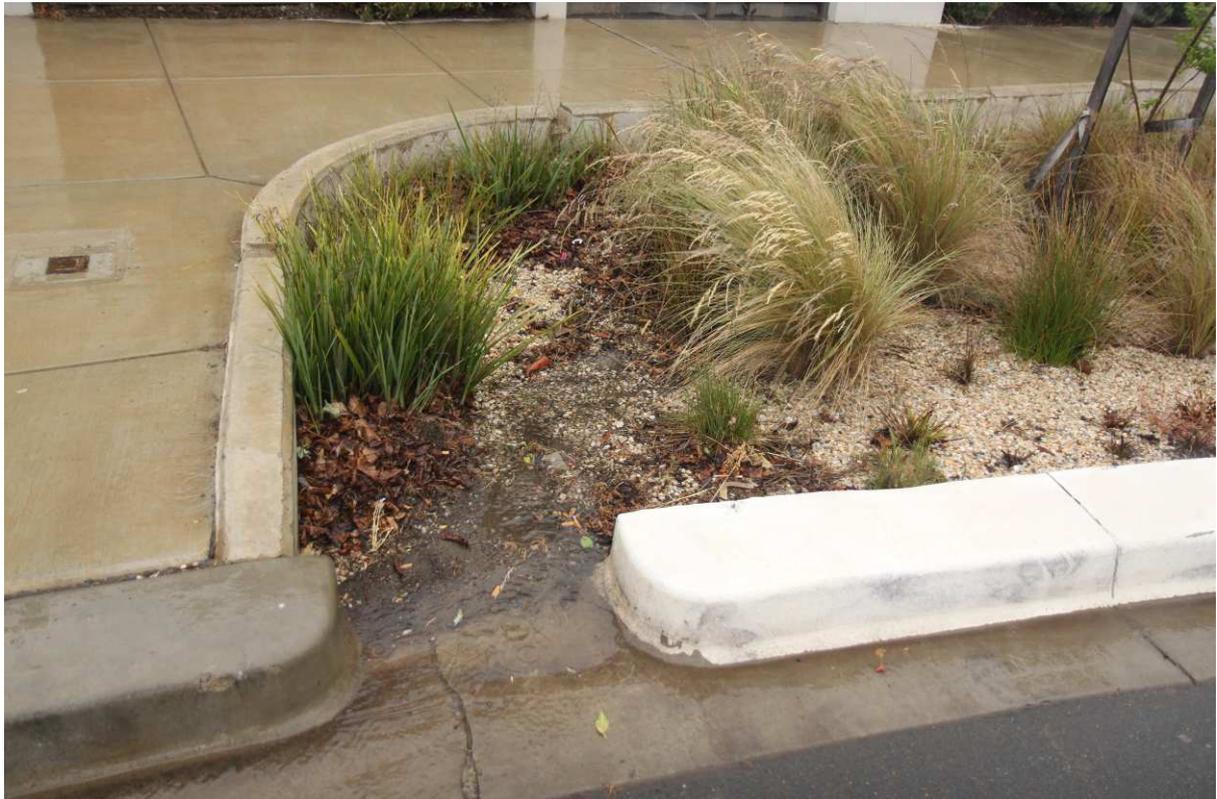
- In the middle western rain garden water was successfully entering one of the inlets and the inlet was able to capture the entire low flows in the gutter. Water was witnessed ponding over the surface (refer Figure 5)
- There was evidence of litter and weeds in the rain gardens, but not substantial amounts and would not take a significant effort to remove (a few minutes for each rain garden, no more than 10 minutes for the whole street)

Figure 5: Example of a kerb inlet functioning and delivering water into the rain garden. Water is flowing left to right and note the lack of water on right hand side of kerb and water ponding in the rain garden (as evidenced by darker sediment)

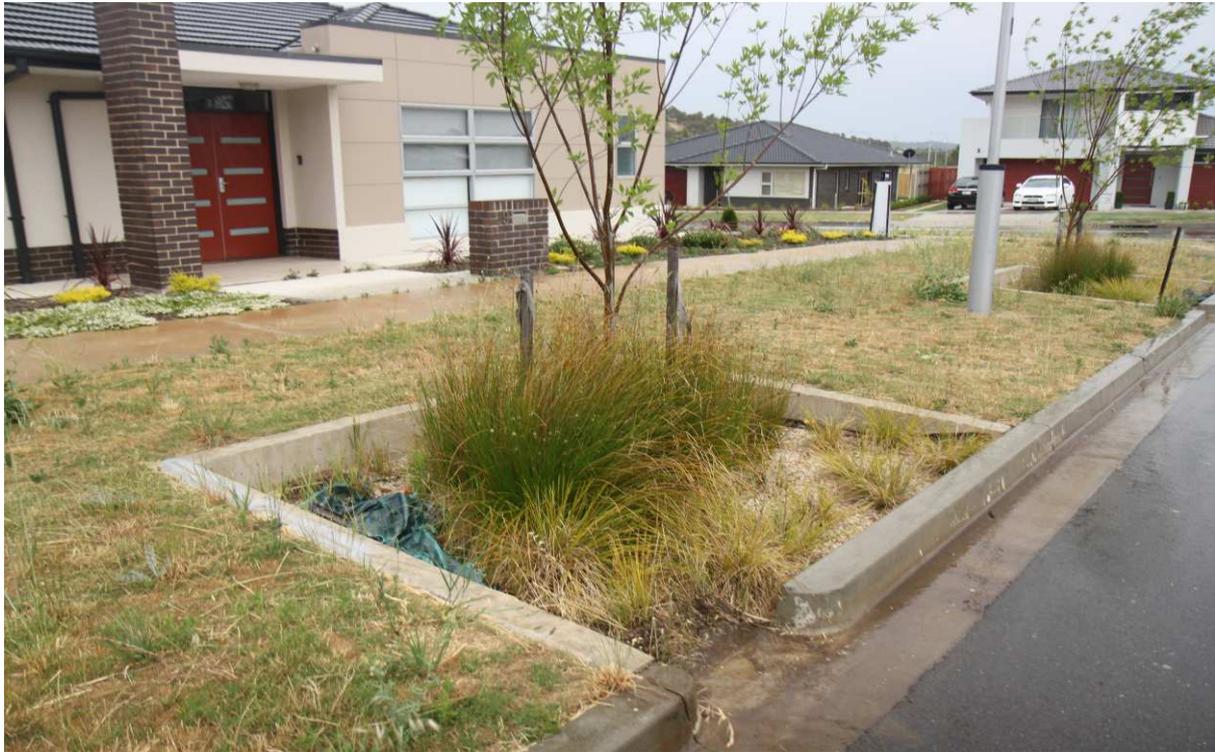
At Digby Cct, construction activity including house-building has been entirely completed (with the exception of one lot) and the systems are no longer affected by construction sediment. While the rain gardens are still to be considered in the establishment phase, within the next 3 to 6 months, it is likely that the rain gardens will be fully established. The surface vegetation condition is shown in Figure 1.

Figure 1: Rain garden on Digby Cct, showing state of vegetation establishment

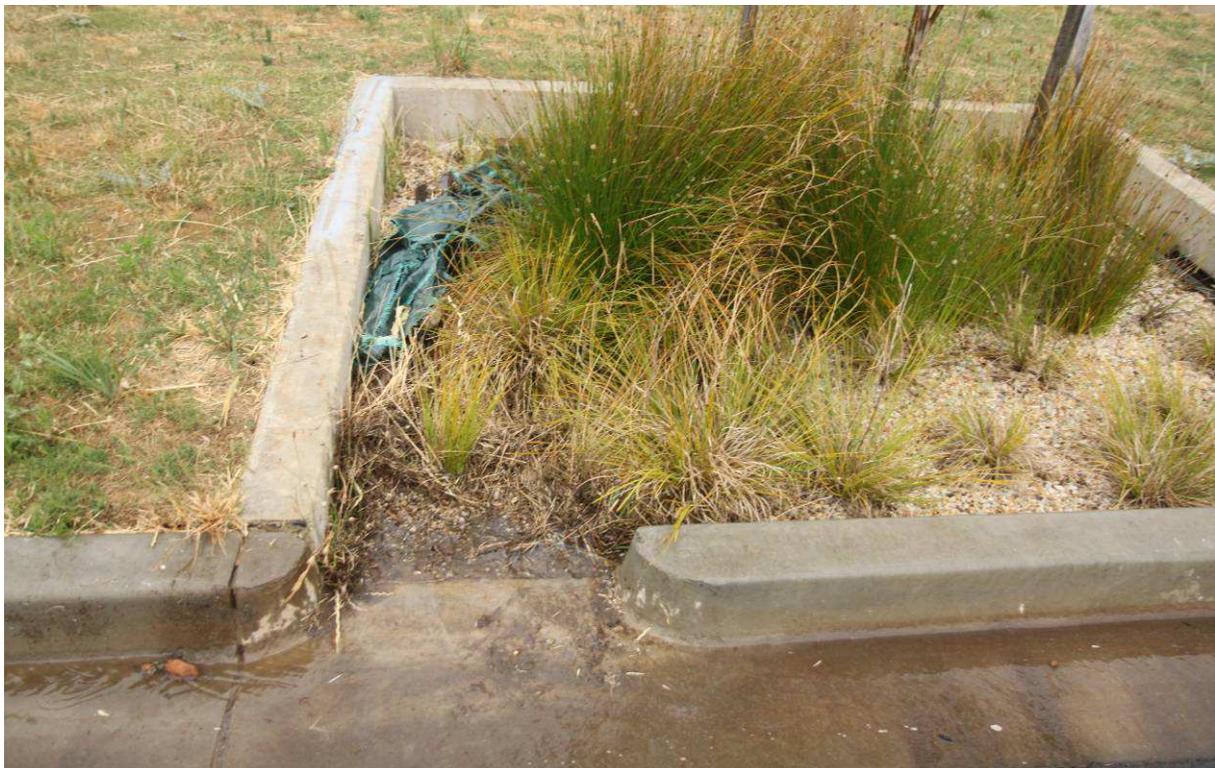
- In most cases a slight build up of debris including sediment and organics caused blockage. In many cases after partially removing the sediment and debris and some of the mulch manually (to simulate maintenance activity), the majority of stormwater was still bypassing the systems. Refer to Figure 2 for example after sediment in the inlet was removed water can be seen bypassing the rain garden.

Figure 2: Rain garden still bypassing after manual removal of debris (flows are from left to right). The water downstream of the rain garden can be clearly seen and the small area of ponding in the rain garden is also clearly visible

As the rain gardens have not been constructed with a sufficient drop from the inlet to the filter surface, flows are generally not entering the rain garden and hence are unable to pond on the surface and appear to have limited extended detention. The lack of a drop between the kerb inlet and the filter surface level and lack of extended detention is the major factor driving the failure of the system at present. Other issues may become apparent once the issue is rectified.

- Lowering of the filter surface level to allow water to enter the rain garden and to provide more extended detention in the system. At best this lowering may potentially be required only at the inlet, but it may possibly be required across the whole rain garden to function effectively. This needs to be further resolved with site survey or similar.
- Reconfiguration of the inlet, to reflect the change in levels and to promote water entering into the basin and potentially also to increase the size of the inlet to reduce the risk of blockage due to single large pieces of litter and debris

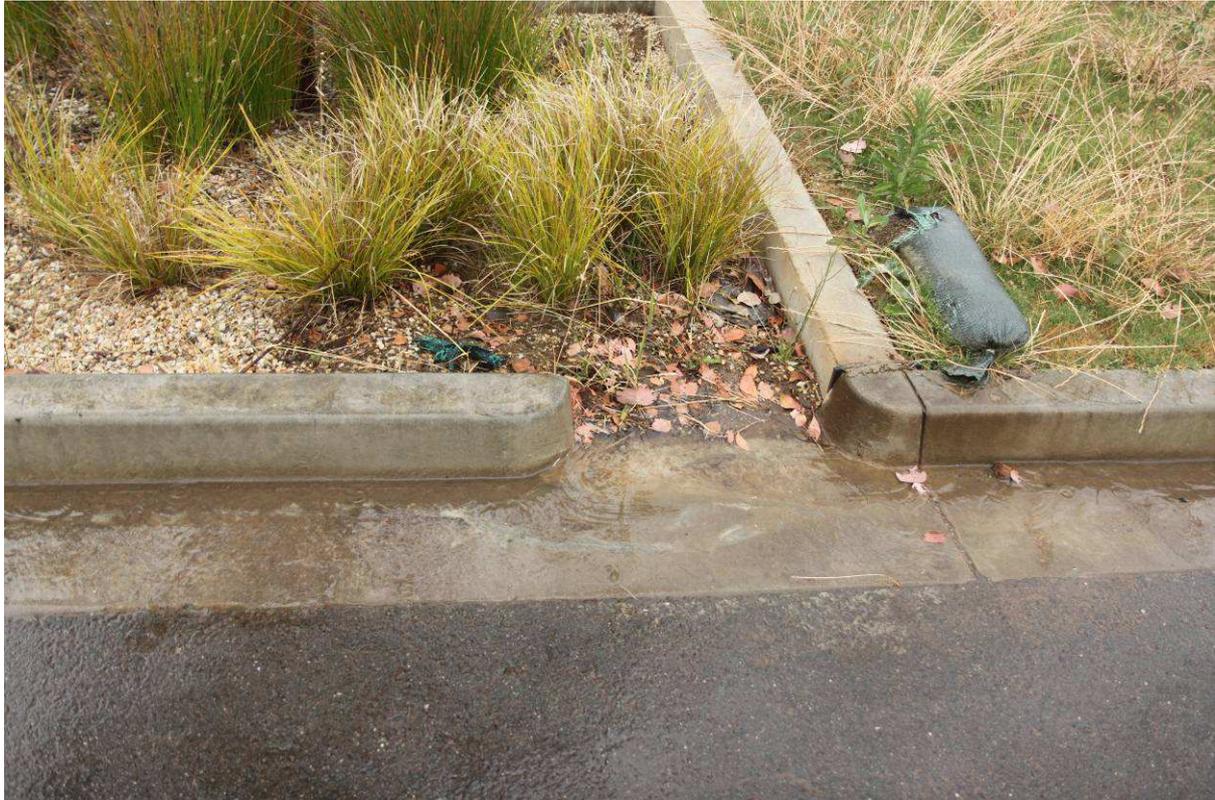
- Some systems have been impacted by the use of sand bags which have been placed at the inlets to prevent water entering the rain garden. The fabric on the bags is deteriorating and is breaking and depositing the material from the sand bag into the rain garden. The fabric around the sand bags becomes brittle over time (refer Figure 3)

Figure 3: Broken sand bag (right hand side of photo) with debris from sand bag deposited in and around rain garden)

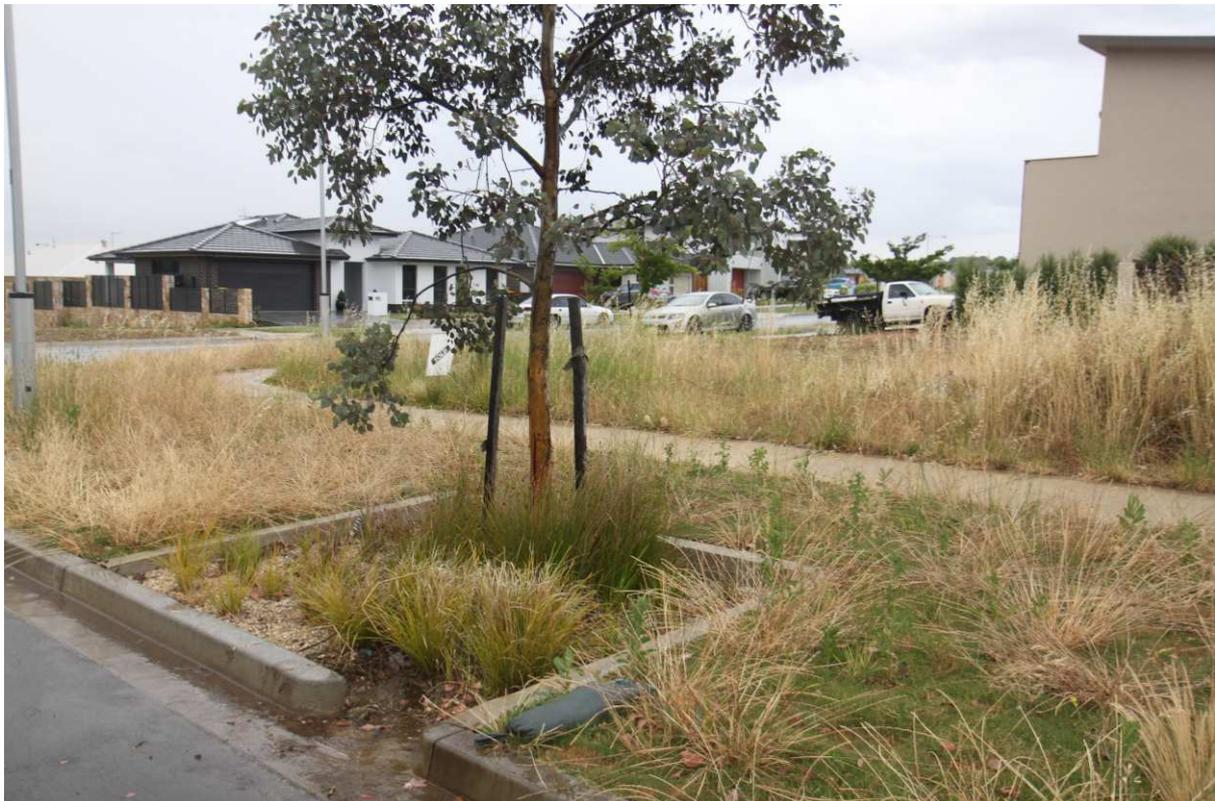
- For some rain gardens the vegetation establishment is patchy with some area establishing well and other areas not establishing as well (refer Figure 4). It is possible that different species were planted in zones and some have thrived while others have not. Most of the trees appeared to be establishing well, however one tree was observed with a pest or disease which is significantly affecting the health of the tree.

Figure 4: Example of patchy vegetation growth in rain garden

The rain gardens also need some simple routine maintenance such as weed removal and litter picking. As discussed above this would not require substantial effort. Some minor re-planting would be beneficial for a few of the systems but is not essential.

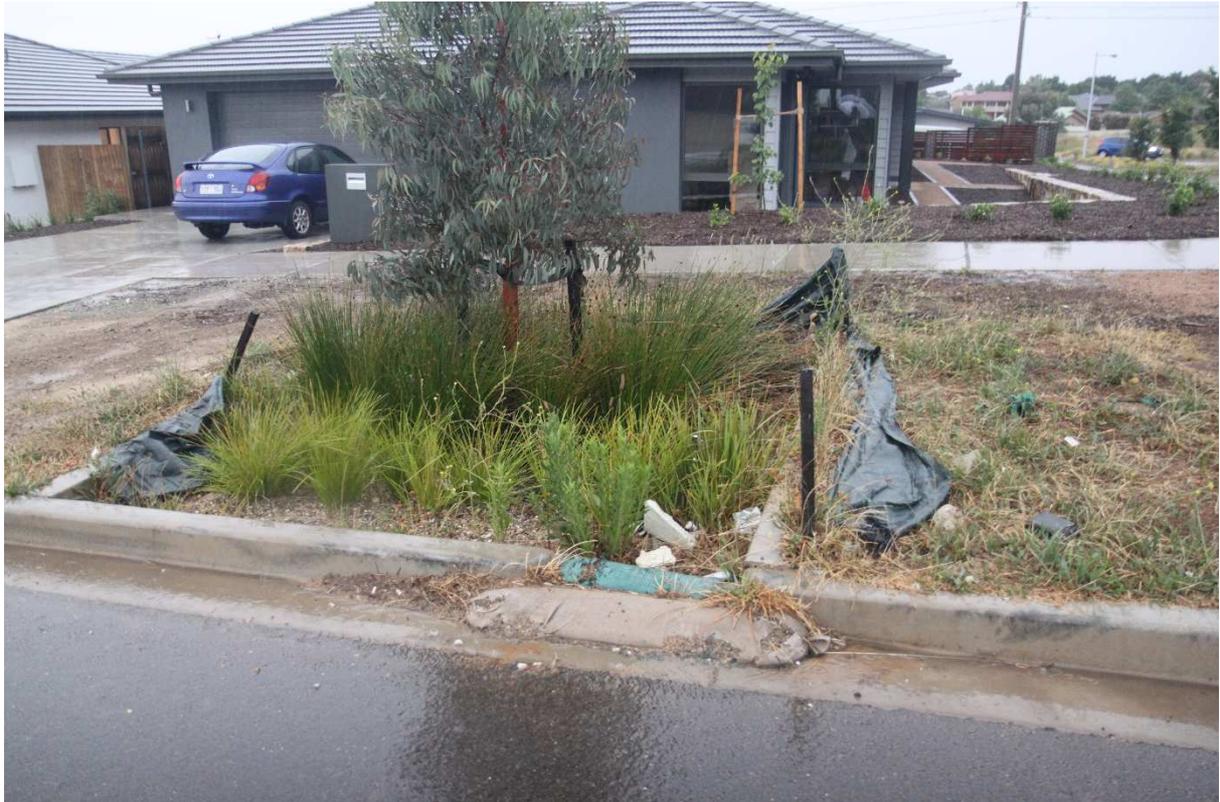
Figure 1: Rain garden on Langtree Crescent, with construction-stage controls in place

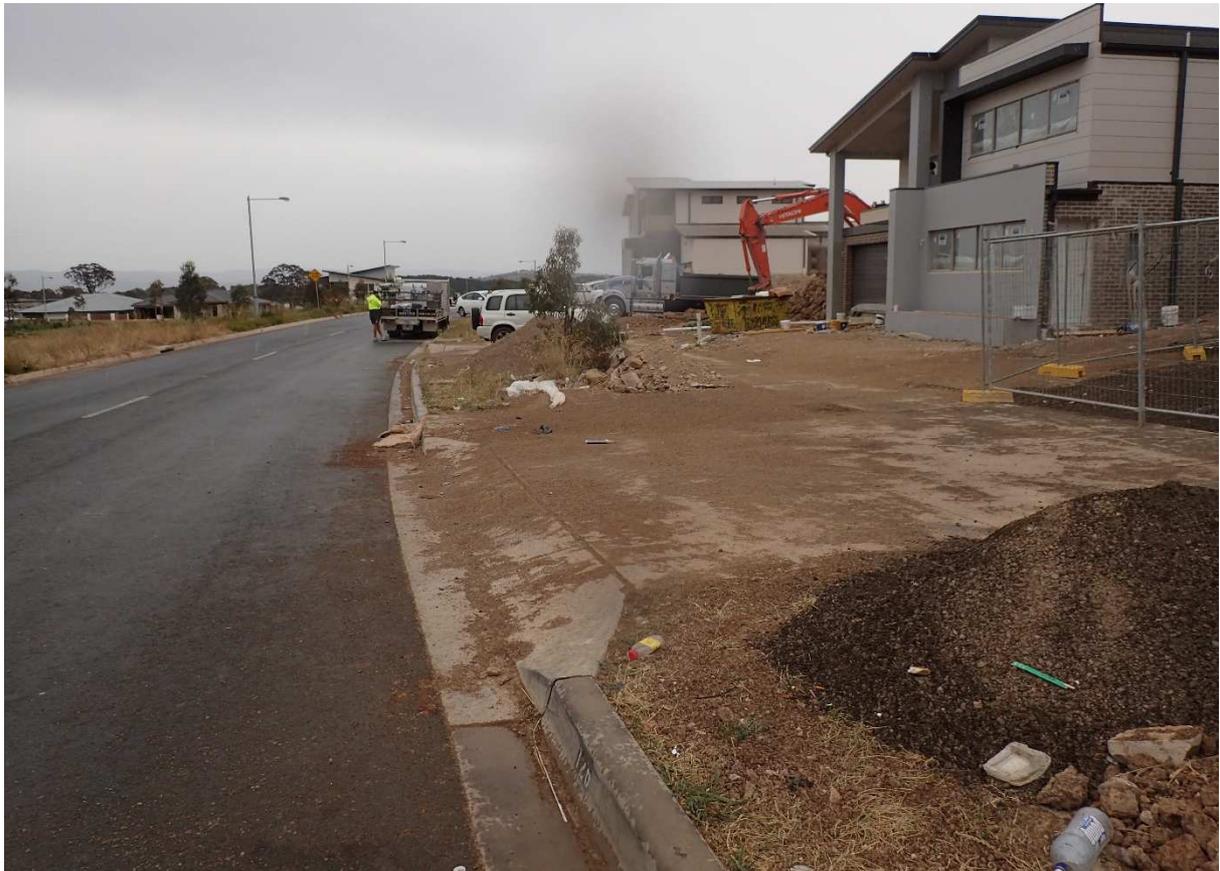
Figure 2: House building still underway at Crace is causing significant sediment loads in stormwater runoff on Langtree Crescent

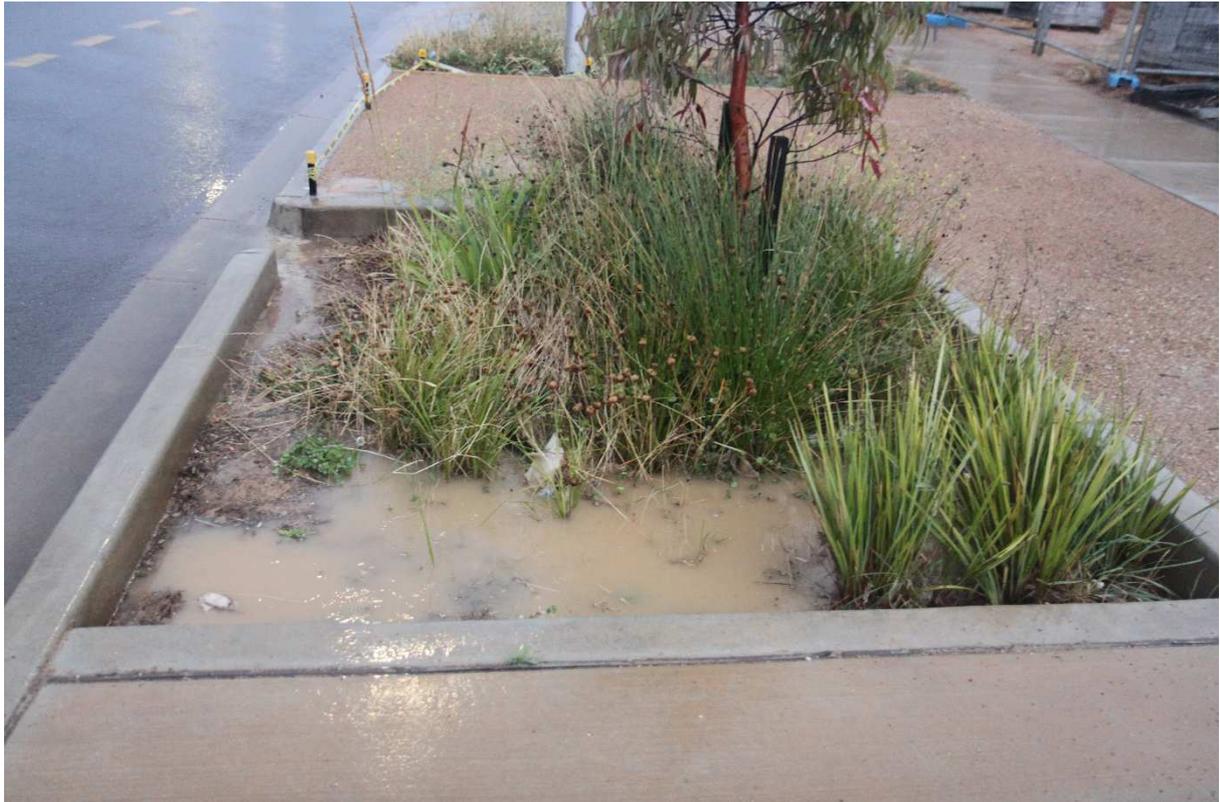
Figure 3: Sediment-laden runoff entering a rain garden on Langtree Crescent, 30 November 2014

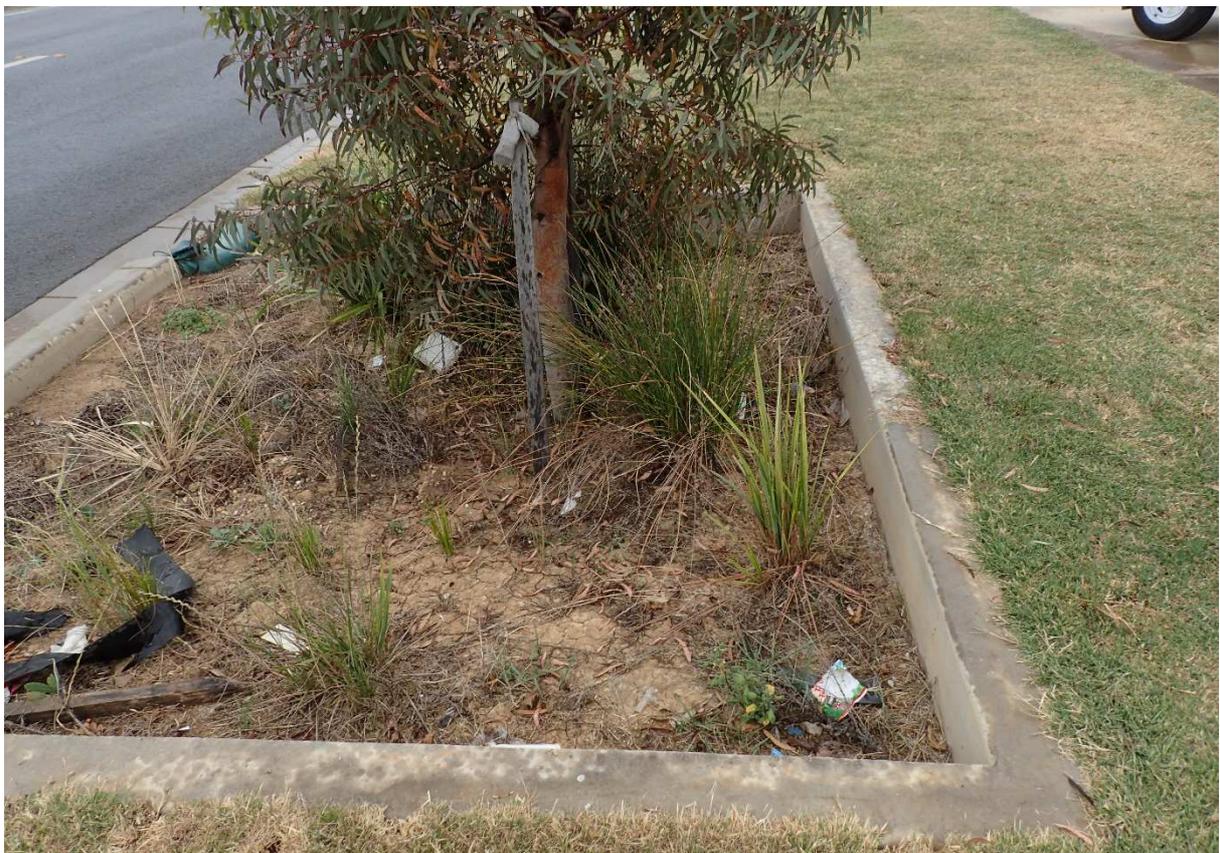
Figure 4: Example of a rain garden clogged by construction-stage sediment (despite the presence of a filter sock on the street inlet – sediment has potentially run in from the footpath side)

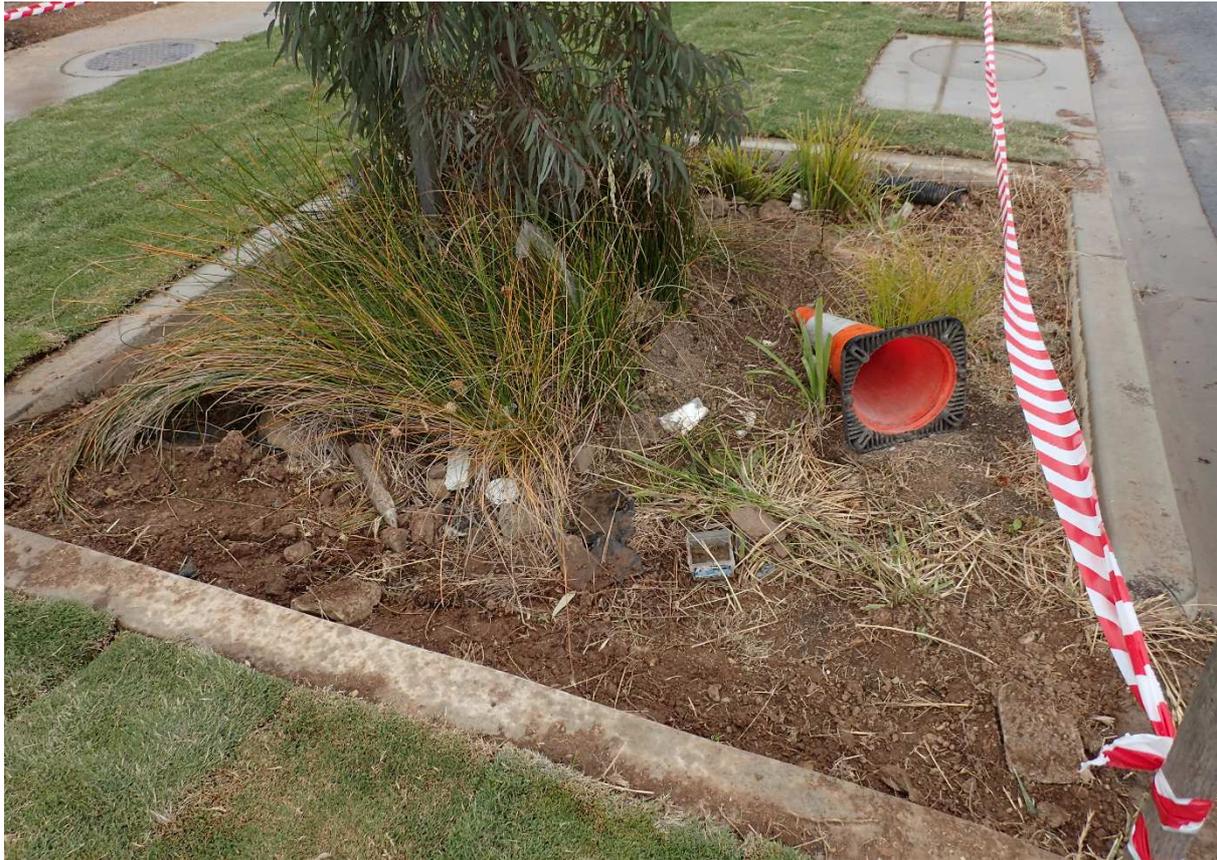
- There were also a number of examples, also concentrated between Drooka Crescent and Kappakoola Street, where construction spoil and debris has been dumped in the rain gardens, filling the extended detention zone, smothering vegetation and blocking the filter. An example is shown in Figure 5.

Figure 5: Example of a rain garden on Langtree Crescent where construction spoil and debris has been dumped into the filter area

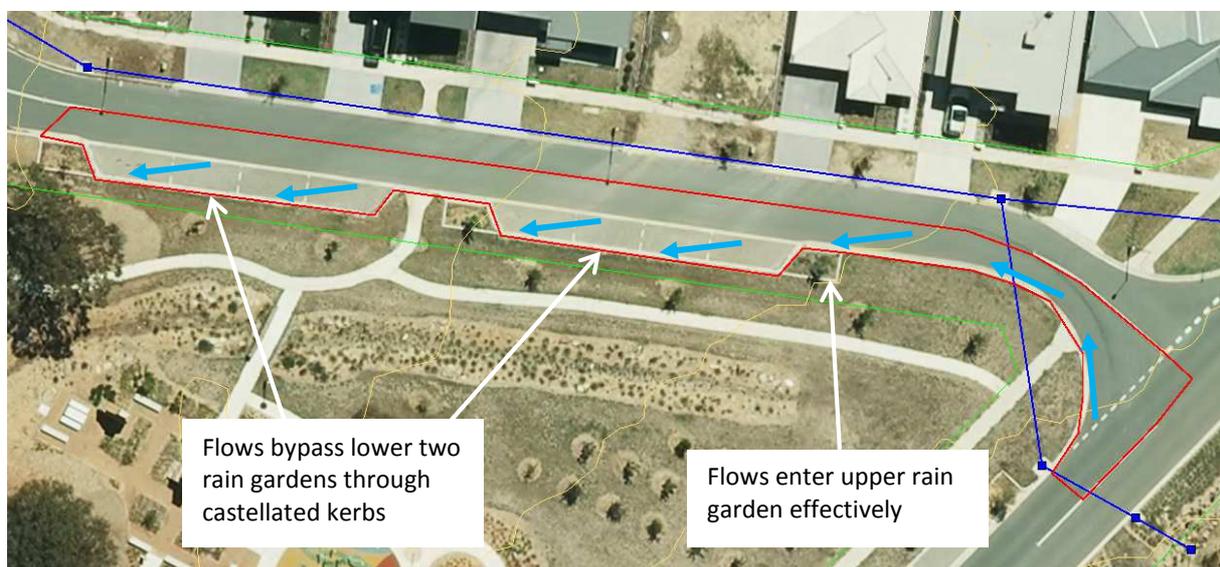
Figure 1: Catchment area and flowpaths observed at Turbayne Crescent

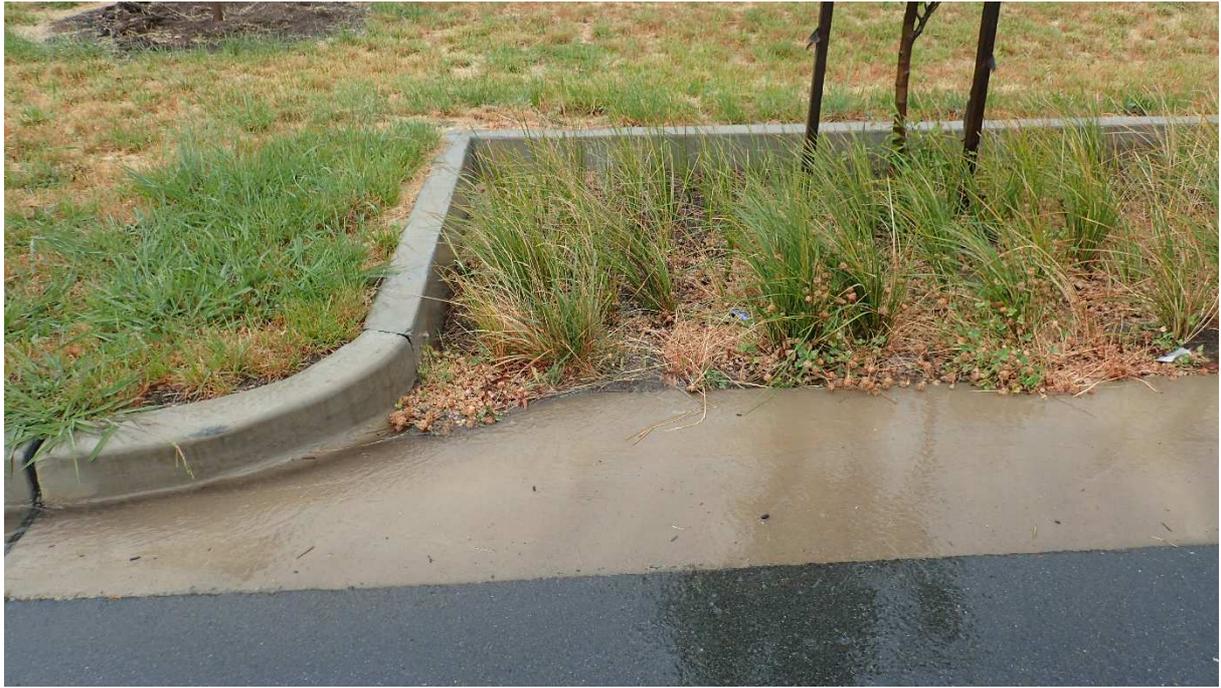
Figure 2: Flows entering upper rain garden

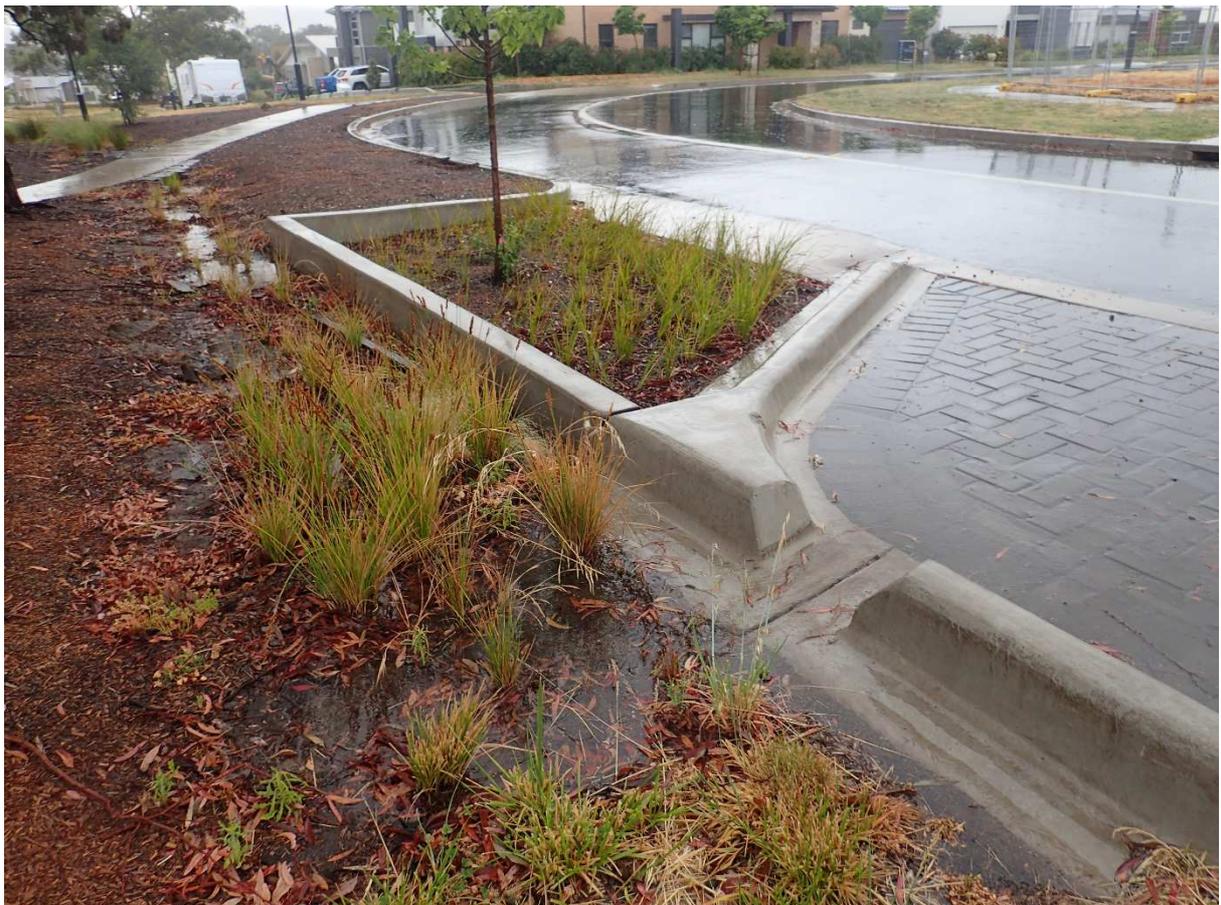
Figure 3: Flows bypassing the lower rain garden into a small swale

- Castellated kerb should be replaced with a solid kerb
- At the low point in each parking bay, adjacent to the rain gardens, an inlet should be made into the rain gardens

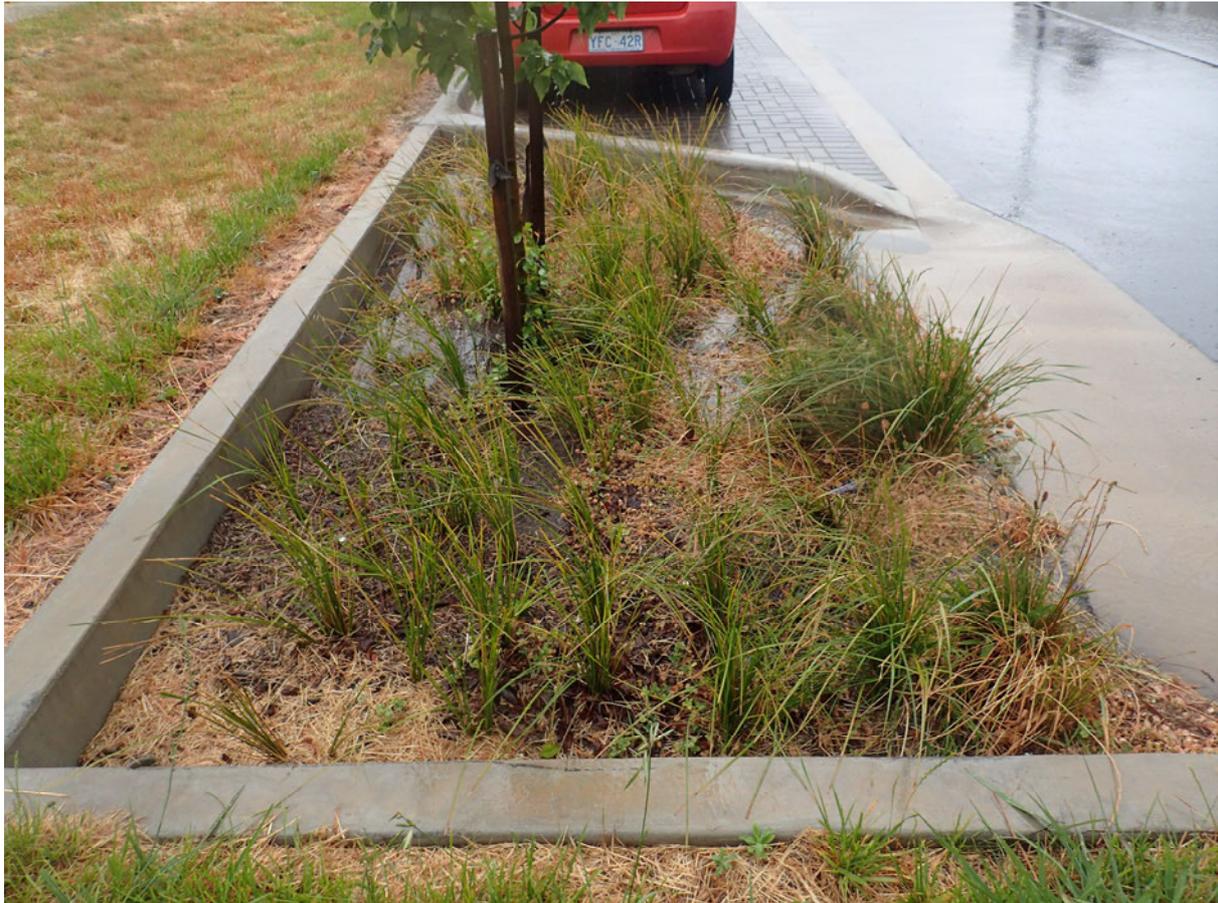
- Water was ponding across part of the rain garden (refer to Figure 4). There was only a small volume of functional extended detention, however many streetscape systems effectively have no extended detention, therefore this is a comparatively good outcome
- Water stored in the extended detention drained away quickly after stormwater inflows eased, indicating that the filter is draining freely

Figure 4: Water ponding in the extended detention in the upper rain garden (16 Nov 2014)

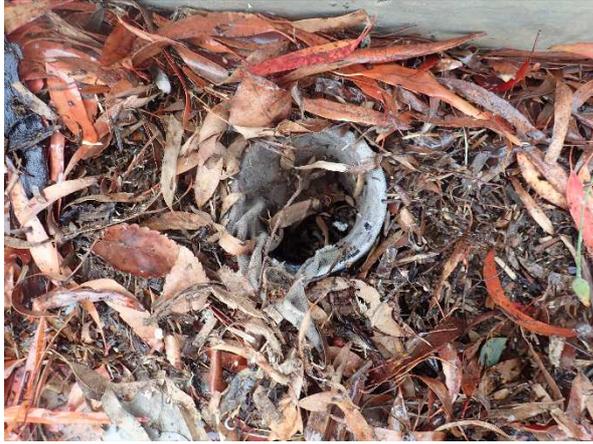
Figure 5: Flushing point in the lower rain garden (photo taken after shifting leaf litter which was covering the pipe)

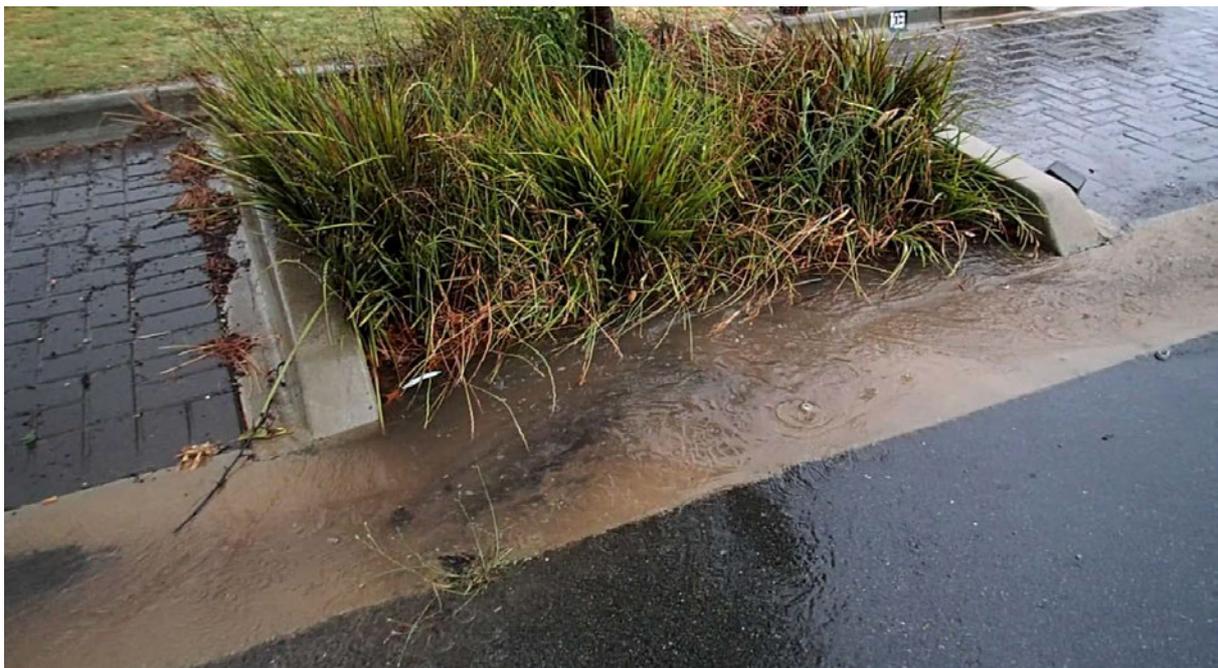
Figure 1 shows a typical example where there was no water entering the filter area. Figure 2 shows an example where there was minimal water entering the filter area and Figure 3 shows an example where there was some water entering the filter area and ponding across part of the surface.

In most cases it appears that the original constructed levels were inappropriate, with the filter located above the gutter invert level. In some cases it appears that levels within the filter have probably built up over time as vegetation has established and sediment and mulch have accumulated in the filter.

Figure 1: Typical example of a Zakharov Avenue rain garden where stormwater runoff completely bypasses the filter

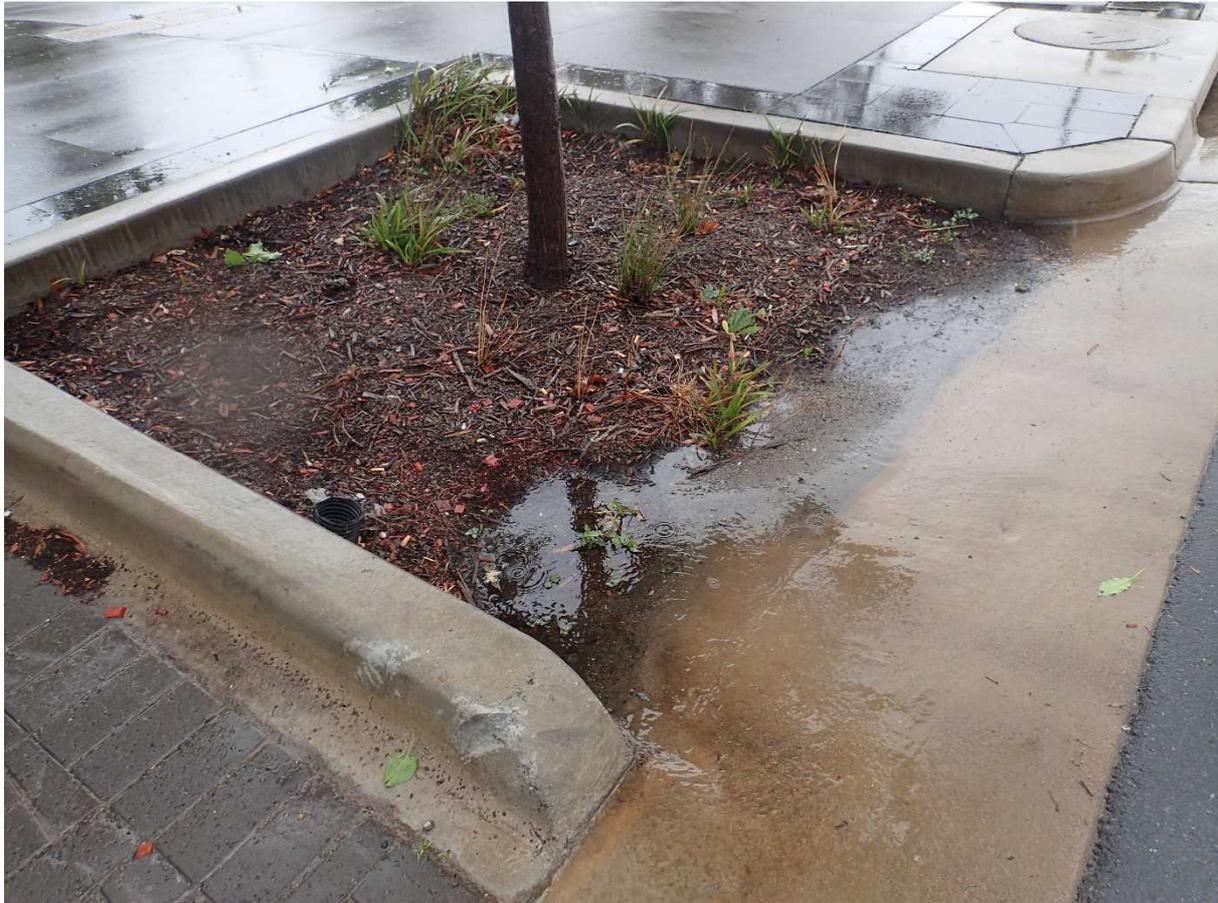
Figure 2: Typical example of a Zakharov Avenue rain garden where stormwater runoff can only enter a small area at the inlet. Extended detention is minimal

- There were several examples of rain gardens where the understory vegetation has died (refer to Figure 2). A rain garden without this understory vegetation is more prone to clogging and less effective in terms of nutrient removal, as densely-rooted vegetation plays a very important role maintaining the porosity of the filter media and taking up pollutants.
- There were several examples of rain gardens with garden waste such as lawn clippings and leaf litter dumped in the rain garden. In some cases the quantity was sufficient to smother vegetation in the rain garden (refer to Figure 6)
