Asset 3: Ultimo St rain gardens (Crace)

Asset 4: Digby Circuit rain gardens (Crace)

Asset 5: Langtree Crescent rain gardens (Crace)

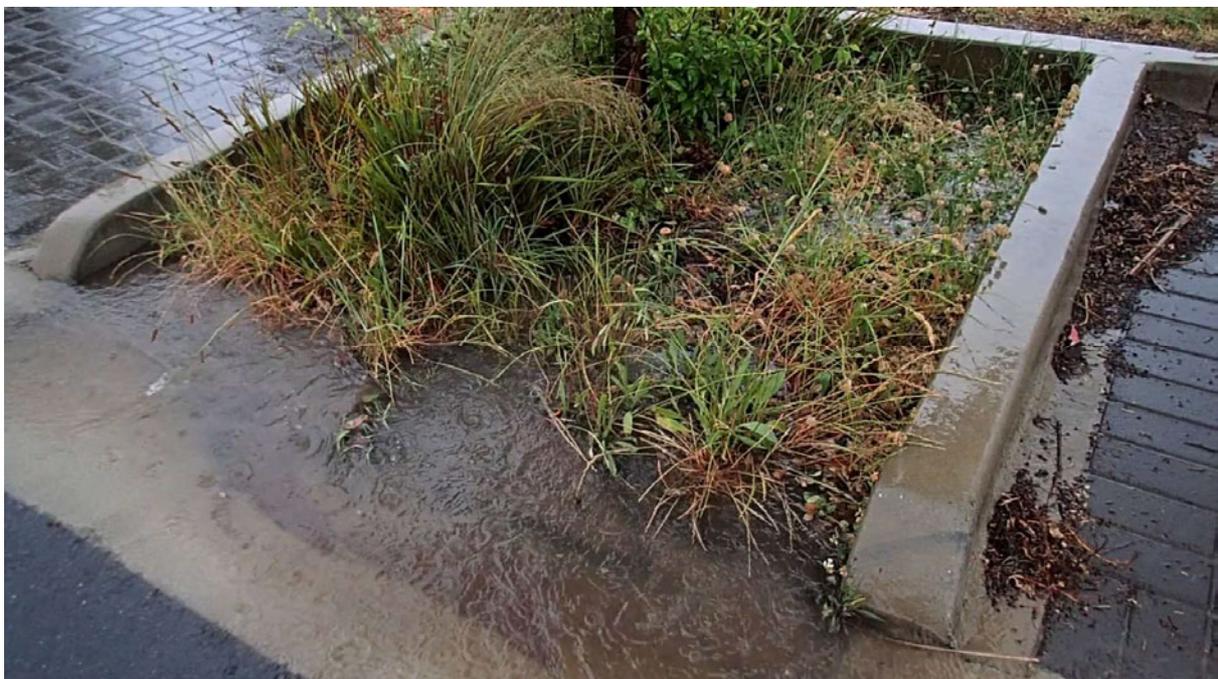
Figure 3: Isolated example of a Zakharov Avenue rain garden where stormwater runoff is able to pond to approximately 30 mm across part of the filter surface

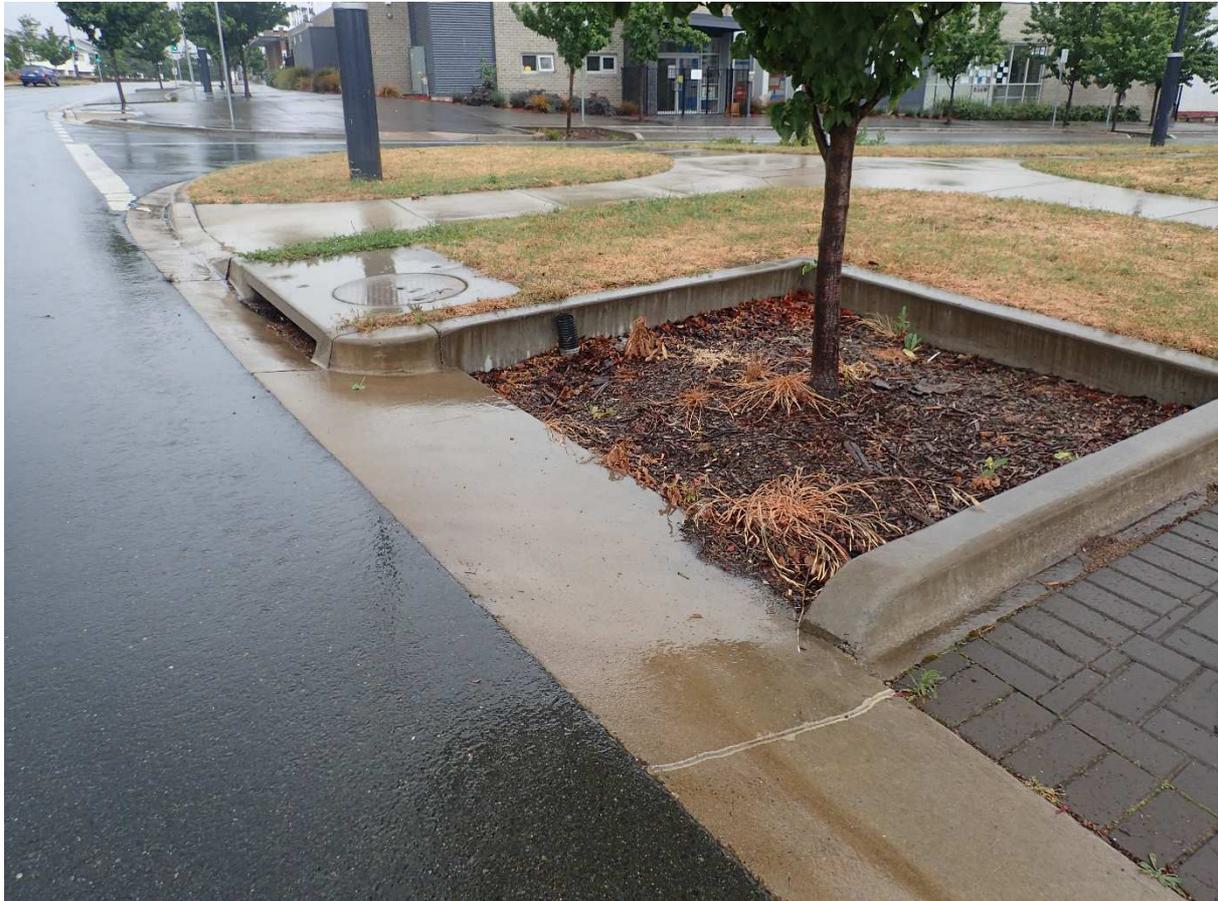
- Some rain gardens are located immediately downstream of stormwater pits, therefore they effectively have no catchment area (refer example in Figure 4)
- It did not appear that any property drainage was connected into the rain gardens, therefore they are only able to treat runoff from the roadway

Figure 4: Stormwater pit located immediately upstream of a rain garden

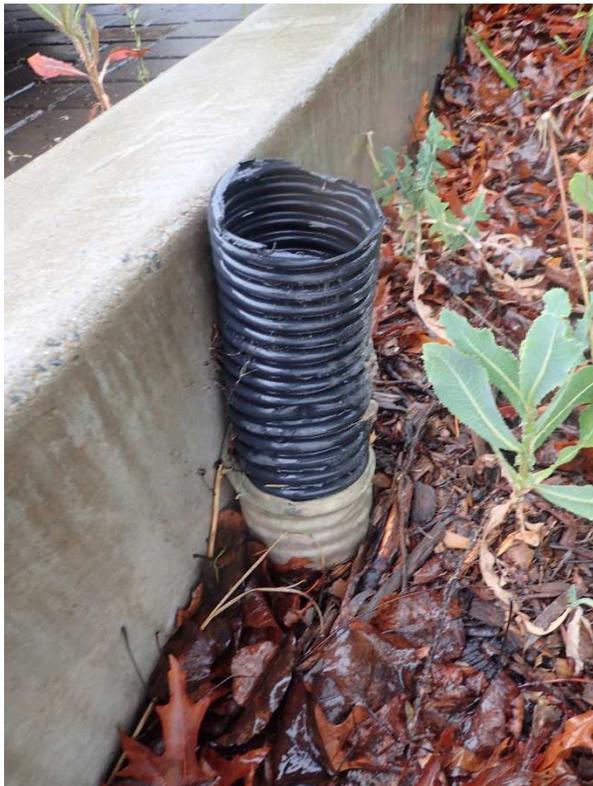
- Flushing points have been installed by leaving a section of flexible slotted pipe protruding from most of the rain gardens (refer to Figure 5). The design drawings do not show flushing points at all, therefore the construction contractor appears to have had no direction on this element. These pipes are easily damaged and also provide a pathway for water to short-circuit the filter media via the drainage pipe. Flushing points should generally be constructed from solid PVC with a PVC cap.

Figure 5: Flushing point in a Zakharov Avenue rain garden

The flushing point and slotted pipe details, as noted above, are also due to inadequate or incorrect details provided at design stage.

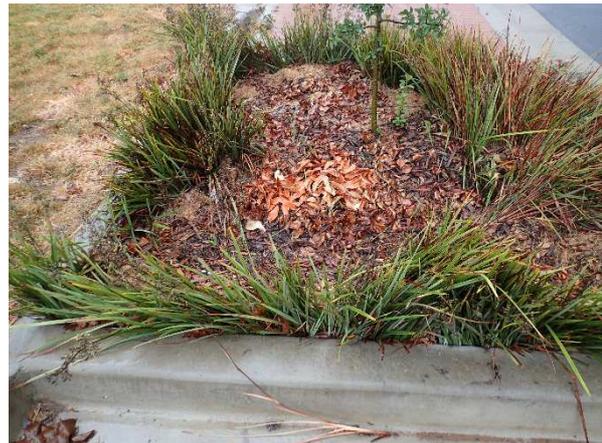
Figure 6: Garden waste dumped in a rain garden on Zakharov Avenue
