Asset 27: Yerrabi Pond

Asset 39: Isabella Pond

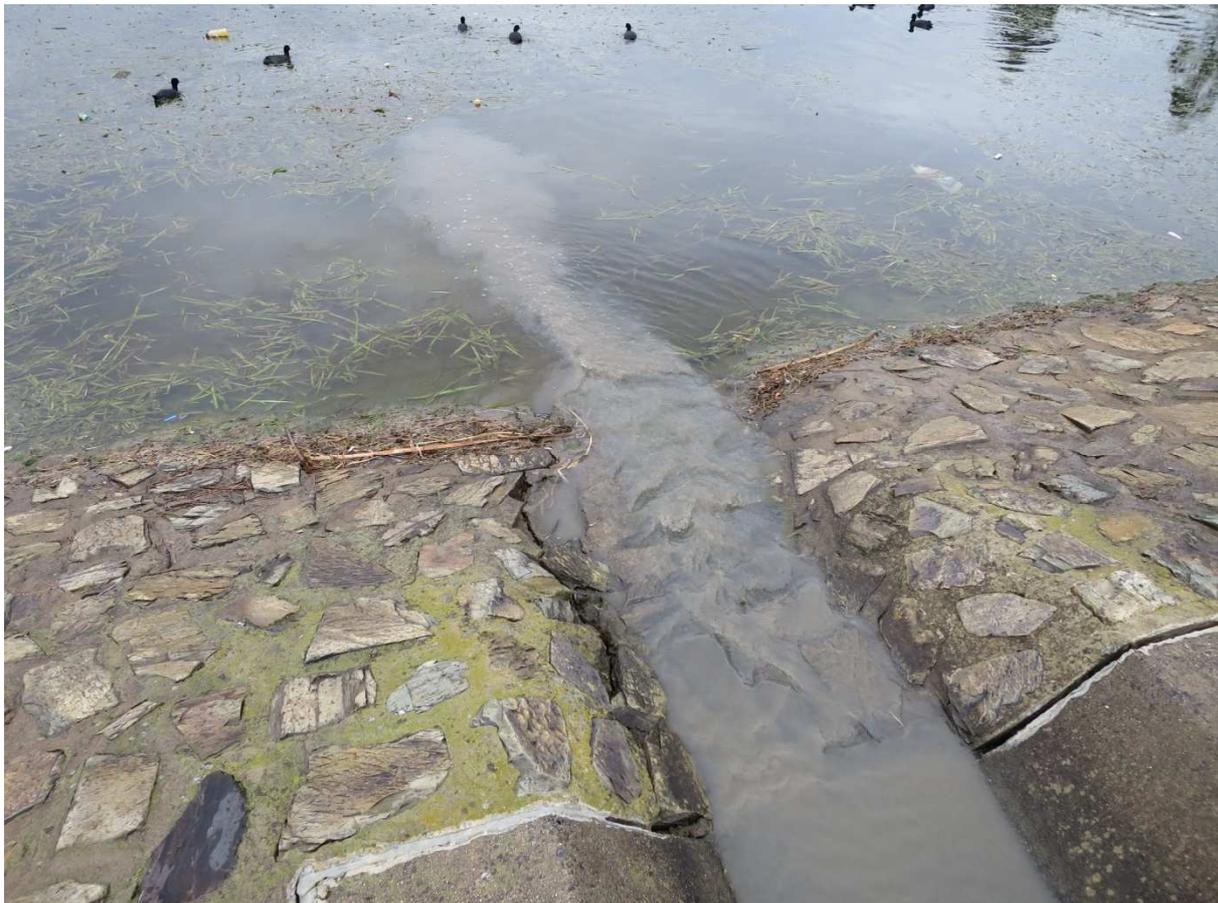
Yerrabi Pond has effectively acted as a sediment basin while significant construction has taken place in its catchment over the past 10 years, including in Bonner, Forde and Gungahlin. There is still residential construction underway in Bonner. Figure 1 shows stormwater with a high total suspended solids (TSS) load flowing into the south-eastern corner of Yerrabi Pond after a very small rainfall event. Aerial imagery also reveals a number of high turbidity events that are likely to have been caused by construction activities within the catchment (Figure 3 and Figure 4). Of the eighteen historic images available on NearMap from 2010 to 2014, eight reveal an episode of high turbidity inflows to the pond.

Figure 1: Stormwater inflows to southeastern corner of Yerrabi Pond – 24 November 2014

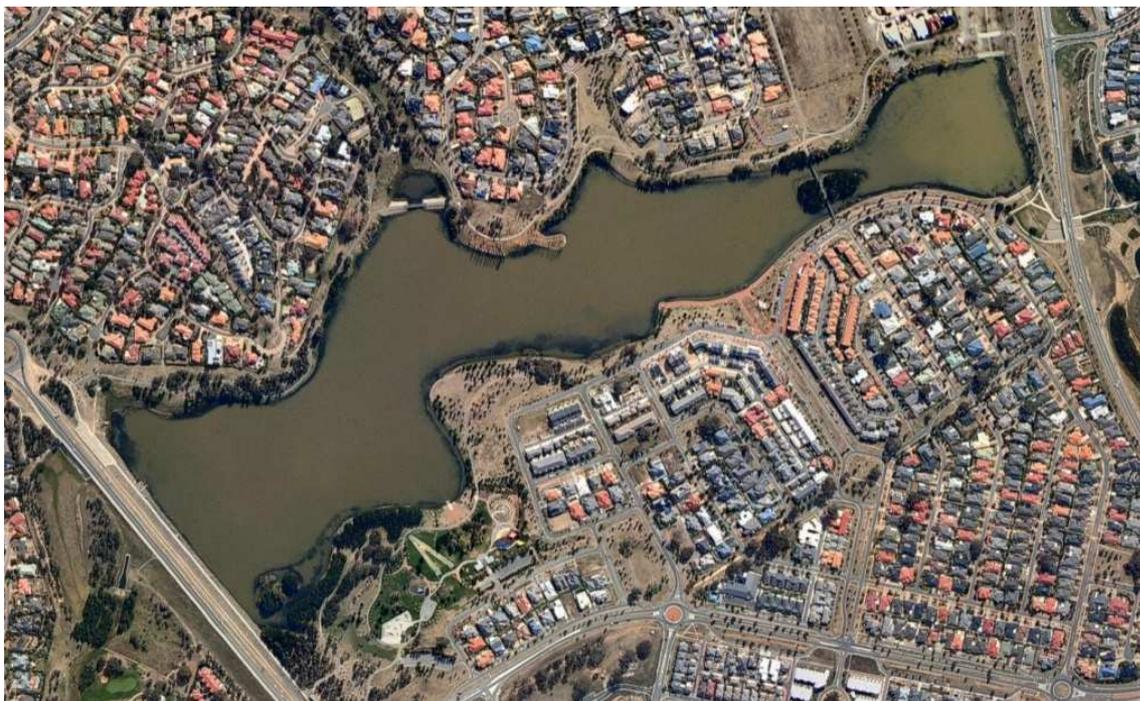
Figure 3: Aerial photo showing turbid conditions (Nearmap 6 May 2011)

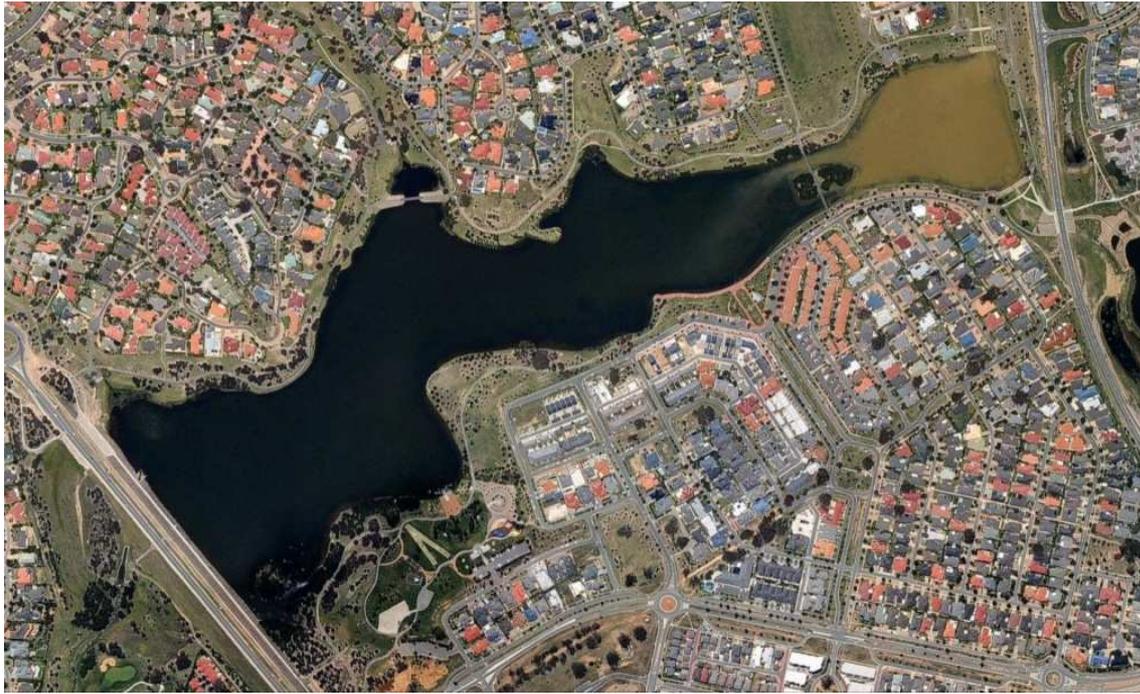
Figure 4: Aerial photo showing very high turbidity at Pond inlet (Nearmap 29 December 2011)

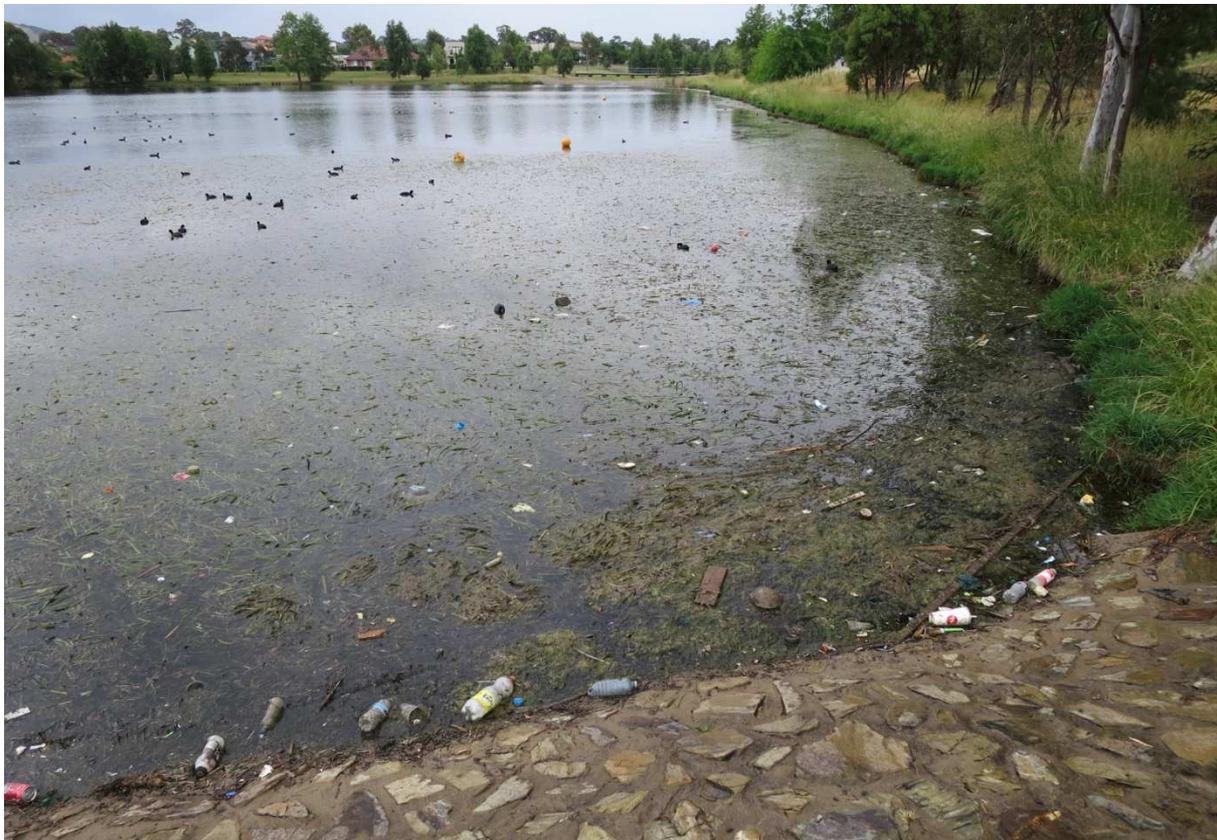
Anecdotal reports indicate that the water quality within Yerrabi Pond has worsened over 2013-14. One possible reason for this has been described (Joel Kelly, *pers. comm.*) as the effects of an increase in the swamp hen population. These birds are thought to have pulled up a large amount of the aquatic Ribbon Weed which subsequently decomposes, as shown in Figure 5. It is thought that this has led to increased nutrient concentrations in the pond which has caused algal blooms and potentially also lowers dissolved oxygen.

Figure 5: Image showing the floating ribbon weed at the south-eastern corner of the pond (24 November 2014)

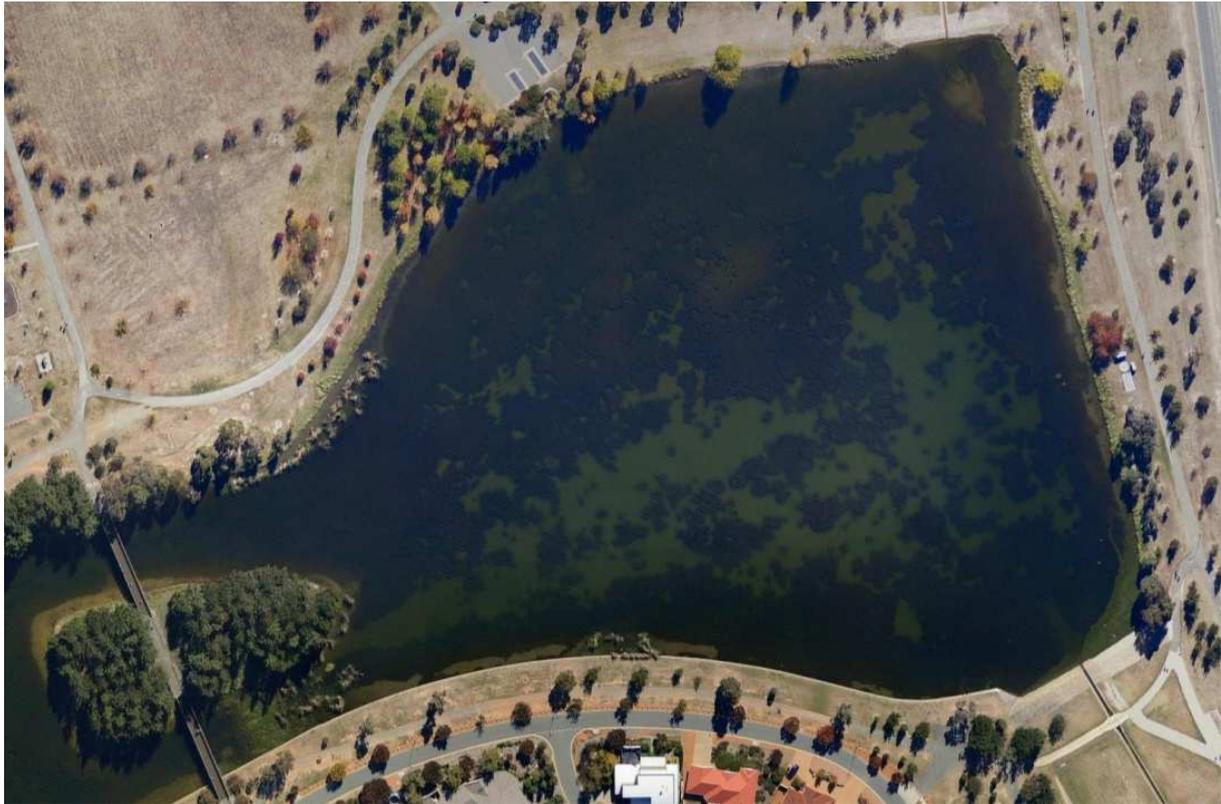
Figure 6: Image showing the areas of ribbon weed in the eastern section of the pond (NearMap – 25 April 2013)

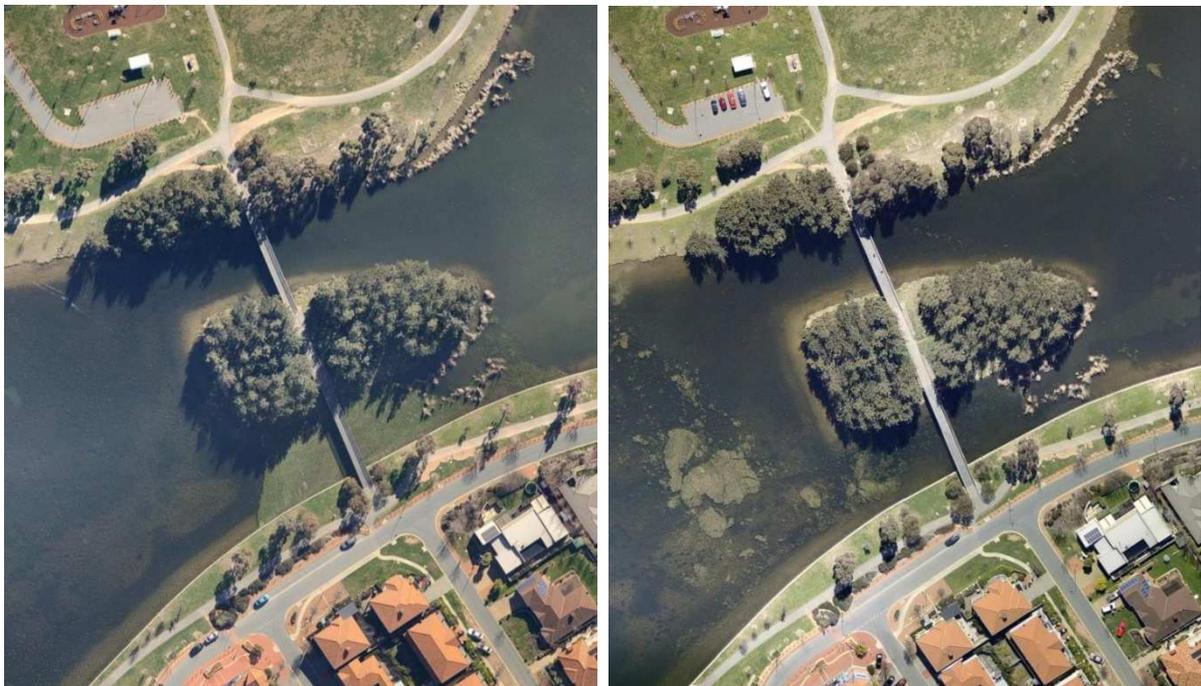
The small amount of macrophytes growing on the south-eastern side of the island as shown in Figure 7 illustrate how aquatic plants can act to trap pollutants within water bodies. However these plants appear to create a 'dead zone' which does not circulate as well as the channel on the northern side of the island.

Figure 7: Accumulated algae/weed in the channel on southern side of island – 31 July 2014 (L) and 31 August 2014 (R)

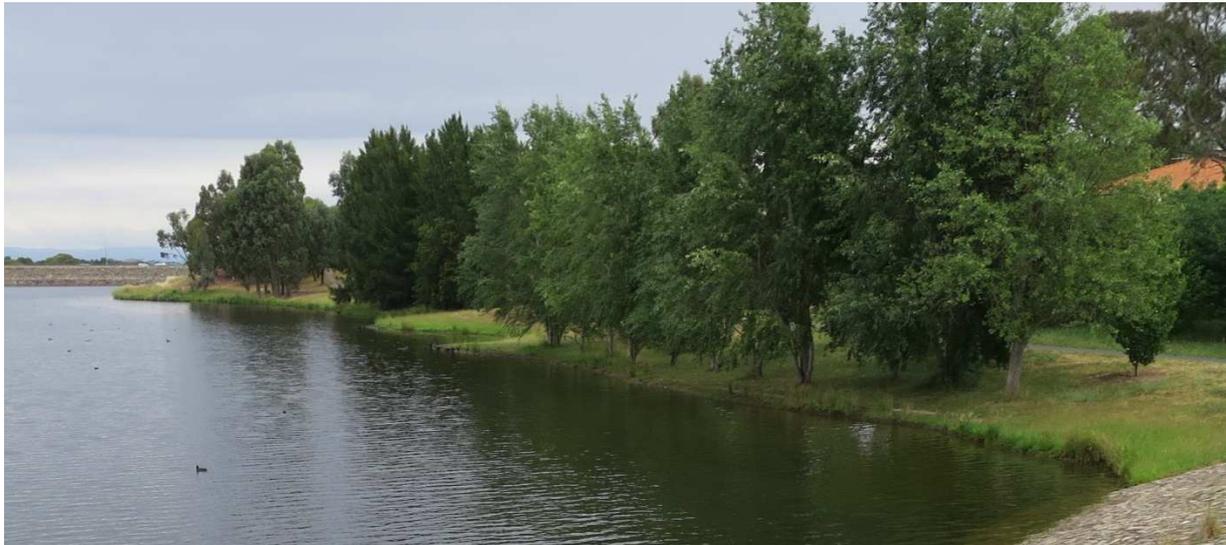
The pond edge has no fringing macrophyte vegetation, typically with turf extending to the edge as shown in Figure 8. Macrophytes may have been unable to establish due to the soil properties or due to bird activity.

Figure 8: The pond banks with no fringing macrophytes (24 November 2014)

- Planting macrophytes would improve the pond's water quality performance, particularly in the inlet zone. This would require the construction of a bench to create an area of shallower water depth (around 0.5m). The bench would ideally be constructed to ensure that no flows could short circuit around the shallow zone, forcing all flows through the vegetation.

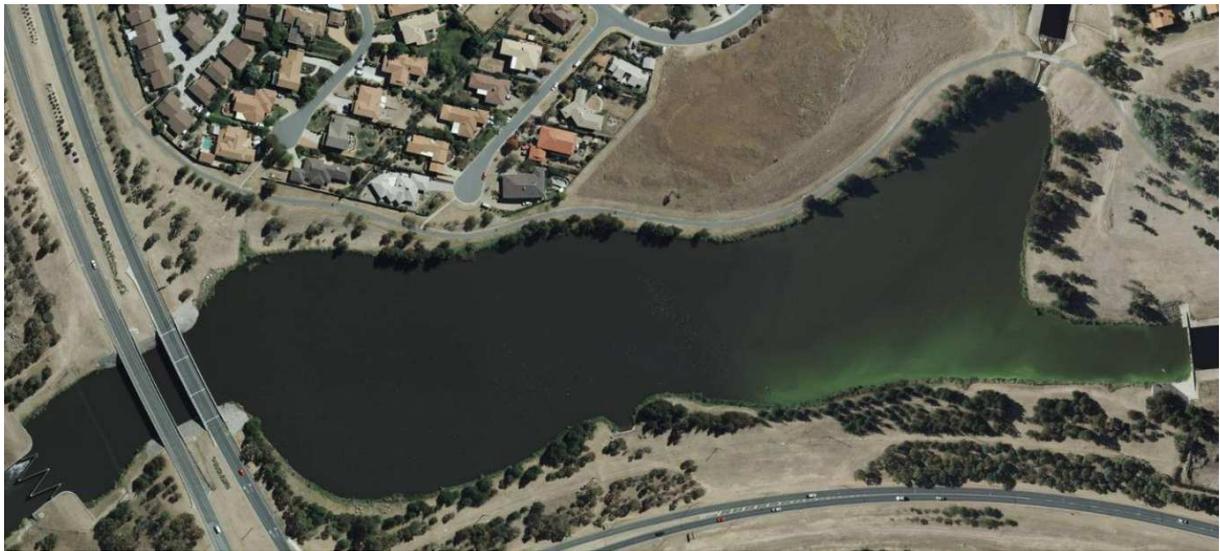
We reviewed past aerial images and saw that algal blooms have been recorded in Isabella Pond in 2009 (refer to Figure 1) and 2014 (refer to Figure 2). It is not known how common these are. TAMS has noted that over the last few years, Lake Tuggeranong has been closed to recreation every Jan/Feb/March, due to algal blooms.

Figure 1: Algal bloom in Isabella Pond, 2009 (ACTmapi)

- Accumulated sediments could be removed from the pond (we would recommend a study first to identify the quantity and quality of accumulated sediments)
- The upstream catchment could be retrofit with stormwater treatment to improve water quality reaching the pond
- The normal water level could be lowered and a new riser outlet could be installed so that extended detention could be incorporated into the pond
- In conjunction with the above, additional macrophyte planting could be established in the edge zone, including the ephemeral zone which would be created
- The pond could be completely rebuilt as an offline wetland with a separate sediment basin and high-flow bypass

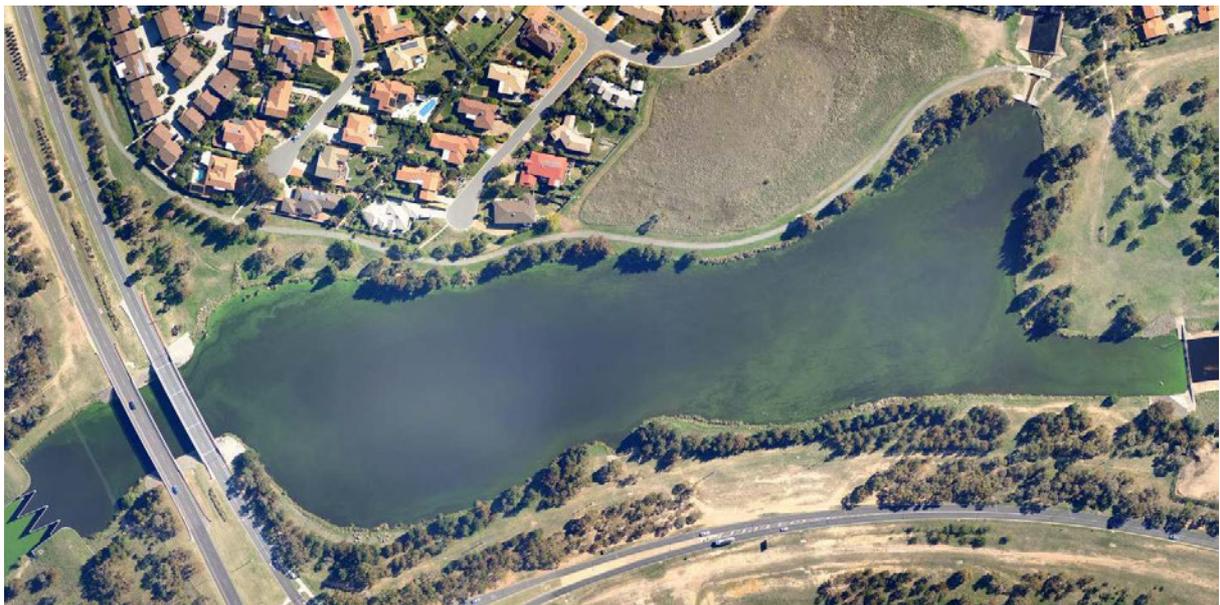
Figure 2: Algal bloom in Isabella Pond, 17 March 2014 (Nearmap)

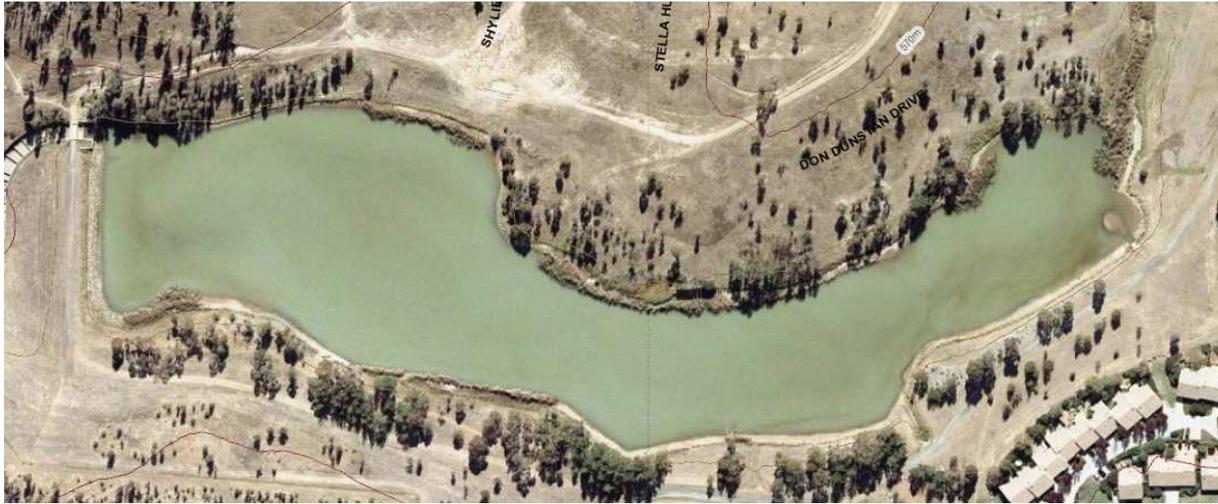
We reviewed past aerial images and saw limited evidence of algal blooms. The only image which looks like it could be an algal bloom is the ACTmapi image from 2004, shown in Figure 1.

Figure 1: Possible algal bloom in Lower Stranger Pond, 2004 (ACTmap)

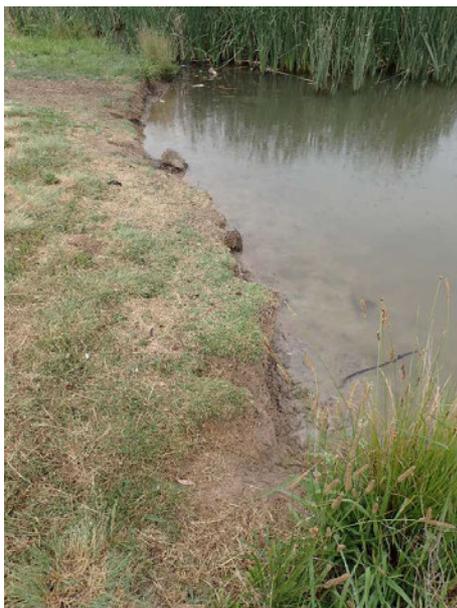
Minor bank erosion was observed in one location at Lower Stranger Pond – refer to Figure 2.

Figure 2: Minor bank erosion in Lower Stranger Pond

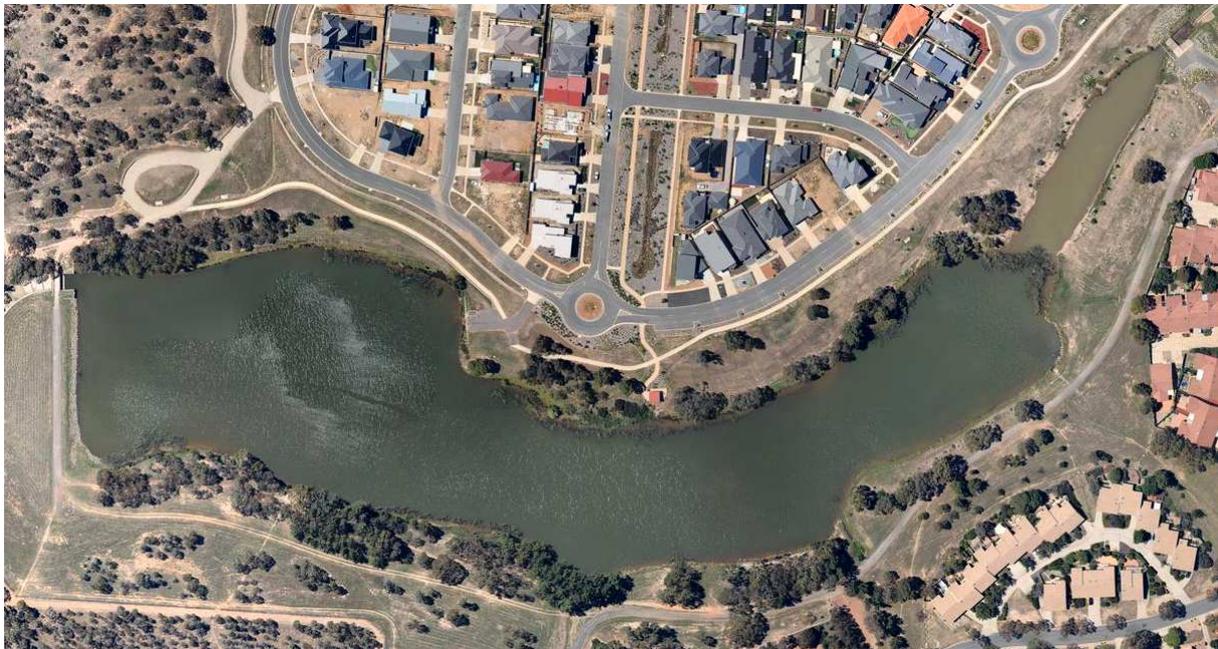
Figure 3: Lower Stranger Pond, 19 January 2010 (Nearmap) showing distinctly different water quality in the inlet zone and main pond

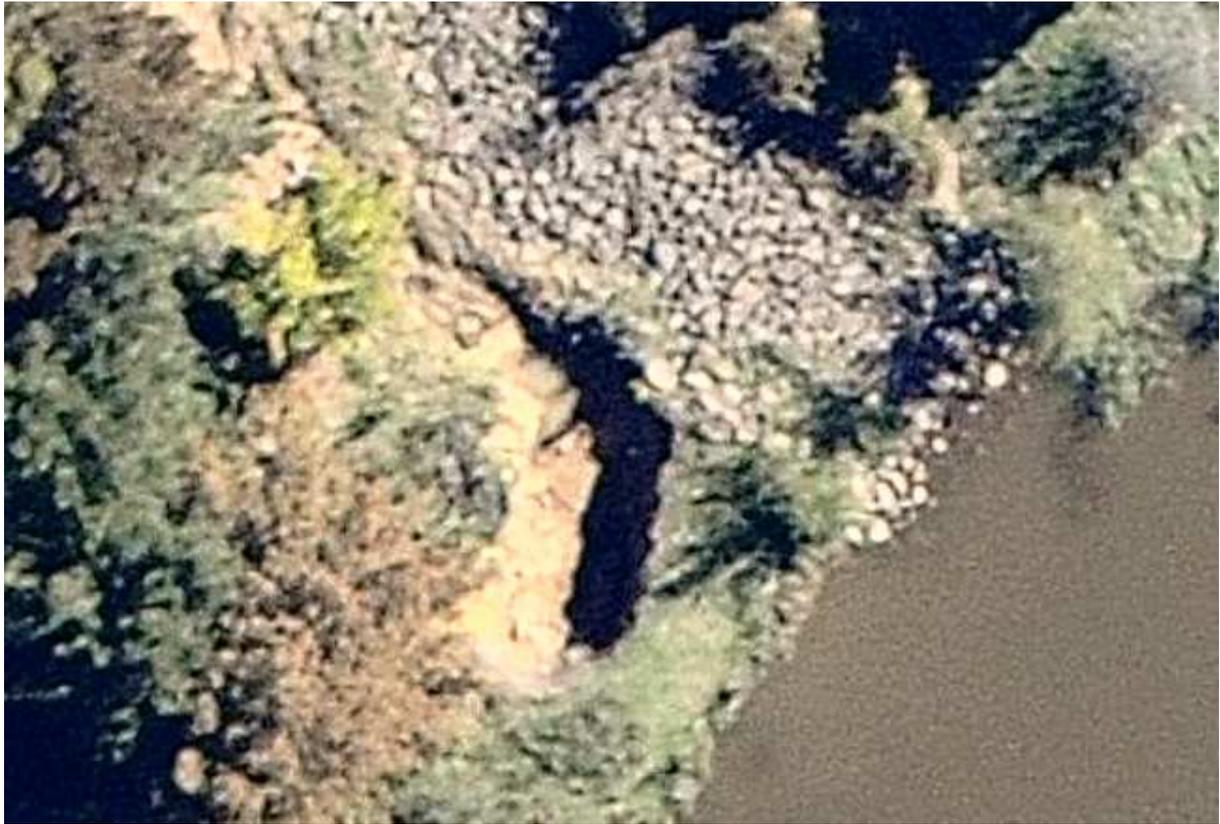
Figure 1: Scour hole in downstream embankment beside rock chute (Nearmap, 17 March 2014)

The scour hole was repaired in 2014 and Reno mattresses were installed either side of the rock chute. The finished works are shown in Figure 2. These works are now relatively stable. We observed minor erosion at the top of the embankment, on the edge of the Reno mattress (refer to Figure 3), however this is not yet threatening the stability of the structure. We observed the site after a moderate rain event on 3 December 2014 and flows were confined to the central (older) part of the chute.

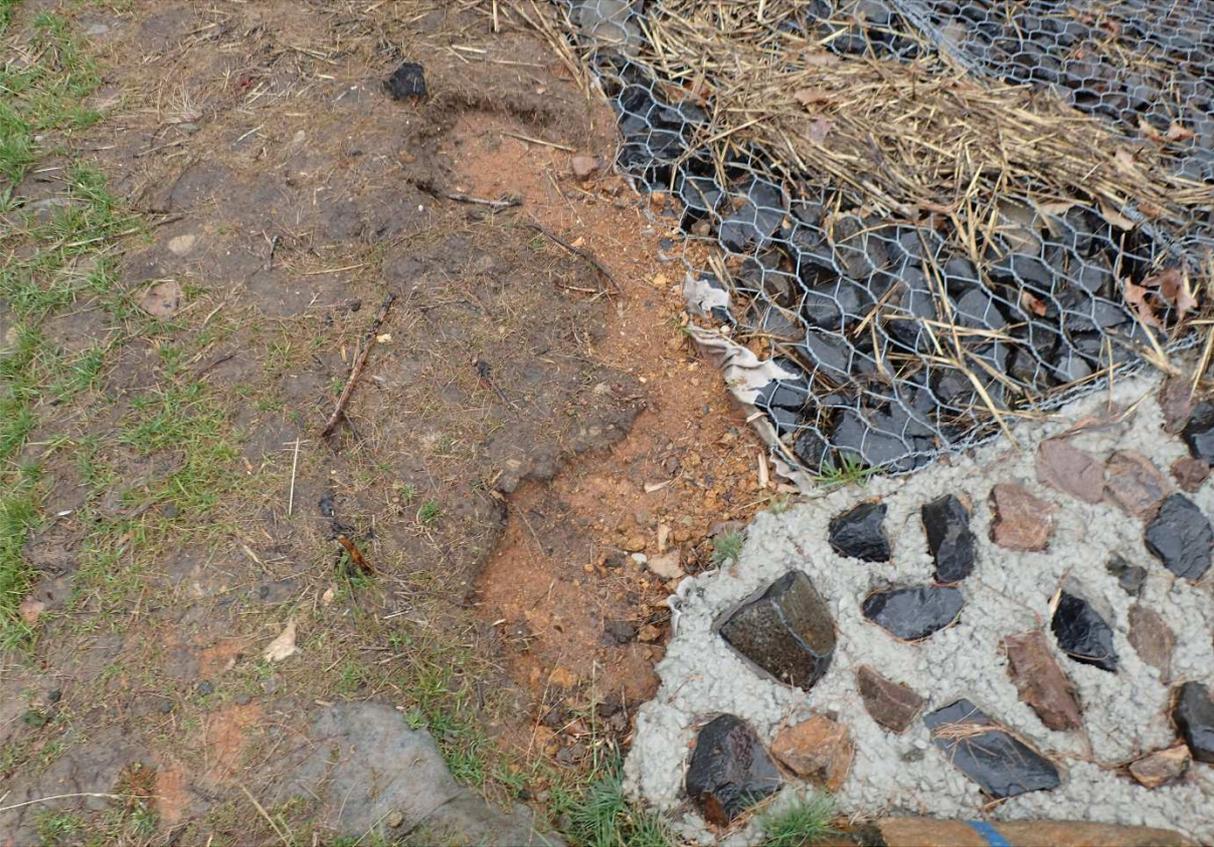
Figure 3: Minor erosion at the top of the new Reno mattress

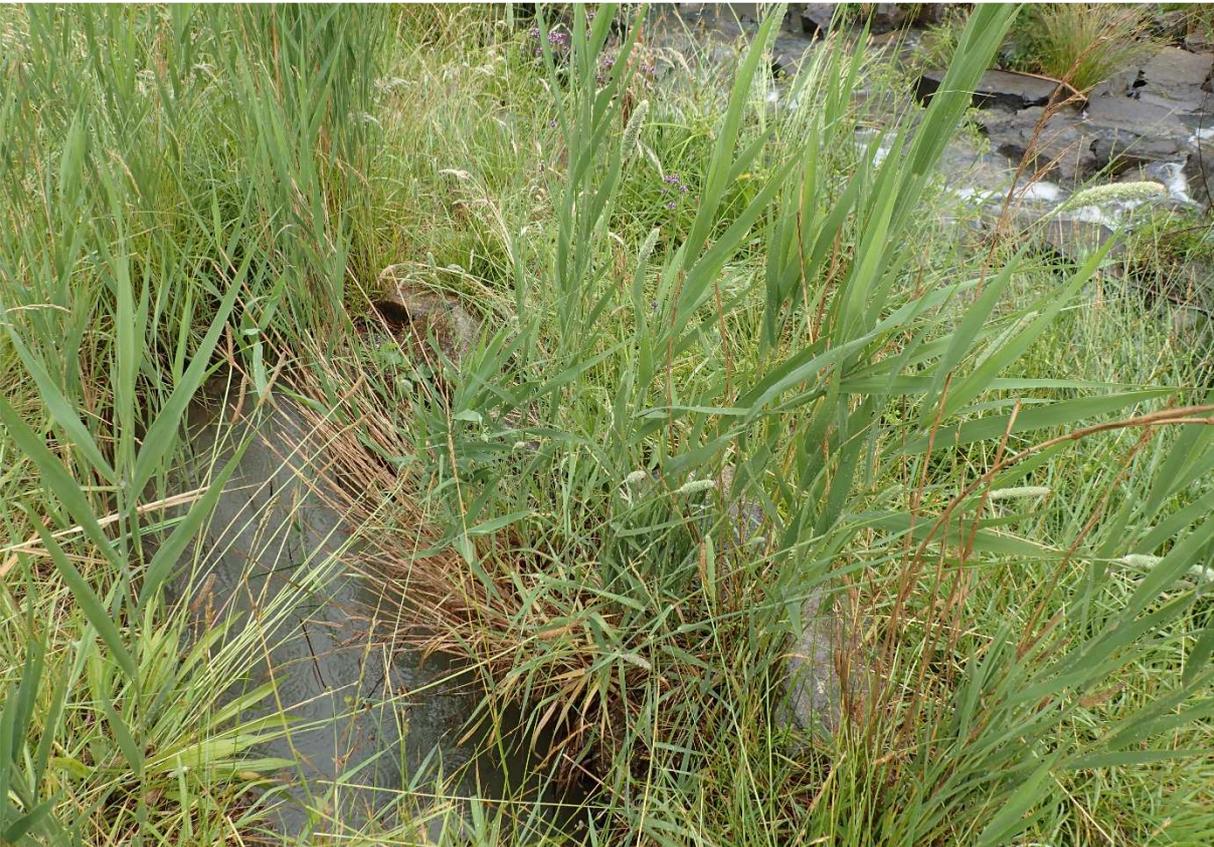
We also inspected the upper rock chute and vegetated bank in December 2014 and found that there is another scour hole starting to form in this embankment. This is shown in Figure 4. At this stage the hole is small (approximately 1 m² and 1 m deep) however it also has the potential to expand over time into a large hole, as occurred on the lower embankment. The same flow conditions occur at each chute and the original design of each was very similar.

Figure 4: Scour hole developing in the upper embankment

It is recommended that the scour hole forming on the upper embankment should be monitored and it will need to be repaired at some stage. Options are:

- Keep the pond and embankment and undertake repairs similar to the downstream site
- Remove the pond and embankment and restore a stable creekline between Point Hut Pond and the lower pond.

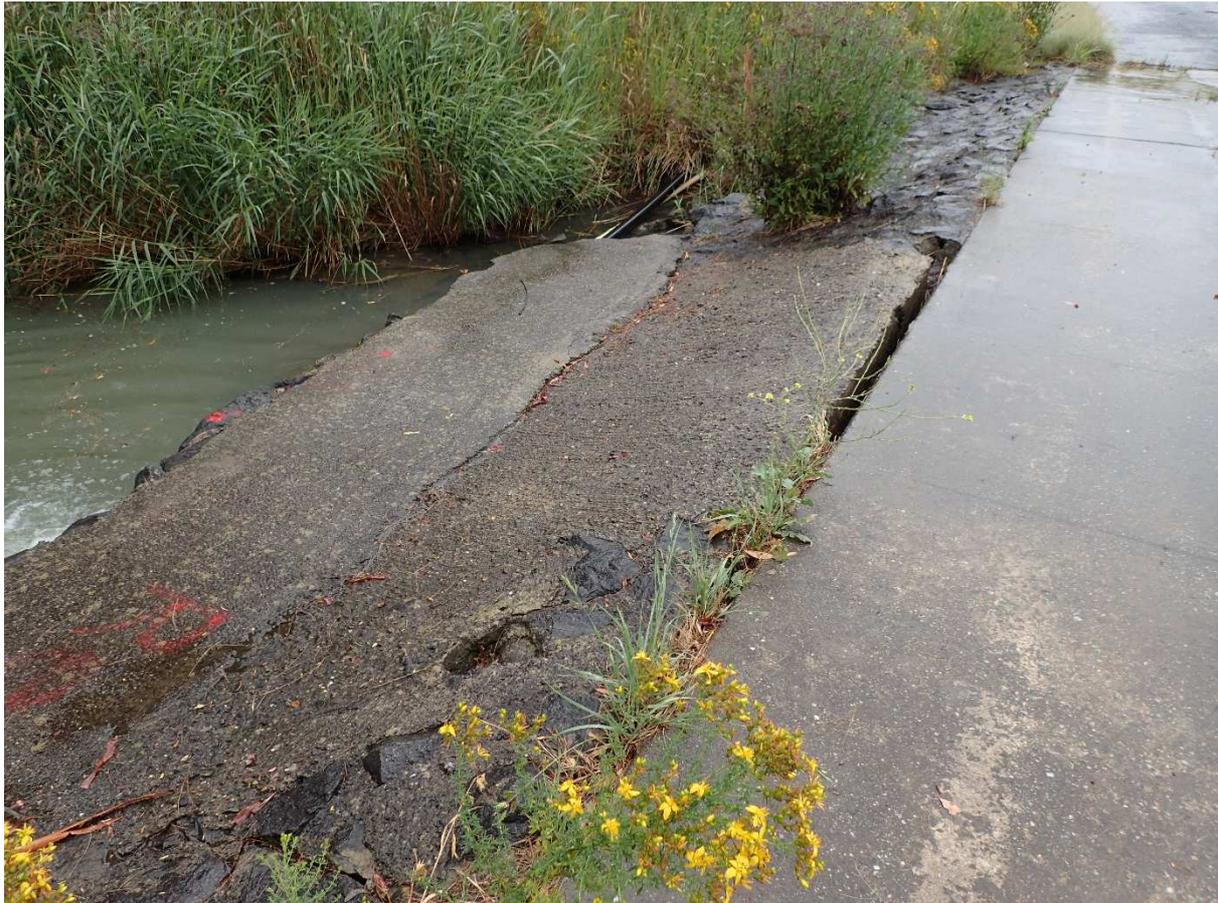
We inspected the creek upstream of the upper pond and the only stability issue noted here was minor damage to the concrete structure at the causeway between Point Hut Pond and the downstream ponds. A crack has opened between the main concrete structure and the concrete apron on the downstream side. This is shown in Figure 5.

Figure 5: Minor damage (crack) to concrete structure at causeway

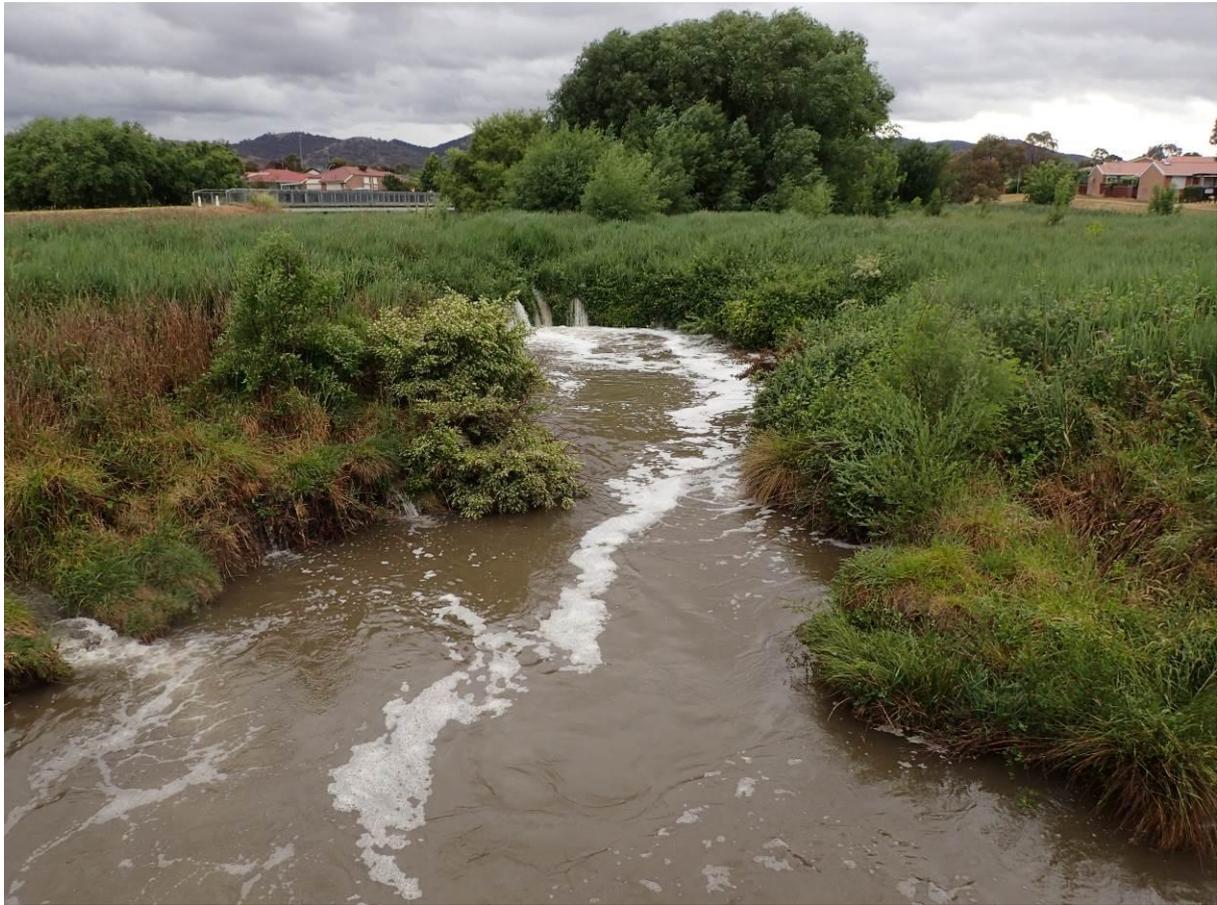
Figure 1: Knoke Ave waterway major headcut, upstream of Point Hut Pond

The headcut at the downstream end of this section is undermining these values. This is being caused by the steep gradient change between the vegetated portion of the channel and Point Hut Pond, the nature of the soils and the quantity of the water flowing in the channel. As the water is flowing over this steep gradient change in an un-controlled manner the bed is eroding and has formed its own informal drop structure to reduce the erosive forces in the channel.

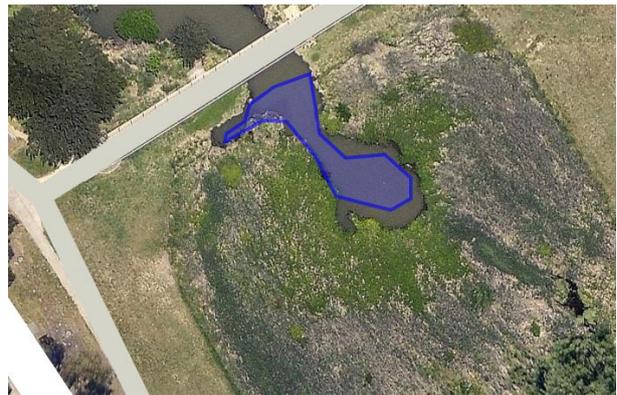
Figure 3: Headcut area in October 2014 (blue shows area of headcut in Sep 2011 for comparison to show expansion)

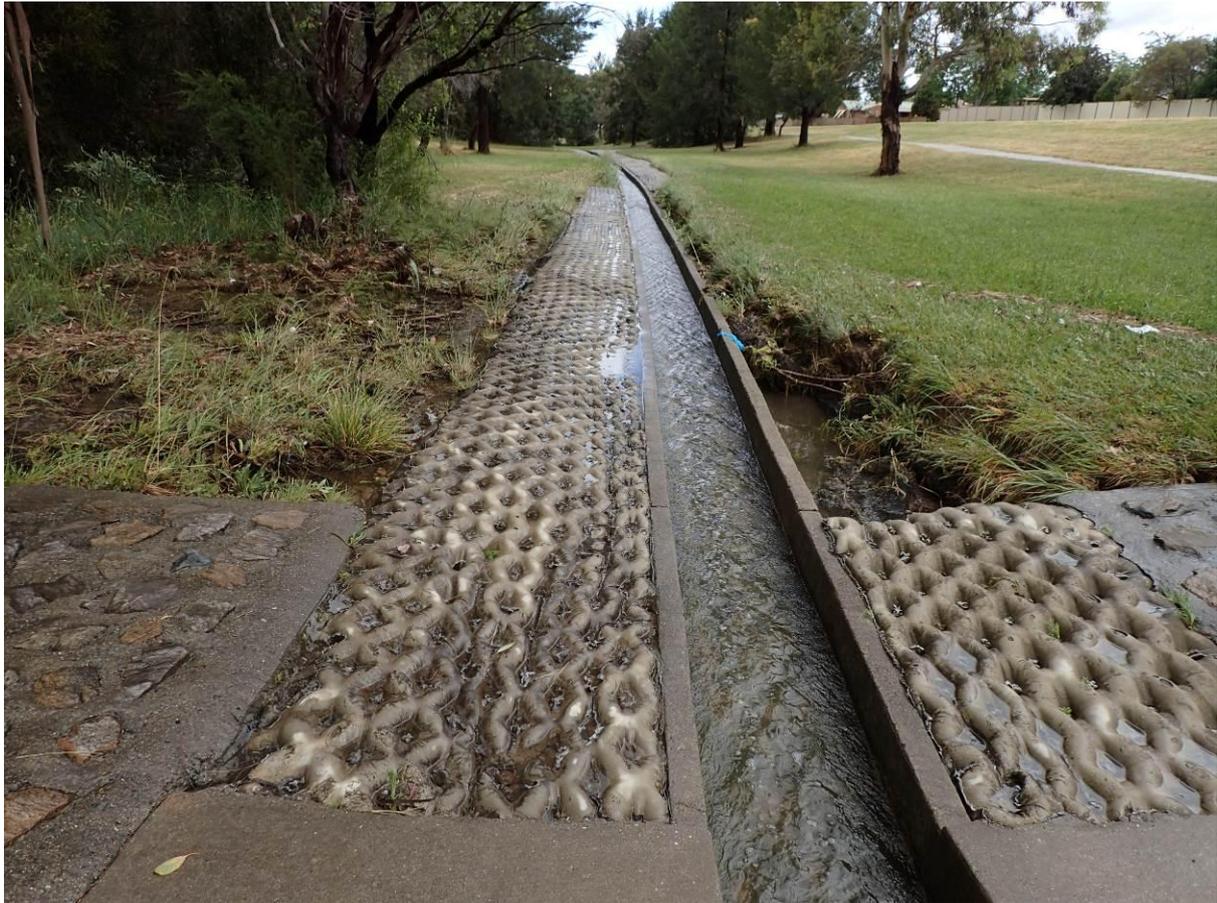
Figure 4, Figure 5 and Figure 6 show the erosion of the waterway at the interface of the concrete low flow channel and the adjacent mown grass channel. The area shown in Figure 4 is significantly eroded with a depth of erosion of approximately 300 mm from the adjacent base. It can be seen that erosion is occurring at the interface of the patchwork scour protection (likely undertaken to address previous erosion). Where the scour protection has ended further erosion has occurred and in this instance been exacerbated by the works undertaken as it has concentrated the erosion in this location.

Figure 4: Knoke Ave waterway with significant erosion at the end of the concrete scour protection to low flow channel

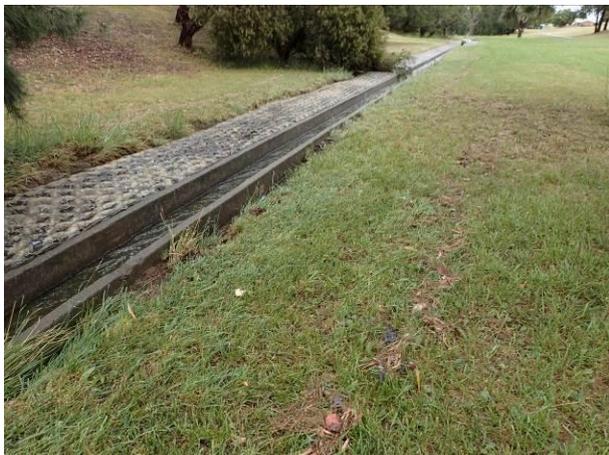
Figure 5: Scouring at interface of low flow channel and mown turf (note debris indicating water level mark, centre)

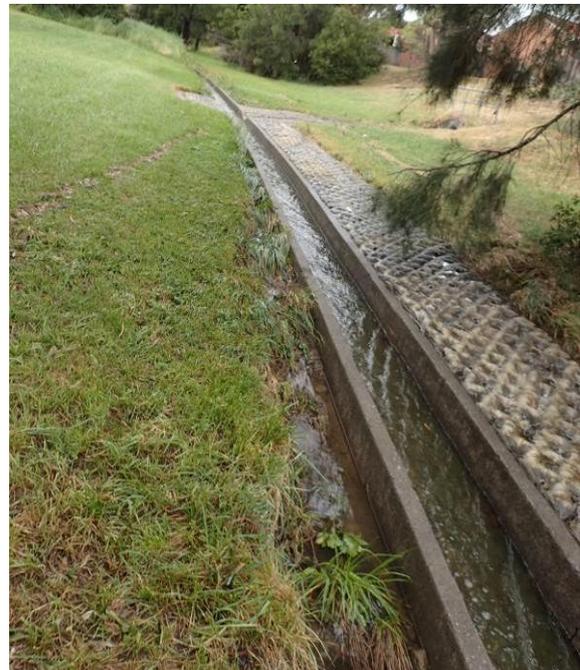
Figure 6: Scouring at interface of low flow channel and mown turf (note debris indicating water level mark, left of photo)

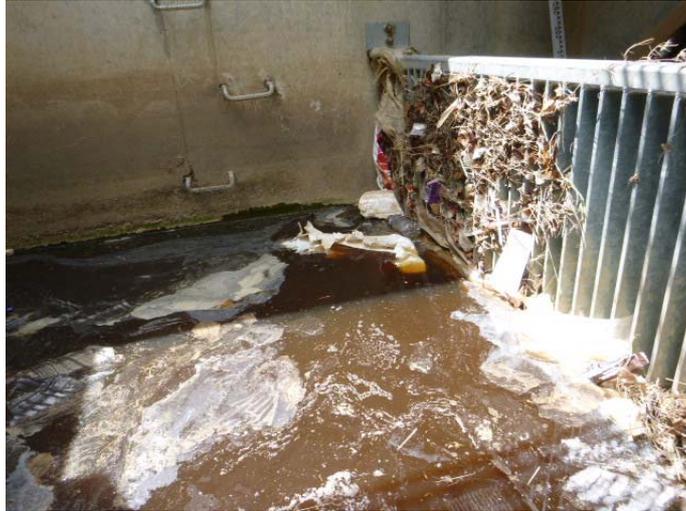
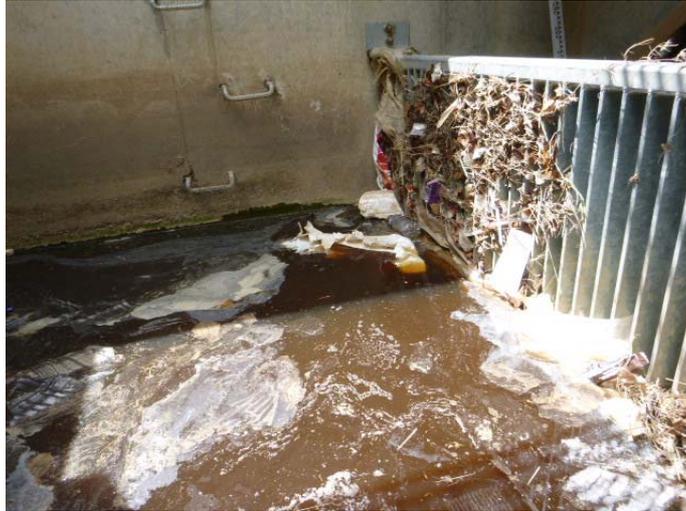
Trash builds up on the end rack very quickly there are tide marks on the wall showing water has built up and been in line with the top of the racks for some time.

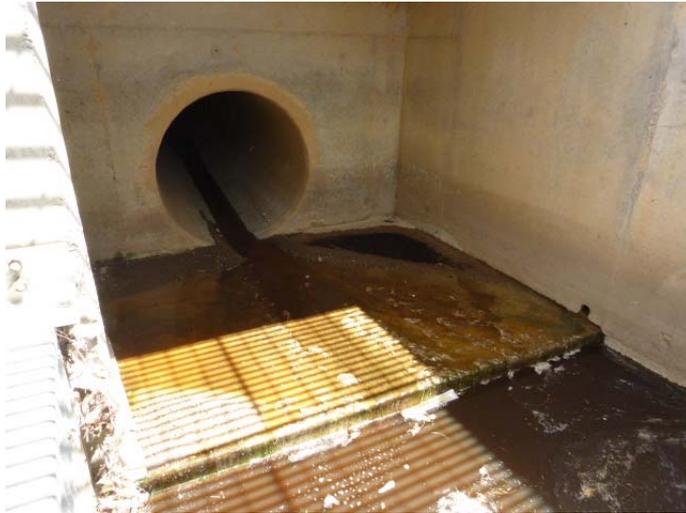
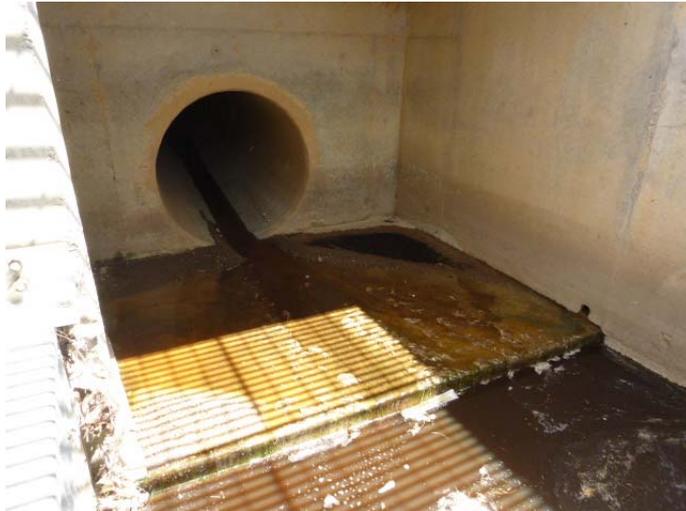
Inlet into the chamber, again tide marks show that backwater has occurred up into the pipe, this is due to the racks being too small and blocking quite often.

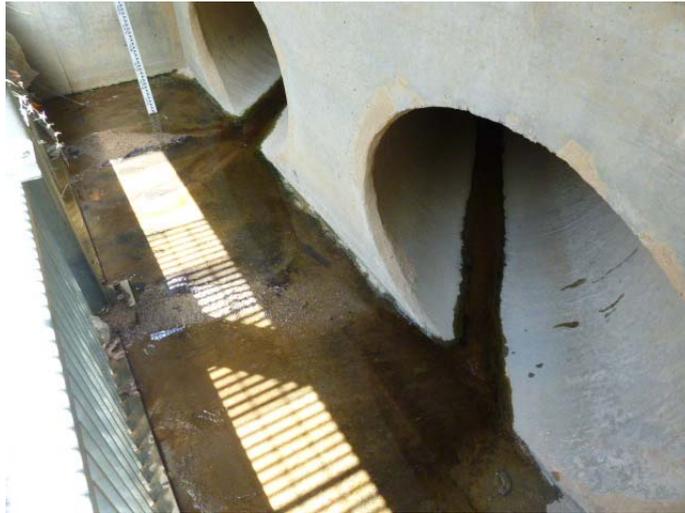
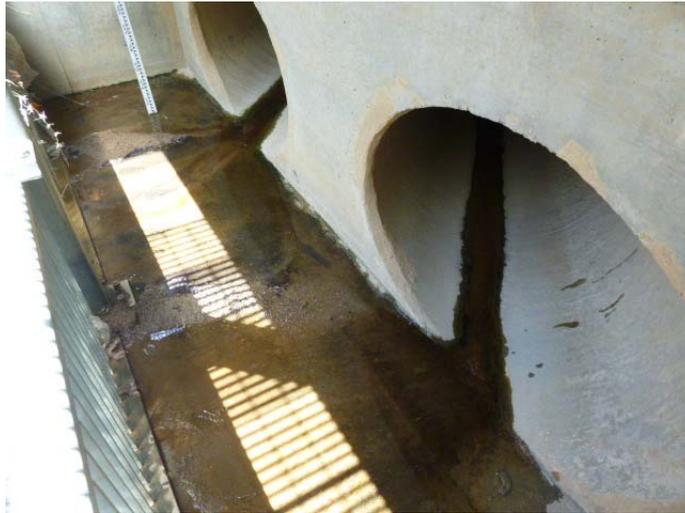
Outlet pipes, there is some sediment build up on the wrong side of the trash racks. One pipe in and 2 pipes out, presumably due to grade or size to get under services.

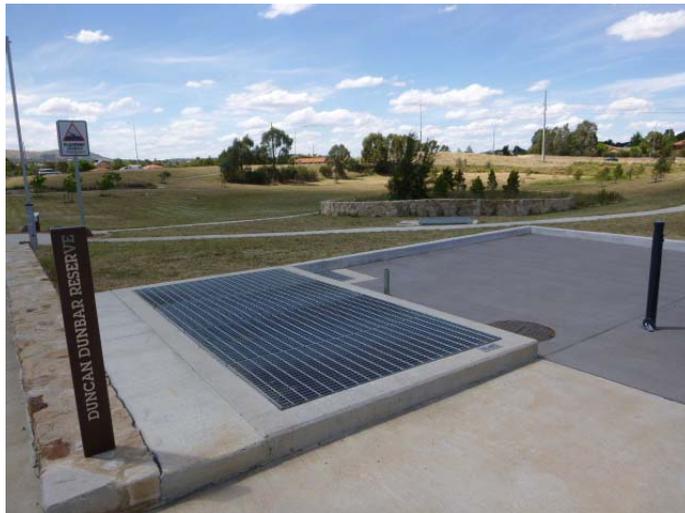
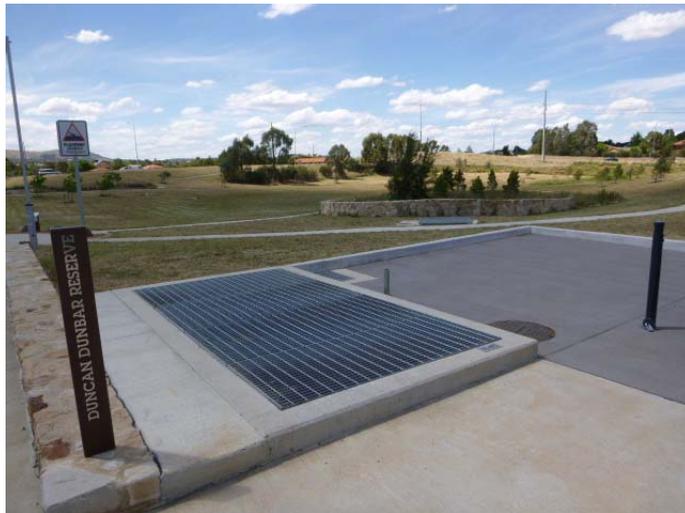
Site and metal grating lids. The site is clean and has plenty of room for maintenance or extra works. For a brand new, high quality residential development, the bioretention system is appropriate, but the GPT is not. This is having a notable negative impact on the bioretention system, letting large volumes of sediment and litter through.

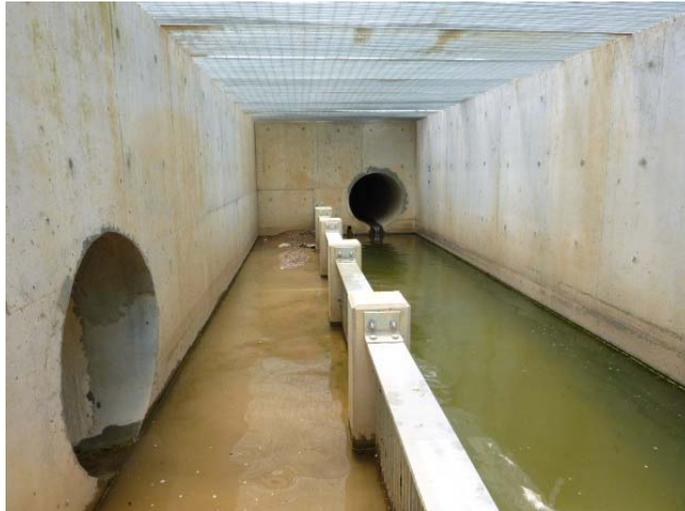
High quality construction in the chamber, but only an average design.

Pollution is pushed to the back rack which is the first place the device overtops.

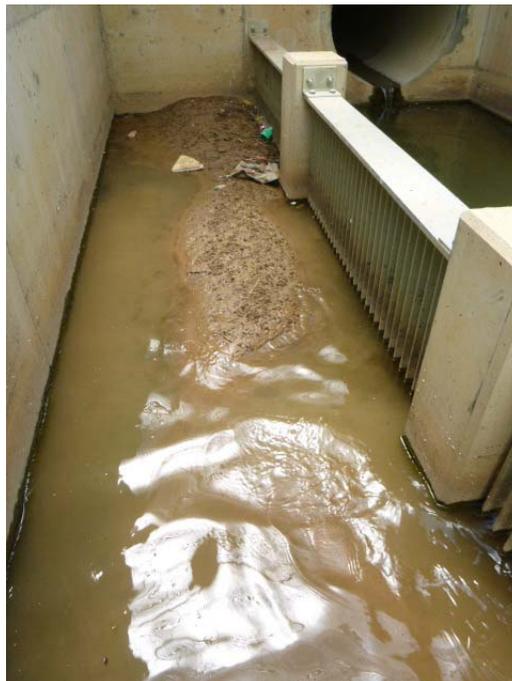
The trash rack has been cleaned recently but there is a large build up of sediment on the downstream side of the trash rack, that was not removed. This shows there is a need for a different type of GPT that will better capture and remove silts/sediment. If this volume was captured purely by deposition in elevated levels of standing water during a storm, imagine how much has come down the line.
