Asset 27: Yerrabi Pond

Asset 39: Isabella Pond

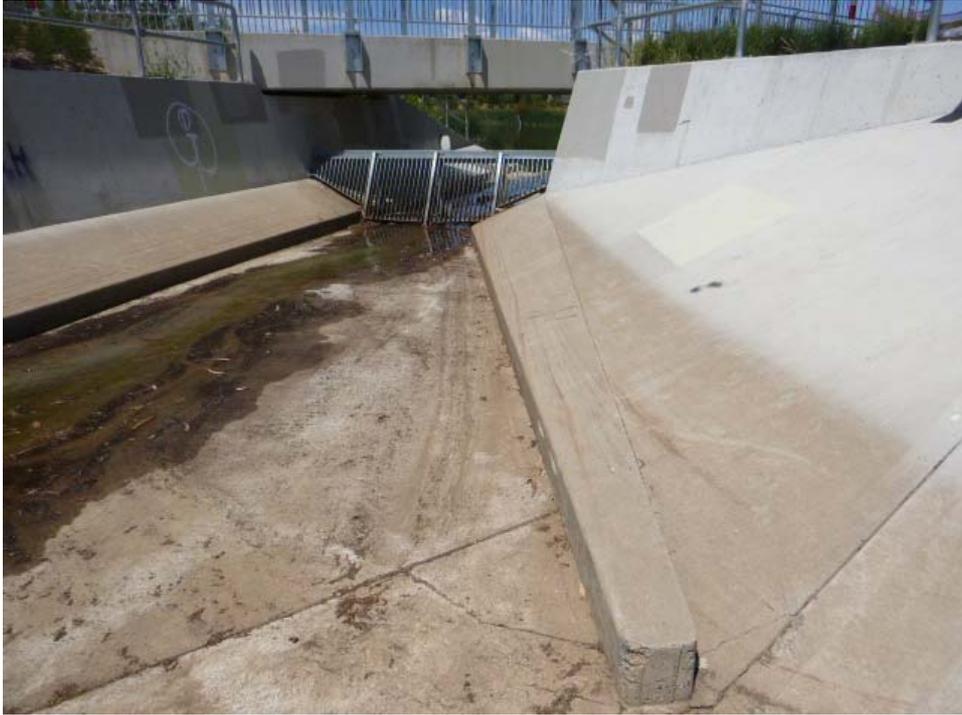
The Trashrack was placed in the smallest cross section of the upstream stormwater to save money on construction, but this means it blocks quickly, then bypasses flow and pollution. In this case, note the tide mark. Pollution higher than this bypasses in the main channel, not over the trashrack and into the pond.

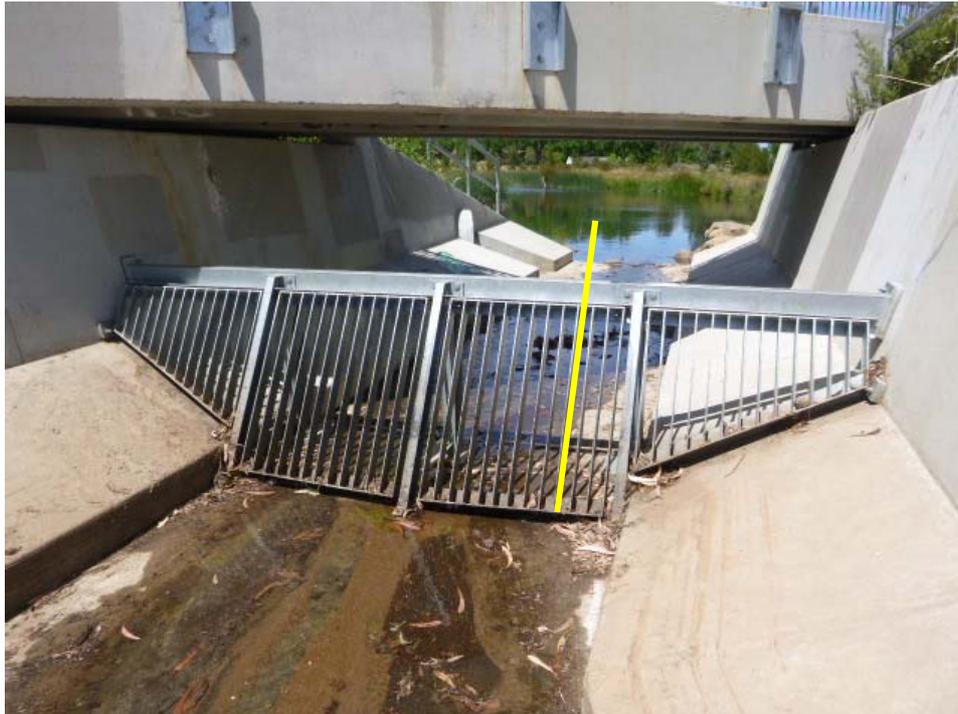
Trashrack under footbridge. This is way too small for the catchment. This could stay, with a massive new trashrack added across the main channel, down to where the yellow joins the main rack here.

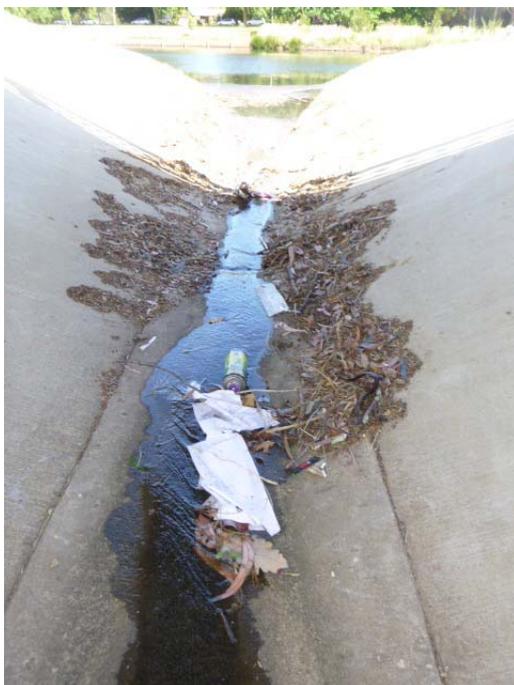
Downstream of the weir showing signs of bypass and some organics build up

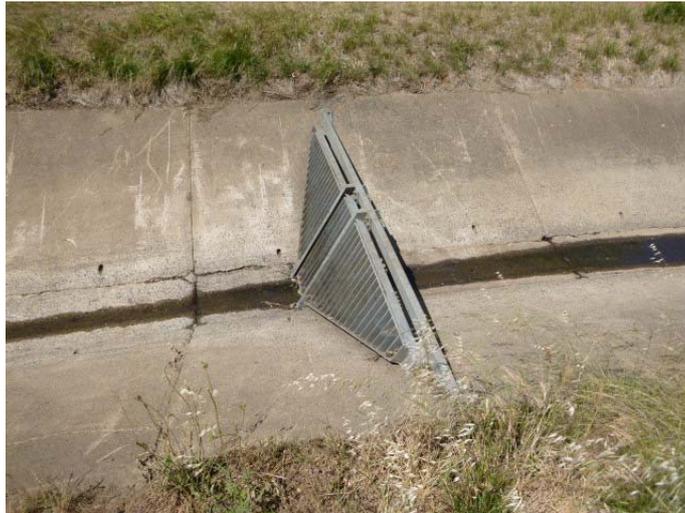
Trash rack which in high flow would almost just become a ramp for floatables and other pollution. Its undersized and online, with bypass straight over the top.

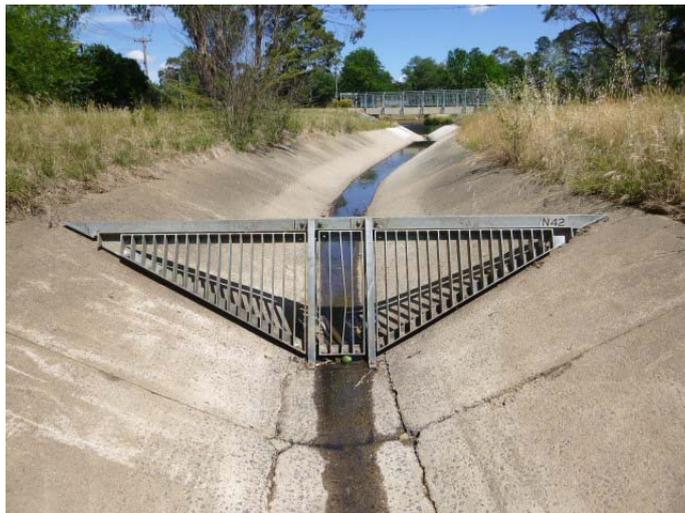
The trash rack is very small and has almost no capture area
It must have been just cleaned, with no rain before this photo.

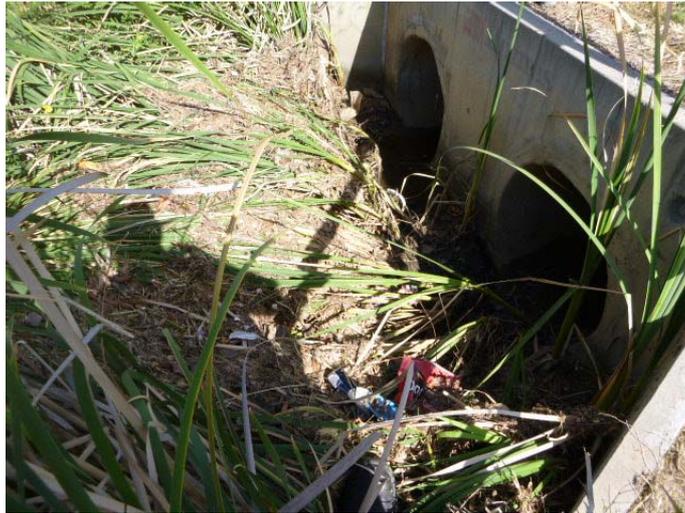
Downstream outlet from CleansAll showing vegetation build up and pollution that has bypassed the device. The water has to jump up to a height that will send the Cleansalls into bypass as it hits this vegetative barrier.

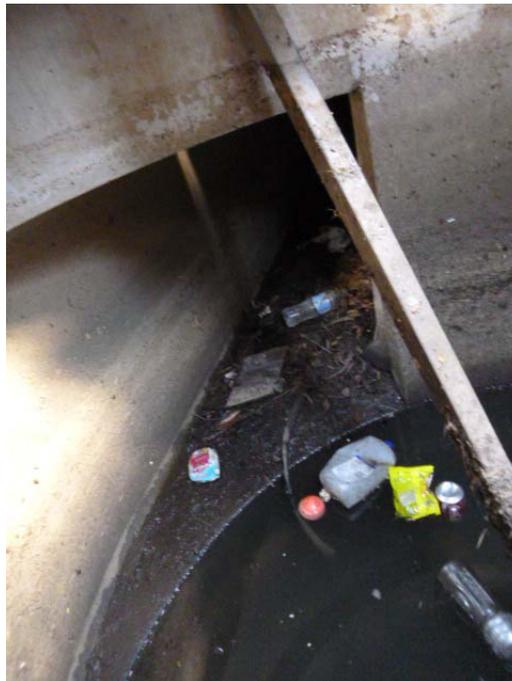
Little pollution inside the Cleansall unit, because the downstream vegetation keeps it regularly in full bypass.

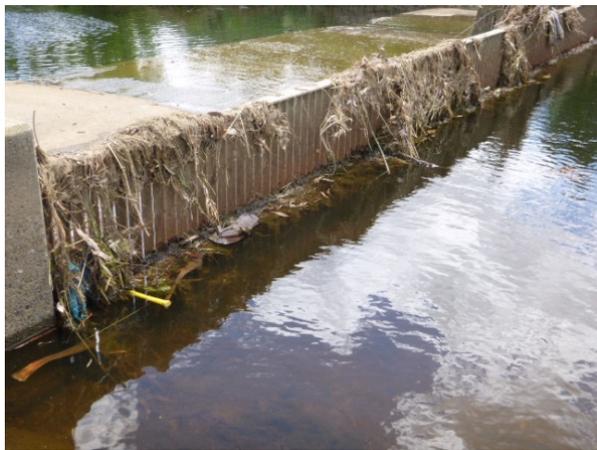
Trash rack showing evidence of overtopping and bypass

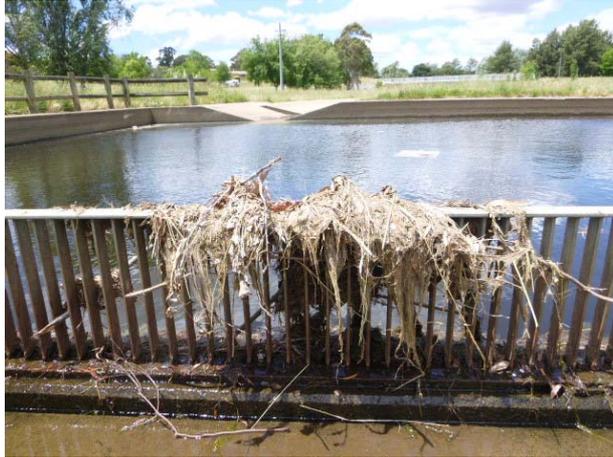
When debris blocks on the vertical racks during a storm, it will eventually slide down or peel off, except if it gets caught partially over the top. This sort of pollution can simply be cleaned from the racks back into the water. It will waterlog and sink, for removal with the other pollution later.
