ACTGPT-24a

Address	McGilvray Close, Gordon
Device	Custom GPT
Site Details	Access way off McGilvray Close
Estimated catchment area	-
Device Status at Nov 2014	Operational, device 15% full
Device comments and recommendations	<p>This device seems appropriately sized for the catchment, but its size is unknown. Regardless it would be improved with increased rack size and design</p> <p>Extra set of racks could be installed or one set of racks running along the northern edge of the sediment basin to create a high flow bypass to help avoid already trapped pollution being washed away.</p> <p>Grass cutting around the area should be done with a catcher as grass is being washed down into the rack and this breaks down and sends the GPT anaerobic</p>
Rectification works required	<p>Install new higher racks and high flow bypass</p> <p>Repair erosion damage upstream</p>
Existing maintenance	TBC
Maintenance expectations with rectifications	Quarterly

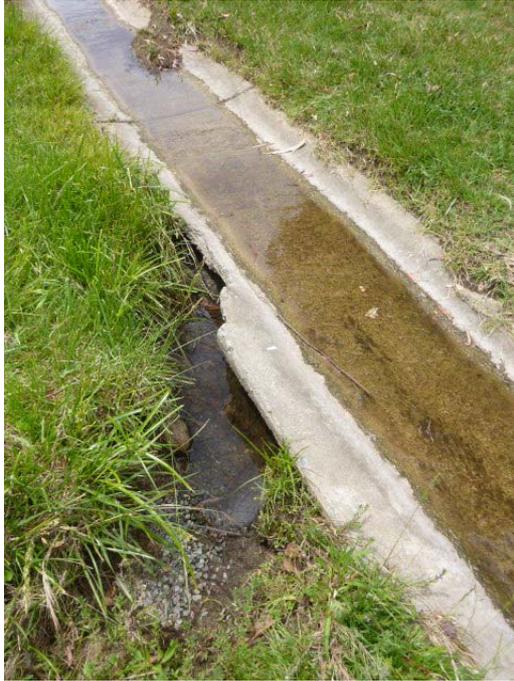
Erosion happening around the concrete low flow dish drain upstream of the GPT

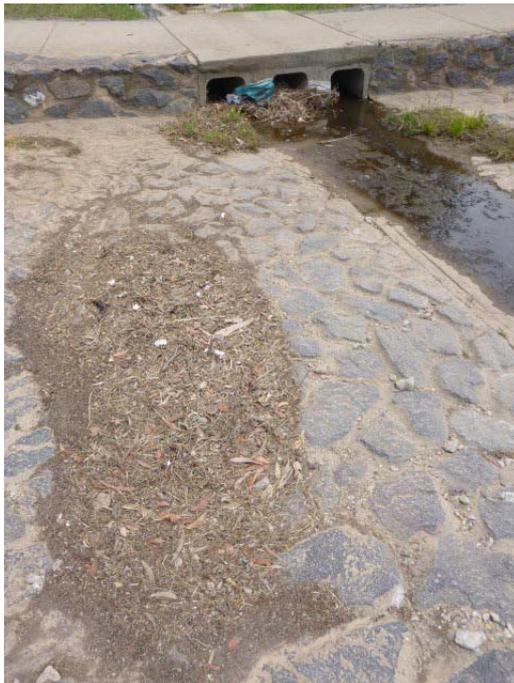
Sediment and organics built up downstream, indicating that certainly some pollution is going through the racks or over them when they block. A high flow bypass would reduce this.

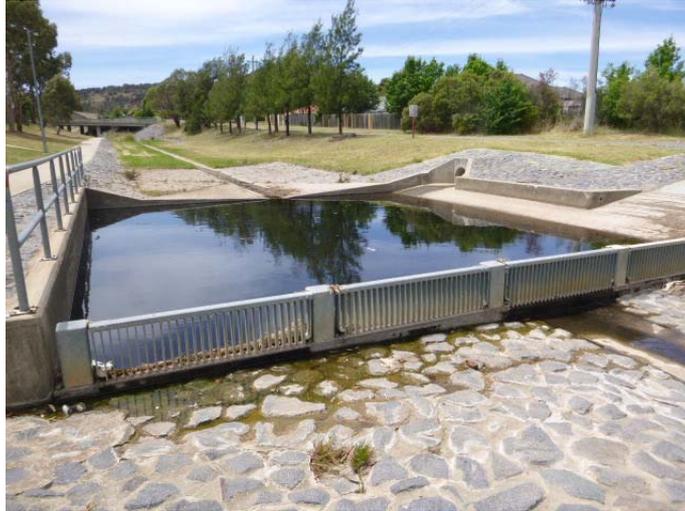
The trash rack could be improved by being made higher and being brought forward in line with the concrete footing to allow the pollution to slide off

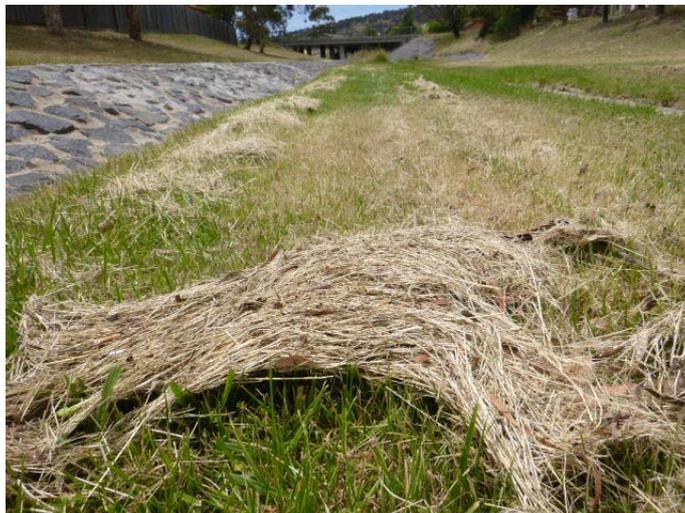
Grass cuttings should be removed when cut as they are building up upstream of the sediment basin, and these are known to be a primary source of poor water quality when their breakdown process sends the water anaerobic.

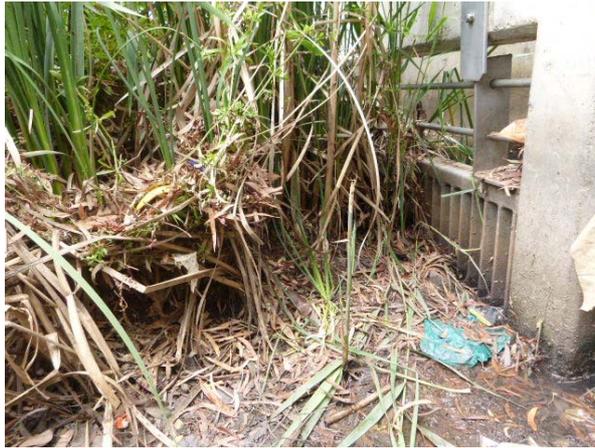
Vegetation growth blocking the outlet from the device. This is causing issues with the flow and allowing pollution to bypass the trash rack.

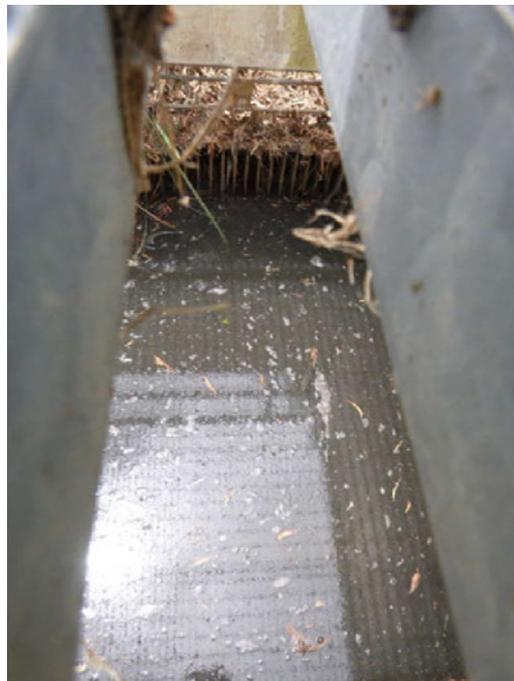
You can see that vegetation has grown to above the height of the trash rack this is causing bypass in low flow conditions. With the racks practically submerged, it could be that the galvanized racks will need replacing.

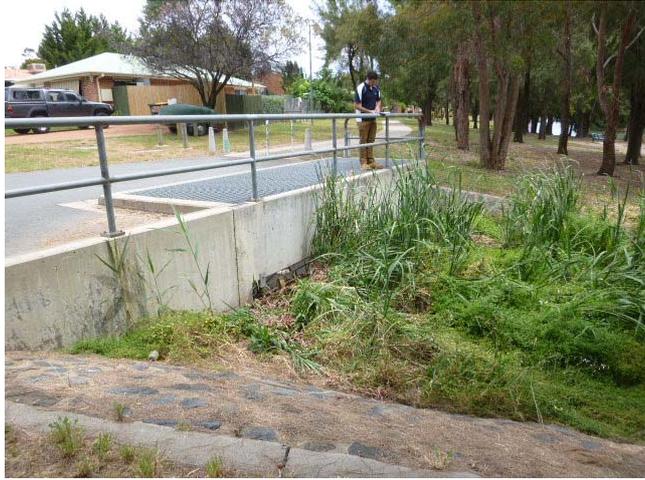
The downstream area is completely overgrown but there is lots of space around the chamber for maintenance and additional works

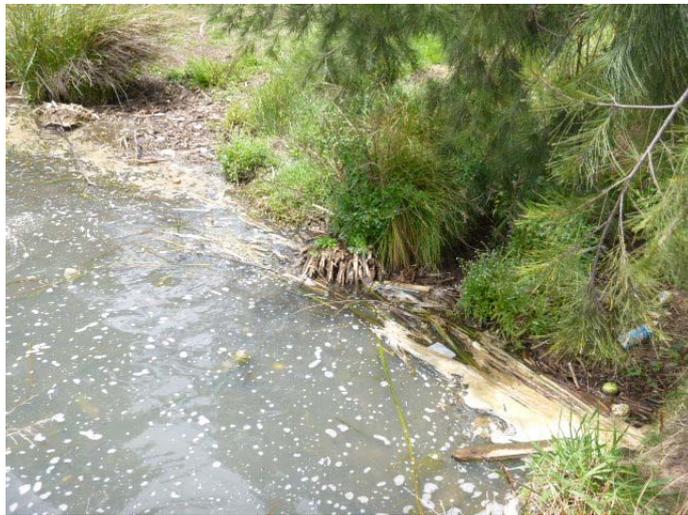
Pollution and scum on top of the water downstream. A GPT retrofitted would reduce this issue.

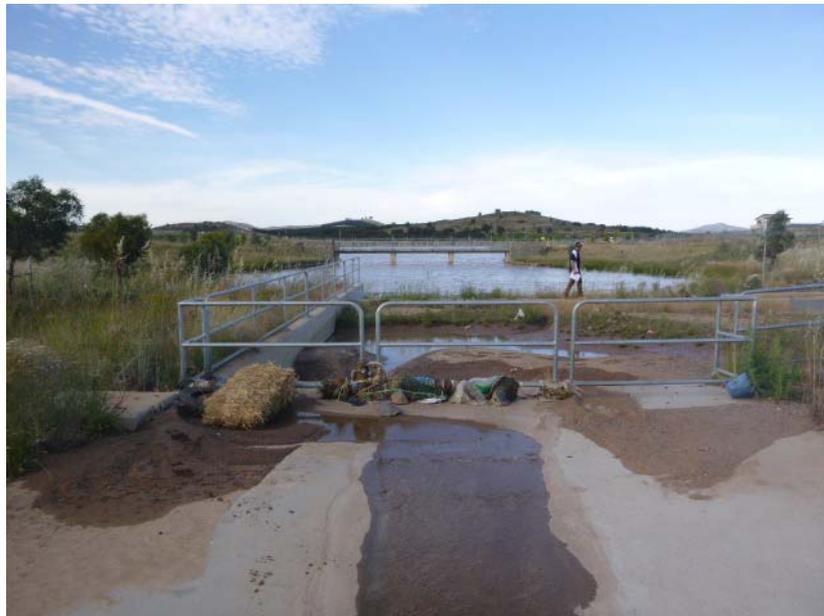
Upstream of trash rack showing where the low flow can bypass the device on the left during cleaning. A hay bale has been placed there over the inlet to this. But note the massive buildup of sediments all over the place, plus blockage on the fencing. This design is flawed based on functionality as well as cleanability.

Rectification works required	<p>Report the issue to the EPA</p> <p>Clean out the very large volume of sediment</p> <p>Dredge the pond for the first 25m to remove the bypassed sediment and debris</p> <p>Decommission the trashrack and install an appropriate GPT</p>
Existing maintenance	Seemingly none
Maintenance expectations	TBC, depends on solution

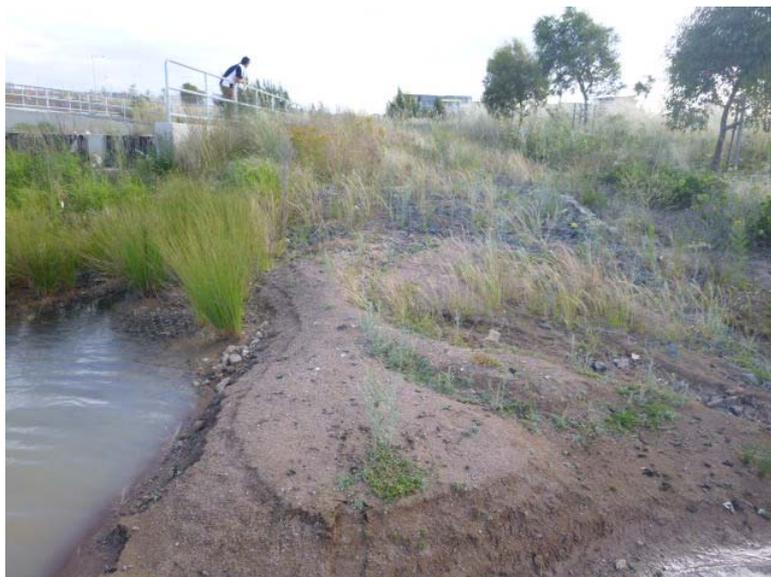
Build up in the pond of sediment that has gone down the low flow bypass for cleaning.

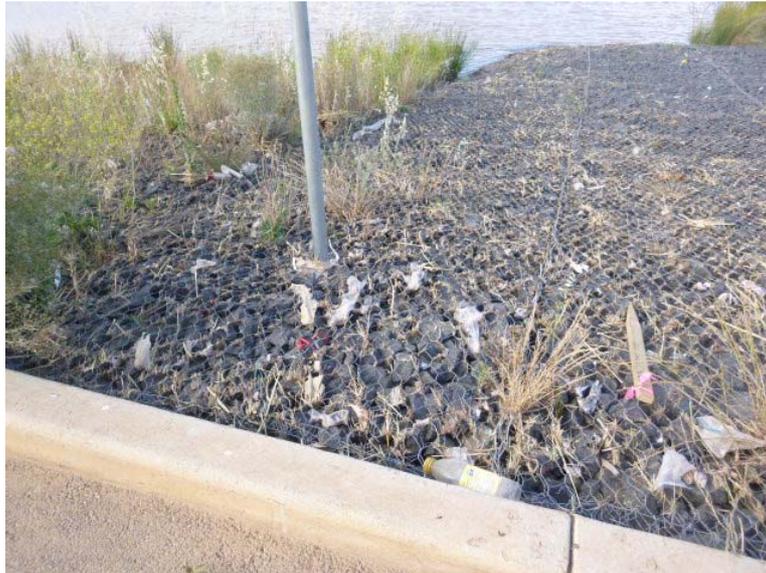
Gabion baskets collecting pollution

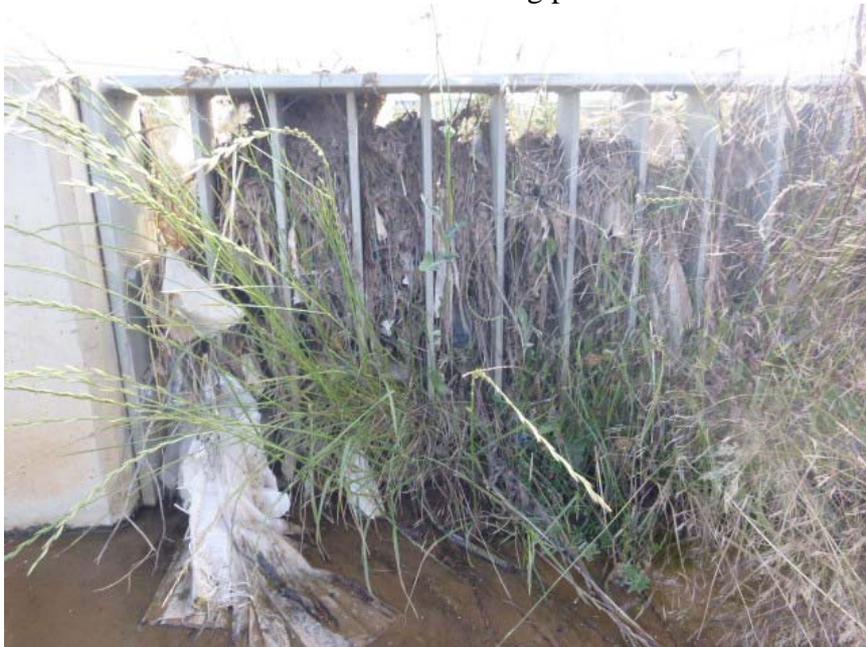
Vegetation and sediment behind the trash rack.

It has been there in bypass for so long it's now alive and growing.

The rack spacing is so wide (110mm) its takes vegetation to block on it, so other pollutants can block on the vegetation. This rack doesn't meet any standard or guideline.

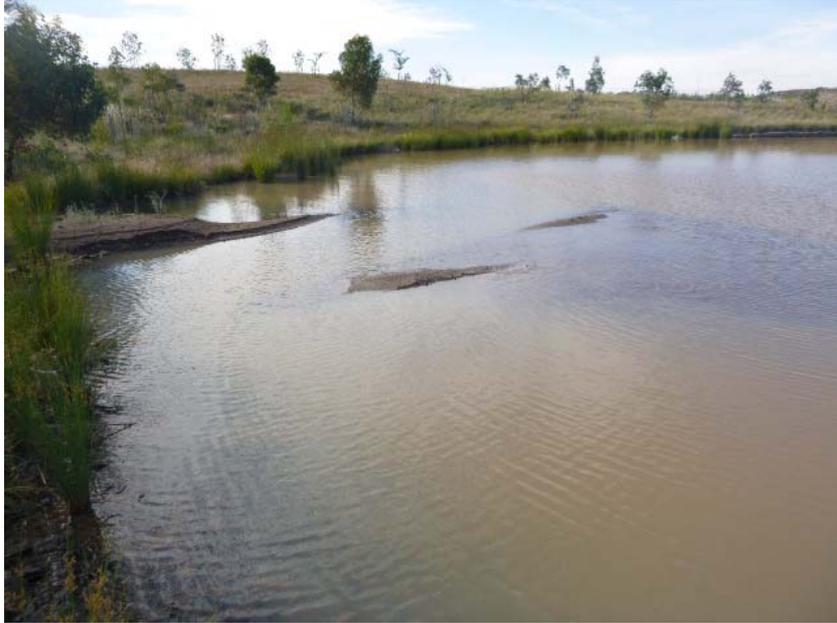
Sediment build-up in the pond downstream of the trash rack. This now needs to be dredged.

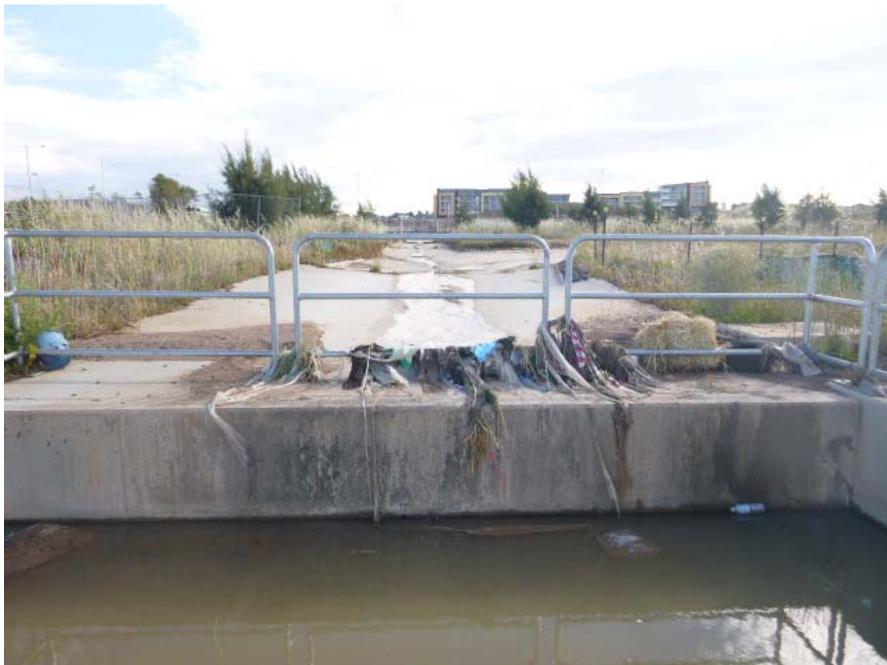
Pollution and rubbish caught on the upstream fence are sending flows into low flow bypass.
This is the worst design of a trashrack ever seen by this auditor.

In the foreground, water is pooled by the 500mm of sediment that is built up to a height equal to the top of the trashrack. There may or may not be a sediment sump in front of the trashrack, it's not possible to tell.

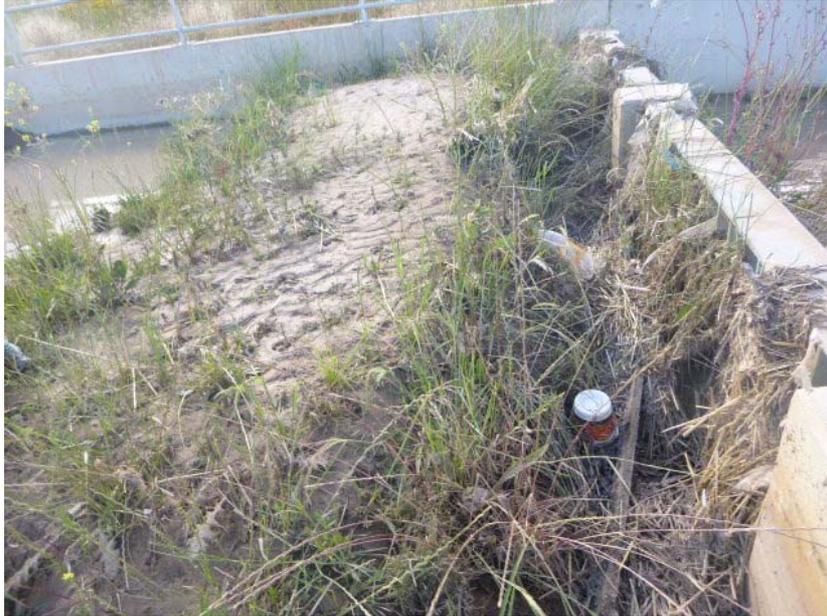
Sediment build-up above trash rack height.

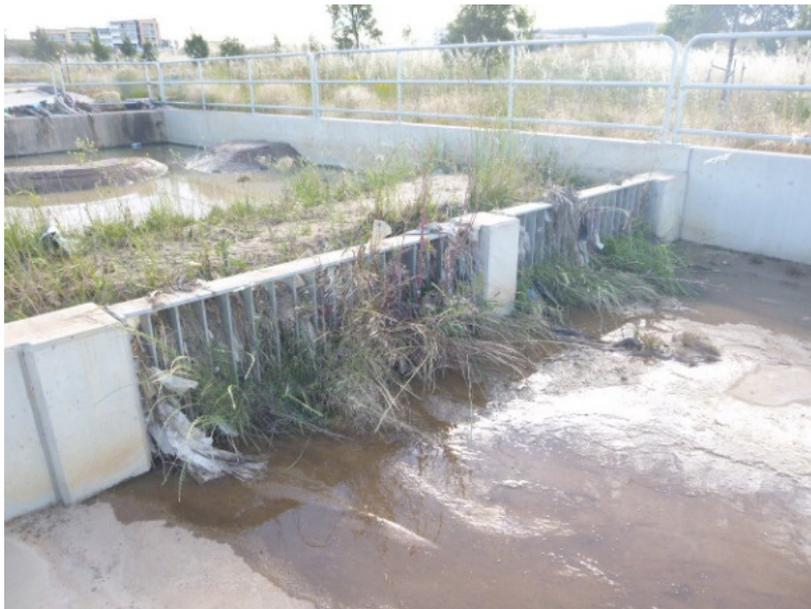
Trash rack overgrown and non-operational

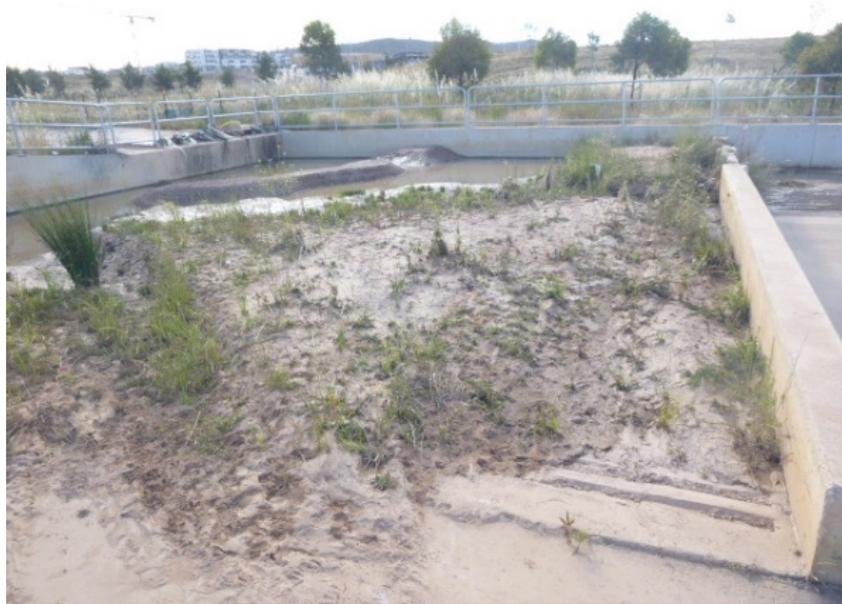
Sediment basin or just an access to the trashrack; there is so much sediment here due to lack of cleaning that it is impossible to tell.

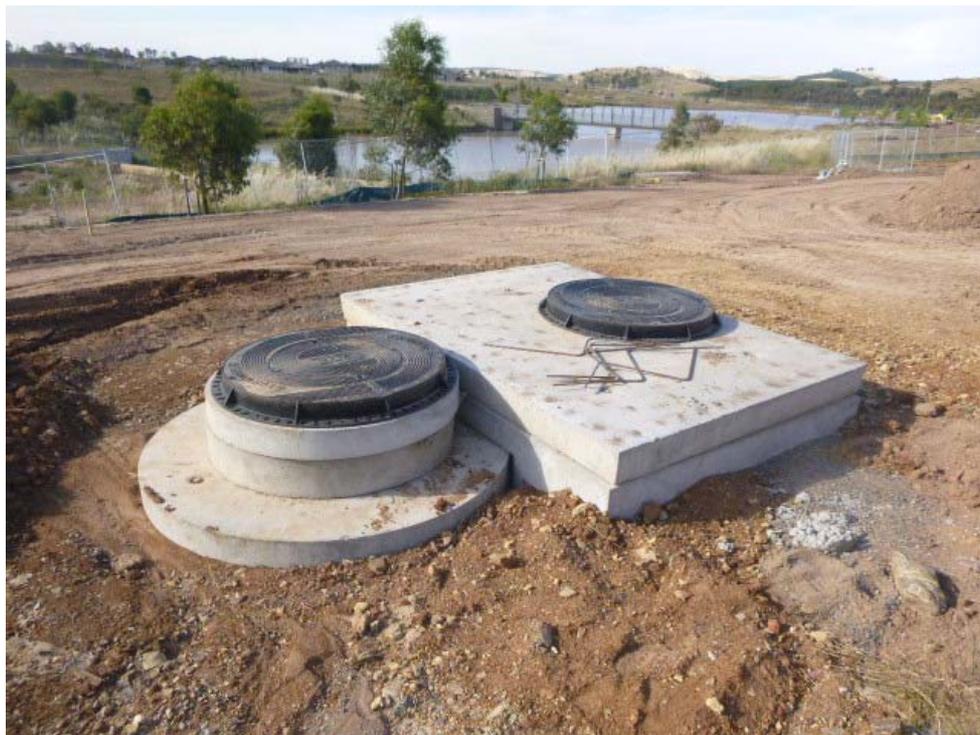
A CDS unit will be used to treat some of the development. This device was not monitored, but there was no point. If the trashrack is in neglect, and the CDS unit is 20 times more efficient, it will be non-operational as well.

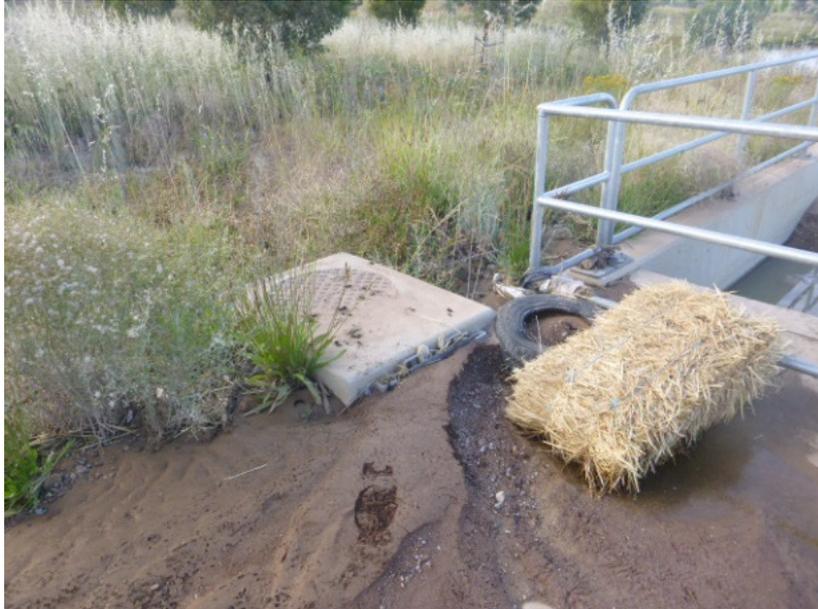
Upstream flow bypassing the trash rack. The sediment loads are massive due to poor erosion control on the development and upstream.

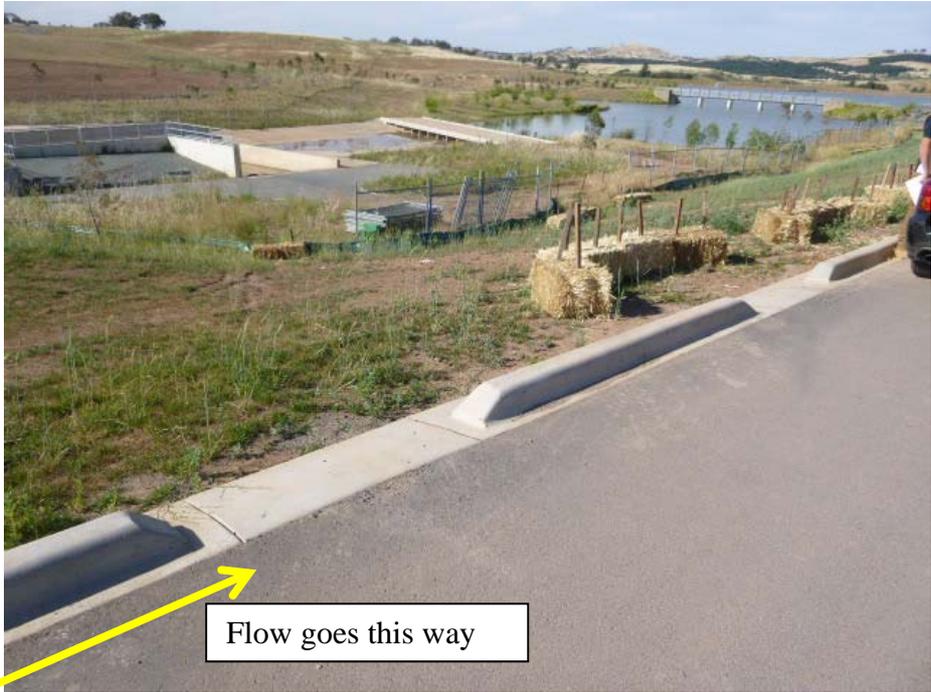
The kerb is designed to allow water to run off in a diffuse way, yet discourage drivers from taking a vehicle down the embankment. However, the hay bale placement is poor.

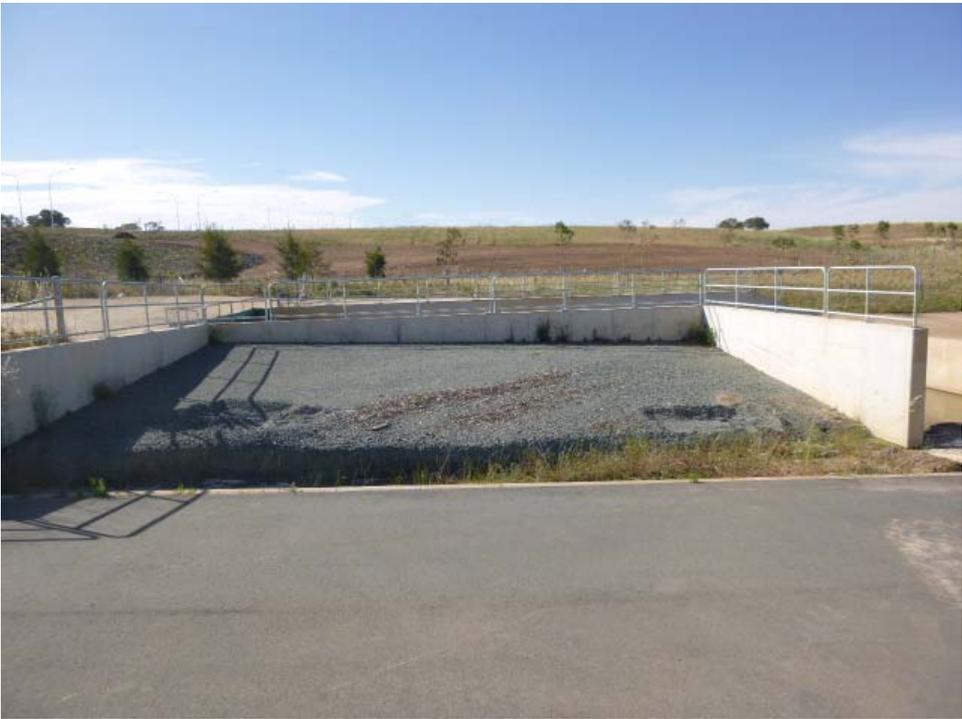
Drying pad at site, the nearest edge is being eroded away

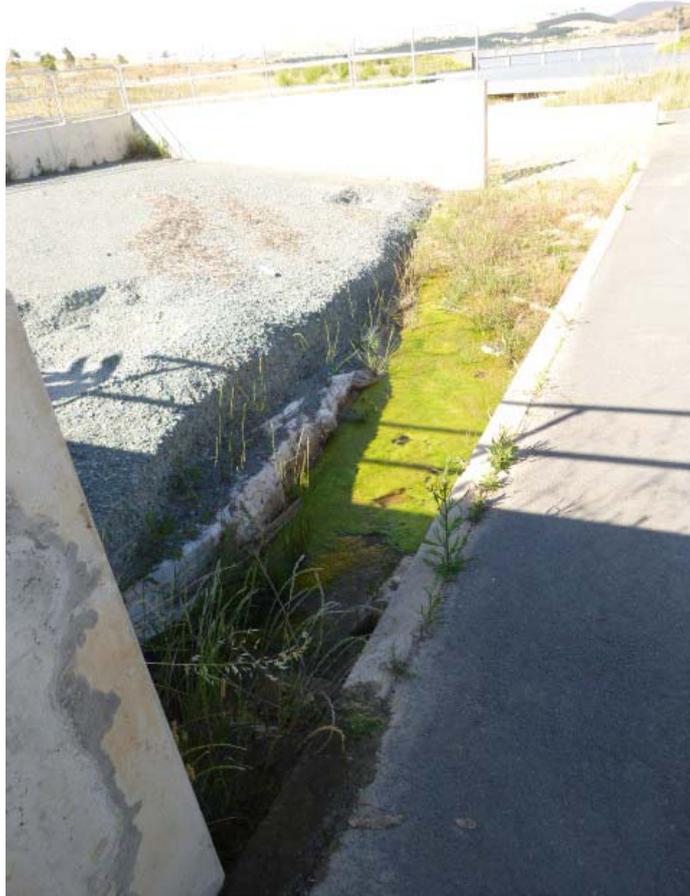
Massive erosion due to a design oversight. This should be fixed as soon as possible to prevent any further erosion.

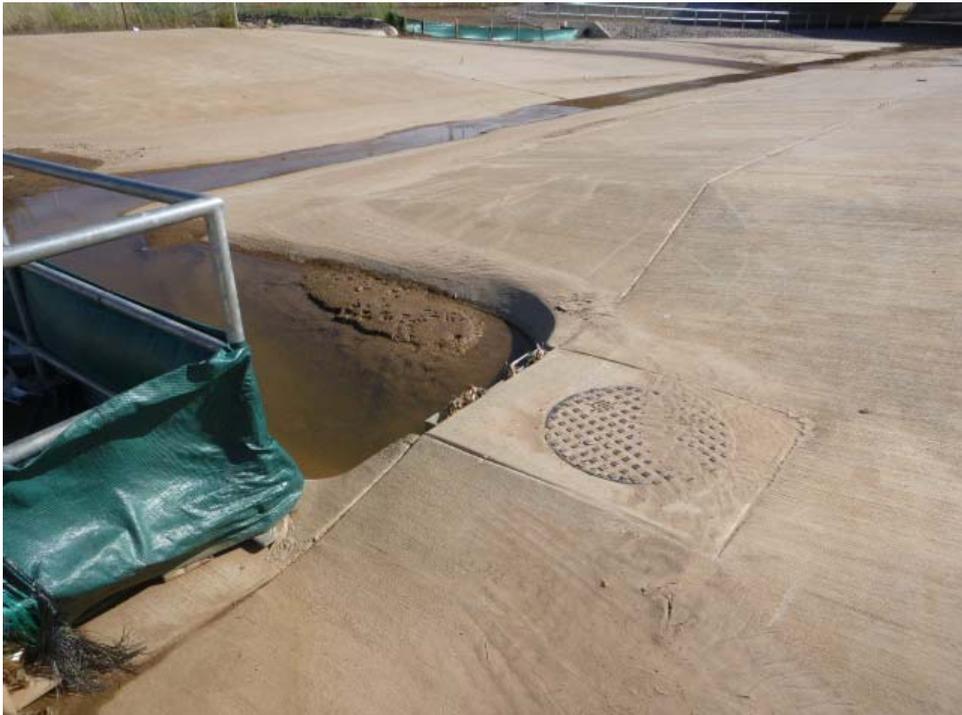
The low flow bypass is silted up and the silt fencing on the site fencing is directing water around the GPT

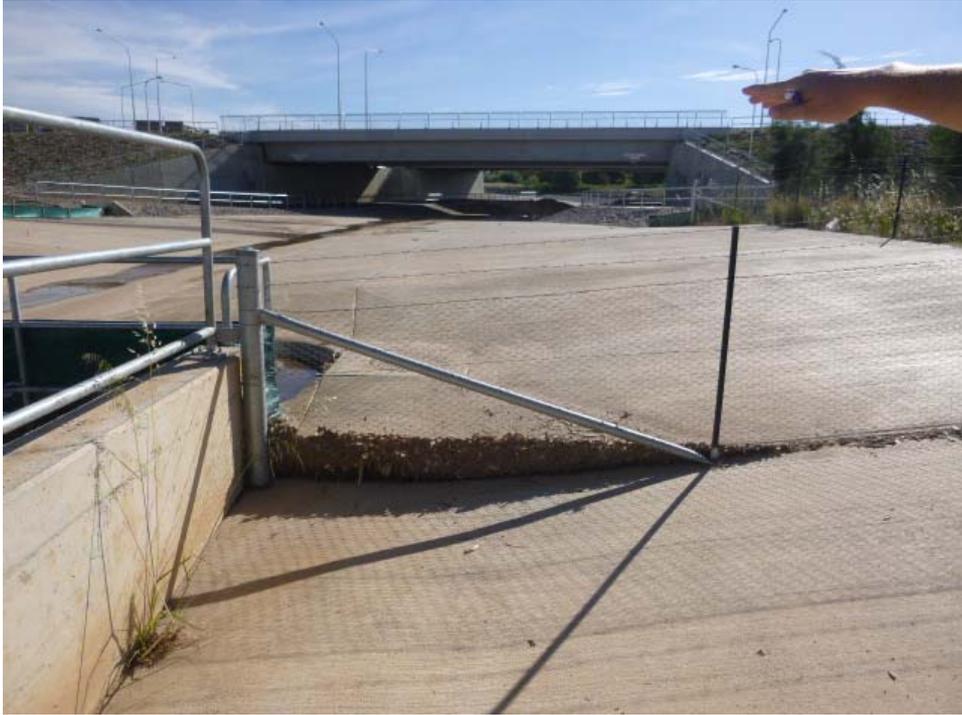
The wire fence beside the GPT is collecting pollution when the device bypasses

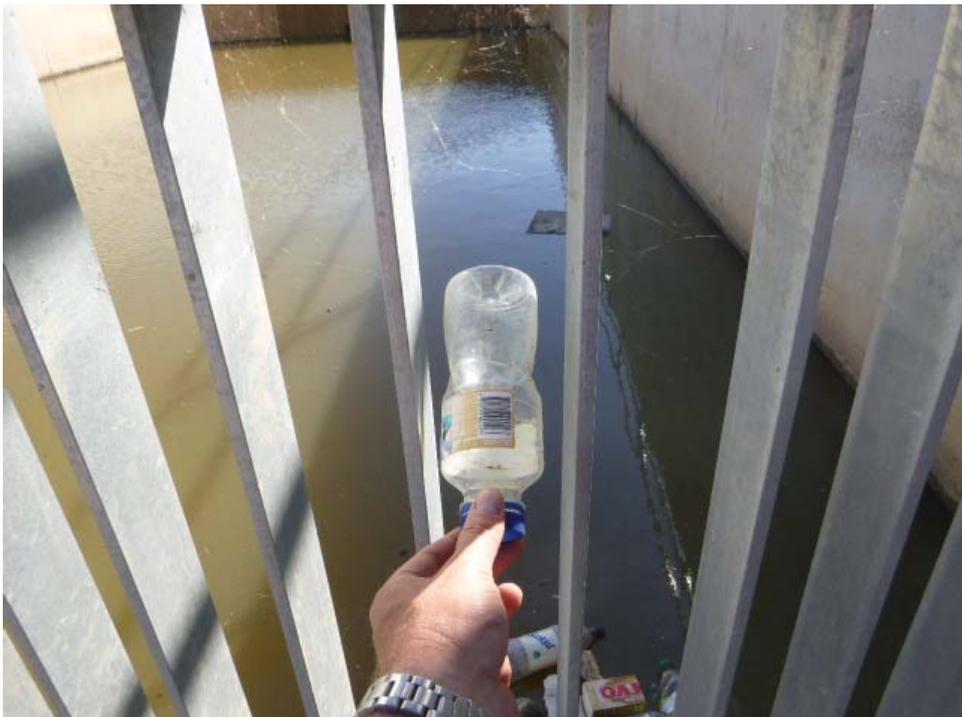
Aperture of the bars is too wide

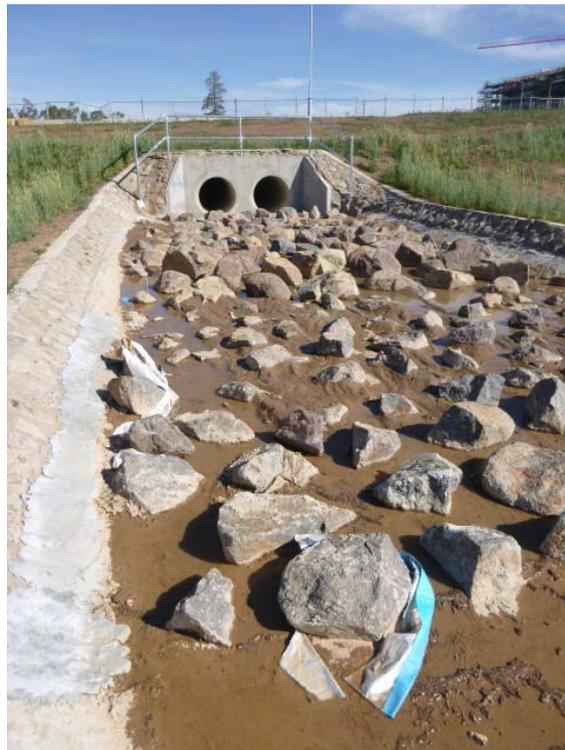
The rocks set into concrete are doing a good job of erosion control and energy dissipation. However, with no upstream treatment, the whole area is filling with sediment and litter. A new CDS unit should be designed and installed upstream of this outlet near the road.

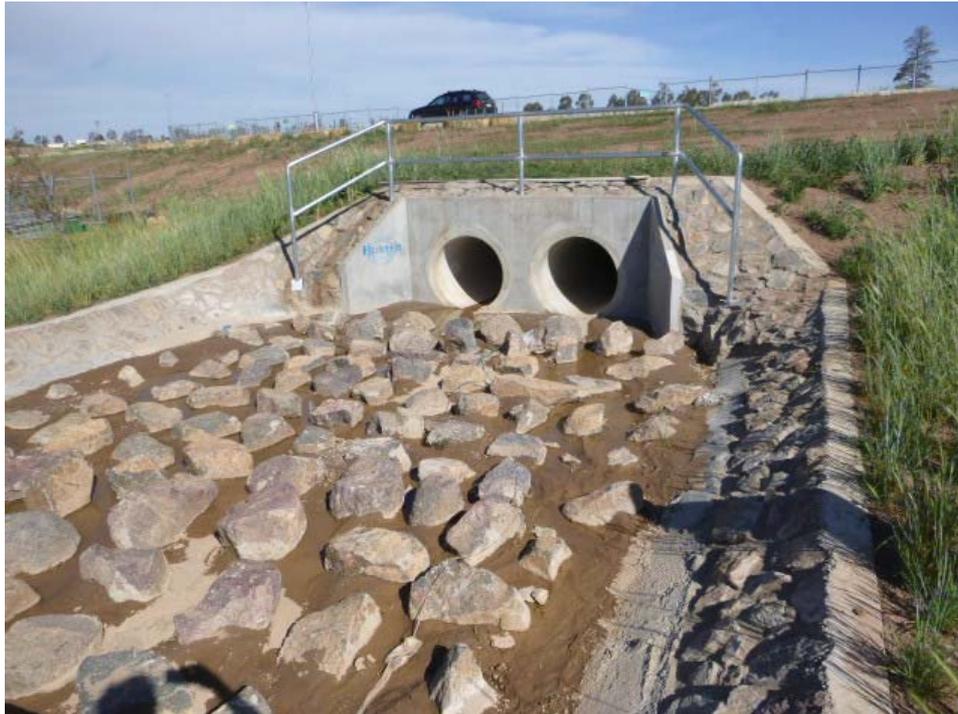
Pipe outlets with rocky open channels downstream become a safety issue for cleaners and local kids alike. There is a good location upstream for a CDS unit to treat both lines.

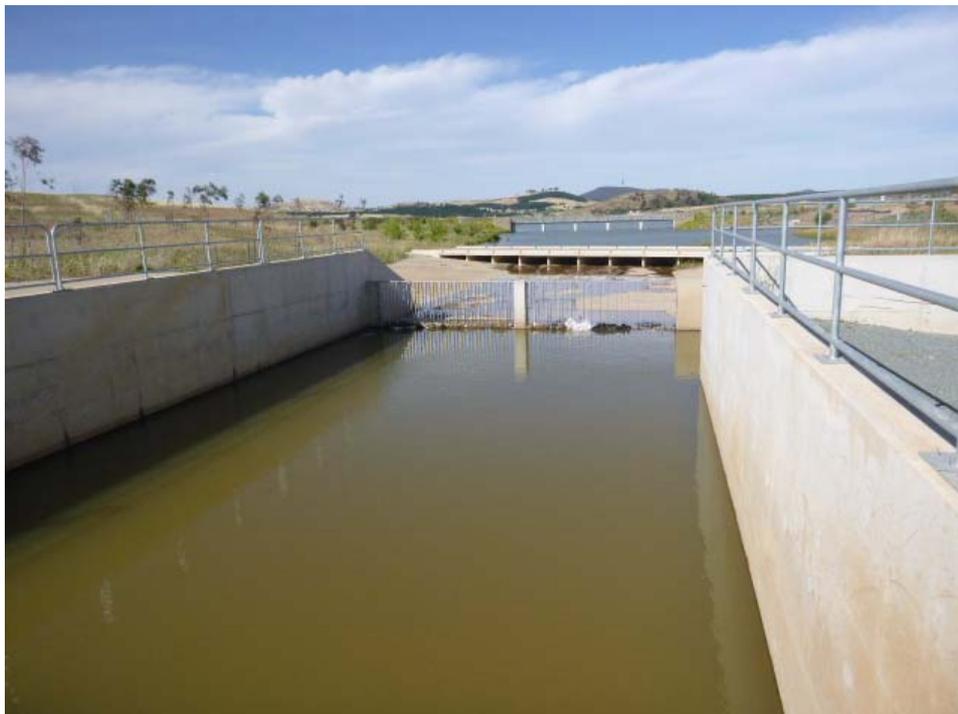
Large sediment basin upstream of trash rack. It's unclear what the plan is when it's dewatered. For this purpose a very large heavily grassed area should be created to the side.

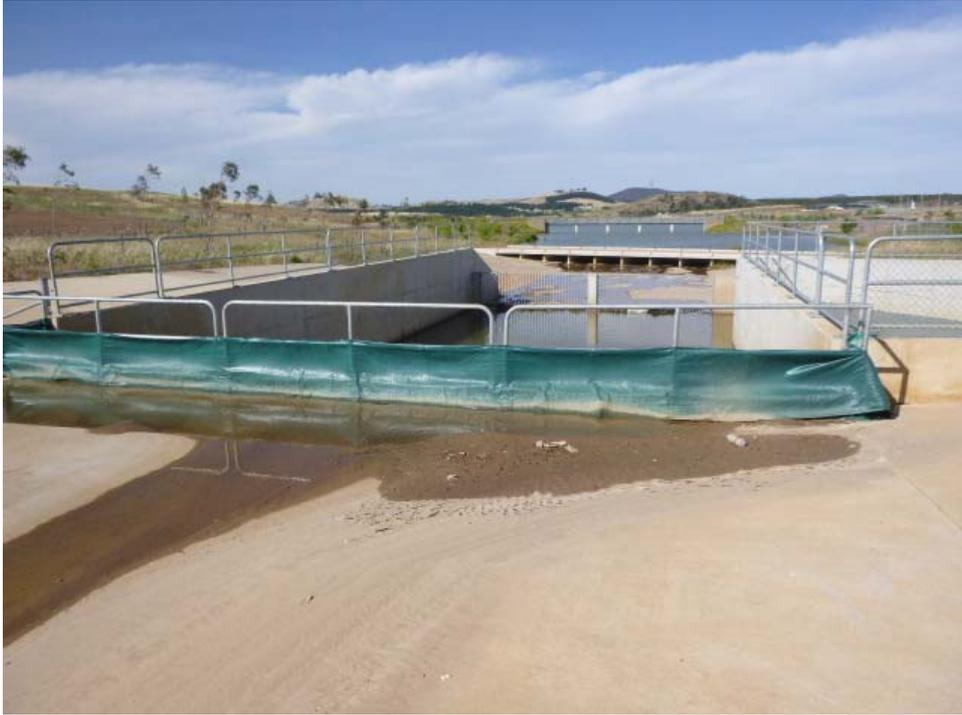
Silt fencing on the site fencing. Not clear as to why.

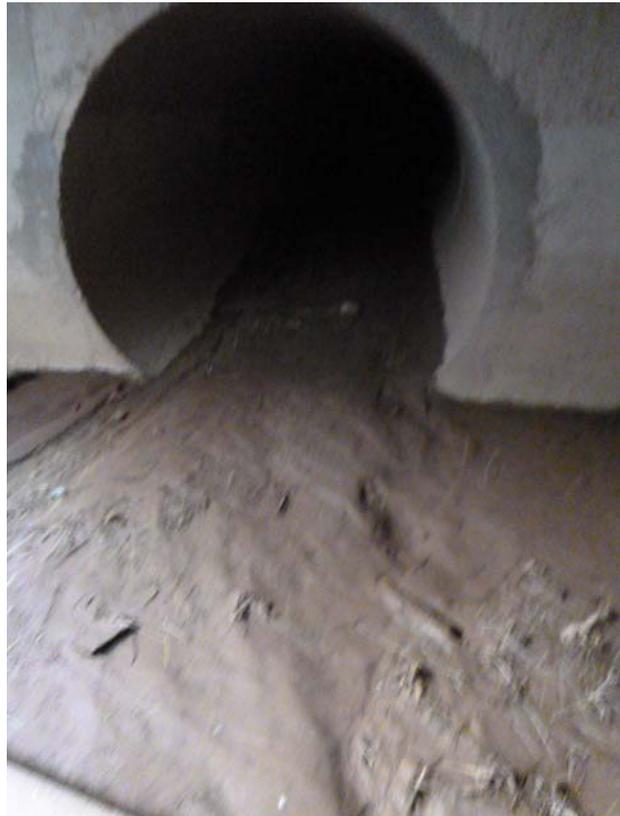
Inside CDS unit chamber showing sediment build up in the pipe upstream

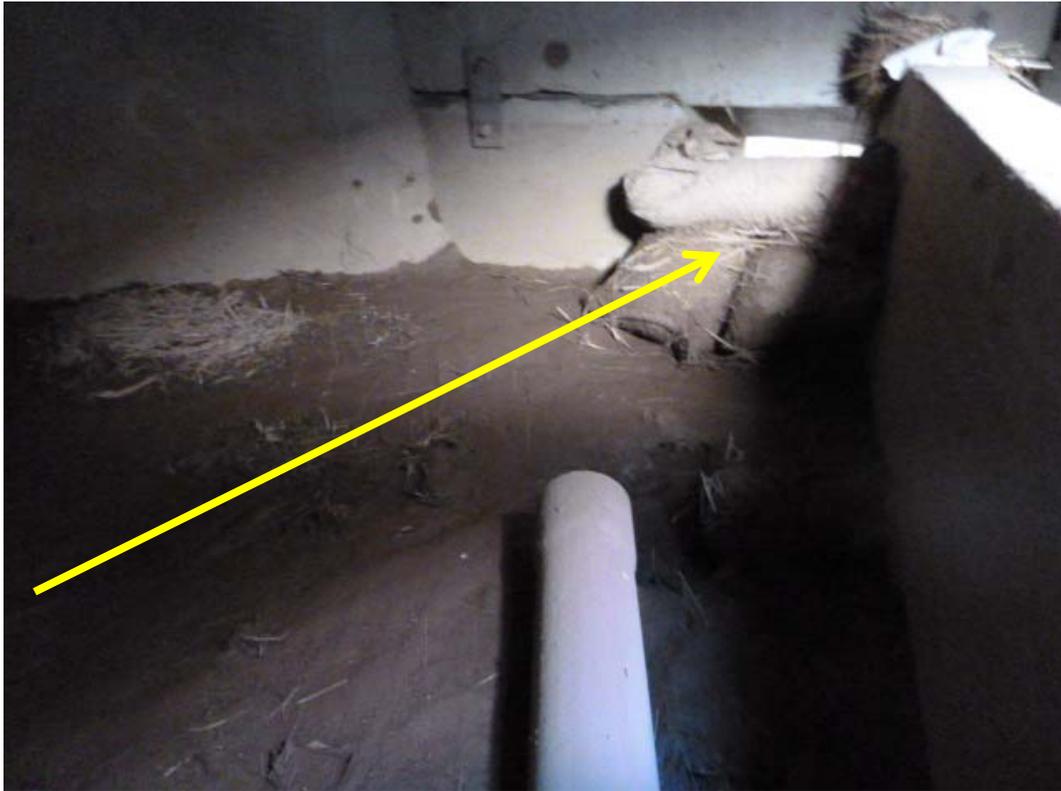
More sediment built up inside the diversion chamber. The low flow bypass was deliberately blocked but it was not installed correctly and will be a huge problem for the flow during operation. The PVC piping in there is not part of the solution. The yellow arrow shows you the flow direction if the inlet hadn't been sandbagged over.

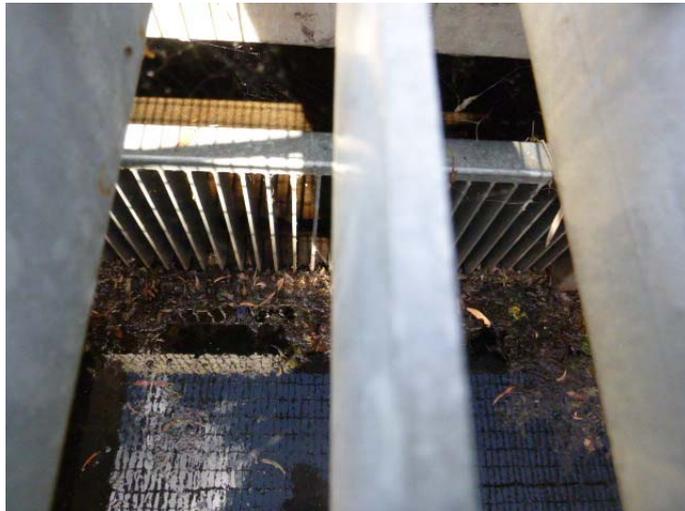
The racks are not catching sediment and organics which are some of the contributors to poor water quality downstream.

There is some evidence of bypassing, and the racks could be better with a smaller aperture. Perhaps a second row of smaller aperture racks could be trialed.

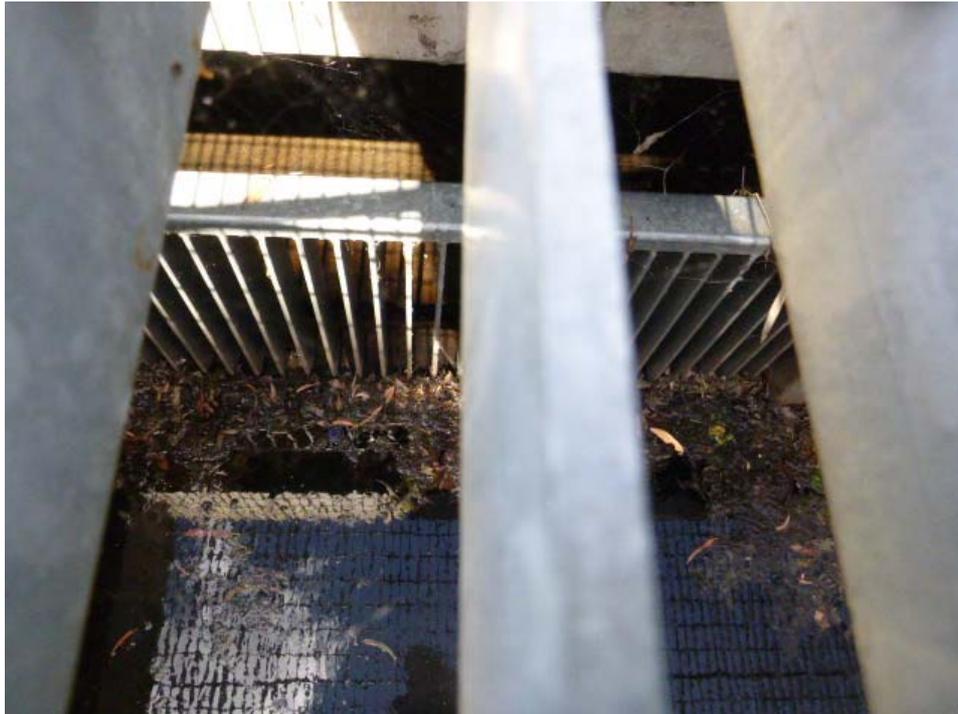
Sediment and organics bypassing the rack

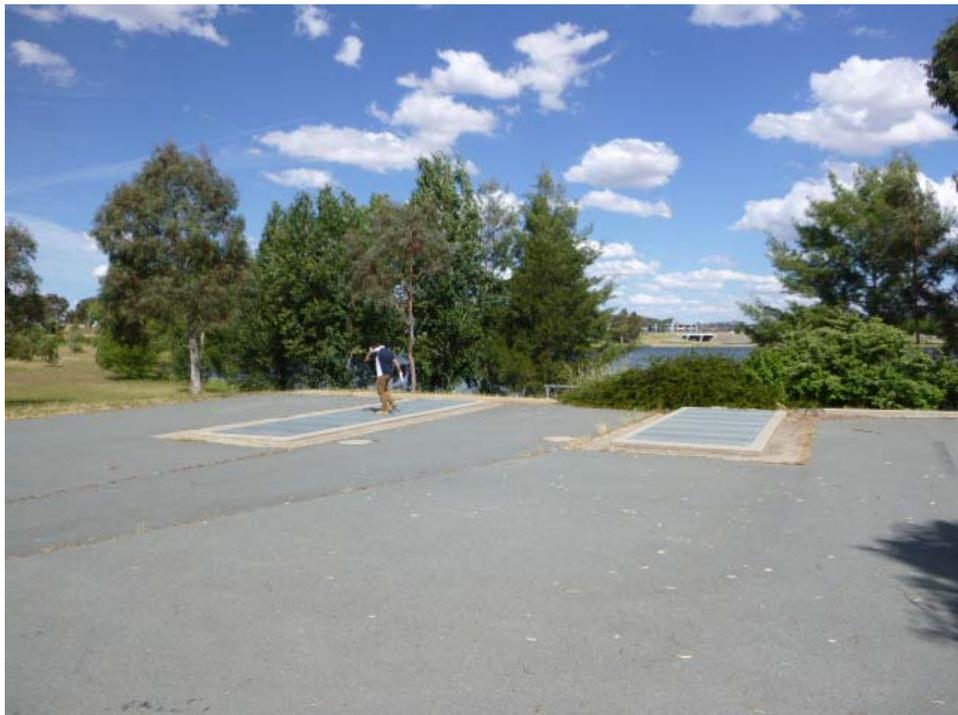
The two underground trash rack chambers could be combined and replaced with a single, better suited GPT

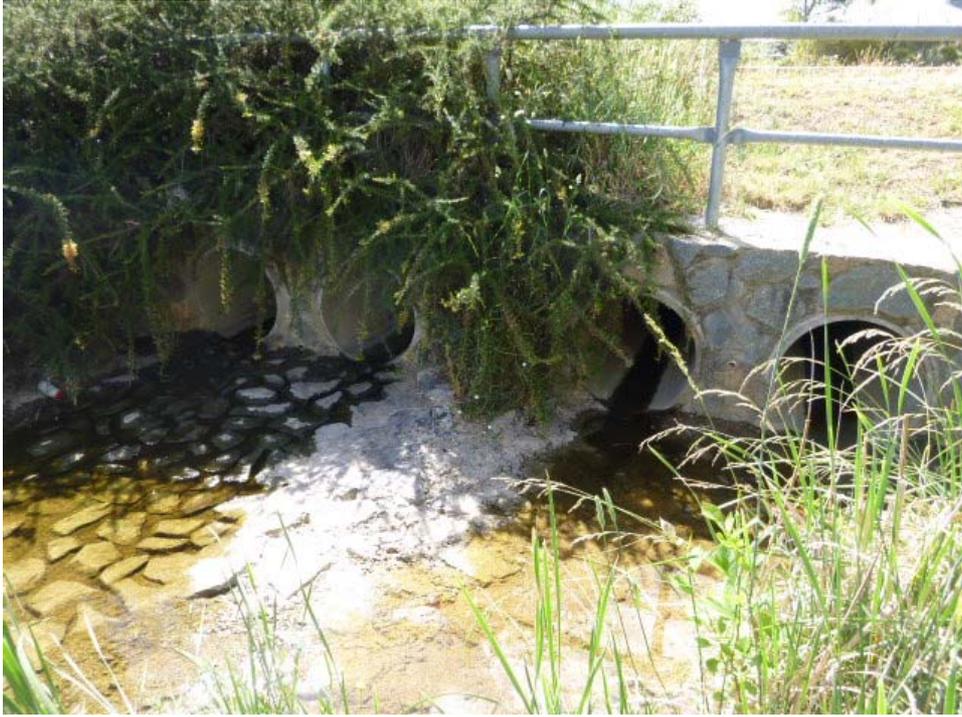
Outlets into the pond. Some vegetation removal required.

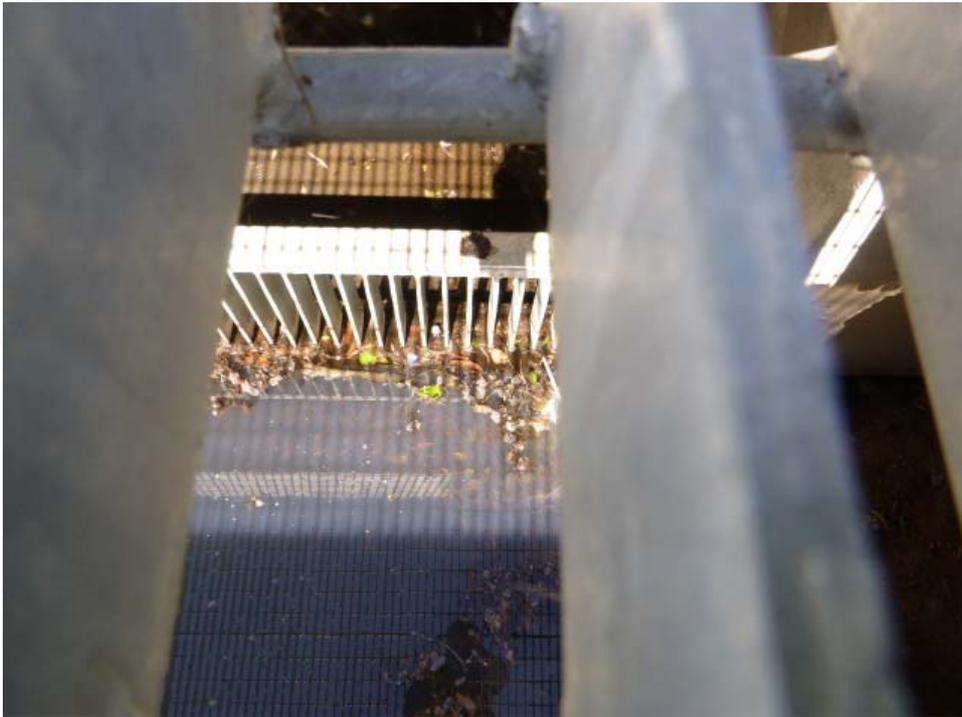
Sediment build-up inside chamber.

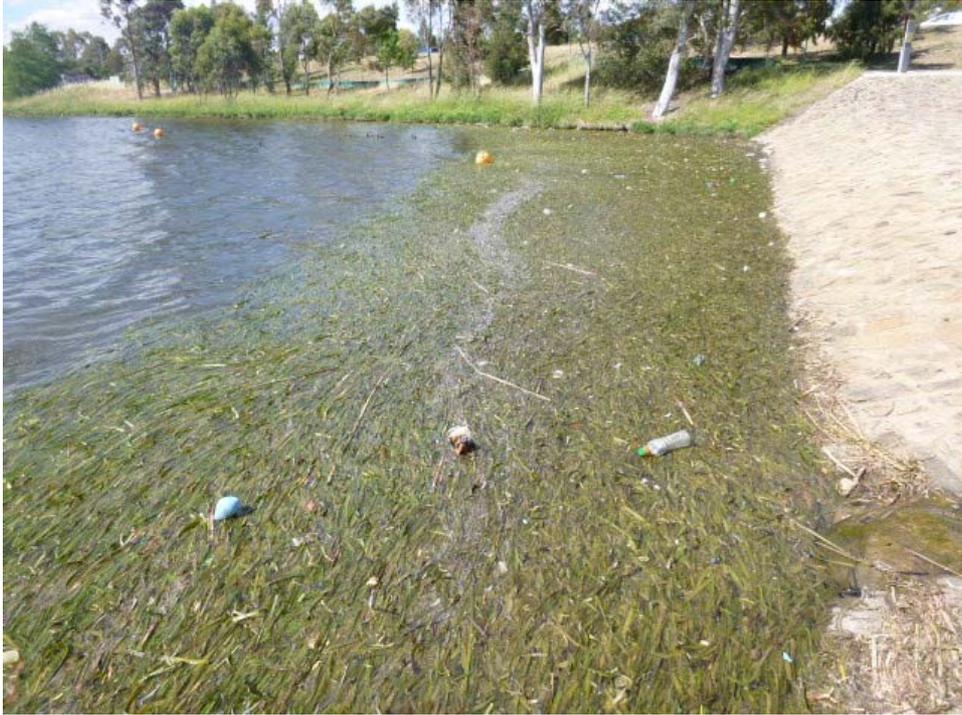
Floatables and organics collect in corners of the lake. This is determined by the prevailing wind, but a walkway around the edge or a floating boom would aid collection.

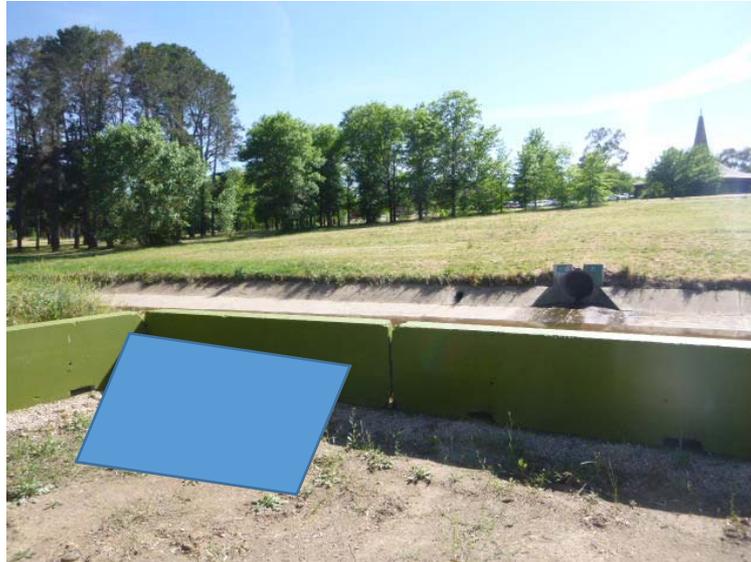
The drying area for GPT pollution is shared with the waste from street sweepers. The very end of this area would make a logical location from which to install a pumped bypass for low flows during the maintenance process. It would need to be completely shielded from flows during normal times, and only be opened up for pumping low flows at cleaning.

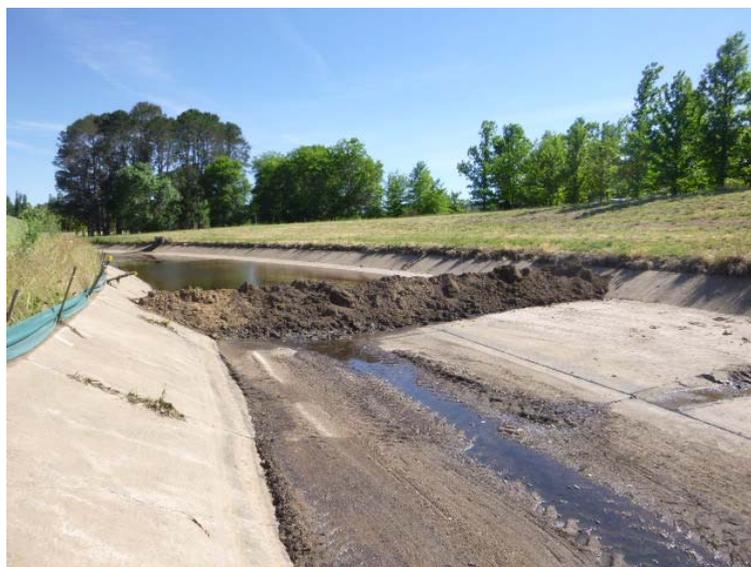
At present the cleaners are forced to create a temporary dam using spoil from somewhere. At the end of the cleaning, most of this is washed into the GPT and has to be removed as part of the following clean. This technique is resource intensive and not a good long-term solution to low flow bypass.
