ACTGPT-24a

Address	McGilvray Close, Gordon
Device	Custom GPT
Site Details	Access way off McGilvray Close
Estimated catchment area	-
Device Status at Nov 2014	Operational, device 15% full
Device comments and recommendations	<p>This device seems appropriately sized for the catchment, but its size is unknown. Regardless it would be improved with increased rack size and design</p> <p>Extra set of racks could be installed or one set of racks running along the northern edge of the sediment basin to create a high flow bypass to help avoid already trapped pollution being washed away.</p> <p>Grass cutting around the area should be done with a catcher as grass is being washed down into the rack and this breaks down and sends the GPT anaerobic</p>
Rectification works required	<p>Install new higher racks and high flow bypass</p> <p>Repair erosion damage upstream</p>
Existing maintenance	TBC
Maintenance expectations with rectifications	Quarterly

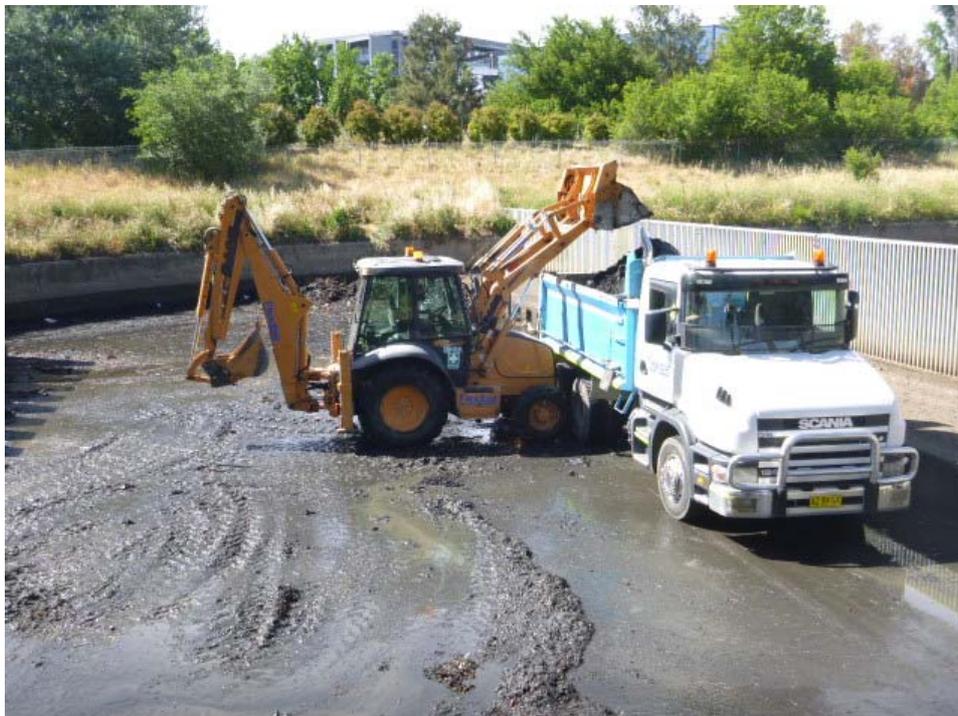
Cleaning is quick and fairly easy, with good vehicle access.
If extra racks were added, they would require some sections to be removable (with the backhoe) but it would also trap and retain a lot more pollution.

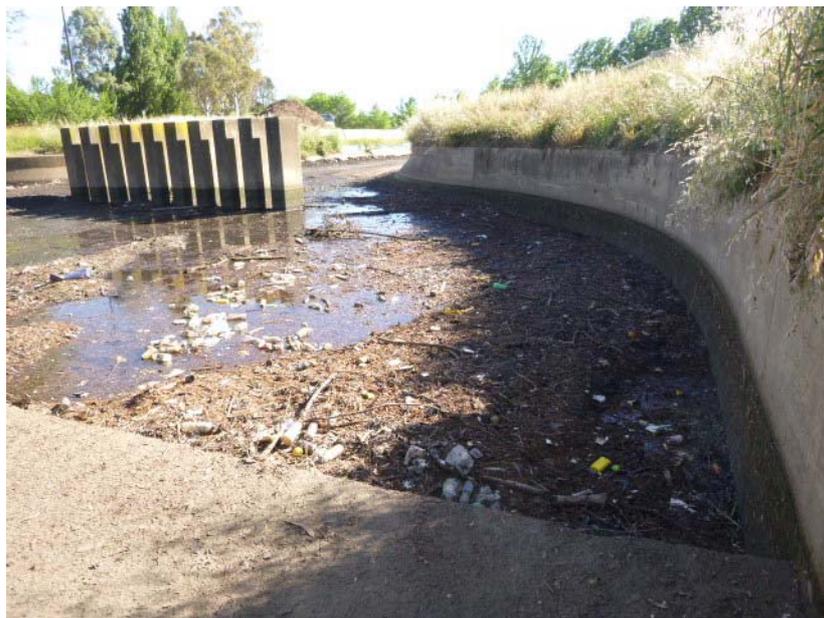
Pollution upstream of trash rack. Needles can be seen and other larger items. The massive energy dissipation vertical columns are a strange design. Whilst they would not do a lot, they are not causing any problems and machinery can still drive around them to get up into the channel (where pollution also deposits).

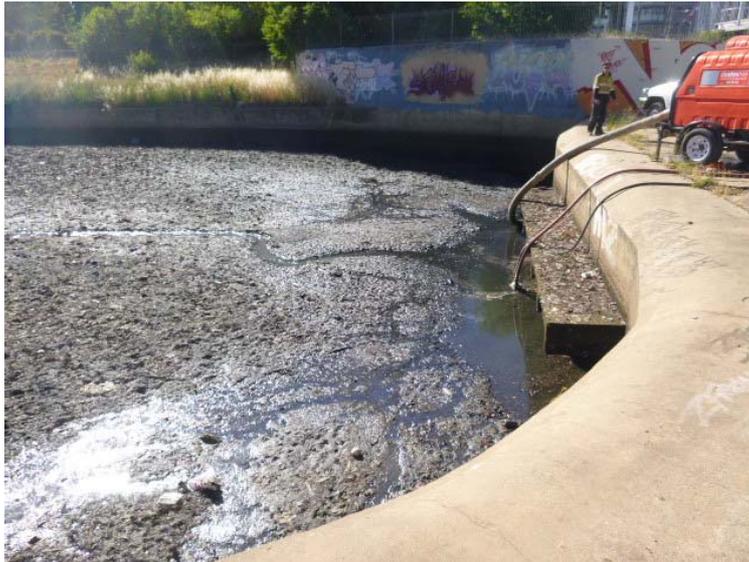
De-watering taking place in the “sediment sump area” behind the trash rack, this currently takes an entire day before cleaning can take place. A large portable pump and a smaller suction pump are brought in to pump down the structure.

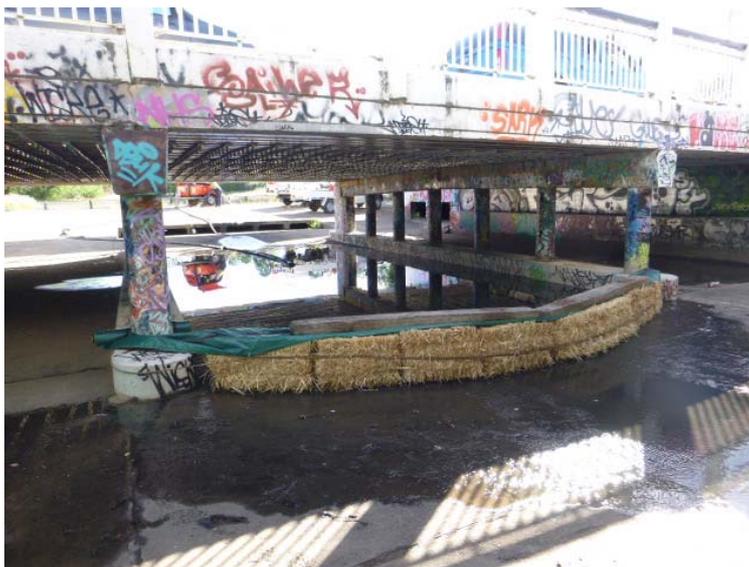
Currently this water is pumped down into a straw bale check dam to filter out any silts. Straw is not good at trapping silts, and gaps of over 100mm on the sides basically allow the water to escape untreated.

A reusable weir that was easy to clean would be a much more appropriate. It could be covered with a geofabric if desired and brushed clean as need be. It could be stored onsite (if done correctly) and reused with ease each time with no need to buy and dispose of straw bales.
