Tablelands Explosives Pty Ltd

Blasting Report

**RE: Contract No: 2015.26841.103
Throsby Stage 3 – Defect rectification Blasting Damage**

Contract No: 2015.26841.103 – Throsby Residential Estate Stage 3 – Civil and Landscape Construction
Defect rectification – Blasting Damage

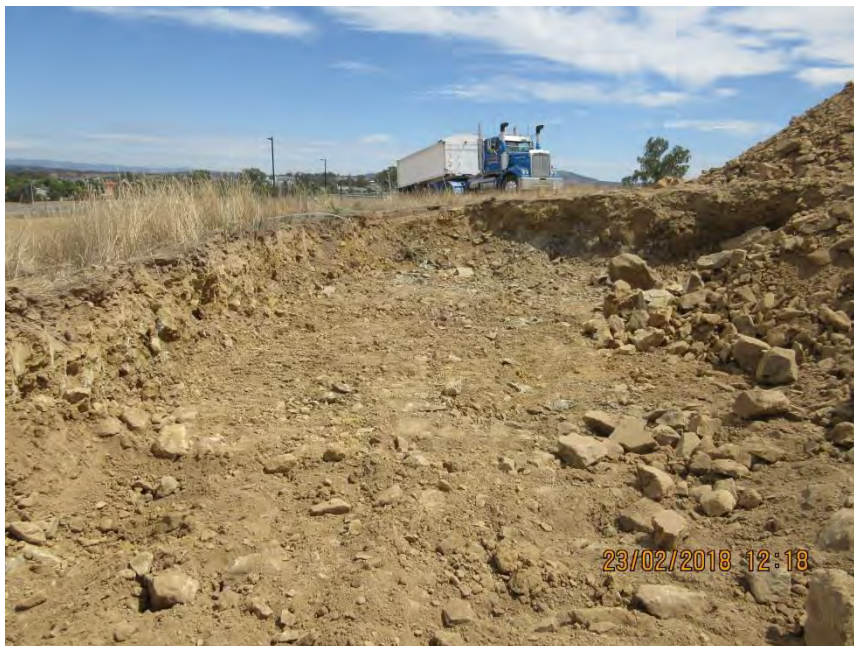
At the time of the site visit, the site excavation for design levels of the proposed residence was underway. The excavation at the rear of the block (excluding the sewer easement) was approximately 1 m deep. The excavation had exposed up to about 0.6 m of filling overlying dacite rock. Loosened very high to extremely high strength, fresh fractured rock was present in the excavation floor and sides in the western corner of the block. The floor of the excavation in the opposite southern corner contained low to medium strength, moderately weathered rock that appeared to be intact and undisturbed.

Figure 1: View of the western corner looking along the rear block boundary

Based on the observed conditions it is our opinion that the loosened rock is a result of blasting works, presumably carried out during bulk earthworks for the subdivision. The effects of the blasting would appear to have loosened the rock to a depth of 2.5 m below the existing ground surface level in this inspected western corner of the block. The presence of the loosened rock would affect foundation performance for any proposed structures and in this state the affected blocks would be considered Class P (problem site) in reference to AS 2870 – 2011.

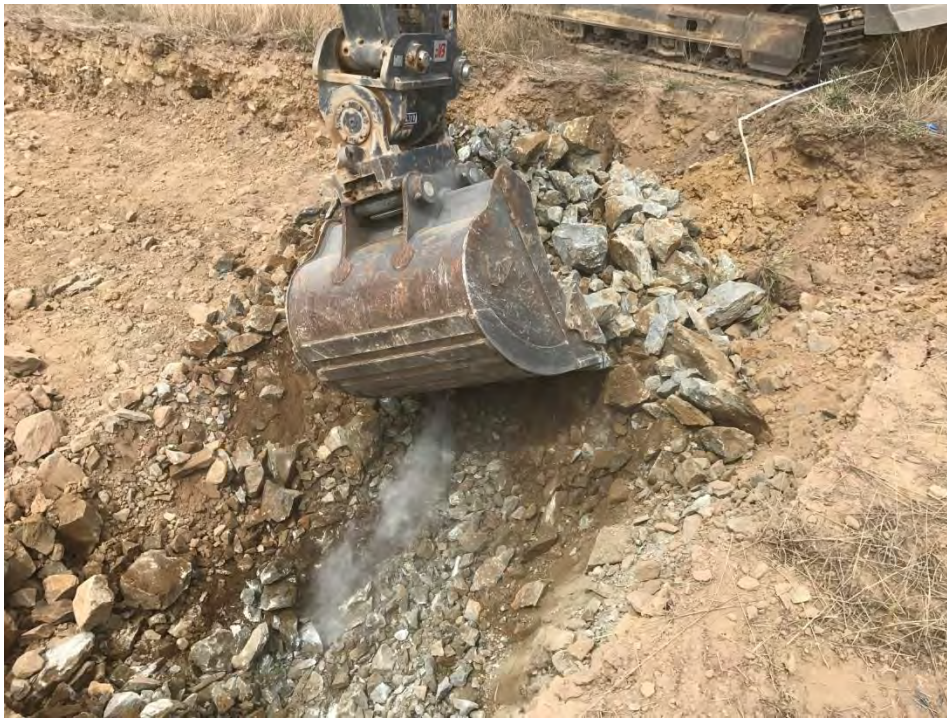
During the site visit a test pit was excavated in the apparently loosened fresh rock mass at the western corner to assess the possible depth of loosened rock. The test pit encountered loosened rock to about 2.5 m depth below site levels (approximately 1.5 m below site excavation levels for the proposed residence). Below the base of the test pit apparent intact rock was exposed.

Figure 2: Test pit excavation within the western corner of the [redacted]

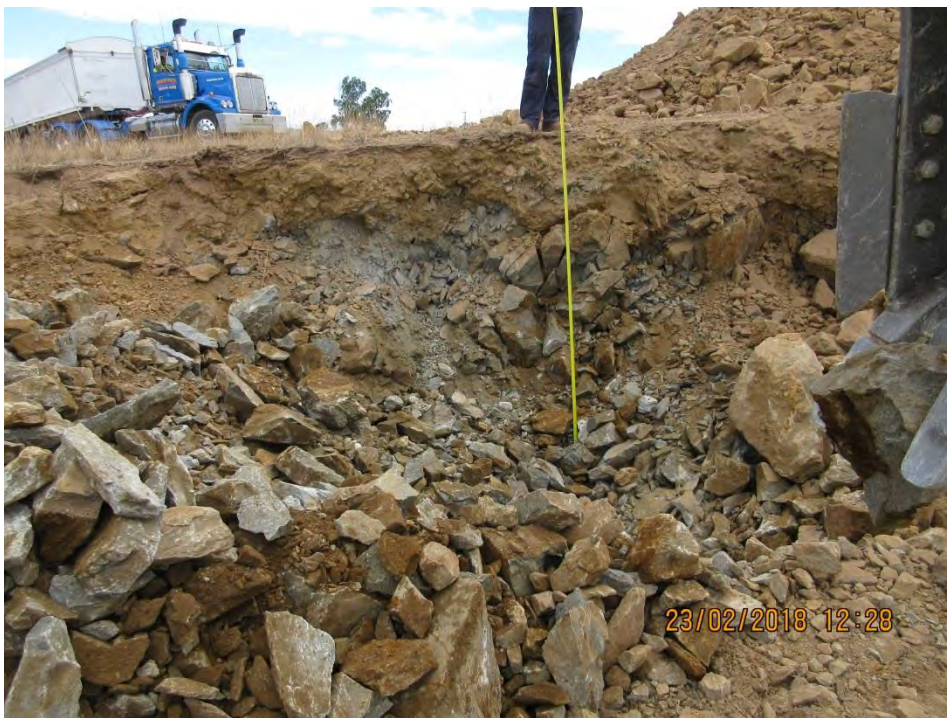
Figure 3: View of the side boundary and test pit excavation profile

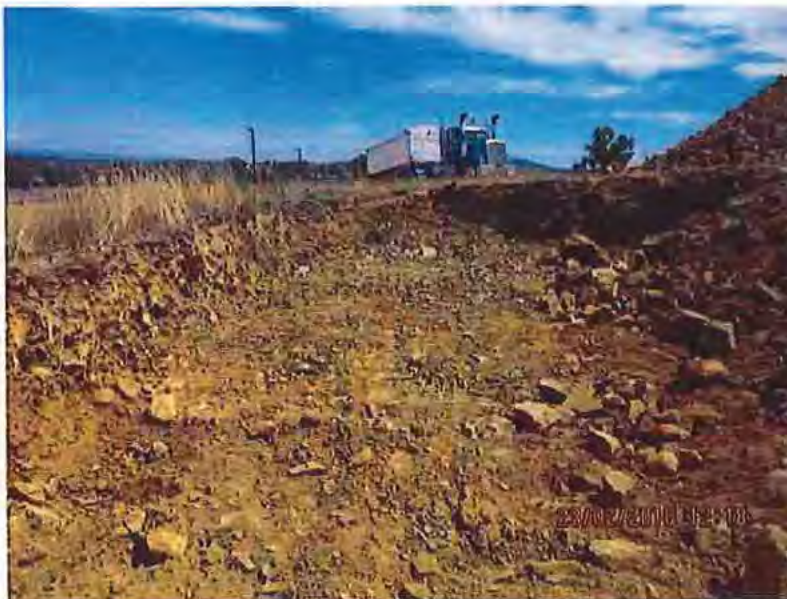
At the time of the site visit, the site excavation for design levels of the proposed residence was underway. The excavation at the rear of the block (excluding the sewer easement) was approximately 1 m deep. The excavation had exposed up to about 0.6 m of filling overlying dacite rock. Loosened very high to extremely high strength, fresh fractured rock was present in the excavation floor and sides in the western corner of the block. The floor of the excavation in the opposite southern corner contained low to medium strength, moderately weathered rock that appeared to be intact and undisturbed.

Figure 1: View of the western corner looking along the rear block boundary

Based on the observed conditions it is our opinion that the loosened rock is a result of blasting works, presumably carried out during bulk earthworks for the subdivision. The effects of the blasting would appear to have loosened the rock to a depth of 2.5 m below the existing ground surface level in this inspected western corner of the block. The presence of the loosened rock would affect foundation performance for any proposed structures and in this state the affected blocks would be considered Class P (problem site) in reference to AS 2870 – 2011.

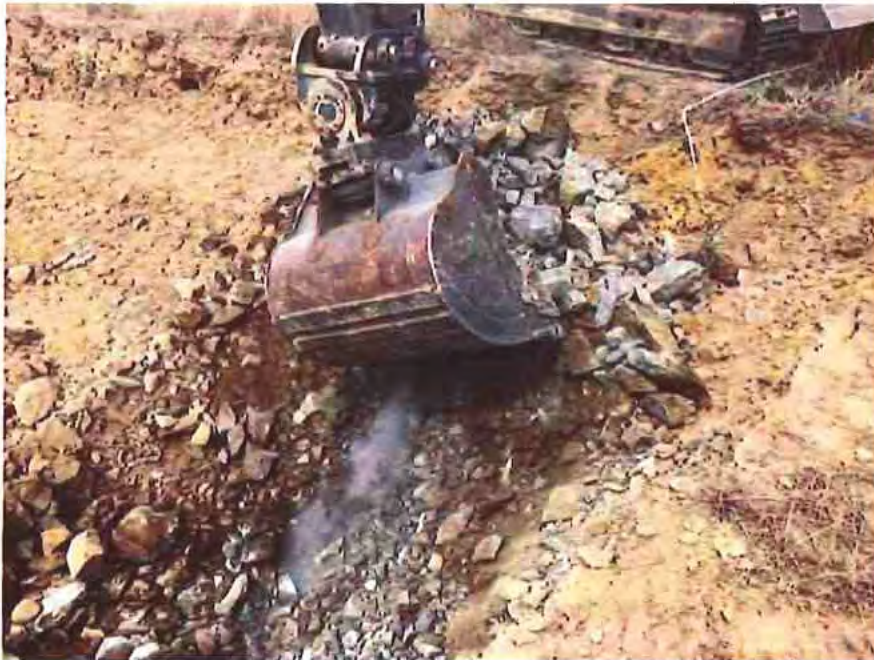
During the site visit a test pit was excavated in the apparently loosened fresh rock mass at the western corner to assess the possible depth of loosened rock. The test pit encountered loosened rock to about 2.5 m depth below site levels (approximately 1.5 m below site excavation levels for the proposed residence). Below the base of the test pit apparent intact rock was exposed.

Figure 2: Test pit excavation within the western corner of the Block [REDACTED]

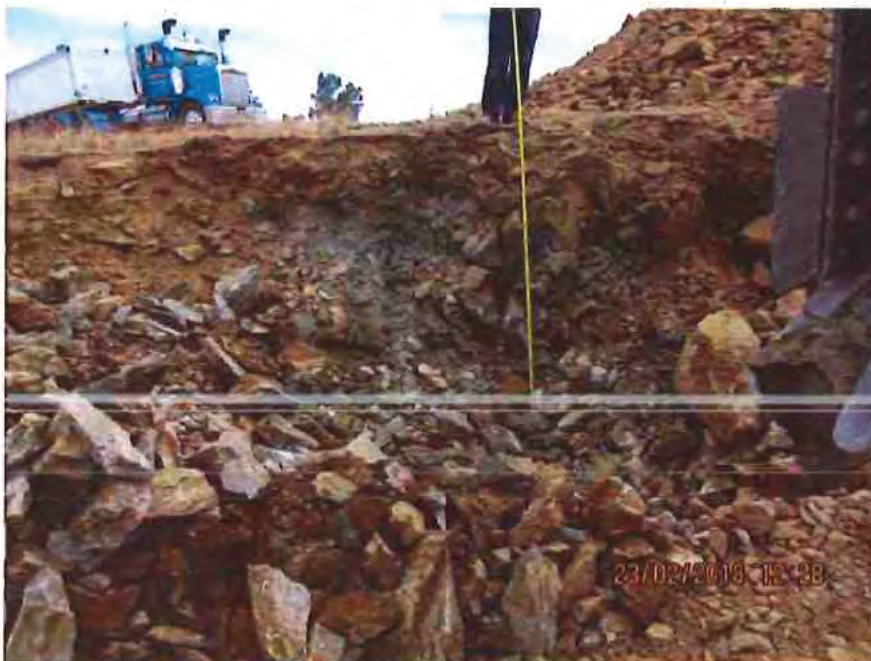
Figure 3: View of the side boundary and test pit excavation profile

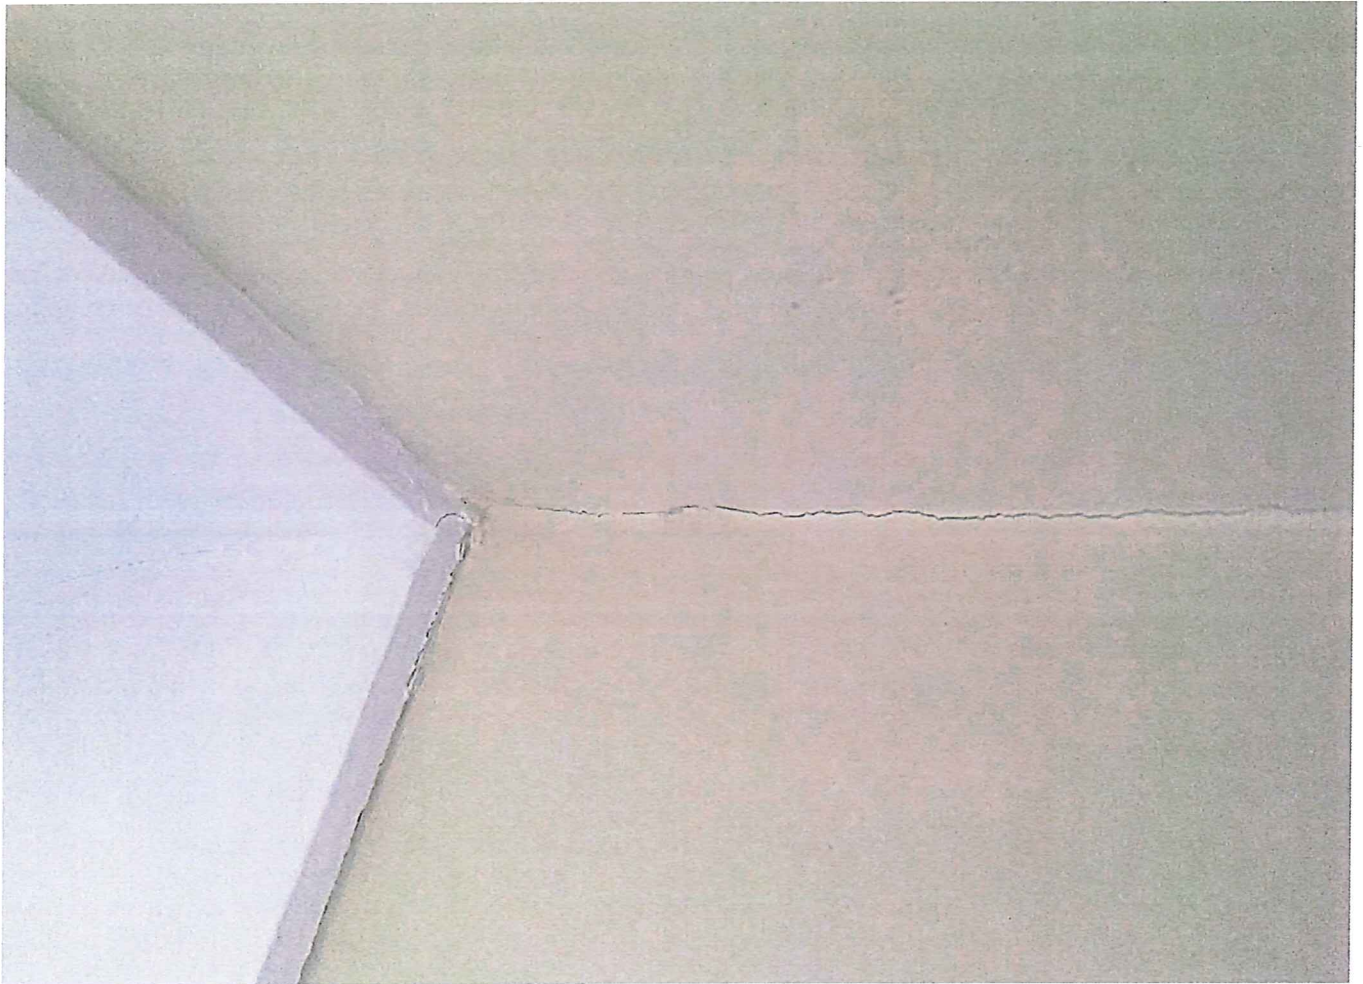
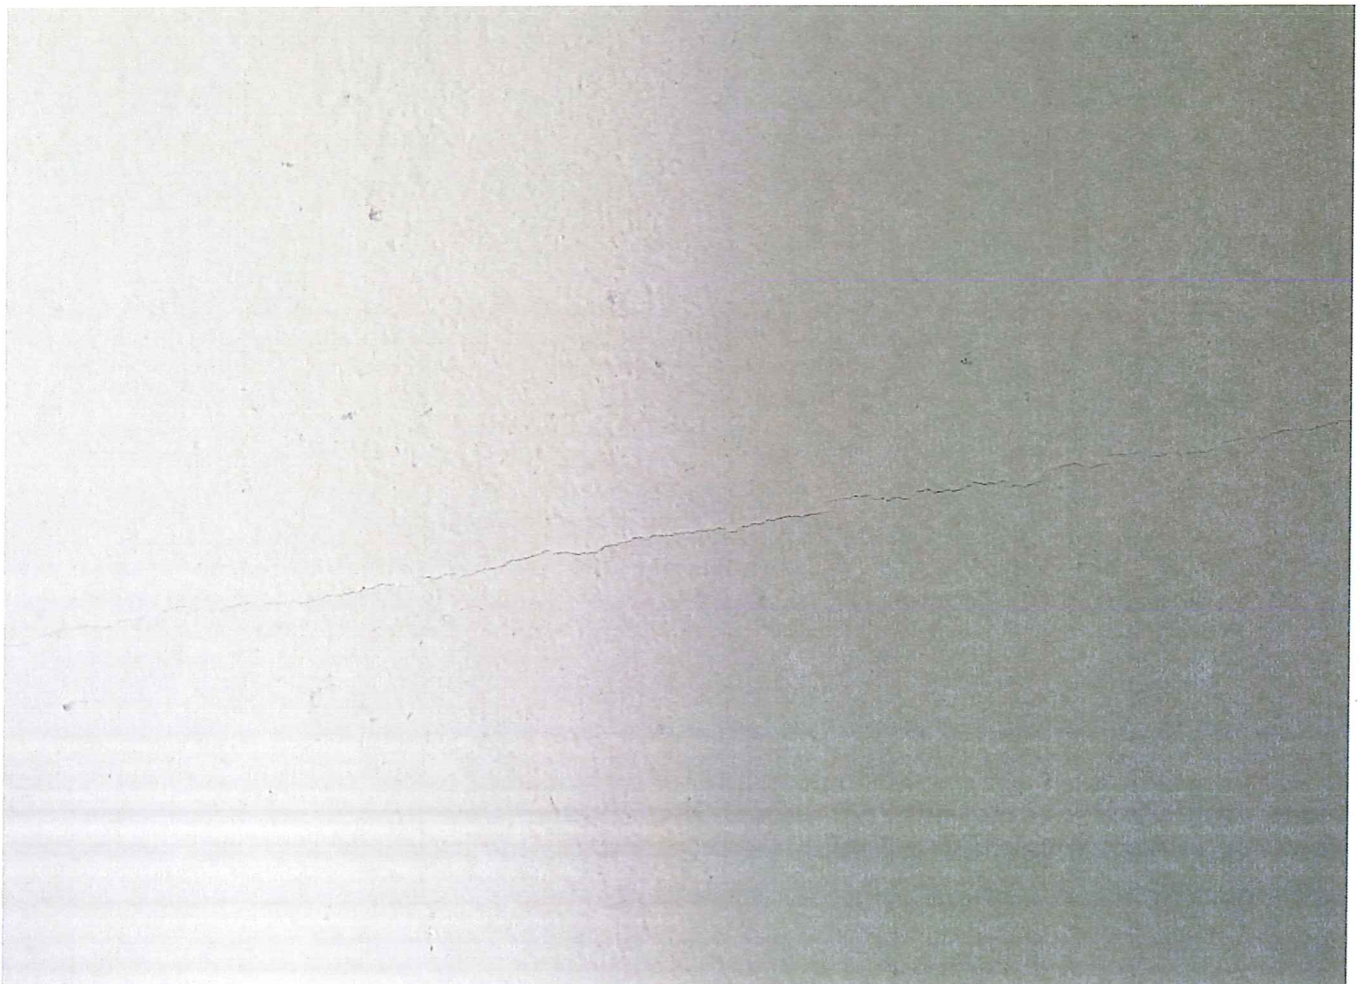
Hi Simon
These are some pictures of the new damage.

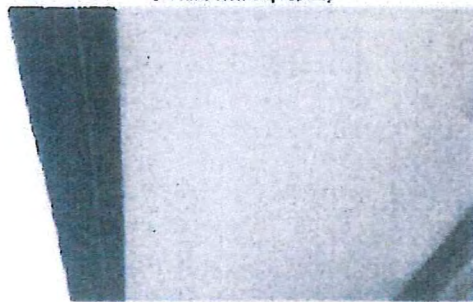
2. Eaves, view of nails protruding out

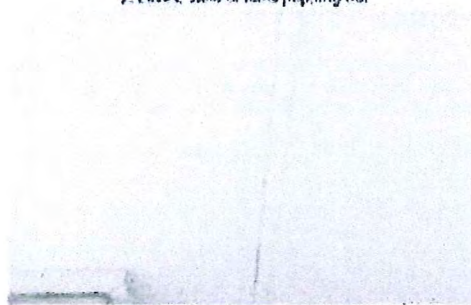
3. Eaves, view of joints opening up

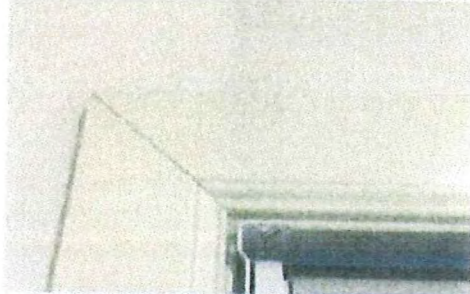
7. Family room, cracking of architrave corners

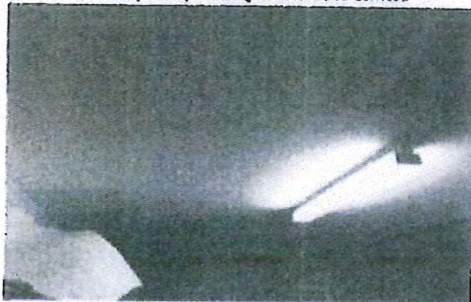
8. Garage, view of plaster sheets sagging

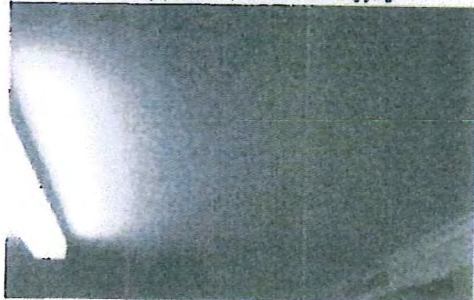
9. Garage, view of plaster sheets sagging

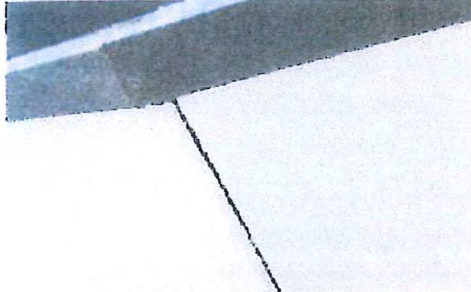
4. Eaves, view of joint opening up

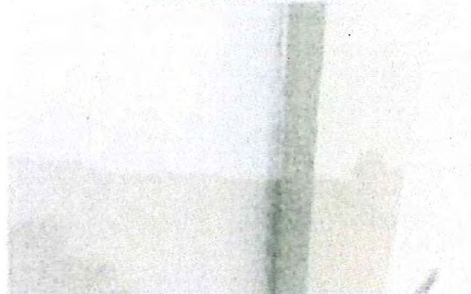
5. Cracking between architecture and wall
