Intrusive Hazardous Materials Survey & Management Plan

**Borrowdale House
Furzer Street
Phillip
ACT, 2606**

November 2014

Title: Hazardous Materials Survey
 Borrowdale House
 Furzer Street
 Phillip, ACT, 2606

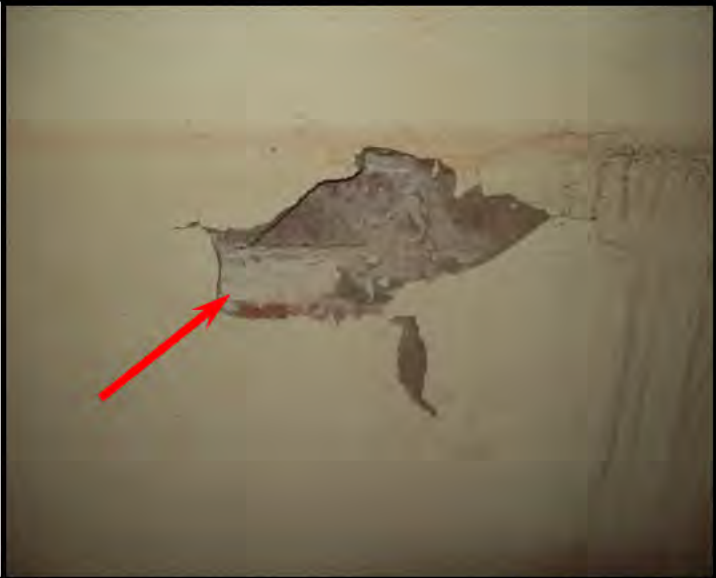
ASBESTOS CONTAINING MATERIALS			
ITEM NO	LOCATION	MATERIAL TYPE	PHOTOGRAPH
1	Second floor – insulation to water pipe in masonry wall	Insulation

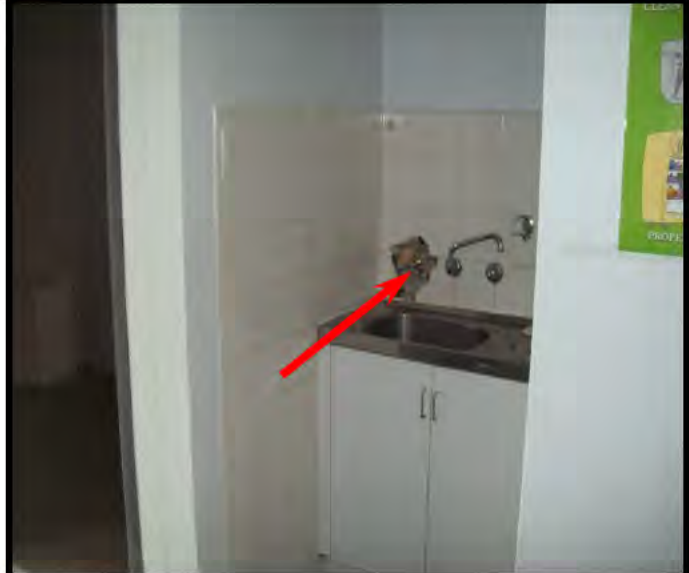
2	First floor – kitchenette – water pipe insulation in masonry wall	Insulation

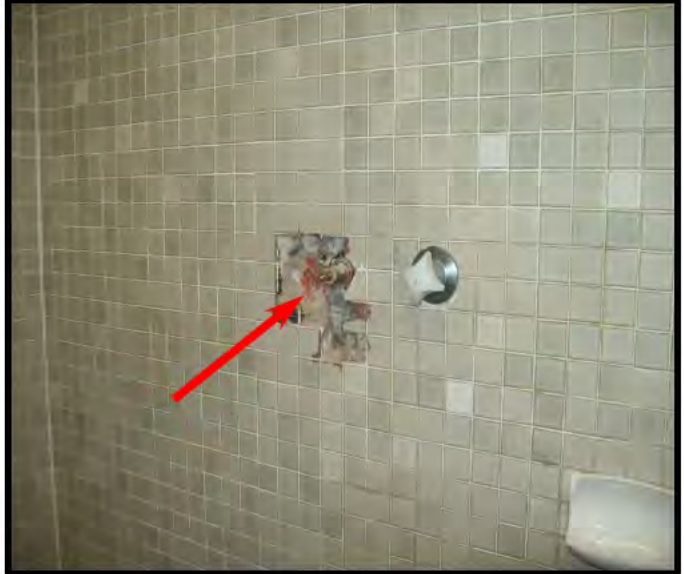
ASBESTOS CONTAINING MATERIALS			
ITEM NO	LOCATION	MATERIAL TYPE	PHOTOGRAPH
3	Ground floor – women's toilet/shower – water pipe insulation in masonry wall	Insulation

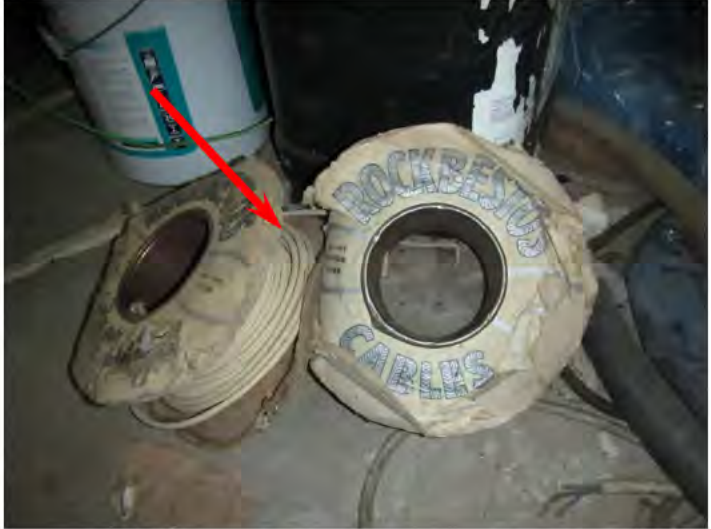
4	Basement Storage – insulated rolls of wire (Rockbestos)	Rope

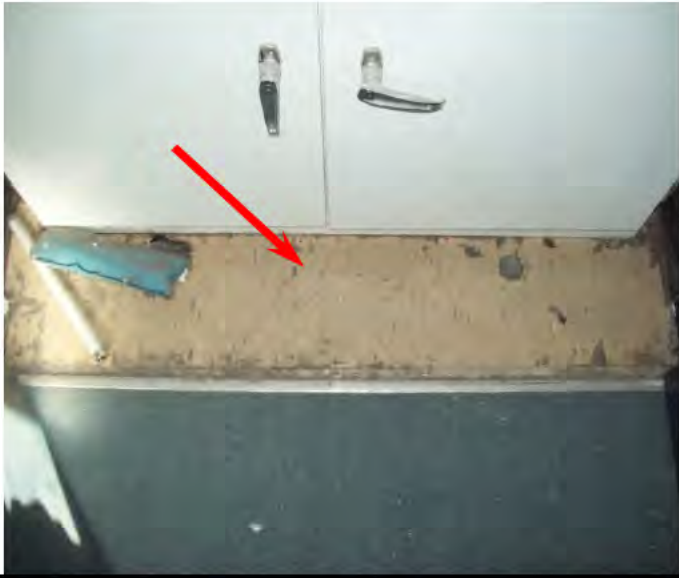
ASBESTOS CONTAINING MATERIALS			
ITEM NO	LOCATION	MATERIAL TYPE	PHOTOGRAPH
5	Second floor – hall electrical cupboard adj. kitchen beige vinyl floor tile	VFT

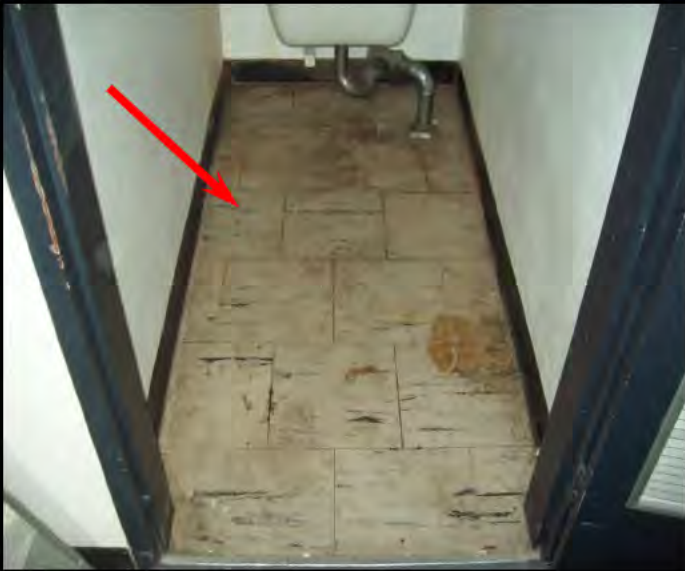
6	Second floor – cleaners room adj. kitchen beige vinyl floor tile	VFT

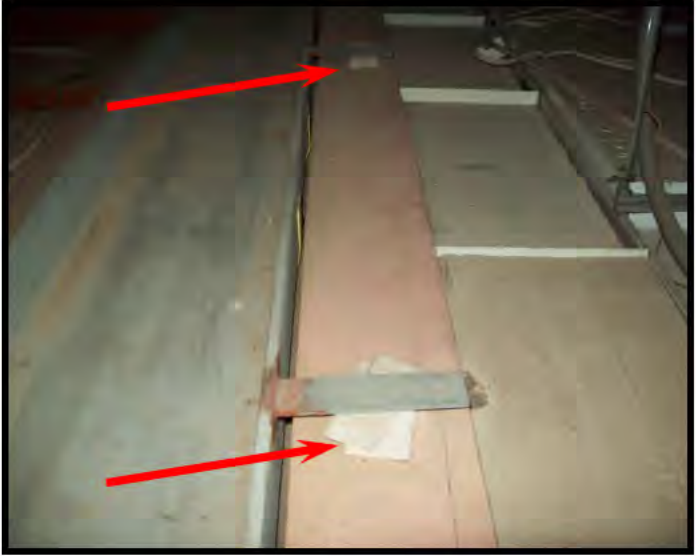
ASBESTOS CONTAINING MATERIALS			
ITEM NO	LOCATION	MATERIAL TYPE	PHOTOGRAPH
7	Second floor – ceiling space packer sheets	Sheet

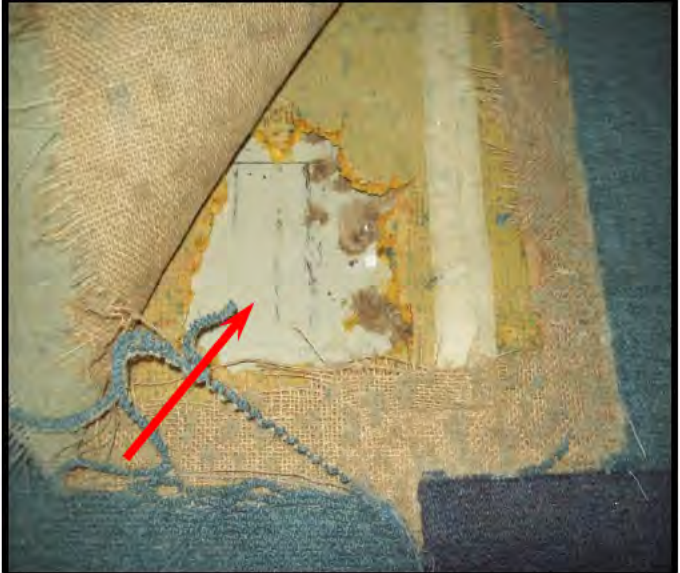
8	First floor – under carpet throughout – beige VFT with black streaks	VFT

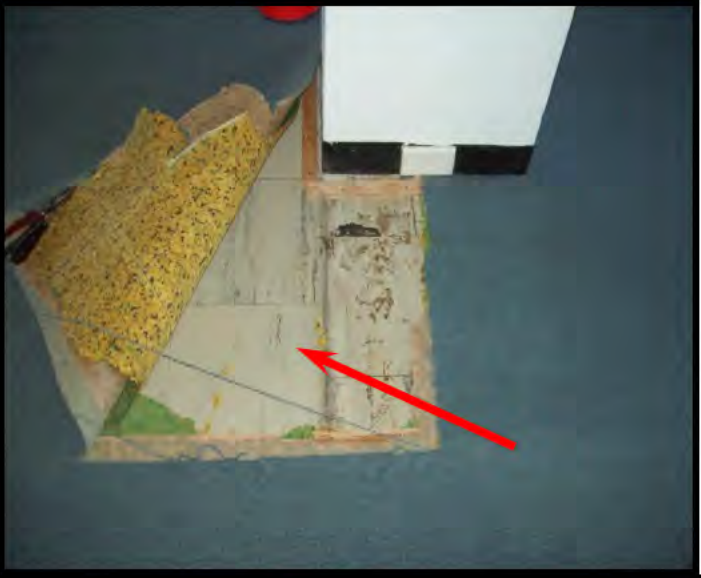
ASBESTOS CONTAINING MATERIALS			
ITEM NO	LOCATION	MATERIAL TYPE	PHOTOGRAPH
9	Ground floor – under carpet throughout –beige VFT with black streaks	VFT

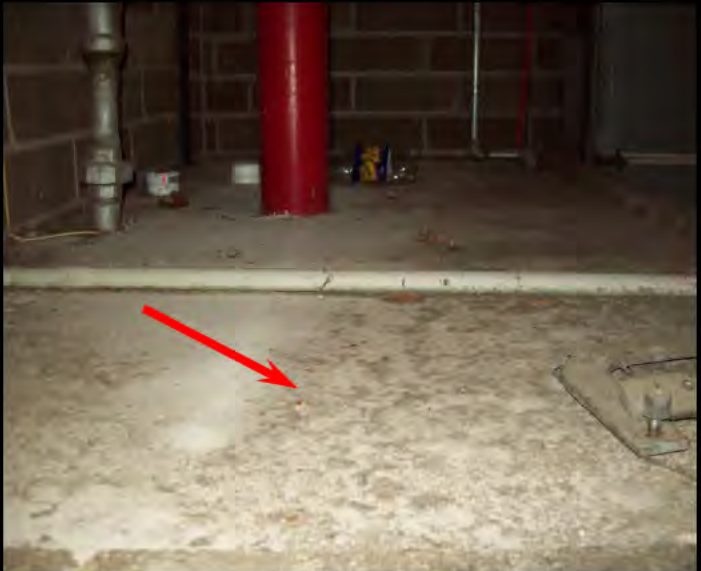
10	Garage interior – fire hydrant closet roof top – sheet	Sheet

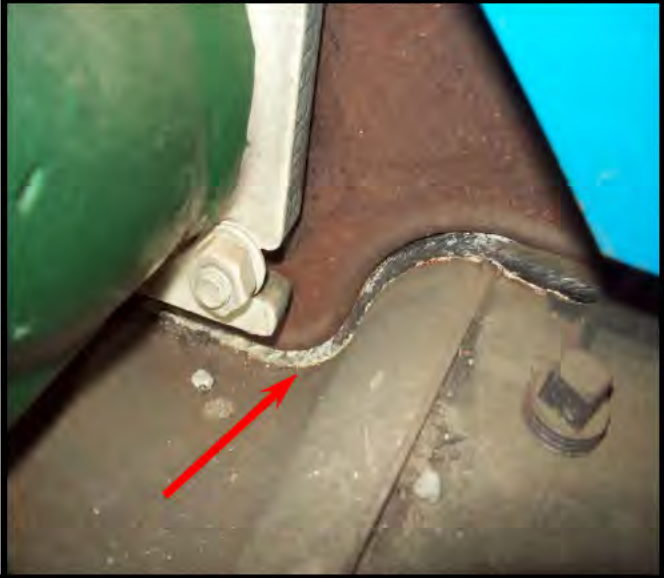
ASBESTOS CONTAINING MATERIALS			
ITEM NO	LOCATION	MATERIAL TYPE	PHOTOGRAPH
11	Basement plant room – rear of boiler – gasket to flue	Gasket

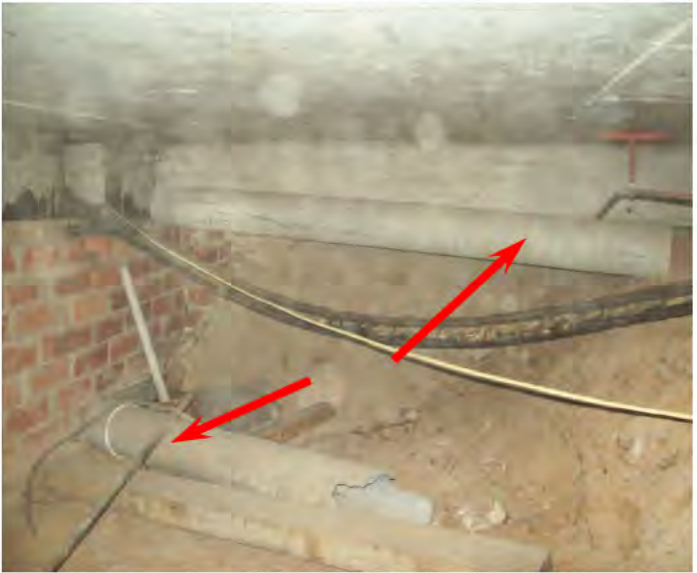
12	Subfloor adj. garage – pipe fragment on top of soil & pipes running under building	Cement pipe

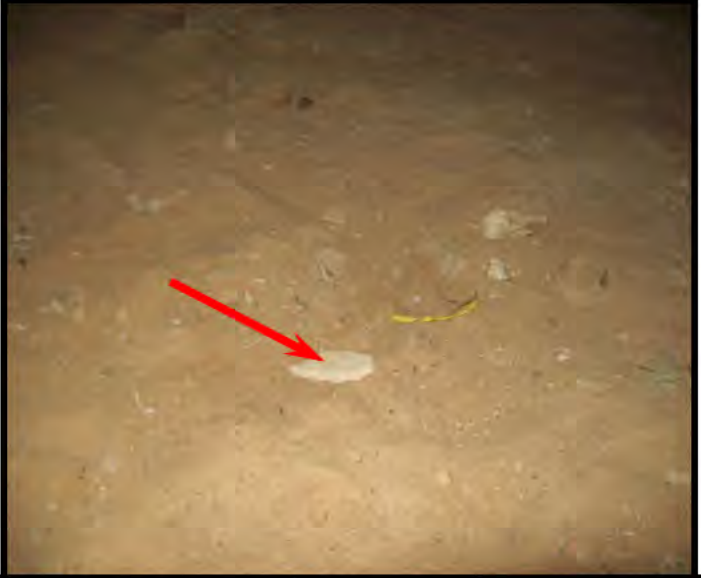
ASBESTOS CONTAINING MATERIALS			
ITEM NO	LOCATION	MATERIAL TYPE	PHOTOGRAPH
13	Subfloor adj. garage – sheet debris on top of soil	Sheet debris

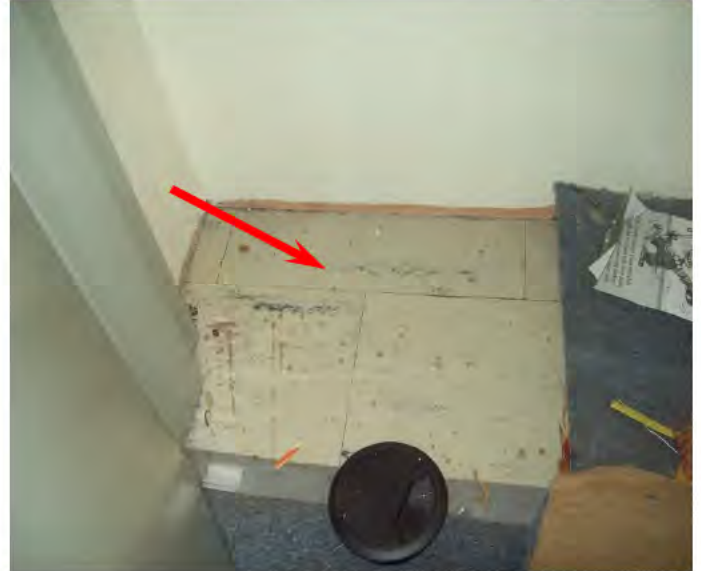
<p>A photograph showing a close-up of a brown, textured surface, likely soil or a subfloor. A red arrow points to a small, light-colored, irregular piece of debris. A yellow object is visible in the background.</p>
14	Post office – rear office space – beige with black streak VFT	VFT

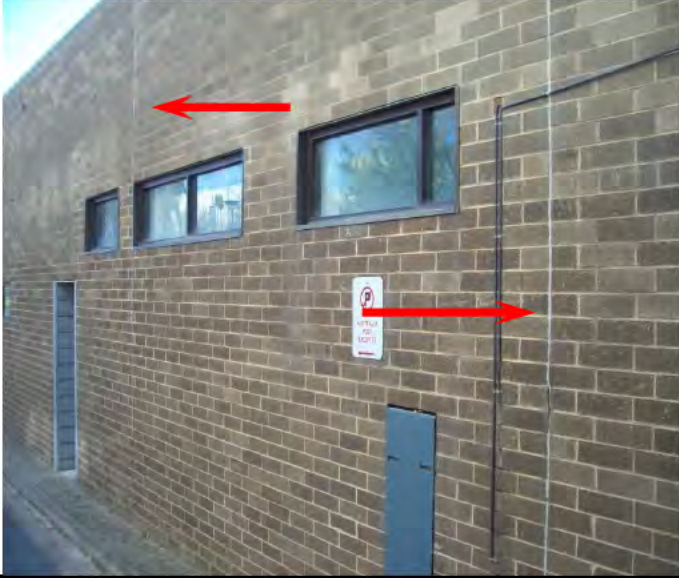
ASBESTOS CONTAINING MATERIALS			
ITEM NO	LOCATION	MATERIAL TYPE	PHOTOGRAPH
15	External expansion joint to garage	Expansion joint

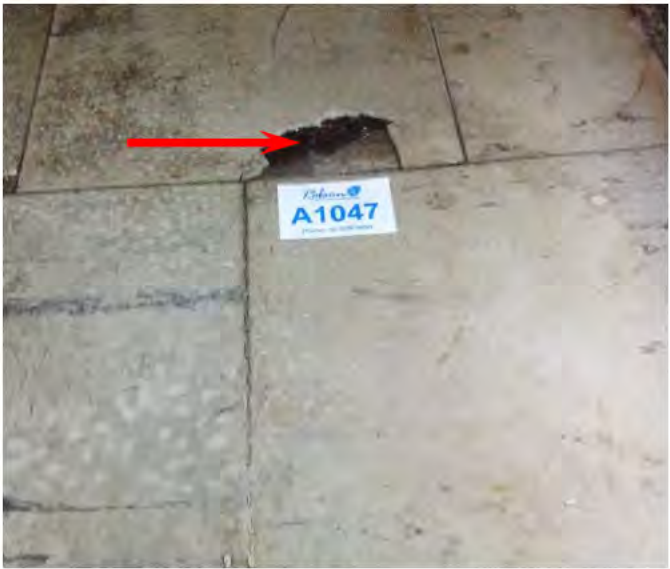
16	Second floor - cleaners room adjacent kitchen - blackjack on VFT	Blackjack

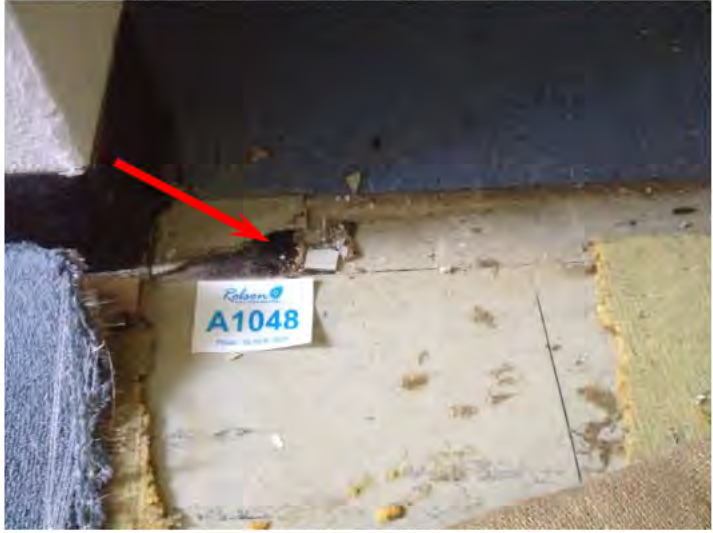
ASBESTOS CONTAINING MATERIALS			
ITEM NO	LOCATION	MATERIAL TYPE	PHOTOGRAPH
17	Second floor – kitchen under blue floor covering and carpet in hallway	Blackjack

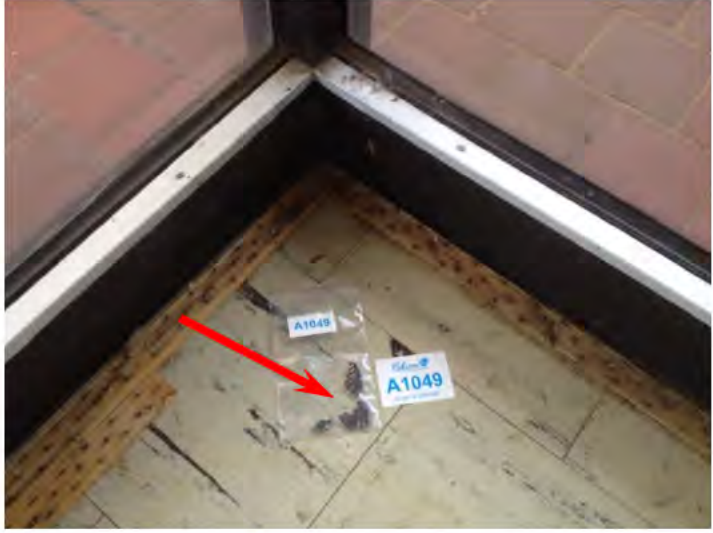
18	Second floor – under carpet in SW corner	Blackjack

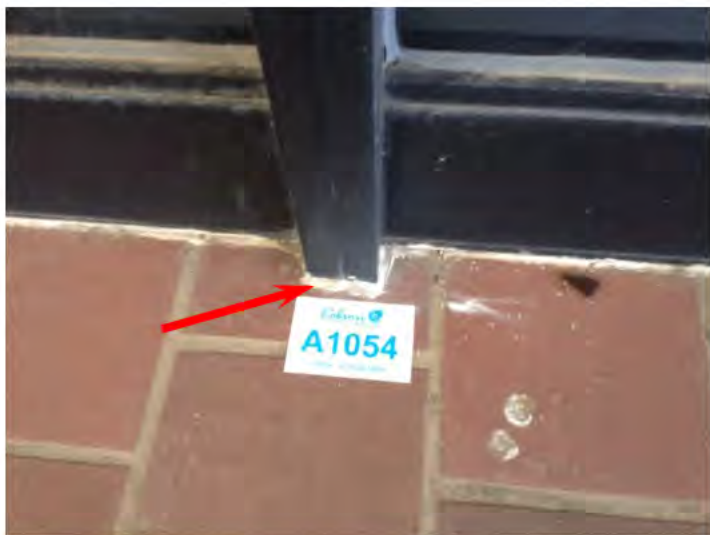
ASBESTOS CONTAINING MATERIALS			
ITEM NO	LOCATION	MATERIAL TYPE	PHOTOGRAPH
21	Second floor – to perimeter of external windows	Caulking

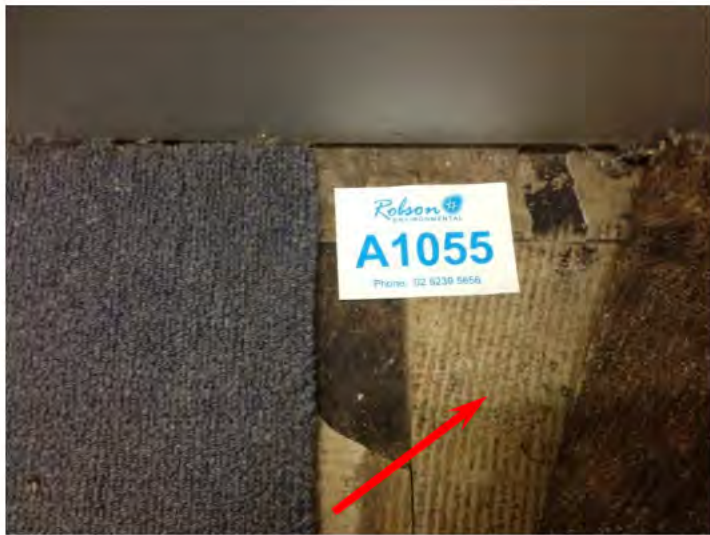
22	Post office – next to fire exit	VFT

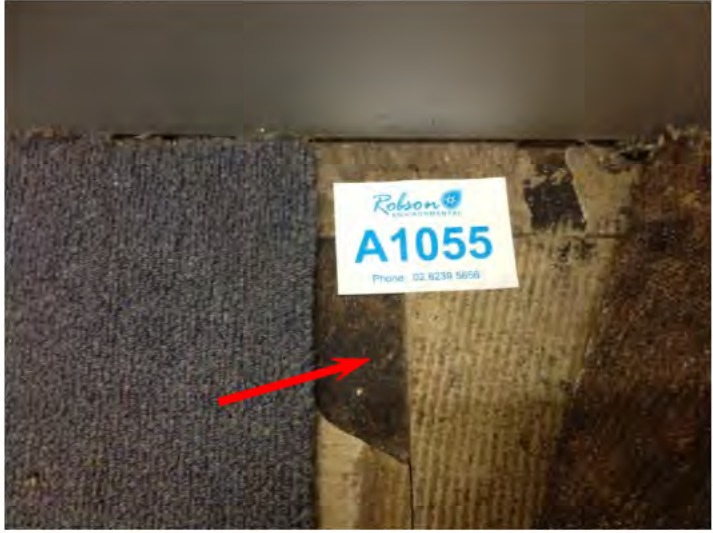
ASBESTOS CONTAINING MATERIALS			
ITEM NO	LOCATION	MATERIAL TYPE	PHOTOGRAPH
23	Post office – next to fire exit	blackjack

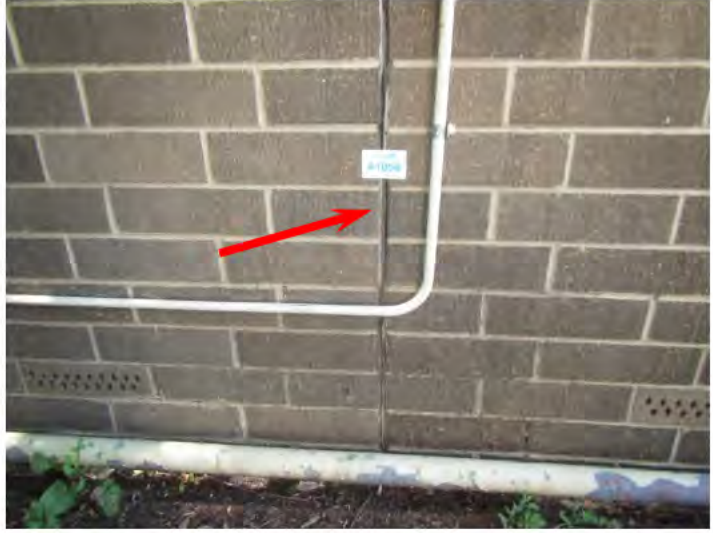
24	To the exterior perimeter of the building	Expansion joint caulking

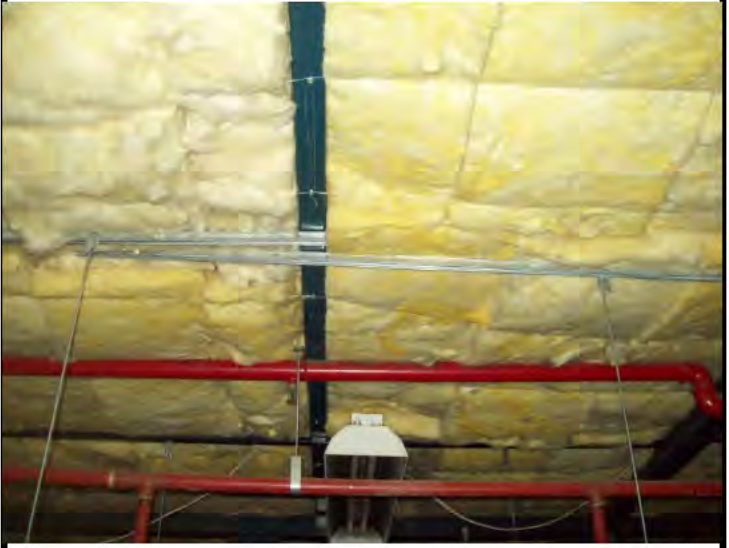
SYNTHETIC MINERAL FIBRE			
ITEM NO	LOCATION	MATERIAL TYPE	PHOTOGRAPH
SMF 1	Basement & second level – insulation batts in ceiling space	Unbonded fibregalss

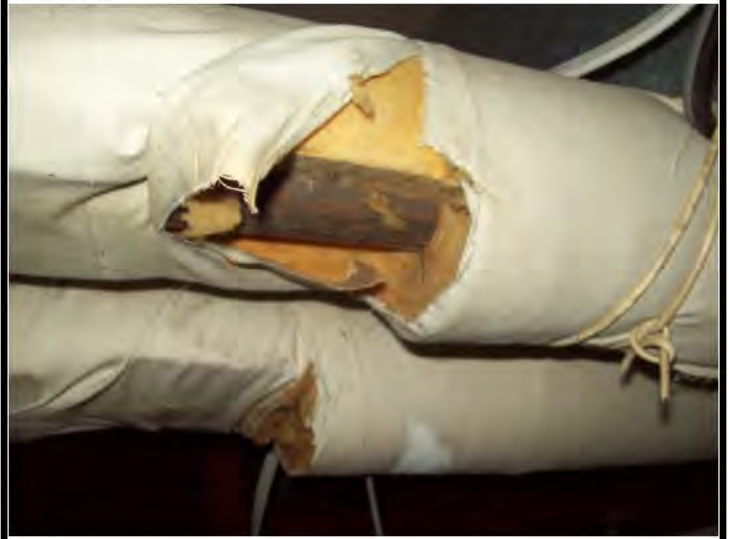
SMF 2	Ground level ceiling space insulation to pipe	Unbonded fibregalss

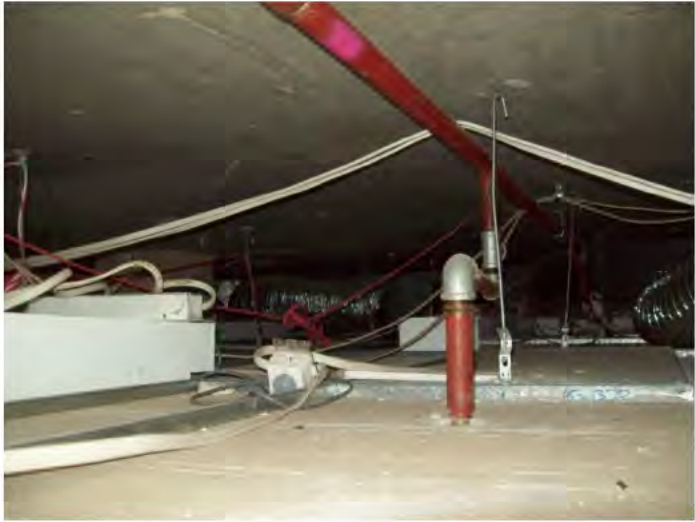
SYNTHETIC MINERAL FIBRE			
ITEM NO	LOCATION	MATERIAL TYPE	PHOTOGRAPH
SMF 3	Basement & ground level ceiling space to flexible ducting	Unbonded fibregalss

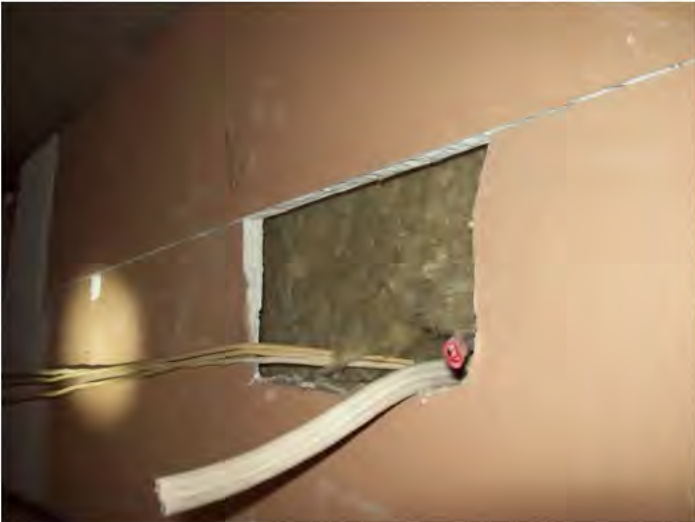
SMF 4	Ground level wall cavity adjacent post office	Unbonded fibregalss

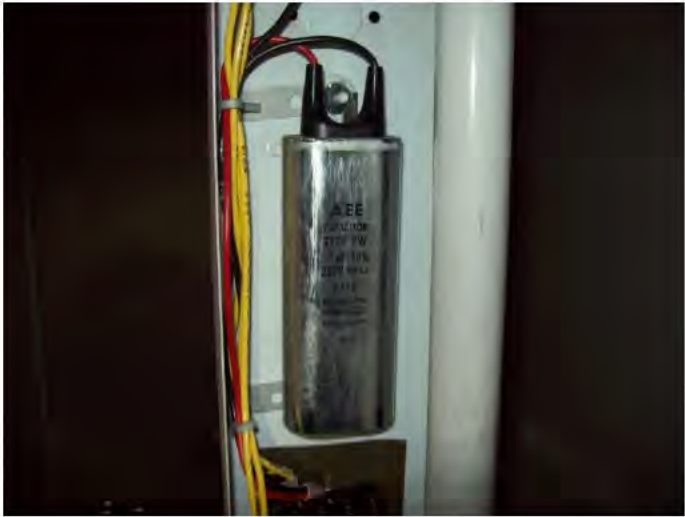
POLYCHLORINATED BIPHENYLS			
ITEM NO	LOCATION	MAKE & TYPE	PHOTOGRAPH
PCB1	Basement storage area	AEE – FW 715

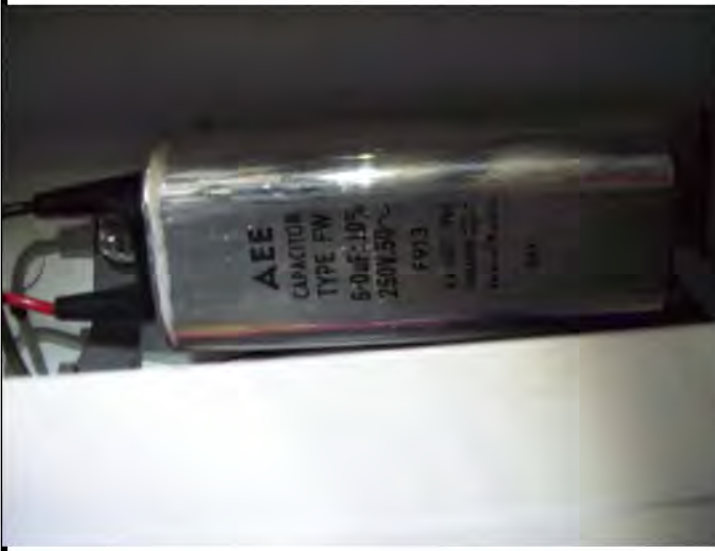
PCB2	Throughout first & second levels	AEE – FW F913

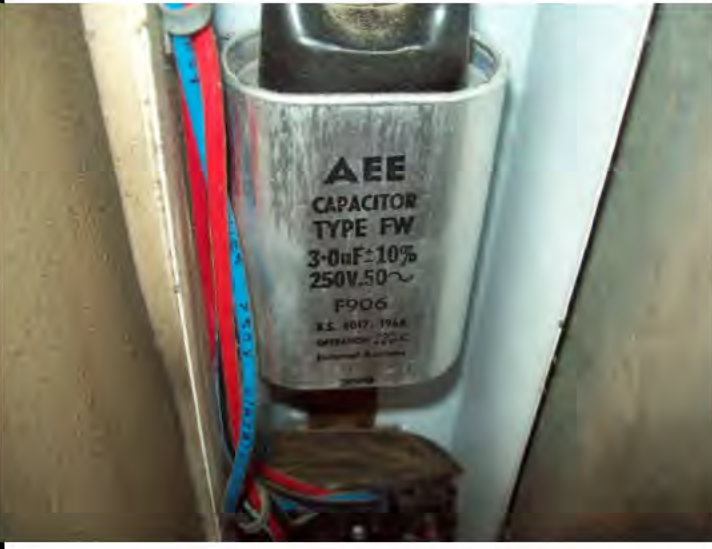
POLYCHLORINATED BIPHENYLS			
ITEM NO	LOCATION	MAKE & TYPE	PHOTOGRAPH
PCB3	First & second level balcony lights in handrail recess	AEE – FW F906

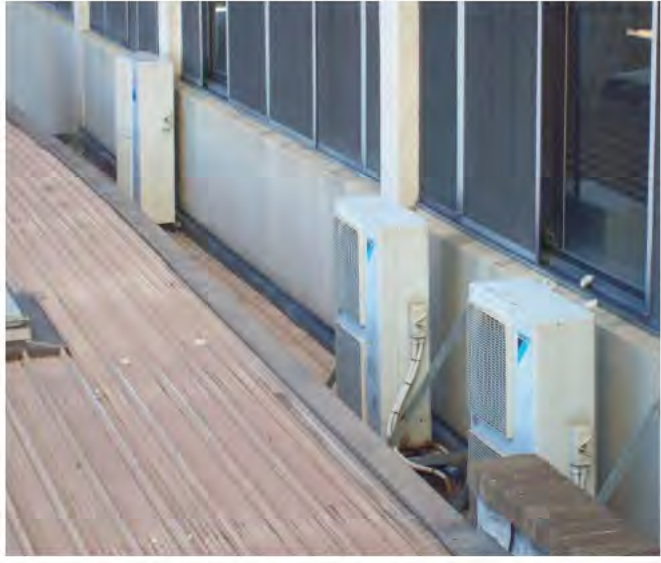
OZONE DEPLETING SUBSTANCES			
ITEM NO	LOCATION	R NUMBER	PHOTOGRAPH
ODS 1	First level roof – Daikin split systems x 2 & Mitsubishi x 1	-

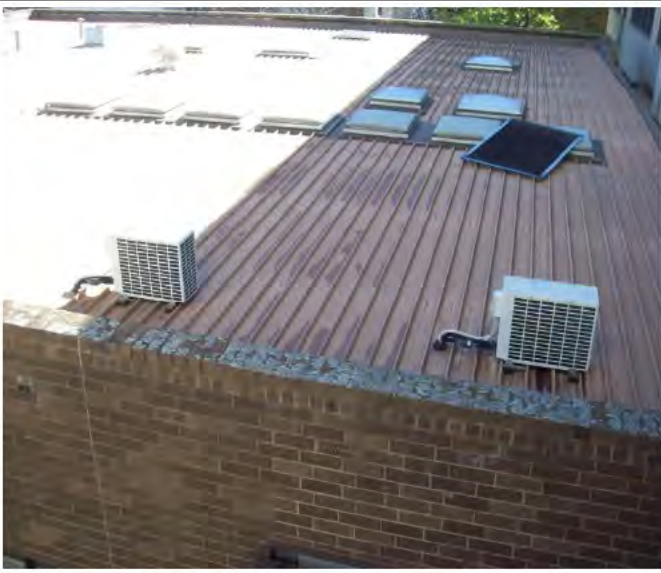
ODS 2	First level roof – unknown make x 2	-

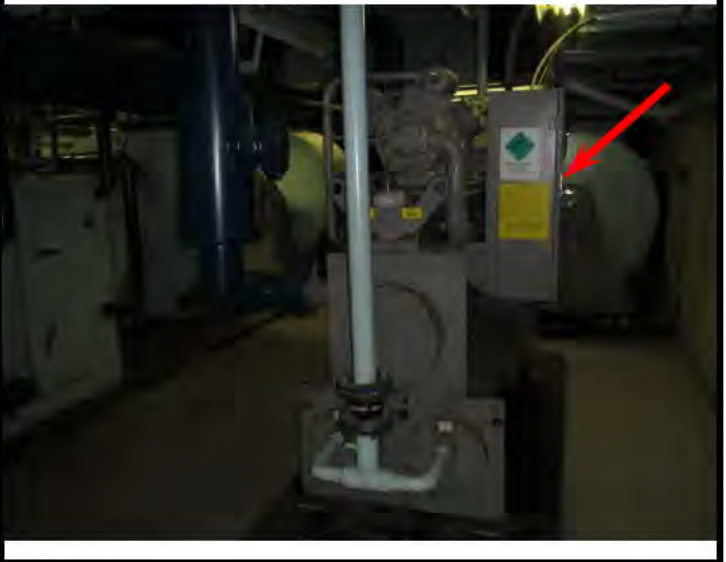
OZONE DEPLETING SUBSTANCES			
ITEM NO	LOCATION	R NUMBER	PHOTOGRAPH
ODS 3	In boiler room	R22
