Appendix C Geotechnical Information

Geotechnical Site Observations (GSO) - Descriptions and Photo Reference List

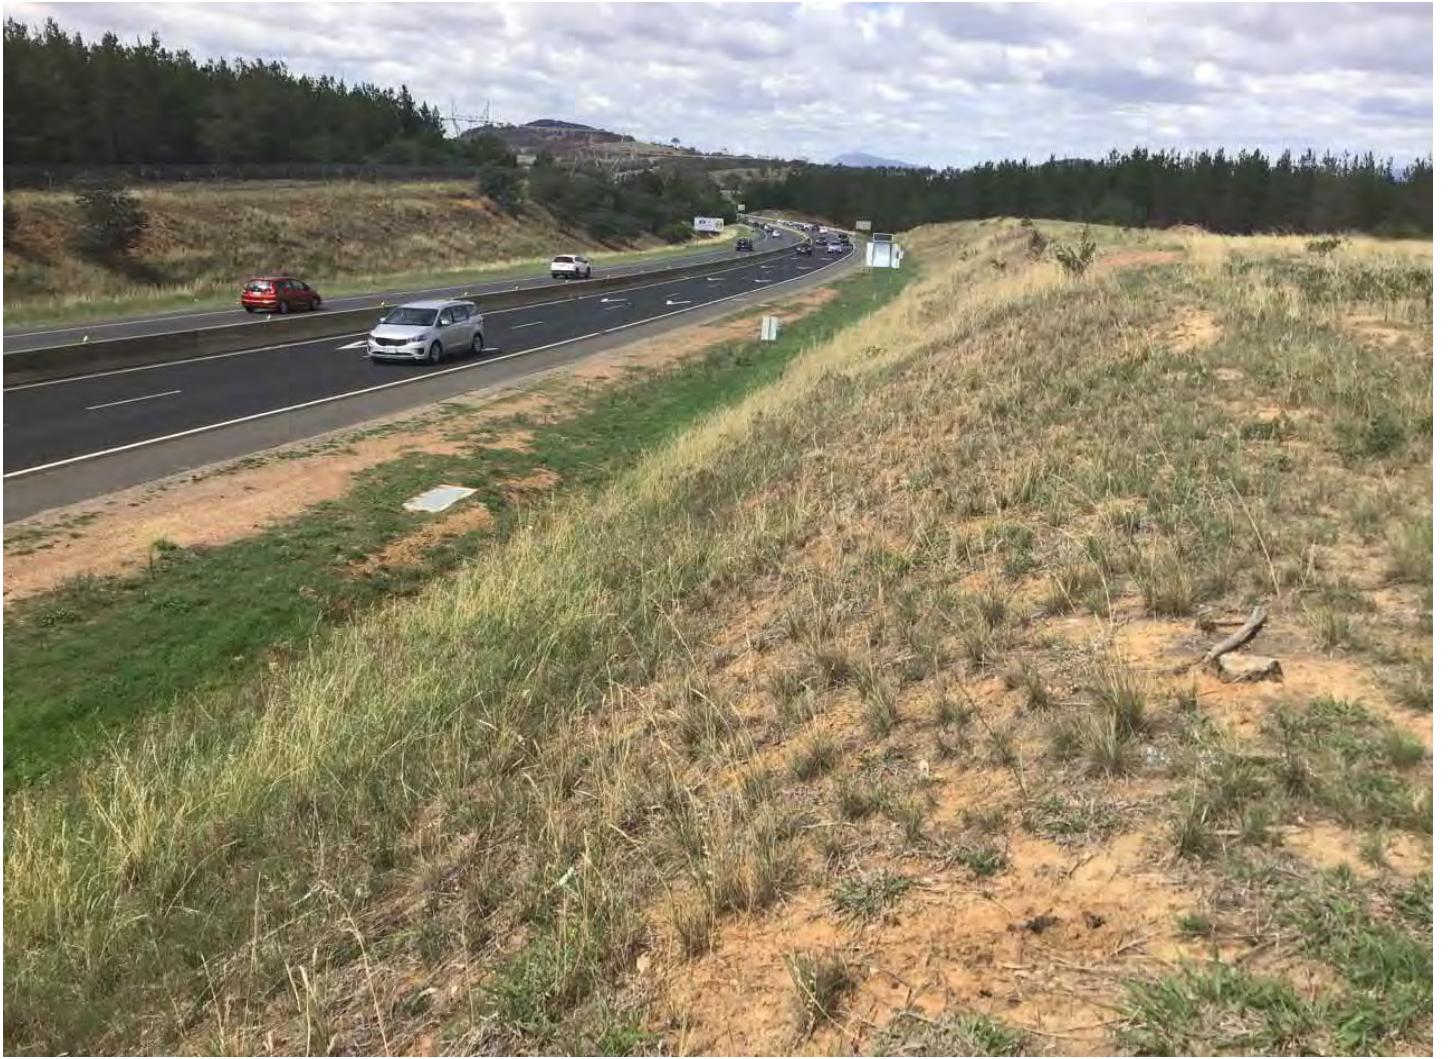
SITE1_ATT35_Photo_1

Site Location	GSO Description	GSO Comments	Photo 1	Photo 2	Photo 3	Photo 4
1	Cutting west of Tuggeranong Parkway	Cutting estimated as 3m to 5m high, comprising orange residual soil, no significant topsoil, no obvious rock outcrops, about 2h:1v to 1.5h:1v.	SITE1_ATT35_Photo_1.jpg			
2	Pine plantation	As per previous observation	SITE2_ATT38_Photo_1.jpg			
3	View west along alignment area		SITE3_ATT12_Photo_1.jpg	SITE3_ATT17_Photo_2.jpg		
4	Filled ground		SITE4_ATT8_Photo_1.jpg			
5	Shallow to rock on western side of Molonglo River	Weathered Dacite, moderately weathered, very to extremely high strength	SITE5_ATT32_Photo_1.jpg	SITE5_ATT4_Photo_2.jpg	SITE5_ATT10_Photo_3.jpg	SITE5_ATT41_Photo_4.jpg
6	View to weathered rock in Molonglo River bed		SITE6_ATT28_Photo_1.jpg	SITE6_ATT49_Photo_2.jpg	SITE6_ATT51_Photo_3.jpg	
7	Southern end of cutting west of Tuggeranong parkway	Cutting estimated as 5m to 6m high at highest point...other observations as per northern end of cut. View south shows Tuggeranong Parkway in up to 4m of fill	SITE7_ATT26_Photo_1.jpg	SITE7_ATT30_Photo_2.jpg	SITE7_ATT34_Photo_3.jpg

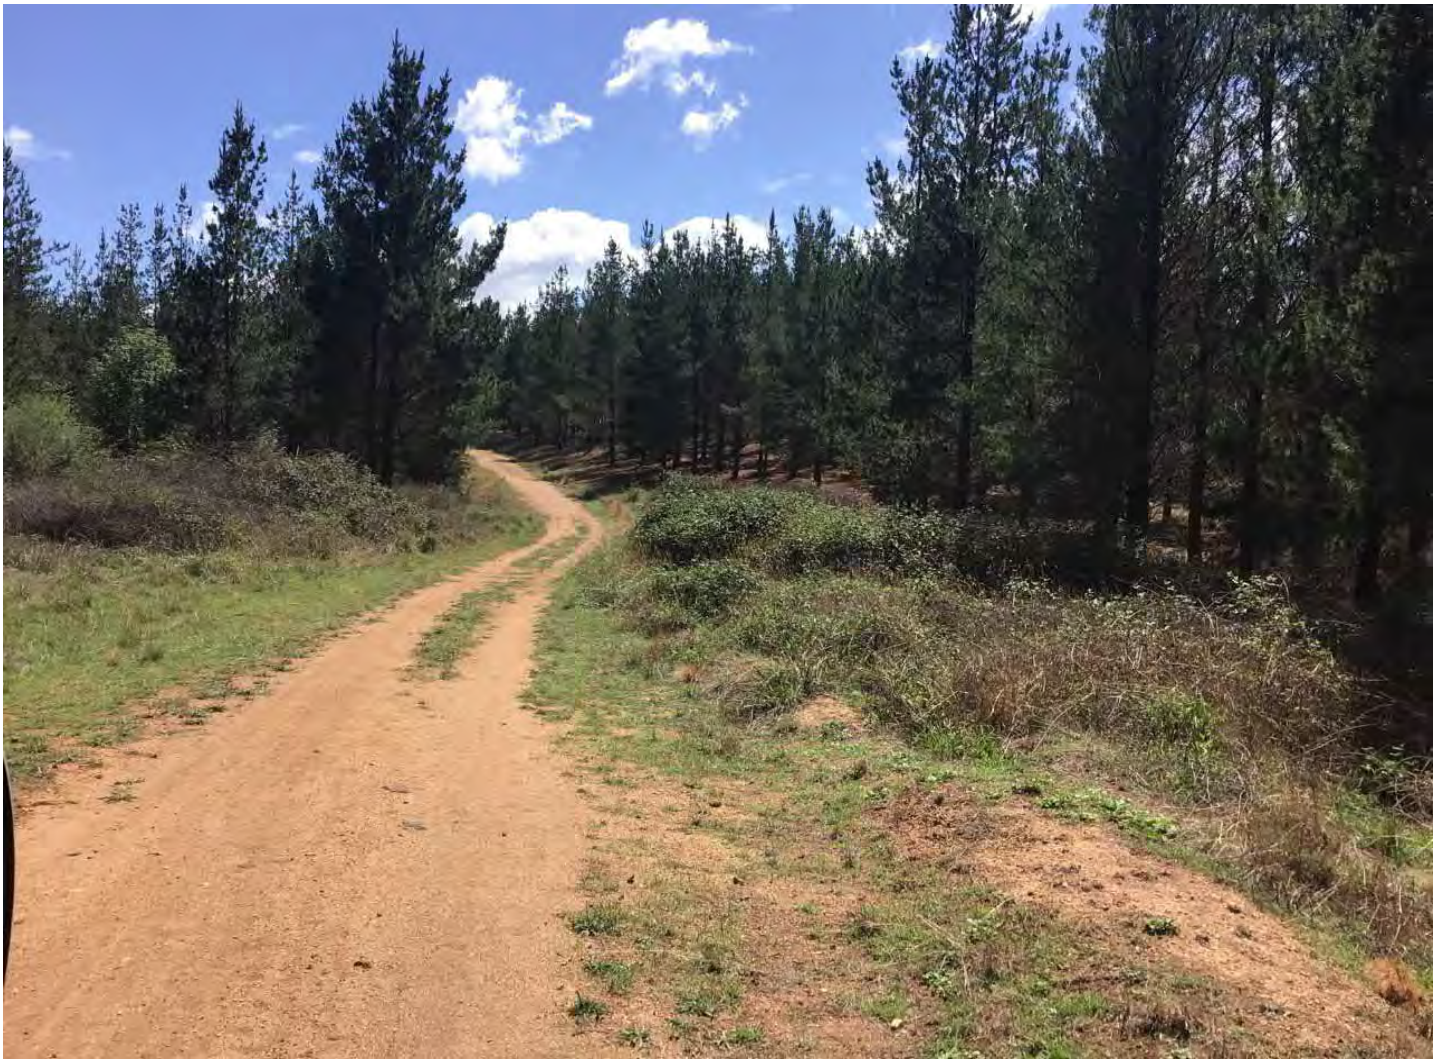
SITE8_ATT7_Photo_1

8	Pine plantation - shallow creek line	Creek has estimated 1m to 2m alluvial soil, over residual then weathered rock	SITE8_ATT7_Photo_1.jpg			
9	Western end of project, view looking east towards fill mounds		SITE9_ATT42_Photo_1.jpg	SITE9_ATT36_Photo_2.jpg	SITE9_ATT11_Photo_3.jpg	
10	View towards east over planned crossing of Molonglo River	Note: shallow to weathered rock beneath ridge line.	SITE10_ATT44_Photo_1.jpg	SITE10_ATT25_Photo_2.jpg	SITE10_ATT18_Photo_3.jpg	SITE10_ATT21_Photo_4.jpg
11	View east along alignment corridor		SITE11_ATT13_Photo_1.jpg			
12	Weathered rock exposure	Volcanic rock origin, fine grained, orange brown to brown, very high strength	No Photos			
13	View west to Molonglo River valley	Shallow to rock estimated 0.5m to 1m to weathered rock	SITE13_ATT37_Photo_1.jpg	SITE13_ATT27_Photo_2.jpg		
14	Creek line exposure	Soil thickness at least 3m thick. Possible weathered rock in base, not confirmed. Rock is likely Dacite, some coarse sand phenocrysts and quartz veins. Some concrete in base of creek...possible sewer alignment nearby.	SITE14_ATT31_Photo_1.jpg	SITE14_ATT5_Photo_2.jpg	SITE14_ATT3_Photo_3.jpg	SITE14_ATT45_Photo_4.jpg
