## Asset 9: Norgrove Park wetland

## Asset 10: Emu Bank wetland

## Asset 11: David Street Pond

## Asset 12: Dickson Pond

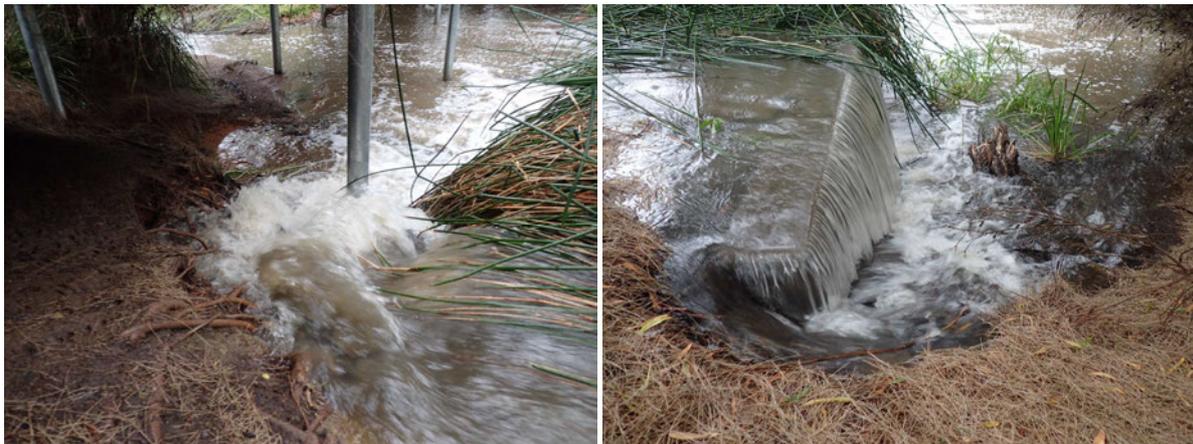
- The wetland has no (or inadequate?) high flow bypass, so high flows pass directly through the macrophyte zone. The velocities are high and would not allow this wetland to sustain an effective biofilm system
- The wetland has no extended detention, so there is only a short residence time for stormwater flows and limited contact time in the macrophyte zone
- Storm flows are effectively short-circuiting within the wetland; following the shortest possible path through the system, out-flanking weirs and following lines of open water through the system. Figure 1 and Figure 2 show some examples where this is occurring.
- Macrophyte coverage in the wetland is mixed, with around half the macrophyte zone currently open water. TAMS noted there have been problems with plant establishment due to ducks and weed infestations.

**Figure 1: High flows passing around vegetation, outflanking a weir and causing bank erosion in two locations**

1. Retrofit a high flow bypass
2. Modify water levels in the system to incorporate extended detention and increase the notional detention time (include a riser outlet)
3. Retain a separate sediment pond upstream of the macrophyte zone

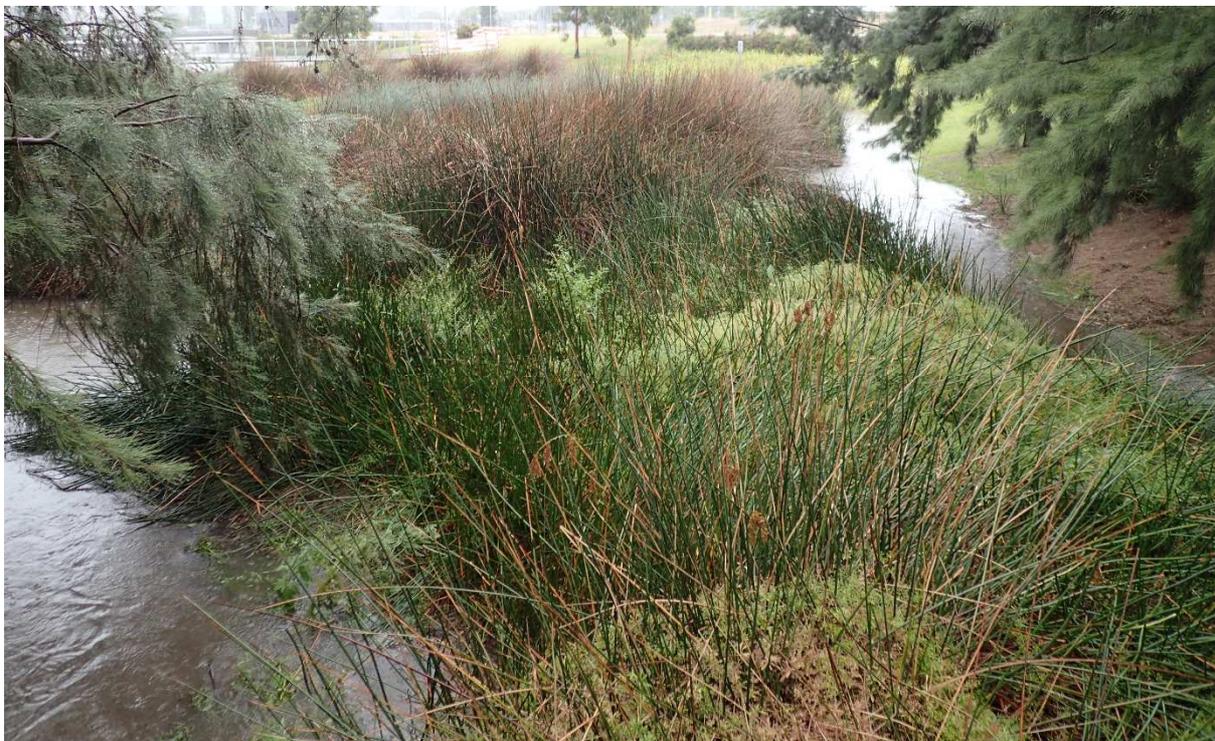
**Figure 2: High flows outflanking vegetation and passing around macrophyte zone in dominant flowpaths either side of the vegetated zone**

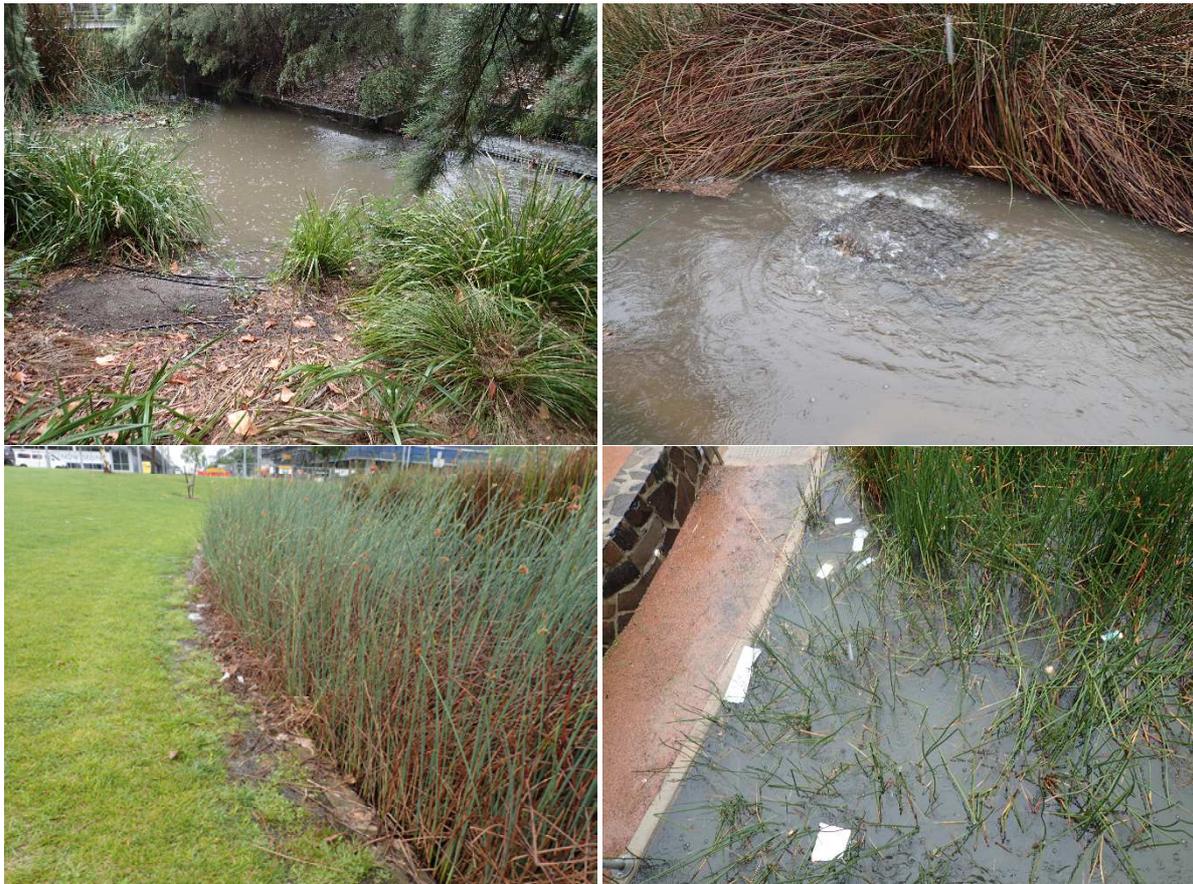
- Some erosion on the bank opposite the inlet pipes
- Significant flows surcharging from a pit within the wetland (unclear whether this is in keeping with the design intent, but appears unintentional)
- Damage to vegetation and loss of mulch around the wetland perimeter where water levels rise above the normal water level during a storm event
- Water inundates the bottom tier of the viewing area

**Figure 3: Minor issues at Norgrove Park wetland – clockwise from top left – erosion opposite inlet; surcharging pit; vegetation damage at edges; inundated viewing area**

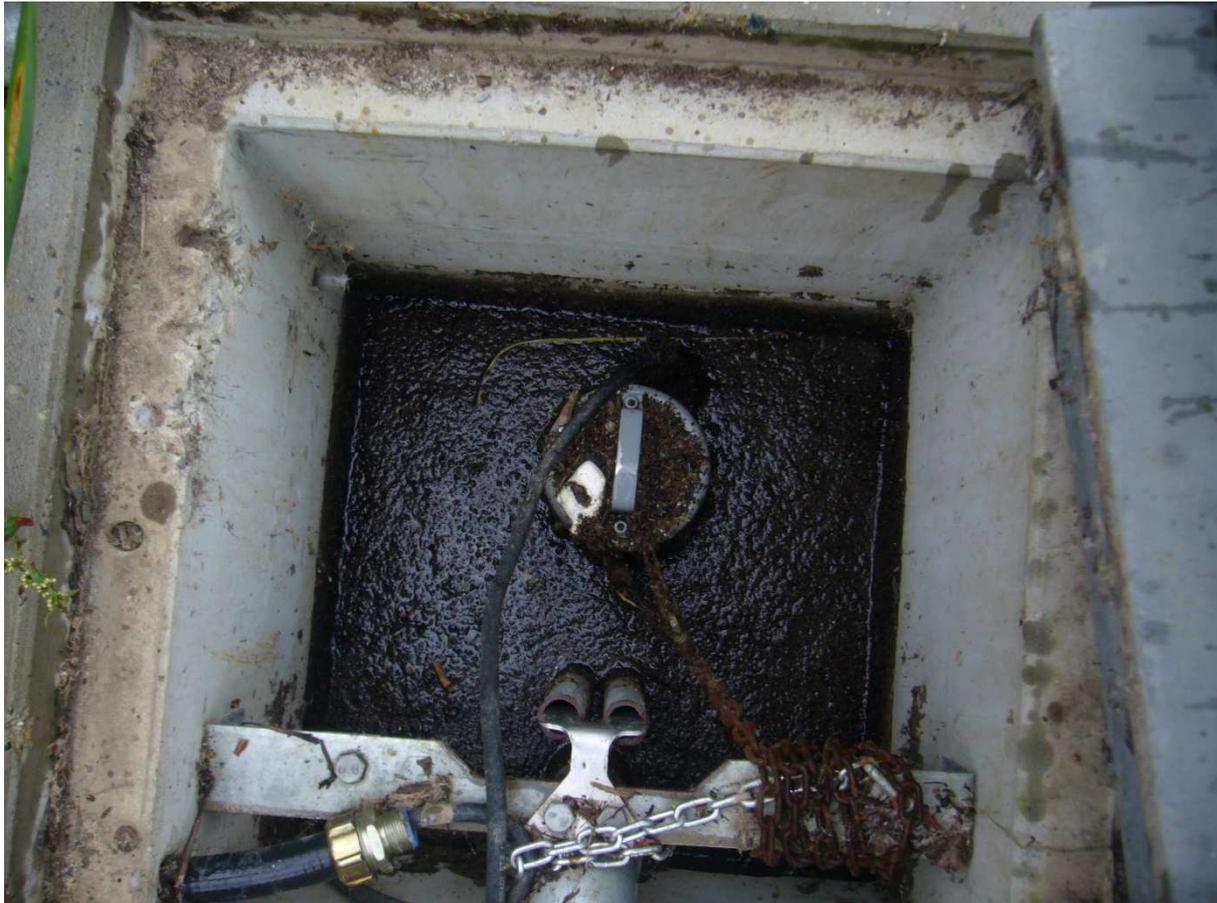
In dry weather, TAMS has noted that in hot conditions, the water in the wetland turns black. TAMS has suggested that the recirculation pump is too small. When we are able to review the design drawings for the wetland we will be able to comment on the size of the recirculation pump and whether it is the appropriate pump for the system. When we checked the pump during our site visit on 24/11/14, it wasn't operating and a build-up of sludge in the pit suggests that it had not operated for a while. A picture is shown in Figure 3. This could also be an important factor contributing to poor water quality in dry weather.

**Figure 3: Recirculation pump in Lake Ginninderra**

- Check the operation of the recirculation pump:
  - Arrange a pump service and check whether the exiting pump is functional
  - Check whether the pump is appropriately sized and whether it is appropriate for the conditions
- Re-plant and establish macrophytes within the wetland:
  - Use those species which have established well at this site and at other relevant sites in the ACT
  - If possible, plant a more extensive area than was done previously

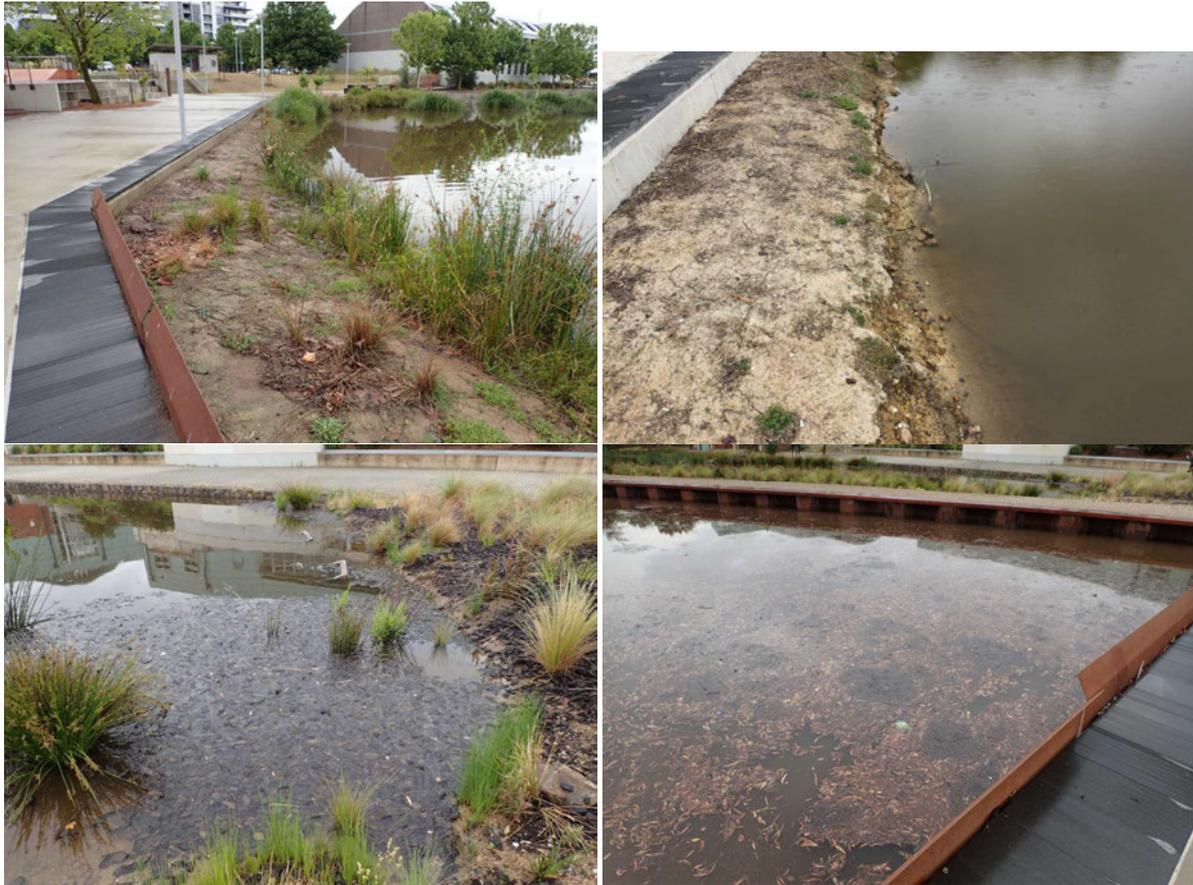
- Some of the edge vegetation has also established poorly
- Some erosion around the wetland edges
- Some mulch washed into the wetland during high water conditions
- Floating leaf litter accumulating at the upstream end of the central channel

**Figure 4: Minor issues at Emu Bank wetland – clockwise from top left – poor establishment of edge vegetation; bank erosion; mulch washed into wetland; floating leaf litter in central channel**

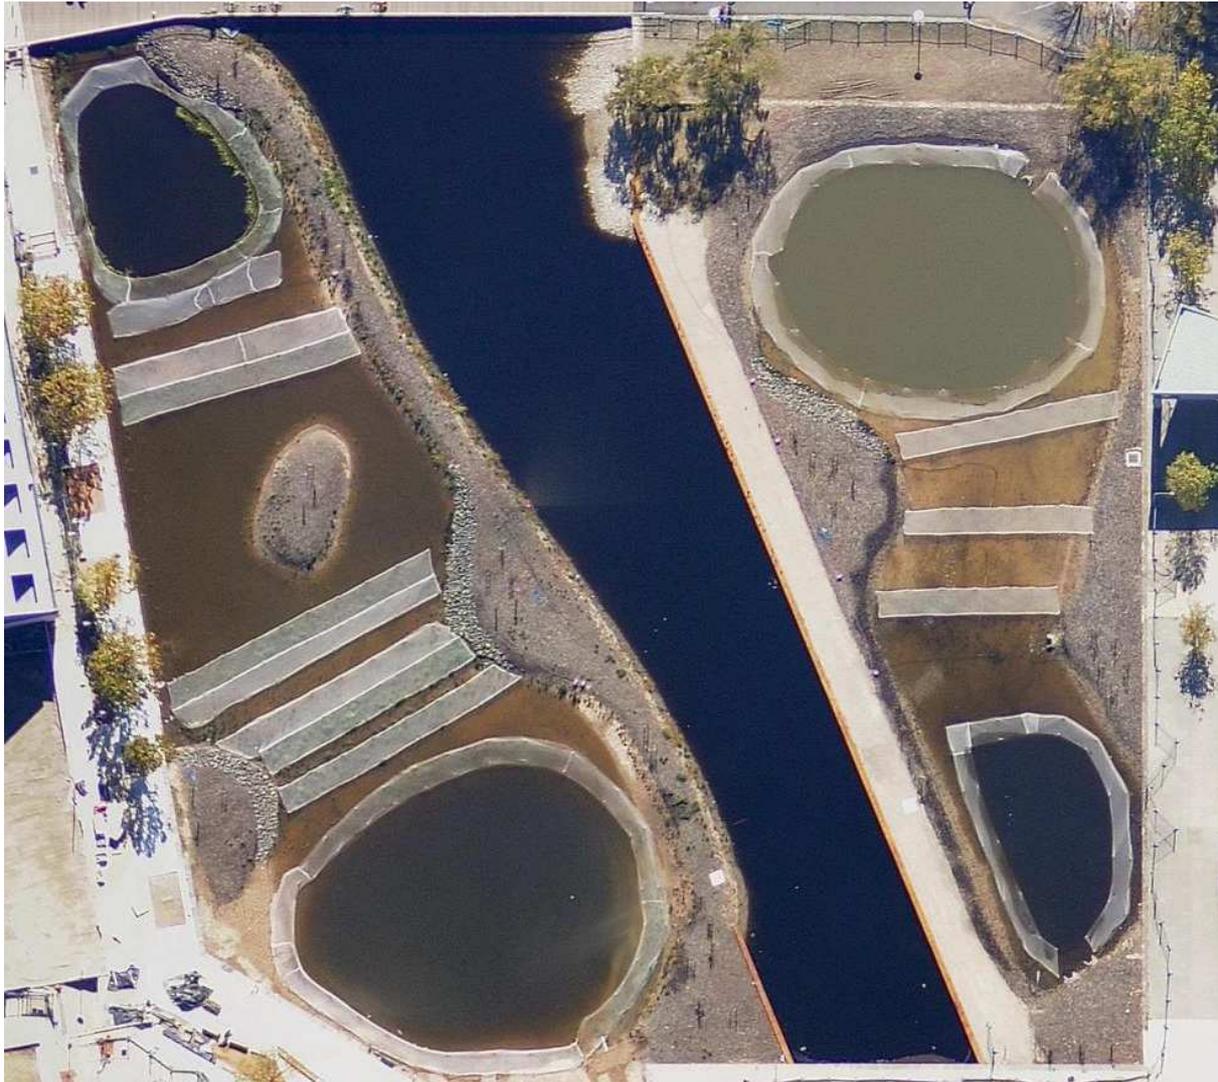
Analysis of subsequent aerial images from Nearmap suggests that water levels were raised too quickly within the wetland, before plants were fully established. Macrophytes need to establish in shallow water so that a large part of the plant is always emergent. If seedlings are drowned, they are not able to establish. Normally in wetlands, water levels are therefore raised very slowly during the establishment phase to assist macrophyte establishment.

**Figure 5: Aerial image from Nearmap, 25 April 2013, showing bird netting over areas where macrophytes were planted**

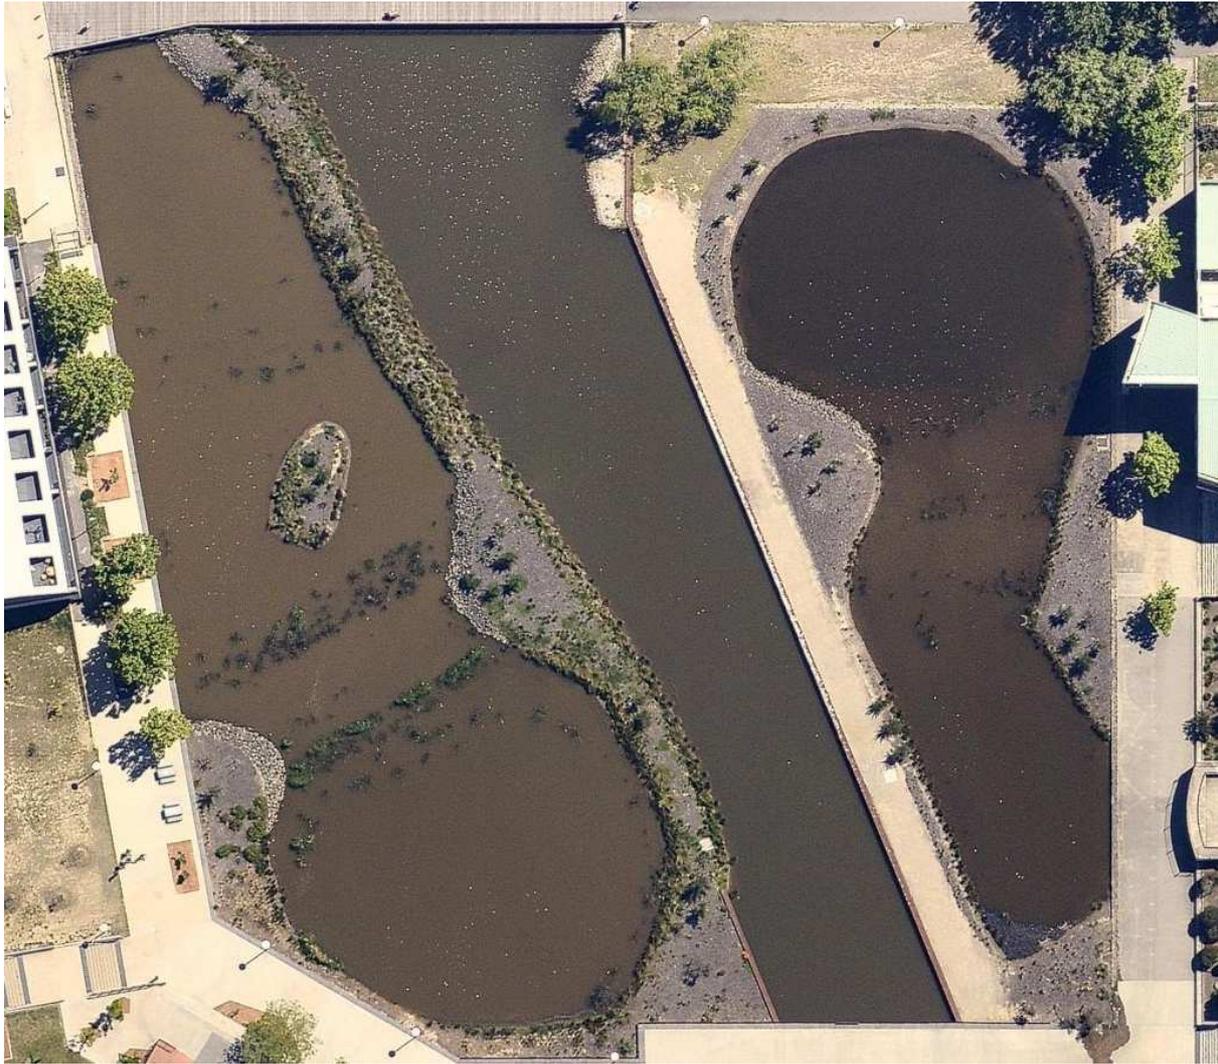
Nearmap images suggest that planting was undertaken around March 2013, then water levels were raised to the normal operating level by July 2013. A few macrophytes survived (perhaps in shallower zones of the wetland), however most failed to establish. Figure 6 shows an aerial image from 29 October 2014, showing very limited remaining macrophyte coverage.

**Figure 6: Aerial image from Nearmap, 29 October 2014, showing that most macrophytes have failed to establish**

- Use a contractor with experience establishing wetland vegetation
- Ensure the contractor is responsible for maintenance during a longer establishment period, and that their contract includes performance targets rather than being purely time-based
- Manage water levels more carefully through the establishment period (note that this requires some thought as to how this will be most effectively achieved, in the context of site specific constraints)
- Use bird netting as done previously
- Our experience establishing vegetation in other wetlands is that it is often more effective to plant a smaller number of larger individual plants (e.g. 150 mm pots) instead of trying to establish wetland vegetation from tubestock.

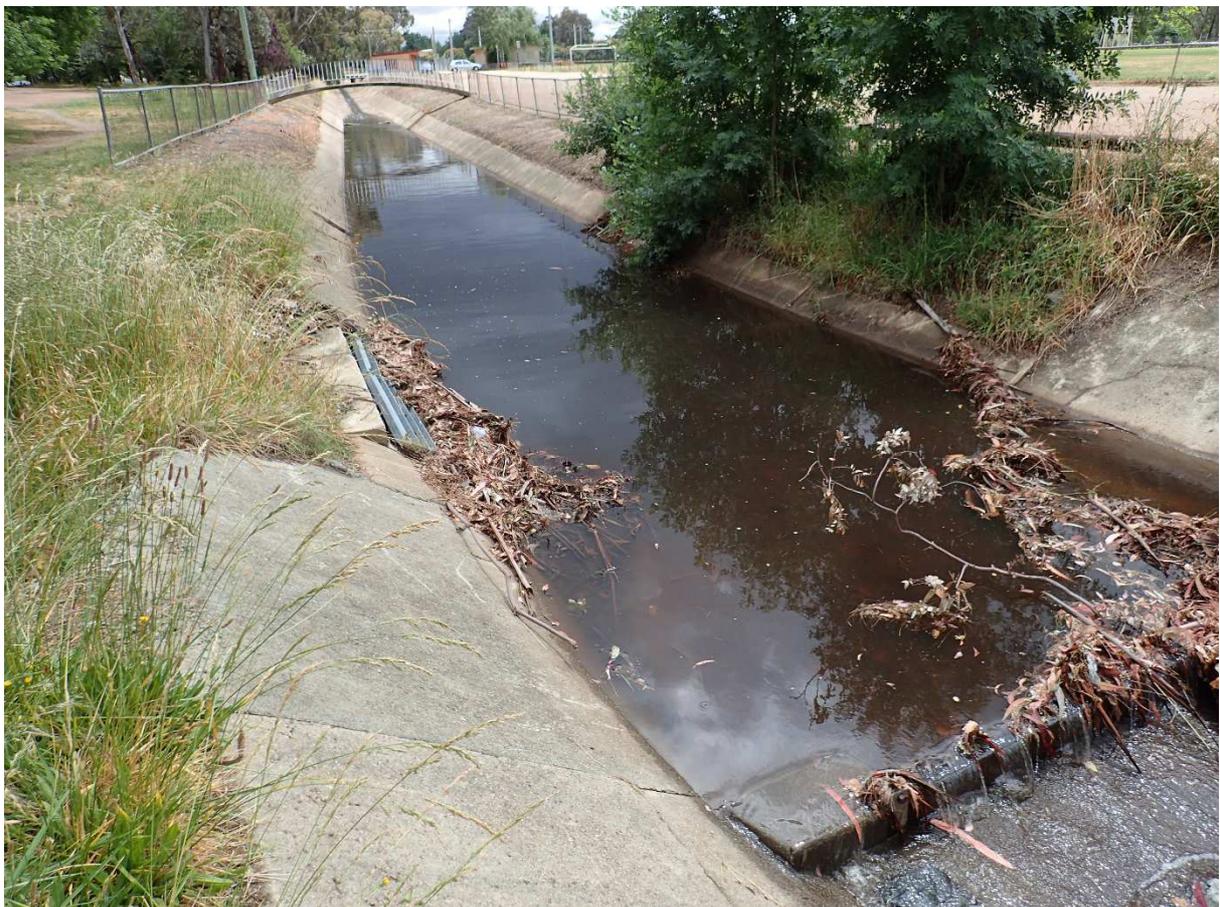
- There is a very small level difference between the diversion weir and the overflow weir, so it bypasses very easily.

Figure 1 shows the condition of the diversion structure when we visited the site on 16 November 2014. Almost all inflows were bypassing the wetland due to significant blockage of the trash rack. We cleaned the trash rack on 16 November and observed that after this, most of the inflows entered the wetland. However we returned to the site during the next rain event on 24 November to find that even with minimal blockage of the trash rack, significant flows were still bypassing the wetland due to a very small level difference between the diversion level and the overflow weir. Design drawings indicate a 100 mm level difference, however it appears to have been constructed with effectively no level difference. The detailed issues are highlighted in Figure 2.

**Figure 1: Flows bypassing the pond after rain event on 16 November 2014**

1. Re-design the diversion to function as originally intended
2. Increase the notional detention time by re-designing the riser outlet

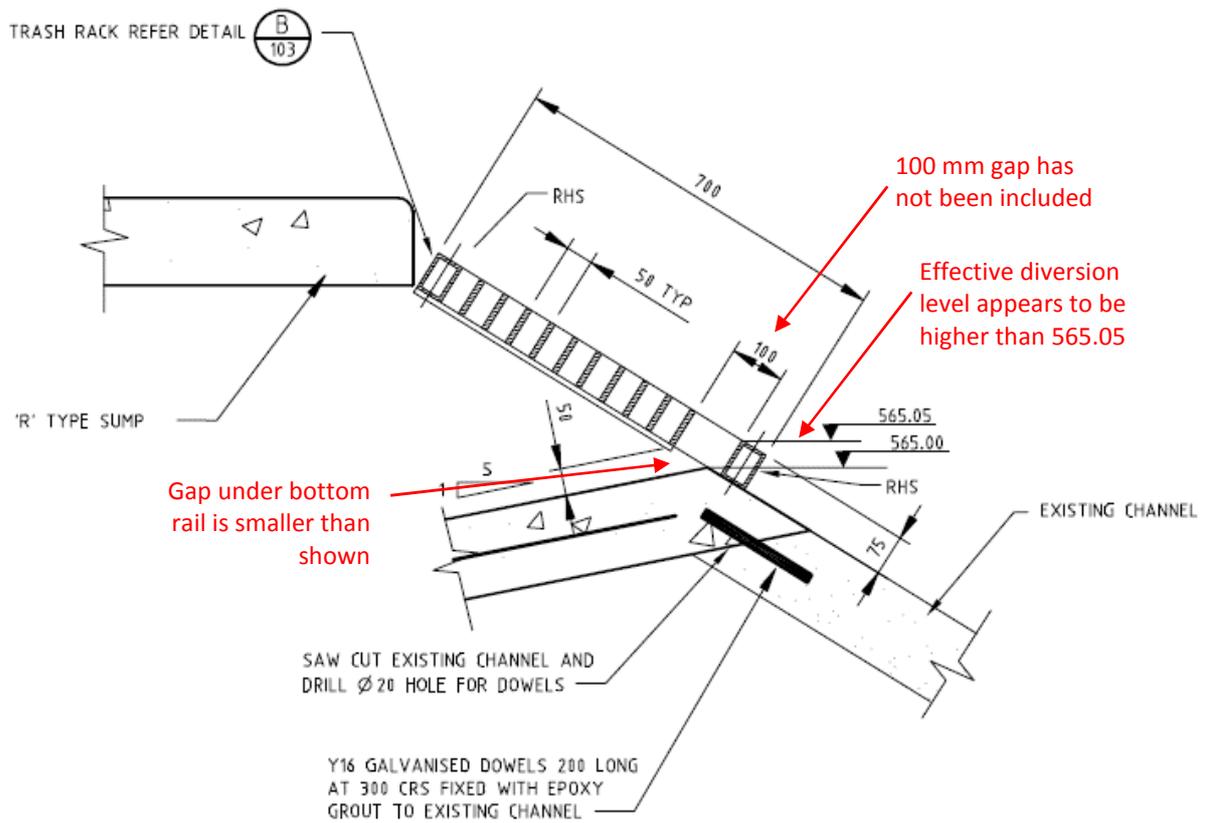
- The trash rack blocks easily. The design of the trash rack is such that at the base of the rack there is a very small opening between the lowest rail and the concrete structure underneath, which is the first part to block.

**Figure 2: Trash rack details**

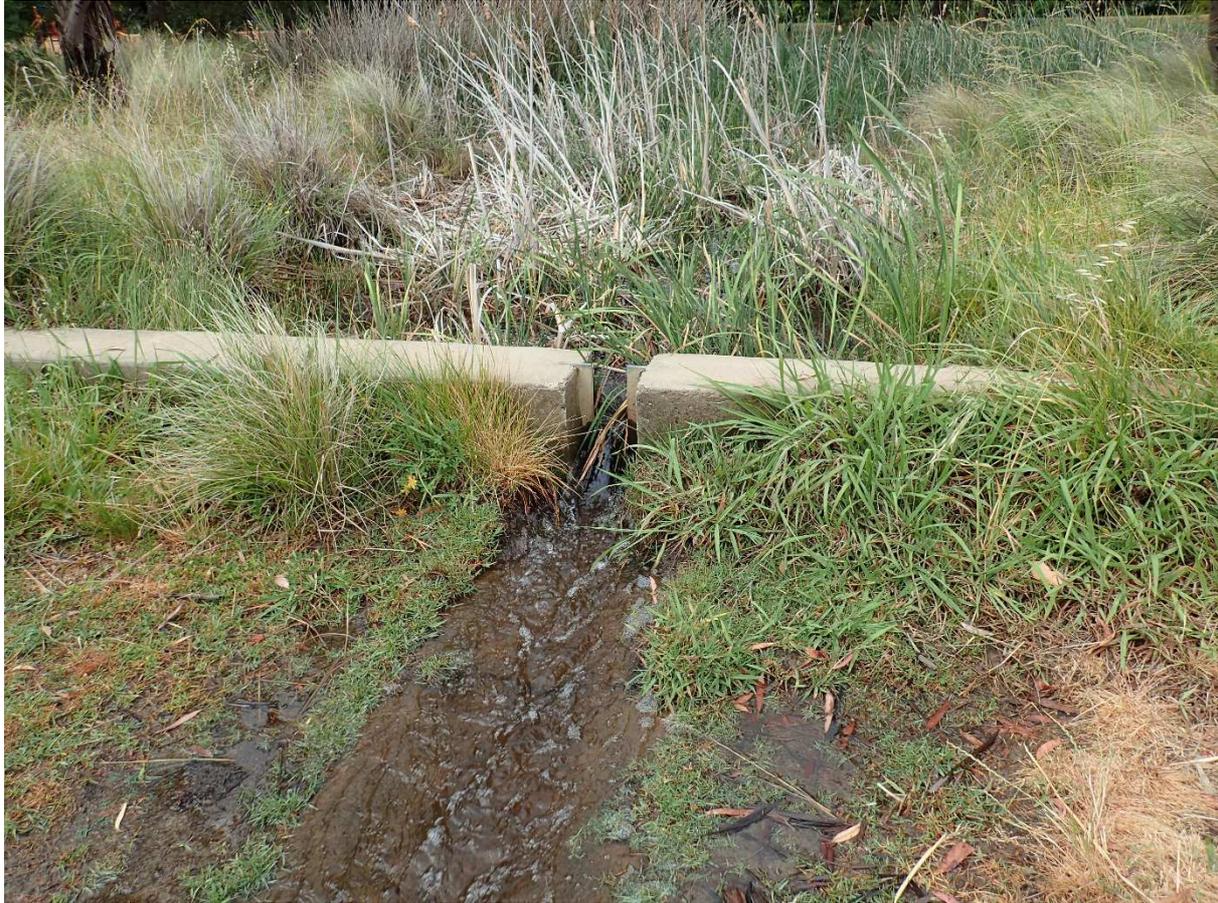
A third aspect which could be modified at David Street to improve the treatment performance is the extended detention. The riser outlet has been designed with a relatively large opening (a 100 mm slot) and therefore allows only short residence times within the pond. Longer detention times allow more time for physical, chemical and biological pollutant removal pathways to be effective.

**Figure 3: Water flowing out the riser outlet at approximately the same rate that it enters the pond (after cleaning the trash rack on 16 November 2014)**

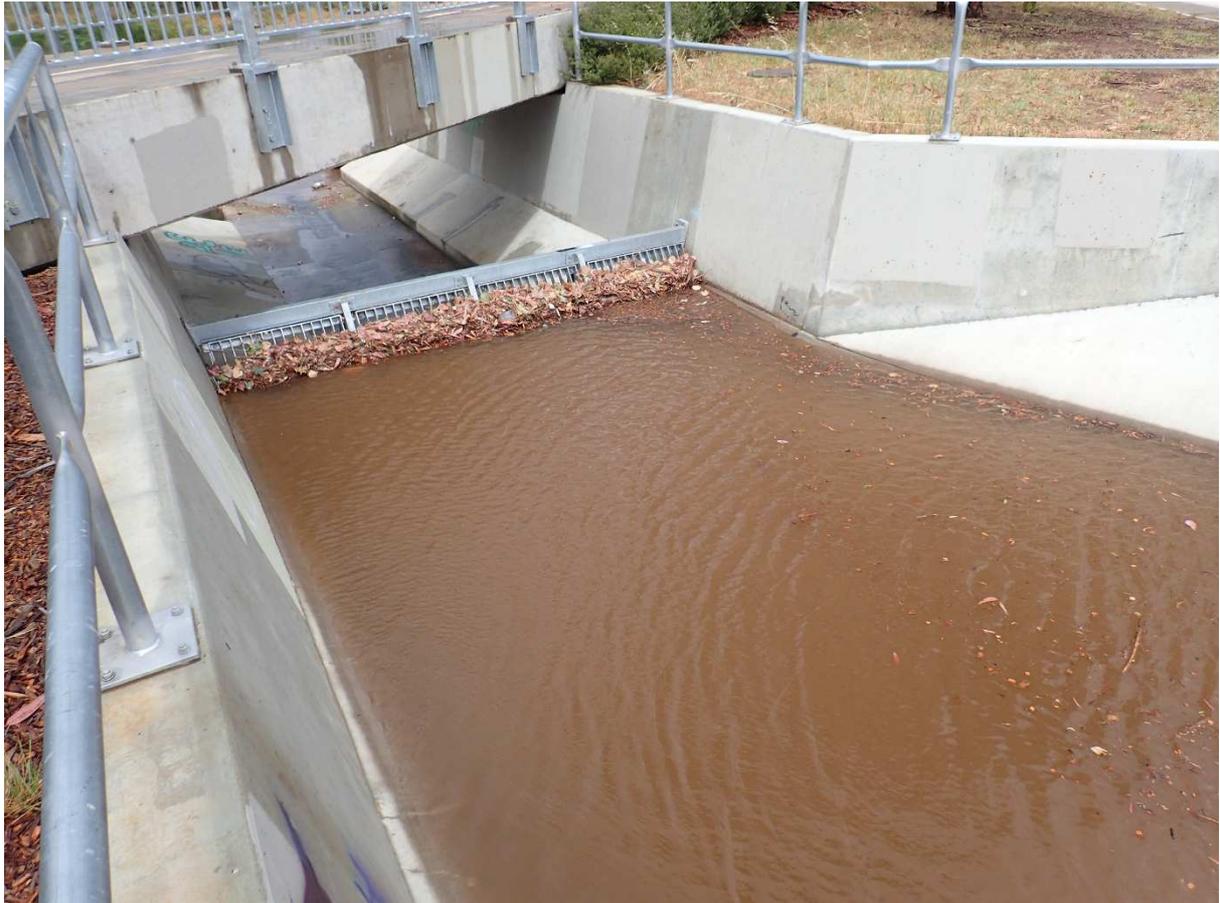
The Final Sketch Report (URS 2010) indicated that the design flow intended to be diverted into the system was 8-10 m<sup>3</sup>/s, equivalent to the 1 in 3 month ARI, however our observations indicate that the actual diversion flowrate in most events would be well below this, due to blockage of the trash rack. It appears that blockage may not have been factored into the design calculations. Design drawings indicate that:

**Figure 1: Blocked trash rack letting very little flow into the Dickson Pond on 16 November 2014**

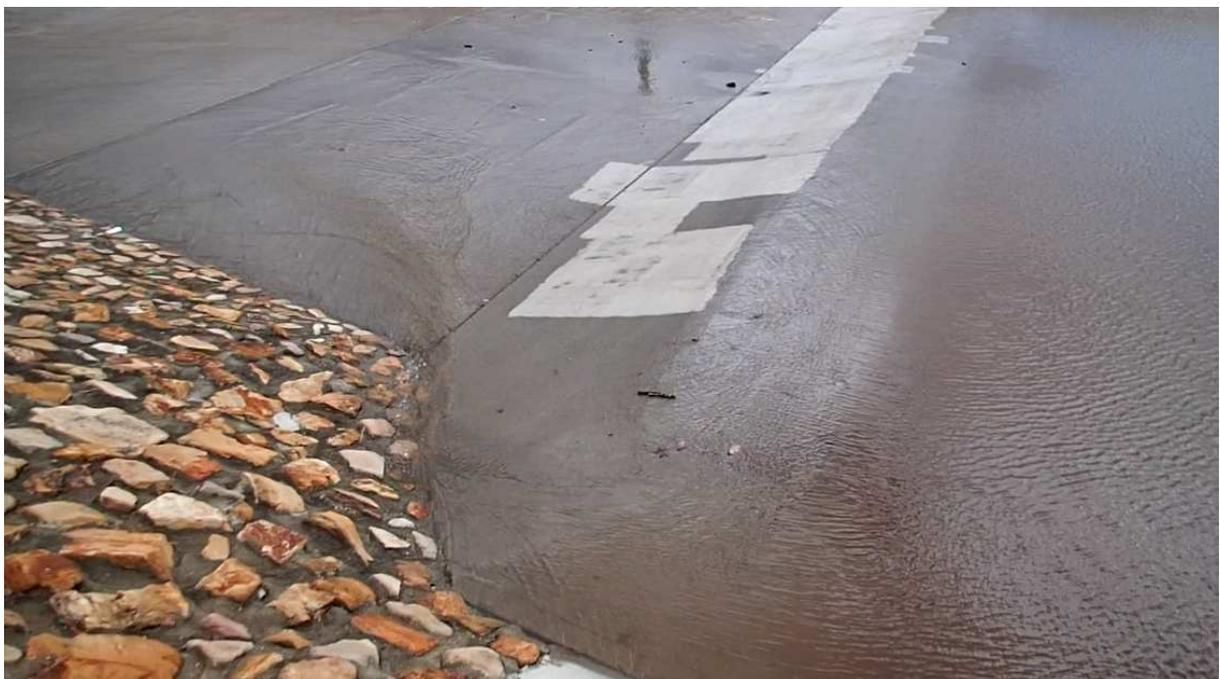
- The trash rack extends between 582.85 and 583.80 m AHD
- The bypass weir has a level of 583.45 m AHD, 0.35 m below the top of the trash rack and the same level as the top of extended detention

**Figure 2: Flows overtopping the bypass weir on 16 November 2014**
