ACT Urban Water Quality Management Infrastructure:
Asset Report

May 2016

Asset 1A: Crace Bioretention Basin - Medhurst Crescent

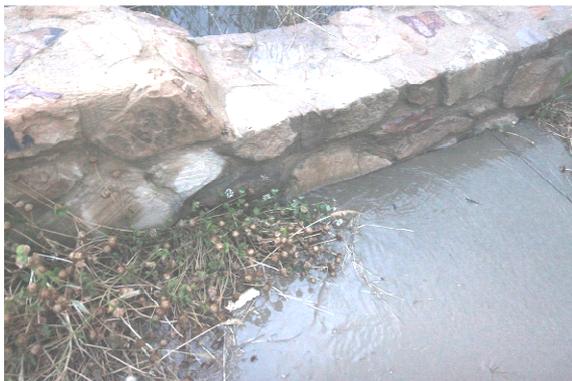
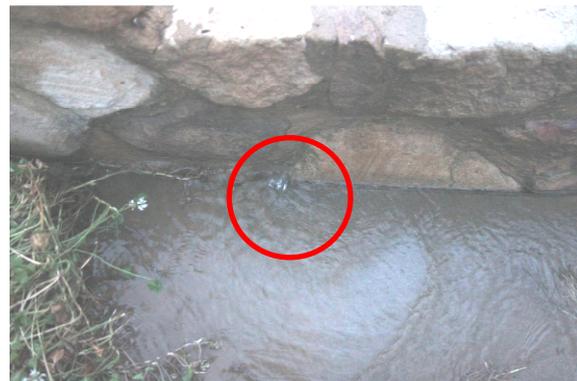
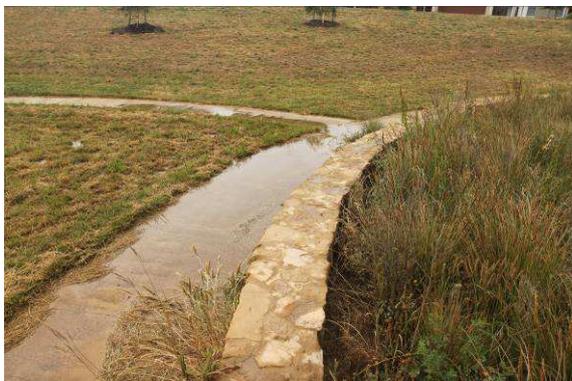
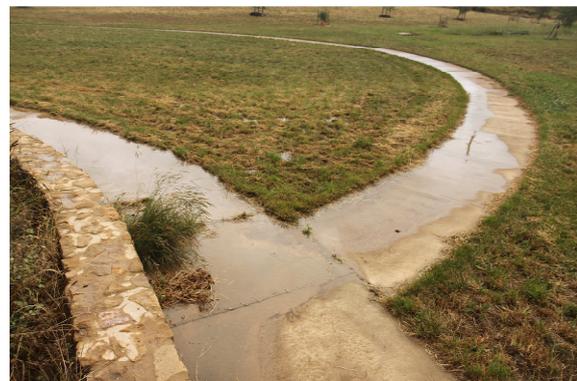
Figure 1: Water flowing under the retaining wall (November 2014)

One of the key performance issues identified at the basin is the failure of the retaining wall around the bioretention system, particularly at the downstream end at the overflow weir. During all site visits there was evidence of water and silt around the base of the wall near the overflow weir and during the second wet weather site visit it was clearly identified that water was flowing underneath the wall (Figure 1).

Water can be seen flowing at base of wall and along path

Water bubbling up at joint between wall and path

Water on path even in a small rain event

This is most evident when the extended detention is full as the pressure of water increases the flow rate underneath the wall. The flows under the wall significantly compromise the performance of the system as water effectively bypasses the filter media. The flows under the wall also impact on the usability of the path in this location, with water flowing directly over the path and depositing silt on the path. Furthermore the stability of the retaining wall could be undermined over the long term. Water was flowing under the wall in a number of locations.

It appears that the key causal factor which has led to failure of the bioretention basin wall is a combination of a poor design detail for the retaining wall around the outside of the basin (to be confirmed once the design drawings are received) and/or poor construction of the wall or a combination of both. This physical defect is unlikely to have been influenced by deterioration since construction or lack of maintenance.

It is recommended to undertake rectification works to the wall to prevent water flowing under the wall. The exact measures to rectify this issue need to be confirmed once the existing design drawings are reviewed and an informed review of the current defect can be determined. However we expect that external patching of the wall is unlikely to be effective and that rectification will require some sort of lining system to the internal portion of the wall to prevent water flowing under the wall, or some rectification works to the wall itself and its sub-grade to prevent water flowing under the wall. Other options could also be considered once the details of the wall are known.

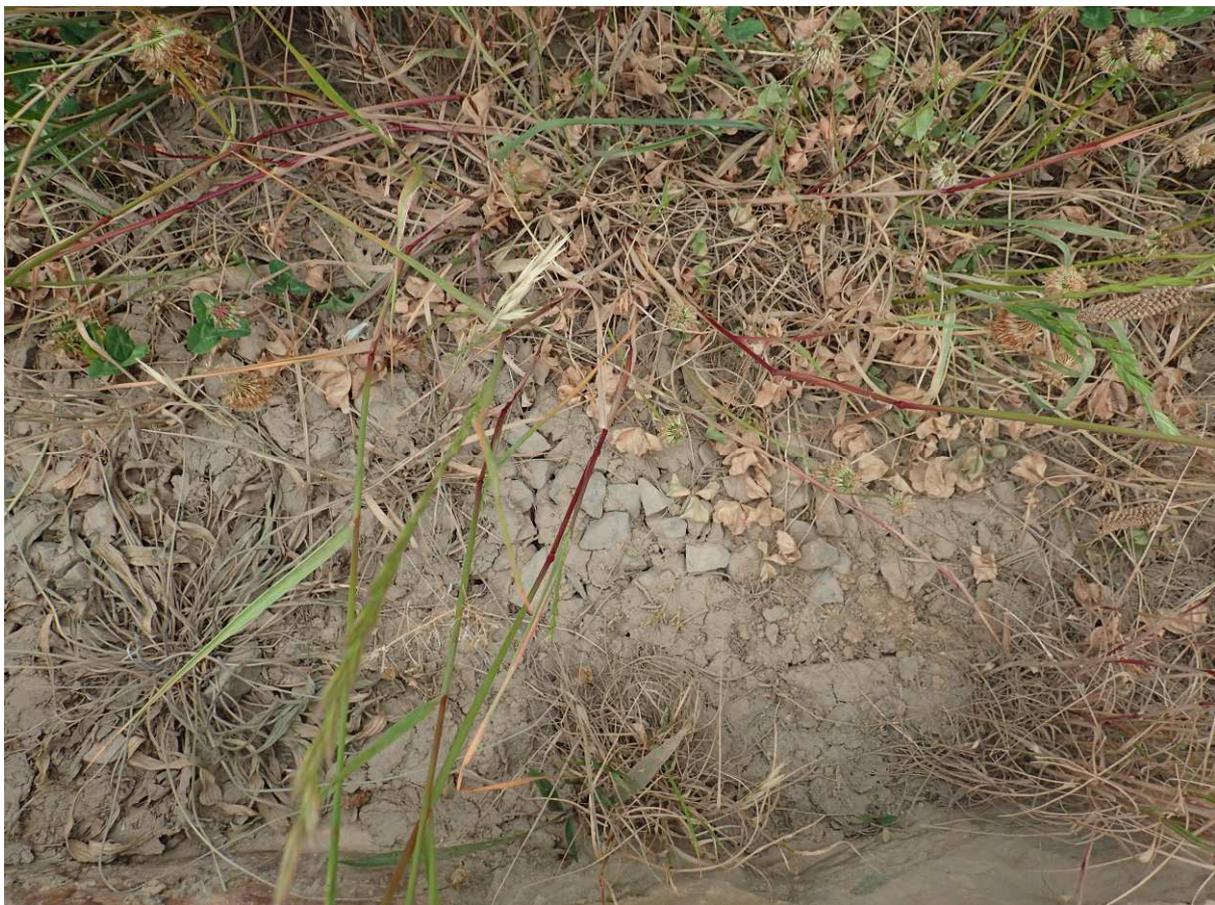
The bioretention basin is also likely to be suffering from a build up of fine soil particles on the surface of the filter. This was particularly evident during the dry weather site visit where a hard crust was clearly visible on the surface (Figure 2). This crust can form a blinding layer which prevents infiltration through the filter media and causes the majority of water to overflow rather than filter through the media due to the reduced infiltration rates into the filtration media. The impact of this blinding layer was not able to be fully established based on visual observations during the site visits. Often the impact of the blinding layer can be obvious as the bioretention system fails to drain after rainfall however because of the flow under the wall, the blinding layer may be bypassed. The impact of this blinding layer would need to be confirmed with further testing.

Figure 2: Blinding layer formed on filter media surface (November 2014)

A key causal factor in the development of the blinding layer to the filter media is the build out of the basin when a large portion of the upstream catchment area was undergoing house construction. This is shown in Figure 7. Discussions with the development manager for the project have indicated that the basin has been affected by construction sediment. The basin was not established offline and stormwater was directed to the basin during the house-building phase.

- Undertake hydraulic conductivity testing on the blinding layer in the basin
- If a blinding layer is confirmed to be reducing the infiltration through the filter media then it is recommended to undertake a trial of raking the surface to break up the blinding layer, without doing significant or terminal damage to the vegetation, and then reassess the hydraulic conductivity of the filter media. It is noted that the follow up testing needs to be carefully considered and conducted to be successful
- If the above is found to be unsuccessful, then approximately the top 100 mm layer of soil will need to be removed (exact depth to be determined based on site investigations above) and ideally replaced or at least permanently removed. The vegetation will need to be removed and replaced. Ground cover plants may be able to be salvaged and re-planted through careful construction methods.

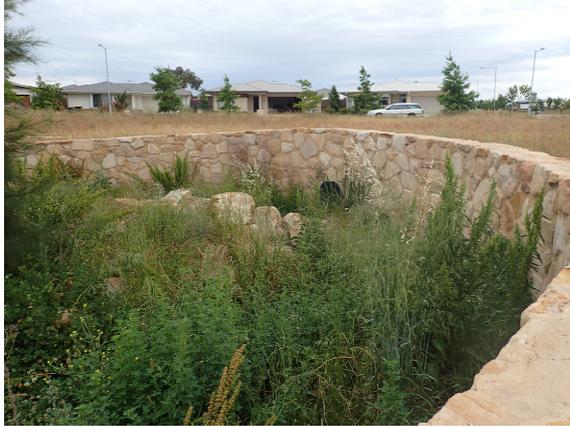
- The scour pad is difficult to clean and desilt and consideration should be given to the role of the inlet zone and its function and how it is to be cleaned. It is possible that it was poorly designed or that the inlet zone has not been constructed to specification (to be confirmed once the design drawings are reviewed) (Figure 3)
- The GPT is not entirely effective so there is litter accumulating the basin (Figure 4).

Figure 3: Inlet zone

Consideration needs to be given to how the coarse sediment forebay is to be maintained, including further discussions with maintenance staff about the current arrangement and their ability to clean the current forebay and potential future arrangements and configurations. Partial removal of the wall may need to be considered to allow for access, although visually it would be preferable if this could be avoided.

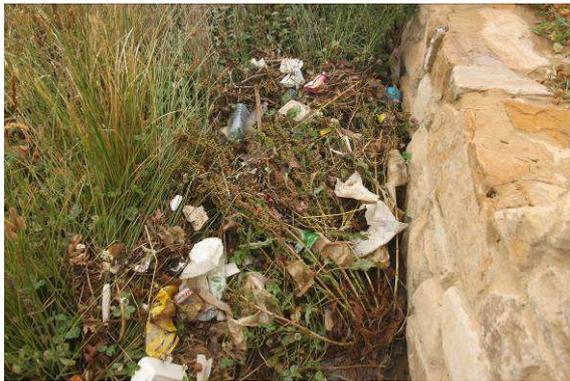
Figure 4: Litter accumulating in system

- Weeding of the entire basin
- Removal of litter from the basin
- Removal and/ or replacement of the casuarina trees

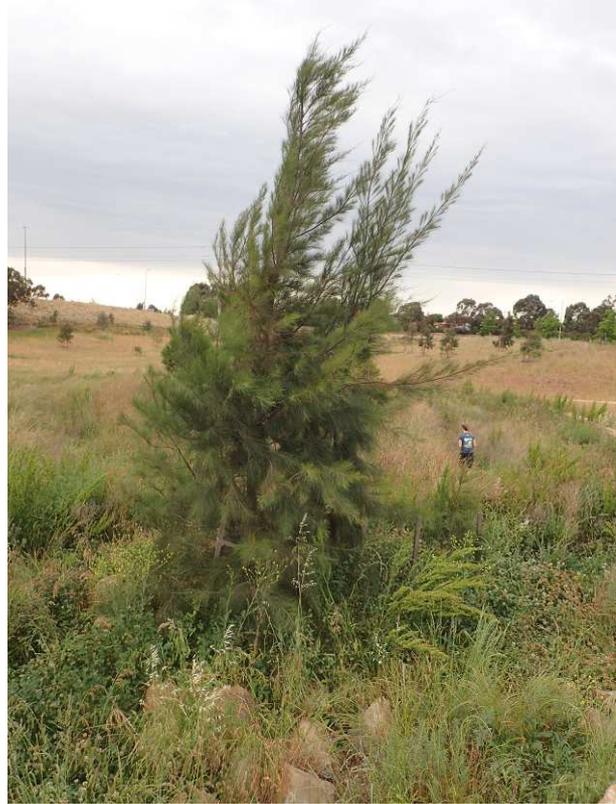
- The vegetation is becoming impacted by weeds and the system requires maintenance to reduce the competition to natives in the system
- The bioretention basin has been planted or opportunistically colonised by *Casuarina* trees. *Casuarina* trees - while suited to the hydrologic regime in bioretention basins – can have an allelopathic impact and can reduce the growth and vigour of other plants (Figure 5)

Figure 5: *Casuarina* trees in bioretention basin

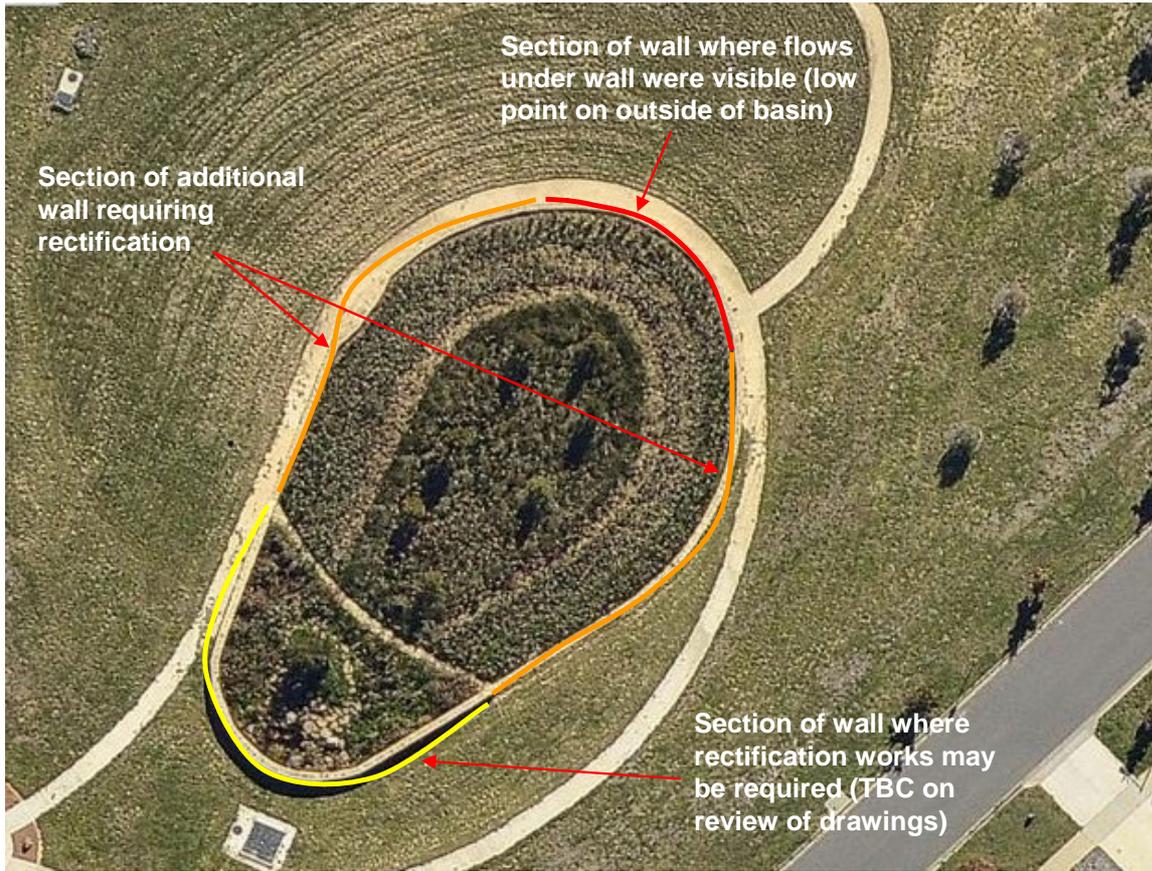
A key constraint in repairing the flows under the wall is the potential for leakage under the entire length of the wall, and therefore a rebuild of the entire wall is likely to be required. Currently the wall is visibly draining out at the lowest point behind the wall. If, for example, only the northern section of the wall was addressed it is highly likely that water would flow out under the wall at the next lowest point. A summary of the works required to the wall is shown in Figure 6.

Another key constraint in rectification works is that to repair the wall the filter media in the basin would need to be removed for two to three metres adjacent to the wall around the entire edge around the basin. The basin filter media could be carefully stored and replaced.

Figure 6: Summary of rectification works required to wall

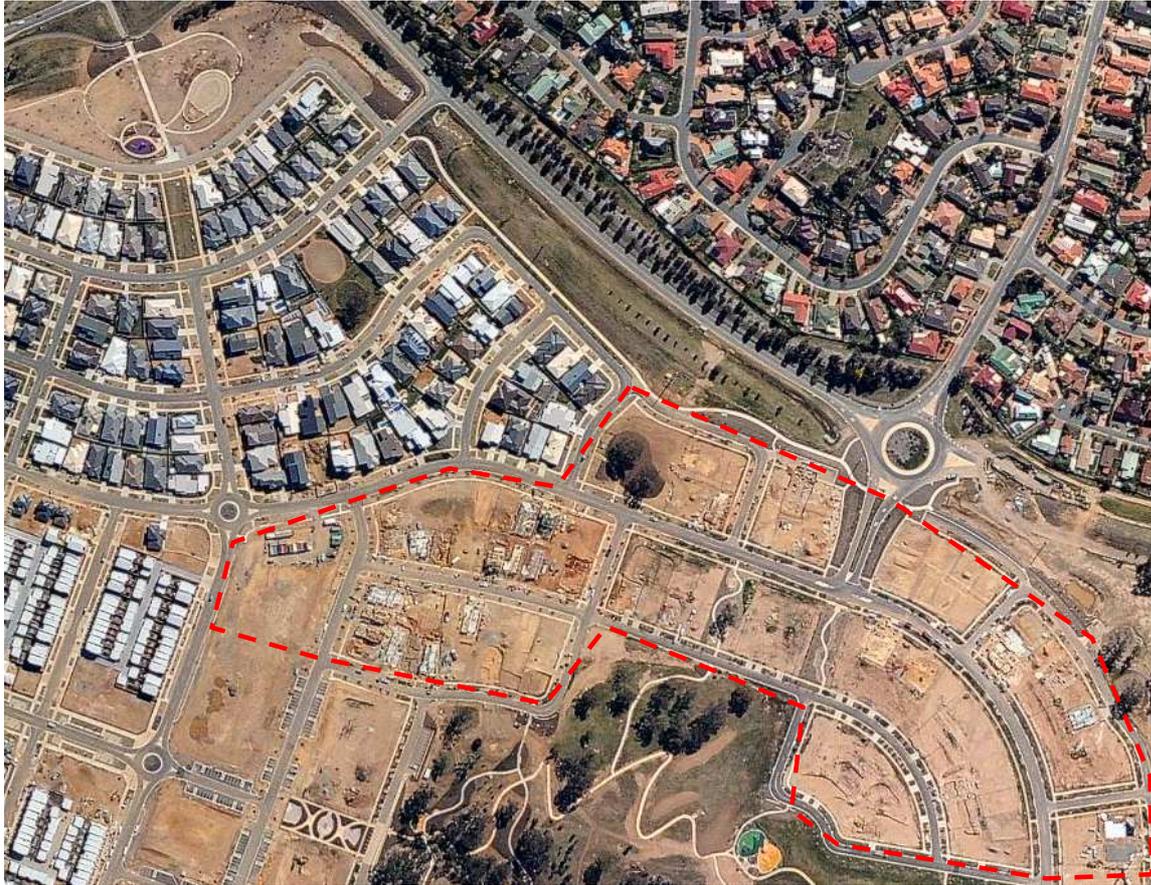
Figure 7: Portion of the bioretention system's catchment undergoing development at time of build out

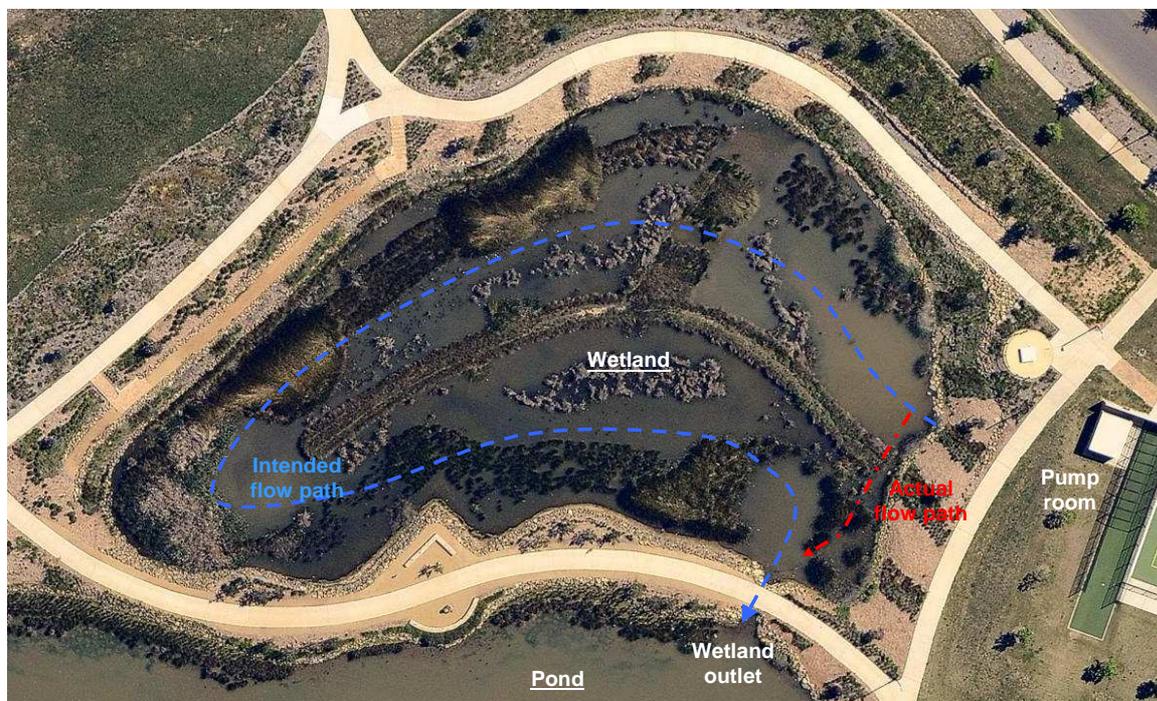
- The flow path through the wetland is seriously compromised. The intended flow path is for water to be directed through the entire vegetated component of the wetland. This is shown in Figure 1 via the blue dashed line flow path. However the central embankment does not extend all the way to the eastern edge and hence flows actually completely bypass the wetland vegetation (as shown by the actual flow path by the red line in Figure 1).

Figure 1: Recirculation flow path: intended vs actual flow path

The key factors which have led to the significantly compromised performance of the Crace recirculation wetland is the bypassing caused by the incomplete embankment and the lack of good vegetation establishment.

1. Rectify the embankment works in the wetland to prevent the short circuiting of the system
2. Re-establish vegetation in the wetland throughout the entire macrophyte cell (further investigations into the failure mechanism of the vegetation is recommended prior to this being undertaken)

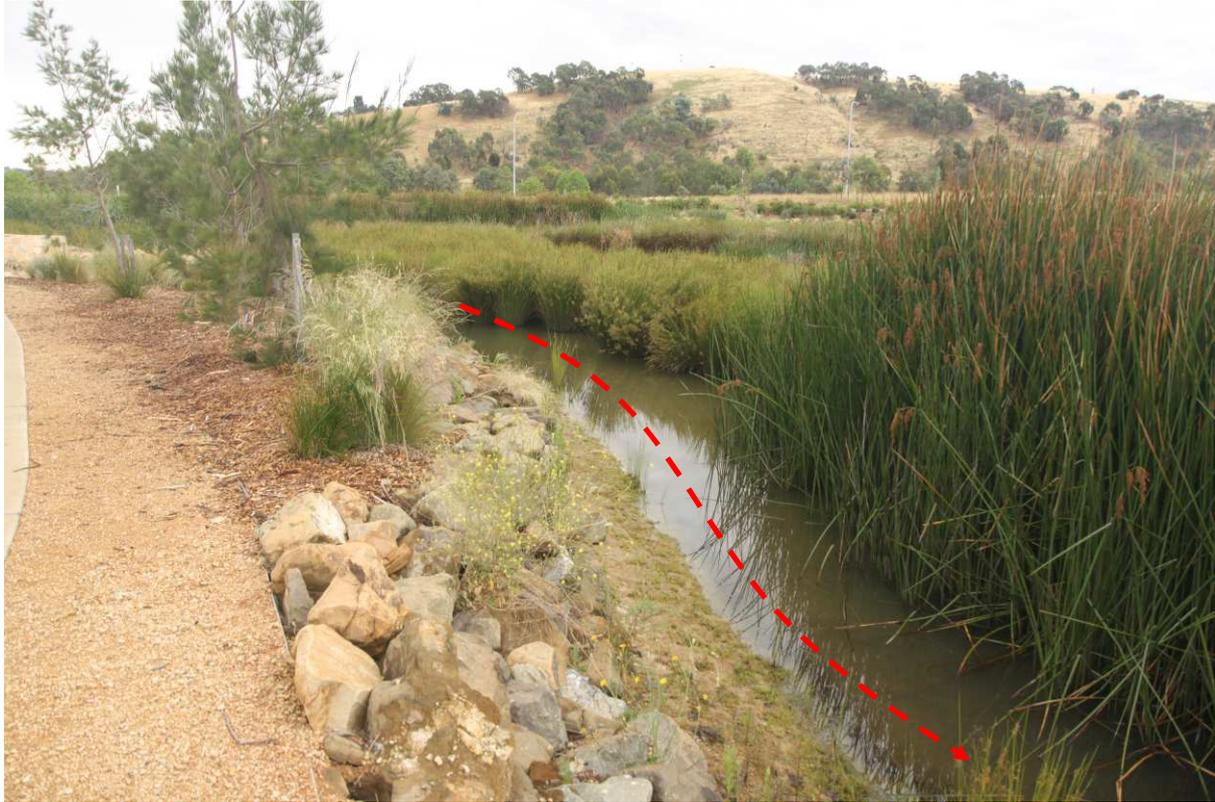
- To be effective, the wetland cell needs to be entirely planted across the wetland. As can be seen in Figure 1 and Figure 2 there are large areas of the wetland which are un-vegetated. The red line in Figure 2 shows how the flows are bypassing the wetland vegetation and significantly reducing the treatment that the recirculation flows are achieving in the wetland. A review of aerial imagery in Nearmap shows that this area of vegetation has not been successfully established at any time. This suggests that rather than the planting being established properly and then dying back the wetland plants have never been properly established. It is likely that either the vegetation failed almost immediately after planting or the wetland cell was not actually entirely planted as per the planting plan - as the planting plans for the wetland shows that these areas were intended to be fully vegetated.

Figure 2: Lack of full wetland vegetation coverage allowing bypassing of the vegetation (red dashed lines indicates dominant flow path bypassing vegetation)

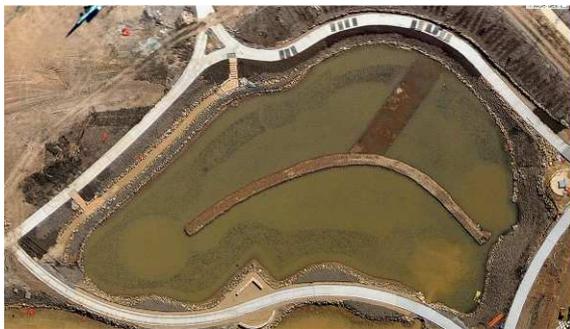
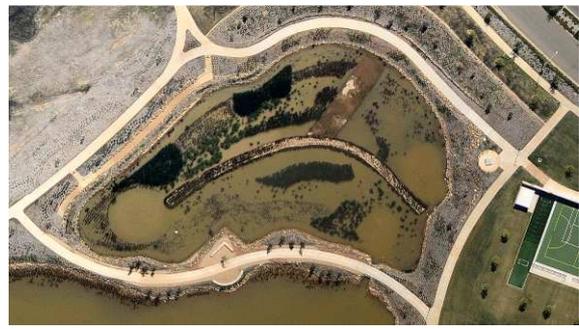
Figure 3: Lack of full wetland vegetation coverage over time (images sourced from Nearmap)

The cause of the lack of vegetation establishment could be caused by a number of factors including

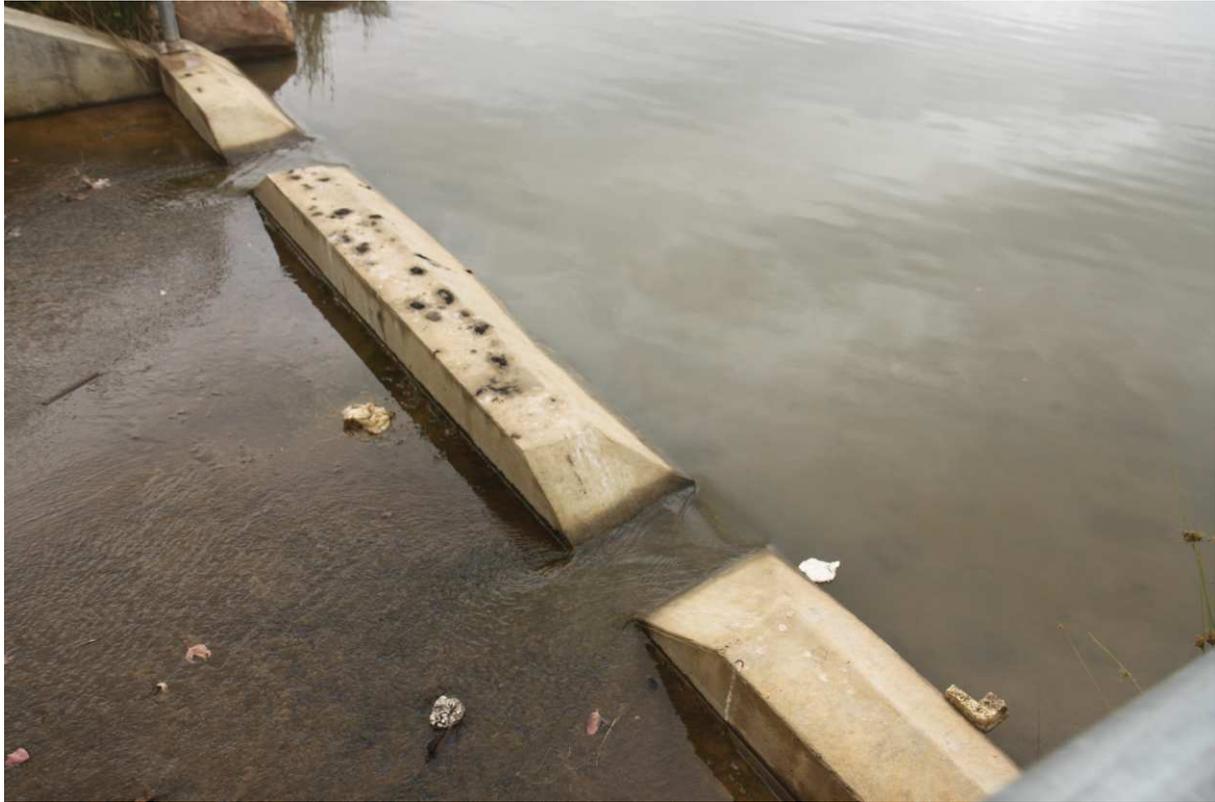
- The outlet was observed during wet weather events to be operating effectively and was hydraulically stable with no signs of erosion, scour or similar, as shown in Figure 5

Figure 5: Pond outlet operating during wet weather event

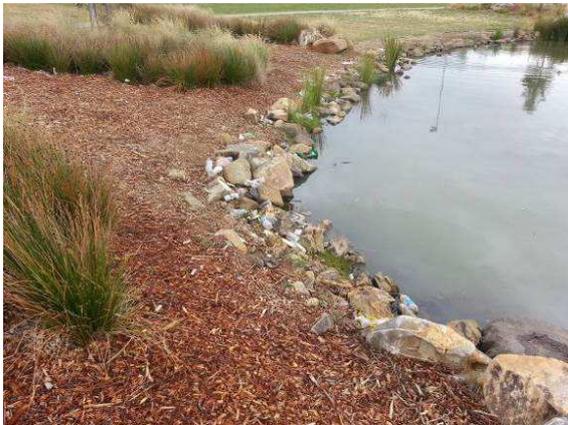
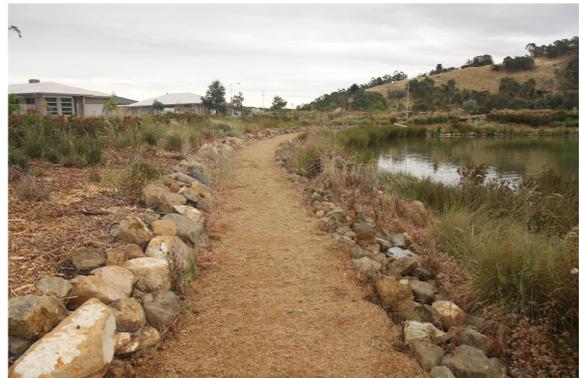
- Litter accumulating around the pond edges, suggesting that the gross pollutant treatment is not effective at capturing floating litter, such as plastic bottles, cans, etc
- Weeds growing in the crushed granite path along the south western edge
- Patchy vegetation establishment on the dry banks and ingress of weeds on the south western edge of the pond

Figure 6: Minor issues at Crace pond and wetland. Left – floating litter washed onto banks. Right weeds growing in crushed granite path and adjacent to path

Other minor issues, including litter and weeding are a combination of a poorly performing GPT and lack of recent maintenance of the pond.

- Consideration should be given to retrofitting water level control into the pond to allow for desilting and maintenance
- The performance of the GPT should also be reviewed to see if it can be improved to prevent litter entering the pond.

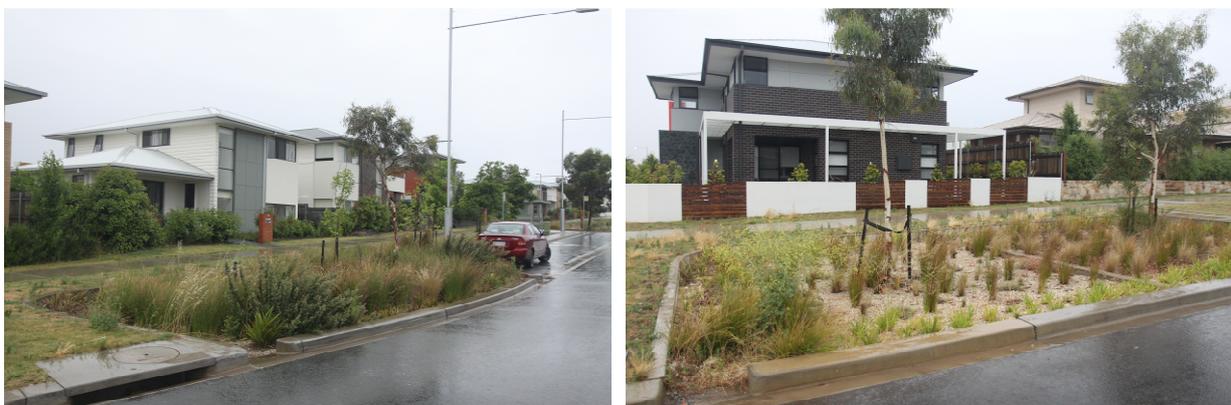
At Abena Ave, construction activity including house-building has been entirely completed and the systems are no longer affected by construction sediment. The western half of the systems generally have well established vegetation (these systems were constructed earlier than the eastern half) as shown in Figure 1. The eastern half of the rain gardens are currently still in the establishment phase, with vegetation coverage increasing but still not providing significant coverage of the filter media as shown in Figure 1.

Figure 1: Rain garden on Abena Ave, showing vegetation establishment. Left hand photo showing typical western Abena Ave rain garden and right hand photo showing typical eastern Abena Ave rain garden.

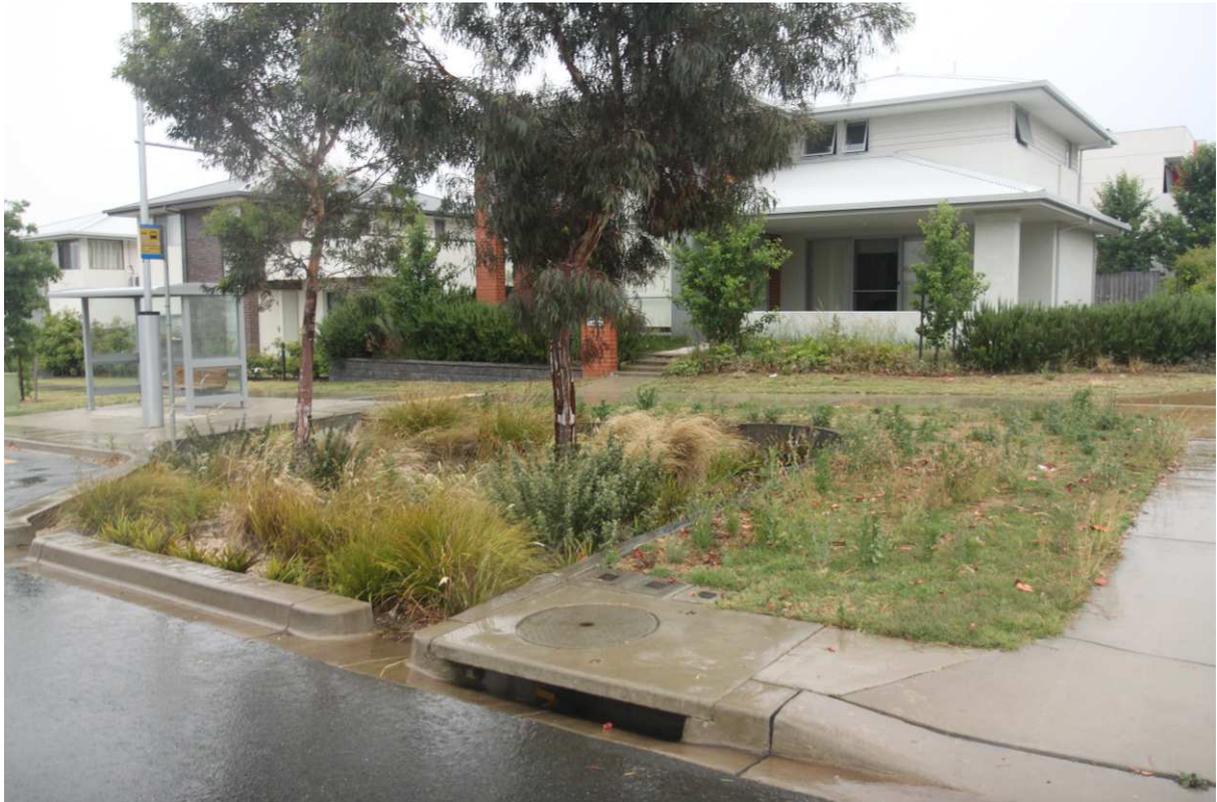
- Approximately 25% of the raingardens have no catchment, typically because this is a pit immediately upstream of the raingarden inlet (refer Figure 2)
- Approximately half of the kerb inlets are blocked at Abena Ave and are not functioning. Runoff is completely bypassing the inlets and is draining to the standard stormwater pits
- One raingarden had a structural defect with the concrete at the inlet tilting the *away* from the raingarden directing the water around the raingarden
- In most cases a slight build up of debris including sediment and organics caused blockage (refer Figure 3). However in many cases, partial removal of the sediment and debris and some of the mulch manually (to simulate maintenance activity) had little effect on encouraging water to enter the system

Figure 2: Example of a rain garden with a stormwater pit immediately upstream of the raingarden inlet

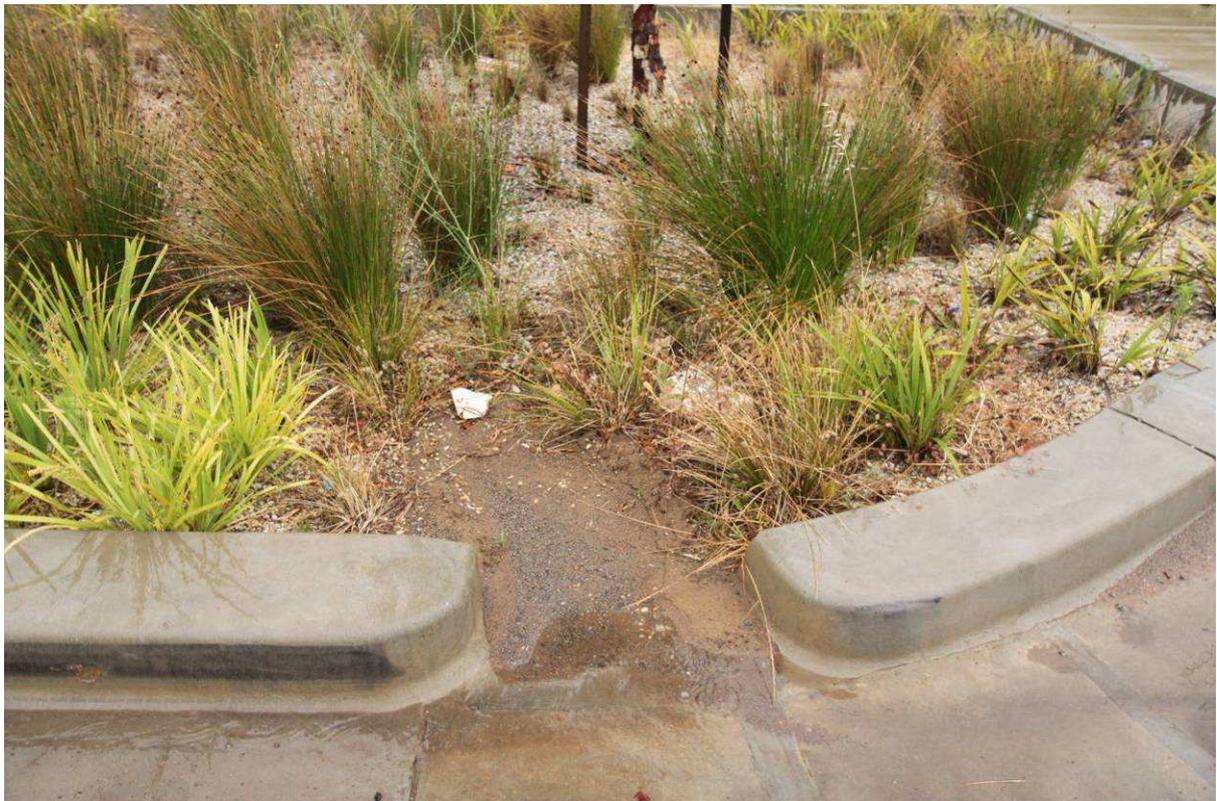
The rain garden cells that had functioning inlets had clear signs of deposition of sediment and debris on the rock mulch. Those systems which had blocked inlets had very clean rock mulch suggesting that flows have rarely entered these rain gardens and that only relatively small amounts of debris were required to block the inlet.

Figure 3: Example of a rain garden on Abena Avenue, with blocked inlet caused by sediment

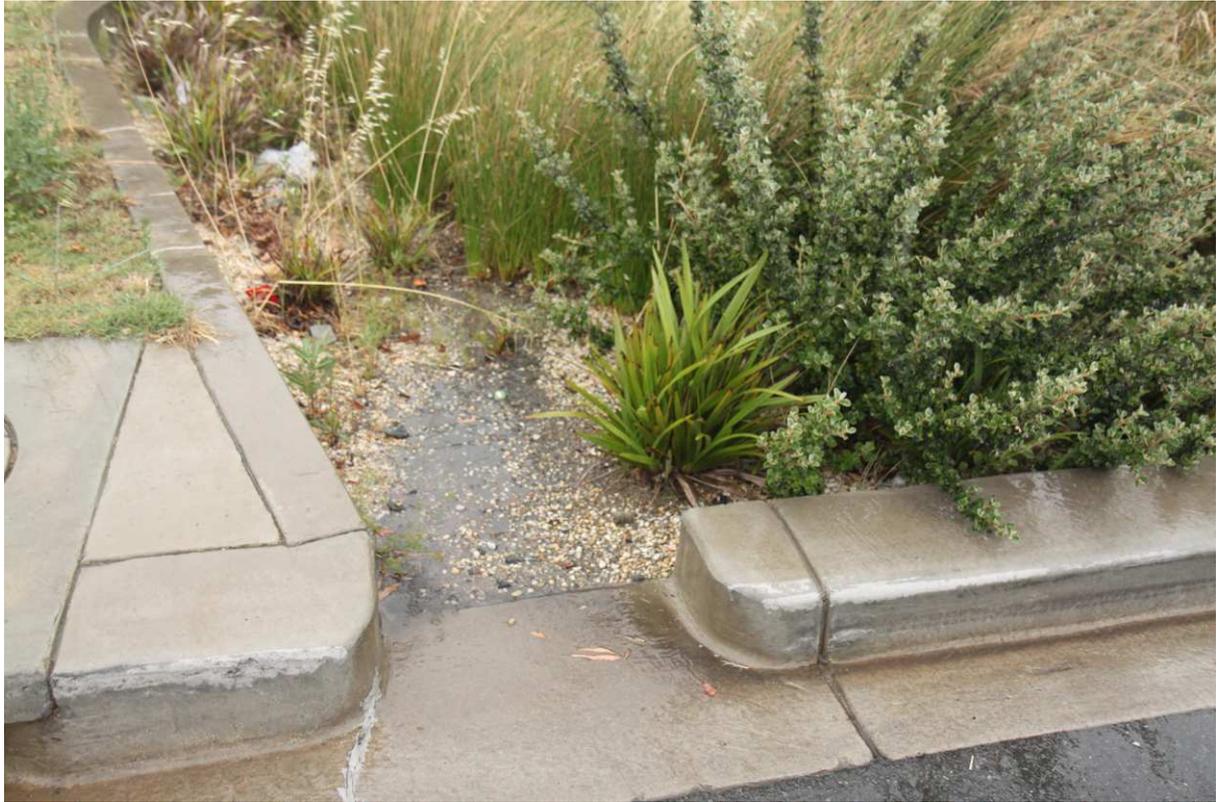
Figure 4: Example of a curb inlet functioning well and delivering water into the rain garden. Water is flowing right to left and note the lack of water on left hand side of curb and water ponding in the raingarden (as evidenced by darker sediment)

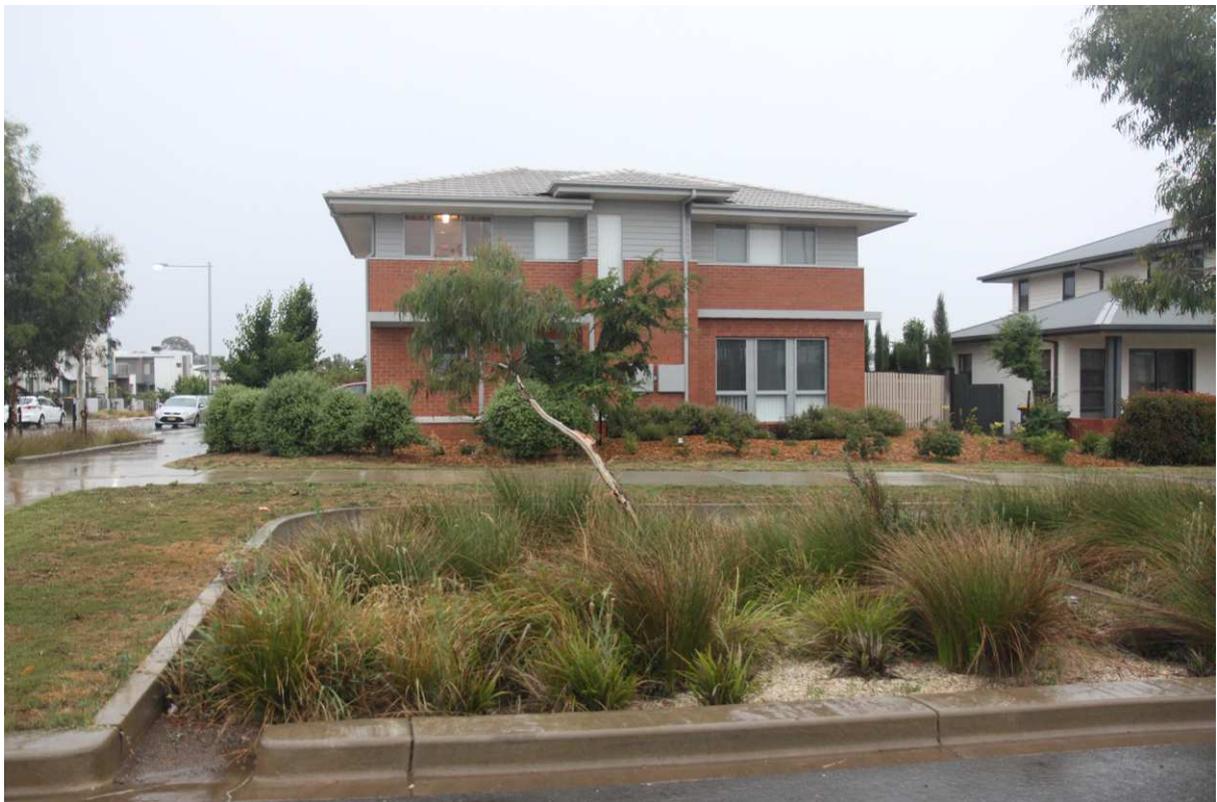
- Some of the trees have suffered significant damage and in a few systems the trees have failed to establish at all and are no longer present (refer Figure 5)

Figure 5: Rain garden on Abena Ave, with significant tree damage

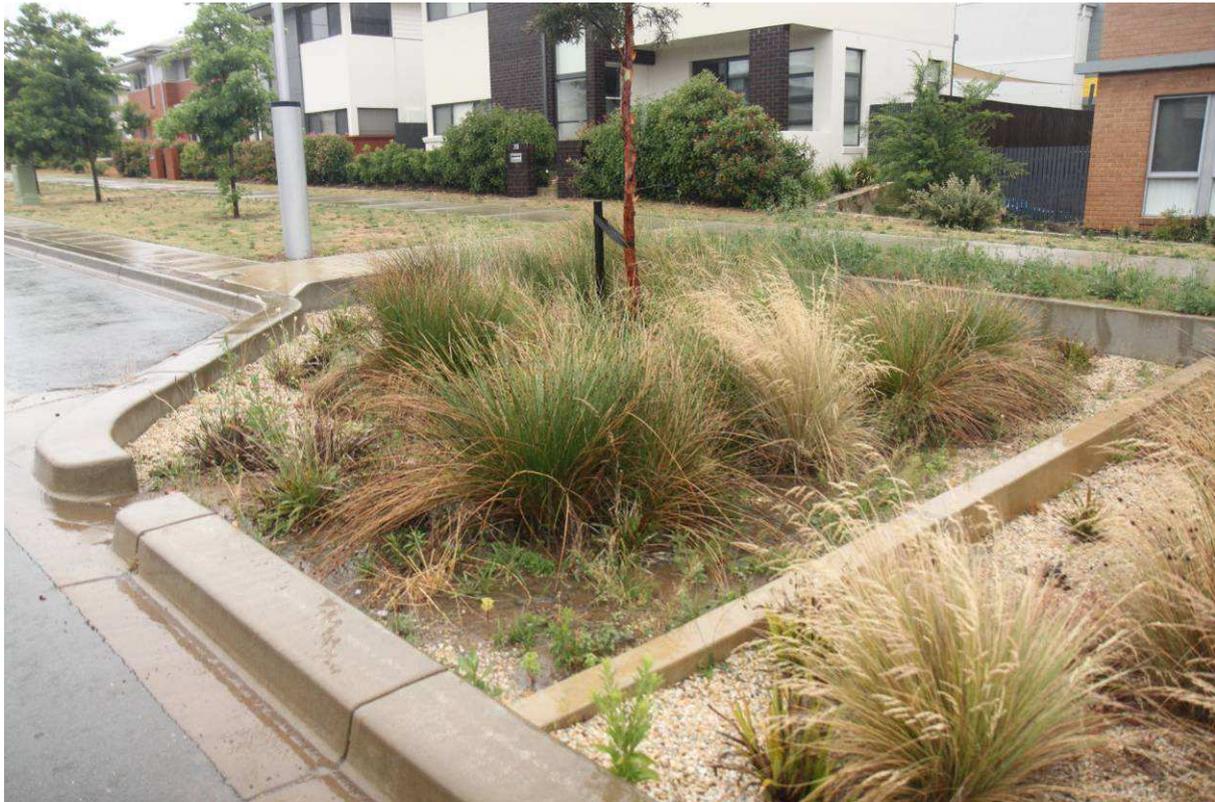
Figure 6: Extended detention is engaged during rain event where inlet is functioning
