## ASBESTOS CLEARANCE CERTIFICATE INSPECTION PASS

**Project/Location:** 37 Rich Street  
Higgins  
ACT 2615

**Job Number:** 9900432

**Date(s) And Description Of Work:** Removal of asbestos containing sheet and sheet debris from the southern boundary fence line, a soil mound on the northern side of the site and scattered ACM debris from soil surface areas across the 37 Rich Street Higgins block on 15 December 2017.

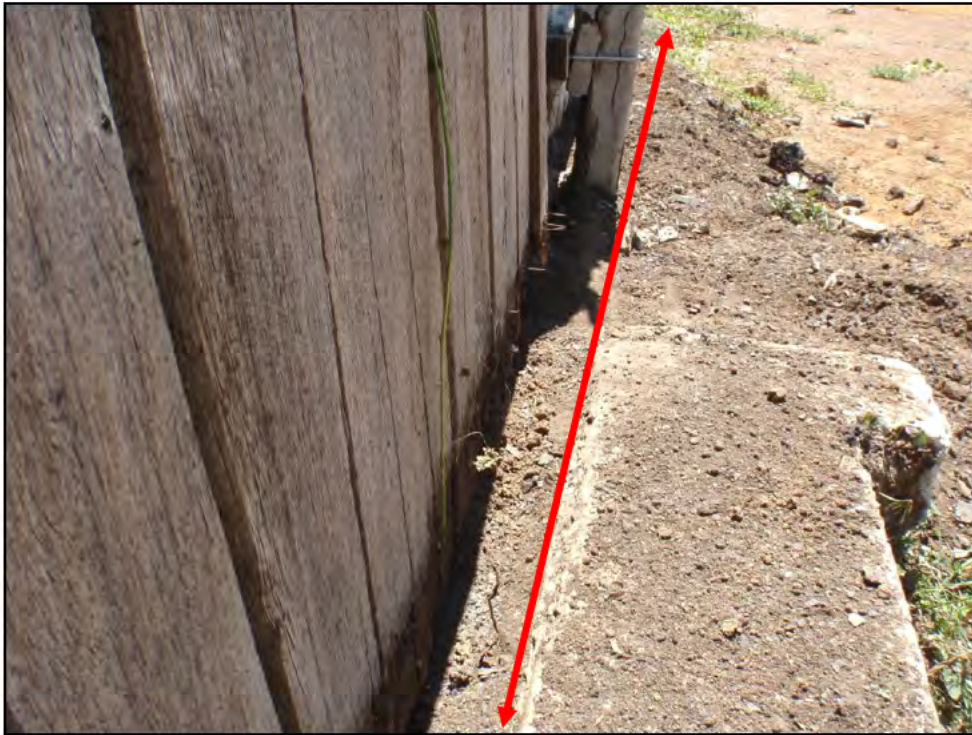
**Photograph 1:** Southern boundary fence line of the 37 Rich St block after removal of asbestos containing sheet form work and debris

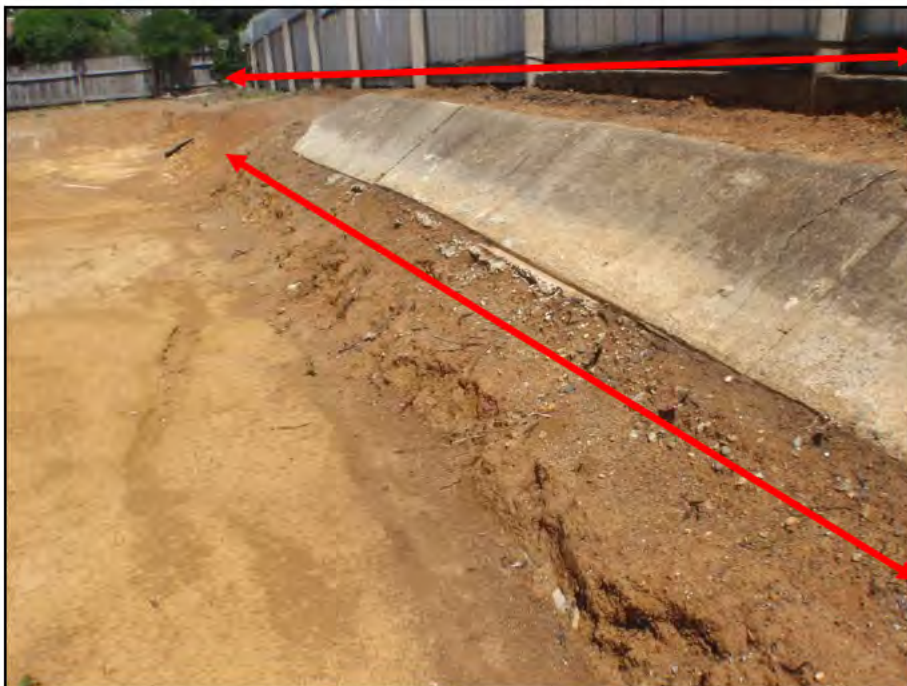
**Photograph 2:** Southern boundary fence line of the 37 Rich St block after removal of asbestos containing sheet form work and debris – also ACM debris removed from areas at base of incline

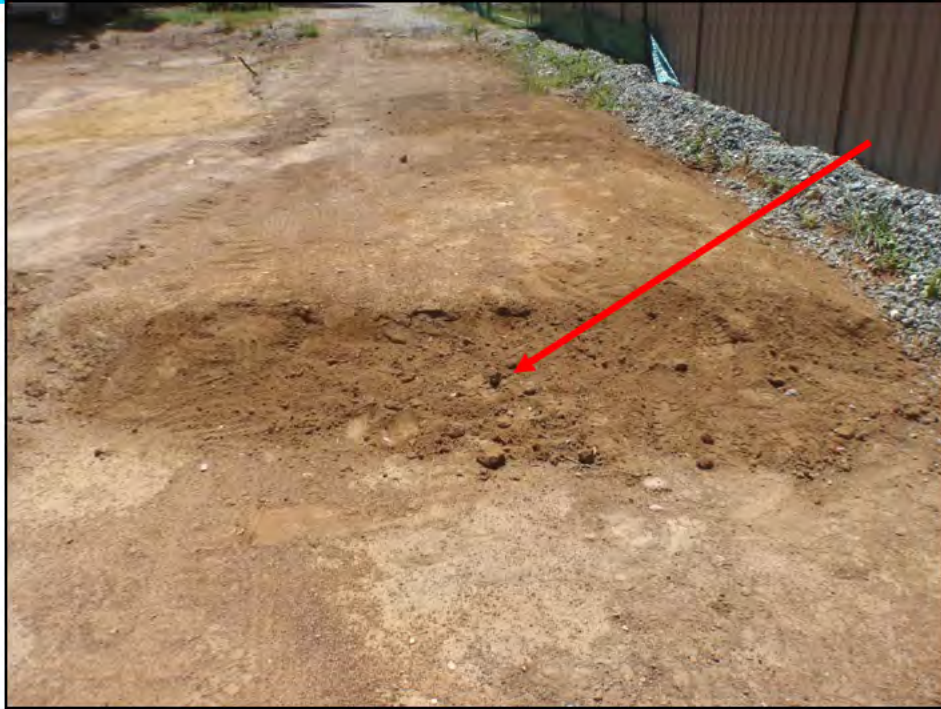
**Photograph 3:** Northern section of 37 Rich St block after removal of asbestos containing sheet debris from the soil mound

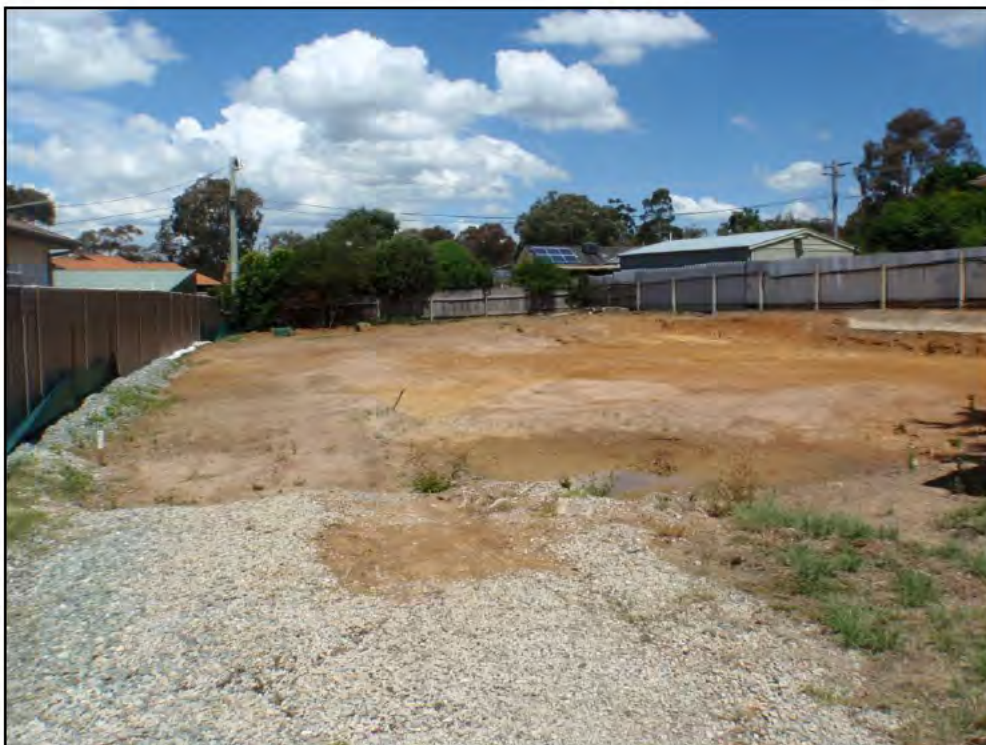
**Photograph 4:** 37 Rich St Higgins block after removal of asbestos containing sheet debris scattered in various locations across the top of the soil

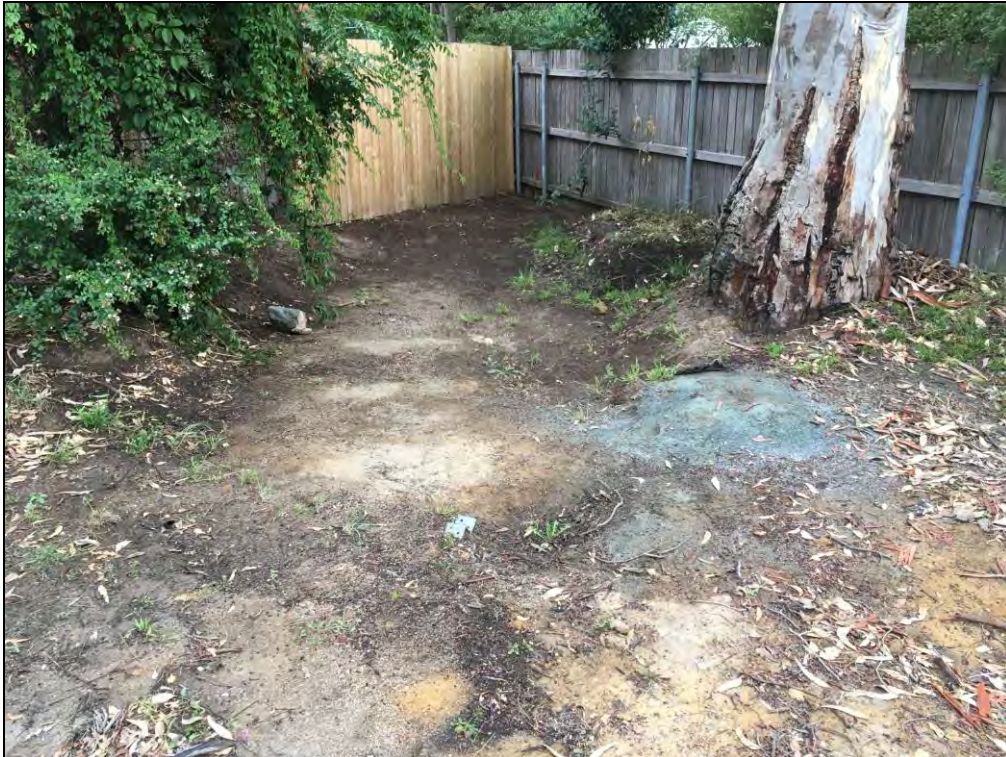
Area in the northwest corner of the property after removal works

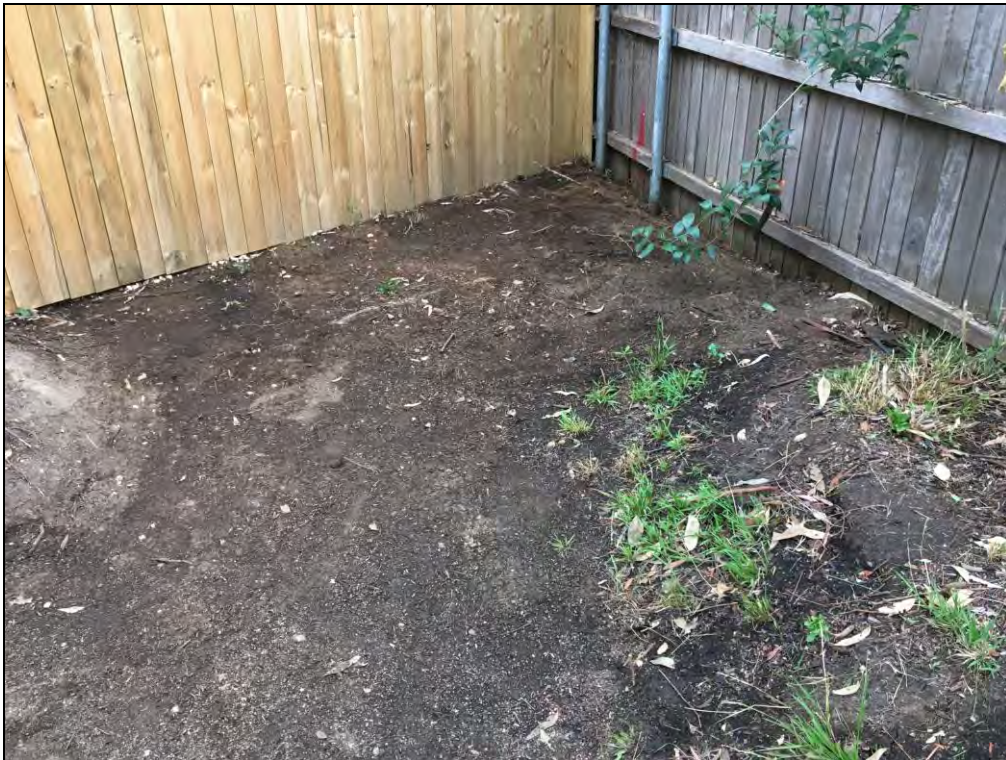
Area in the northwest corner of the property after removal works

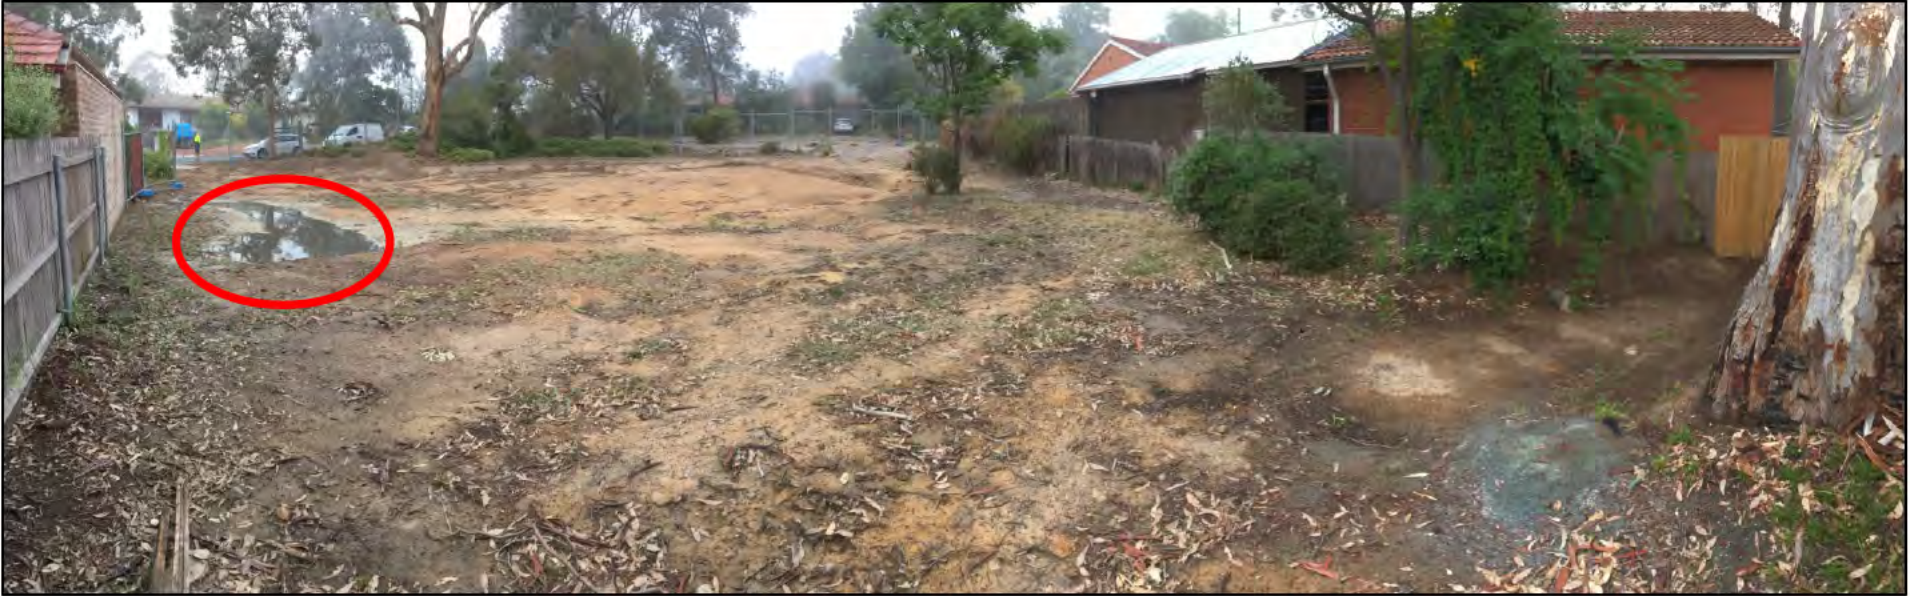
Entire block from northeast corner after removal works

Note: The submerged portion of ground on the east boundary could not be inspected.

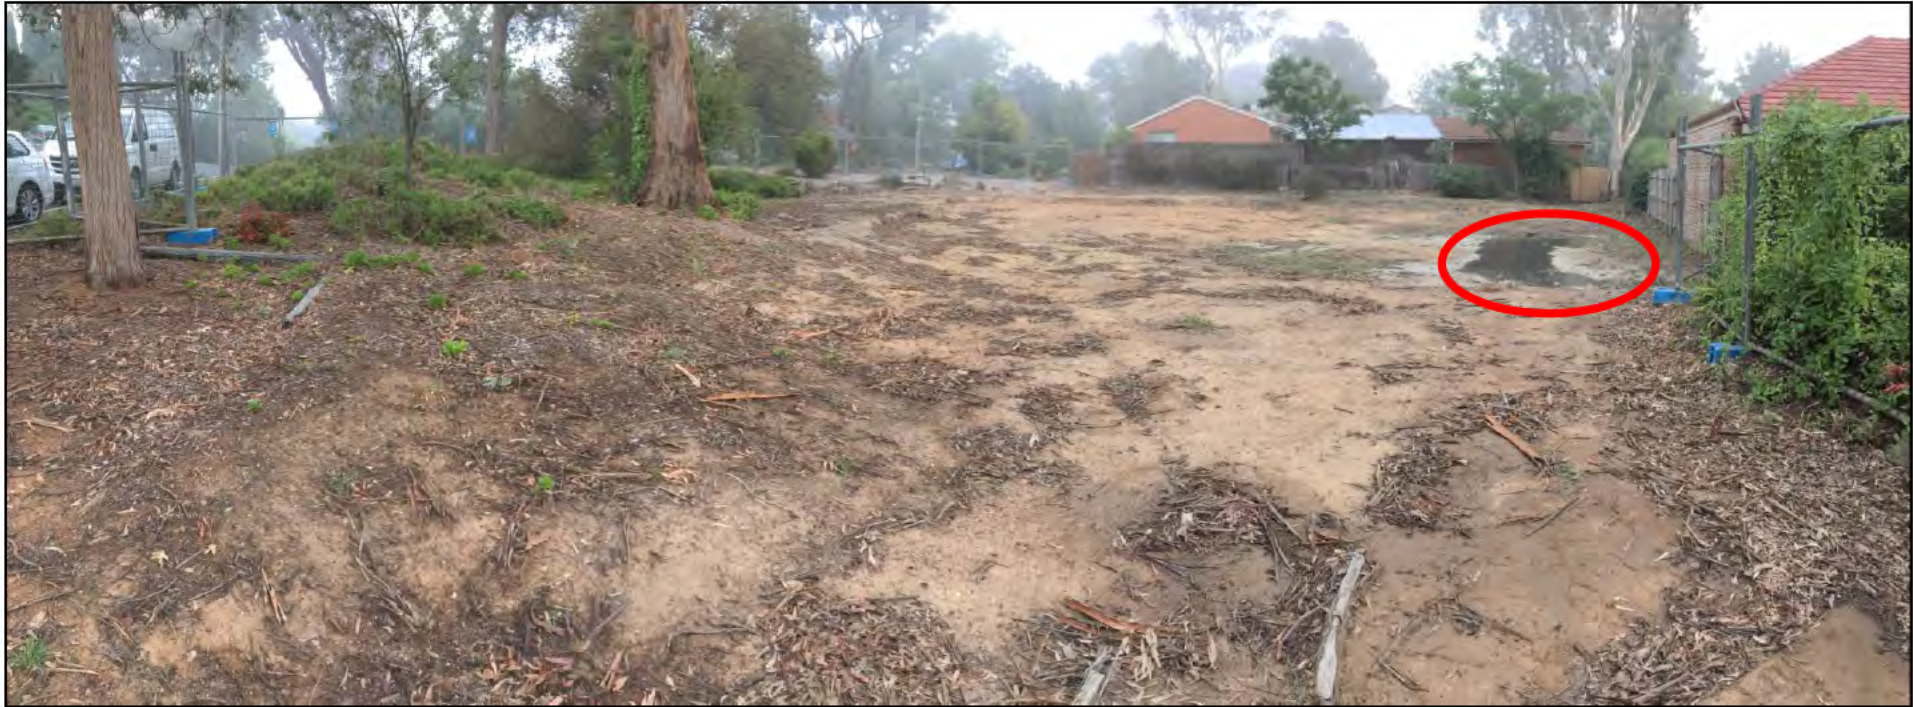
Entire block from northeast corner after removal works

Note: The submerged portion of ground on the east boundary could not be inspected.

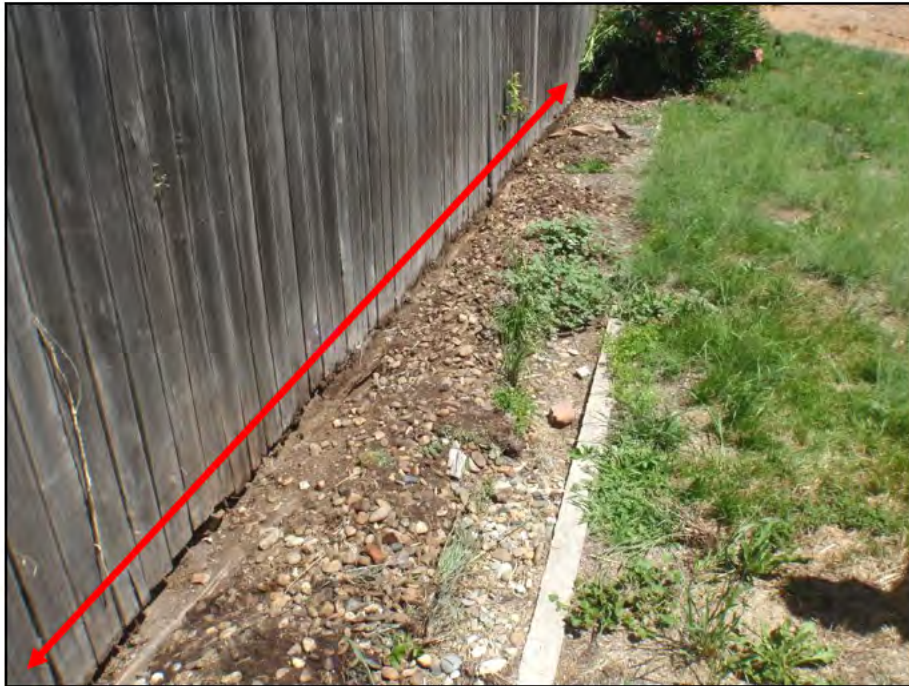
**Photograph 1:** Eastern boundary fence line garden bed of the 56 Belconnen Way block after removal of asbestos containing sheet debris

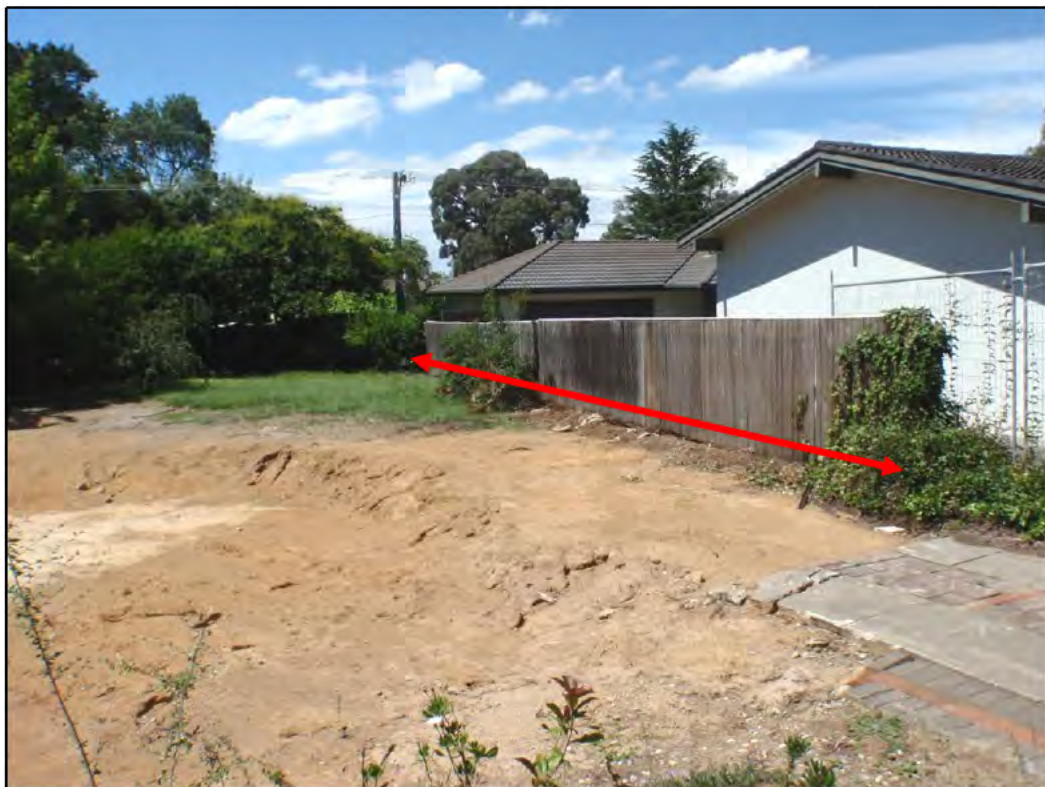
**Photograph 2:** Location from which asbestos containing sheet debris was removed from the eastern boundary fence line garden bed of the 56 Belconnen Way block

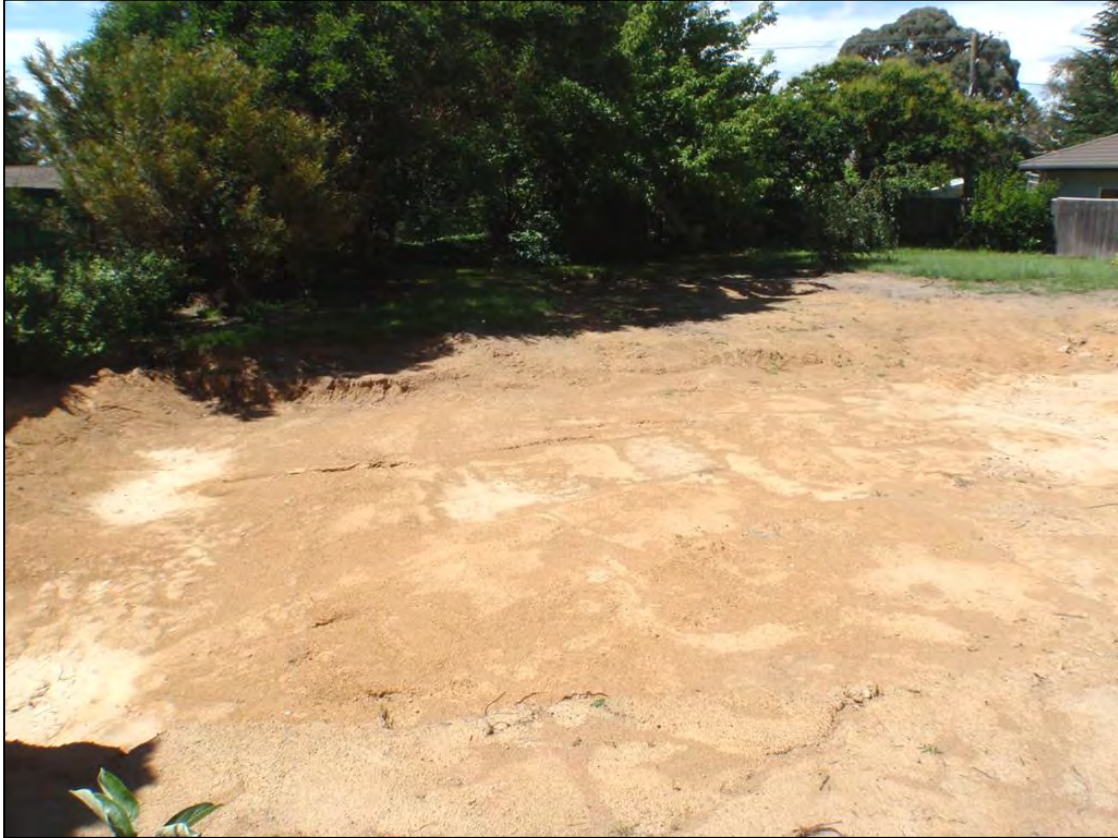
**Photograph 3:** 56 Belconnen Way Page block after removal of asbestos containing sheet debris scattered in various locations across the top of the soil

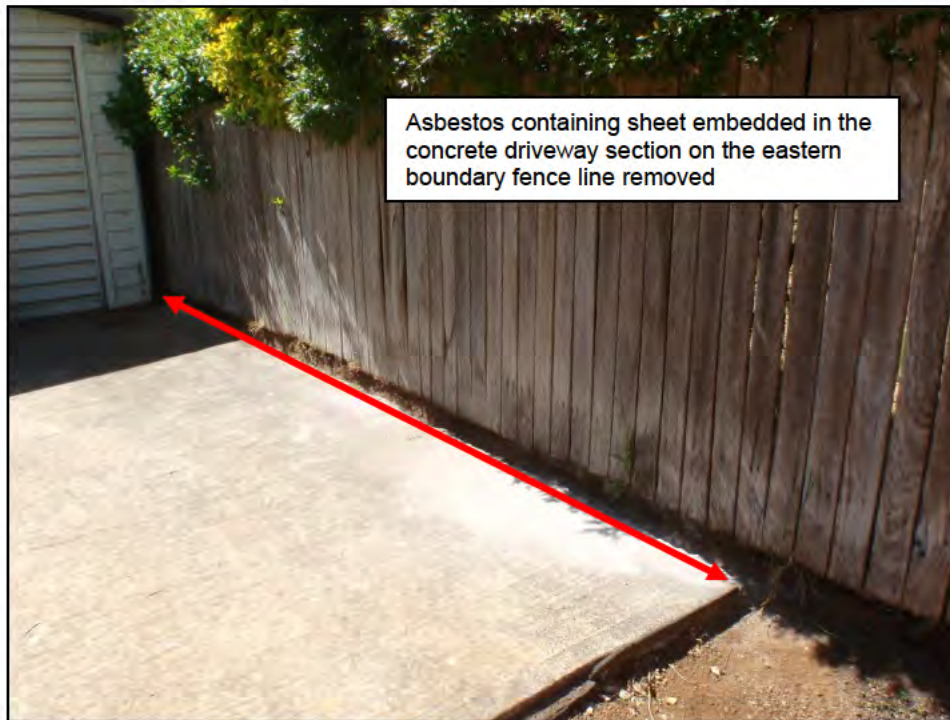
**Photograph 1:** Location from which asbestos containing sheet embedded in the edge of the concrete driveway section on the eastern boundary fence line was removed

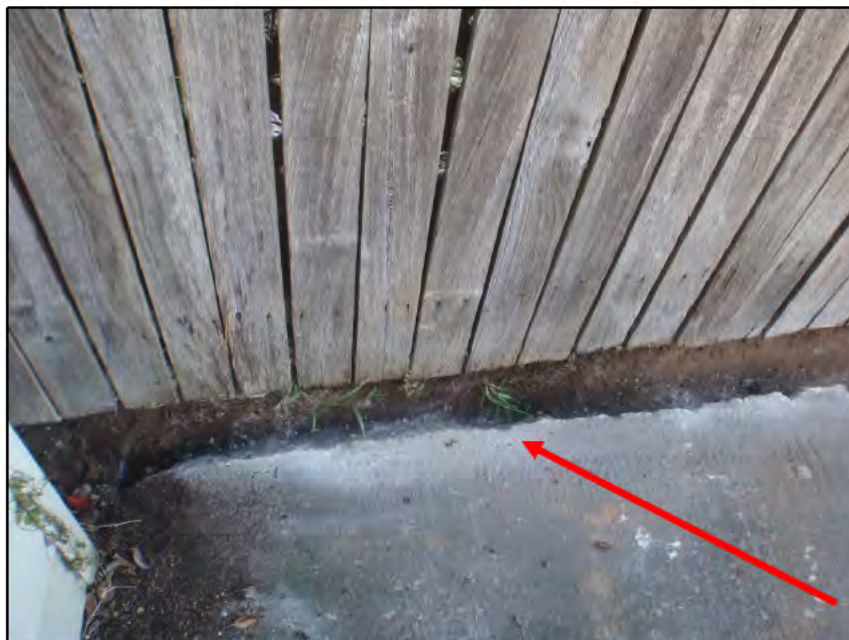
**Photograph 2:** Close up of edge of the concrete driveway section on the eastern boundary fence line from which ACM sheet was removed

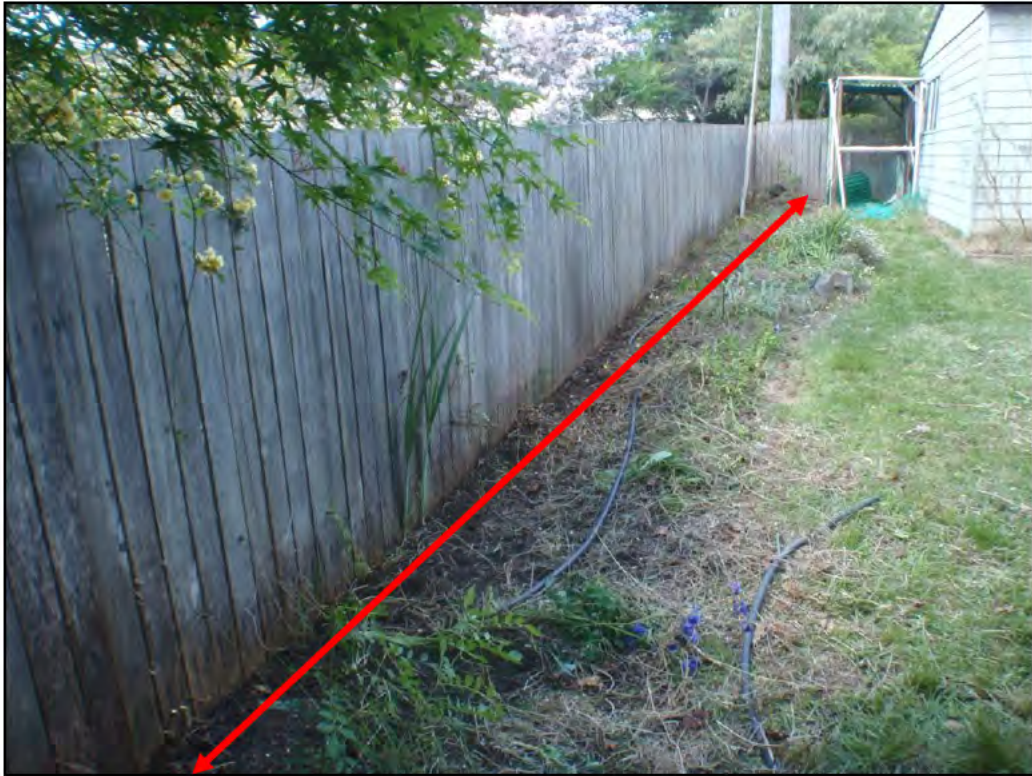
**Photograph 3:** Location from which asbestos containing sheet and sheet debris was removed from the northern side boundary fence line and garden bed

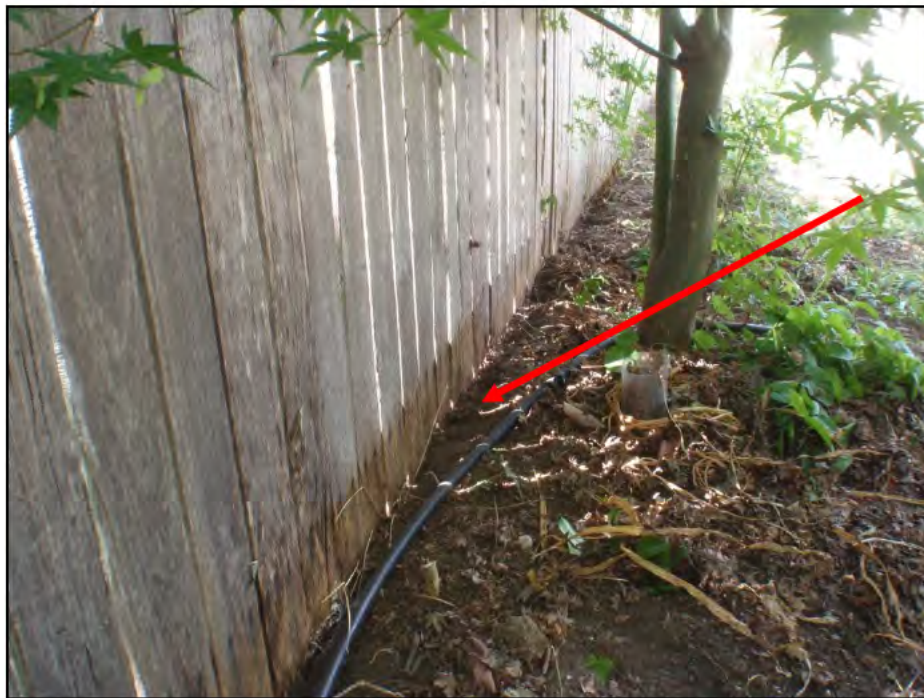
**Photograph 4:** Close up of northern side boundary fence line and garden bed from which ACM sheet and debris was removed

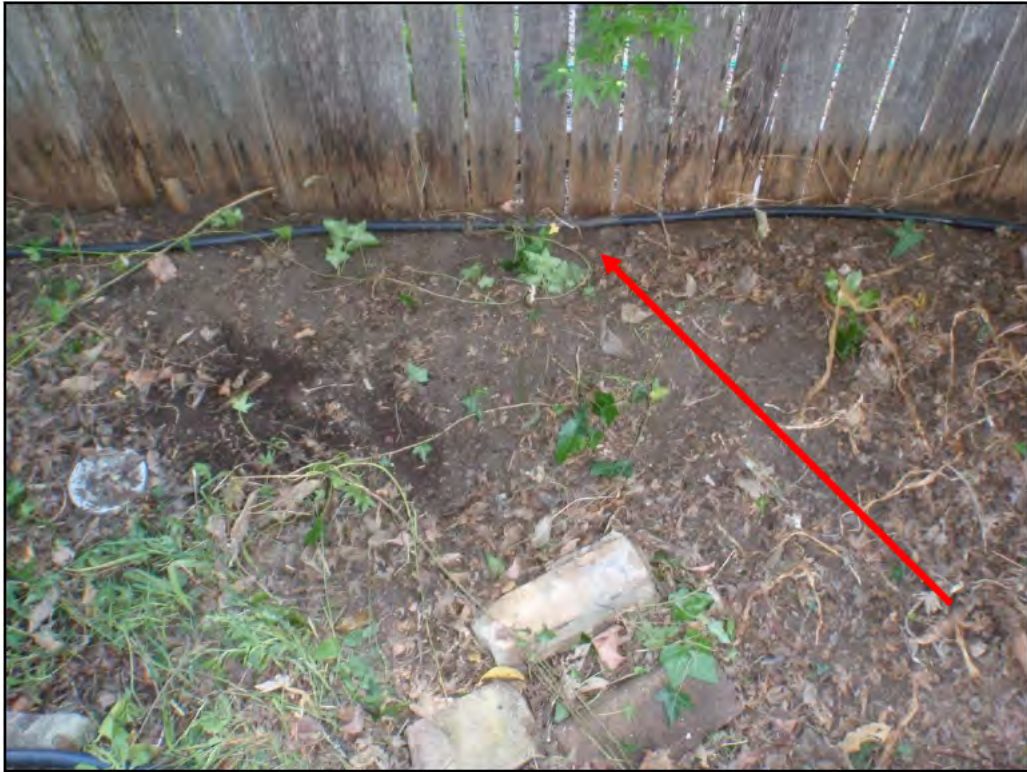
**Photograph 5:** Close up of northern side boundary fence line and garden bed from which ACM sheet and debris was removed

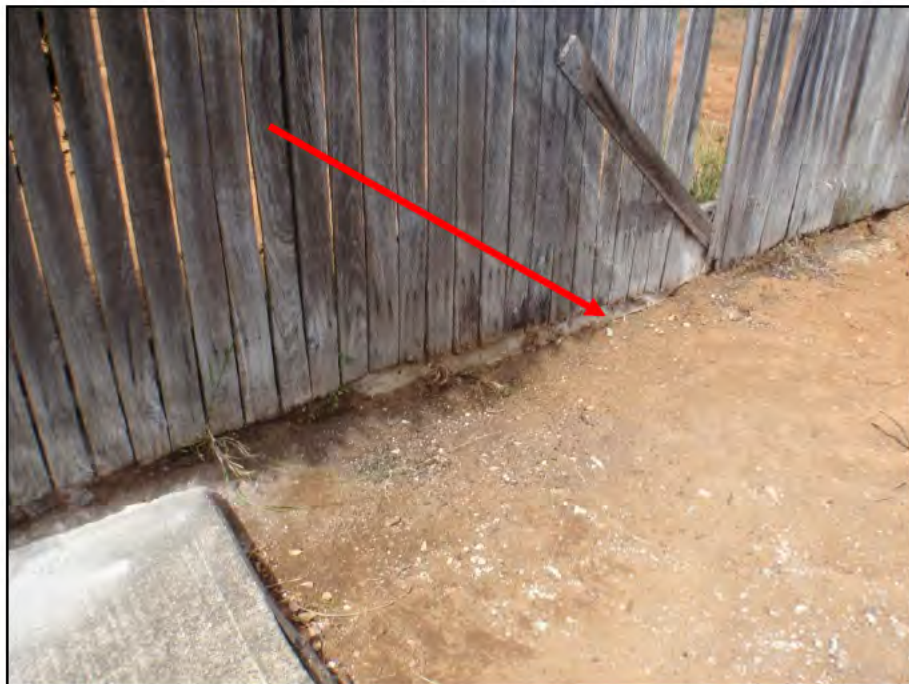
**Photograph 6:** asbestos containing sheet material remaining along the base of the eastern side boundary fence line adjoining block 29 Rivett St – sheet physically located on 29 Rivett St side of boundary fence and not on the 27 Rivett St block side

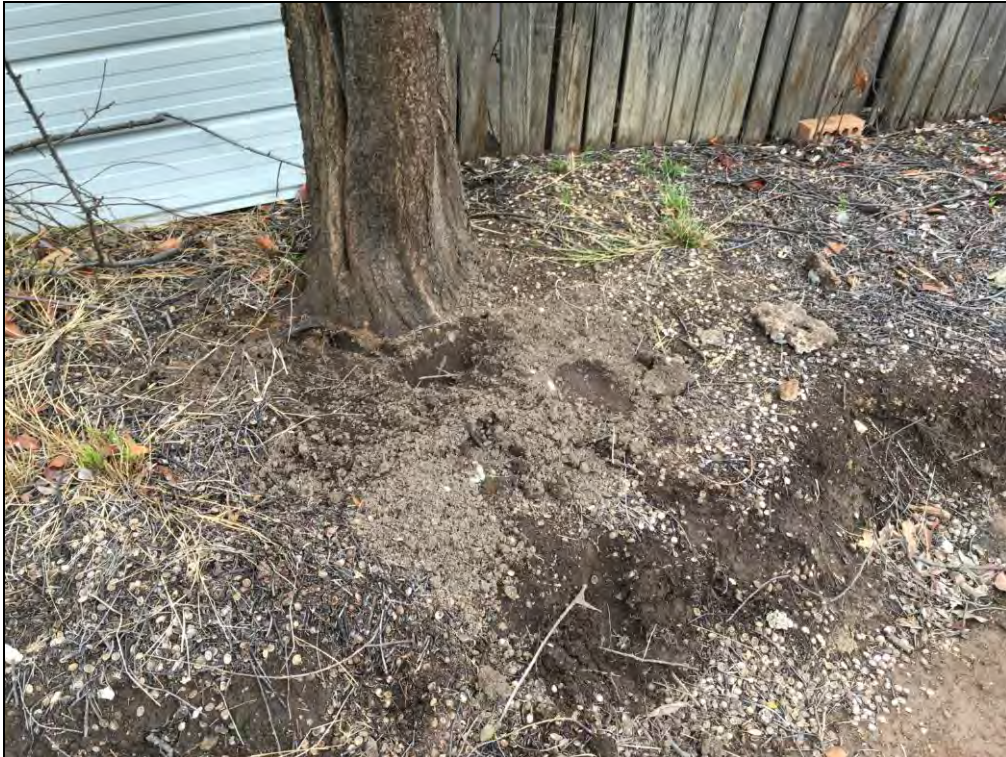
Area adjacent to the tree on the east property boundary after removal works

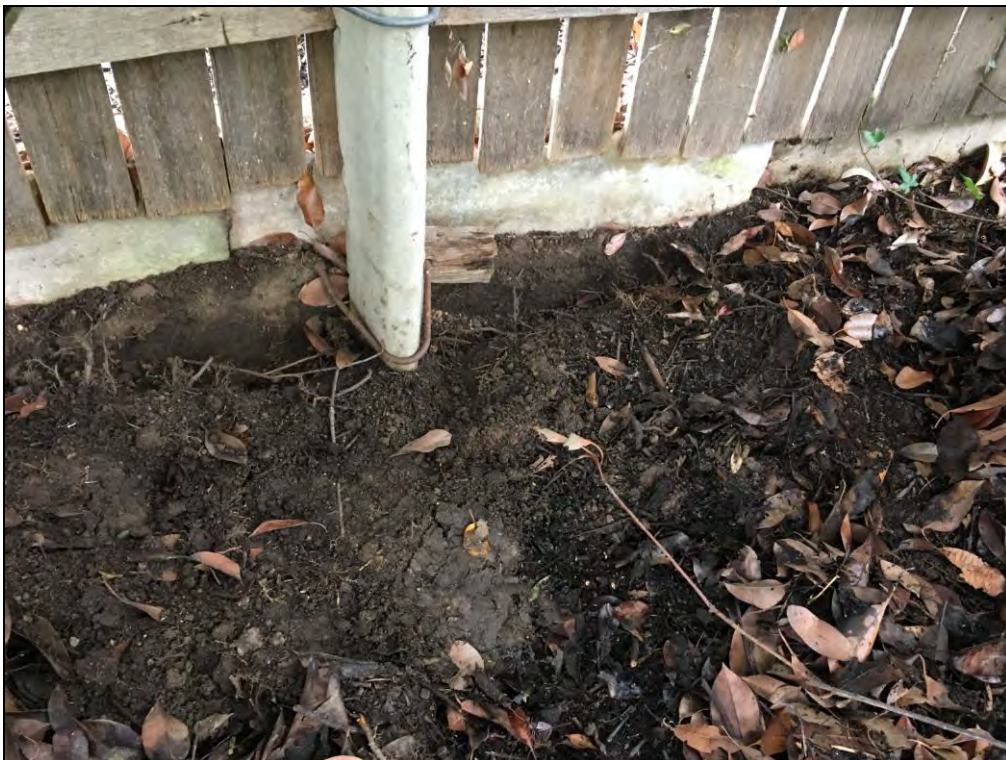
Area adjacent to the north property boundary after removal works

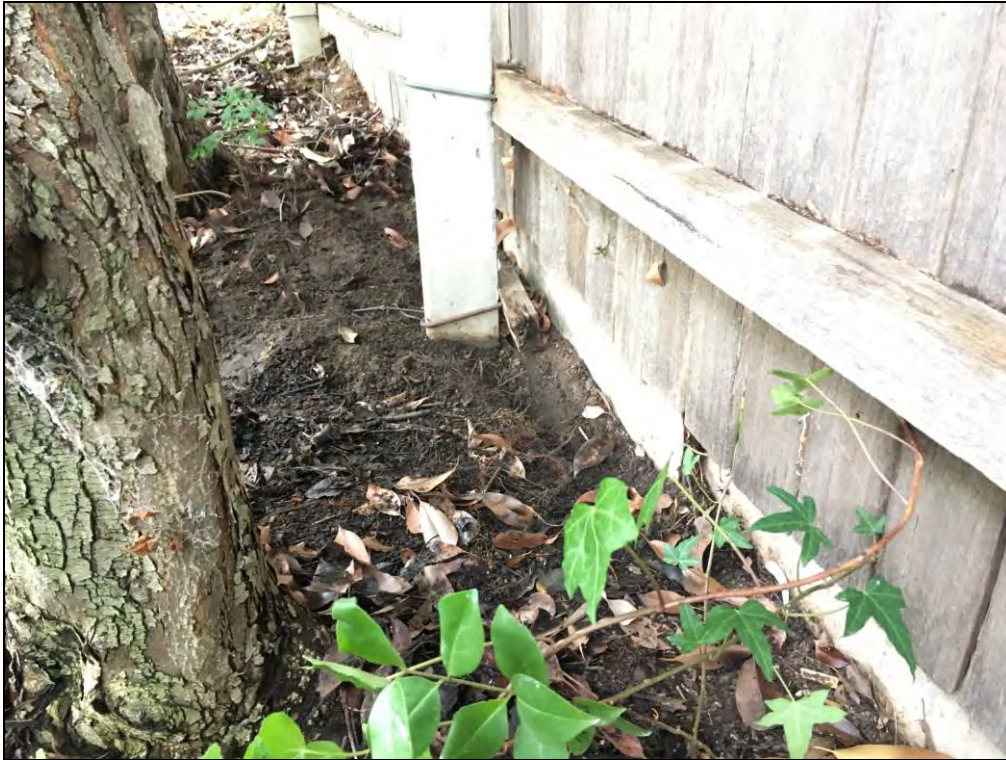
Area adjacent to the north property boundary after removal works

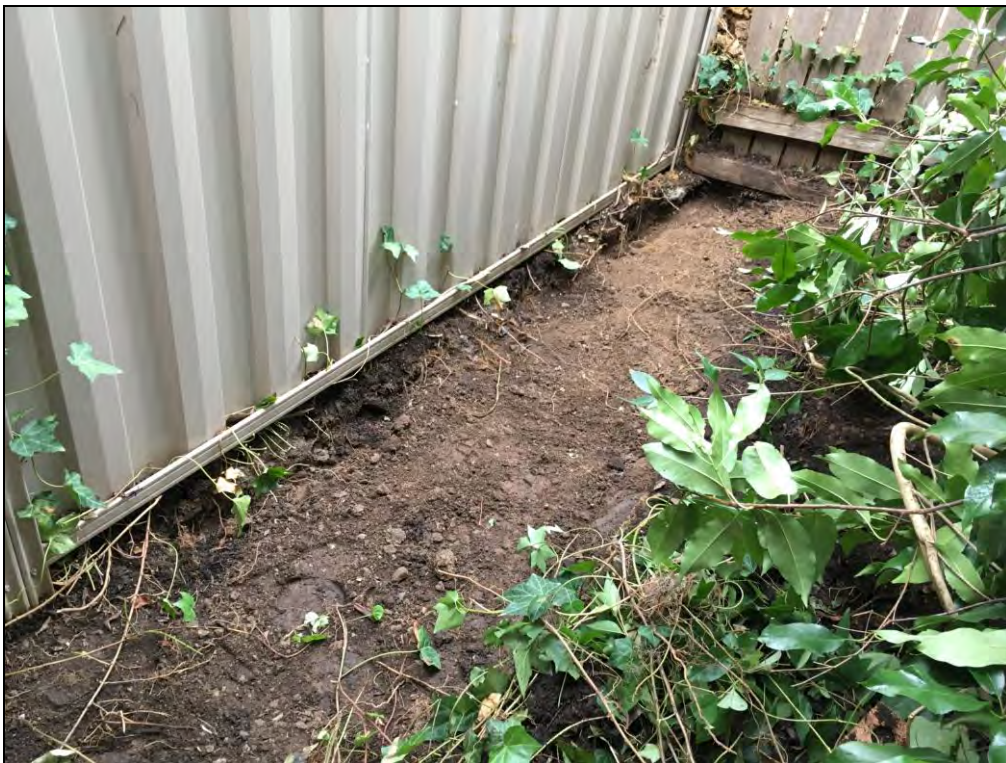
Area adjacent to the west property boundary after removal works

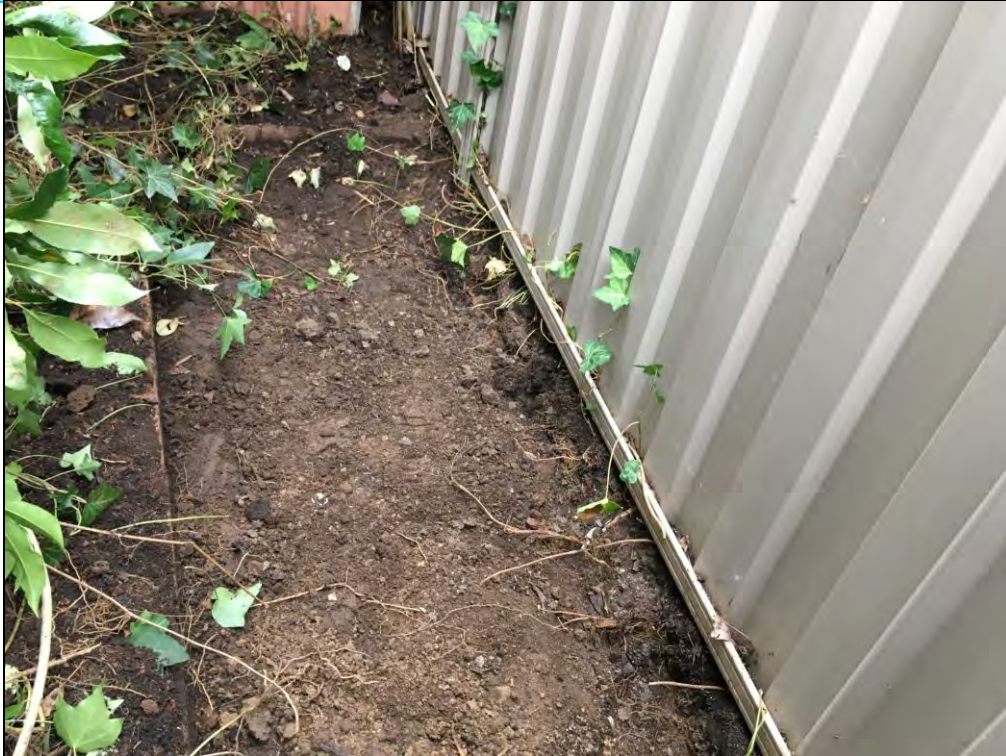
Area adjacent to the west property boundary after removal works

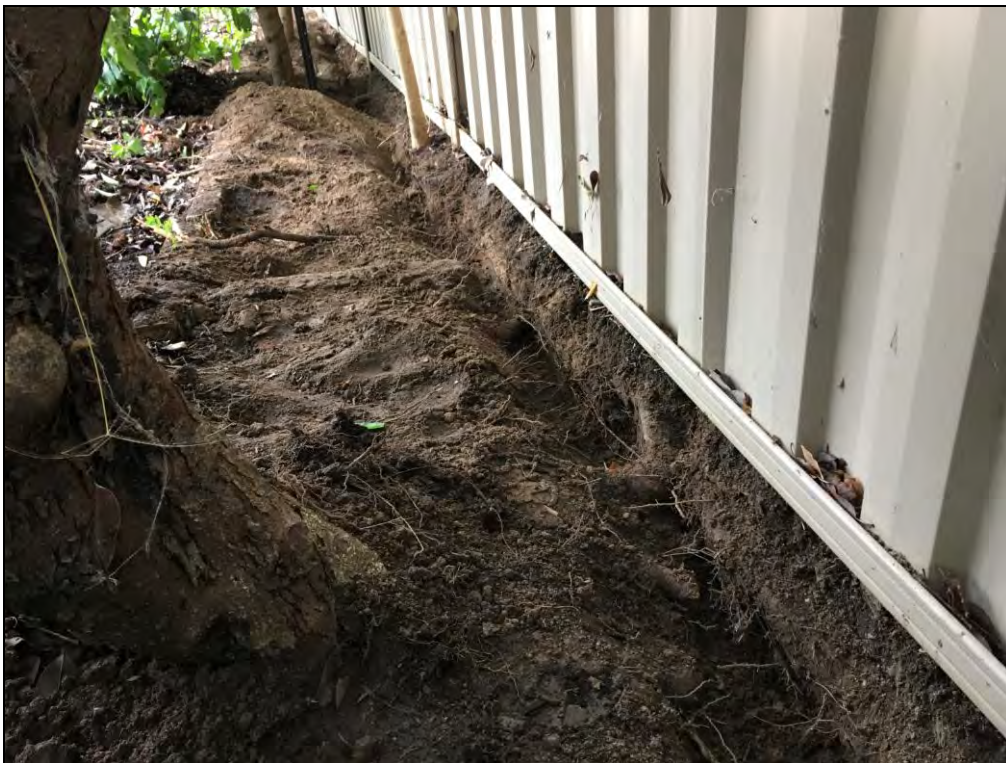
Area adjacent to the west property boundary after removal works

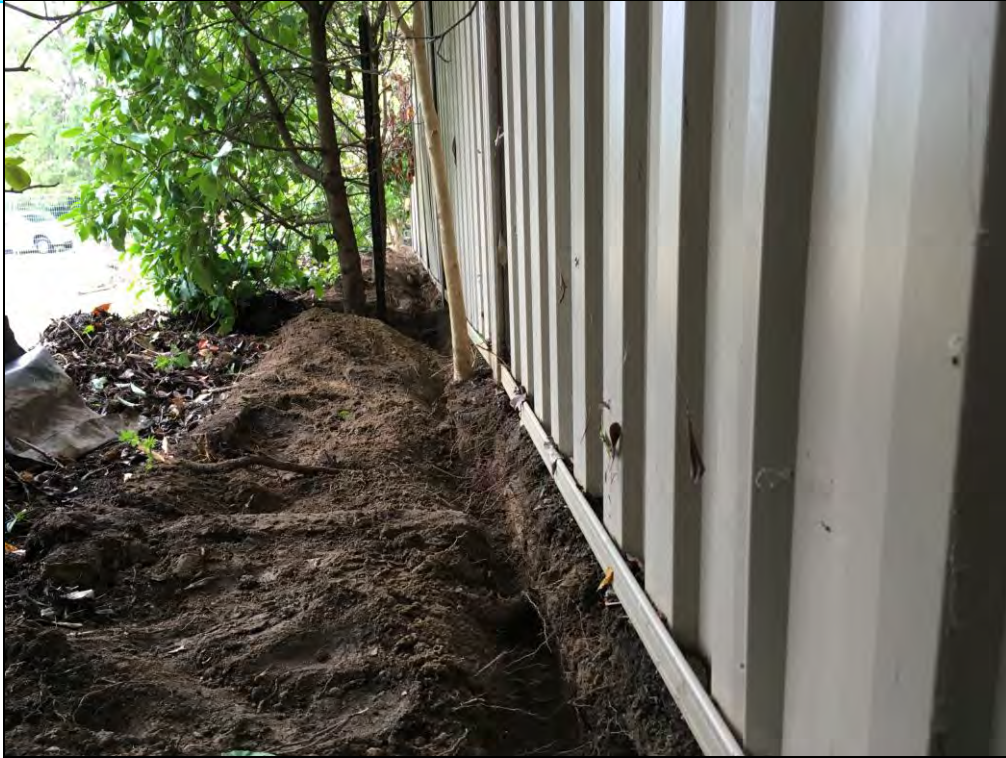
Area adjacent to the west property boundary after removal works

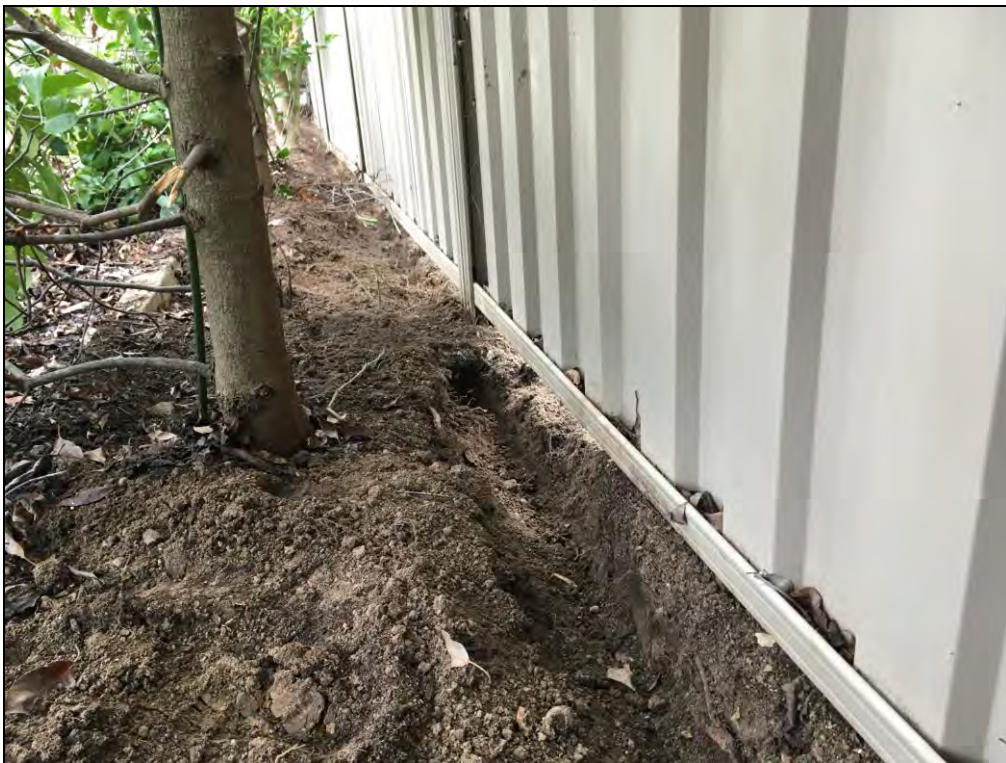
Area adjacent to the west property boundary after removal works

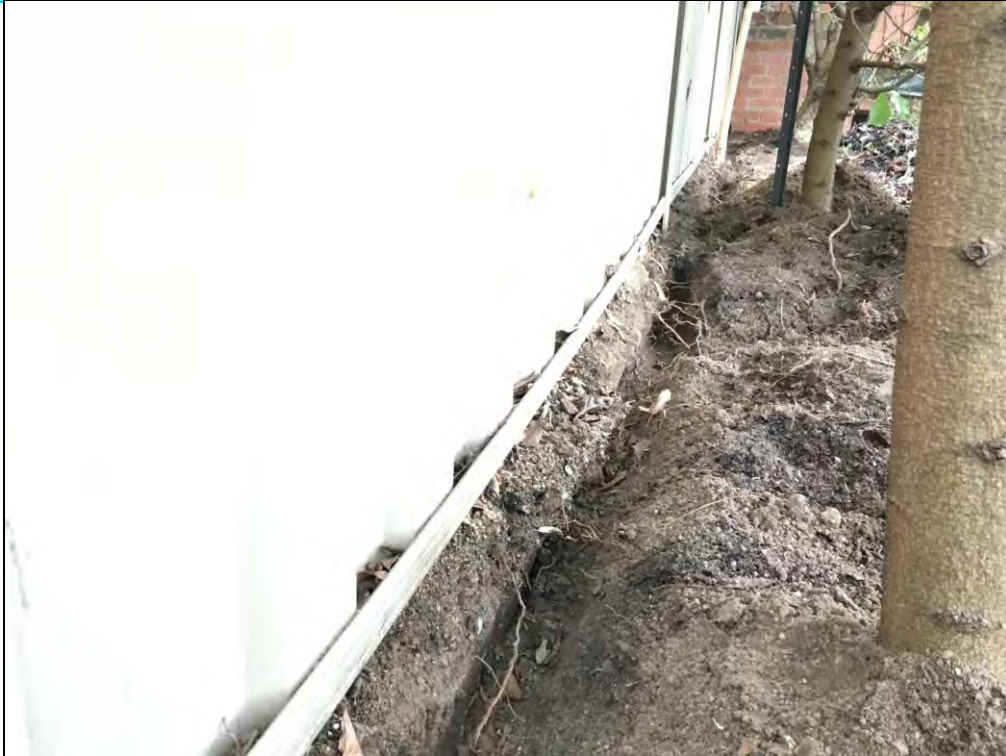
Area adjacent to the west property boundary after removal works

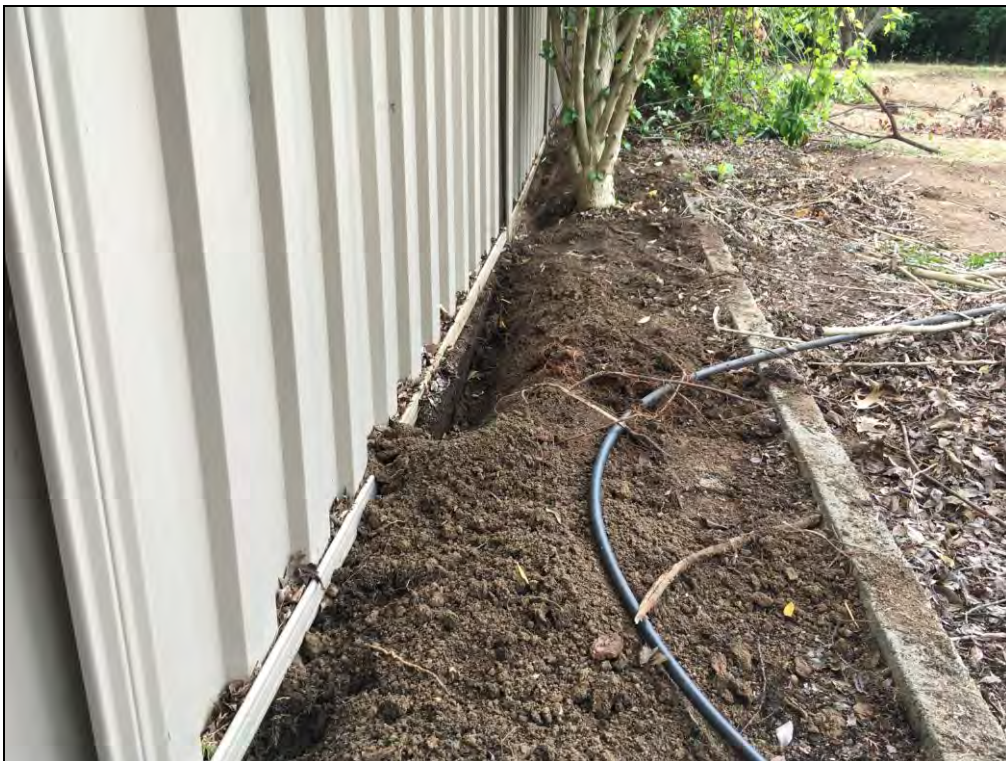
Area adjacent to the west property boundary after removal works

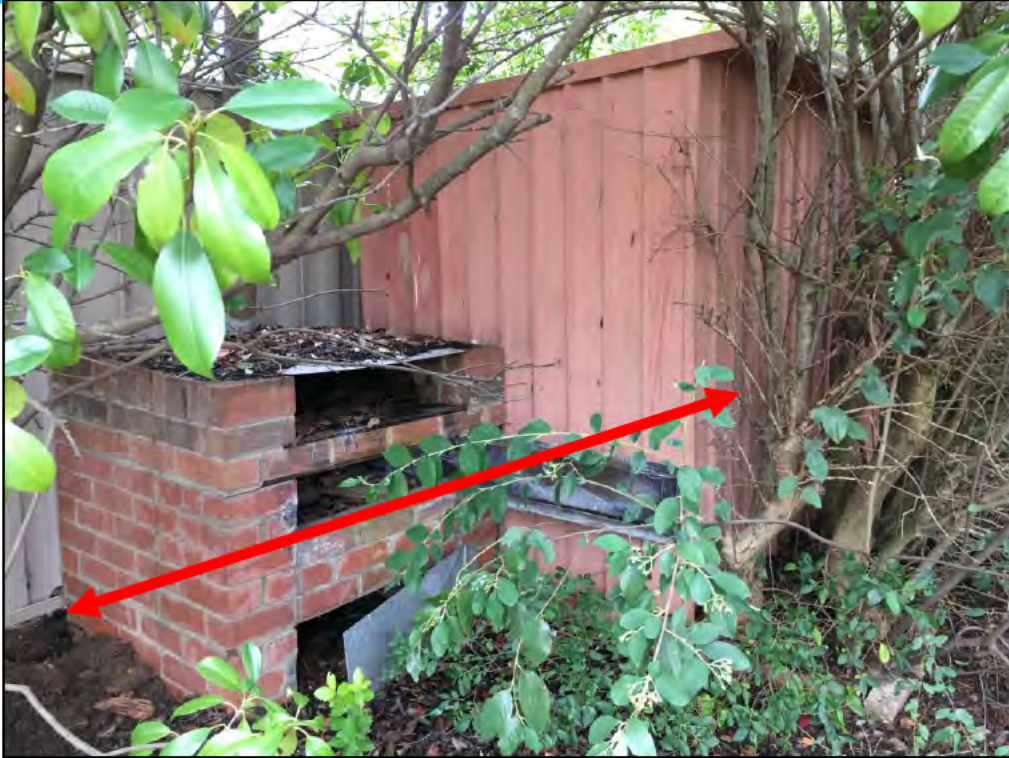
- Partially buried and loose asbestos sheet debris may still be present behind the brick outdoor oven and the metal clad shed located in the northwest corner of the property. These structures will need to be demolished and removed to verify whether or not asbestos sheet debris is present in this location.

Brick outdoor oven and metal clad shed behind which loose and partially buried asbestos cement sheet debris may remain
