## ASBESTOS CLEARANCE CERTIFICATE INSPECTION PASS

**Project/Location:** 37 Rich Street  
Higgins  
ACT 2615

**Job Number:** 9900432

**Date(s) And Description Of Work:** Removal of asbestos containing sheet and sheet debris from the southern boundary fence line, a soil mound on the northern side of the site and scattered ACM debris from soil surface areas across the 37 Rich Street Higgins block on 15 December 2017.

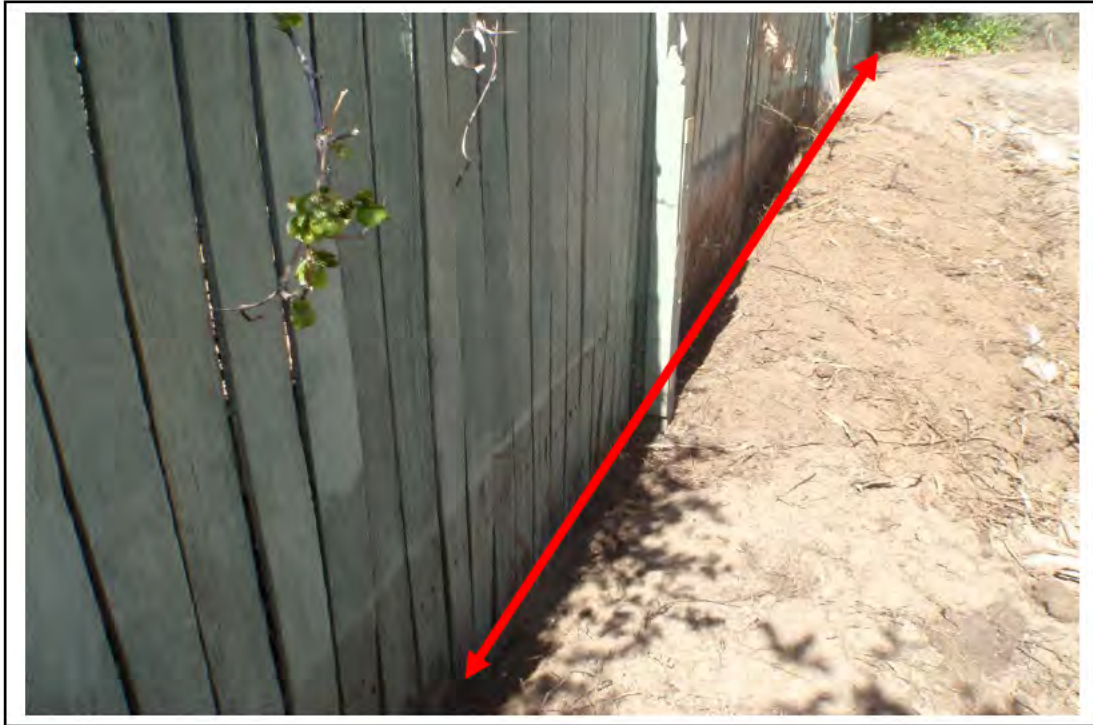
Photograph 1: Removal of non friable asbestos sheeting buried in the garden beds and along the southern boundary fence.

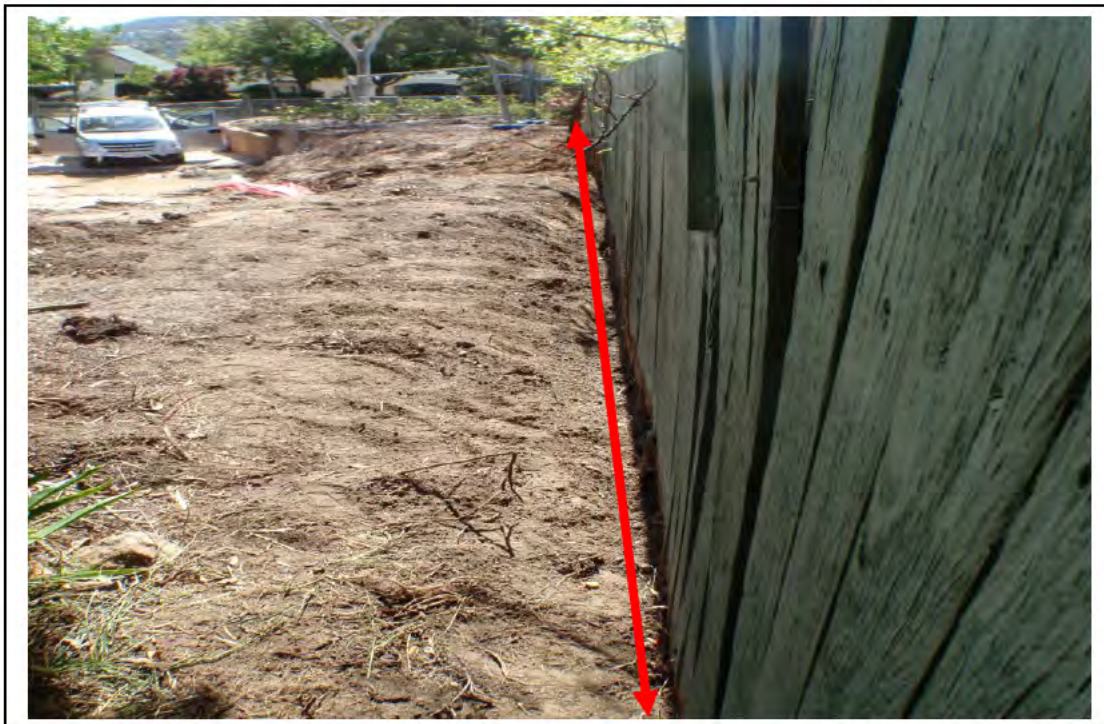
Photograph 2: Removal of non friable asbestos sheeting buried in the garden beds and along the southern boundary fence.

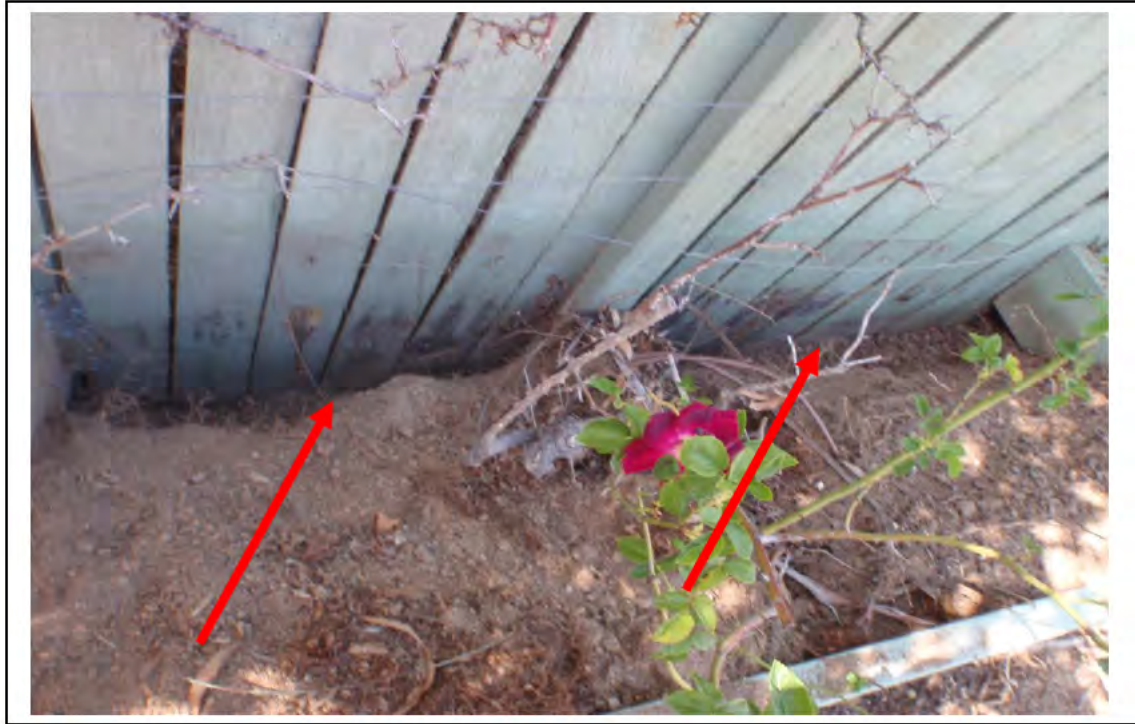
Photograph 3: Removal of non friable asbestos sheeting buried in the garden beds and along the southern boundary fence.

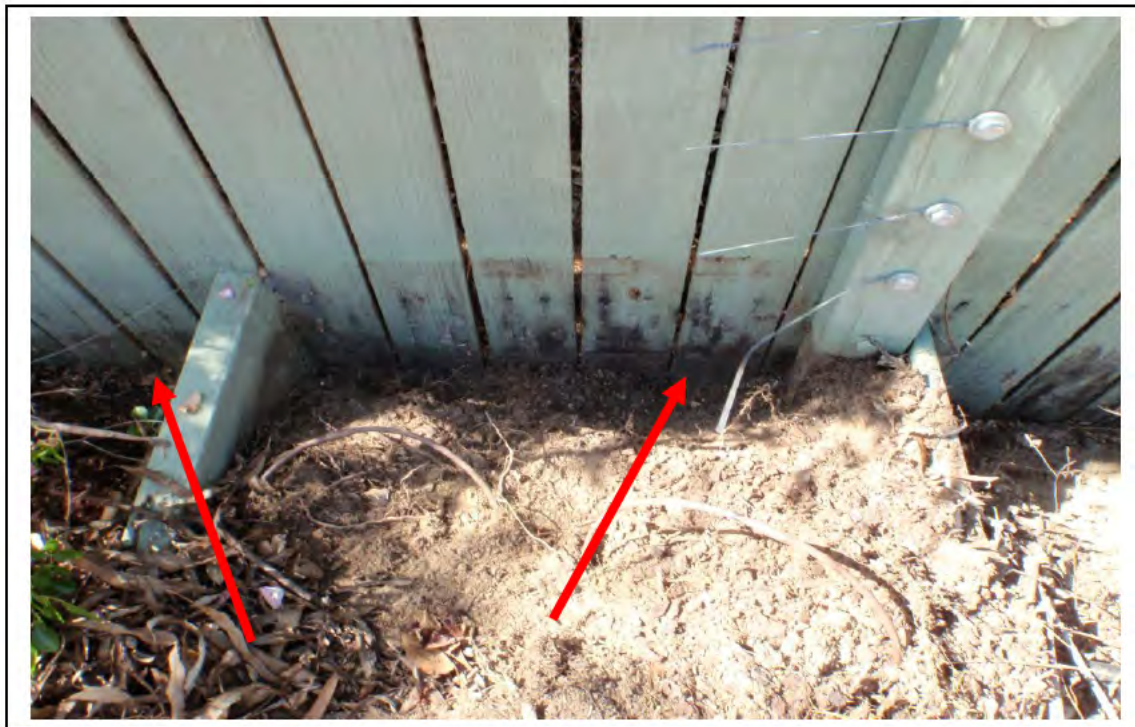
Photograph 4: Removal of non friable asbestos sheeting buried in the garden beds and along the southern boundary fence.

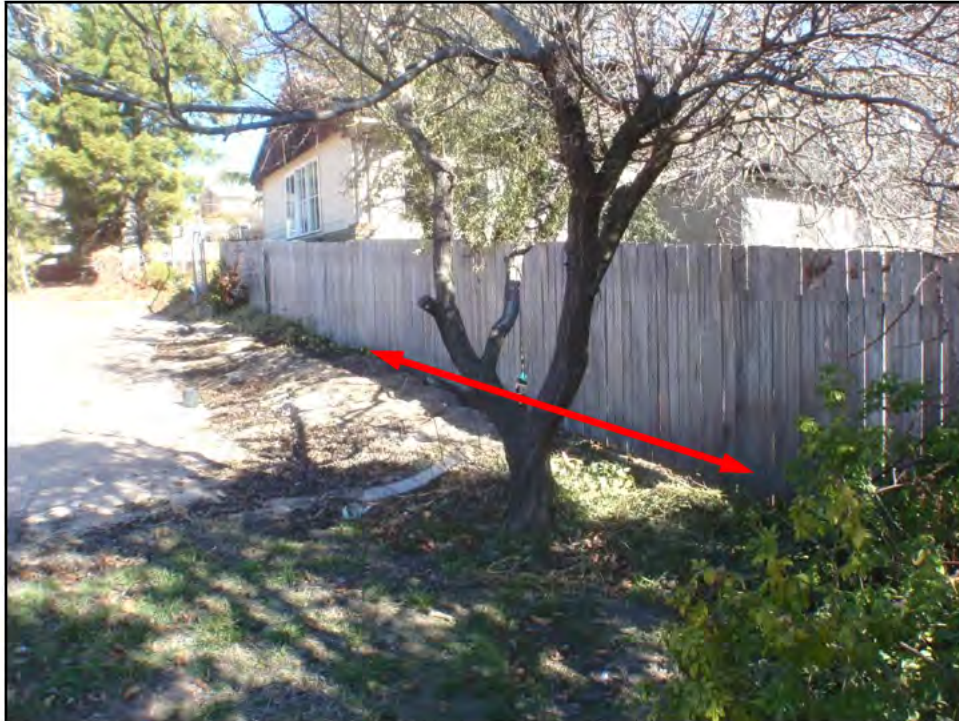
**Photograph 1:** Western boundary fence line of the 18 Darke Street Torrens block from where asbestos containing sheet was removed from the base of the timber fence

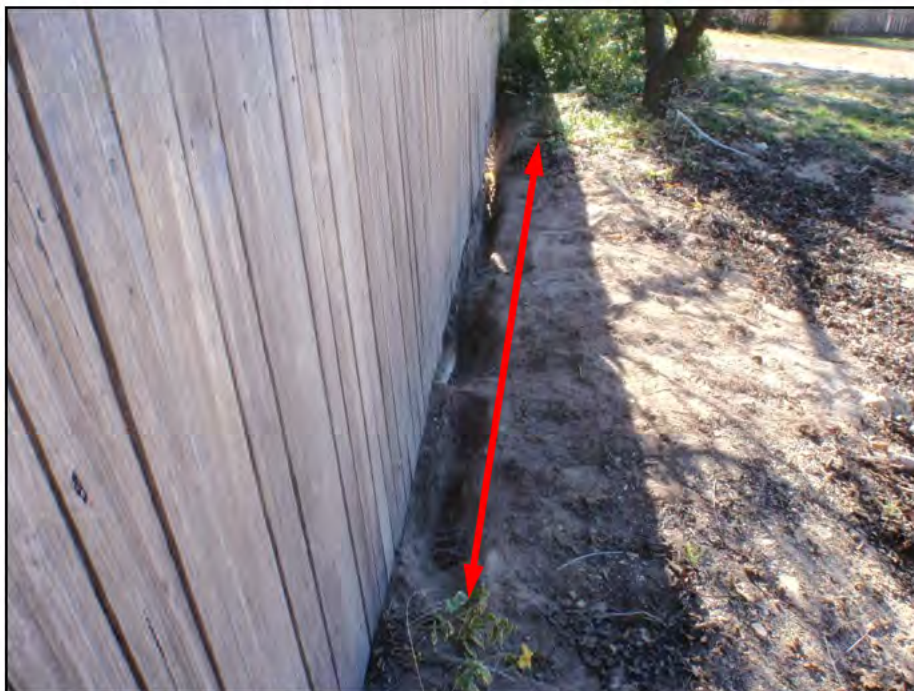
**Photograph 2:** Western boundary fence line of the 18 Darke Street Torrens block after removal of asbestos containing sheet from the base of the timber fence

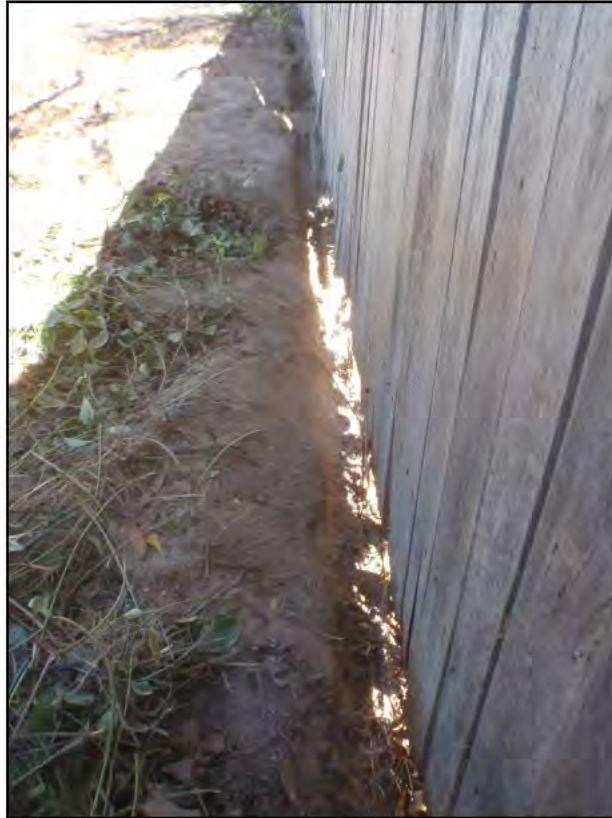
**Photograph 3:** Western boundary fence line of the 18 Darke Street Torrens block after removal of asbestos containing sheet from the base of the timber fence

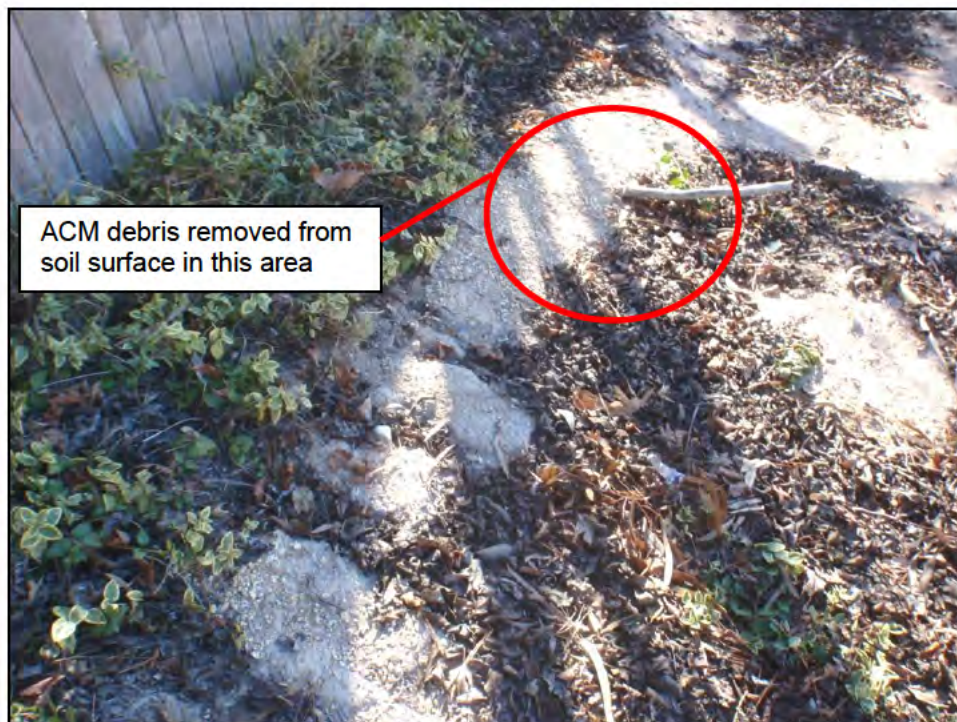
**Photograph 4:** 18 Darke Street Torrens block after removal of asbestos containing sheet debris located on top of the soil on the western side of the block

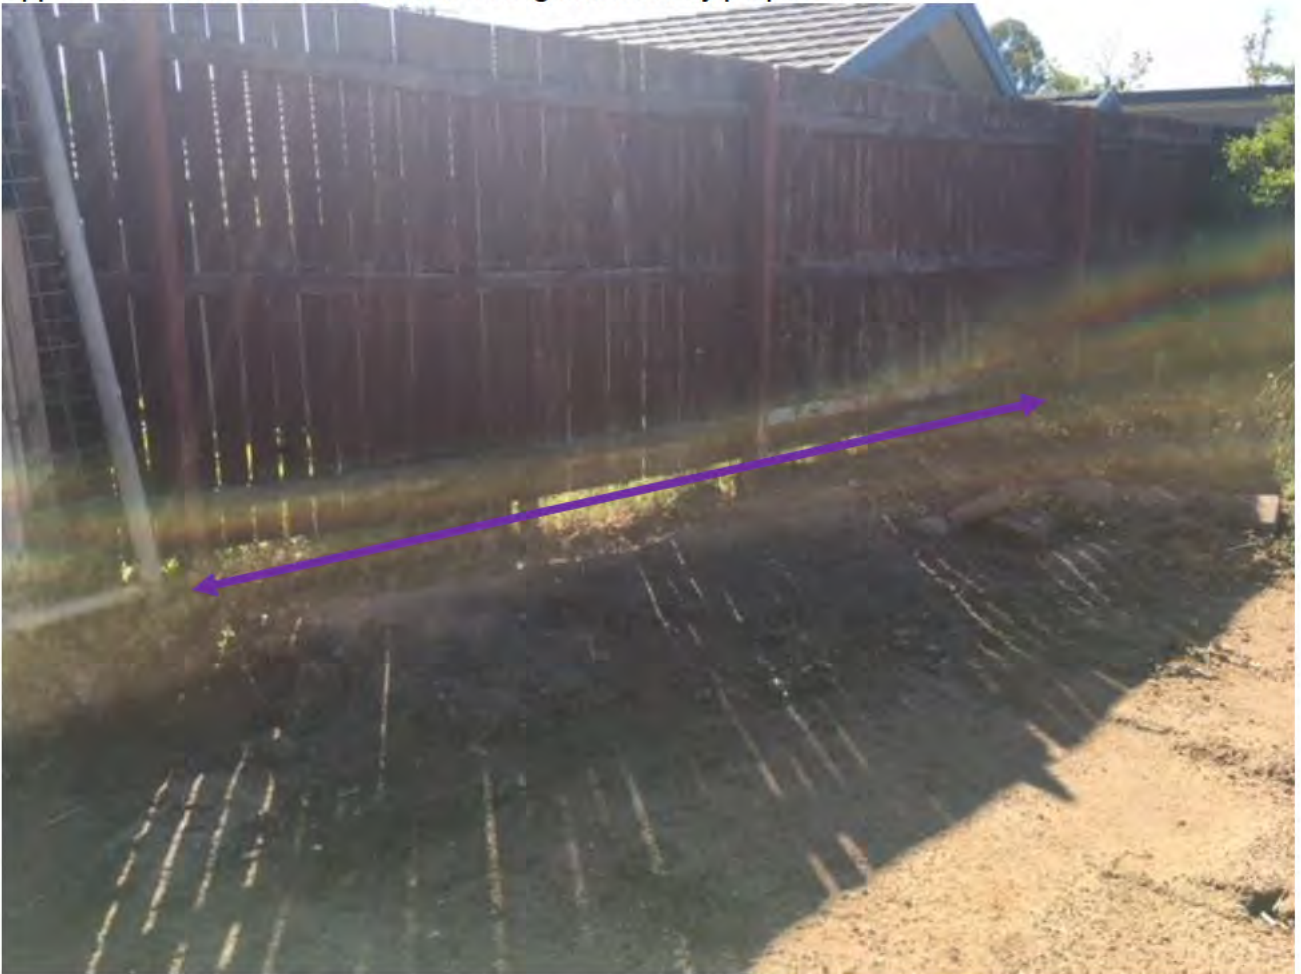
Approximate location of removed sheeting indicated by purple arrow.

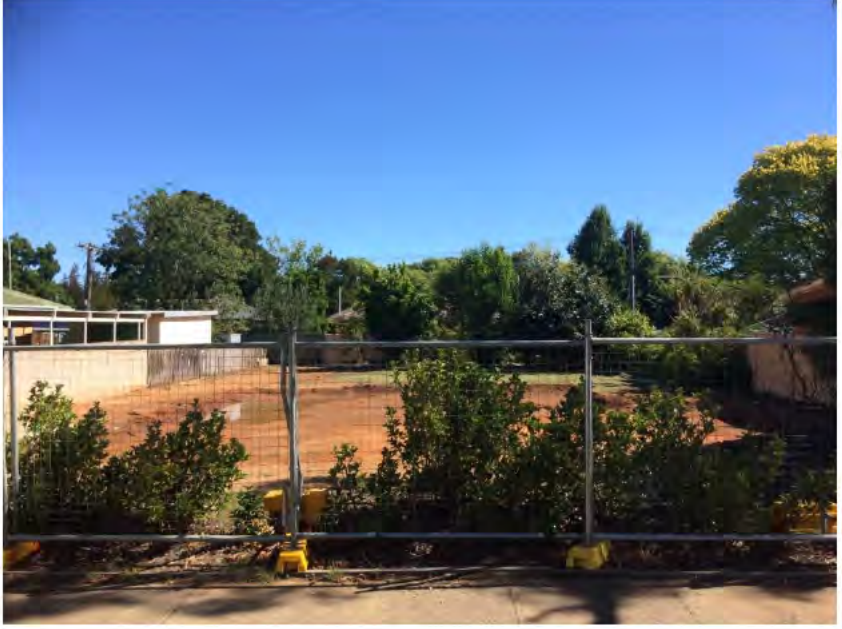
2	Driveway to property. Red arrows show removal locations

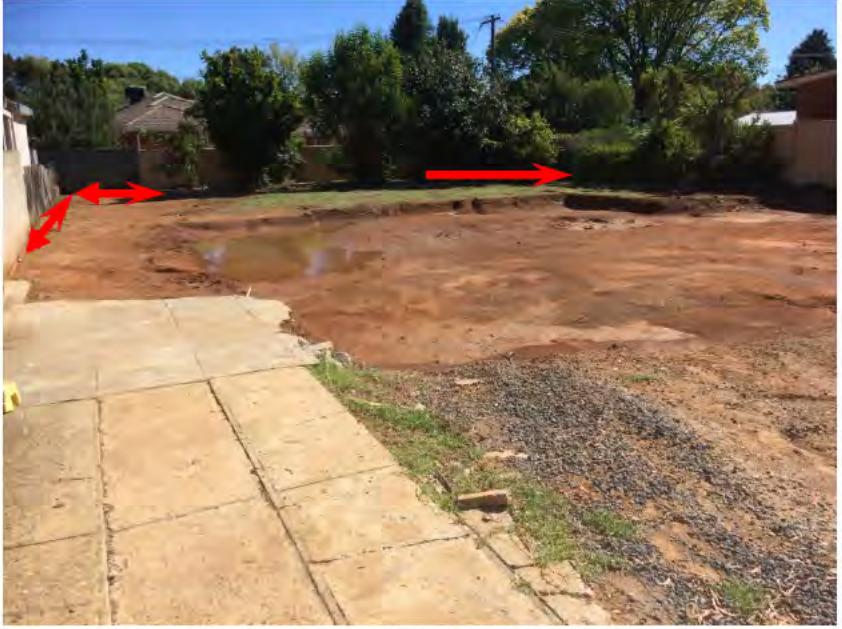
PHOTO NO	LOCATION DESCRIPTION	PHOTOGRAPH
3	South eastern side of property following the removal of asbestos cement sheeting fragments

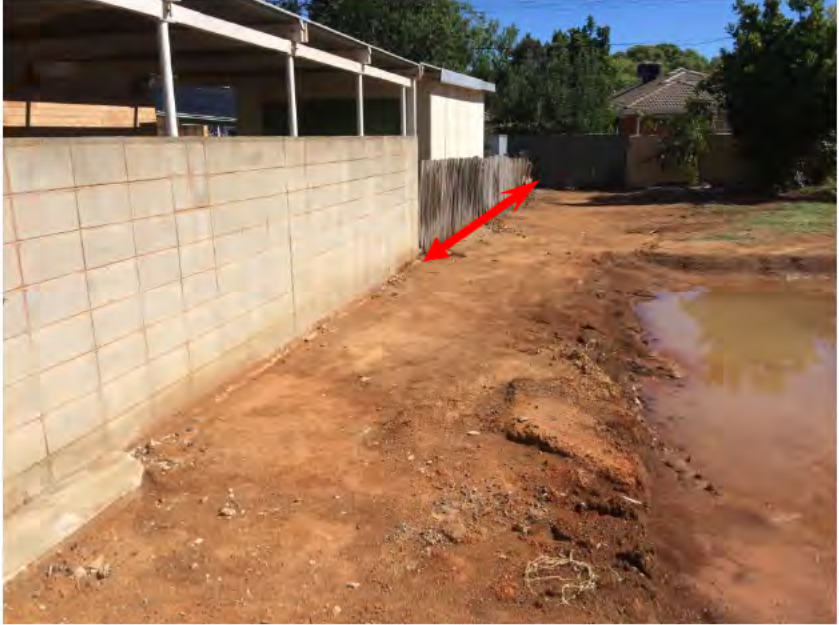
4	South western side, southern corner of property following the removal of asbestos cement barrier sheeting from the base of the perimeter fence

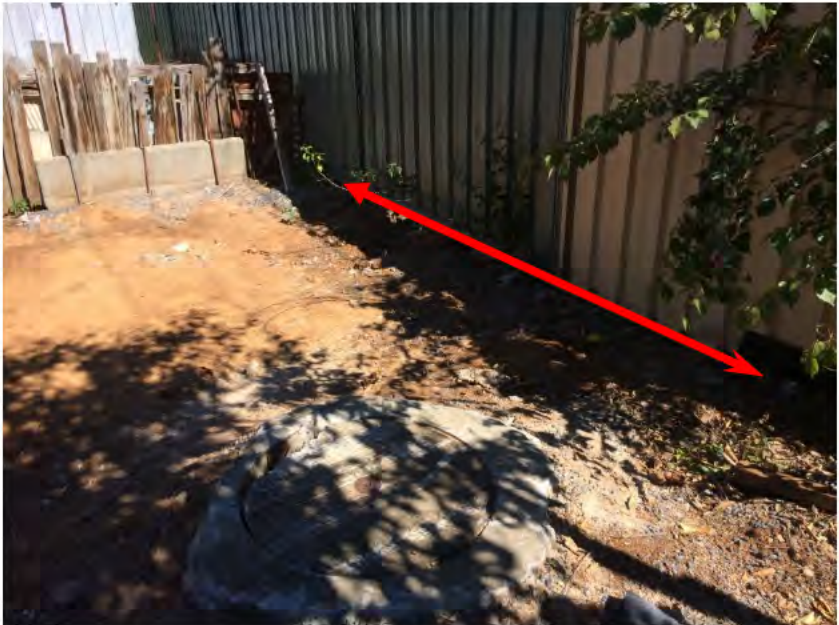
PHOTO NO	LOCATION DESCRIPTION	PHOTOGRAPH
5	<p>North western side, of property following the removal of asbestos cement barrier sheeting from the base of the perimeter fence</p>

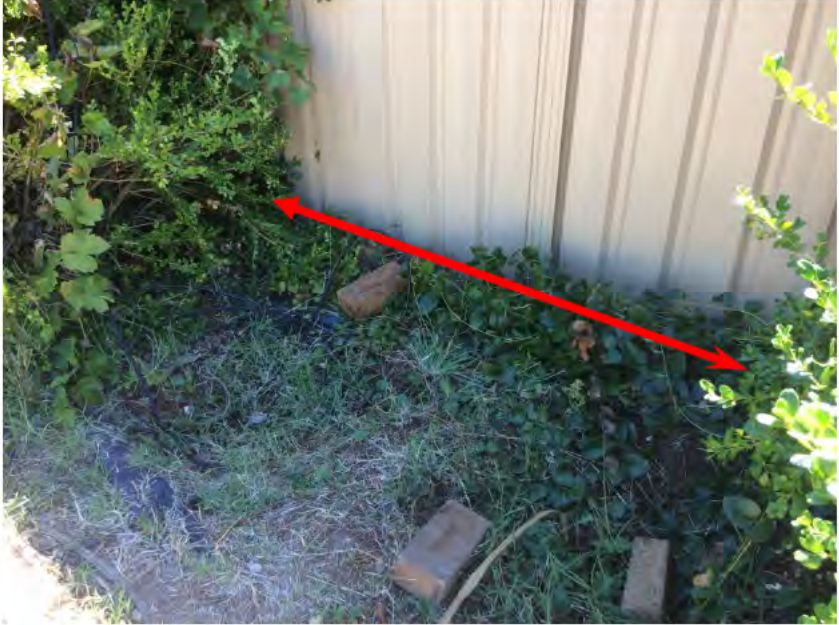
6	<p>North western side, of property following the removal of asbestos cement barrier sheeting from the base of the perimeter fence. Arrow shows the removal location.</p>
