Braddon Place - Block 4 Section 60 Braddon Review of Potential Impacts on adjacent Heritage Places

HEALTH AND CONDITION TREE AUDIT

Arboricultural Impact Assessment

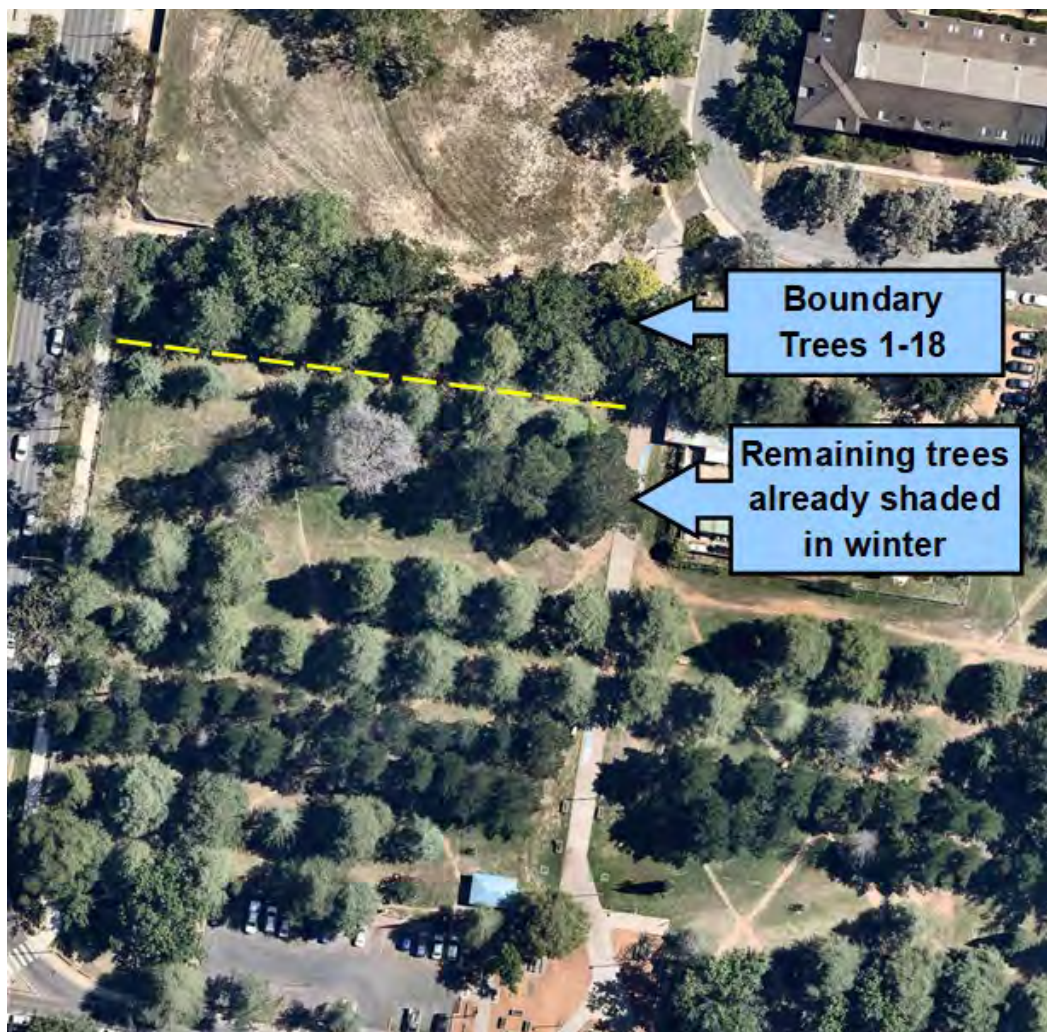
Additionally, winter is a period of dormancy for trees when they generally are not actively growing. Their requirements for light, air, water and nutrients are greatly reduced (Evert & Eichhorn, 2013). Reduced winter lighting to Trees 1-18, as a result of the proposed buildings is expected to have a negligible effect on tree health.

Figure 6: Most trees already shaded in winter from boundary trees.

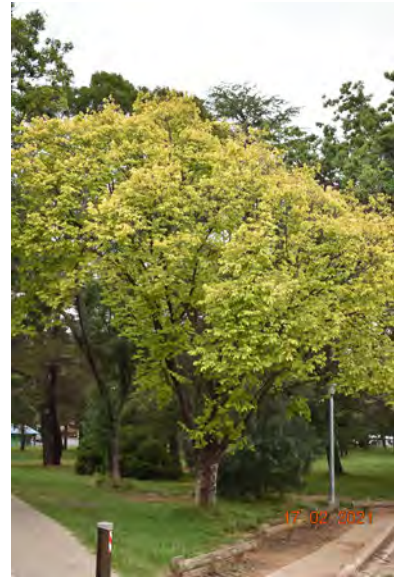
Tree Number: 2 **Botanical Name:** *Fraxinus 'Raywood'*
Common Name: Claret Ash
Origin: Exotic
Height & Width (m): 11 x 9
DBH (cm) 41
TPZ Radius (m): 4.92 **TPZ Impact:** 0%
Health: Poor **TPZ Enchroachment**
Structure: Fair **(AS 4970):** No impact
ULE: 5 to 10 years
Landscape Contribution: Medium
Individual Significance: Low
Retention Value: Third party ownership
Comments:

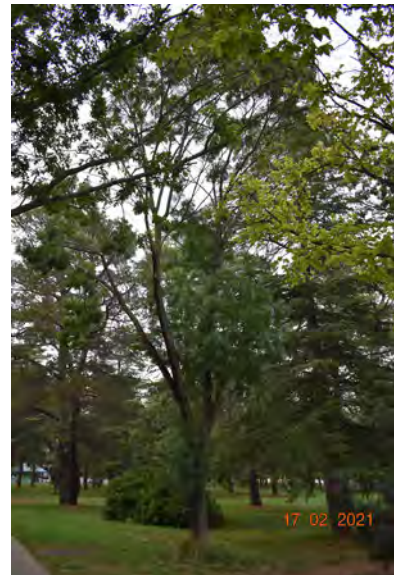
Tree Number: 3 **Botanical Name:** *Fraxinus 'Raywood'*
Common Name: Claret Ash
Origin: Exotic
Height & Width (m): 4 x 4
DBH (cm) 8
TPZ Radius (m): 2 **TPZ Impact:** 0%
Health: Good **TPZ Enchroachment**
Structure: Good **(AS 4970):** No impact
ULE: 40+ years
Landscape Contribution: Low
Individual Significance: Low
Retention Value: Third party ownership
Comments:

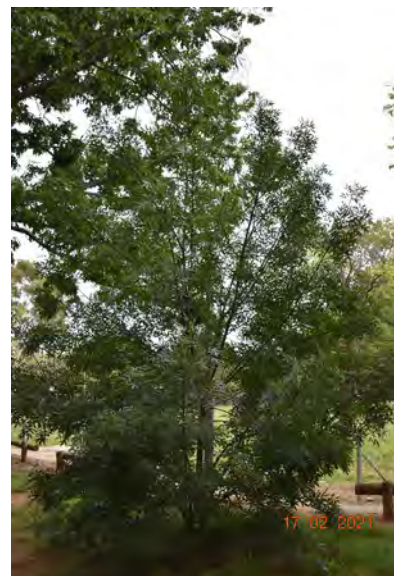
Tree Number: 4 **Botanical Name:** *Quercus palustris*
Common Name: Pin Oak
Origin: Exotic
Height & Width (m): 13 x 12
DBH (cm) 79
TPZ Radius (m): 9.48 **TPZ Impact:** 13%
Health: Fair **TPZ Enchroachment**
Structure: Good **(AS 4970):** Major
ULE: 10 to 20 years
Landscape Contribution: High
Individual Significance: Valuable
Retention Value: Third party ownership
Comments:

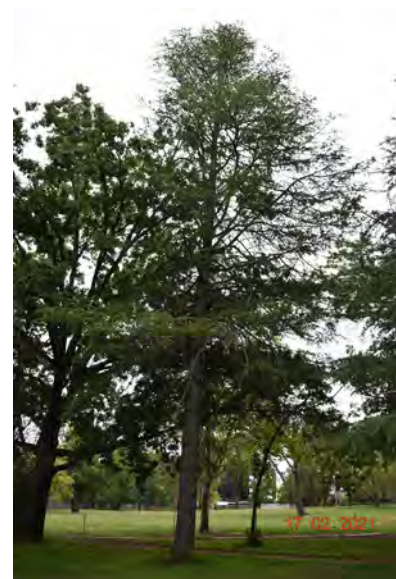
Tree Number: 12 **Botanical Name:** *Quercus palustris*
Common Name: Pin Oak
Origin: Exotic
Height & Width (m): 17 x 18
DBH (cm) 81
TPZ Radius (m): 9.72 **TPZ Impact:** 14%
Health: Fair **TPZ Enchroachment**
Structure: Fair **(AS 4970):** Major
ULE: 10 to 20 years
Landscape Contribution: High
Individual Significance: Valuable
Retention Value: Third party ownership
Comments:

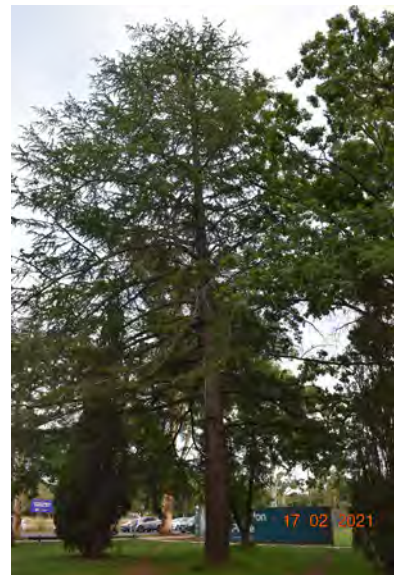
Tree Number: 15 **Botanical Name:** *Cupressus sempervirens*
Common Name: Italian Cypress
Origin: Exotic
Height & Width (m): 11 x 4
DBH (cm) 38
TPZ Radius (m): 4.56 **TPZ Impact:** 0%
Health: Fair **TPZ Enchroachment**
Structure: Fair **(AS 4970):** No impact
ULE: 10 to 20 years
Landscape Contribution: Low
Individual Significance: Moderate
Retention Value: **Third party ownership**
Comments: Unable to measure trunk, DBH estimated

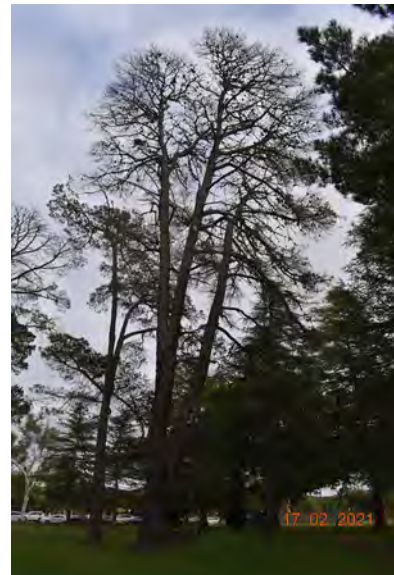
Tree Number: 30 **Botanical Name:** *Pinus radiata*
Common Name: Monterey Pine
Origin: Exotic
Height & Width (m): 21 x 13
DBH (cm) 68
TPZ Radius (m): 8.16 **TPZ Impact:** 0%
Health: Poor **TPZ Enchroachment**
Structure: Fair **(AS 4970):** No impact
ULE: Less than 5 years
Landscape Contribution: Medium
Individual Significance: Low
Retention Value: Third party ownership
Comments:

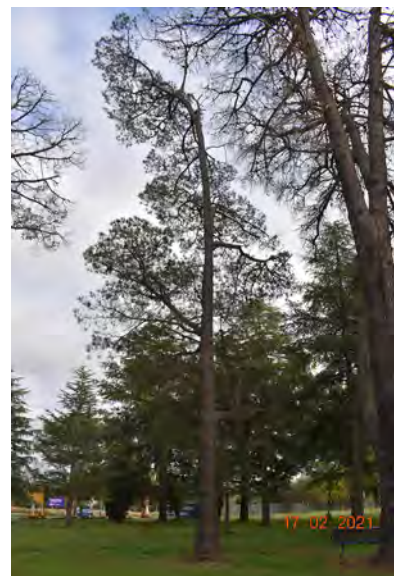
Tree Number: 31 **Botanical Name:** *Pinus radiata*
Common Name: Monterey Pine
Origin: Exotic
Height & Width (m): 25 x 14
DBH (cm) 94
TPZ Radius (m): 11.28 **TPZ Impact:** 0%
Health: Very Poor **TPZ Enchroachment**
Structure: Poor **(AS 4970):** No impact
ULE: Less than 5 years
Landscape Contribution: Medium
Individual Significance: Low
Retention Value: Third party ownership
Comments:
