# **SURVEY OF VEGETATION AND HABITAT IN KEY RIPARIAN ZONES OF TRIBUTARIES OF THE MURRUMBIDGEE RIVER IN THE ACT: Naas, Gudgenby, Paddys, Cotter and Molonglo Rivers**

Technical Report 23

November 2011

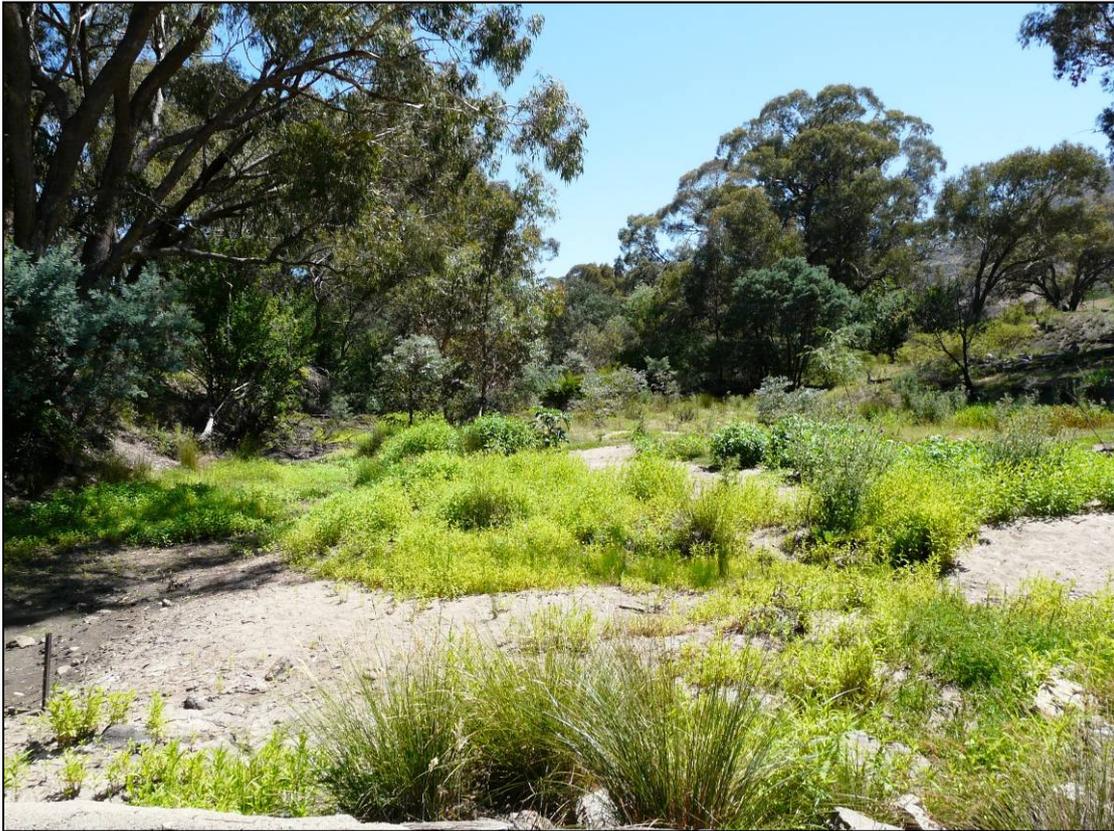
The riverine vegetation near the Caloola Farm crossing is highly degraded and infested by weeds. At the time of the survey there was no surface water in the river bed, resulting in the encroachment of Tableland Aquatic and Fringing Vegetation Complex into the stream bed (Plates 3.6, 3.7). The river bed is very sandy with a strip of fringing vegetation, including a high proportion of remnant *E. bridgesiana* and *A. dealbata*. There are numerous infestations of blackberries, prune trees (*Prunus* sp.) and other herbaceous weeds.

**Plate 3.6: Dry river bed on the Naas River near Caloola Farm showing encroaching Tableland Aquatic and Fringing Vegetation Complex**

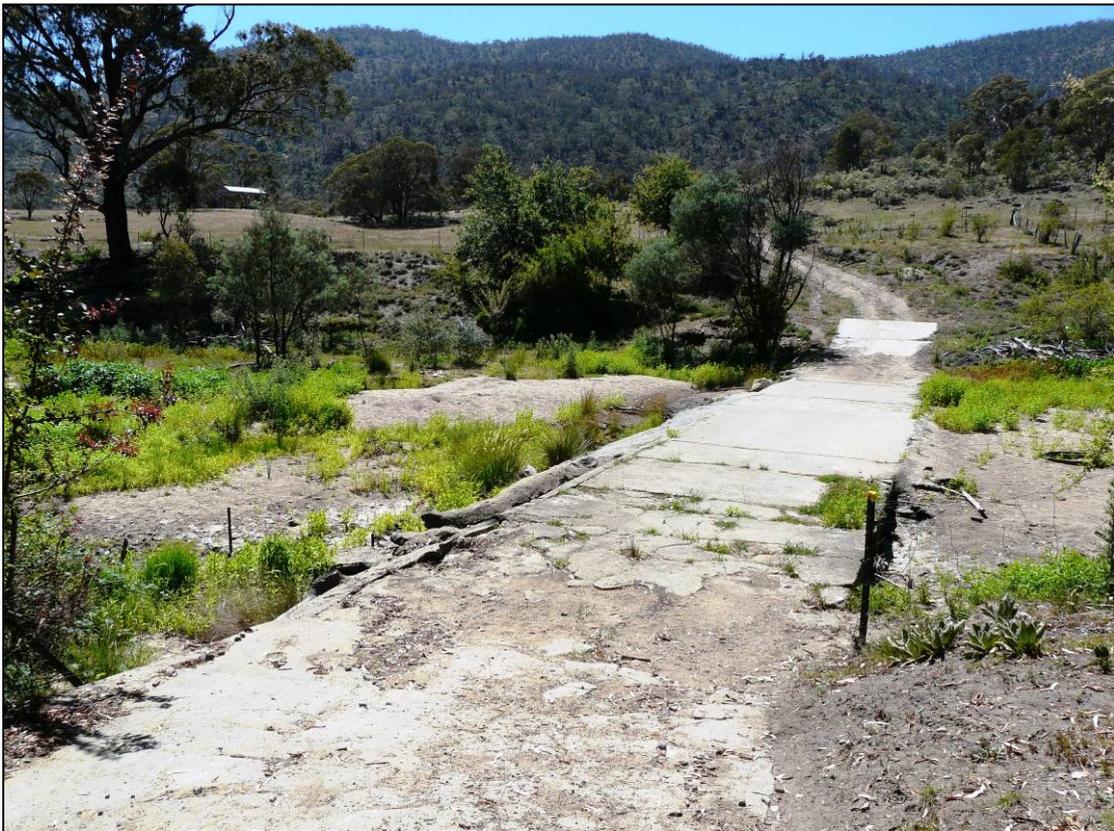
**Plate 3.7: Naas River crossing at Caloola Farm showing encroaching Tableland Aquatic and Fringing Vegetation Complex**

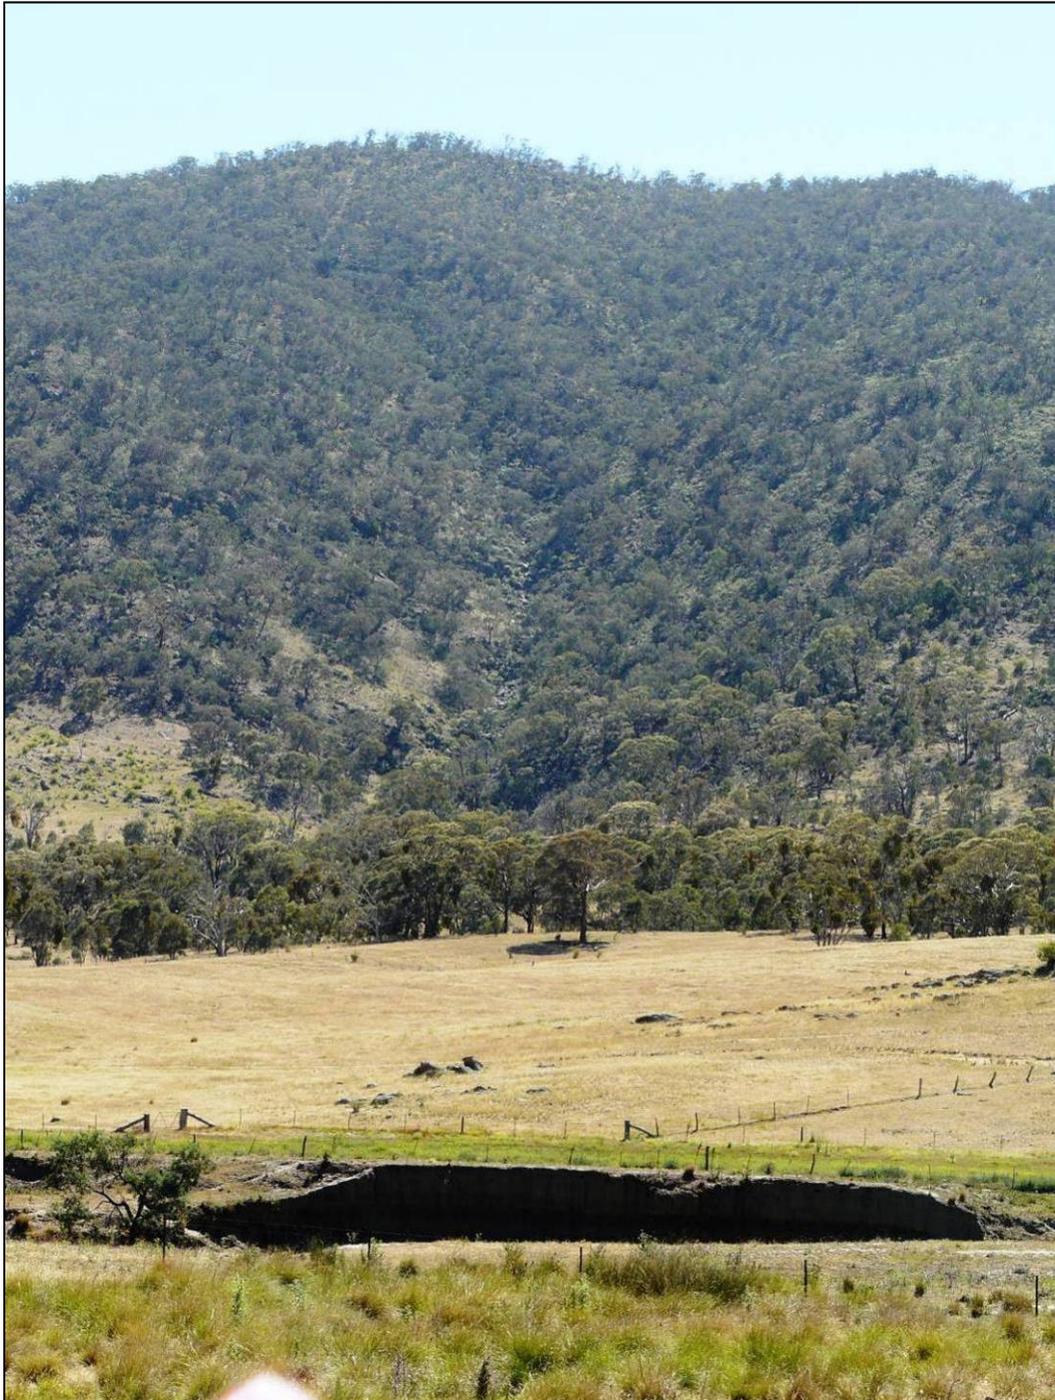
**Plate 3.8: Lower Naas River: bank slumping in stream channel, grazed river flats and wooded footslopes**

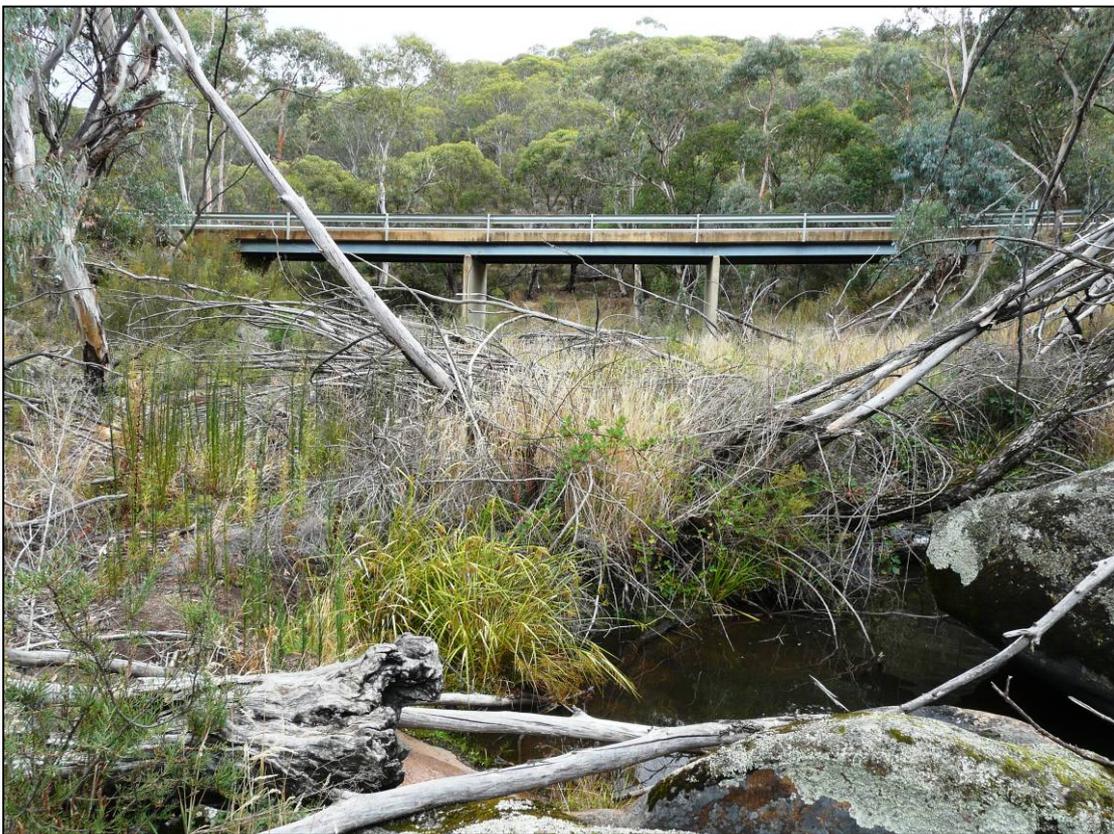
This section was impacted by the 2003 bushfire but is regenerating well. Willows within the river, particularly at the bridge, are dead possibly due to fire or willow control work. Some of the weed species present may be a result of the close proximity to the road and the bridge site is used also as a public access point to the river.

Plate 4.6: Willow control on the Gudgenby River at Boboyan Road bridge

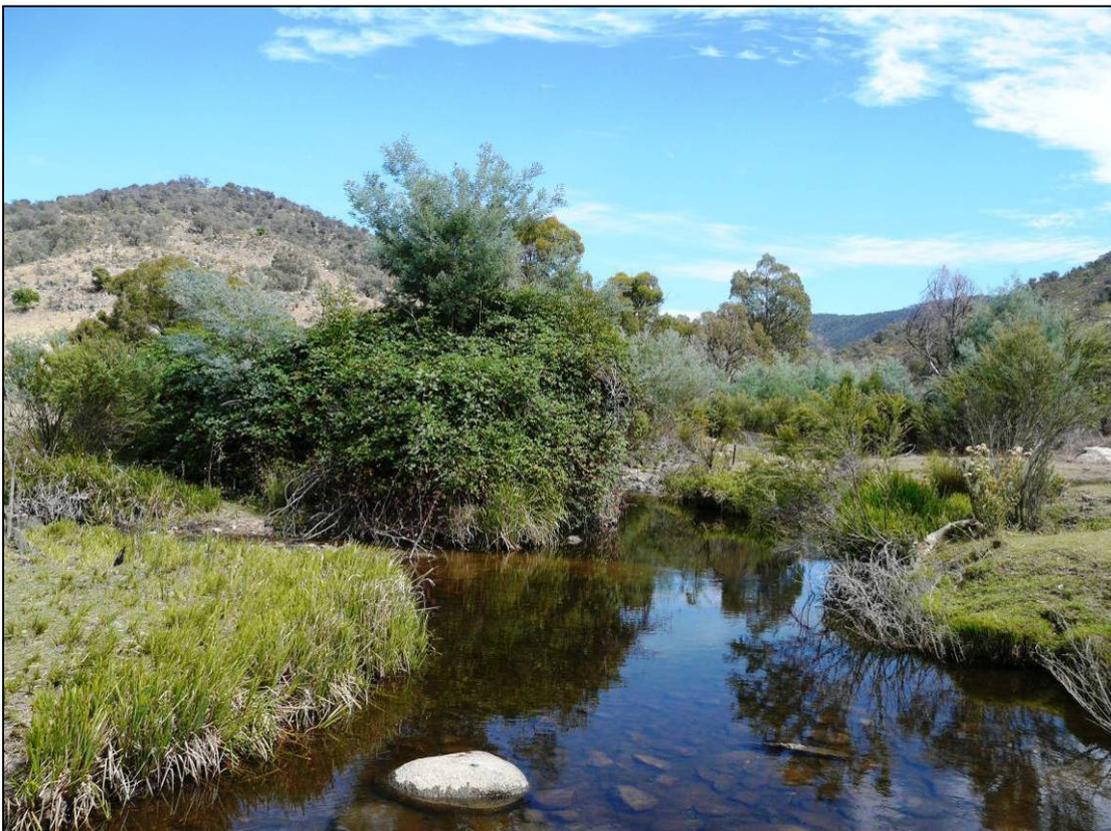
**Plate 4.9: Tableland Aquatic and Fringing Vegetation Complex, Gudgenby River below Fitzs Hill, rural lease with large infestations of blackberry.**

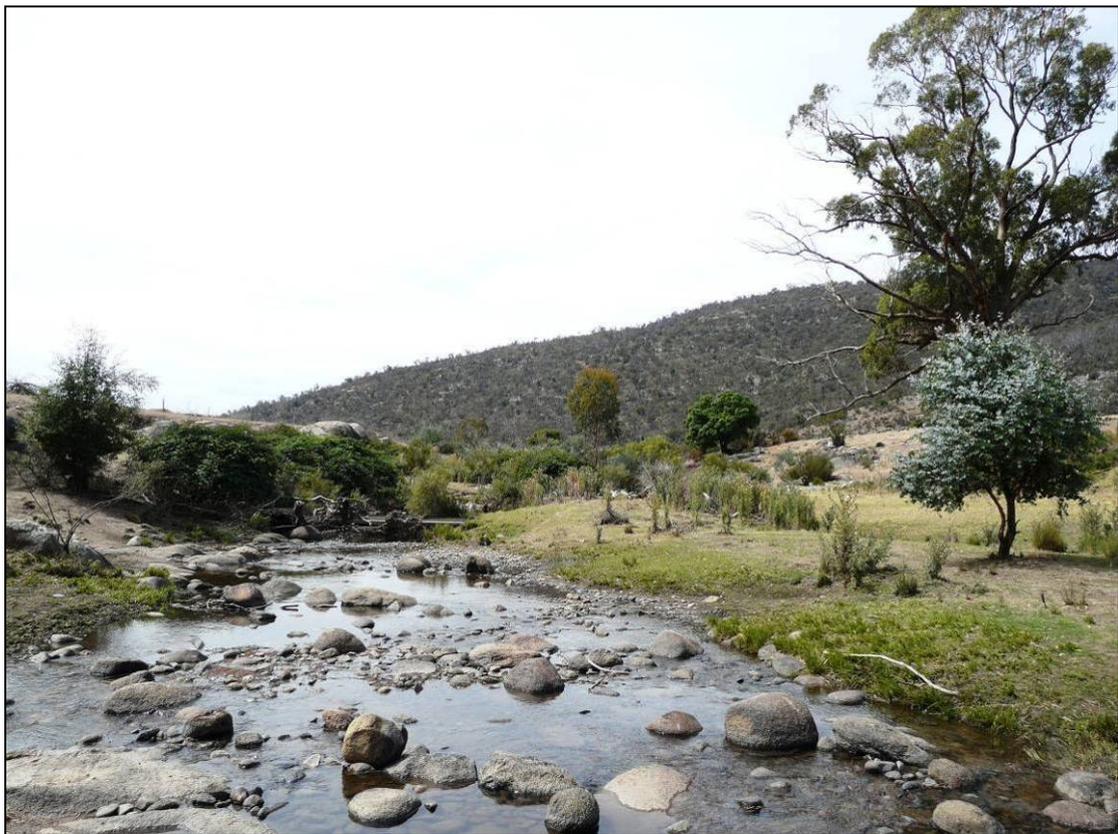
Overall the entire broad floodplain is covered in pasture grasses and associated weed species (Plate 4.11). The entire valley has been modified by rural land uses and the river is lined almost entirely by exotic tree and shrub species including blackberries, willows, poplars, elms (*Ulmus* sp.), *Prunus* sp. and *Malus* sp. The riverbank has long been used, especially close to homes, for orchards and gardens. The Europeanisation of the riverbank is very pronounced downstream to the confluence with the Naas River

**Plate 4.11: Gudgenby River, old homestead crossing**

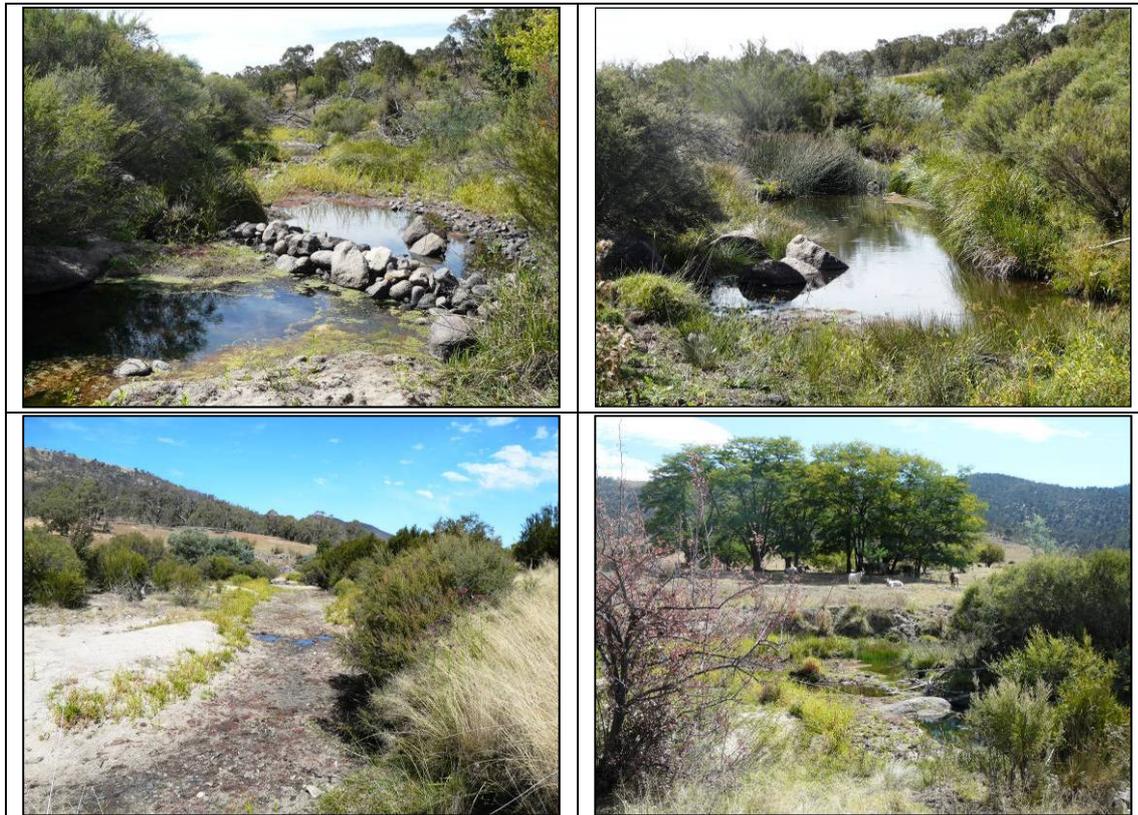
Overall, the riparian zone downstream of Sunshine Rd through to the confluence with the Murrumbidgee River is in low condition and is highly degraded and modified. The river bank shows signs of trampling and compaction by cattle, which were observed accessing the river (Plate 4.14). Adjacent valley and hillslope vegetation is in moderate condition on the eastern side of the river, while the western side comprises low quality, cleared rural land.

**Plate 4.14: River Bottlebrush – Burgan Tableland Riparian Shrubland, Gudgenby River; near Sunshine Road (top); dry river bed (bottom left); stock grazing within riparian zone (bottom right)**

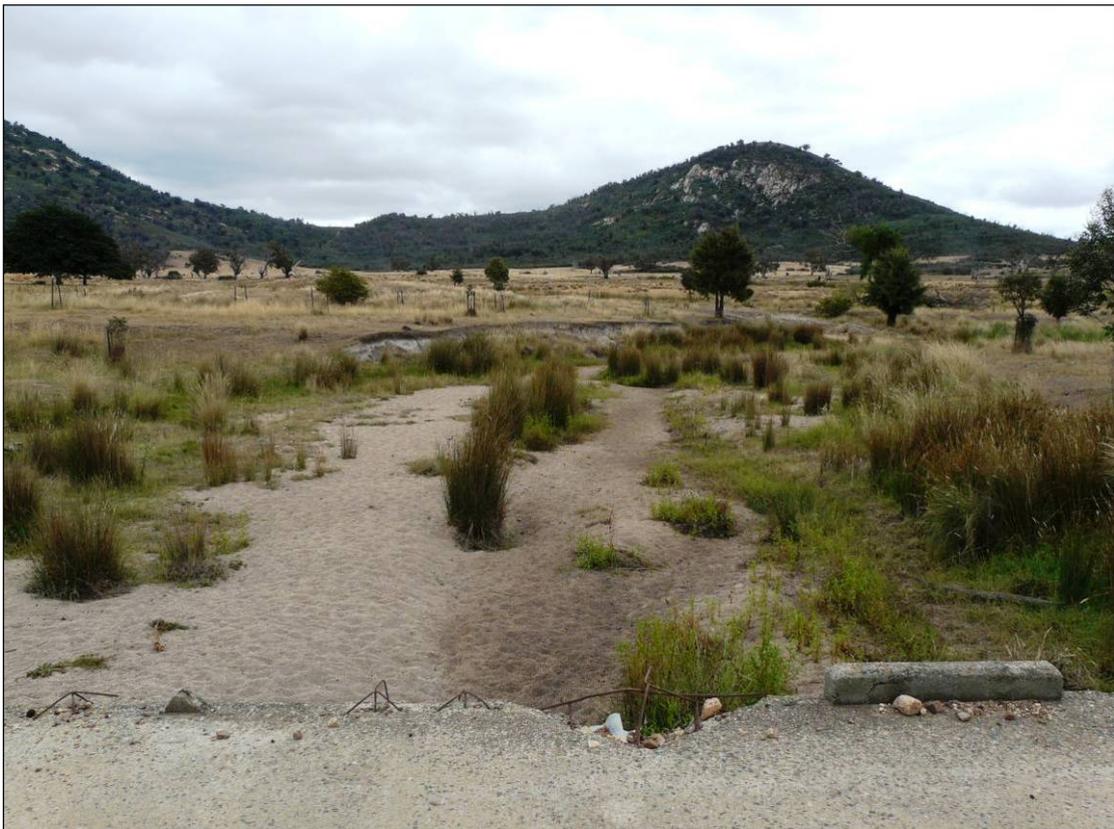
**Plate 5.4: Paddys River: erosion and zonation at Booroomba.**  
Note stream bed infill and minor stream incision.

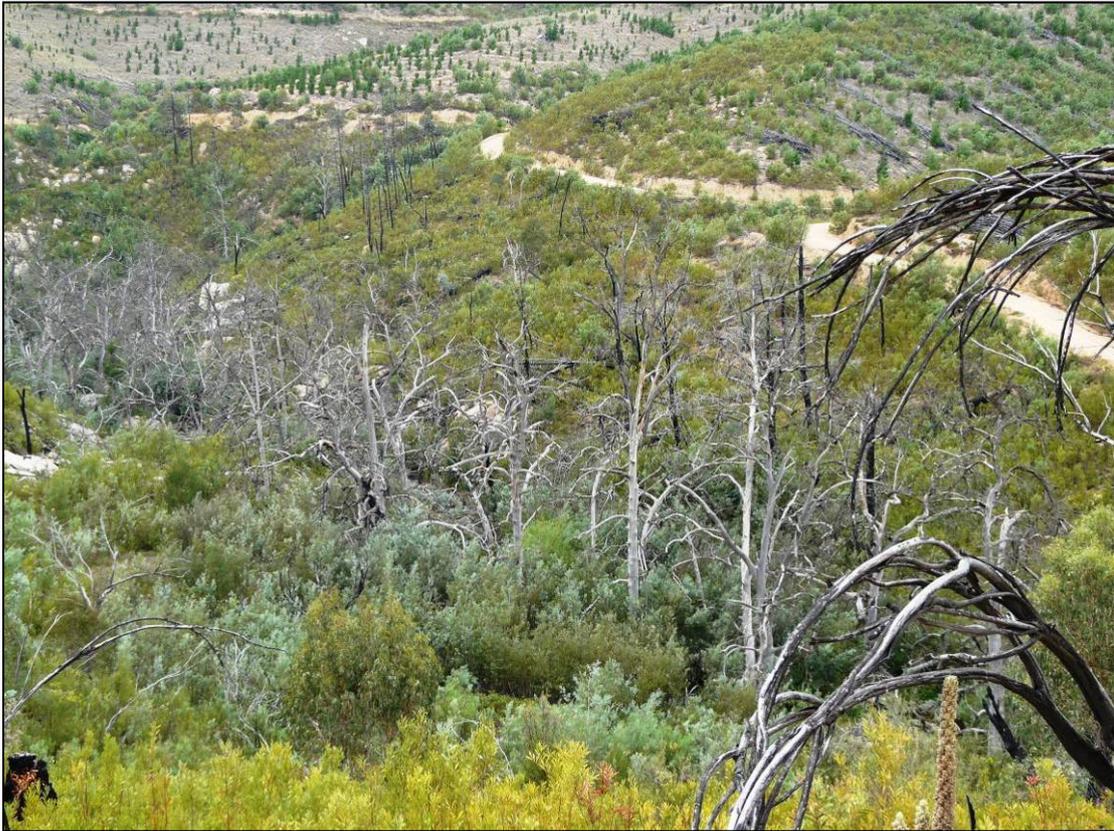
**Plate 5.13: Paddys River downstream of Murrays Corner showing dead standing *Casuarina cunninghamina* and dense growth of *Acacia dealbata* following the 2003 bushfire**

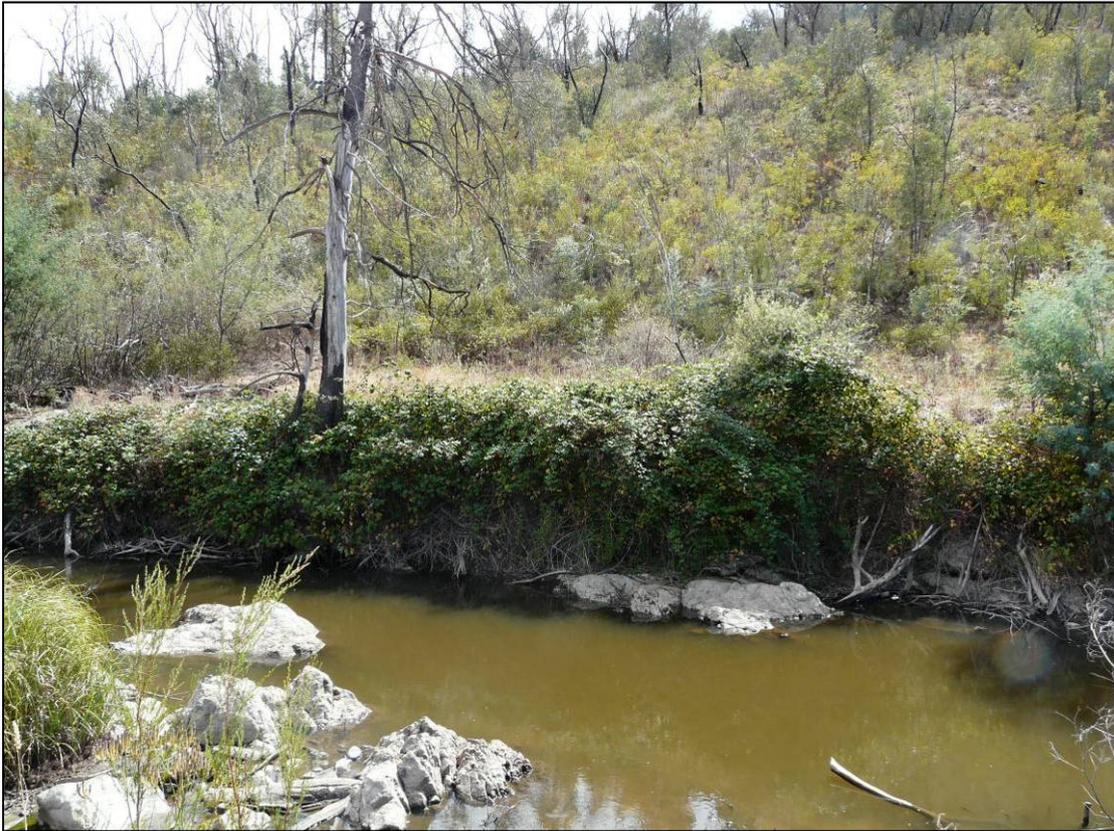
**Plate 5.14: Blackberry fringing Paddys River near confluence with the Cotter River**

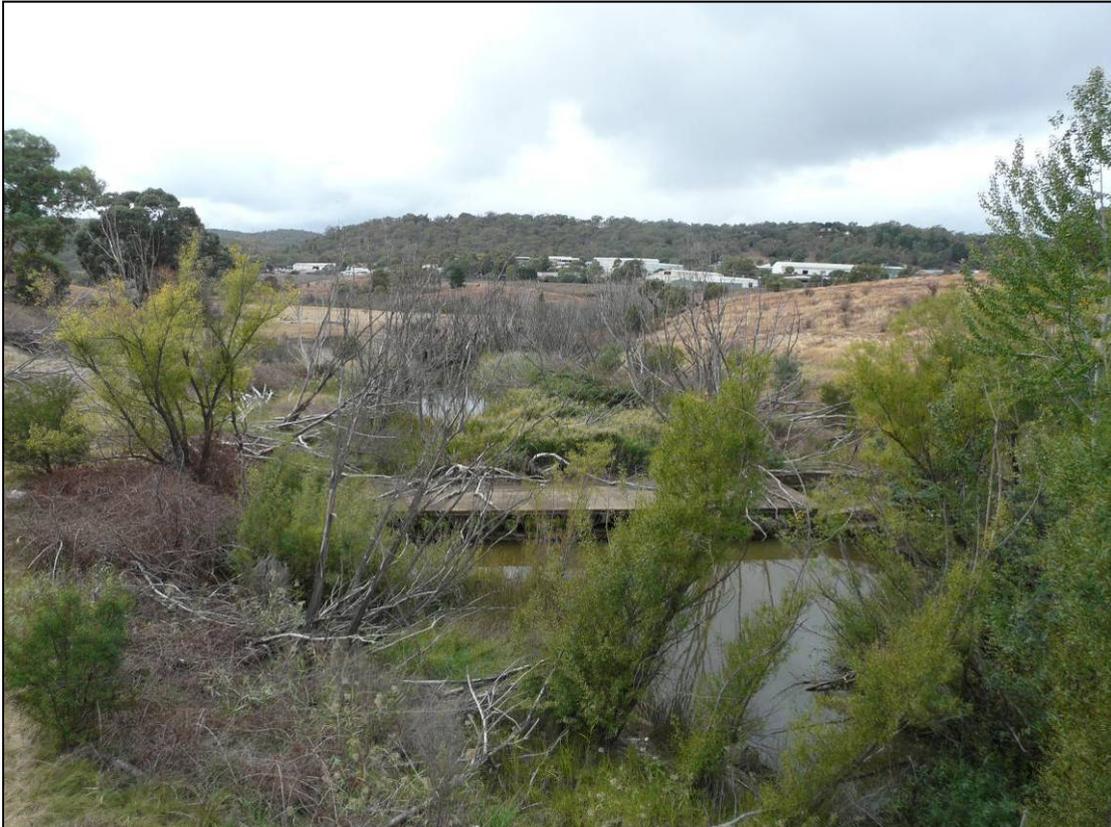
**Plate 7.6: Upstream view of Molonglo River at Oaks Estate Bridge showing blackberries and willows**

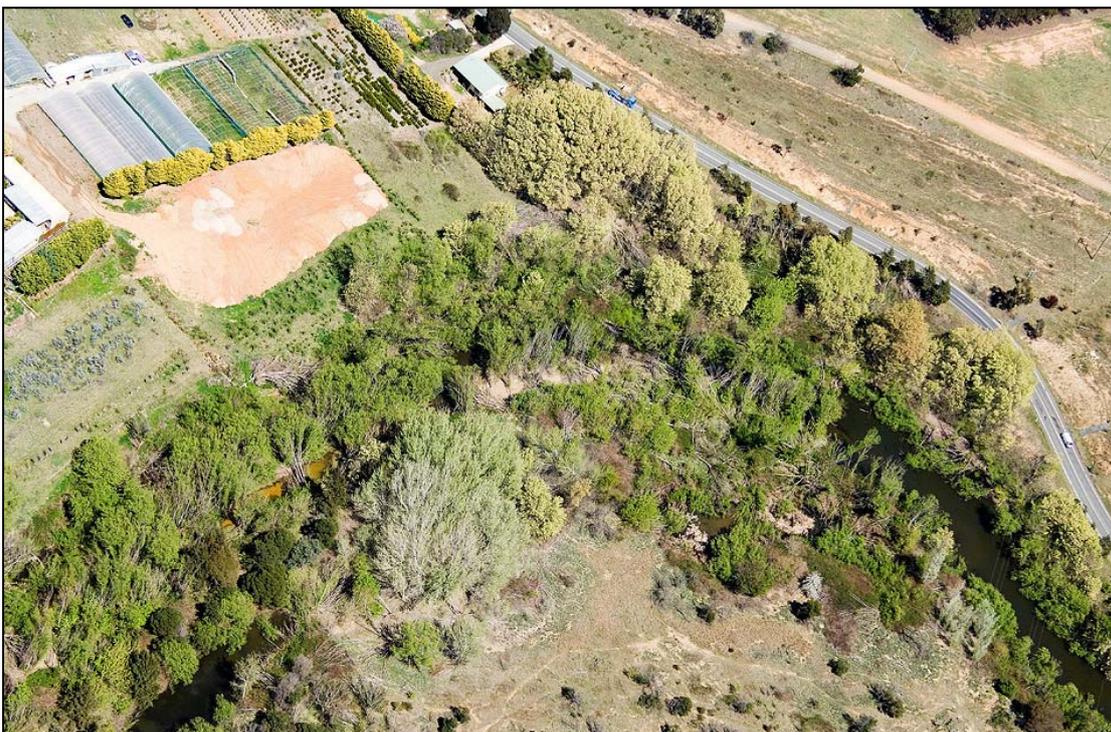
**Plate 7.7: Molonglo River: willows downstream of Oaks Estate**

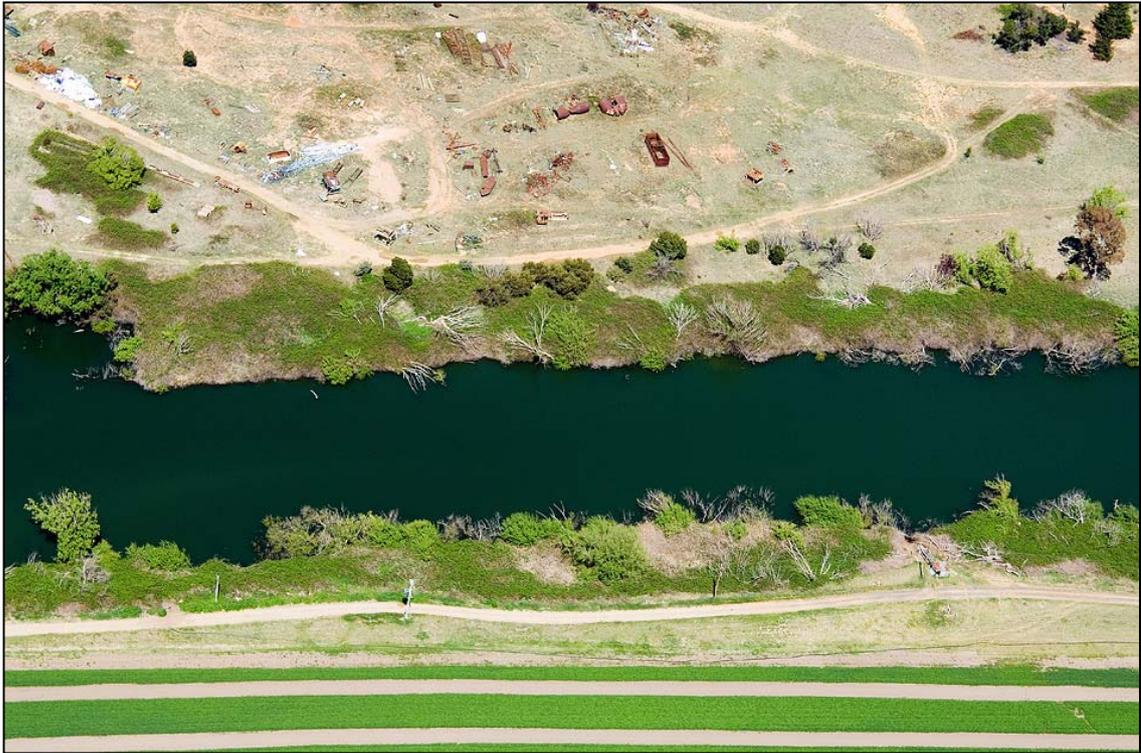
**Plate 7.8: Blackberries on Molonglo River at Pialligo (foreground) and near Fyshwick (opposite bank)**

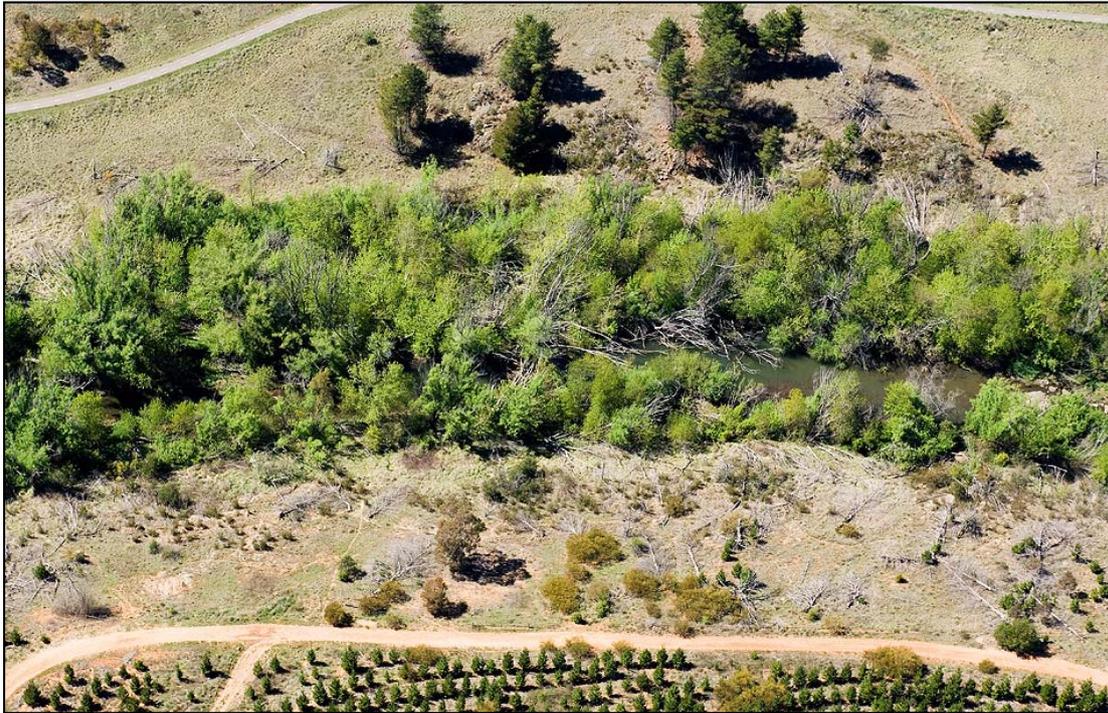
**Plate 7.9: Molonglo River downstream of Scrivener Dam showing willow infestation**

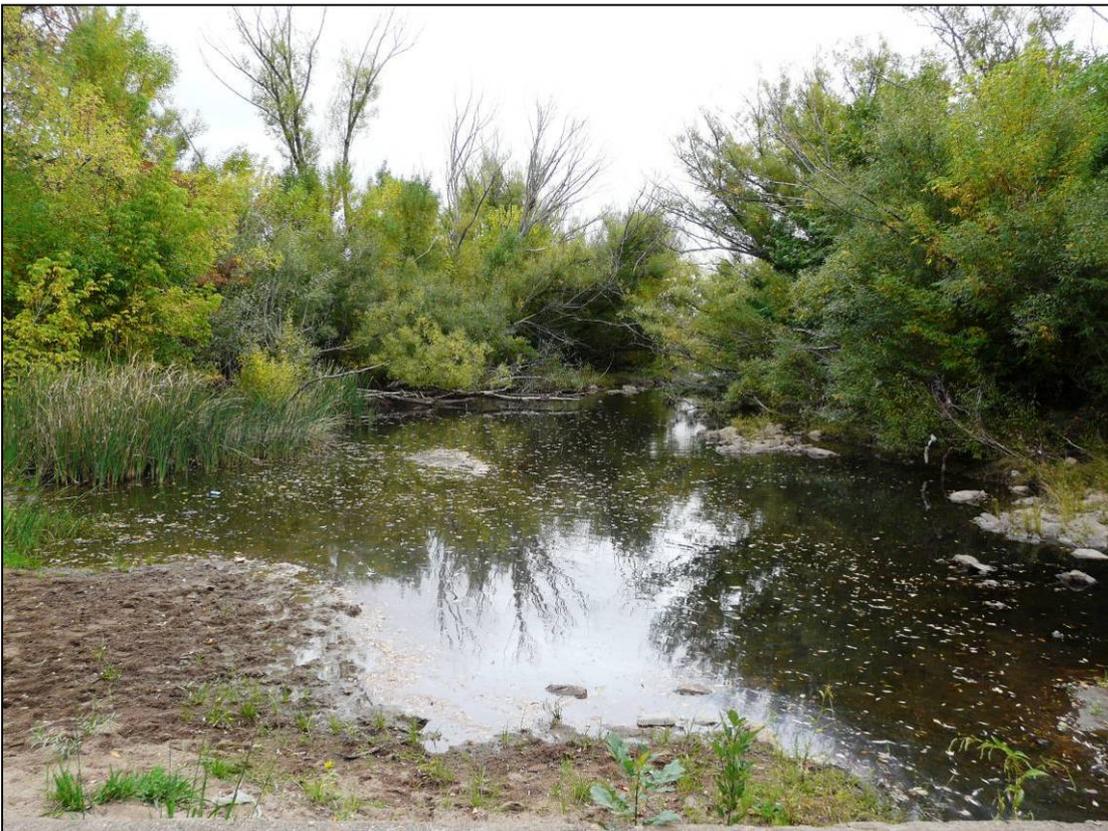
**Plate 7.10: Molonglo River below Scrivener Dam showing willows choking the river and some native aquatic fringing species**

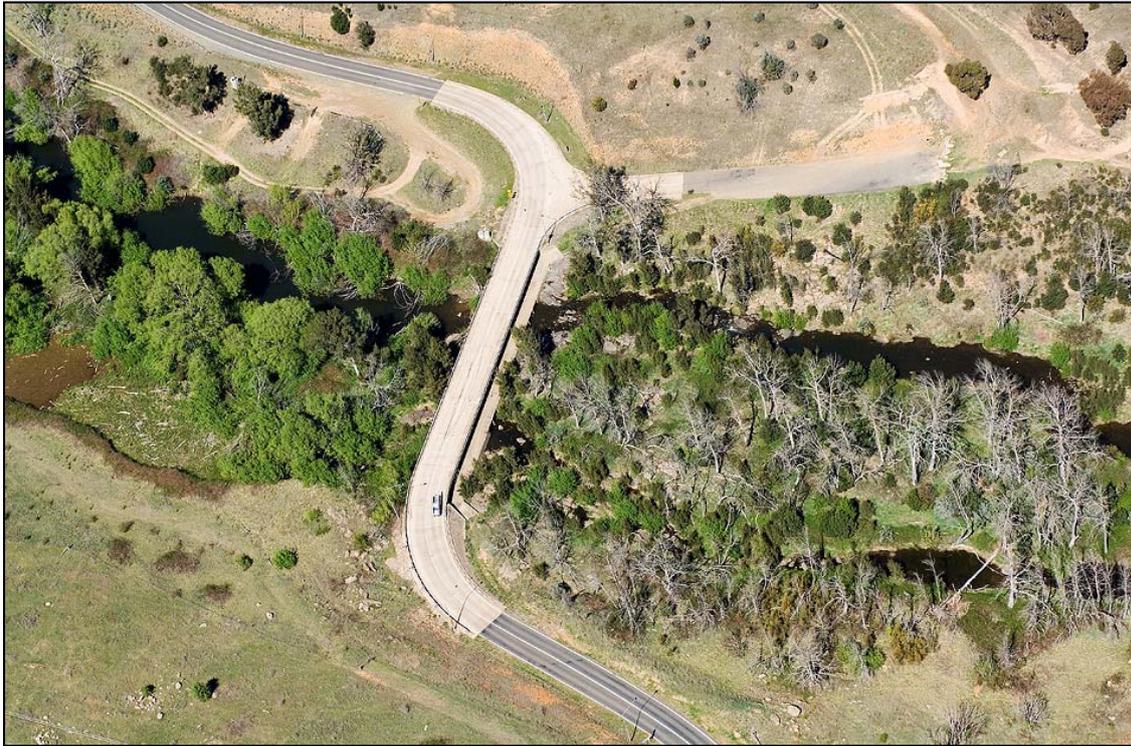
**Plate 7.12: Molonglo River at Coppins Crossing showing willow and blackberry infestation and fire affected She-oak Tableland Riparian Woodland**
