CHIEF MINISTER TREASURY AND ECONOMIC DEVELOPMENT DIRECTORATE

ISSUE: Soil Validation and Deregistration Processes

Loose Fill Asbestos Insulation Eradication Scheme

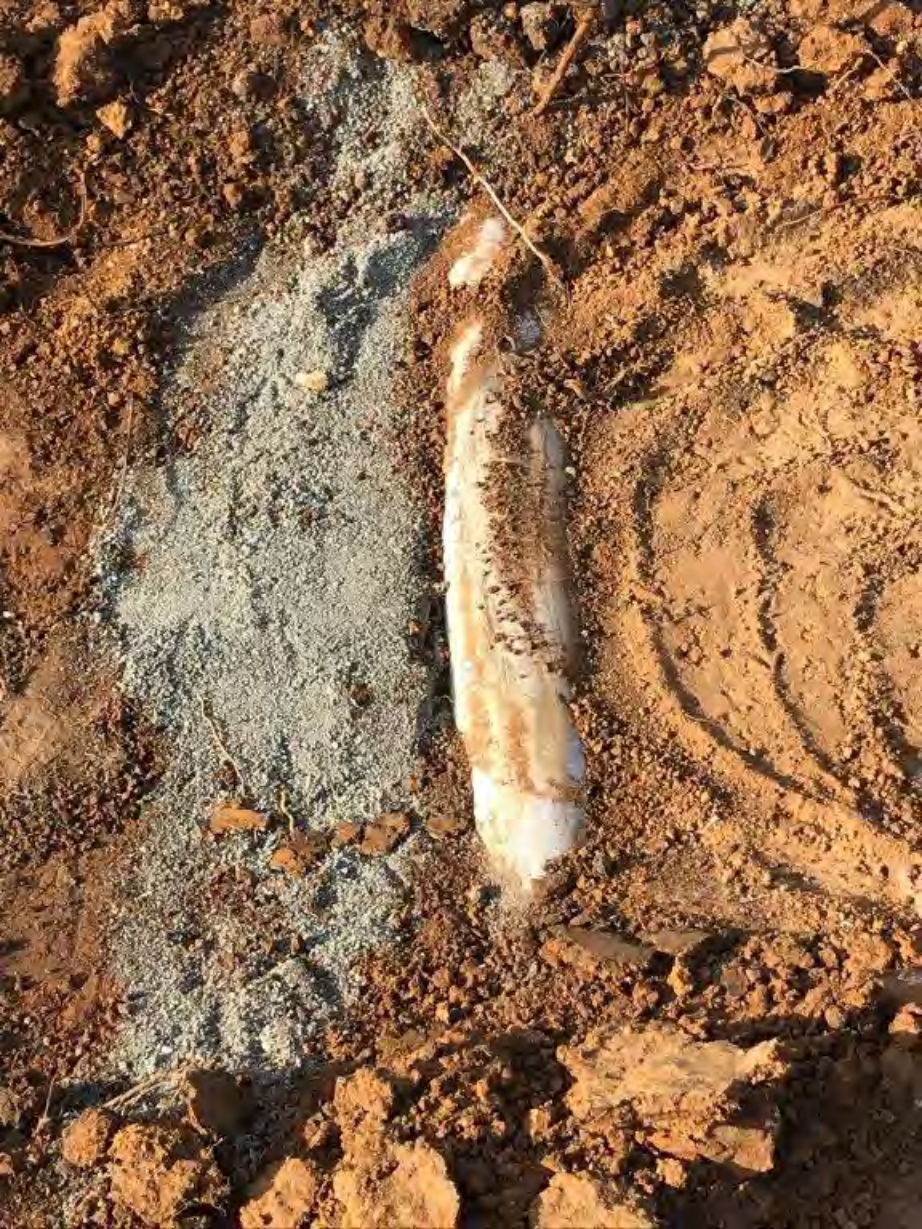
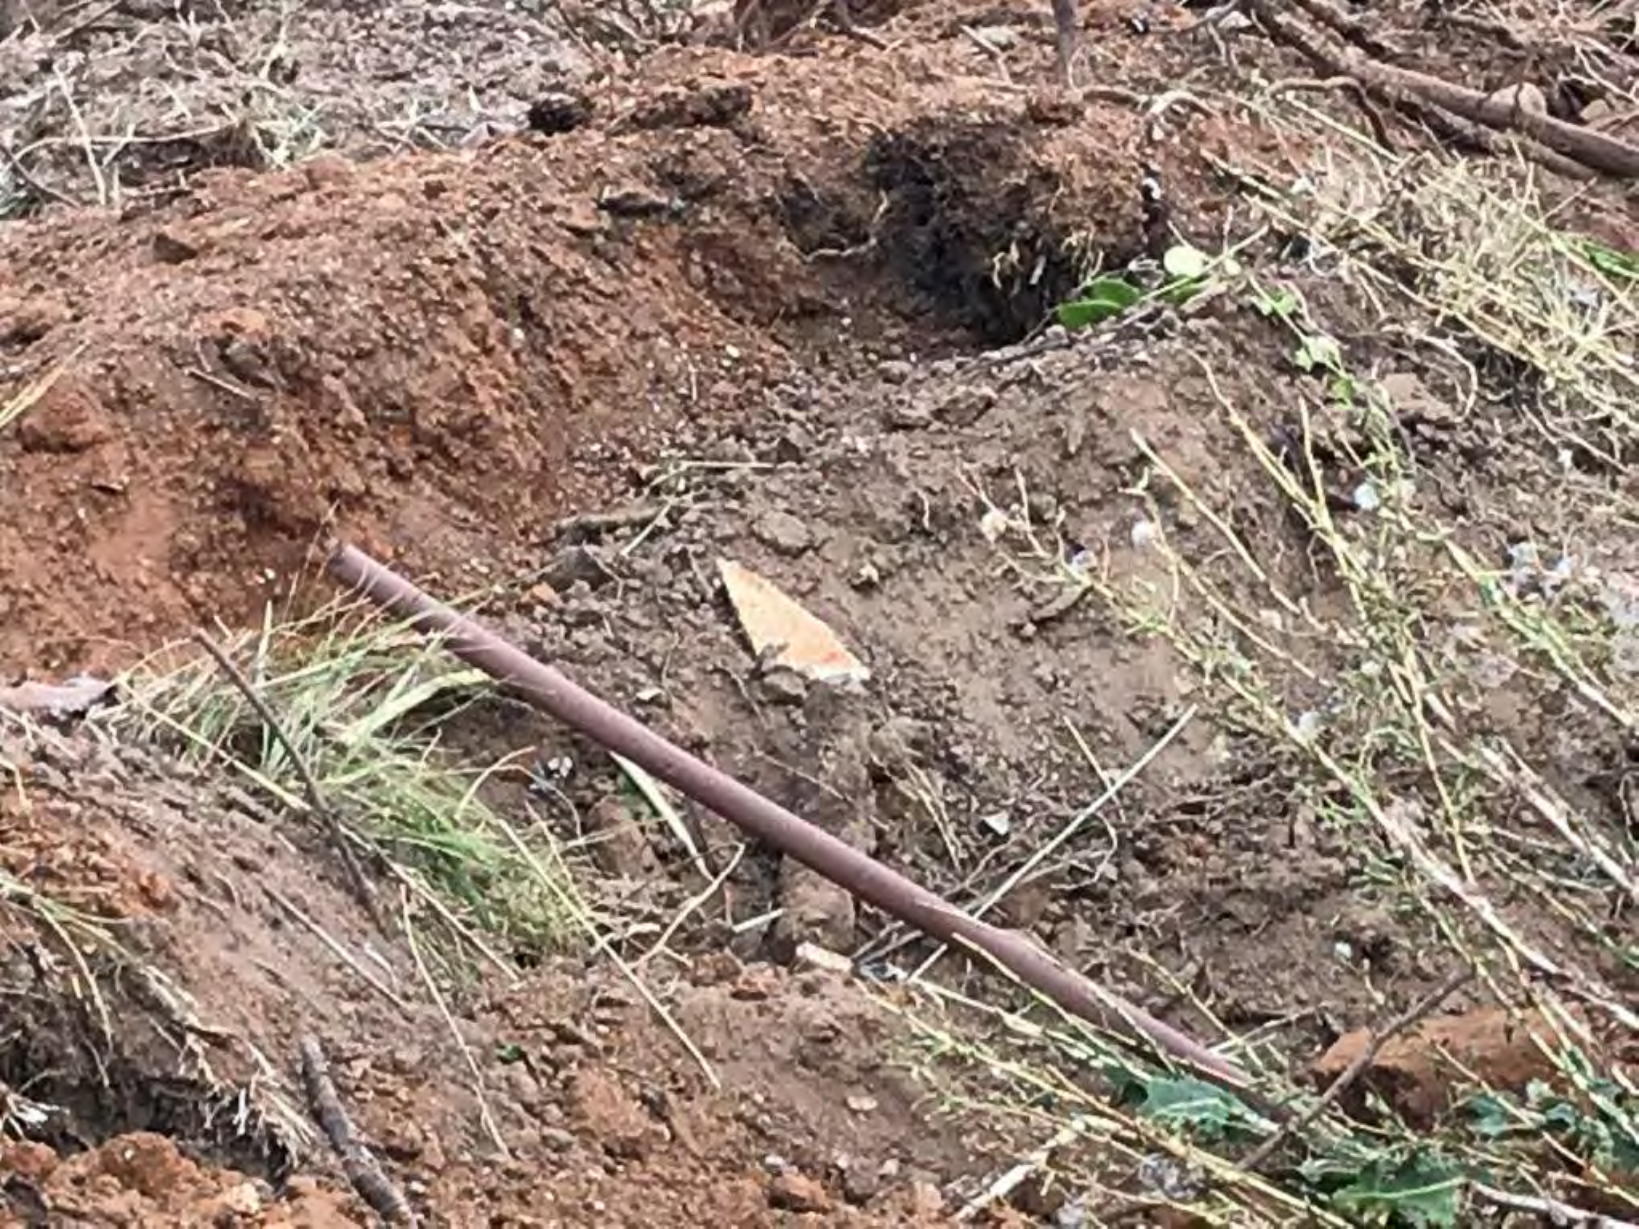
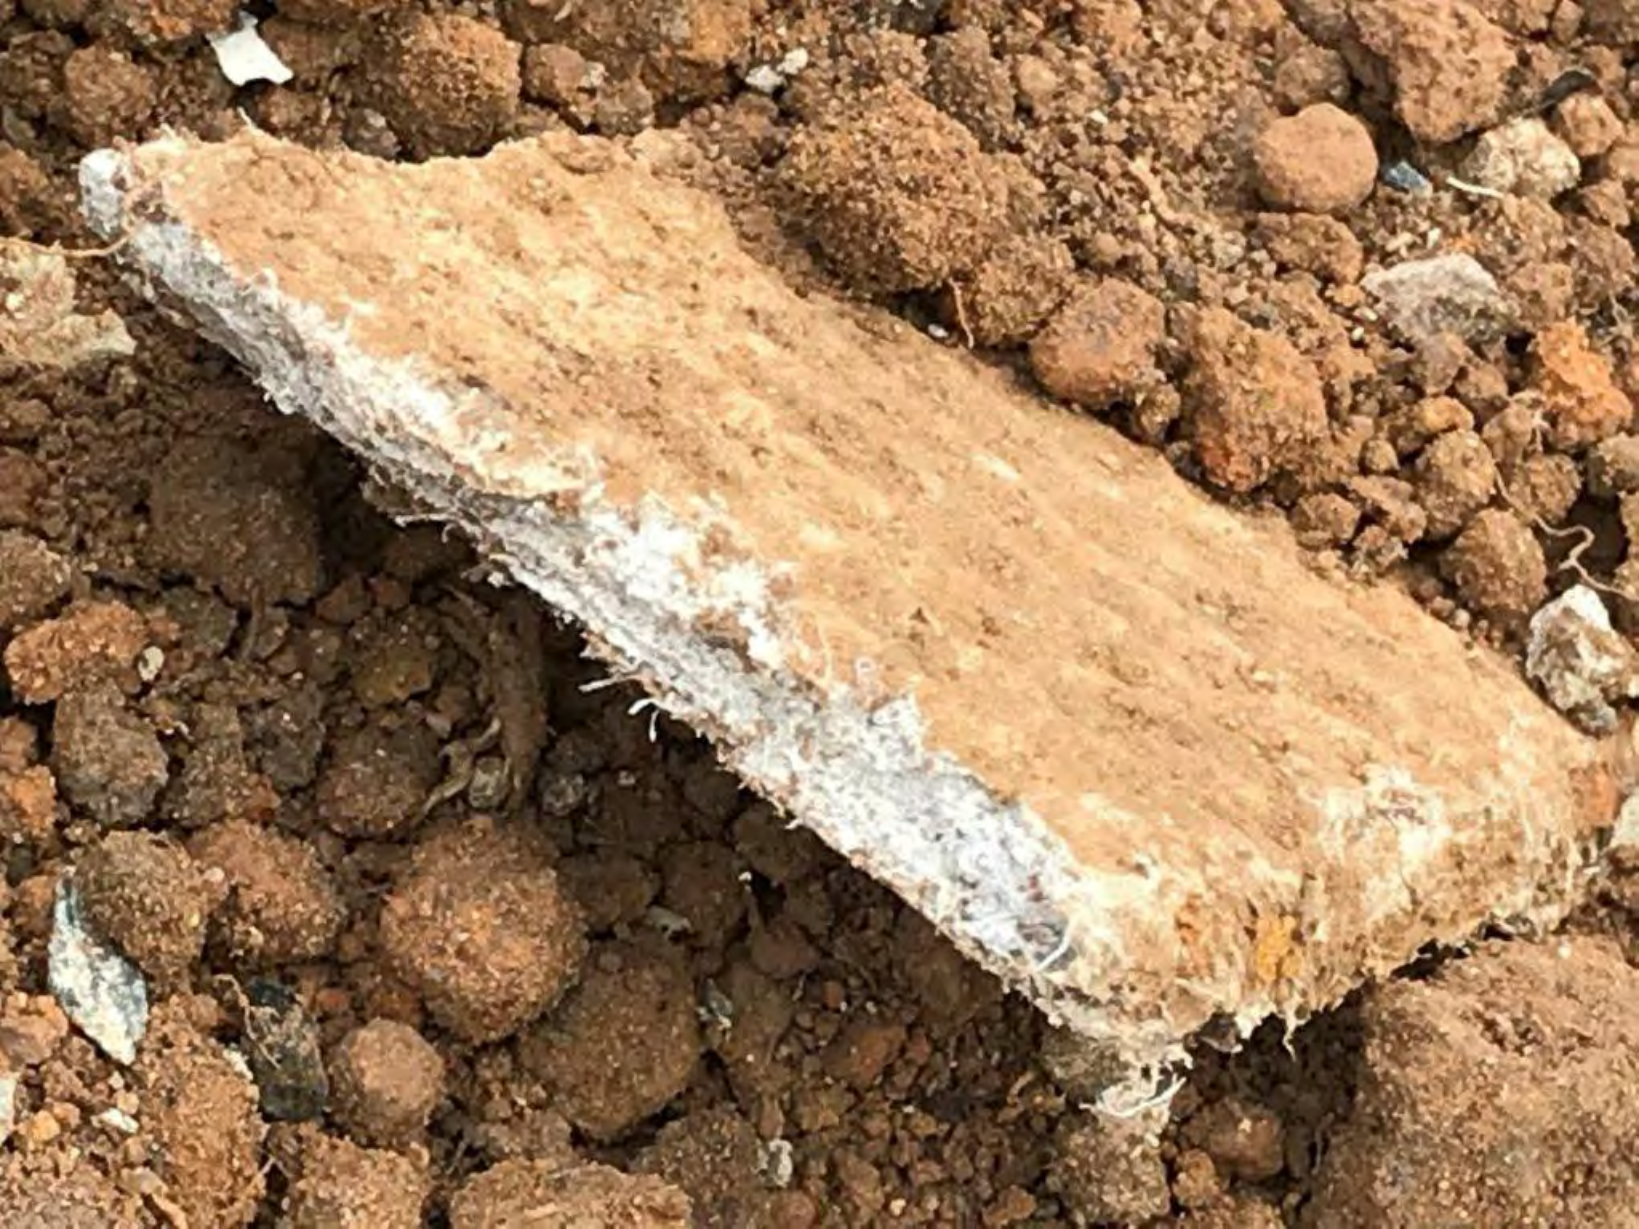
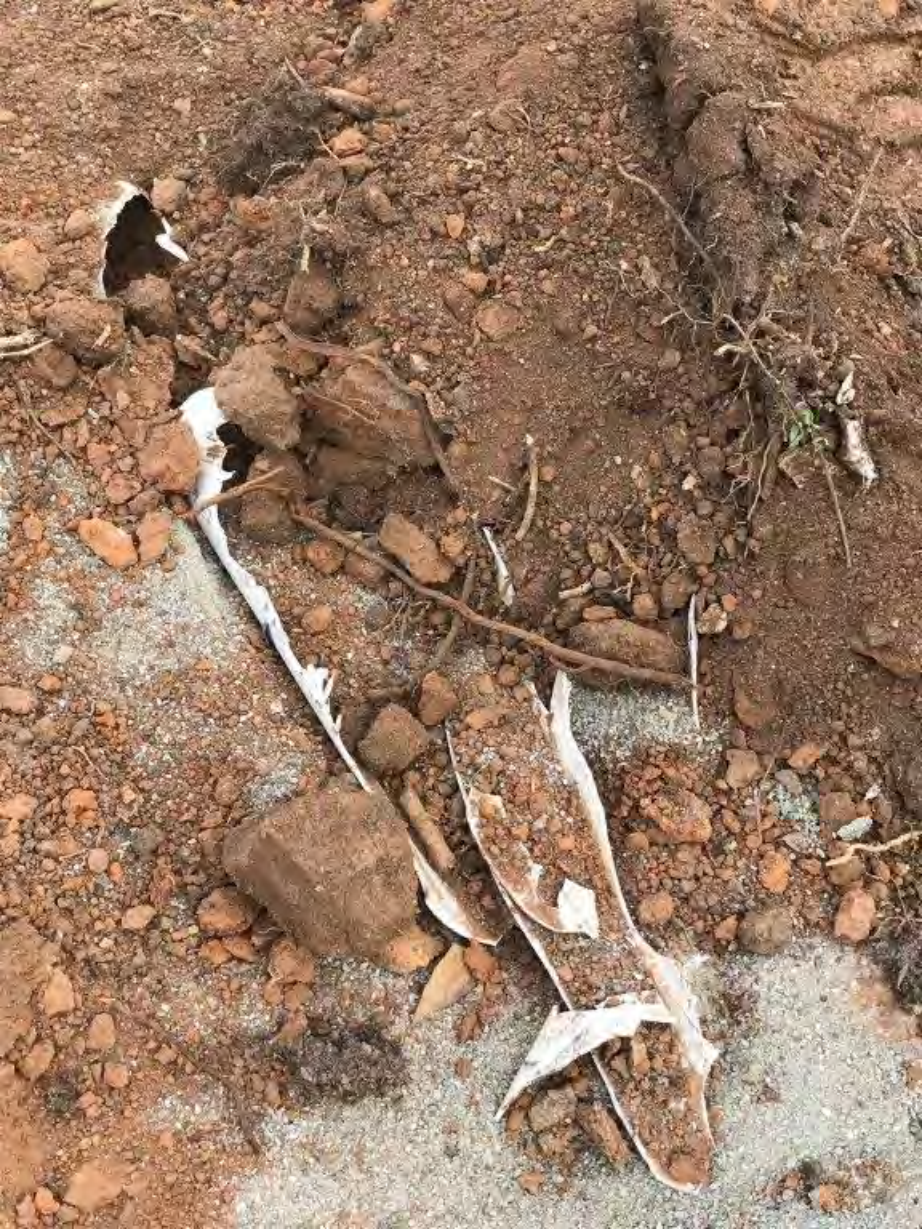
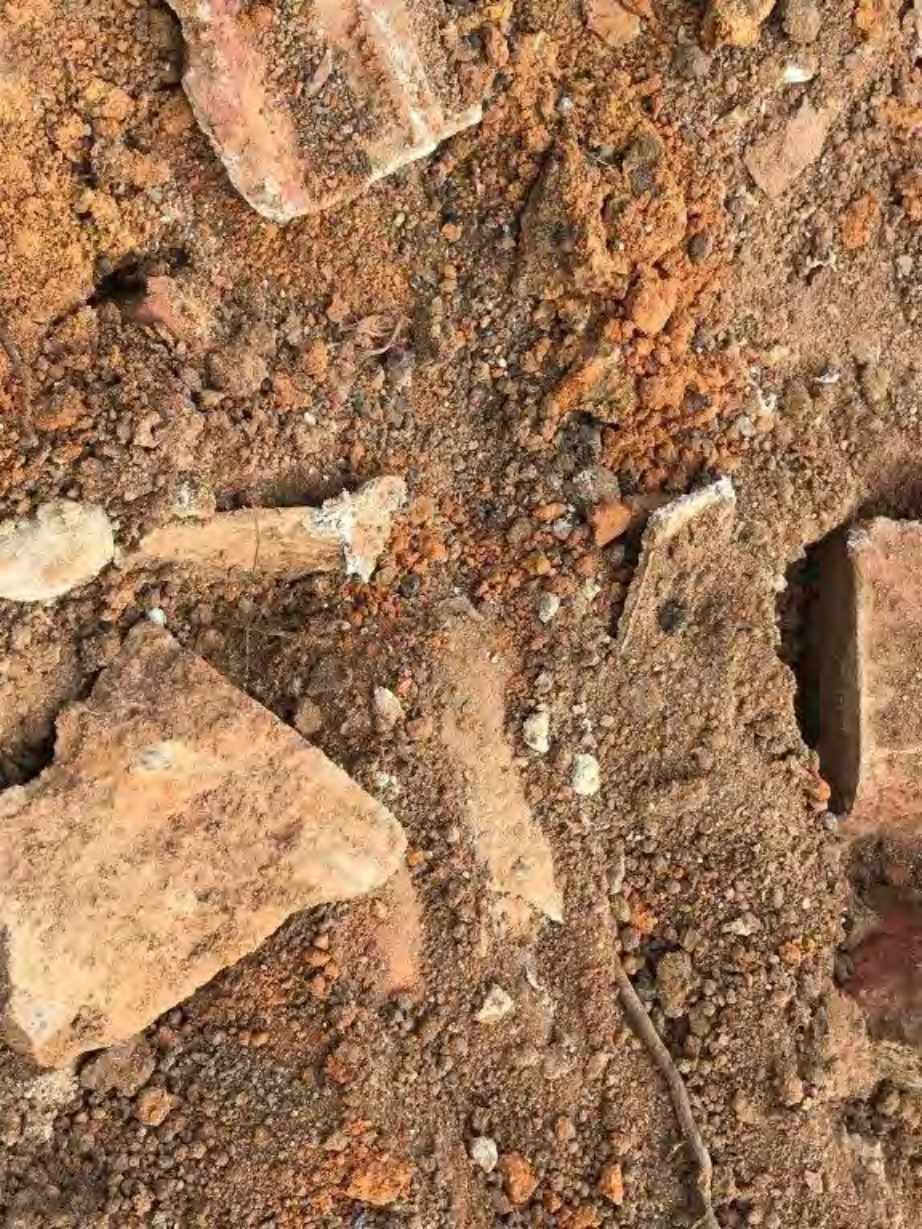
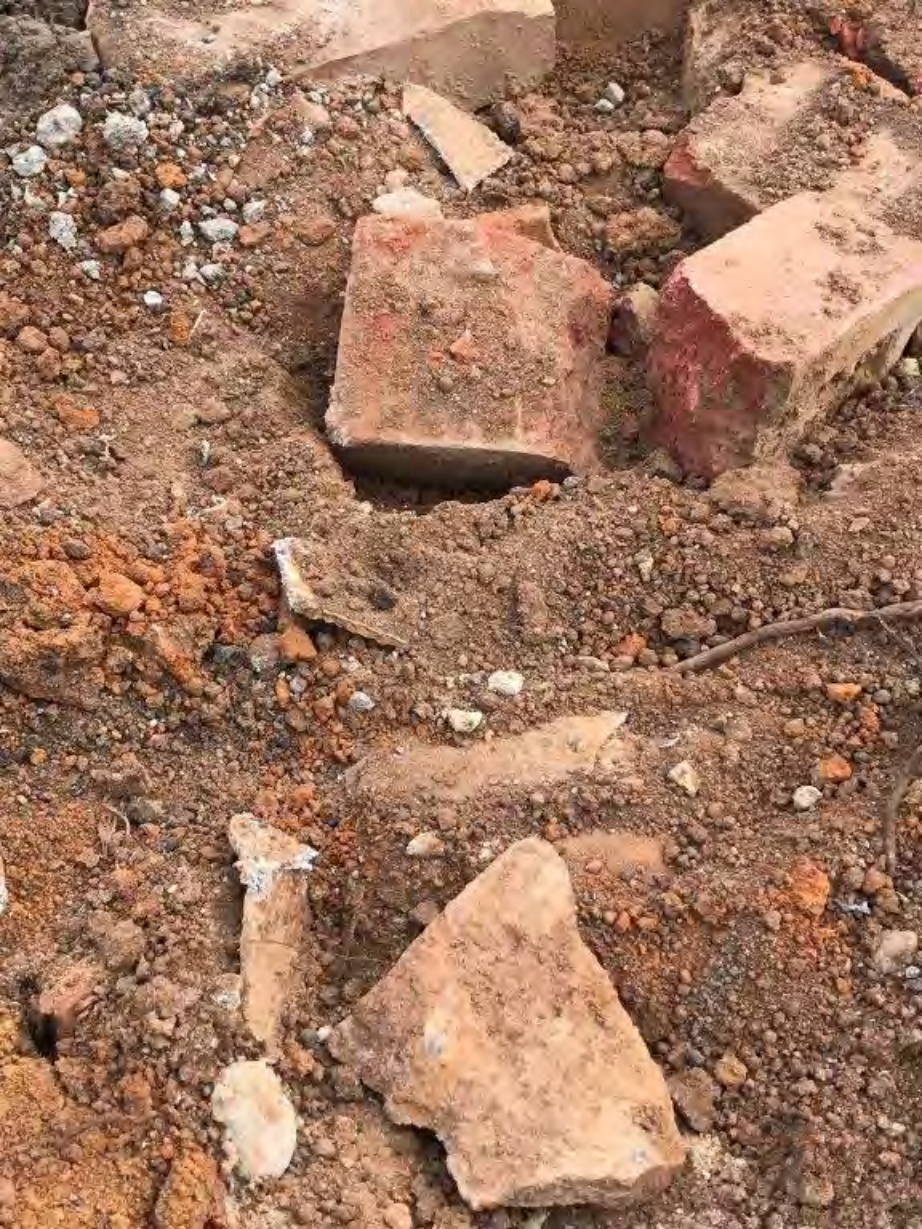
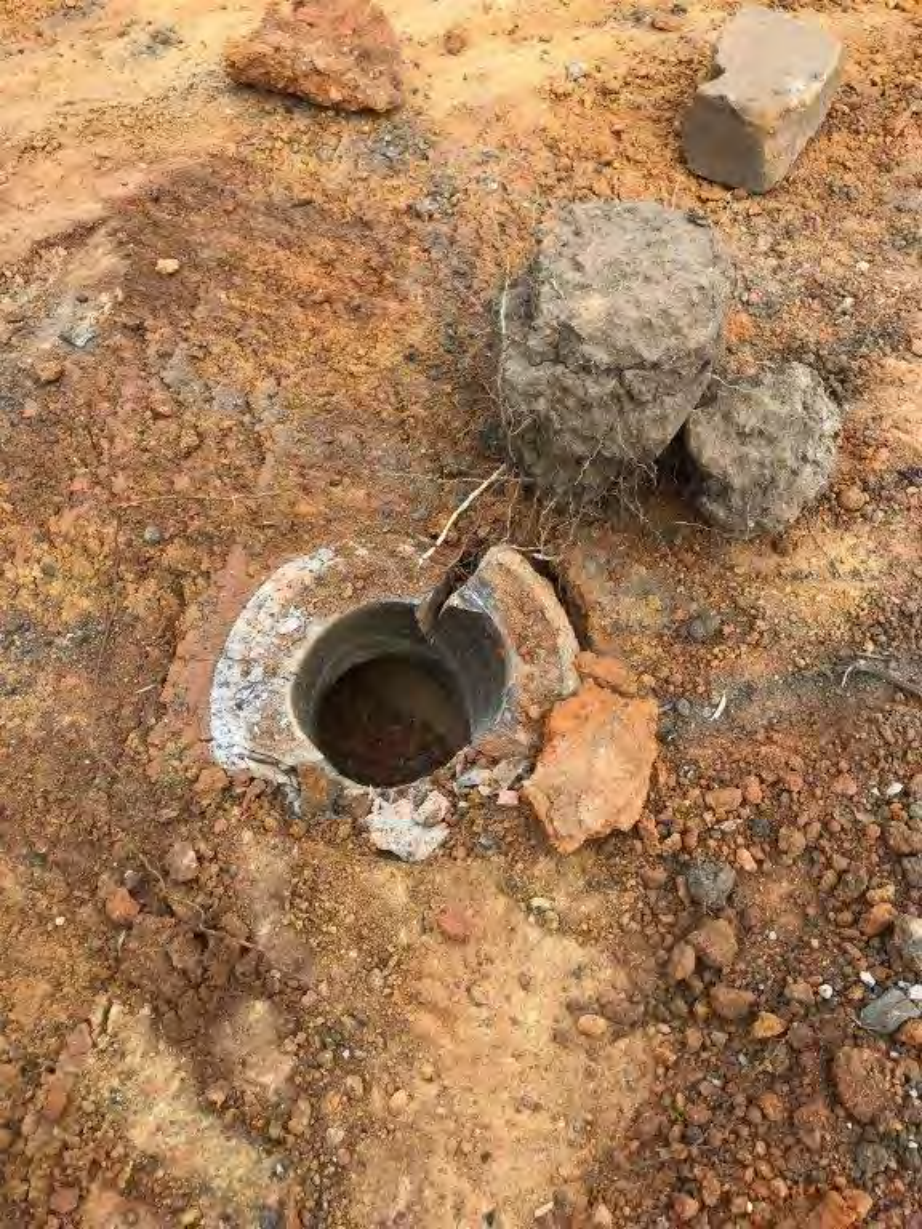
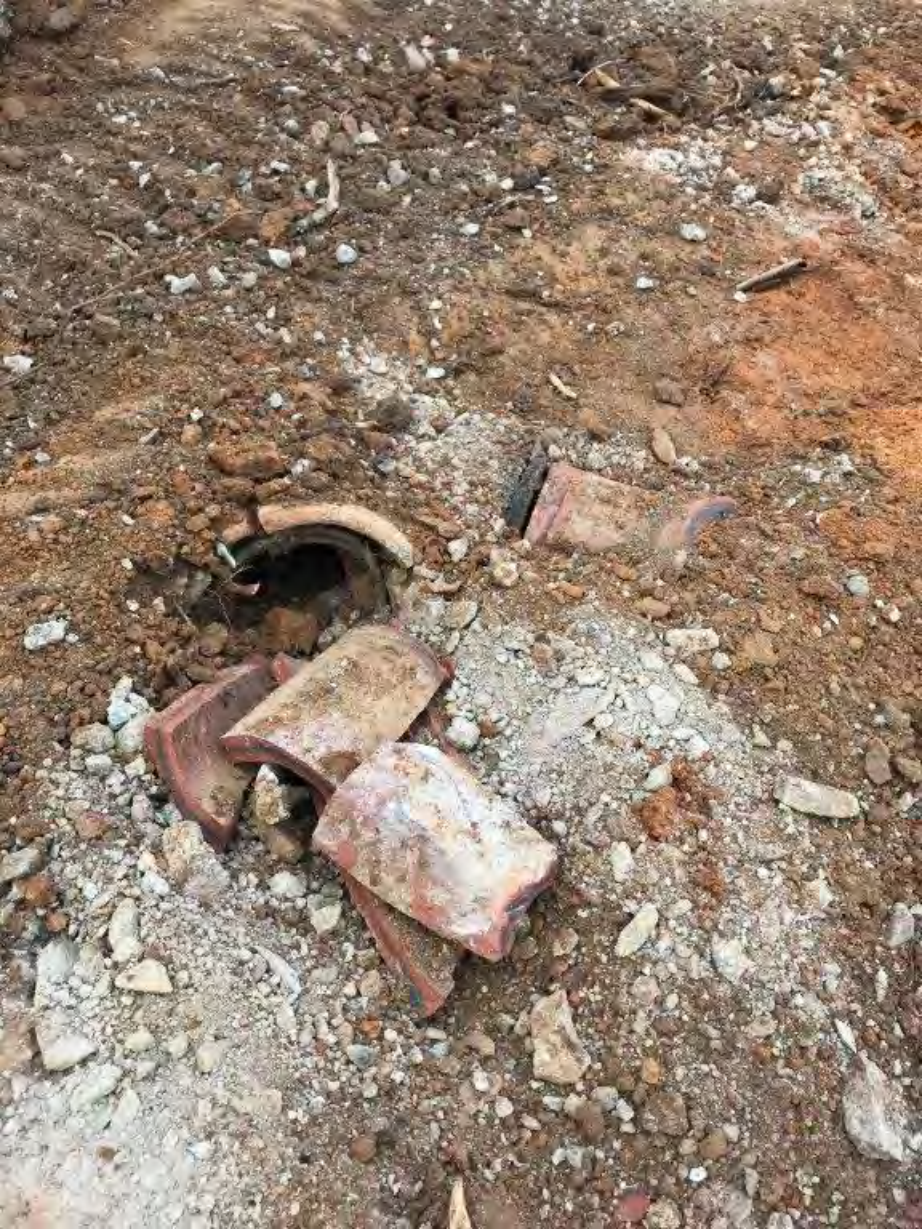
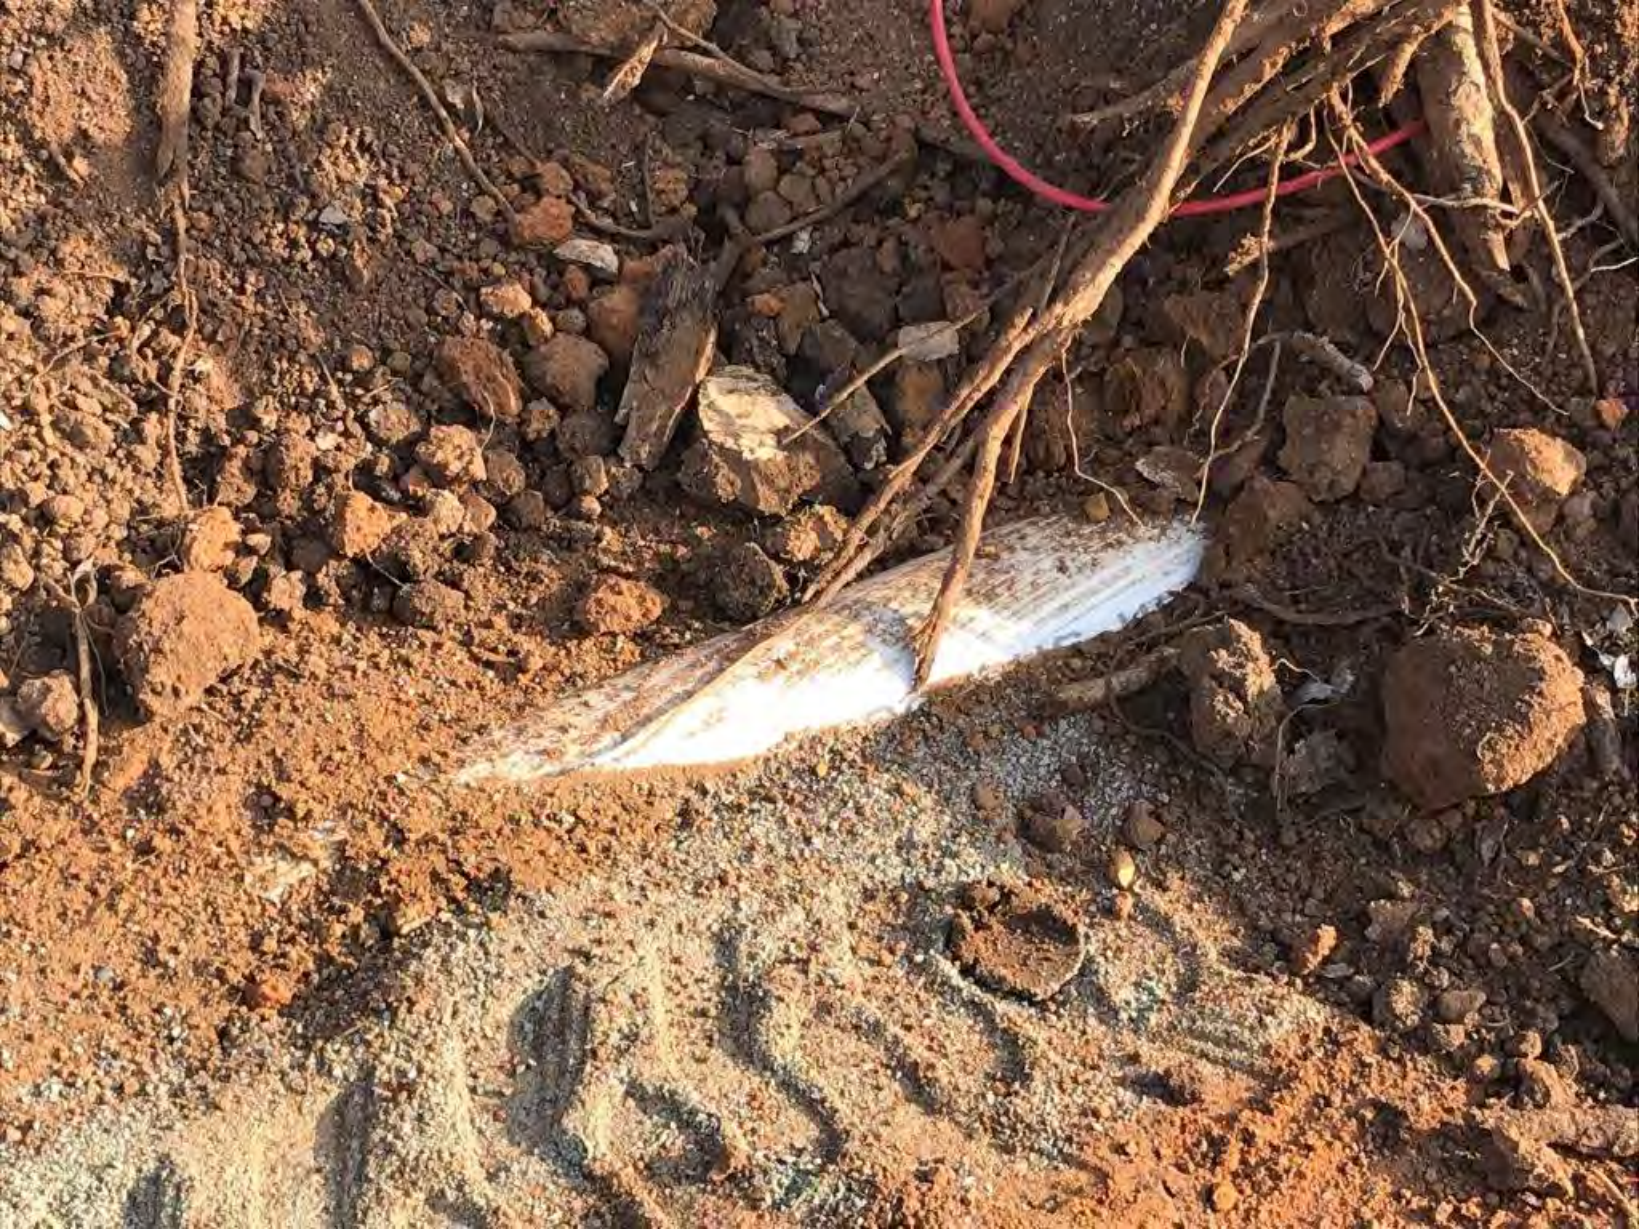
As discussed with your office, on Friday 2 February my builder commenced preparing the site for the slab. However as part of the preparation he found all existing plumbing (both clay and PVC pipes - refer to attached photos) still is situ on site.

Even more distressing is that as part of the site preparation, he found also bonded asbestos in an area on site (refer to attached photos). This bonded asbestos is now mixed in with the soil which was scraped from the site for the preparation of the slab and thus the soil is contaminated.

- Asbestos **was not** removed in line with Work Safe Australia and ACT Demolition Work Code of Practice
- Services **were not** disconnected in line with ACTEWAGL's regulations regarding disconnection of services with both clay and PVC pipes still on site
- Building rubble from the existing dwelling **was found on site** including roof tiles, bricks and bonded asbestos as per the photo.
- The removal of asbestos **was not** undertaken as described in the Asbestos Response Taskforce's Demolition Overview where - "The contractors will also remove any **non-friable or bonded asbestos** prior structural demolition... The house is demolished only when a clearance certificate for **both friable and non-friable** asbestos removal has been issued by an independent licensed asbestos assessor."

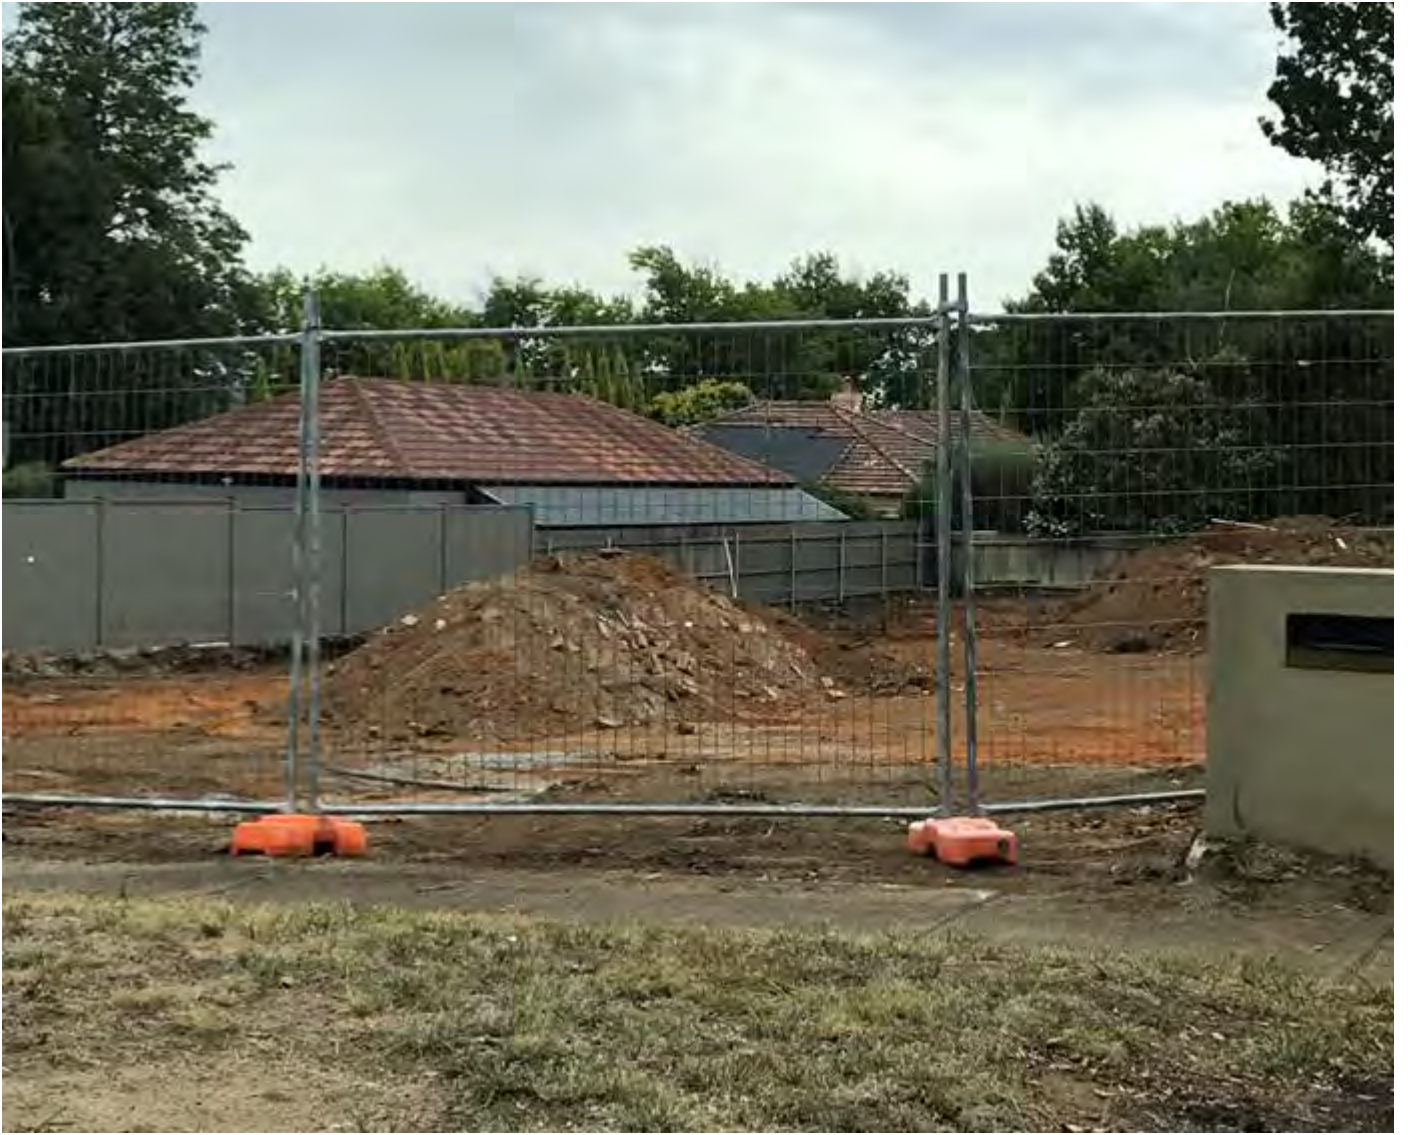
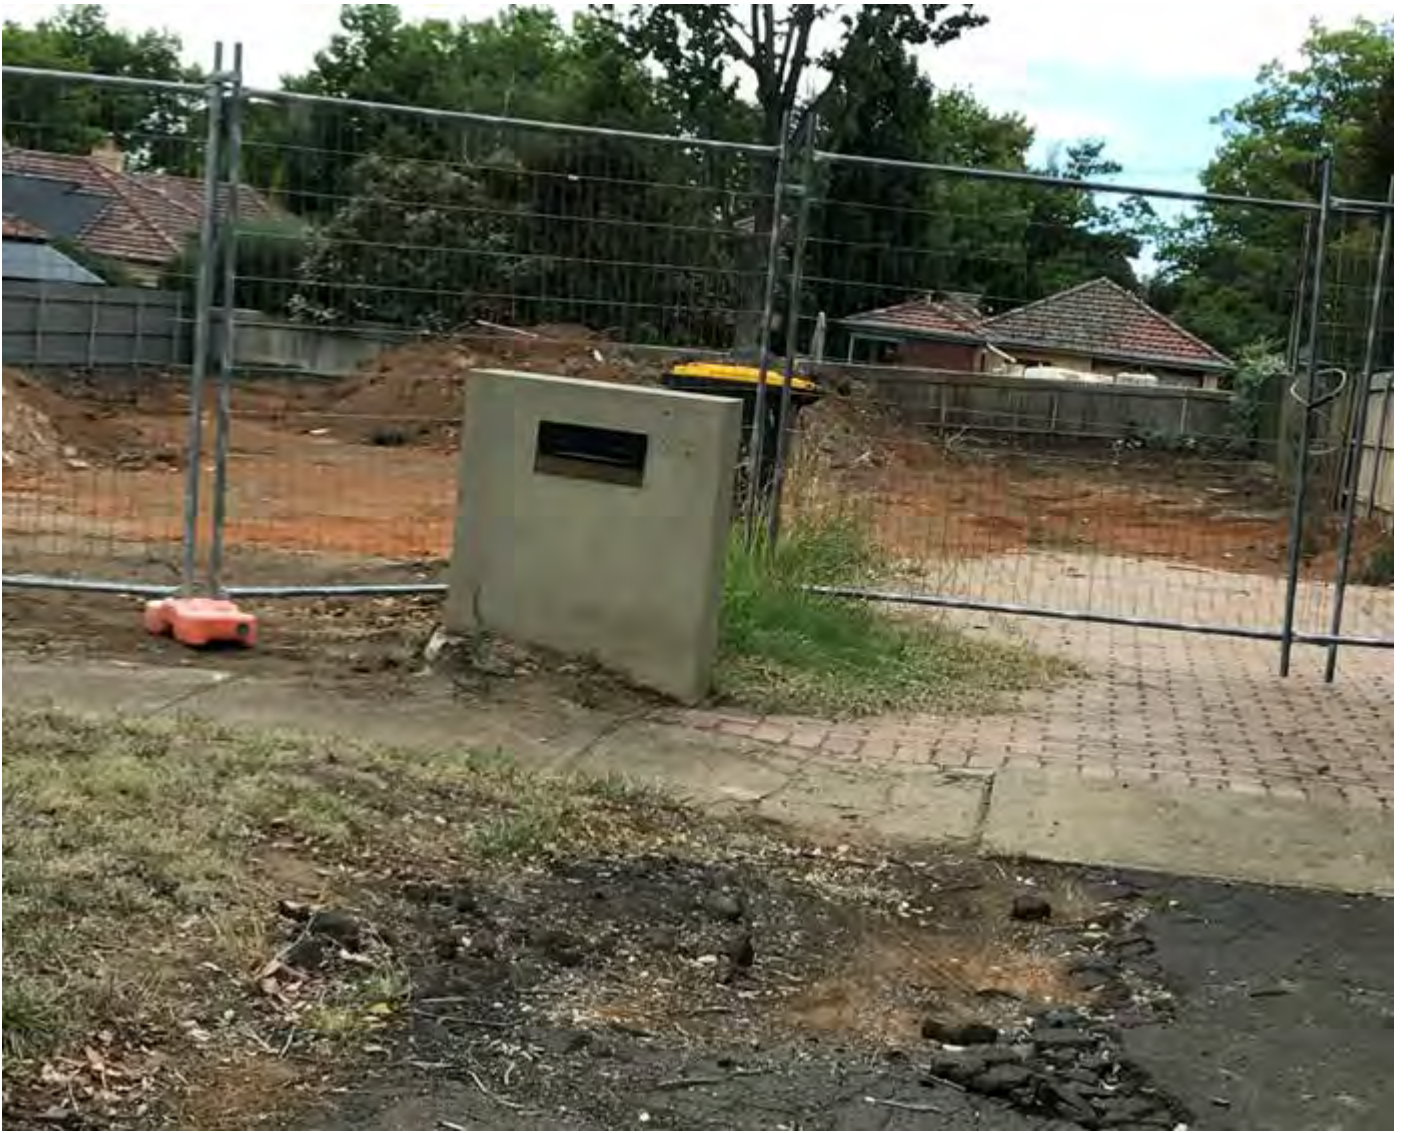
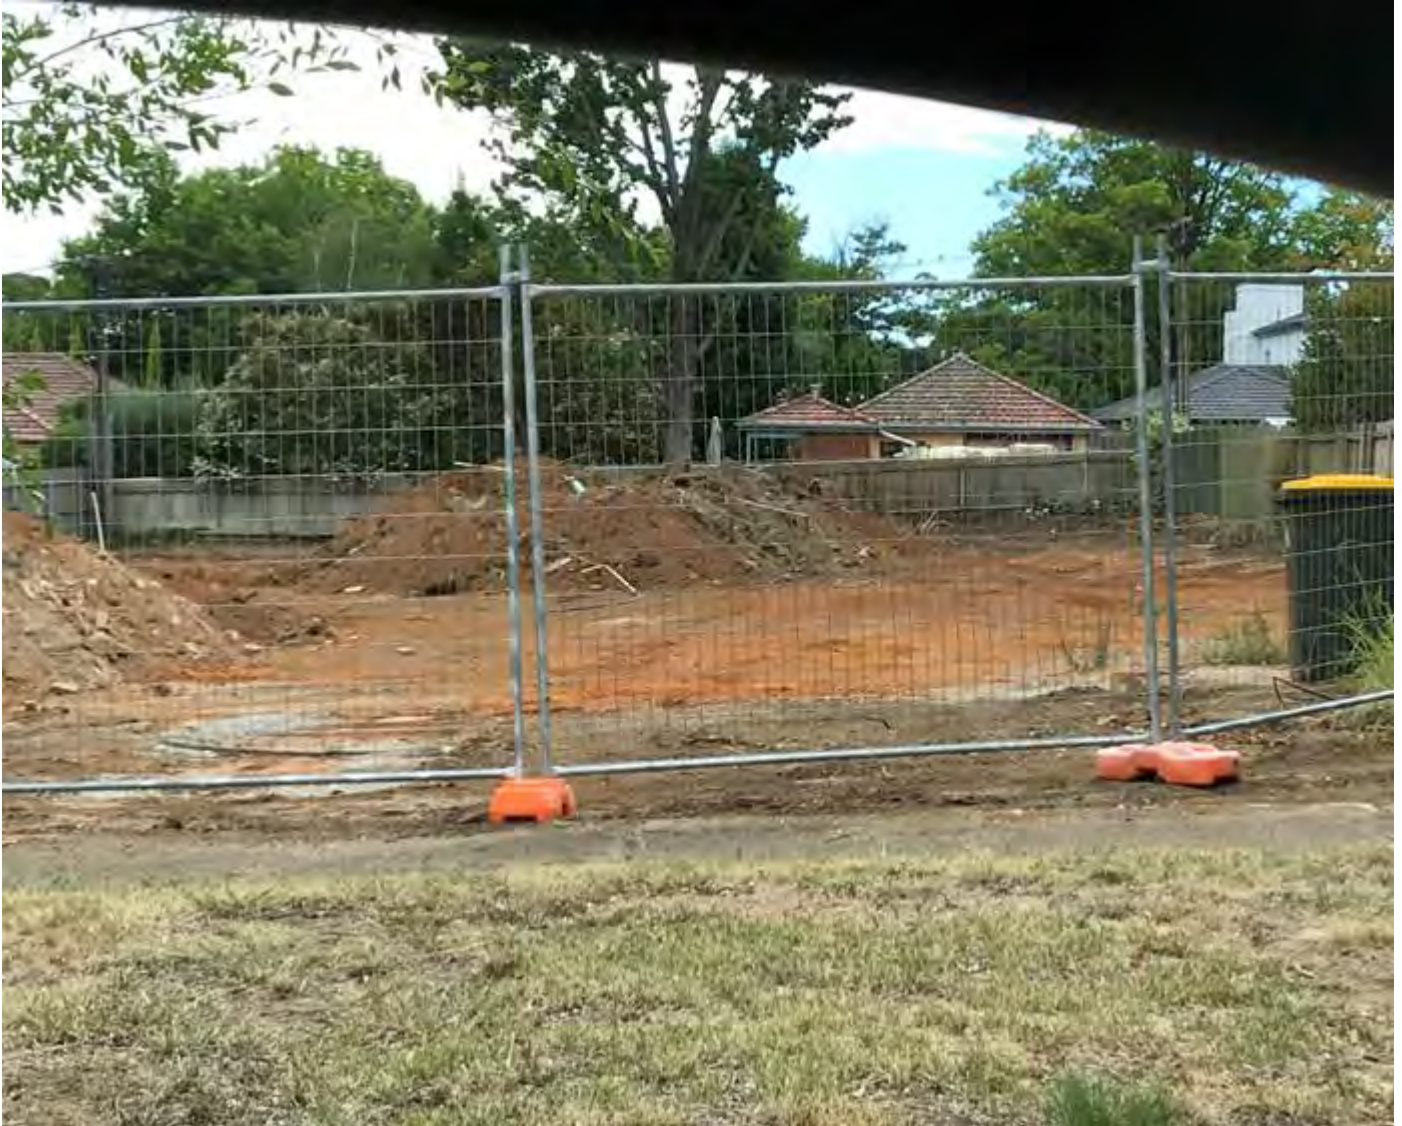
Here are photos I covertly took today.
