ACT Heritage Council

BACKGROUND INFORMATION

GUNGAHLEEN SCHOOL (Block 10 Section 95 Lyneham)

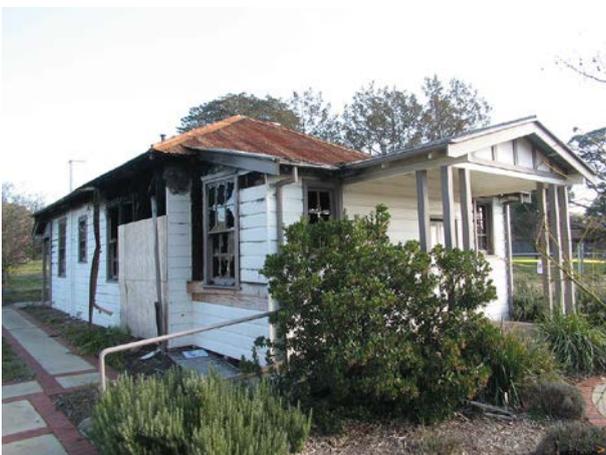
Image 6. Gungahleen School c.2008 after fire (CampPix via Bonzle, <http://bonzle.com/c/a?a=col&fn=h22apjff&c=49&col=show&or=2&sz=4&pg=0&yr=0&mo=19836786>)

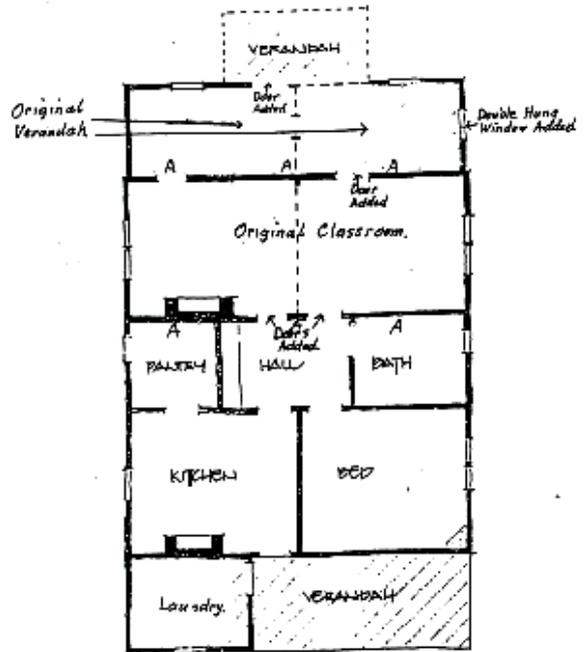
Image 7. Sketch Plan of Gungahleen School c.1991 (National Trust ACT)

*Original ship-lap external cladding removed and replaced with tongue-and-grooved pine lining.
Added Structures to the original school building*

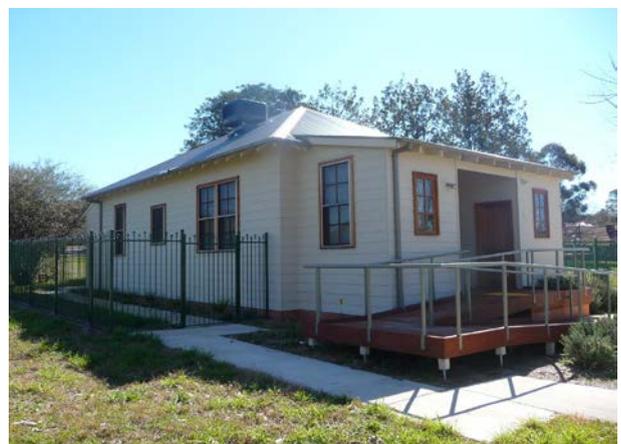
Image 8. Gungahleen School southeast corner (ACT Heritage Unit, 2013)

As a relatively recent structure the Gungahleen School is in excellent physical condition. However, the integrity of its heritage values is very low. The only remaining physical materials from the original building are the bricks that have been used to recreate the fireplaces, but the fireplaces themselves are not original, nor are they of a comparable nature in extent.

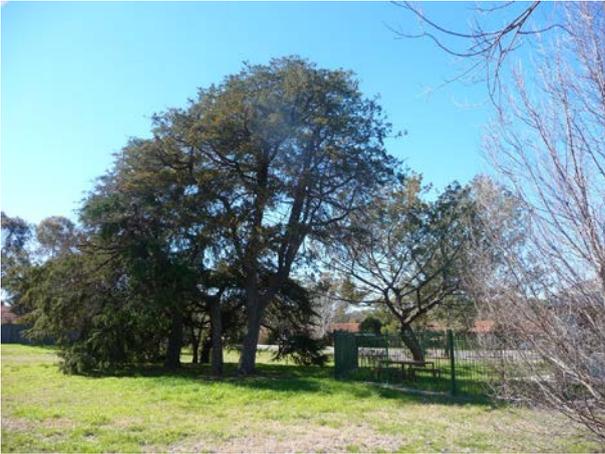
Image 9. Gungahleen School central Cyprus tree cluster (ACT Heritage Unit, 2013)

Although the site visit occurred during winter, making it difficult to judge the condition of deciduous species, the surviving trees appear to be in fair condition (Image 9) with the exception of the remaining three apple trees (Image 10) from the orchard which require some horticultural care.
