Kaleen Group Centre

Stage 1 Site Investigation Report

14 August 2024

JPS Engineering Consultants

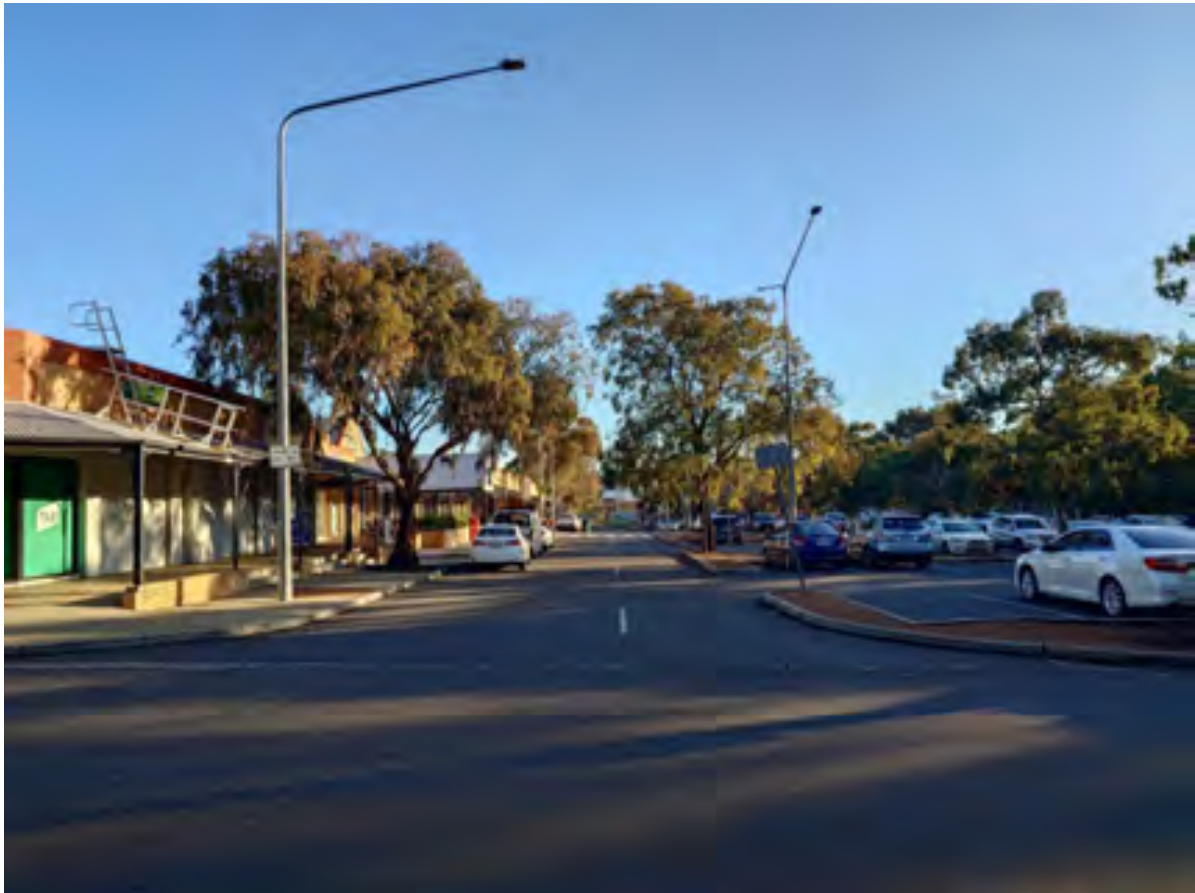
During a site inspection, it was observed that the topography of the site is relatively consistent falling from its south east corner to the north west corner of the site. The site has an average approximate grade of 4%, with some flatter areas in car parks. The highly developed nature of the site, along with the varying grades in different sections compared to surrounding areas, suggests that significant earthworks may have been carried out on the site.

Figure 7 – General Site Photo taken from Georgina Crescent (east) Looking West

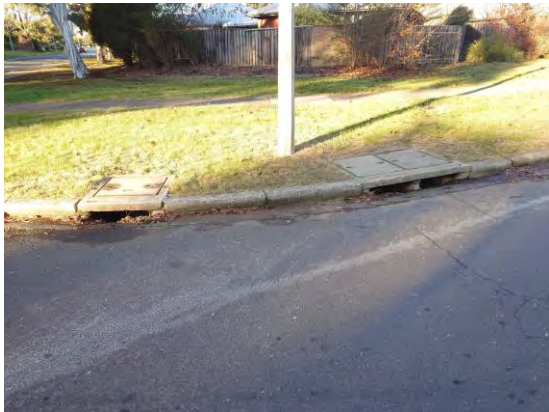
Several stormwater kerb side sumps were observed during a site inspection along the roads within and surrounding the subject site of varying condition from poor to good. Photos of some sumps are provided in Figure 26, Figure 28, and Figure 27 below.

Figure 28 – Stormwater Kerb Side Sumps at Intersection of Georgina Crescent (east) and Maribyrnong Avenue

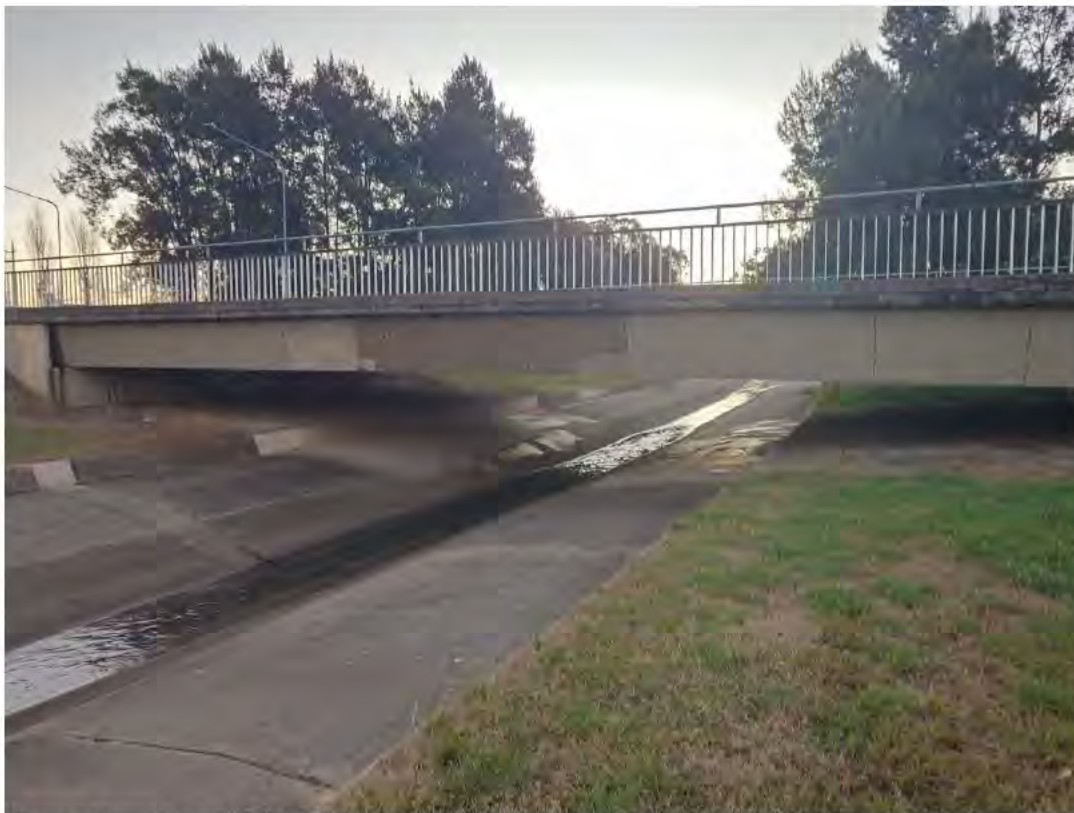
Figure 31 – Concrete Lined Channel in Baldwin Drive and Bridge over Maribyrnong Avenue Looking North

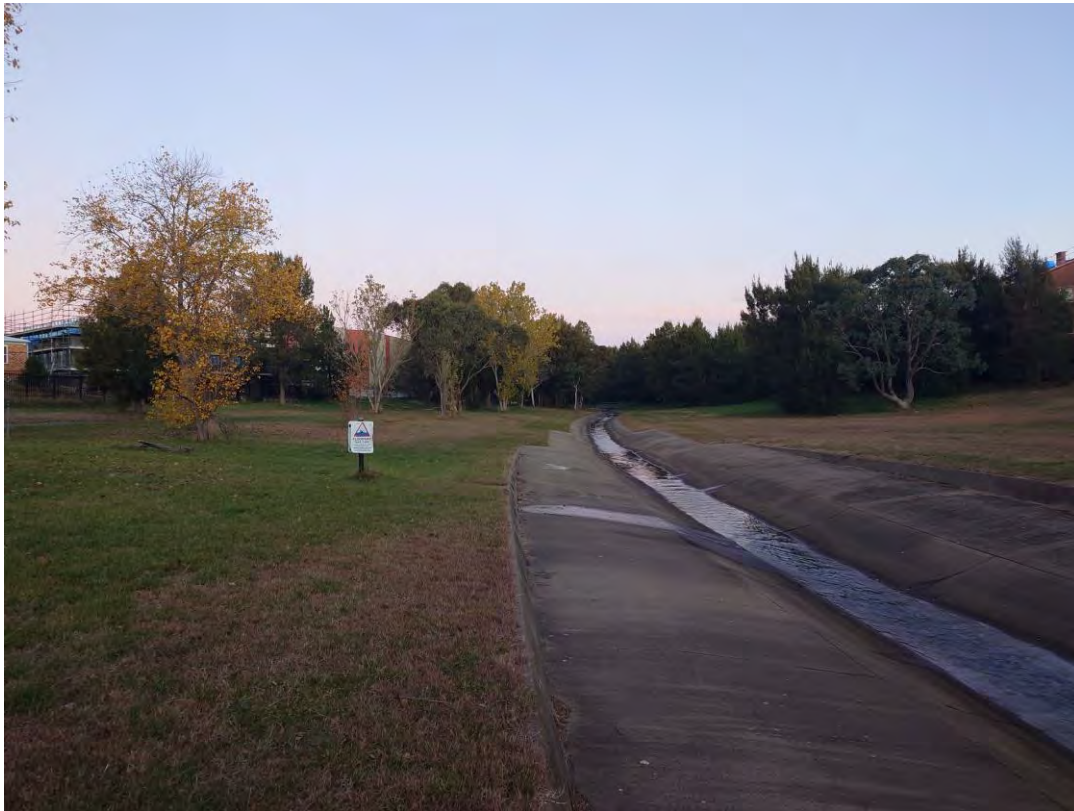
Figure 32 – Concrete Lined Channel in Baldwin Drive Looking South
