SECTION 2: WATER QUALITY CONDITION

Water Quality Monitoring Program

Condition of ACT Waters 2004-2005

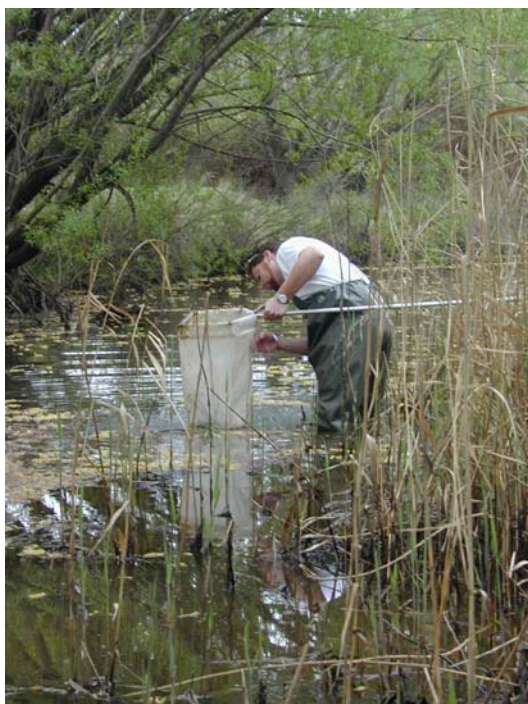
Seeing who's home....
Collecting waterbugs to assess water quality and habitat conditions

Whilst water chemistry analysis such as pH, total phosphorus and dissolved oxygen provide a snapshot of the water quality at the time when the sample is taken. Biological assessment, in this case the sampling of waterbugs (benthic macroinvertebrates), can indicate much about the water quality over time and show what type of environment the water and waterway is to live in.

Macroinvertebrate biological assessment is where the tally of the type of waterbugs sampled at a site are processed by a predictive model. The bugs that the model predicts should be at the site are compared with the bugs actually sampled from the site and a rating (band) is generated from the comparison. A brief summary of the bands and what they mean is presented below. A full explanation of the AUSRIVAS biological assessment method for the ACT is available from <http://ausrivas.canberra.edu.au> and the full biological assessment reports are available on request from Water Resources.

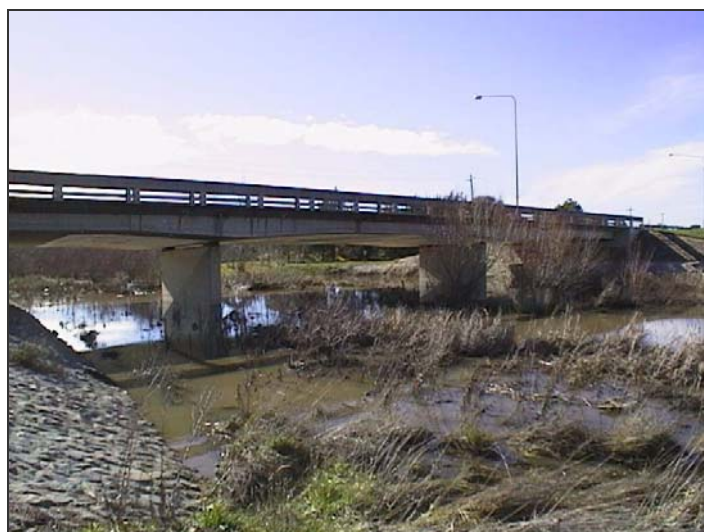
Ginninderra Creek is constrained as it flows through urban areas. Substantial modification of instream habitat results in poor AUSRIVAS scores even when water quality is good

In both spring 2004 and autumn 2005 the sites were showing below reference or impoverished levels in the macroinvertebrate sampling. This is a reflection of the low flows and degraded habitat conditions in the area. It is hoped that recent willow removal and other habitat restoration work along Ginninderra Creek will help improve the biological health of the creek. Improvements in condition will probably be seen after some time of higher creek flows.

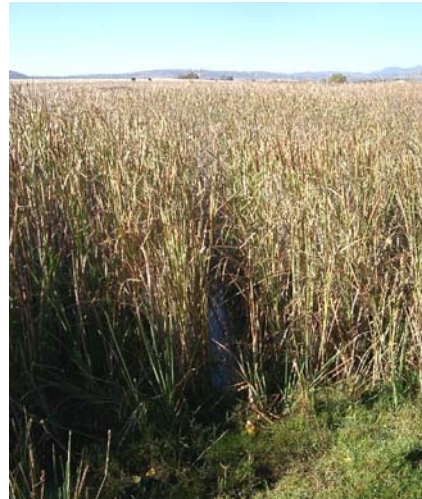
Extensive reed growth choking instream habitat along Jerrabomberra Creek

Site 246 (Figure 8) on Jerrabomberra Creek is only sampled using the AUSRIVAS macroinvertebrate rapid bioassessment protocol in spring and autumn. Water quality results presented for this site are those sampled in conjunction with the macroinvertebrate sampling. Jerrabomberra Creek drains through industrial, rural and urban settings and generally instream habitat conditions are poor.
