ACT WATER REPORT 2009–2010

DEPARTMENT OF
THE ENVIRONMENT,
CLIMATE CHANGE,
ENERGY AND WATER

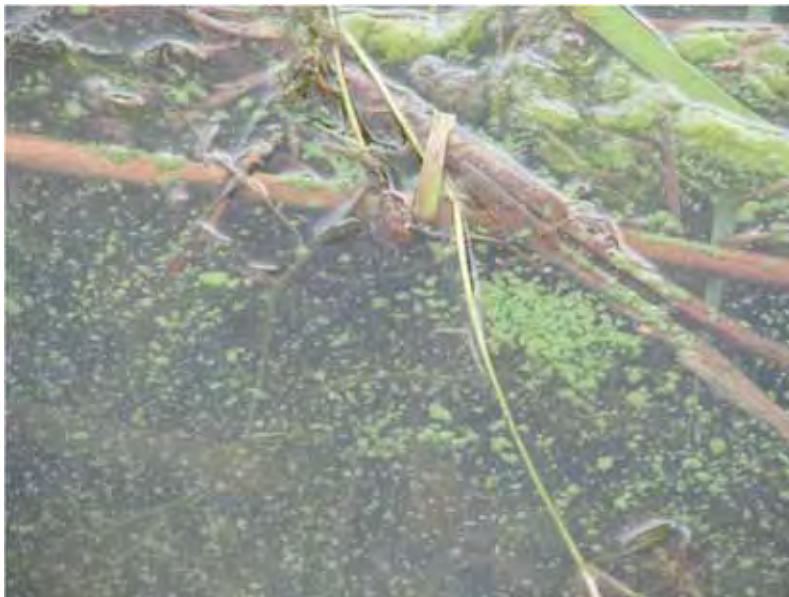
Figure 8: Blue-green algal flakes, bloom on Jarramlee Pond, February 2010

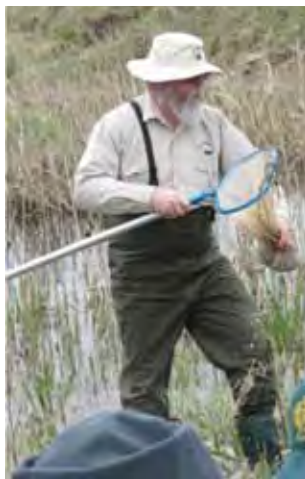
Collecting water bugs to assess water quality and habitat conditions

Water chemistry analysis such as pH, total phosphorus and dissolved oxygen provides a snapshot of the water quality at the time when the sample is taken. Biological assessment, in this case the sampling of waterbugs (benthic macroinvertebrates), can indicate much about the water quality over time and show what kind of environment the water and its waterway provide for animals to live in.

Macroinvertebrate biological assessment is based on a comparison between a tally of the range of waterbugs found at a site with those predicted to occur there. If all those animals expected at a site actually occur there, the site is judged to be in good condition. Conversely the absence of expected animals indicates a site has been disturbed. The rating scale for AUSRIVAS outputs is presented below (Table 17). A full explanation of the AUSRIVAS biological assessment method for the ACT is available from www.ausrivas.canberra.edu.au and the full biological assessment reports are available on request from Water Resources.

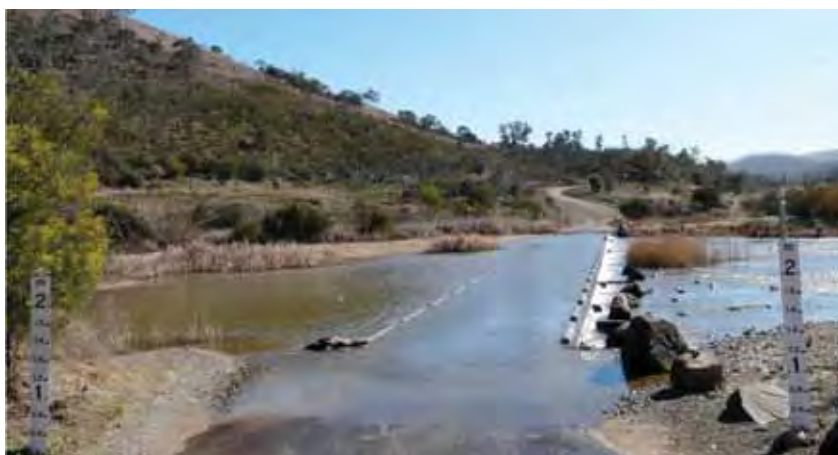
Murrumbidgee River, Angle Crossing, August 2009

Table 29: Values of Indicators sampled on Site 213 on the Murrumbidgee River at Angle Crossing

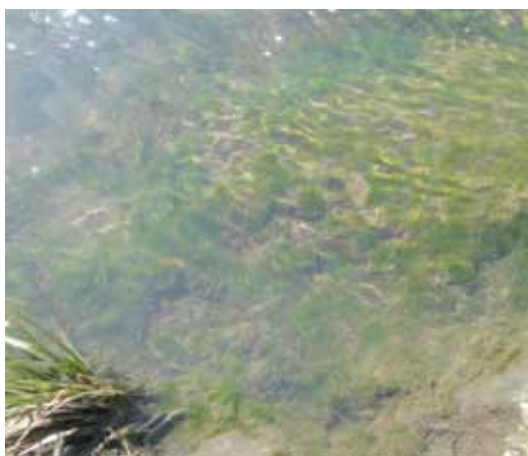
*Spring tufts of conspicuous green algae on a concrete culvert.
Poor riparian vegetation encourages compensatory growth of filamentous algae.*

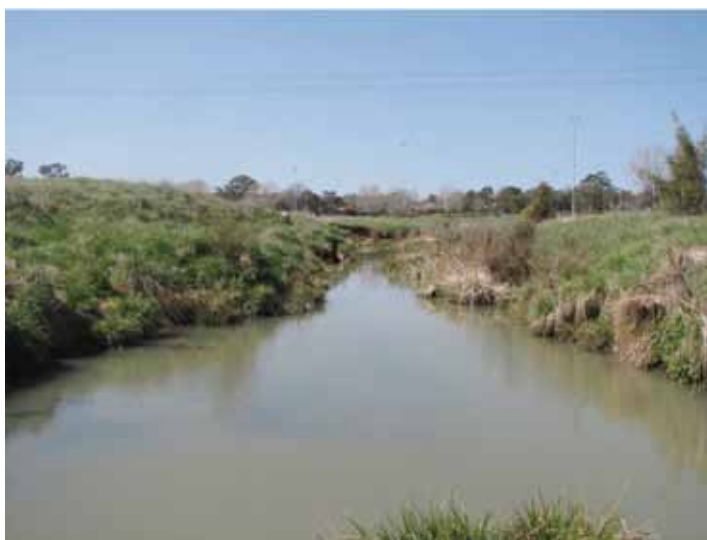
Yarralumla Creek, upstream of Cotter Road bridge with playing fields and Curtin in the distance

Site 189 (Figure 7) on Yarralumla Creek is only sampled using the AUSRIVAS macroinvertebrate rapid bioassessment protocol in spring and autumn. Water quality results presented for this site are those sampled in conjunction with the macroinvertebrate sampling. This creek is mostly a concrete lined drain meandering through the urban areas of Phillip and Woden, but becomes more creek-like as it crosses the horse paddocks before joining the Molonglo River below Scrivener Dam. Conductivity, usually well above 250 $\mu\text{S}/\text{cm}$, has improved with the rains. With much of Yarralumla Creek confined to concrete drain lines, and the lower creek in horse paddocks, the severely impaired AUSRIVAS rating in May 2010 is unsurprising.

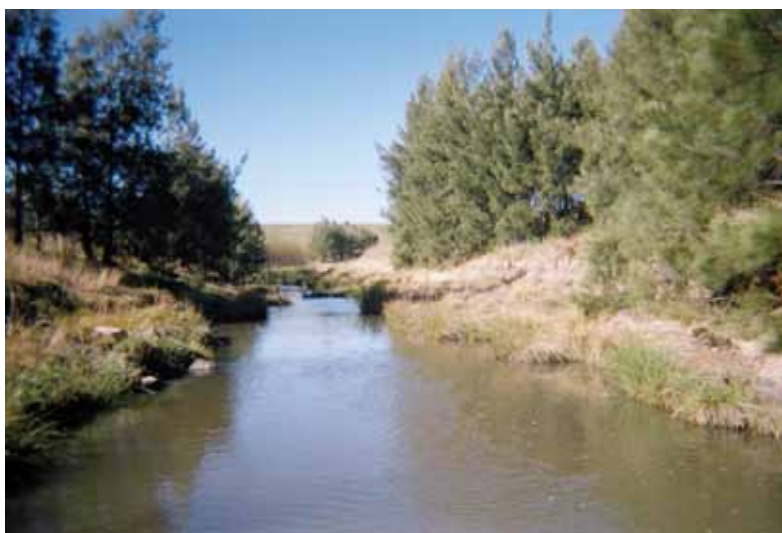
Tuggeranong Creek, looking back towards the Lake Tuggeranong wall, May 2007

Site 58 (Figure 7) on Tuggeranong Creek is only sampled using the AUSRIVAS macroinvertebrate rapid bioassessment protocol in spring and autumn. Water quality results presented for this site are those sampled in conjunction with the macroinvertebrate sampling. This site is in the creek downstream of Lake Tuggeranong. Although Lake Tuggeranong helps prevent sediments and pollutants from reaching this section of the creek habitat, the surrounding land use of grazing and the disturbance by bushfires means this site is susceptible to degradation. Water quality at sampling times in this year was good, except for the alkaline pH.

The AUSRIVAS rating for this small waterway is quite variable. The creek vegetation has recovered from the bushfire, but the flow regime through Lake Tuggeranong is partly dependent on storms, and the test site may become a pool for significant periods. While the rating in spring 2009 was at severely impaired, it had risen to significantly impaired in autumn 2010, most probably in response to improved flow rate fluctuations and some related habitat rejuvenation as light sediments were flushed from the system.

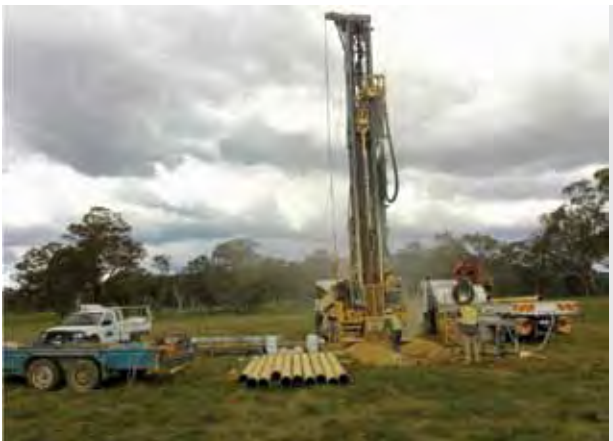
Monitoring bores

DECCEW's Environment Protection and Water Regulation Branch currently maintains 14 dedicated monitoring bores, with information from another 6 sites coming from interested groundwater abstractors. These monitoring bores provide information about the transmissivity (capacity for water to move through the aquifer), hydraulic conductivity, storage capacity potential, and recharge rates of the various aquifer types within water management areas. Monitoring of the aquifer recharge response to rainfall is seen as a critical activity that may enable us to quantify potential effects of changed rainfall patterns expected from climate change.

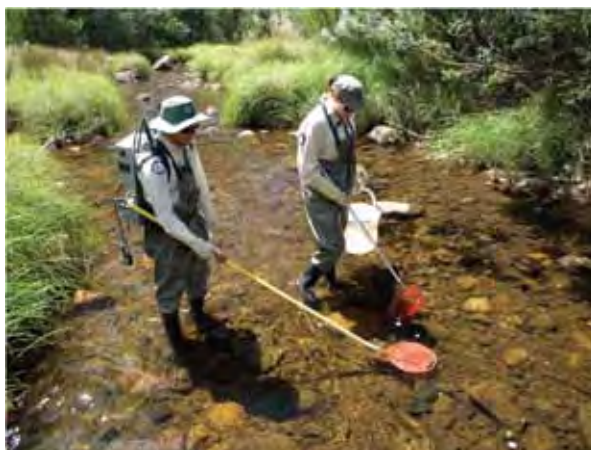
PCL Staff backpack electro-fishing on the Cotter River in 2009. Photo Mark Jekabsons
