ACT Heritage Council

BACKGROUND INFORMATION Glenburn Precinct (Blocks 16, 30, 60, 71–73, and 94, Kowen)

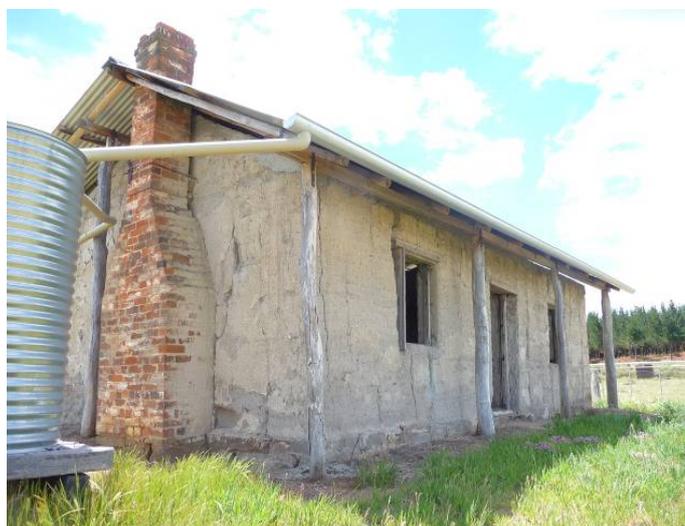
Figure 3 Glenburn Homestead Pisé Cottage southeast facade (ACT Heritage 2013)

The walls of the pisé structure are original; approximately 30cm thick and have been rendered. The walls were originally covered in a lime render, but it has weathered across most of the surfaces, exposing the pisé matrix underneath. The exposed pisé reveals the impressions left by the formwork during construction. The largest cracks in the walls have occurred where the different sections join each other as the construction method leaves these areas as weak points. The footings for the walls are local rock laid in a single random rubble course with soft local sand cement.

The southwest and southeast walls have suffered extensive weathering at their bases and as a consequence threaten the stability of the structure. An example of this extreme deterioration can be seen at the base of the southeast wall where deterioration of the pisé matrix has caused complete penetration into the interior. The floor, originally wooden on stumps (Appendix A) is of earth throughout, which has recently been topped up with about 15cm of decomposed granite gravel. A brick chimney and internal fireplace are in the centre of the southern wall. The internal fireplace is open and the bricks have been whitewashed. Two pieces of iron support an archway of brick above the opening. Holes at either side above the fireplace indicate there was probably a mantle shelf in place but it no longer exists. The windows are timber framed, although there is no glass or covering remaining. There was a verandah along the southeastern facade of the building, but all that is left are some remnant posts or depressions to indicate where they once were.

Commonwealth funding in 2009 allowed a major conservation project to be undertaken at the Glenburn Homestead. The Pisé house had bulges in the walls corrected and major cracks filled in. The walls were then braced with metal rods and capped with concrete. The slab hut had a significant lean corrected, footings stabilised with concrete, an internal metal bracing structure erected and several timbers replaced. (Roberts 2010)

Although the structure is at present stable, it cannot be said that it is in good condition. During the restoration program a large crack from top to bottom of the northern wall was braced with a metal tie and the western and eastern walls have been braced to stop outward leaning using a series of wire and rod ties. Even though this has supported these walls and the structure as a whole for 26 years, there is an urgent need to protect against the basal erosion of the southern corner wall sections of the building. These are slowly but relentlessly being eroded away. Additionally, while previous conservation works were done with the best intentions, the use of stiff concrete and metal rods within the pisé matrix may cause differential movement between the different materials and is likely to exacerbate existing faults.

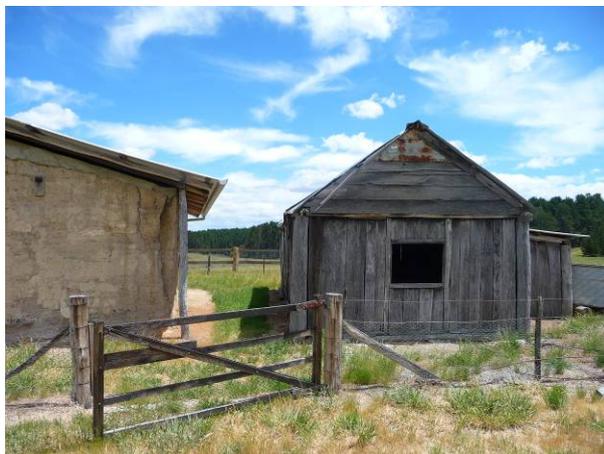
Figure 4 Glenburn Homestead Slab Cottage (ACT Heritage 2013)

The slab hut appears to have originally been a two room cottage with a later addition of a skillion along the northwest side. There was likely to have been additional rooms or a verandah on either side of the skillion as indicated by remnant posts. During the conservation works some of the weathered original timbers were replaced. Dowling & Cosgrove (2002: 15) suggest that the original timber was probably obtained locally from scribbly Gum (*Eucalyptus rossii*) that would have originally formed part of the native vegetation in the area before it was cleared. Over time the timbers have shrunk and the building has shifted, opening a gap between the timbers. There have been several attempts to plug the holes with various materials, from metal sheeting nailed between

The roof is constructed of sapling bush poles with sawn joists supporting corrugated iron roofing. It is assumed that the original roof cladding was corrugated iron due to the spacing of the ceiling joists, and at the time of its construction corrugated iron was becoming a popular building material. It is likely that this was the material used. The floor is of timber planks replaced during the restoration programme. The windows are timber framed with a mixture of adze-cut and newer sawn wood. The machined wood sections were added during conservation works. Glass fragments indicate the presence of glass windows, which are no longer in position.

The fireplace and chimney is located on the southwest wall. It is made out of sandstock brick and joined by the same type of soft mortar that was used for the stone footings of the pisé house. The materials are of a low quality with many of the bricks being poorly fired and crumbling and the mortar has weathered away, creating large gaps and significant cracking through the structure. The top of the chimney has previously fallen and the bricks have been collected and piled within the fireplace.

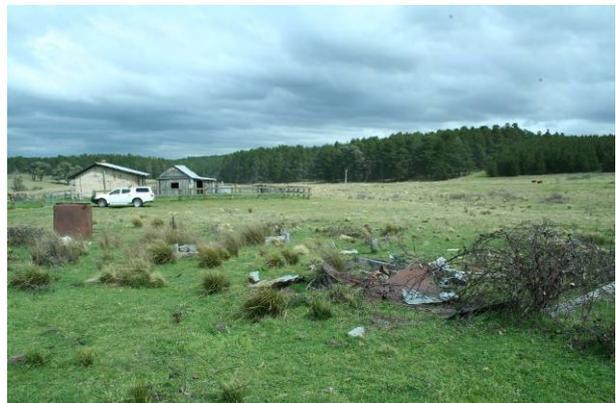
Figure 5 Glenburn Machinery Shed remains in the foreground with pisé and slab cottages in the background (ACT Heritage 2014)

The Glenburn Hay/Machinery Shed and Yards Site is located about 30 metres to the north-east of the Glenburn Homestead. Little of the structural fabric remains. It was described by Futter in his 1914 valuation of the property as slab walled with an iron roof, measuring 54'x12' (Appendix A). Today, the machinery shed location is marked by a small scatter of metal parts, fragments of the wooden structure, and stone and bricks scattered about. Among the ruins of these structures are a metal 19th century ships tank, a rusted bed frame, a metal trough and sheets of flat and corrugated iron.

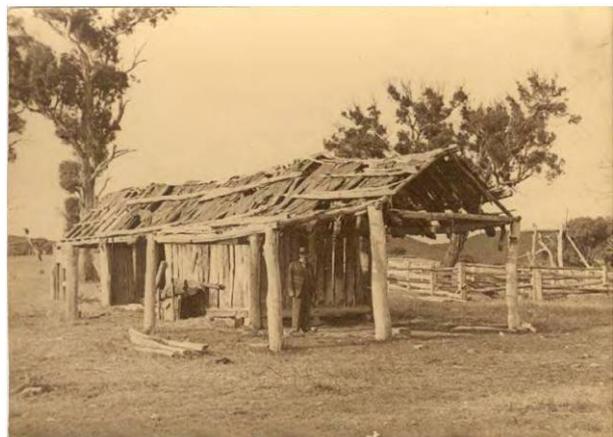
Figure 6 Glenburn Machinery Shed in 1947 (source Arthur Wilson, from McAlister 2007: 15)

Figure 6 shows the wooden slab structure in a dilapidated state by 1947 (Photo by Arthur Wilson in 1947 with James Edmonds standing in front of the still standing shed, from McAlister 2007: 15). The shed is supported on a series of large bush pole posts set in a 2x4 pattern, with a lean-to extending the western side of the shed. There are two mature trees in the background which are no longer extant. The date of construction for the shed is unknown, but the 1947 photograph shows that it had a bark roof. The 1913 valuation by Moriarty and the 1915 disposal schedule both describe this building as having a bark roof (McAlister 2007: 21).

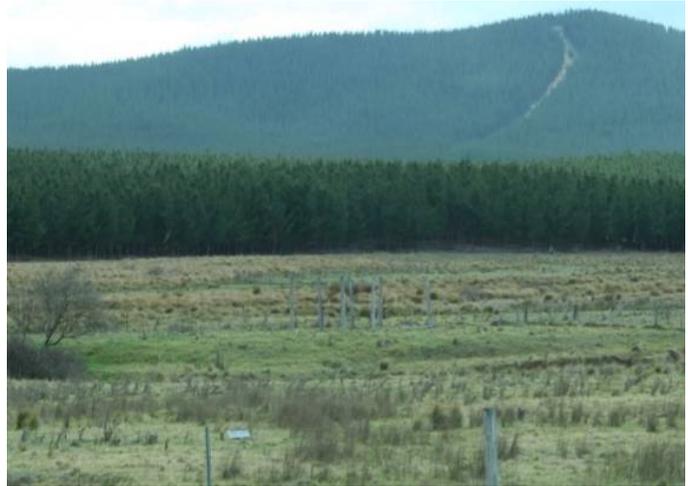
Figure 7 Glenburn Hayshed remaining posts (ACT Heritage 2014)

Located 160m to the north-west of the Shearing Complex, near Glenburn Creek, was the hay storage area. The date of construction for the Glenburn hayshed is unknown, but as the hay shed was included in Moriarty's 1913 valuation as being in good condition, it is likely that the structure was built during the time of John James Edwards. It existed in a good condition as noted in Moriarty's 1913 valuation, which also notes that it included a skillion (of which there is no longer any evidence) and a chaff cutting and engine room (Appendix A). He also noted that there were associated yards, although there is very little evidence left of them today. The shed was built using four pairs of vertical posts as the main supports. Bulbeck and Boot (1990: 29) suggest that this shed is

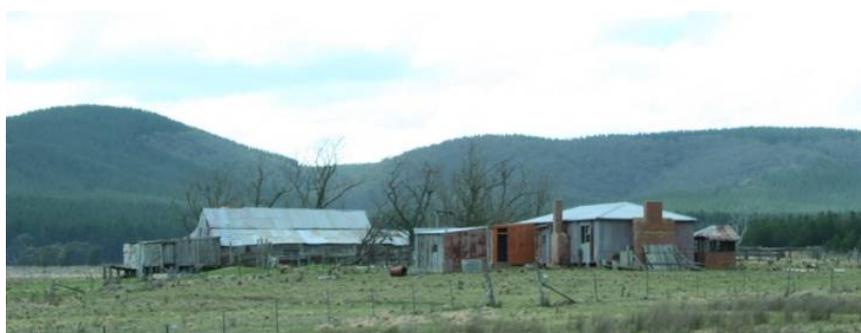
Figure 8 Glenburn Shearing Complex. Shearers' Quarters are in the foreground and the Woolshed in the background. (ACT Heritage 2014)

Most of the present structure and associated sheep dip and yards are of later construction. The shed is a wood slab building that has been constructed in several phases and has been subject to continual repair and maintenance resulting in a mixture of original and later materials, including adzed and machined timber as well as bush pole piers.

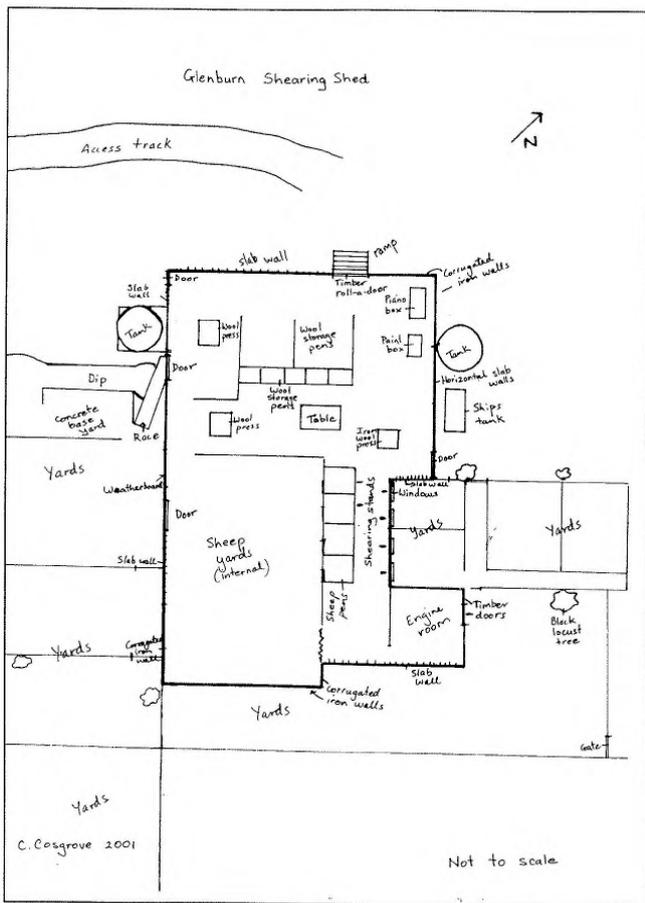
Figure 9 Plan showing the internal layout of the Glenburn woolshed (Dowling & Cosgrove 2002:34)

The shed has four shearing stands with Lister shearing mechanisms, which run off a motor located in a room on the north-eastern side of the building. There are also two electric *Sunbeam* shearing mechanisms used for smaller jobs such as crutching. As well as the shearing stands, the internal space includes holding pens, wool bays, a table for spreading fleeces, and three wool presses, two of which are of wood the other of metal.

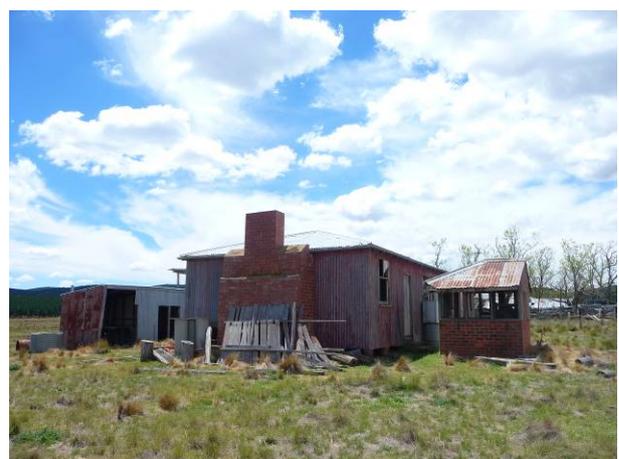
Figure 10 Glenburn Shearers' Quarters (ACT Heritage 2013)

The building is of corrugated galvanised iron on a timber frame with a small extension attached to the northern corner. The building consists of six bedrooms, four in the main building and two in the extension, which are all accessed directly from outside, with no internal access. The southern end of the main building has two large rooms which form the communal, kitchen and dining areas. The layout of the accommodation is a direct result of the *Rural Workers Accommodation Ordinance 1938* which stated

The quarters have been abandoned for several years and are now in a very poor state of repair. Several windows and door locks have been damaged and there is smoke damage to internal walls and ceilings, most likely caused by occasional squatting. It should also be noted that the building may not be sound and entering could be dangerous.

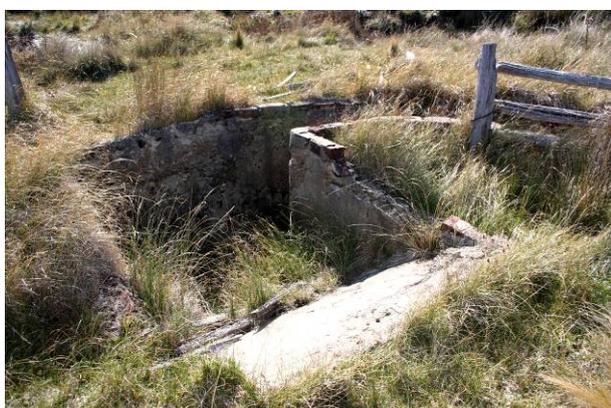
Figure 12 Sheep Dip and Yards (early 20th century) detail of the dip ramp (ACT Heritage 2015)

The sheep dip and yards are located 500m to the west of the woolshed, at the confluence of Glenburn Creek and a smaller tributary. Built by the early 20th century and improved in 1940, the dip and yards presumably ceased being used after the new dip was built adjacent to the shearing complex c.1945 (McAlister 2007: 23). The sheep dip is dug into the ground and lined with brick that has been rendered. The sheep dip and yards are a good example of the use of local materials to build rural structures that have been sited to take advantage of water sources as well as the higher, rocky ground adjacent to the site to help the sheep dry without creating muddy patches.

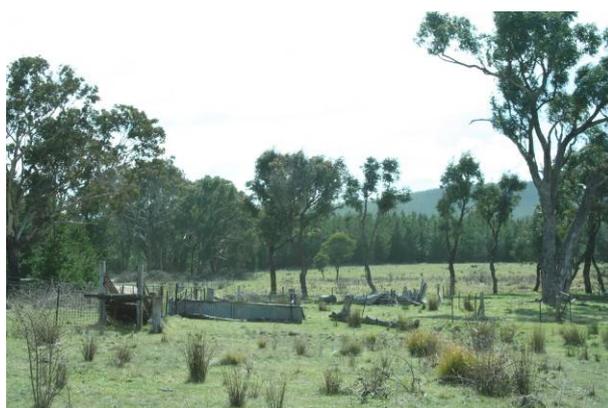
Figure 11 Sheep yard and Loading Ramp (ACT Heritage 2014)

The sheep yards, built in the 1980s by Ken McInnes, are a continuation of the pastoral use of the place and demonstrate changes in farming practices. They consist largely of recycled materials, demonstrating the resourcefulness that is a hallmark of Australian rural properties.

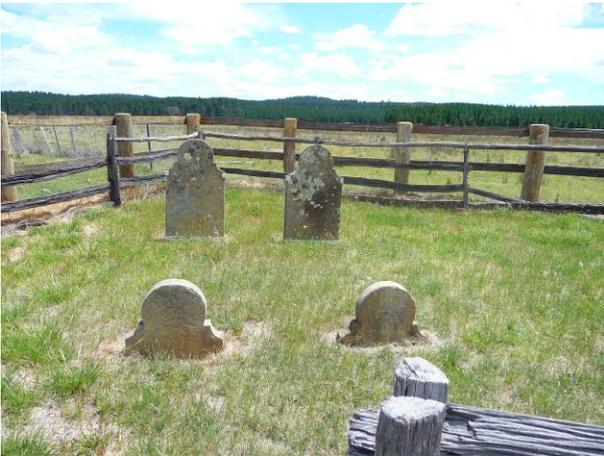
Figure 15 Colverwell Graves (ACT Heritage 2013)

The epitaphs contain several mistakes (Figure 15) and the two headstones are likely carved by different people as evidenced by the different fonts, sizes and spacing used. This is also an indication that the carving was done by amateurs, although it is unlikely that it was done by the Colverwells given that the surname was misspelt twice on each headstone.

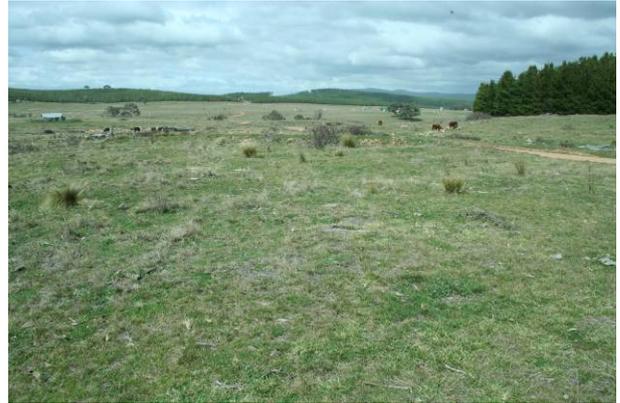
Figure 16 Charcoal Kilns remains (ACT Heritage 2014)

The remnants of charcoal kilns are situated near the northwest corner of the precinct. Surface remains of nine kilns are still visible as small clusters of blackened bricks and earth. The kilns had a circular concrete base of ~4.5 metres in diameter with a slightly raised border on the rim and were arranged in pairs. The brick walls from the kilns, which would have been built on the raised borders, have been removed (Bulbeck and Boot 1990:26).

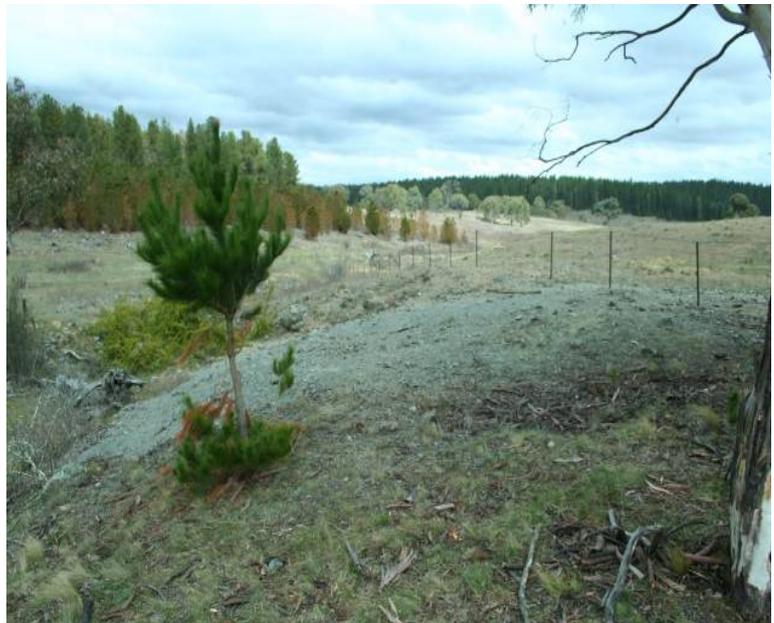
Figure 17 Glenburn Copper Mine (ACT Heritage 2014)

Within the boundary for the original Portion 1 (currently Block 72) there is an area containing a spoil heap of blue-grey gravel in the southeast of the Precinct, 500m east of Collier's Homestead Ruins, noted by Moriarty's valuation (Appendix A) as a former copper mine. Copper mining is a hard rock process that requires crushing of ore and processing on a large scale, so it is likely that the area is a test pit, or a small sample that was mined to see if it would be worthwhile to establish mining operations proper. While the area may have been in the Gundaroo Goldfields area, it is not too far from the copper/gold/zinc/silver mines at Captains Flat to the south for someone to think it worthy of testing. This appears to be the case as evidenced by the neighbouring Portion Plan 20 (cited in McAlister 2007: 26) which includes a note in 1882 for a mineral lease (minerals other than gold or coal) by JB Thompson Jnr, J J Wright, J Kinsela and JB Thompson Snr which was refused.

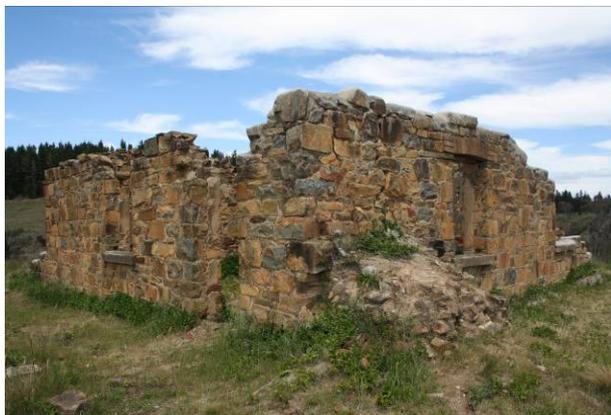
Figure 18 Collier's Homestead Ruins (ACT Heritage 2013)

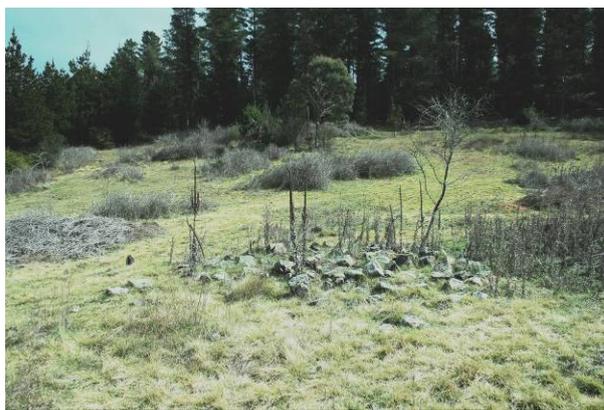
Figure 19 Curley's Homestead ruins (ACT Heritage 2014)

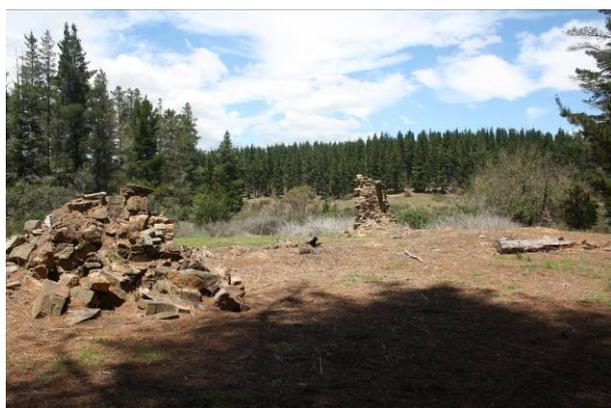
Figure 20 Coppin's Homestead ruin (ACT Heritage 2013)

In 2012, ACT Parks with the volunteer group, Friends of Glenburn, cleared the site which was covered in blackberries (Boxdall 2013: 26). Artefact scatters, comprising pottery fragments and a metal washing tub were observed on the ground surface. Conservation works are still needed to stabilise the fireplaces, particularly the southern, taller structure which is poorly consolidated and leaning badly. In 2015 further site work was done, including removal of vegetation and the erection of a fence.

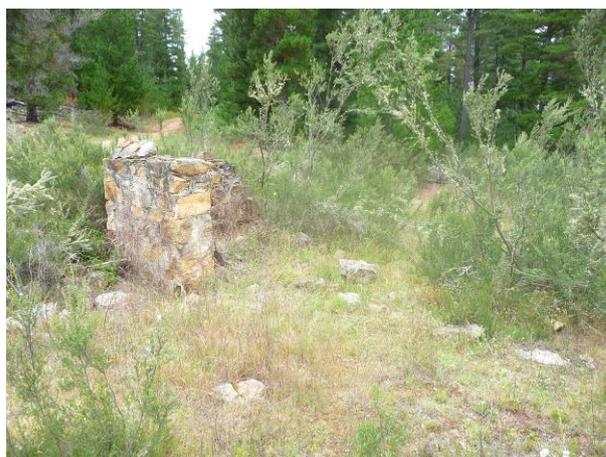
Figure 21 Argyle Homestead Ruins (ACT Heritage 2014)

The only remains of the Argyle Homestead Ruins are the corner of a fireplace made from roughly dressed and coursed stone. Bulbeck and Boot (1990: 36) note that there were several depressions marking out post holes, indicating that the building was wood and measured roughly 11.5m x 6m. McAlister (2007: 34) argues that it was built by Luke Colverwell Jnr sometime after 1891 as there was no mention of the house in the census of that year so it must post-date Colverwell's purchase of the land.

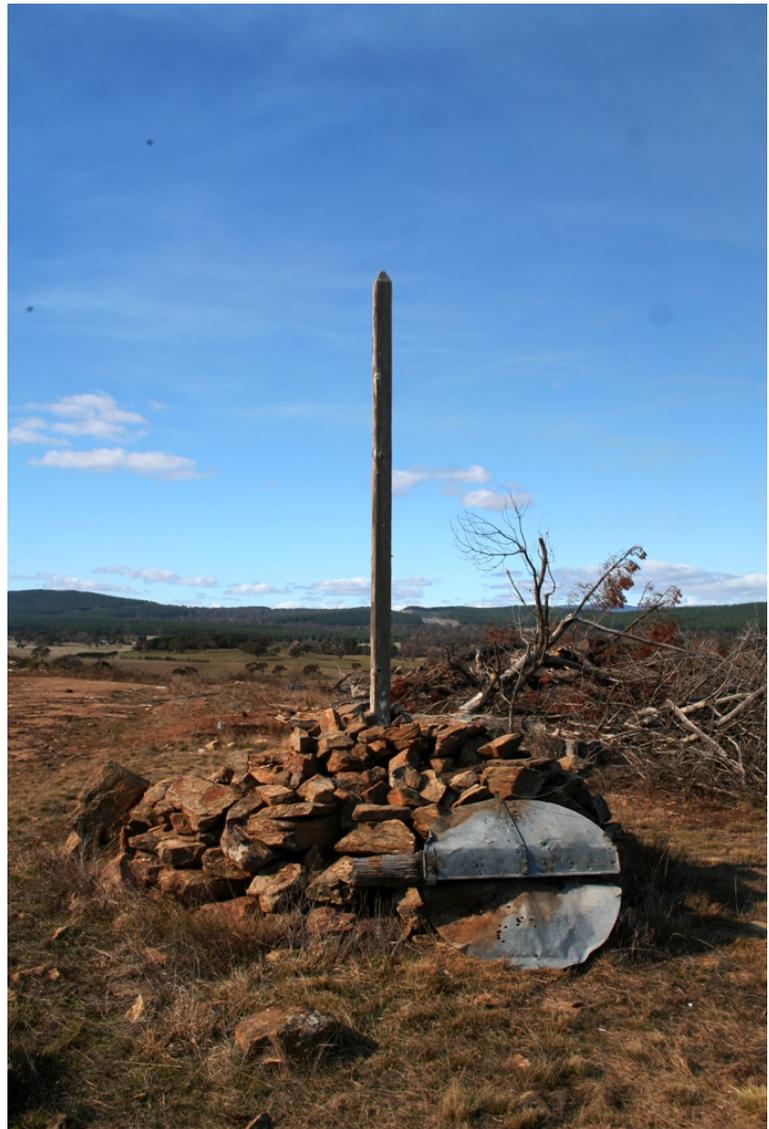
Figure 22 Atkinson Trigonometrical Station facing east. (ACT Heritage, 2015)

The cairn sits atop a primary survey mark and the pole and vanes sits atop of this mark. The mark itself is rarely accessed, instead the vanes are used for sighting towards the Trig or one of the nearby recovery marks (one or more survey marks that are offset from the Trig station) are used to set up equipment directly.

The types of equipment used in conjunction with the Trig station has varied over time from compass and chains, to optical theodolites, to total stations, right up to advanced GPS systems that have been used to prepare the ACT for the GDA2020 datum adjustment. Throughout all of these advances in technology, with increasing complexity and accuracy, the same survey mark for the Trig station remains and the equipment works off the same point of reference.
