## ACT Heritage Council

### BACKGROUND INFORMATION

#### Calvary Homestead Ruin

#### (part Block 29, Paddys River)

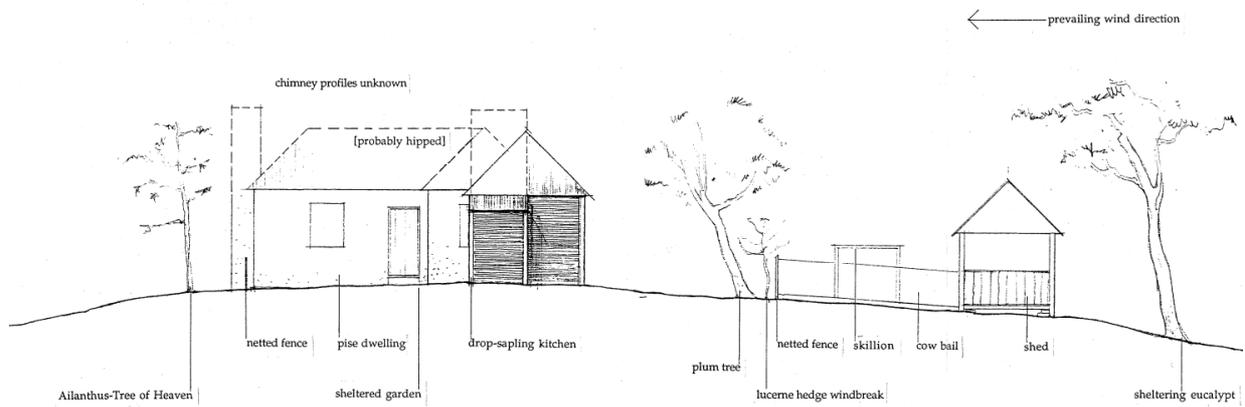
Image 5 Calvary Homestead Group (Hobbs 1996)

The six by eight metre pisé dwelling is of an unusual L-plan form and was possibly a two room structure (see Images 3 and 4). Several remnant posts and metal fragments of a cow bail, slab-sided shed and skillion lie immediately west of the pisé ruin (see Image 5).

The location of the cow bail, slab shed and skillion is evident in a collection of collapsed posts and stone foundations immediately west of the pisé dwelling. The sheds and cow bail would have provided effective shelter for the homestead on the exposed western side of the range.

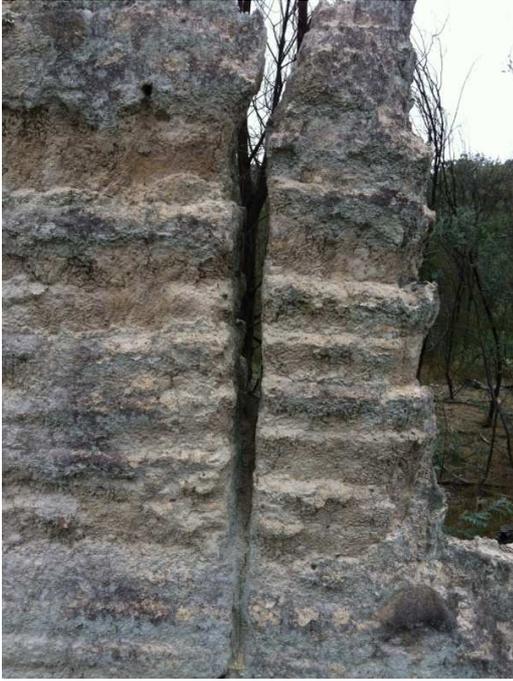
Structural distortion of the walls has caused cracking of the pisé at vertical joints which define sections of walling rammed in relatively small formwork that was moved progressively around the building (see Image 6). Corner formwork does not appear to have been used. Common formwork lengths are 1200 mm with 750 mm on the inside corners allowing for the wall thickness. There is a distinct difference in the erosion of the wall surfaces, which contain feldspar grains and small mica flakes, expressed in the striation of the rammed layers suggesting that the earth mixture or its source was changed during construction.

While the pisé appears to be well rammed and of suitable materials and consistency for such work, the building shows little evidence of an appreciation of structural issues by the builders as there is too little bonding or overlap between rammed sections. This has resulted in long vertical 'joints' which have contributed to the failure of the structure and suggests that the formwork used for the pisé may have been extremely limited in size and flexibility.

**Image 6** Calvary Homestead Ruin wall cracking (ACT Heritage 2015)

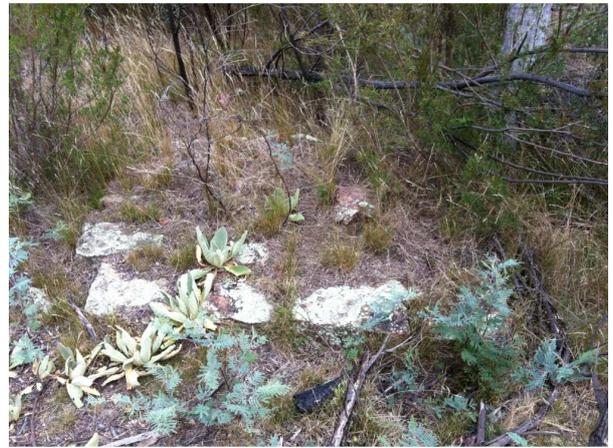
The kitchen building is of low integrity having lost its roof, wall infill panels and chimney, although a stone hearth remains at the north of the building's footprint (see Image 8). Timber posts, some squared, remain at the site (see Image 9). A limited surface scatter of late nineteenth and early twentieth century domestic artefacts occurs within the footprint of the former kitchen building.

**Image 8** Calvary Homestead Ruin kitchen fireplace (ACT Heritage 2015)

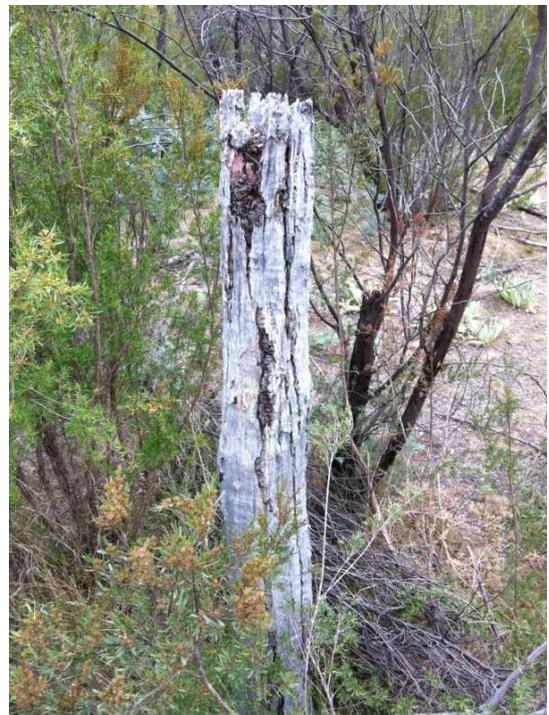
**Image 9** Calvary Homestead Ruin kitchen post (ACT Heritage 2015)
