SECTION 2: WATER QUALITY CONDITION

Water Quality Monitoring Program

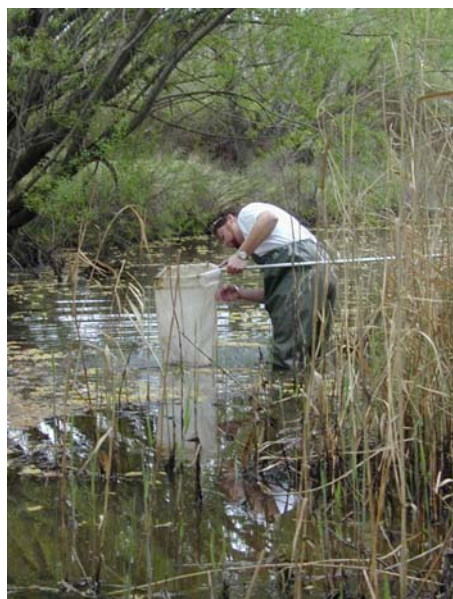
Seeing who's
home....
Collecting water
bugs to assess
water quality and
habitat conditions

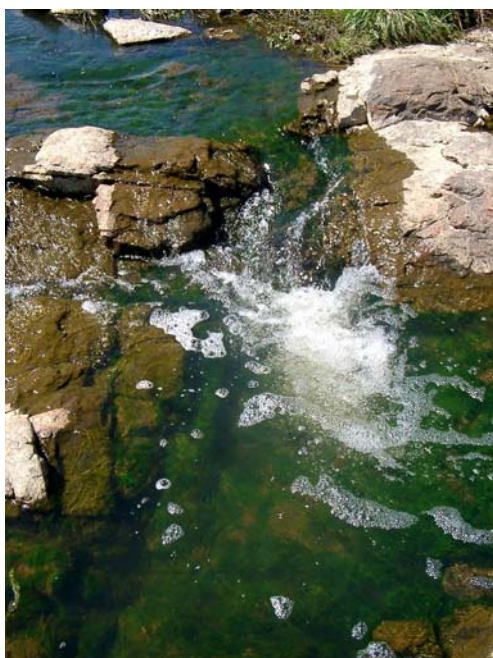
Ginninderra Creek is constrained as it flows through urban areas. Poor riparian vegetation encourages excessive growth of filamentous algae .

While it is expected that willow removal work in the area will eventually make inroads towards improving Ginninderra Creek habitat, the compounding affect of the continued low flows and degraded habitat has resulted in a further reduction in AUSRIVAS spring scores at two sites (195 and 64) for this reporting period. Overall both spring 05 and autumn 06 sampling continues to reveal impoverished AUSRIVAS scores for Ginninderra Creek.

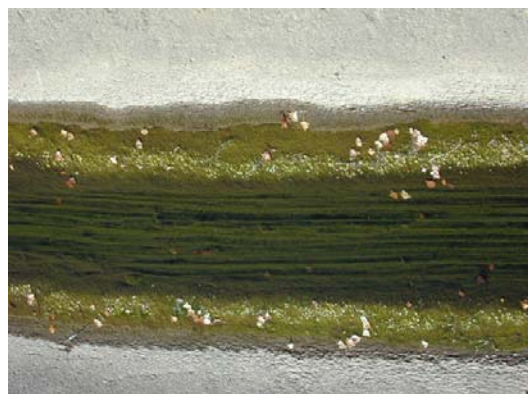
Concrete lined sections of Yarralumla Creek provide poor habitat for anything but filamentous algae
