Chapter 3: CAMPFIRE findings

3.1 Turbidity and sediment

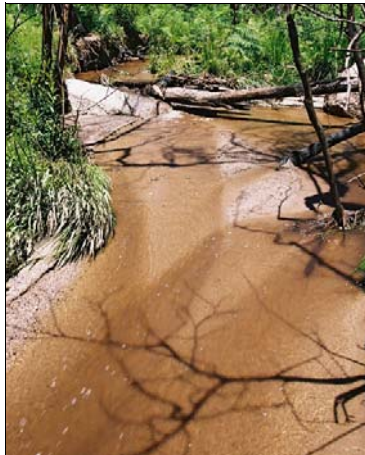
1. Tidbinbilla Nature Reserve Upper Site

A hill slope analysis of Tidbinbilla Valley has identified sections of streams that are vulnerable to sediment build up. These sections of stream (Gibraltar Creek Lower and Tidbinbilla Upper sites) are surrounded by steep terrain in areas of high fire severity. Other sections of stream (Gibraltar Creek Upper and Tidbinbilla Lower sites) are less prone to sediment accumulation due to the flatter topography, lower fire severity and larger riparian buffering zones.

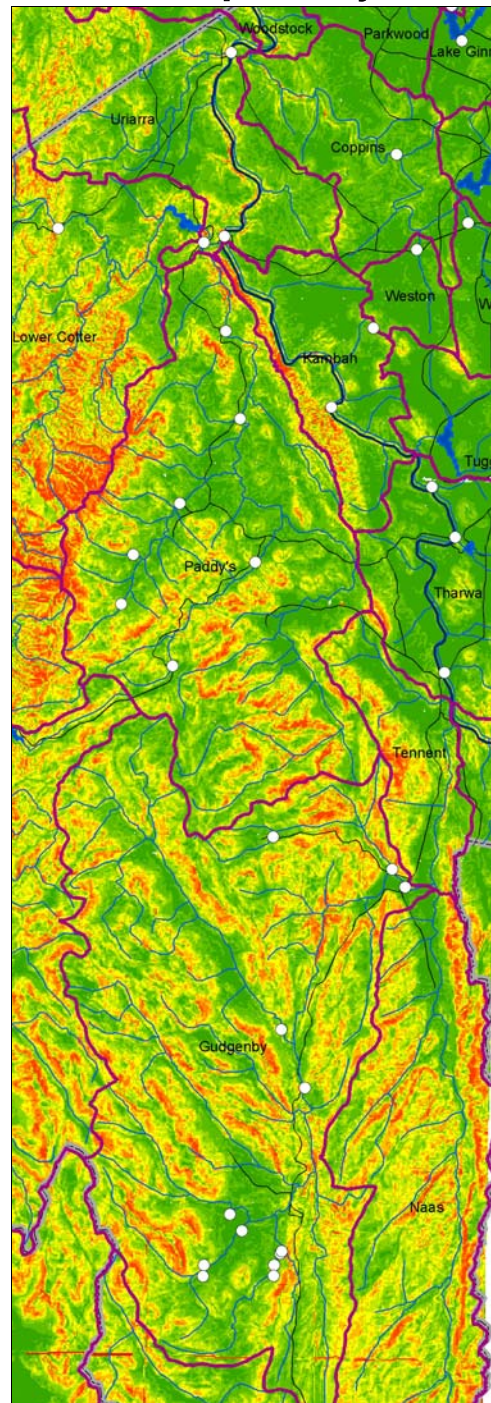
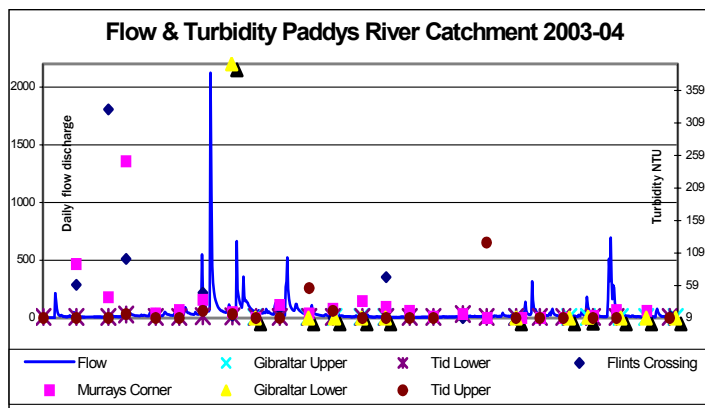
Figure 7 (above): Dry conditions experienced since the 2003 bushfires have resulted in sustained period of low flows in the Paddys River catchment. A rain event in August 2003 resulted in a sharp increases in turbidity levels.

Figure 8 (below): The seasonal flow variations in the Murrumbidgee River at Lobbs Hole can be attributed to environmental flow releases from the Cotter and Tantangara dams. Riffle maintenance and channel maintenance flows are designed to mimic the natural condition of a river and are important for the maintenance of aquatic ecosystems.

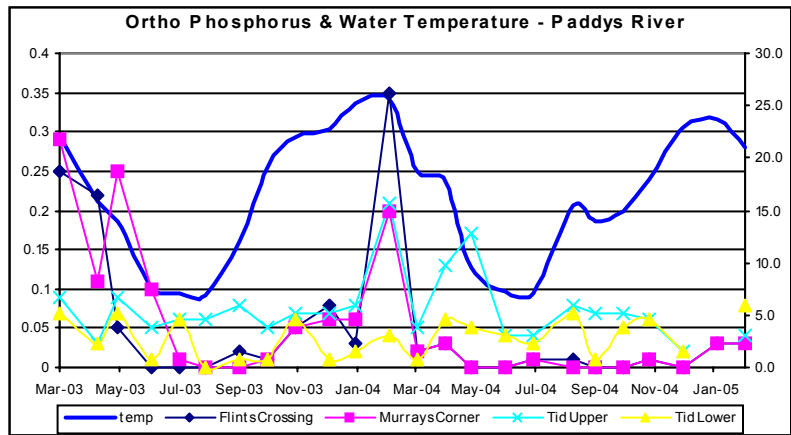
Figure 10: High phosphorus levels immediately after the fires and during the 2004 summer period. Higher temperatures and lower flows in summer months can cause significant increases in phosphorus levels as happened in Paddys River.

After the bushfires, increased amounts of nutrient rich soil, ash and organic material were washed into our waterways. This resulted in increased phosphorus levels in the first few months after the fires (Fig. 10). This organic rich sediment can contain significant amounts of phosphorus that can become attached or bound to sediment. This phosphorus bound sediment can settle at the bottom of the stream acting as a nutrient storage sink. During warmer weather, increased biological activity can release this sediment bound phosphorus into the water column as happened in Paddys River (Fig. 10).

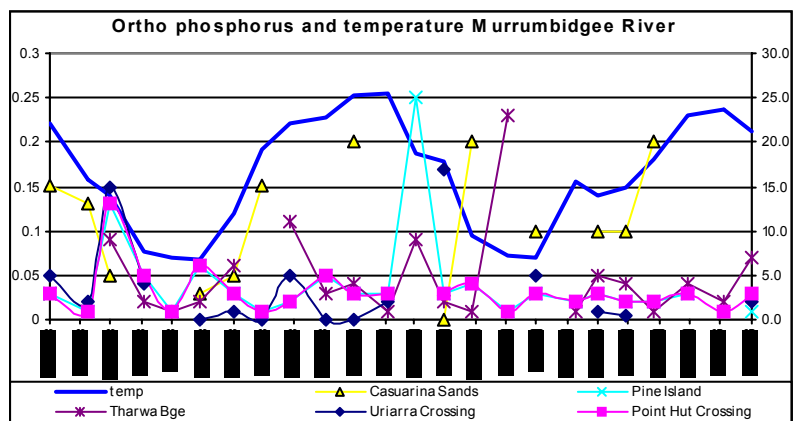
Figure 11: In larger rivers such as the Murrumbidgee, nutrient rich sediment from the bushfires settled on the shoulders of the River. This sediments goes through a cycle of drying and rewetting which when combines with seasonal temperature variations release significant amounts of phosphorus into the waterway.

In larger rivers like the Murrumbidgee, significant amounts of nutrient rich fine sediment can be deposited on existing sand bars (Fig. 11). Low water levels and high water temperatures in summer can cause this nutrient rich organic sediment to dry out along the stream edge. This drying process can cause a sudden release of phosphorus in the waterway.

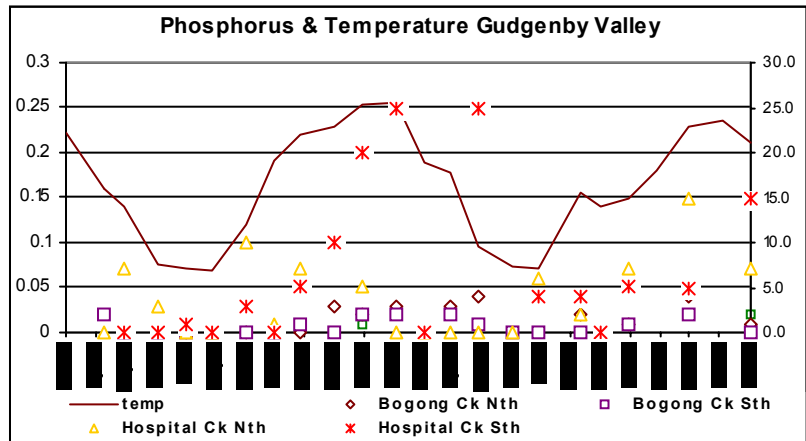
Figure 12: Unusually high phosphorus readings in Hospital Creek. These increases in phosphorus was usually during the summer months.

Hospital Creek water quality results reveal an alarming increase in phosphorus levels mostly during the summer months. An investigation was undertaken by a team of intrepid hikers who trekked 10 km along the stream in search of the nutrient source.

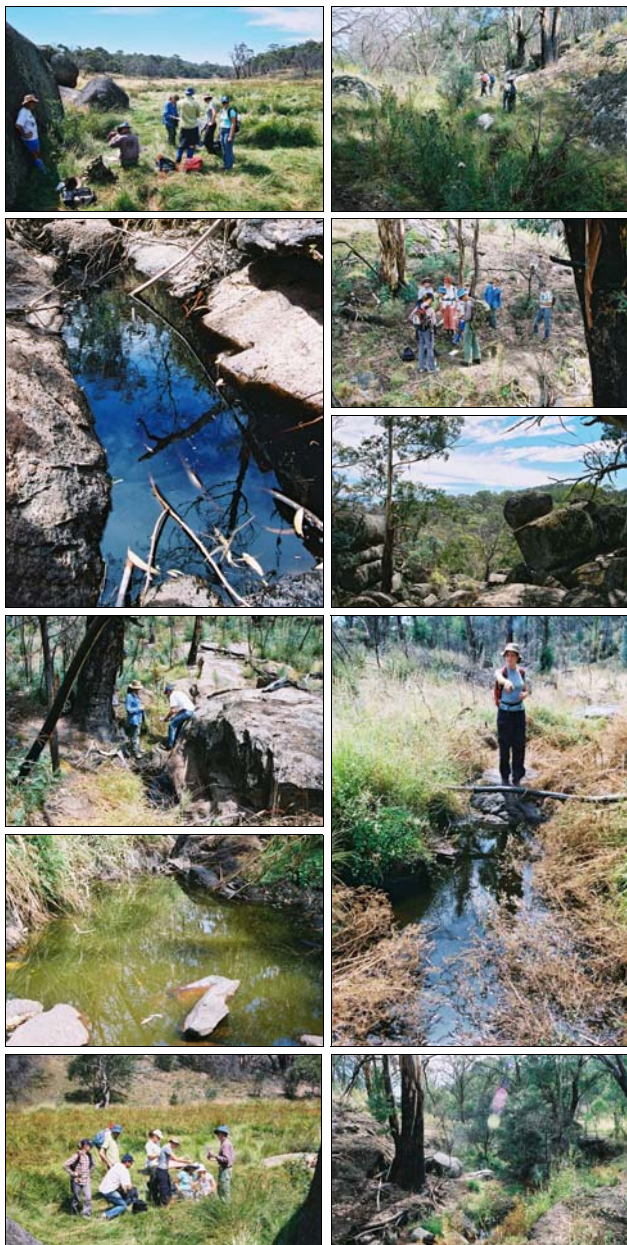
The expedition found a chain of ponds along the ephemeral stream. Some of these ponds were distinctively black in colour, were high in phosphorus and turbidity and low in dissolved oxygen. They also had an intense sulphur odour.

The low fire intensity may have resulted in large amounts of unburnt or scorched leaf litter being delivered to stream ponds as organic sediment. This layer of organic sediment can settle on the bottom of the pond and as there is no flow the still water doesn't transfer oxygen to the sediment. Bacteria decompose the sediment anaerobically with sulphur because no oxygen is available. The by-products of this are sulphide (which produces a rotten egg smell) and carbon dioxide (a weak acid). The acid then facilitates the release of phosphorus from the sediments. These ponds are called bacteriological dominated ponds (left).

Phytoplankton dominated ponds (far left) were also discovered in Hospital Creek, which were bright green in colour and low in phosphorus and turbidity.

Left—Images from the Hospital Creek Waterwatch expedition. A team of intrepid hikers undertook monitoring along Hospital Creek to find the source of unexplained high phosphorus. The group found an unusual chain of ponds which had there own unique characteristics.

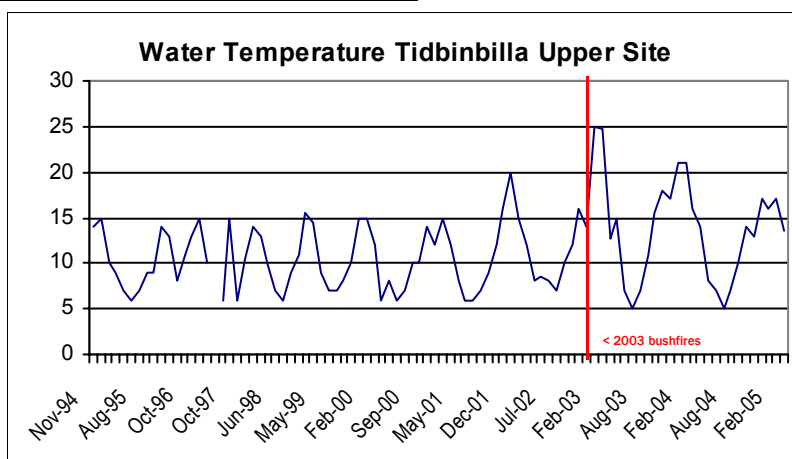
Figure 13: Tracking water temperature before and after the 2003 bushfires.

Waterwatch monitoring undertaken by the Friends of Tidbinbilla since 1994 has established a link between the bushfires and changes in water temperature. In fire-affected catchments, vegetation cover was removed and streams were more vulnerable to changes in climatic weather conditions. In summer months more direct sunlight reached the stream and resulted in higher water temperatures. Conversely in winter the vegetation cover that acted to shelter streams from winter frosts was removed and as a result water temperatures were much lower than normal.

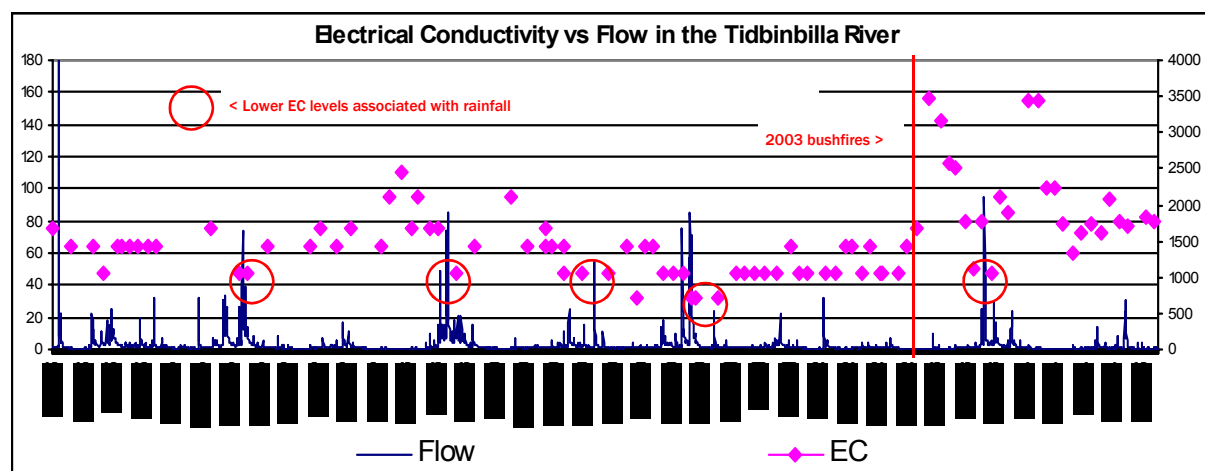
Figure 14: Electrical Conductivity before and after the 2003 bushfires highlights a drop in EC after rainfall and increases in EC levels after the bushfires.

The electrical conductivity results at the Upper Tidbinbilla monitoring site since 1995 shows peaks in EC immediately after the fires and during times of low flow. One possible explanation for this may be that organic and mineral matter being flushed into this small stream may carry conductive ions that can cause these increased results.

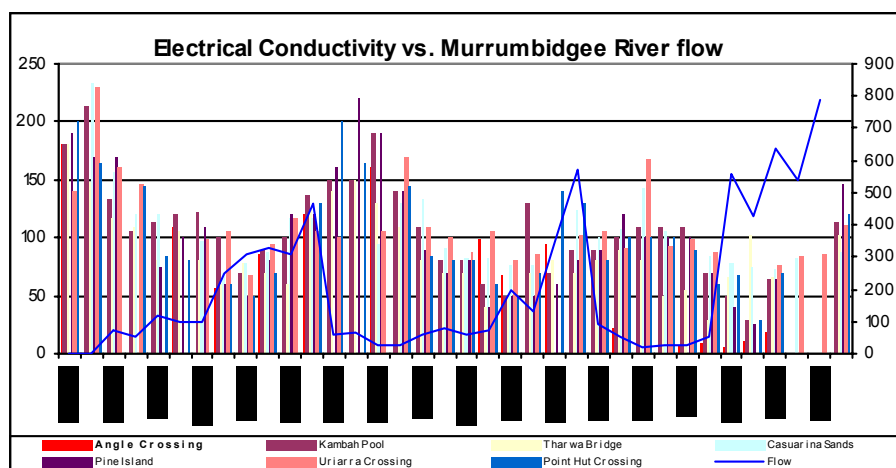
Figure 15: EC levels in the Murrumbidgee River vs monthly average flow at Lobbs Hole. A clearly defined seasonal trend in EC levels can be recognised.

At first glance the Murrumbidgee EC graph appears to have a seasonally declining trend. But is this declining trend due to the fires, or are other factors at play?

The seasonal EC fluctuations are usually associated with changes in flow. In summer, lower flows result in less fresh water dilution and as a result higher EC levels, conversely higher flows in winter usually result in higher fresh water dilution and lower EC levels. If we undertake a covariance analysis (i.e. adjust for the correlation between flow and conductivity) it appears that the fires had no significant influence on the electrical conductivity levels in the Murrumbidgee River. This is probably due to the significant size of the Murrumbidgee catchment and all its associated catchment influences.

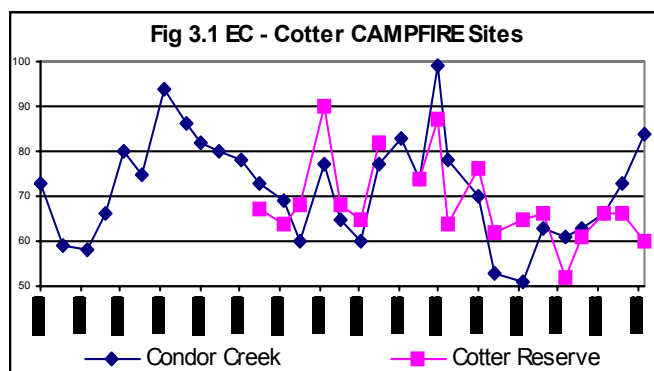
Figure 16: EC readings in Condor creek and Cotter confluence.

The Condor Creek monitoring site is located high on Brindabella Road at Thompsons Corner, 5km downstream of Blundells Flat. This mountain stream is not affected by any major reservoir or weir. The Cotter River Reserve site is located close to the confluence of the Cotter River and is downstream of the Cotter, Bendora and Corin dams. Data collected from these sites can be used to assess the impact of bushfires on water quality, as well as provide an insight into the influences of the Cotter reservoirs.

The 2003 bushfires had a devastating affect on the Cotter catchment with many studies undertaken to assess the impact on Canberra’s water supply. One interesting aspect of the CAMPFIRE data is the alternating higher EC readings at the two CAMPFIRE sites. When we compare results from Condor Creek and the Cotter Reserve we can observe alternating higher monthly EC reading at these sites. One possible explanation is that typically there is a larger seasonal and rainfall EC variation in mountain streams when compared with water discharged as environmental flows from the Cotter Dam.

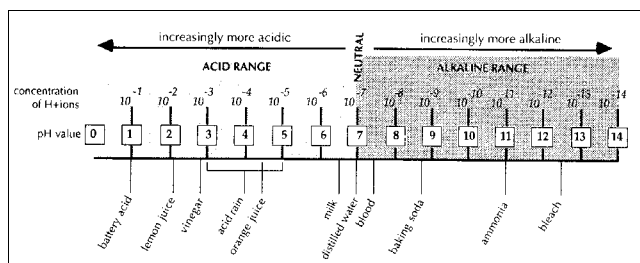
pH scale and pH of selected liquids (Behar, S. 1997).

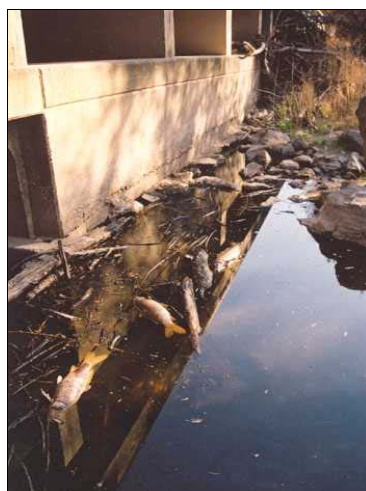
These dead fish were photographed in the Molonglo River at Coppins Crossing immediately following the fires. It is unclear what killed these fish, however this site recorded one of the lowest dissolved oxygen readings in the ACT with 2.7 Mg/L.
