## SECTION 2: WATER QUALITY CONDITION

### Water Quality Monitoring Program

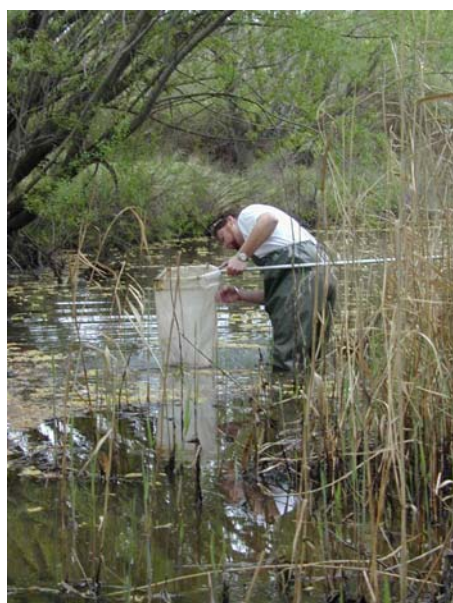
Seeing who's  
home...  
Collecting water  
bugs to assess  
water quality and  
habitat conditions

Macroinvertebrate biological assessment is based on a comparison between a tally of the range of waterbugs found at a site with those predicted to occur there. If all those animals expected at a site actually occur there, the site is judged to be in good condition. Conversely the absence of expected animals indicates a site has been disturbed. The rating scale for AUSRIVAS outputs is presented below (Table 16). A full explanation of the AUSRIVAS biological assessment method for the ACT is available from <http://ausrivas.canberra.edu.au> and the full biological assessment reports are available on request from Water Resources.

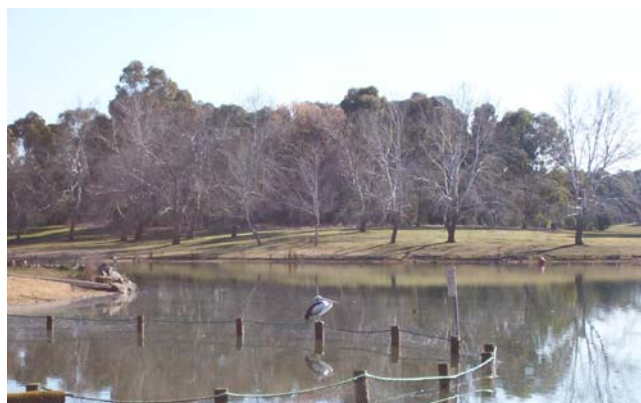
Two sites are monitored in Lake Ginninderra, one near the inflow in the East Arm (Site 321) and the other at the outflow dam wall, or West Arm (Site 318). Water quality in the lake was good and generally better than the other lakes monitored. Localised weather events, like the rain of 3<sup>rd</sup> and 4<sup>th</sup> November 2006, which subsequently raised suspended solids and turbidity levels at the dam wall, stand out in otherwise consistent figures.

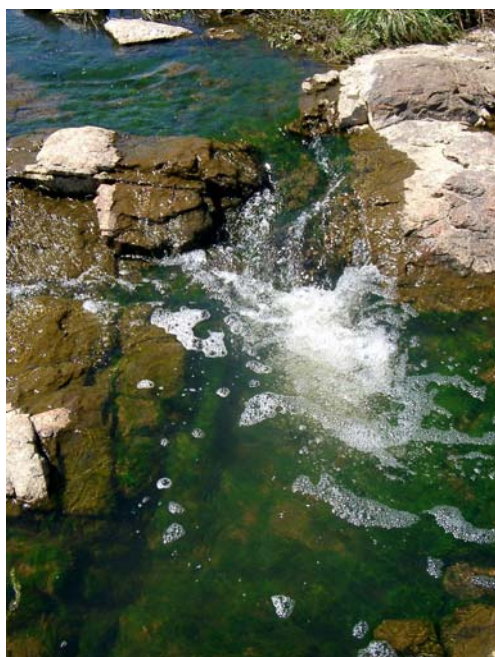
Ginninderra Creek is constrained as it flows through urban areas. Poor riparian vegetation encourages excessive growth of filamentous algae.

While it is expected that willow removal work in the area will eventually make inroads towards improving Ginninderra Creek habitat, the compounding affect of the continued low flows and degraded habitat has resulted in a reduction in AUSRIVAS spring scores at two sites (196 and 64) for this reporting period. Spring 06 sampling continues to reveal impoverished AUSRIVAS scores for Ginninderra Creek. Very low levels of dissolved oxygen in summer and autumn 2007, associated with water flow of <10 ML/day (Figure4) may coincide with poor AUSRIVAS scores indicating continued degraded riparian habitat. The raised level of chlorophyll 'a' for October is related to a normal spring phytoplankton flush. High faecal coliform counts after rain events (June 2007) are not uncommon in urban catchments, especially following long dry periods.

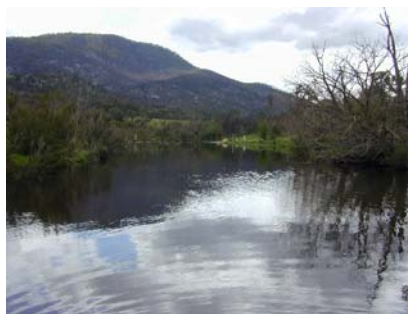
The Gudgenby River drains a rural catchment dominated by native forest, and is a fire affected site. Nevertheless, water quality at this site was in good condition. Late autumn and winter rain this year has elevated turbidity and suspended solids and may have washed in soil phosphates as well. Similarly the biological condition of the site at Smiths Road Crossing (20) remained at reference condition in spring 2006, indicating good river health.

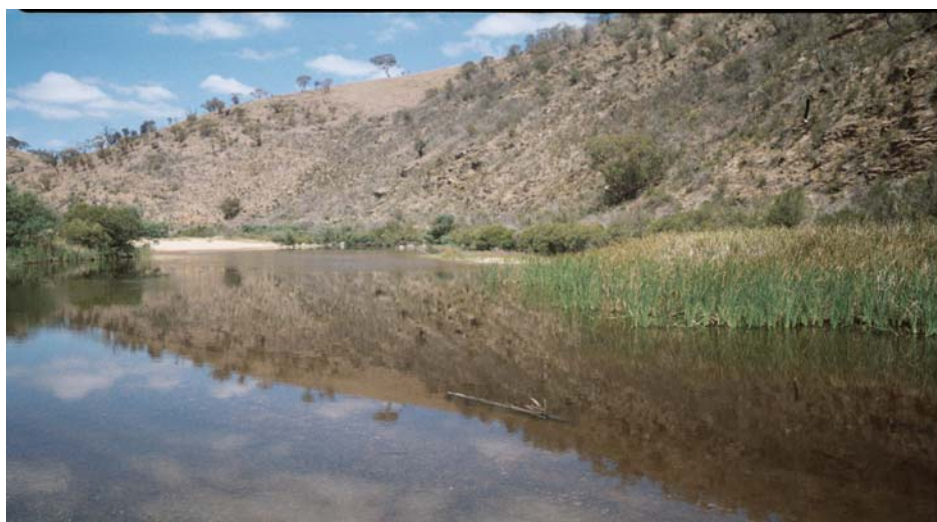
Murrumbidgee River upstream, Angle Crossing, February 2007

The poor spring AUSRIVAS score for Angle Crossing confirms the stress the long drought has put on non-riparian catchment vegetation. The continued satisfactory AUSRIVAS score at Hall's Crossing may indicate that the ACT's contribution of water is beneficial at that point in the system.

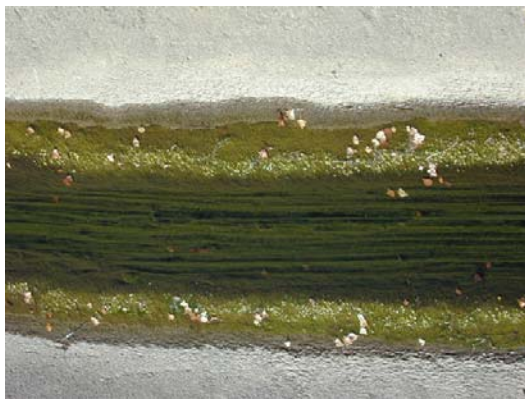
Concrete lined sections of Yarralumla Creek provide poor habitat for anything but filamentous algae

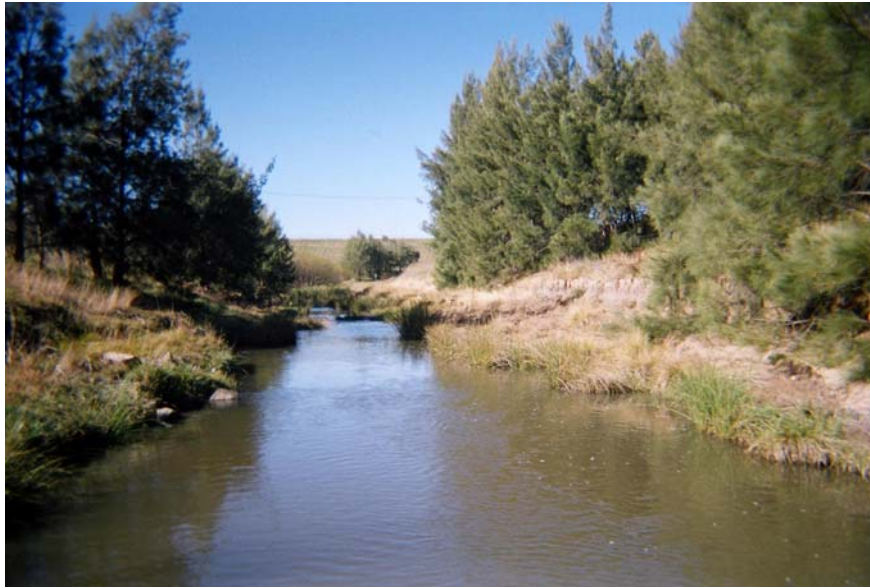
Tuggeranong Creek, looking back towards the Lake Tuggeranong wall, May 2007.

Site 58 (Figure 7) on Tuggeranong Creek is only sampled using the AUSRIVAS macroinvertebrate rapid bioassessment protocol in spring and autumn. Water quality results presented for this site are those sampled in conjunction with the macroinvertebrate sampling. This site is in the creek downstream of Lake Tuggeranong. Although Lake Tuggeranong helps prevent sediments and pollutants from reaching this section of the creek habitat, the surrounding land use of grazing and the disturbance by bushfires means this site is susceptible to degradation.
