# 6.4 Casuarina Sands—Murrumbidgee River

## Water Quality

# 6.5 Uriarra Crossing—Murrumbidgee River

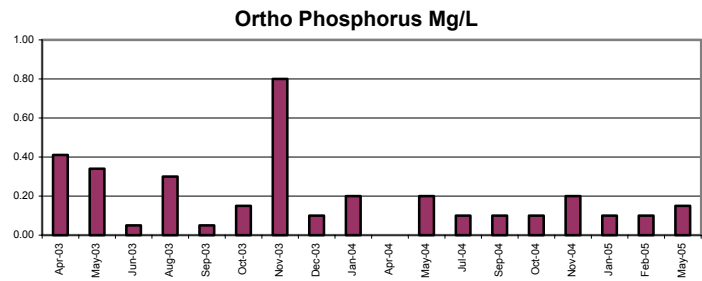
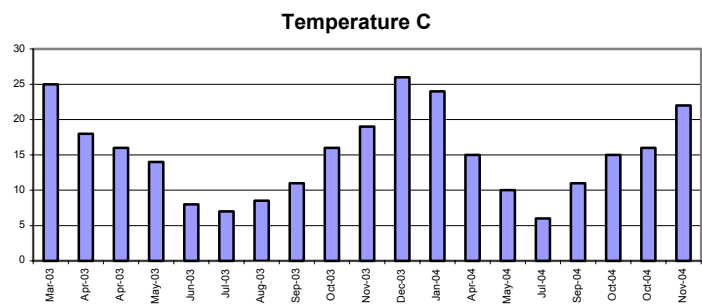
- Heavy rain caused high turbidity and spikes in phosphorus levels.
- At times high turbidity made algal monitoring difficult due to visibility.
- Algal growth fluctuated with increased algae observed at times of low turbidity, slow flows and moderate water levels.

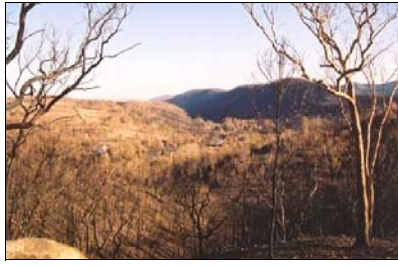
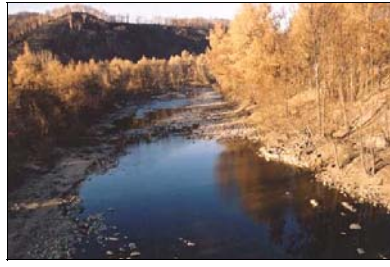
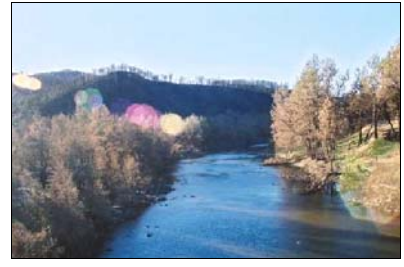
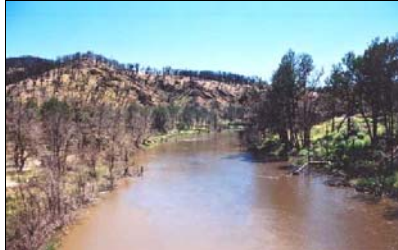
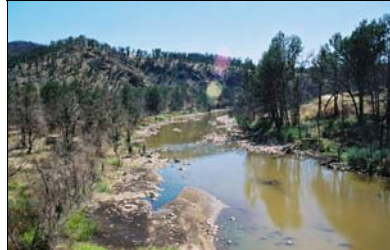
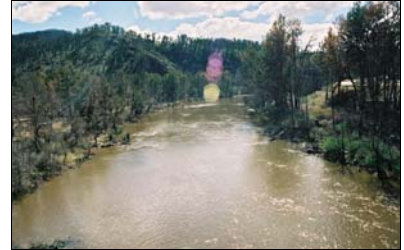
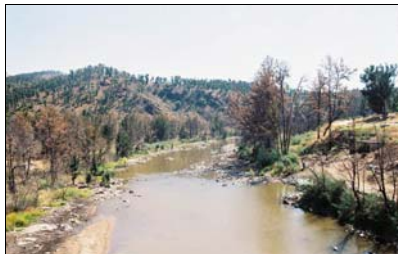
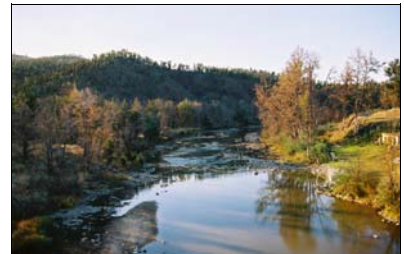
## Habitat recovery upstream

- After rain, extreme amounts of black sooty silt deposited on river banks after the water level dropped.
- Slow regrowth of vegetation on the surrounding hillsides.

- Casuarina's struggling to regrow.
- Fires have impacted on recreational opportunities including picnics and swimming.
- Drought seems to have severely affected recovery.

- Casuarinas that were initially recovering have died (80-90% of large trees).
- Erosion on steep slopes has stabilised but is vulnerable to heavy rain.

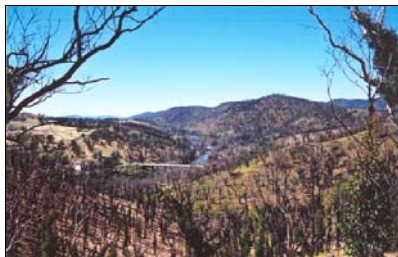
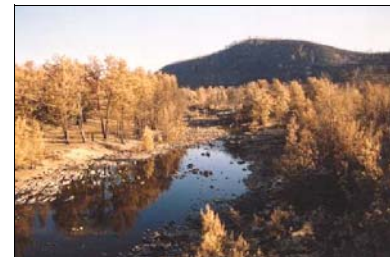
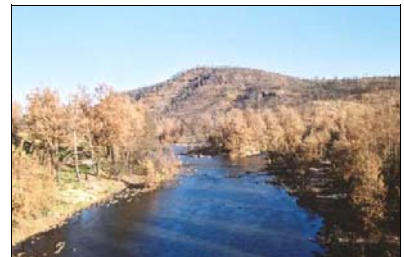
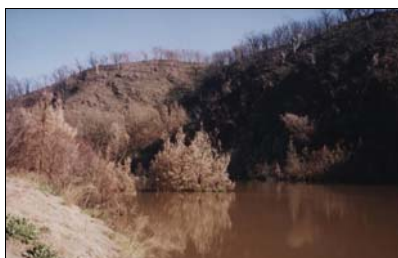
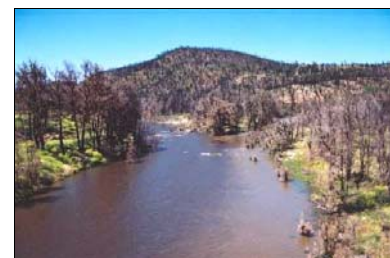
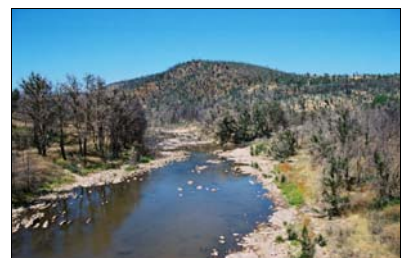
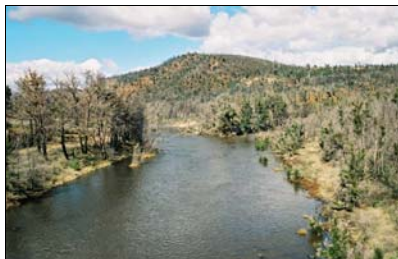
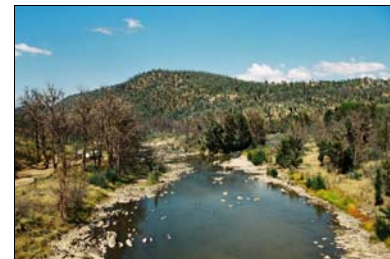
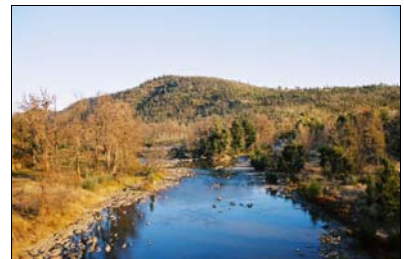
## Habitat recovery downstream

- Sediment smothered stream habitats, few birds, insects or reptiles were seen at the site.

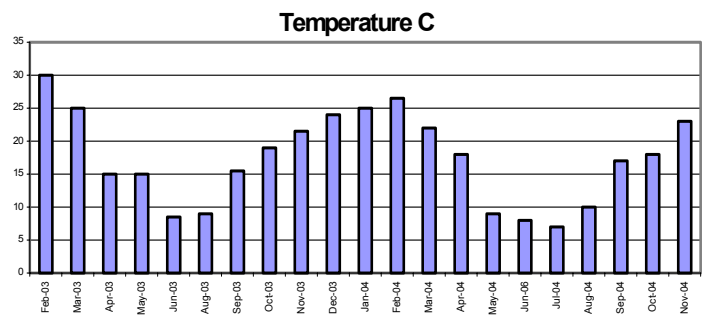
## Water Quality

- Occasional slight rainfall recorded within 24 hrs of monitoring had no impact on results.
- Relationship between lower flows and temperature and a slight increase in algae and low dissolved oxygen.
- Weeds species are flourishing.
- Very dense weed growth at site; blackberry and Paterson's curse, castor plants, Datura weed, capeweed and melon.
- Eastern snake necked tortoise spotted.
- Site was moved after weed growth made former site impossible to reach.
