ORRORAL VALLEY FIRE RAPID RISK ASSESSMENT NAMADGI NATIONAL PARK

RAPID RISK ASSESSMENT TEAM

Environment, Planning and
Sustainable Development Directorate

March 2020

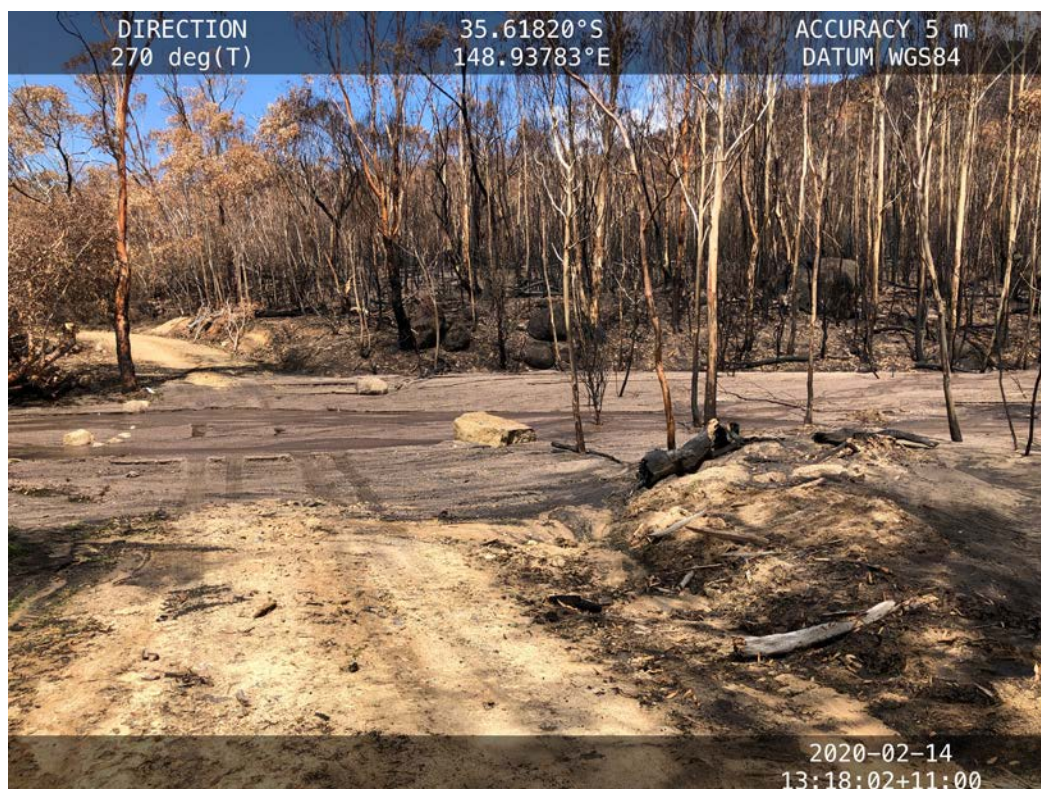
With elevated runoff rates and erosion potential in areas of high burn severity, roads and walking tracks that intersect such areas within the burn are likely to be impacted by debris flows, mass movement, and sedimentation. At high erosion risk locations, 3 km of roads and 5 km of walking tracks have been identified, and for debris flow risk, 2.5 Ha adjacent to walking tracks and 6.5 Ha adjacent to roads have been identified.

Sedimentation on Cotter Hut Road, Julian Seddon

A thorough field assessment of these roads and walking trails will determine the damage extent, to develop specific remediation measures. Where roads and walking tracks intersect highly erodible hillslopes, upslope stabilisation works will mitigate sedimentation impacts.

- > Assessment of roads and walking tracks that intersect with high erosion risk hazard modelling
- > Refer to prescribed management strategies for invasive plants and animals to mitigate riparian vegetation impacts
- > Direct stabilisation works, where required

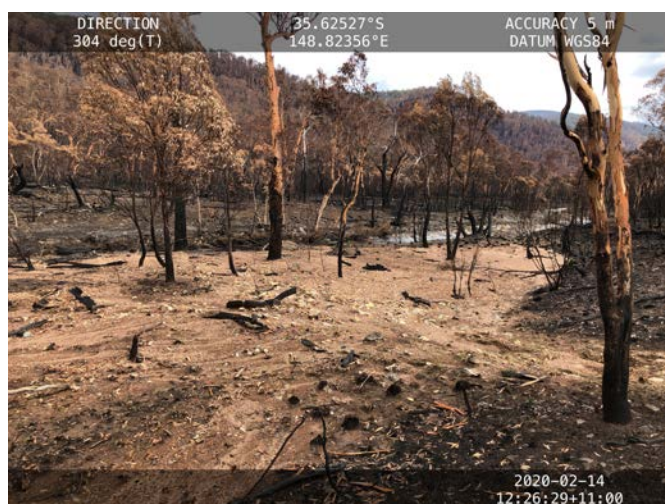
At a catchment scale, where high burn severity, high erosion risk, and waterways of second order and above intersect, the likelihood of elevated stream flows and subsequent waterway erosion is increased. This is exacerbated when riparian vegetation is also impacted by fire.

Relative to catchment area, the Cotter River draining into Corin Dam and the Gudgenby River catchments are the most impacted by high severity fire. The increased runoff rates in these catchments are, therefore, the most likely to impact the geomorphic stability of waterways, which can result in wider, shallower and less sinuous stream channels. These changes directly impact aquatic habitat. An assessment of riparian and waterway condition will determine the need for specialised streambank and bed stabilisation works, such as bank and bed revetment and sedimentation controls.

Sediment deposition adjacent to Cotter River
Julian Seddon

- > Detailed survey of the extent of riparian vegetation and waterway condition in high risk sub-catchments
- > Refer to prescribed management strategies for pest plants and animals to mitigate riparian vegetation impacts
- > Direct stabilisation works, where required

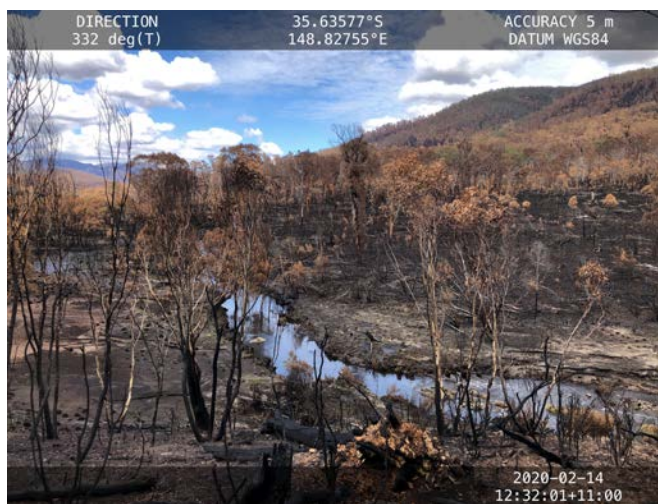
Riparian vegetation adjacent to Cotter River
Julian Seddon

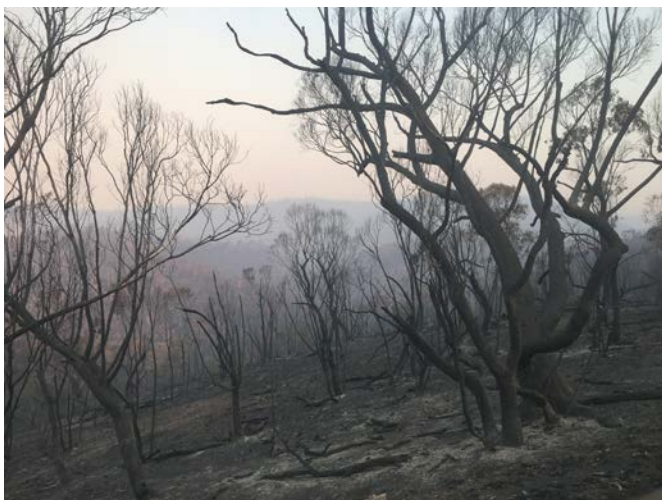
The erosion risk hazard of hillslopes is directly correlated with the localised severity of the fire and the extent to which hillslopes are naturally susceptible to erosion. After fire, as surface vegetation that would otherwise capture rainfall is reduced, the proportion of rainfall that results in overland flow significantly increases. Soil protection measures that reduce runoff and increase infiltration are proposed, including the installation of coir logs, felled timber barriers and contour furrowing.

High severity burnt hillslope

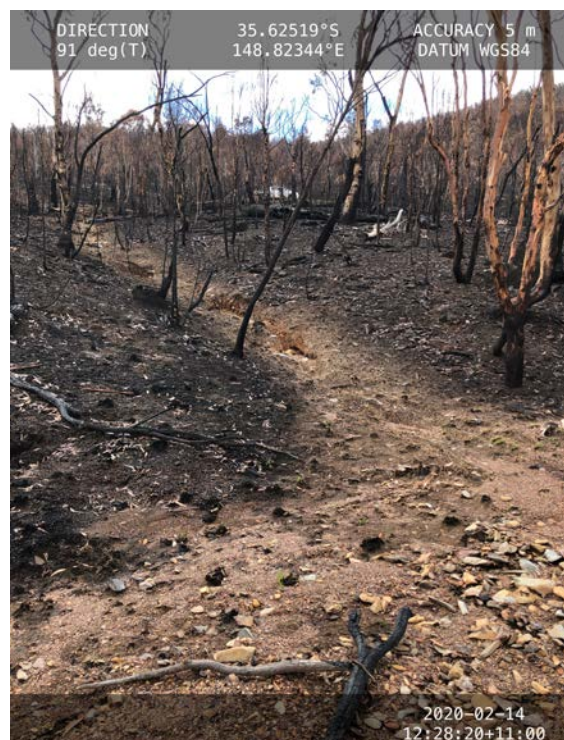
Erosion initiated from culvert outlet

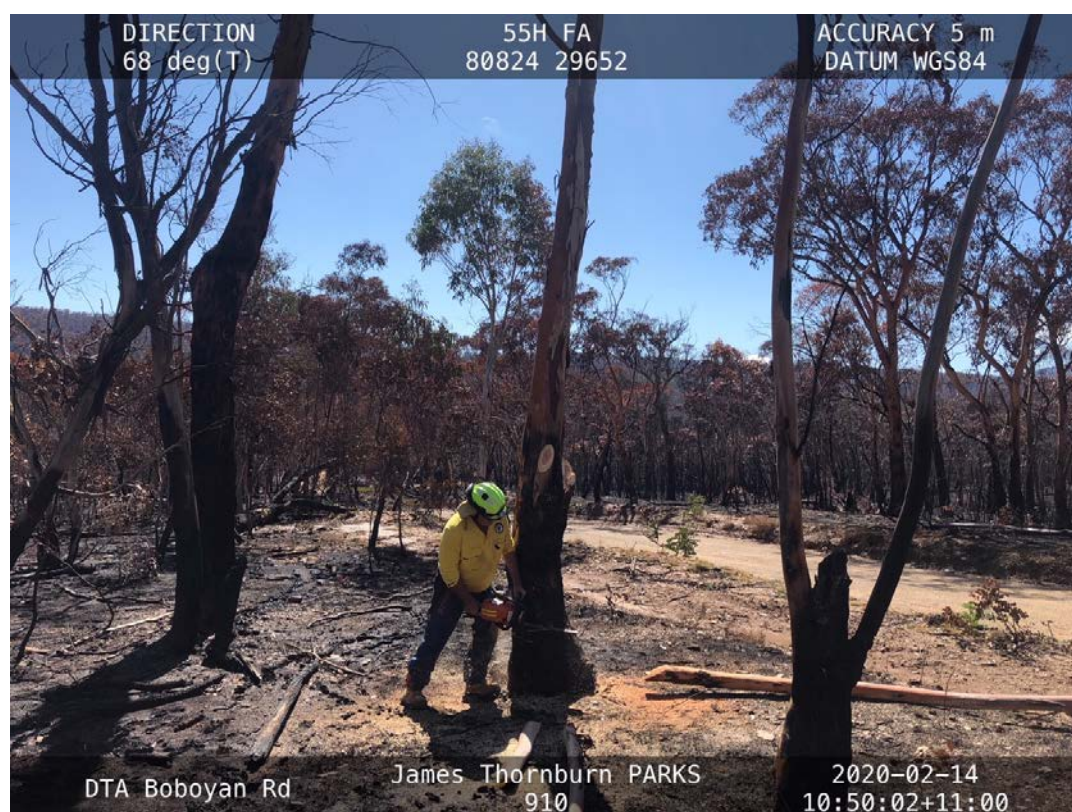
290 km of fire trail, 84 km of walking tracks and 19 recognised visitor nodes are within the burn area. Falling trees and limbs are an extreme risk to life and will need to be mitigated prior to reopening these areas to the public.

Tree assessment and tree clearing, Boboyan Road
Amanda (AJ) Johnson

- > Keep areas closed to the public until safety assessments and works have been completed
- > Maintain barriers, signage and regular compliance patrols
- > Identify sites where minimal work is required and prioritise to allow public access
- > Arborists to inspect hazardous trees and make recommendations
- > Ongoing monitoring of hazards will be required, particularly following storm events

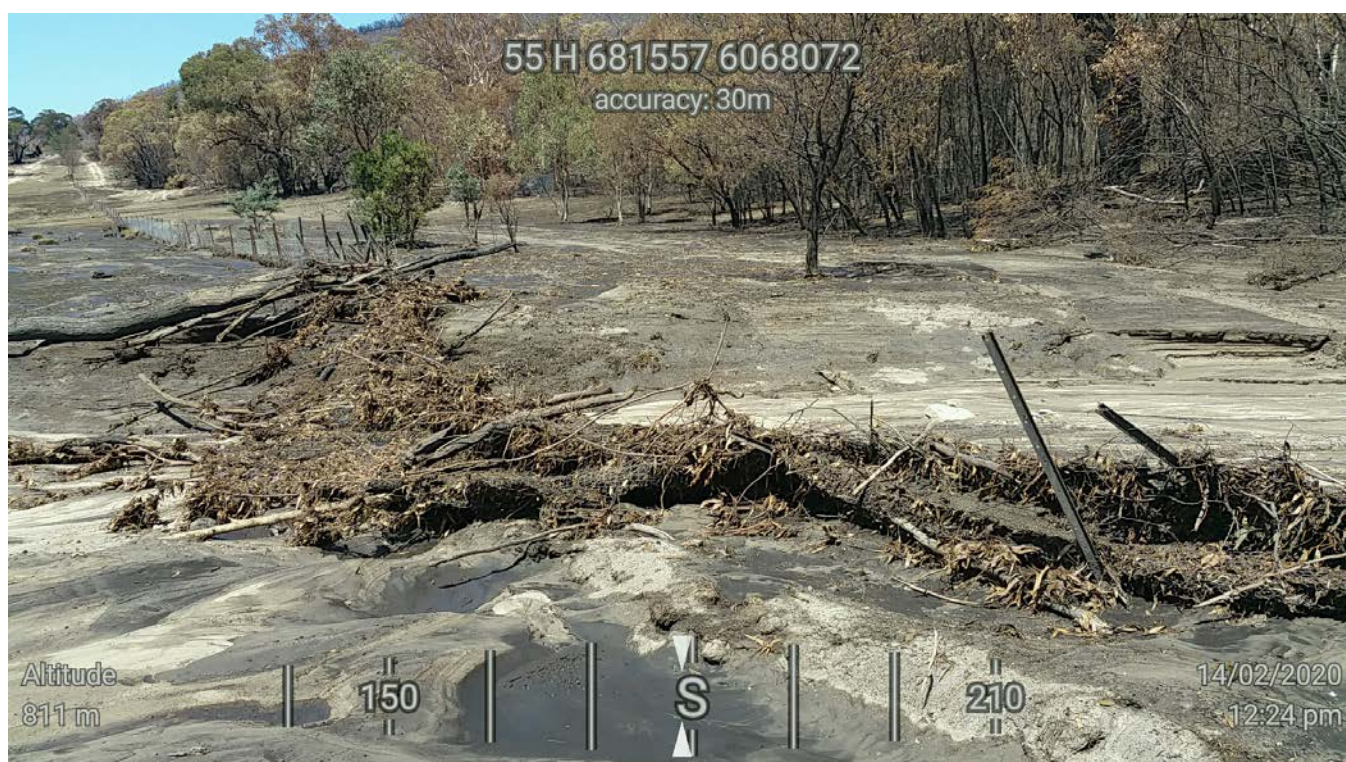
Fence damage from fire and runoff
Scott Seymour

Assets	Fencing	Stock movement, illegal access	Fire impact	Wandering stock, illegal vehicle access causing environmental/asset damage	High	Engage fencing contractors to repair/replace boundary fences within 3 months. Engage fencing contractors to repair/replace internal fences within 12 months. Consider using flame resistant fencing materials.	Possible	Minor	Medium
Assets	Visitor infrastructure	Fire impacted infrastructure requiring repair. Staff and public safety	Fire impact	Injury to staff and public, damage to infrastructure, environmental contamination	High	Keep areas closed to public until safety works have been completed. Assess damaged infrastructure and remove and rebuild as required. Consider using flame resistant materials to enhance durability.	Unlikely	Moderate	Medium
Assets	Cultural assets (not heritage listed - in heritage section)	Damage/destruction of European cultural sites not registered on the Heritage Register	Fire impact, moderate to heavy rainfall event	Loss/damage to European cultural sites	Medium	Field assessment of European cultural sites. Provide report on future actions and ongoing costs of management. Consult with ACT Heritage regarding recovery actions and ongoing maintenance or reconstruction.	Unlikely	Minor	Medium

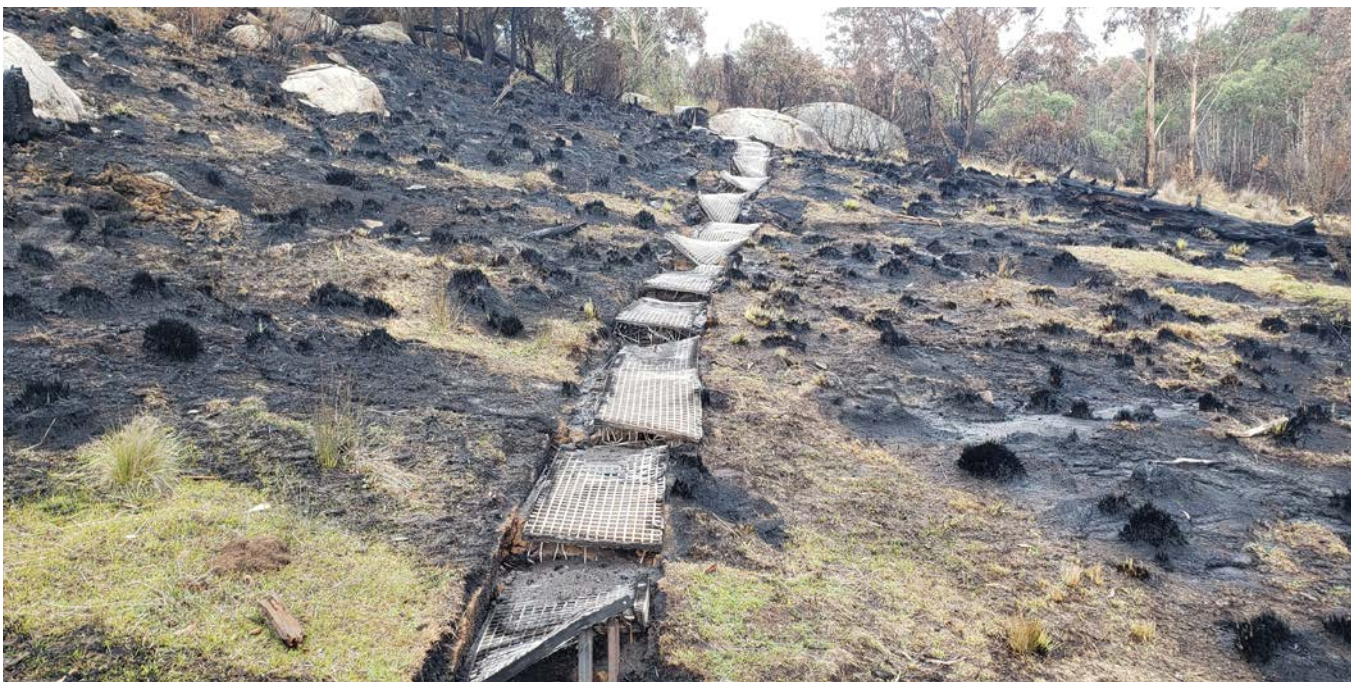
Damaged boardwalk Brandy Flat Walk
Deklyn Townsend

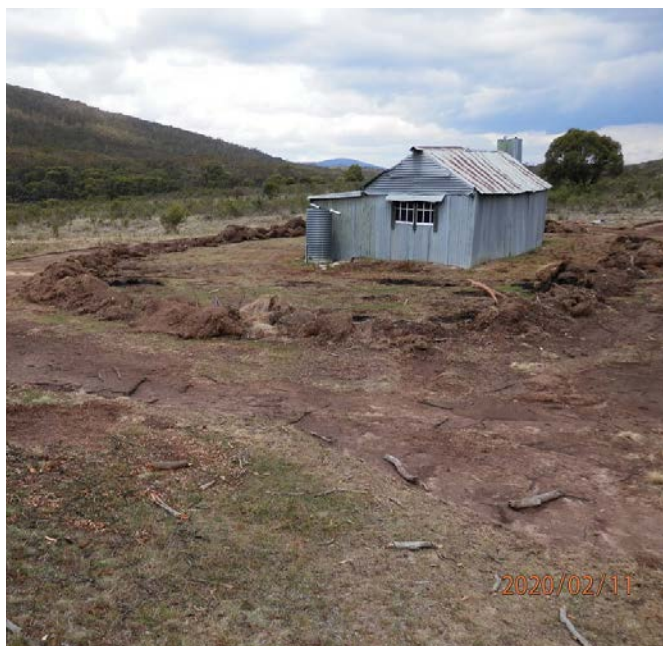
Waterholes Hut, 2020 dozer line
Adam Henderson

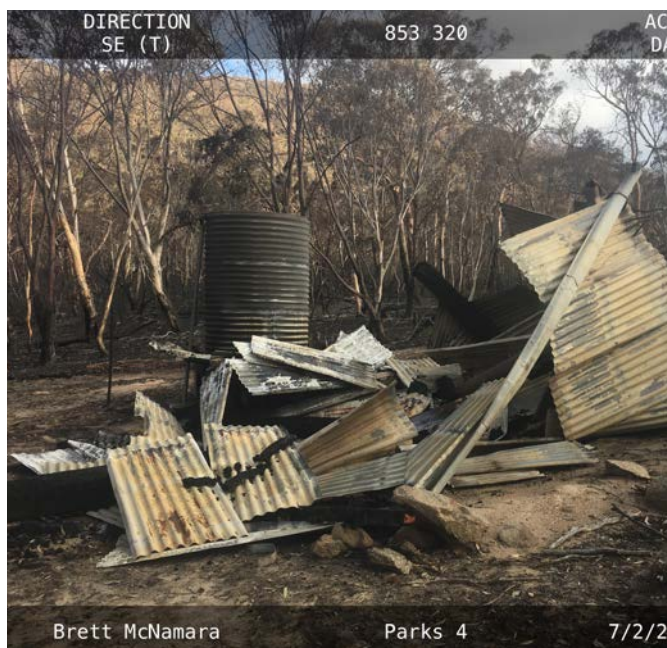
Two historic huts within the fire affected area – ‘Demanding Hut’ and ‘Max and Bert Oldfield’s Hut’ – have been directly impacted by fire, resulting in collapse and major damage.

Demanding Hut, post 2020 fire

Cultural Heritage	Historic heritage - high country huts	Damage to historic huts from fire. Damage to historic fabric.	Fire impact	Loss of heritage values	Extreme	Condition assessment of Demanding Hut and Max and Bert Oldfield's Hut by heritage specialist to identify any additional management actions needed. Install temporary fencing prior to park reopening. Medium priority - undertake within 3 months.	Likely	Major	High
Cultural Heritage	Aboriginal and historic heritage - timber heritage sites	Loss of heritage trees (standing/fallen) due to fire impacts. Health impacts that shorten tree life.	Moderate to very high fire severity areas	Loss of cultural heritage	High	Includes scarred trees, survey marker trees, and brumby yards. Condition assessments by archaeologist, including arborist and RAOs for Aboriginal cultural tree inspections. Identify any additional management actions. Medium priority - undertake within 3 months.	Possible	Moderate	Medium

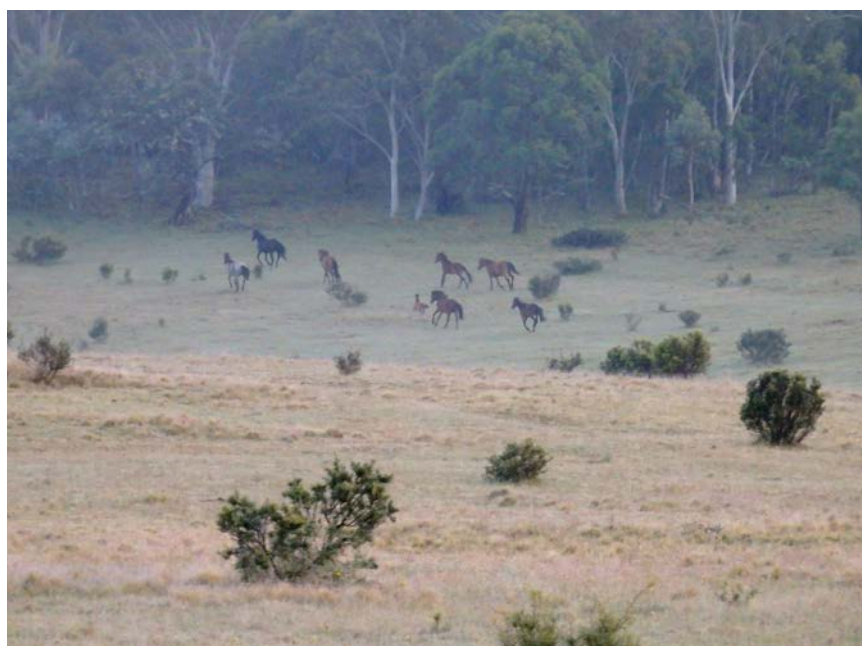
Horse damage in sub-alpine bog
D Butcher
