Common Ground Dickson Historical Archaeological Test Excavation Report

Prepared for Housing ACT

October 2020—Final

| Project: | Common Ground Dickson Archaeological Investigations |

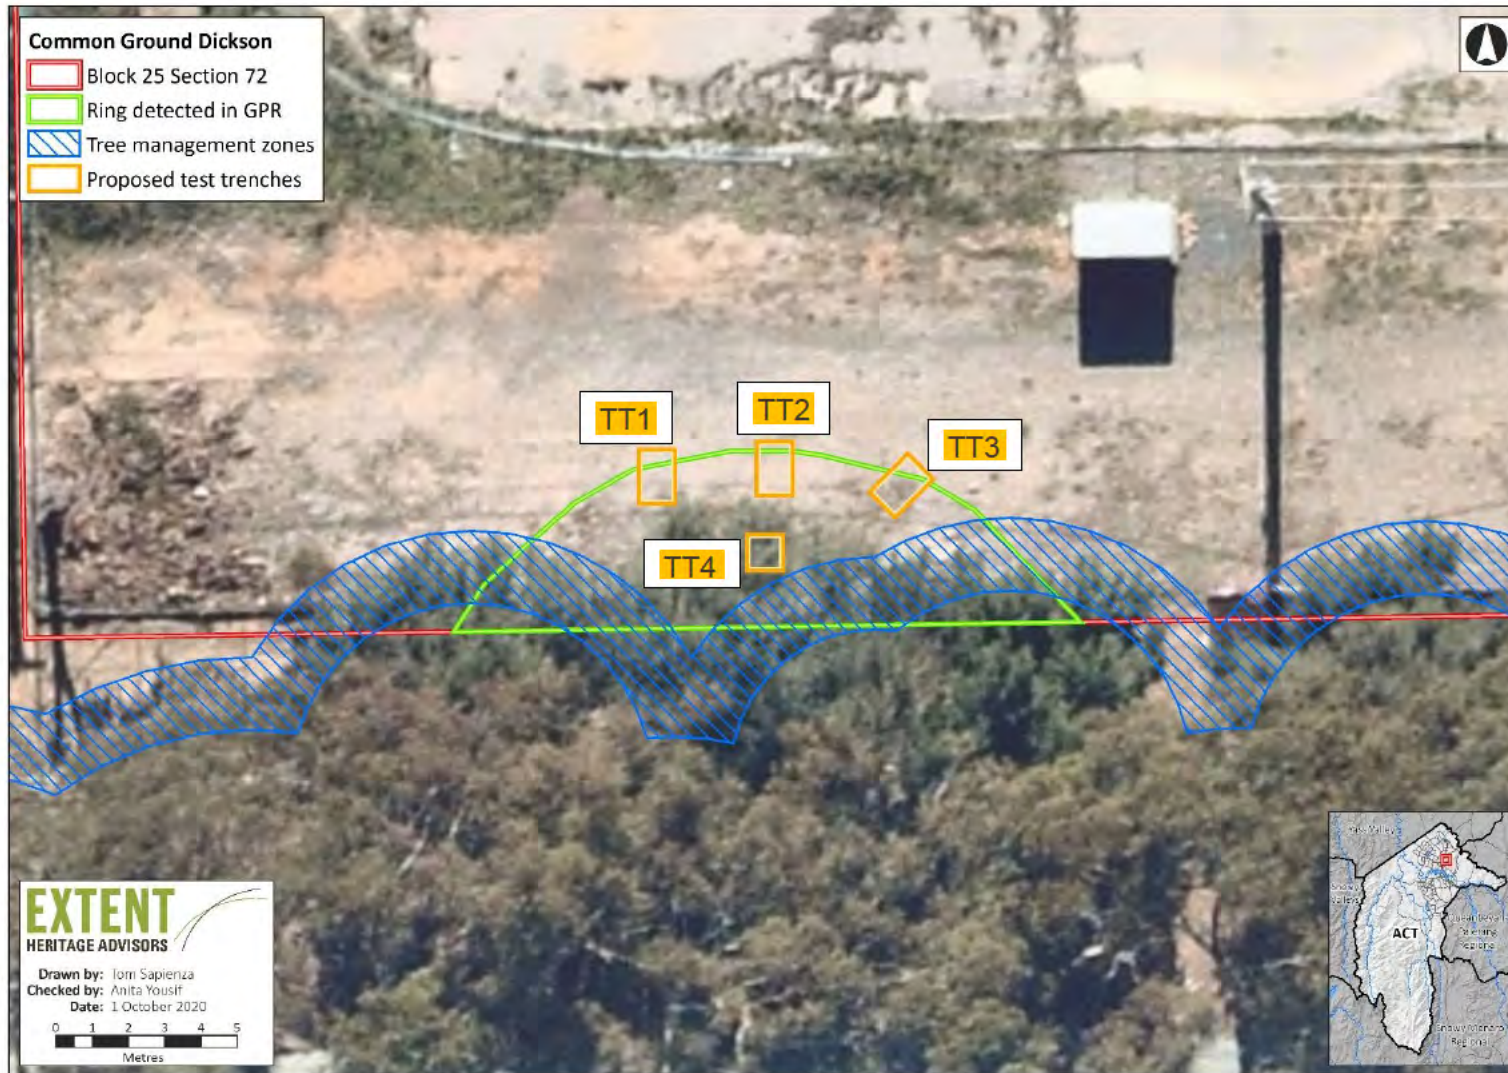
Appendix B. Location of the proposed test trenches relative to the TZP

Appendix B. An aerial showing the location of the proposed test trenches relative to the tree protection zone (TPZ)

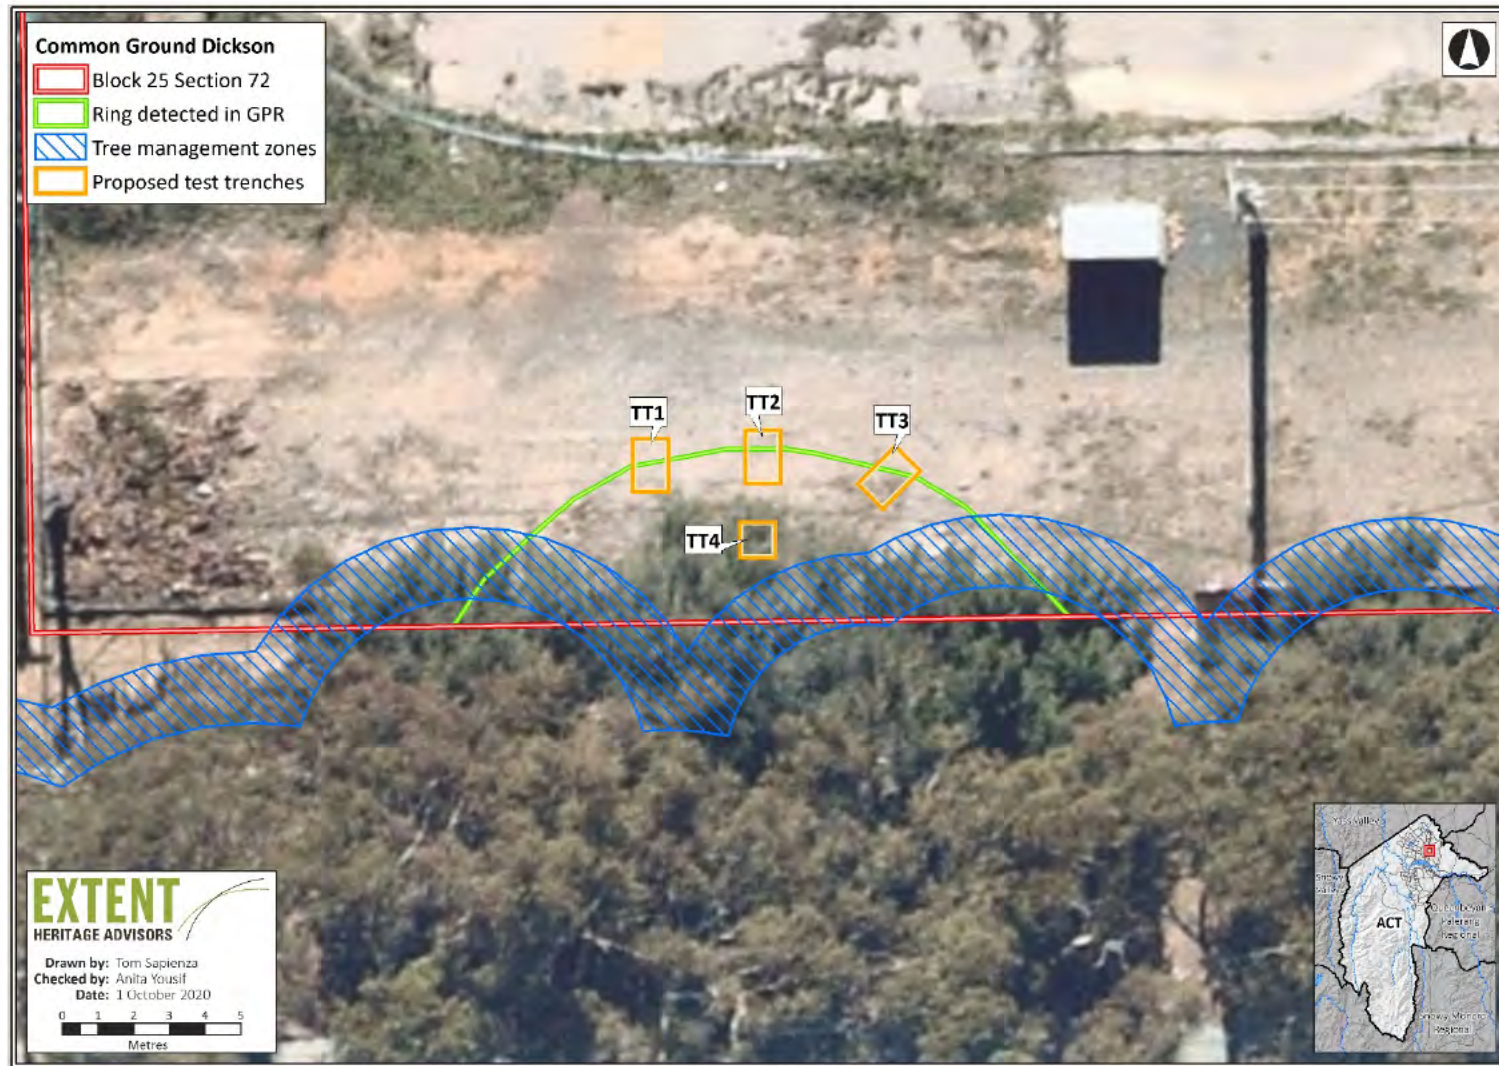
Figure 4. The proposed location of test trenches TT1-TT4 over the probable location of Fragment A.

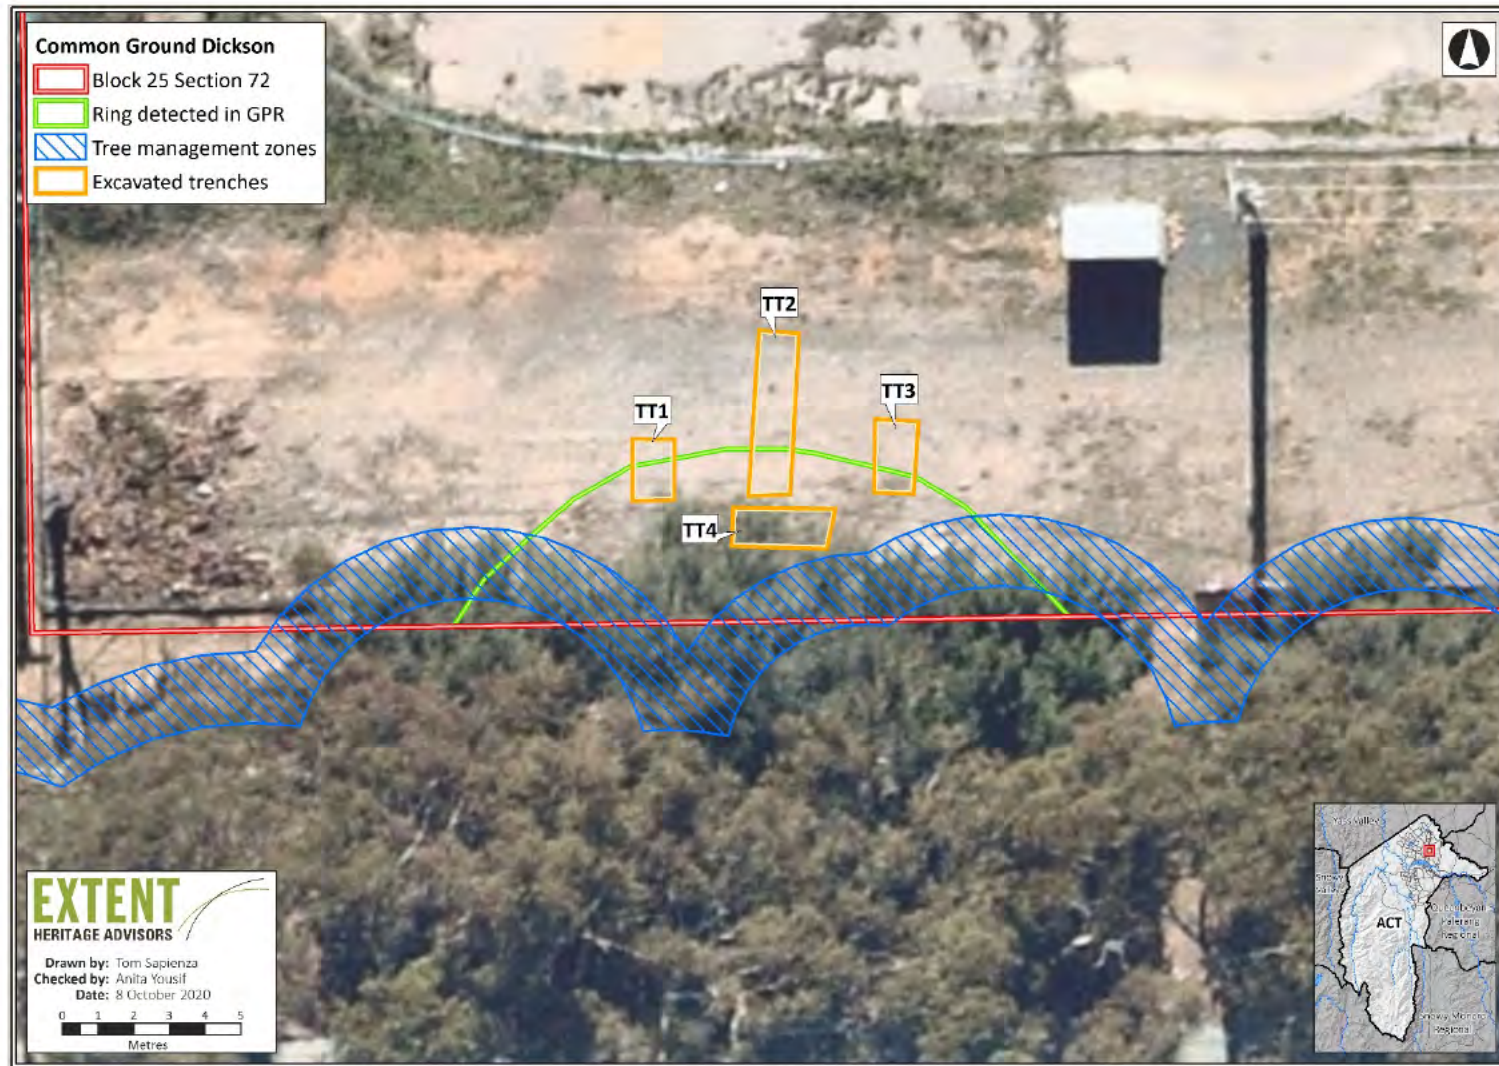
Figure 5. The final size and location of test trenches TT1-TT4 over the probable location of Fragment A.

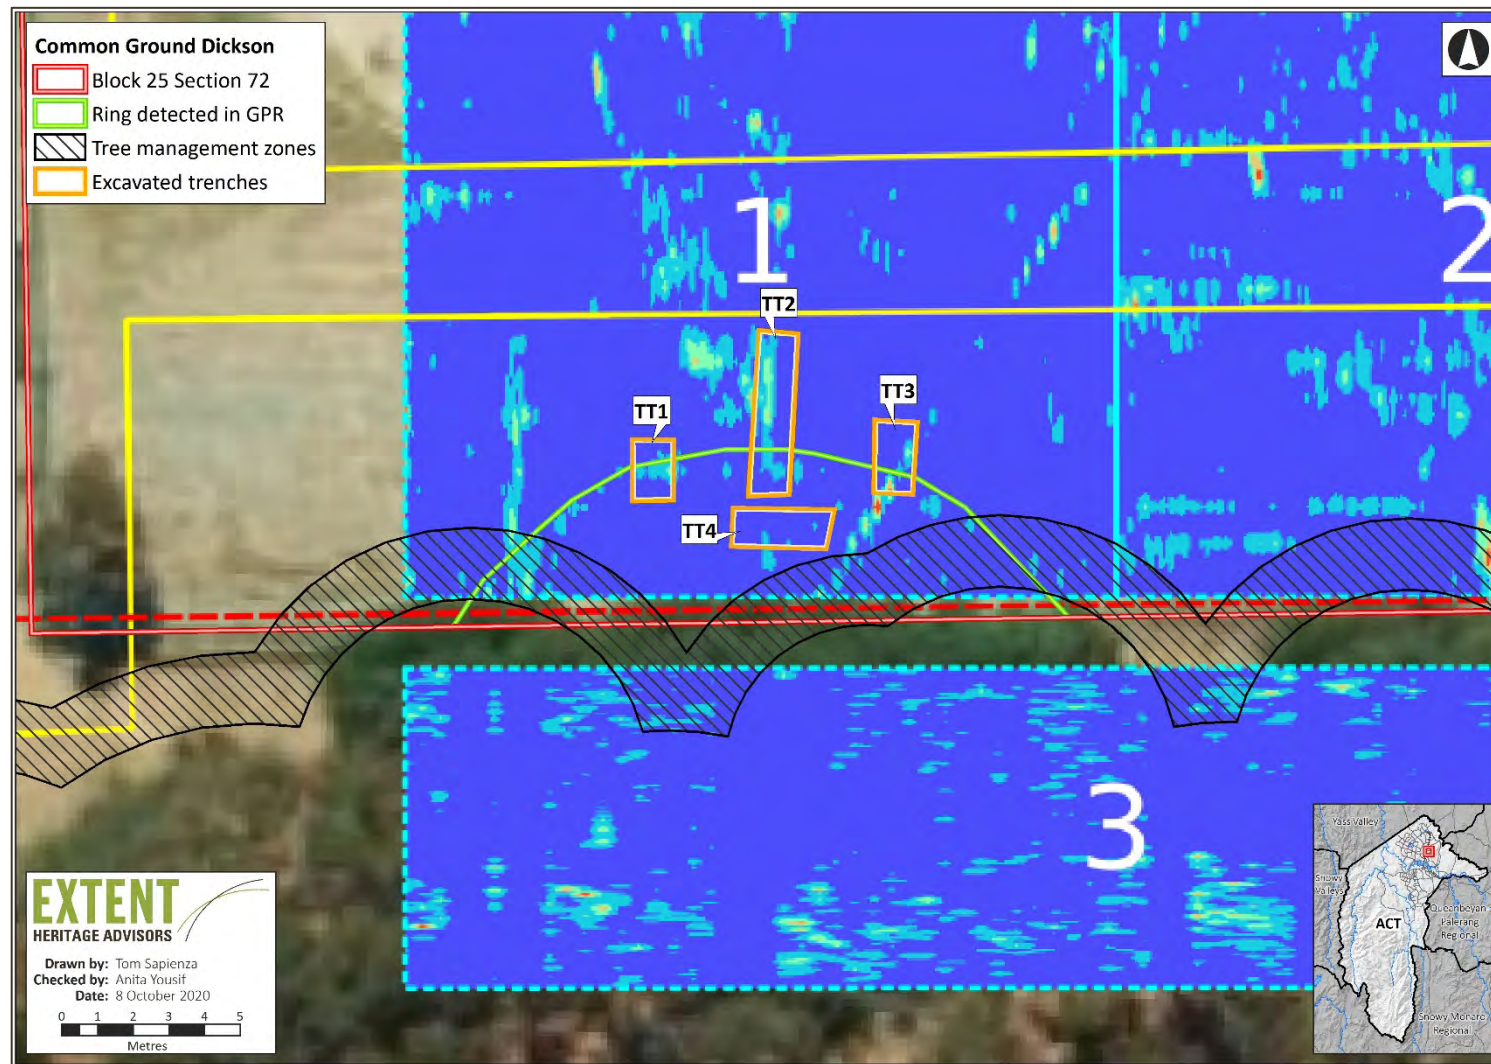
Figure 6. The final size and location of test trenches TT1-4 over the GPR detected location of Fragment A.

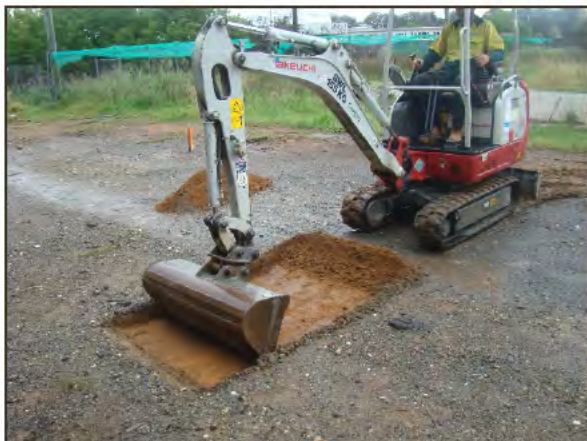
Figure 7. Mechanical excavation of the initial spits in TT1 (facing north-west).

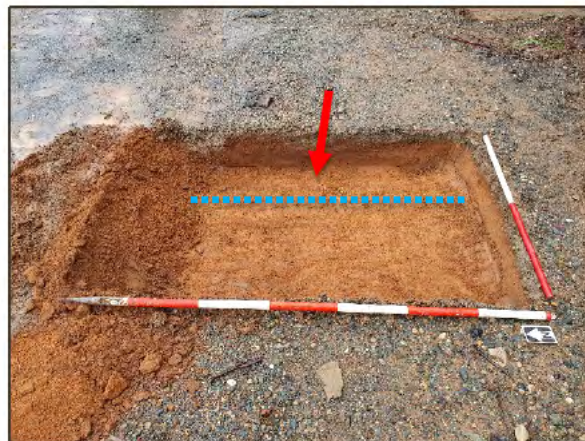
Figure 8. The base of TT1 with a service line (indicated by blue dashed line) containing yellow plastic tape running along the east end of the trench (facing east).

Excavation commenced at TT1. This trench measured 1 x 1.5m and was excavated to a depth of 250mm when a service line was encountered. It is a narrow trench containing yellow plastic indicating a gas line, which was supposed to be further west, according to Dial. Before you dig investigations, the trench included unformed light brown-orange clayey silt.

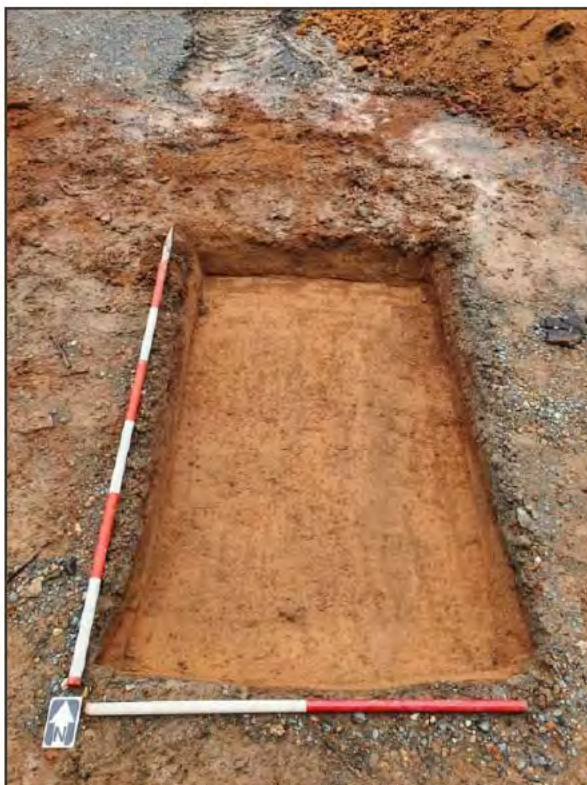
Figure 9. TT1, after excavation (facing north).

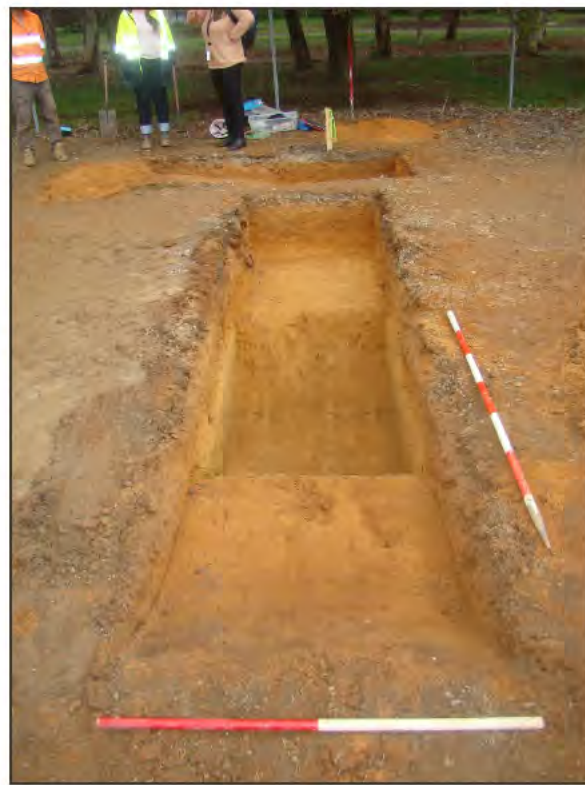
Figure 10. TT2, after excavation (4500 mm x 1100 mm x 1050 mm). TT4 is visible in the background (facing south).

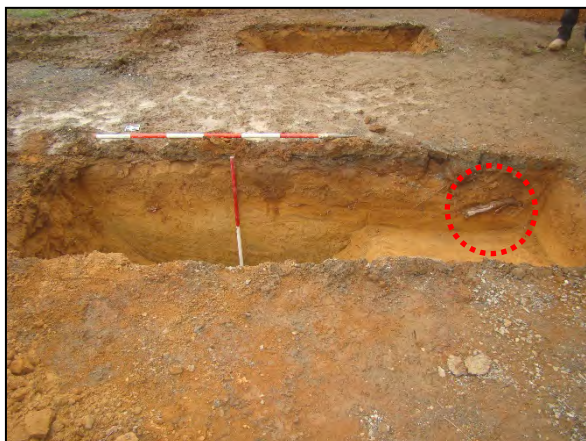
Figure 11. The medium-sized tree root (~60 mm diameter; outlined in red) in the southern portion of the east section of TT2. The root is 400 mm deep and originally ran across TT2 to the west section (see Figure 17).

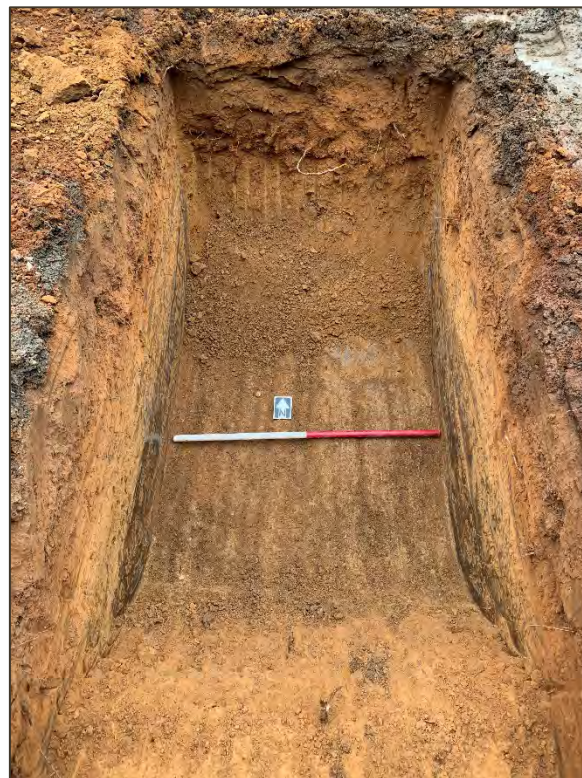
Figure 12. The base of TT2 (~1050 mm deep) comprising deposit 7: dark brown silty clay with frequent coarse sand and charcoal inclusions (facing north).

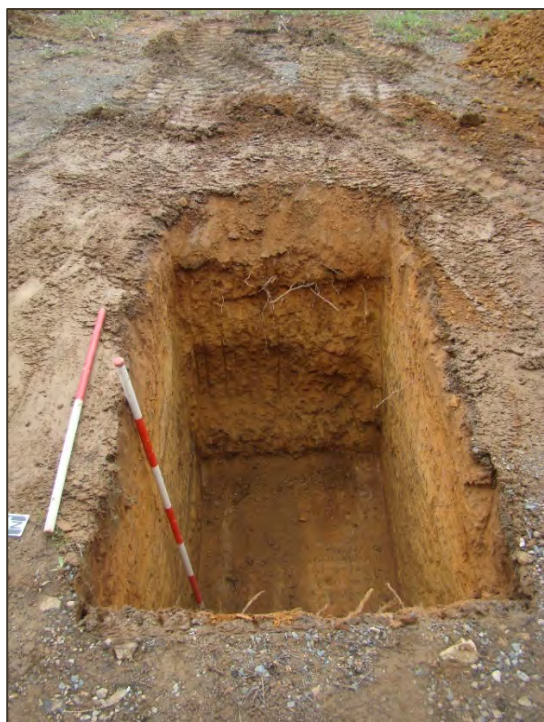
Figure 13. TT3, after excavation (2600 mm x 1100 mm x 1600 mm; facing north).

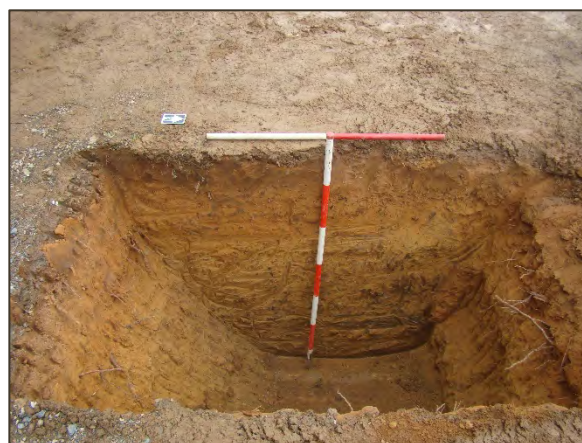
Figure 14. The west section of TT3, showing an identical stratigraphic soil profile to that seen in TT2 (facing west).

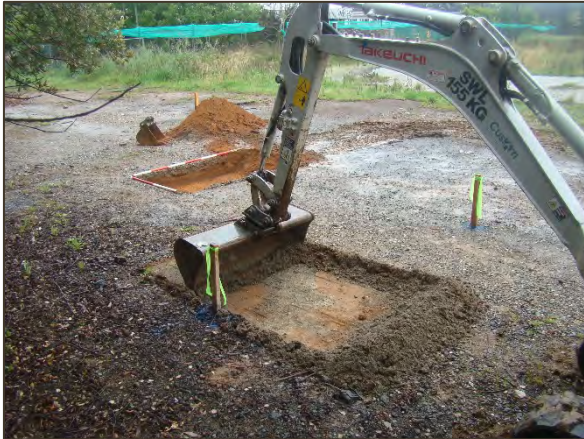
Figure 15. Mechanical excavation of the initial 50 mm spits at TT4. TT1 is visible in the background (facing north-west).

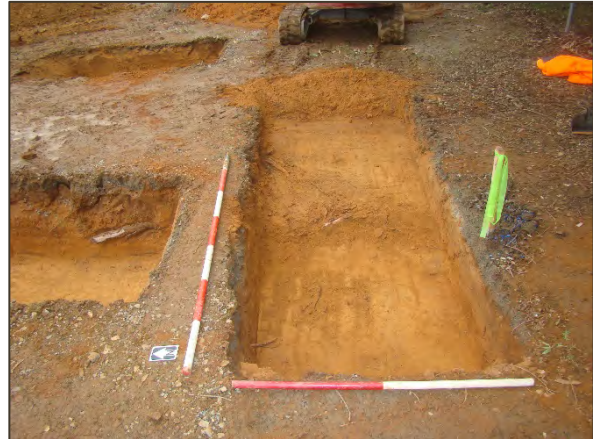
Figure 16. TT4, after excavation (2600 mm x 1100 mm x 450 mm). TT1 and TT3 are visible to the left of TT4 in the foreground and background, respectively (facing east).

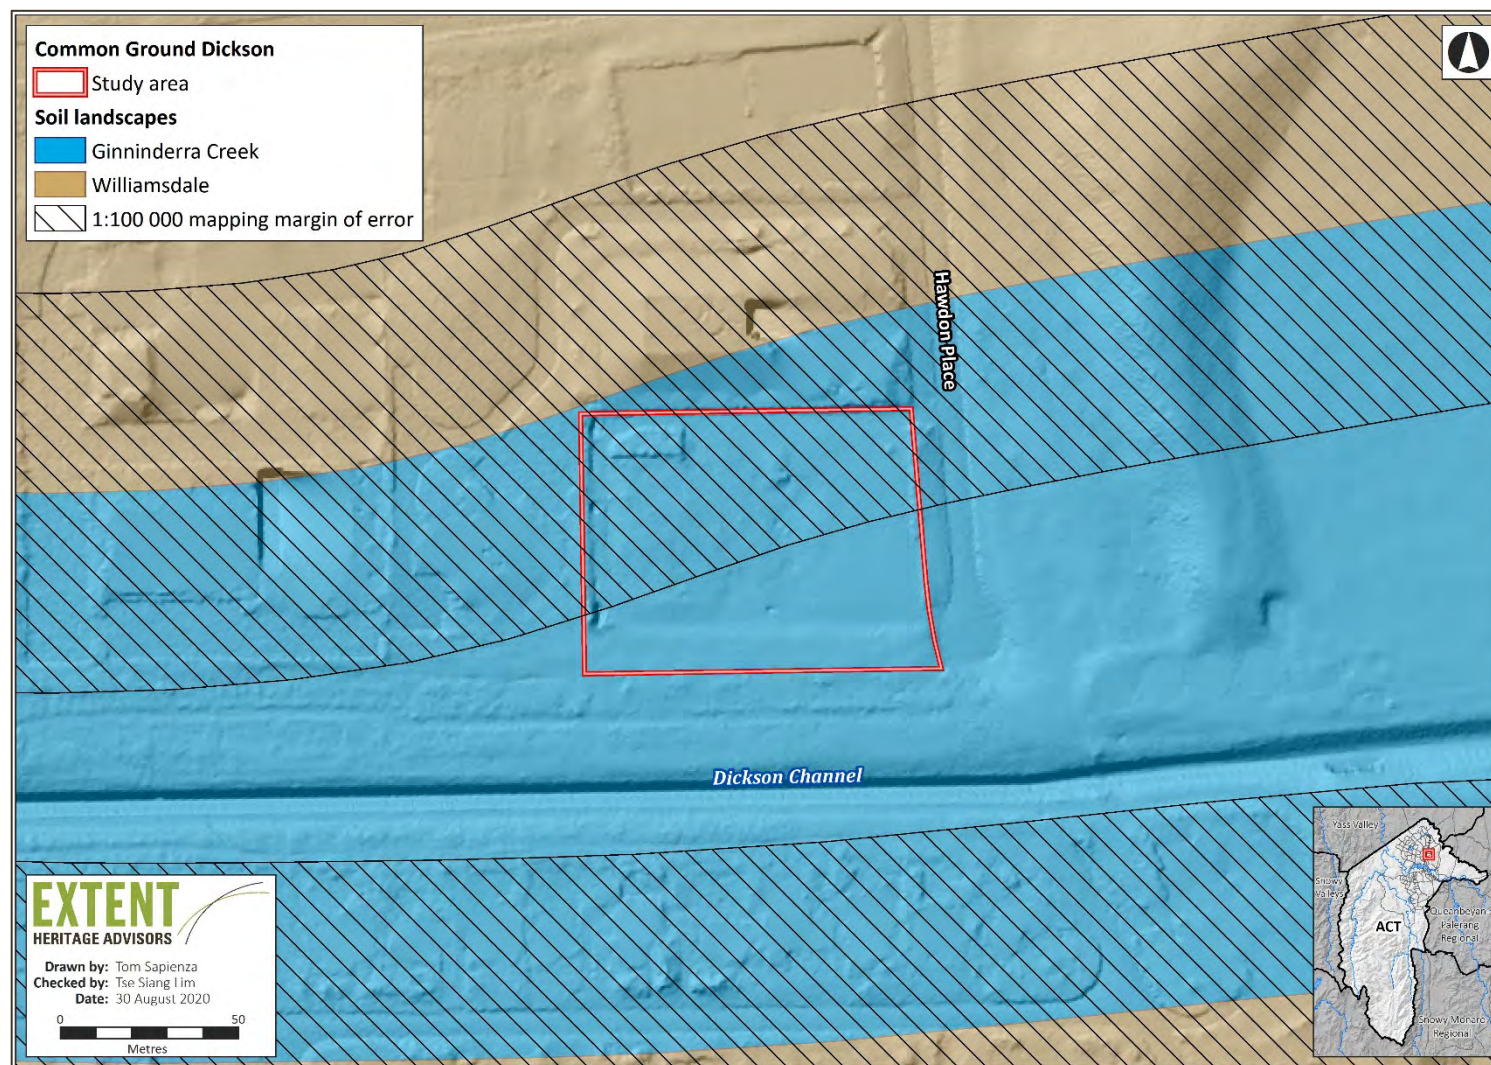
Figure 18. The Ginninderra Creek and Williamsdale soil landscapes in and around the study area (outlined in red).

Geotechnical testing undertaken within the study area approximately 30m north of the test trenches revealed clear signs of the Ginninderra Creek alluvial landscape: 200-500 mm of topsoil and fill over 2000-3000 mm of alluvium (ACT Geotechnical 2019a; 2019b), but the soils in the excavation trenches were definitely of the Williamsdale soil landscape. This result directly contradicted the expected subsurface conditions predicted by the soil landscape mapping (Figure 18).
