Ampol Holt

1 Hardwick Crescent, Holt, Australian Capital Territory (ACT)

CALTEX HOLT SERVICE STATION
1 HARDWICK CRESCENT
HOLT ACT

APPENDIX B

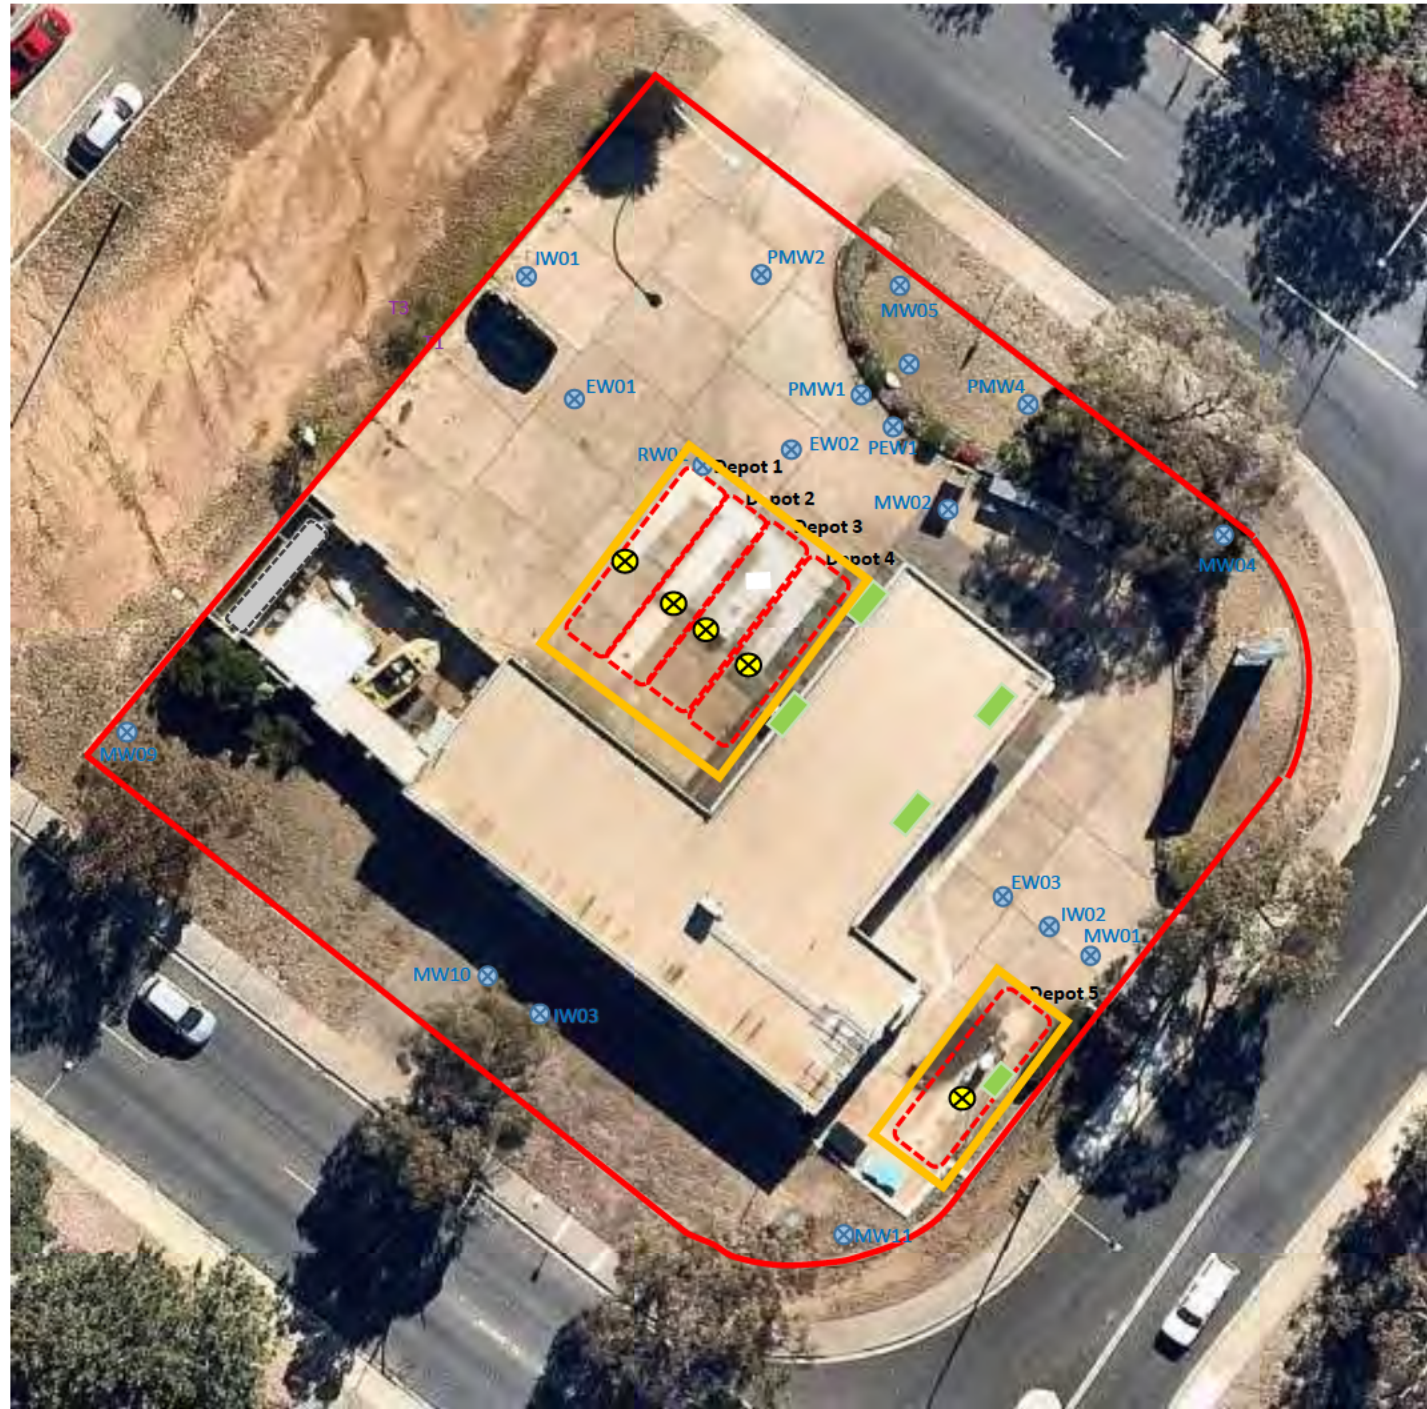
Figure 2 – Excavation extent

DEPOT	PRODUCT TYPE	VOLUME (L)	STATUS
1	V95	27,400	
2	Diesel	27,400	
3	E10	27,400	
4	V98	20,000	Out of service from 14 February 2020.
5	E10	59,400	
6	LPG	7,500	Decommissioned

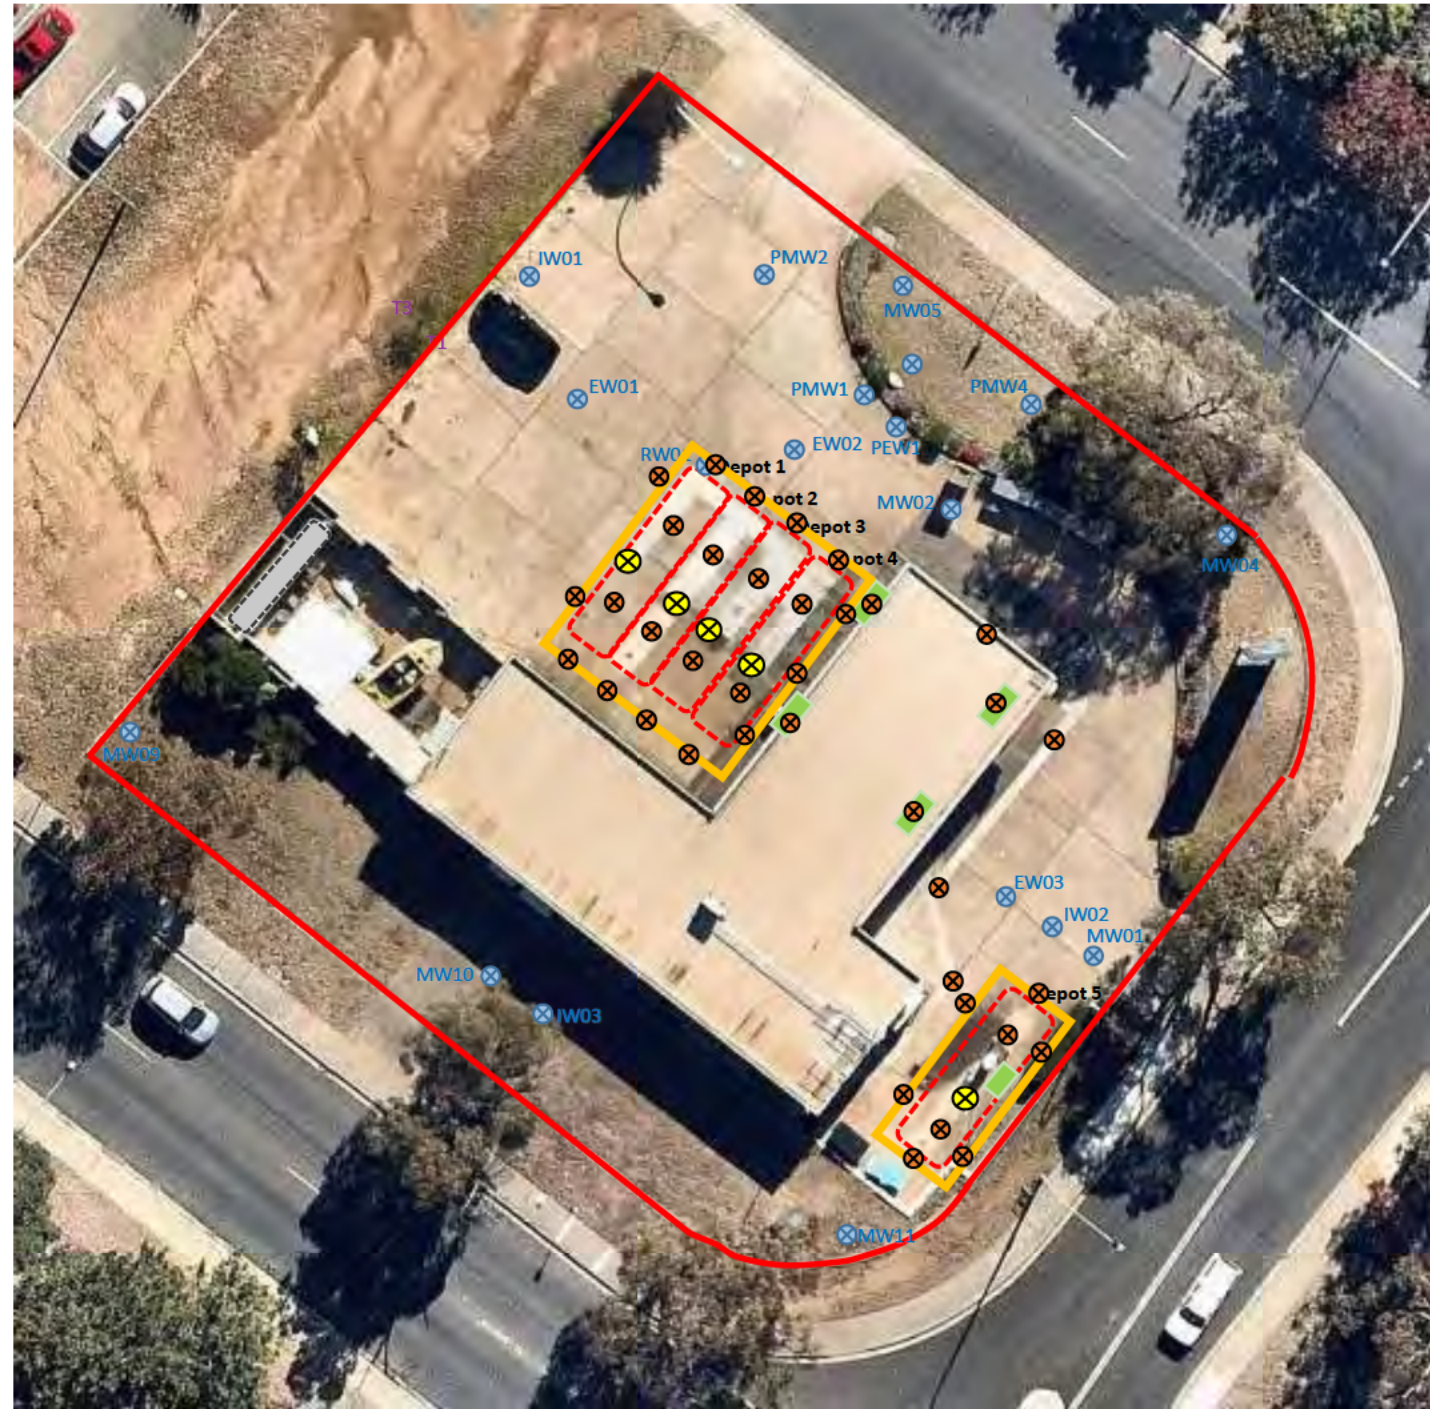
Figure 3 – Validation and sampling plan

DEPOT	PRODUCT TYPE	VOLUME (L)	STATUS
1	V95	27,400	
2	Diesel	27,400	
3	E10	27,400	
4	V98	20,000	Out of service from 14 February 2020.
5	E10	59,400	
6	LPG	7,500	Decommissioned

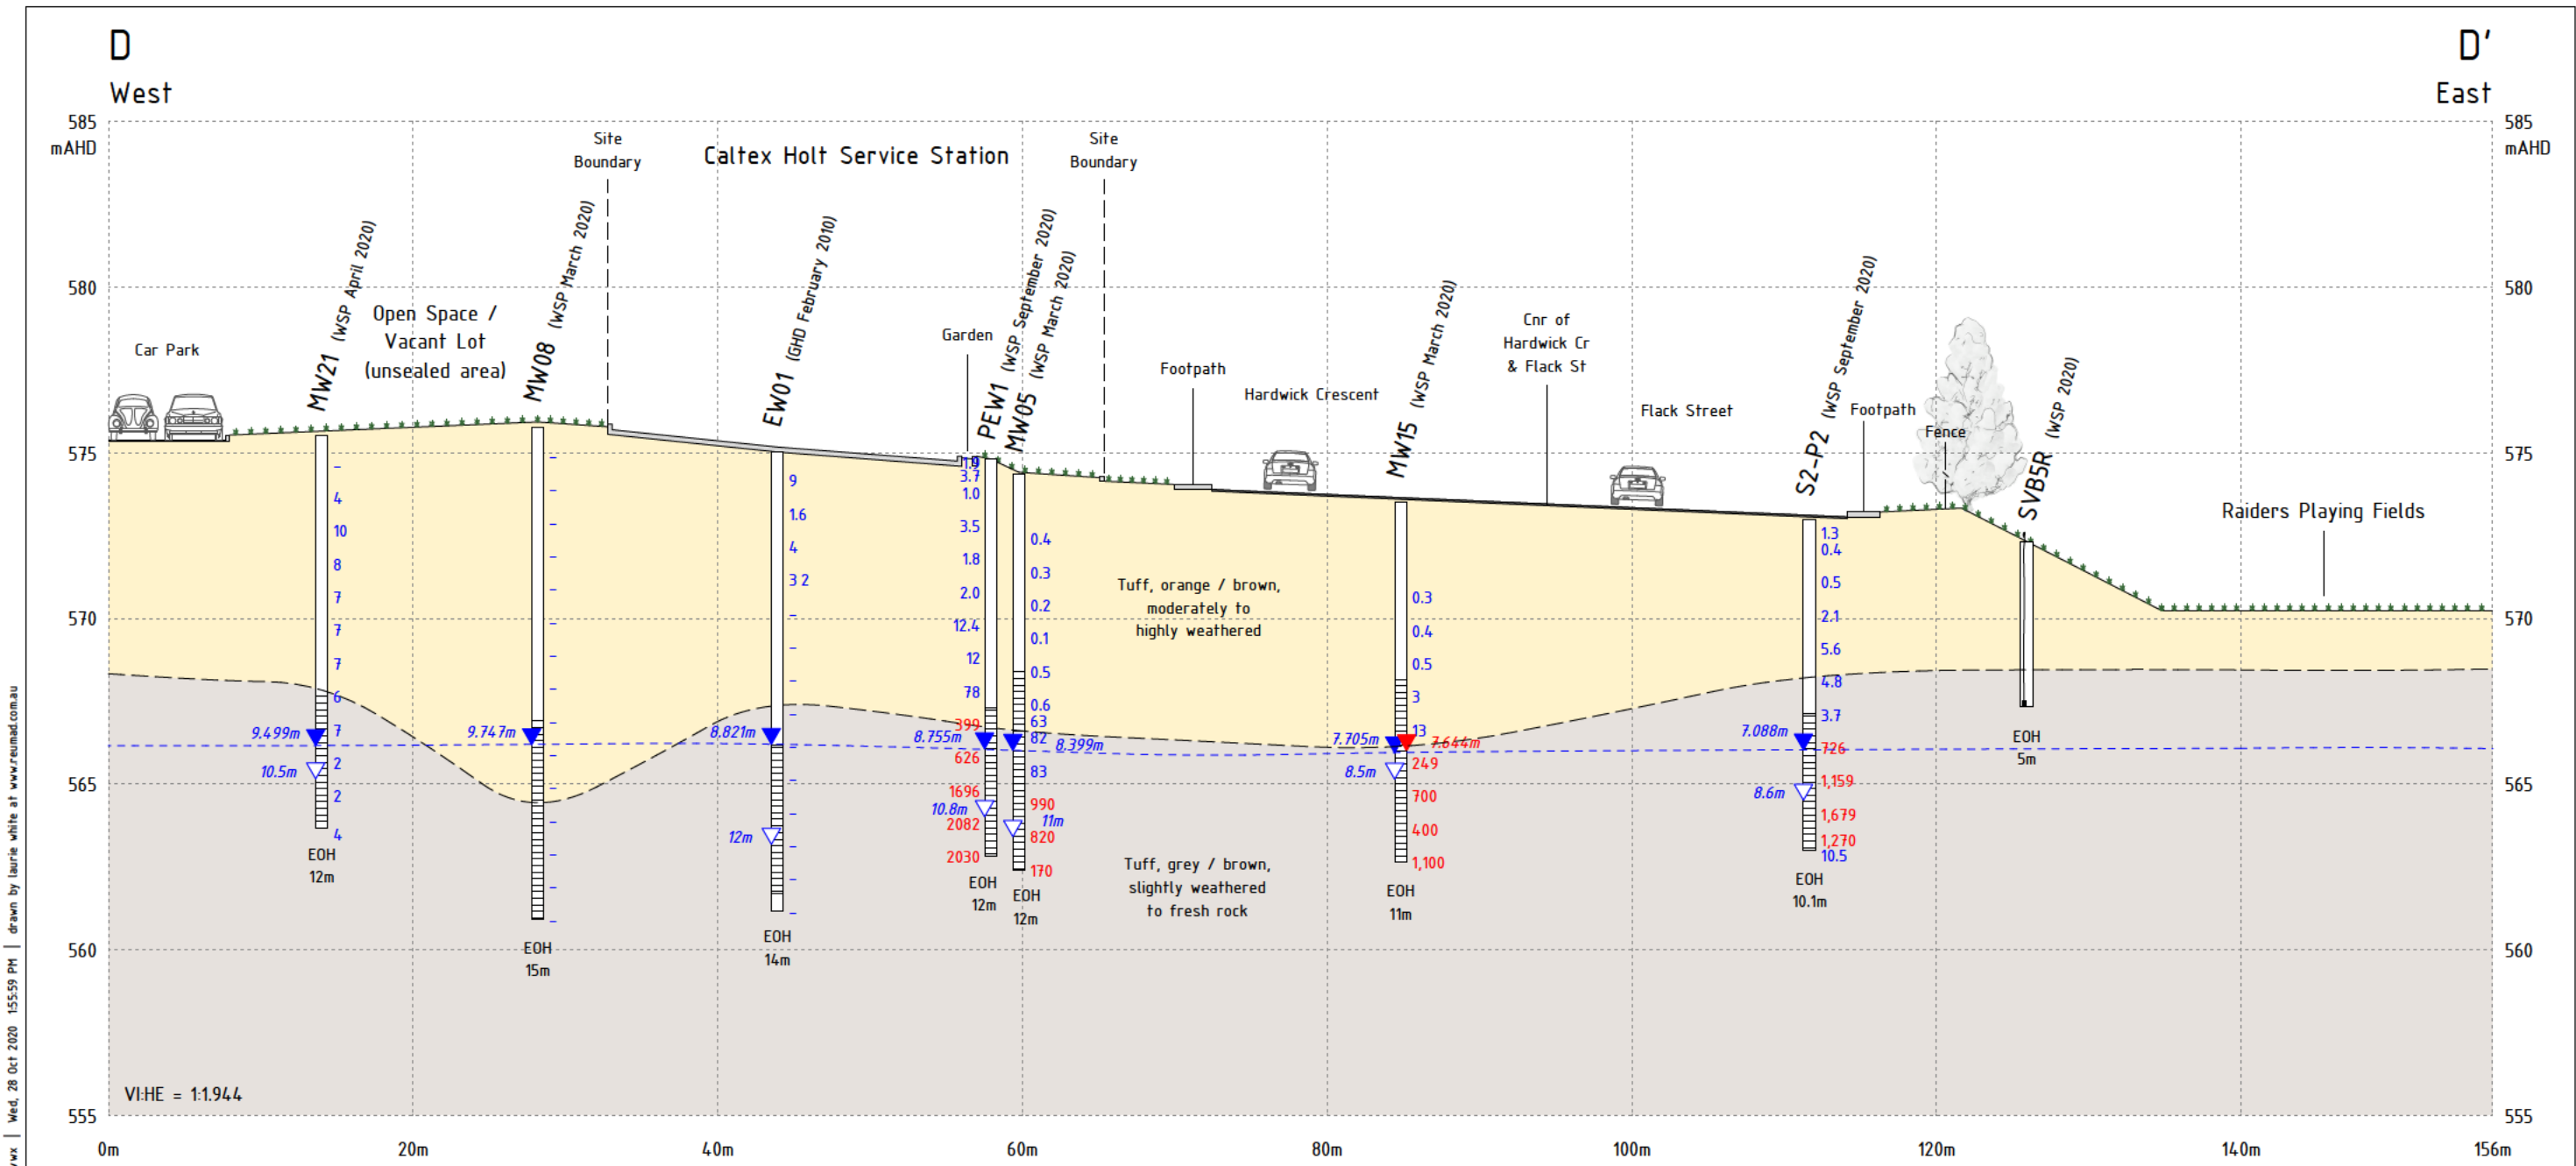
FIGURE 4f
CROSS SECTION D-D'

EW01 INSTALLED BY GHD FEBRUARY 2010, MW05, MW08 & MW15 INSTALLED BY WSP MARCH 2020, MW21 INSTALLED BY WSP APRIL 2020 AND S2-P2 & SVB5R INSTALLED BY WSP SEPTEMBER 2020. GROUNDWATER & LNAPL LEVELS GAUGED 28 & 29 SEPTEMBER 2020.

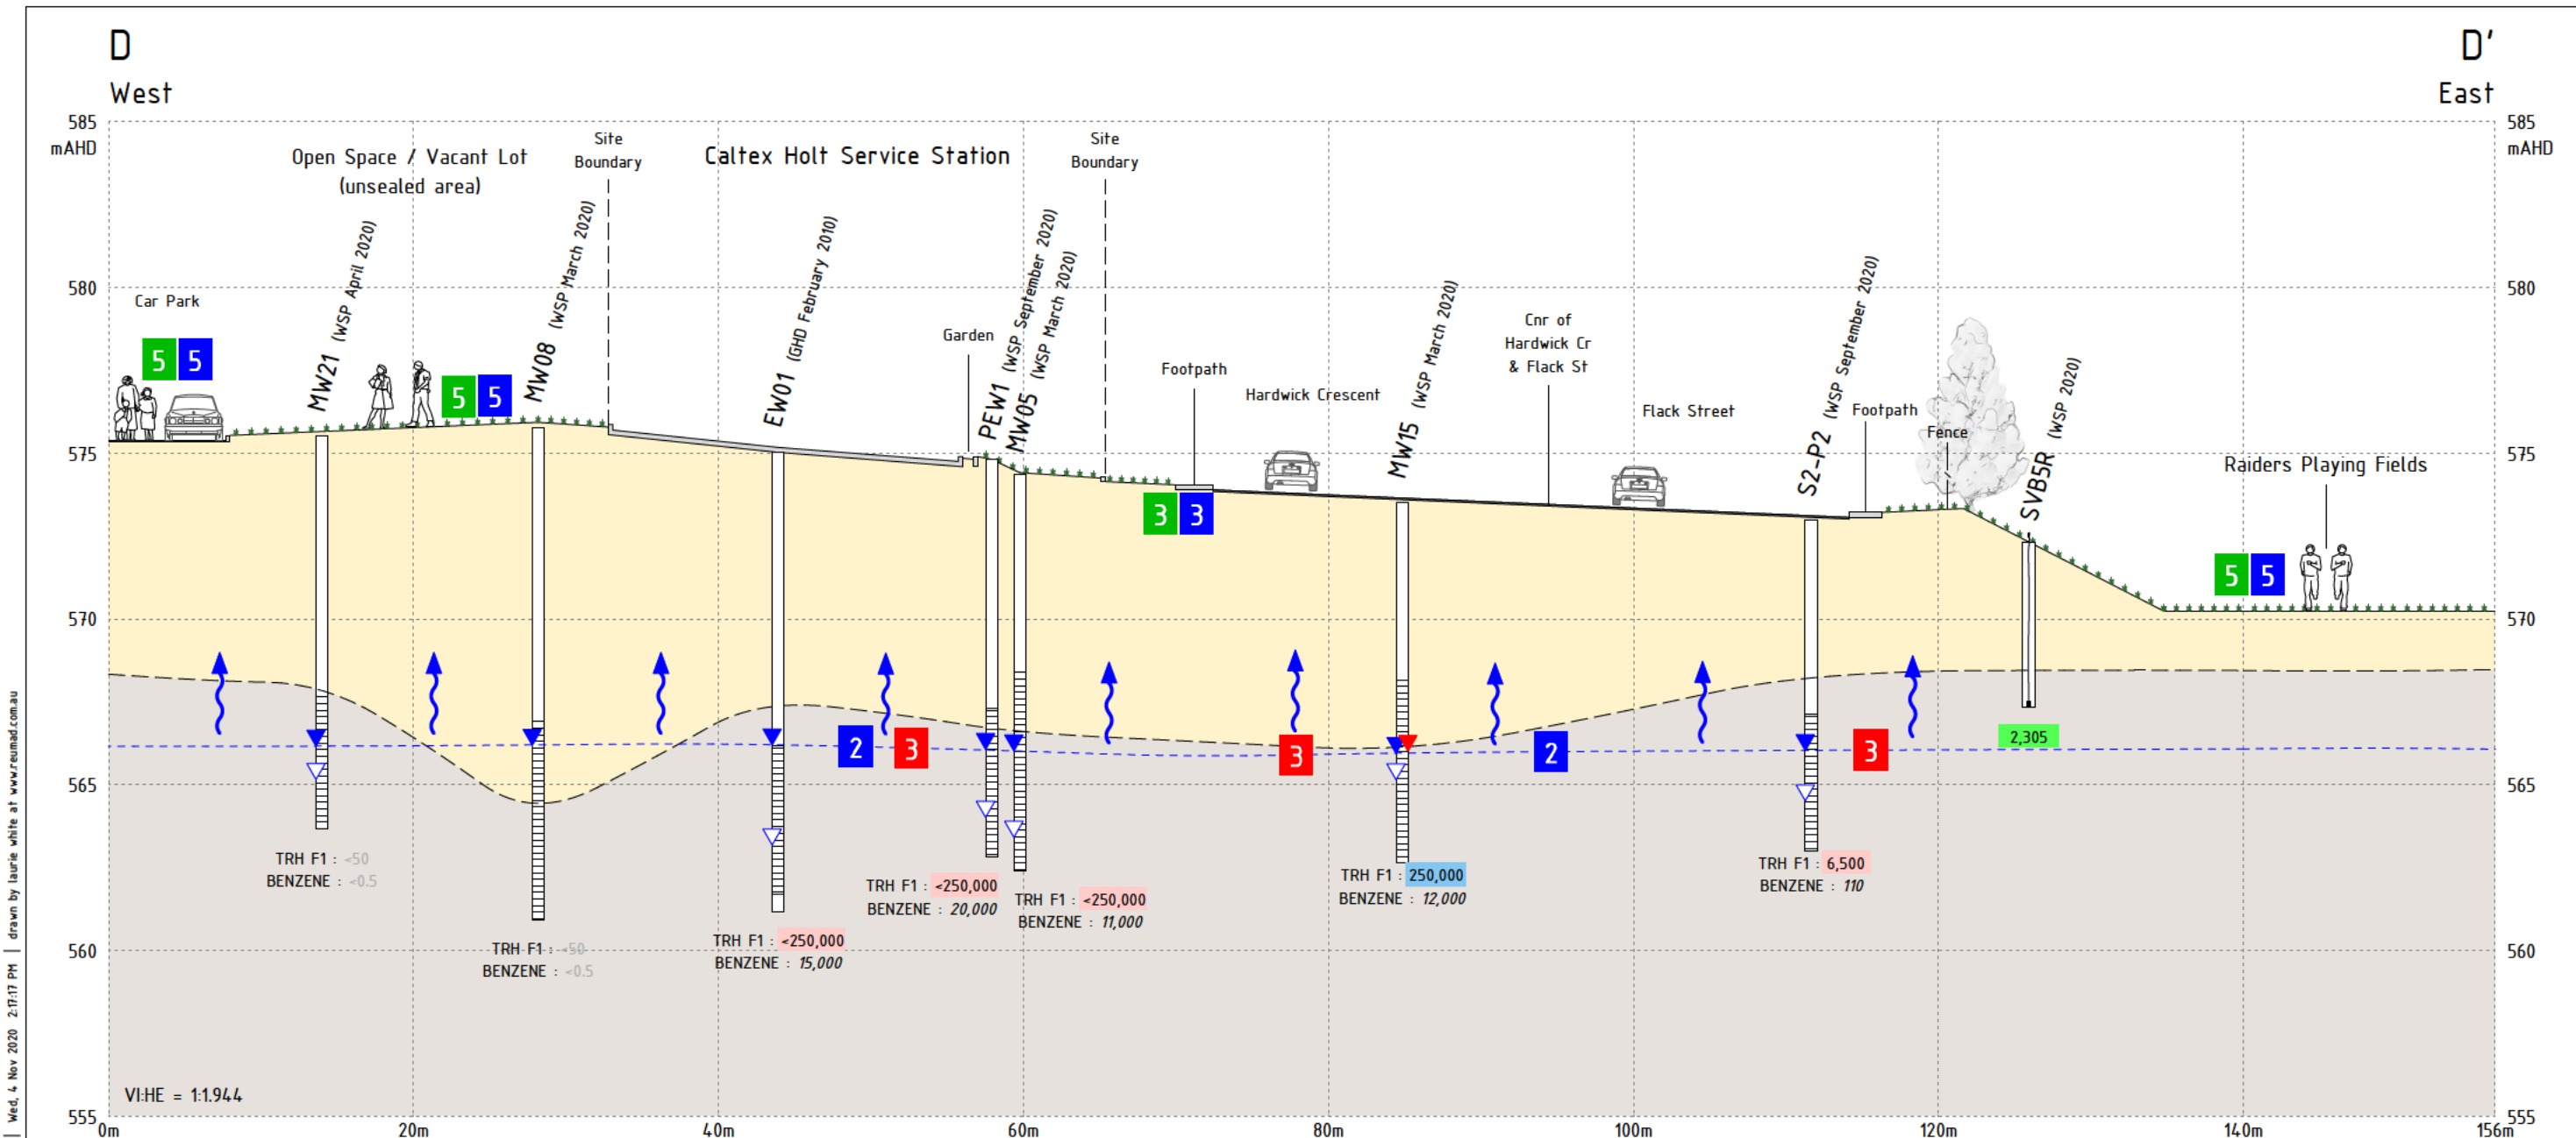
FIGURE 5d
CONCEPTUAL SITE MODEL
ALONG CROSS SECTION D-D'

1. REMNANT SPILLED PETROL IN AND BENEATH THE TANK PIT
2. IMPACTED SOIL/ROCK GENERALLY BENEATH THE TANK PIT
3. IMPACTED GROUNDWATER INCLUDING LNAPL IN THE AQUIFER

1. MIGRATION OF PETROL THROUGH THE SOIL PROFILE
2. MIGRATION OF PETROL THROUGH GROUNDWATER, AS DISSOLVED PHASE OR LNAPL
3. VAPOUR INTRUSION INTO BUILDINGS AND UTILITY PITS/TRENCHES
4. INGESTION AND/OR DERMAL/DIRECT CONTACT
5. VAPOUR INHALATION
6. DISCHARGE OF GROUNDWATER INTO SURFACE WATER BODIES

1. COMMERCIAL WORKERS WITHIN THE ON-SITE BUILDINGS
2. OCCUPANTS OF RESIDENTIAL PROPERTIES
3. INTRUSIVE MAINTENANCE WORKS BOTH ON-SITE AND OFF-SITE
4. ECOLOGICAL RECEPTORS - SURFACE WATER BODIES (NEAREST IS A CREEK 580 METRES TO THE NORTH-WEST)
5. HUMAN RECEPTORS ON OPEN SPACE LAND
