## Volume 1 - Route Options Assessment Report

# Molonglo East-West Arterial Road Feasibility Study and Molonglo Strategic Traffic Study

ACT Reference No. 52911-NCT-001  
Prepared for ACT EPSDD  
27 April 2021

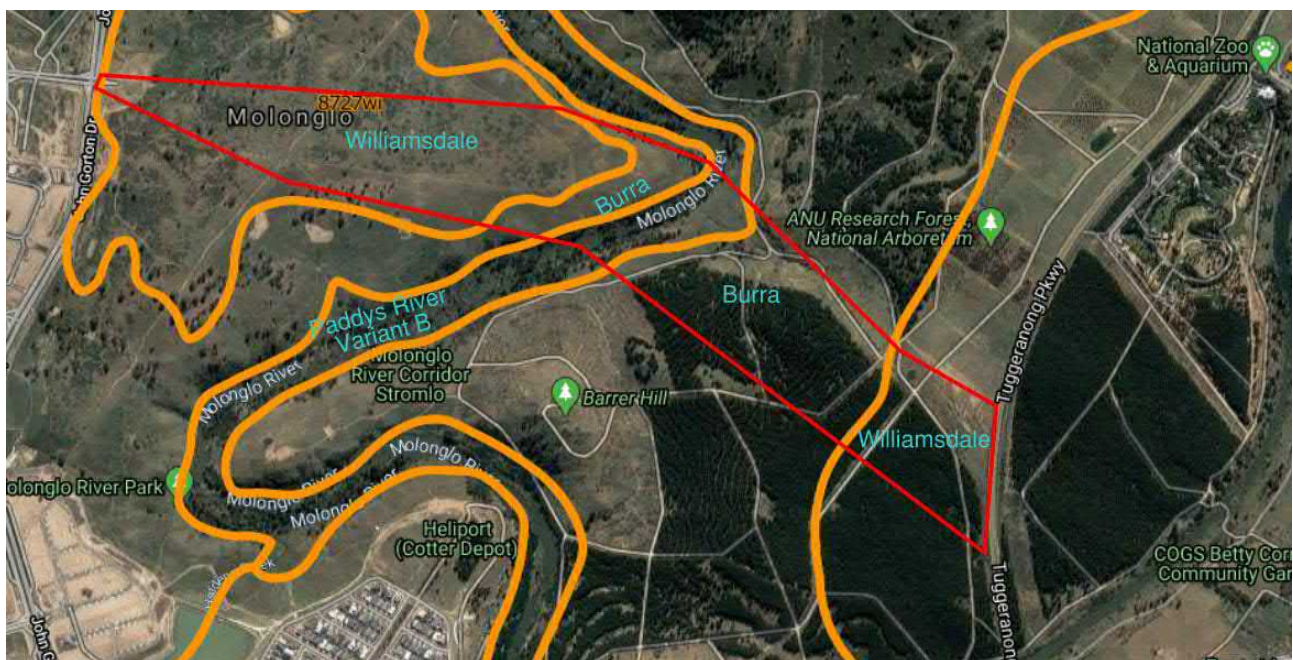
Based on the Soil Landscape mapping by ACT Government and the State of NSW Office of Environment and Heritage, the site soils are mapped as predominately three main soil landscapes, Williamsdale, Burra and Paddy River Variant. Williamsdale is found at the East and Western ends of the site, with the Burra soil landscape located between the Williamsdale landscape and the Molonglo River. The Paddy River Variant B soil landscape follows the banks of the Molonglo River.

Figure 2-1 Soil Landscapes at Proposed EWL Site

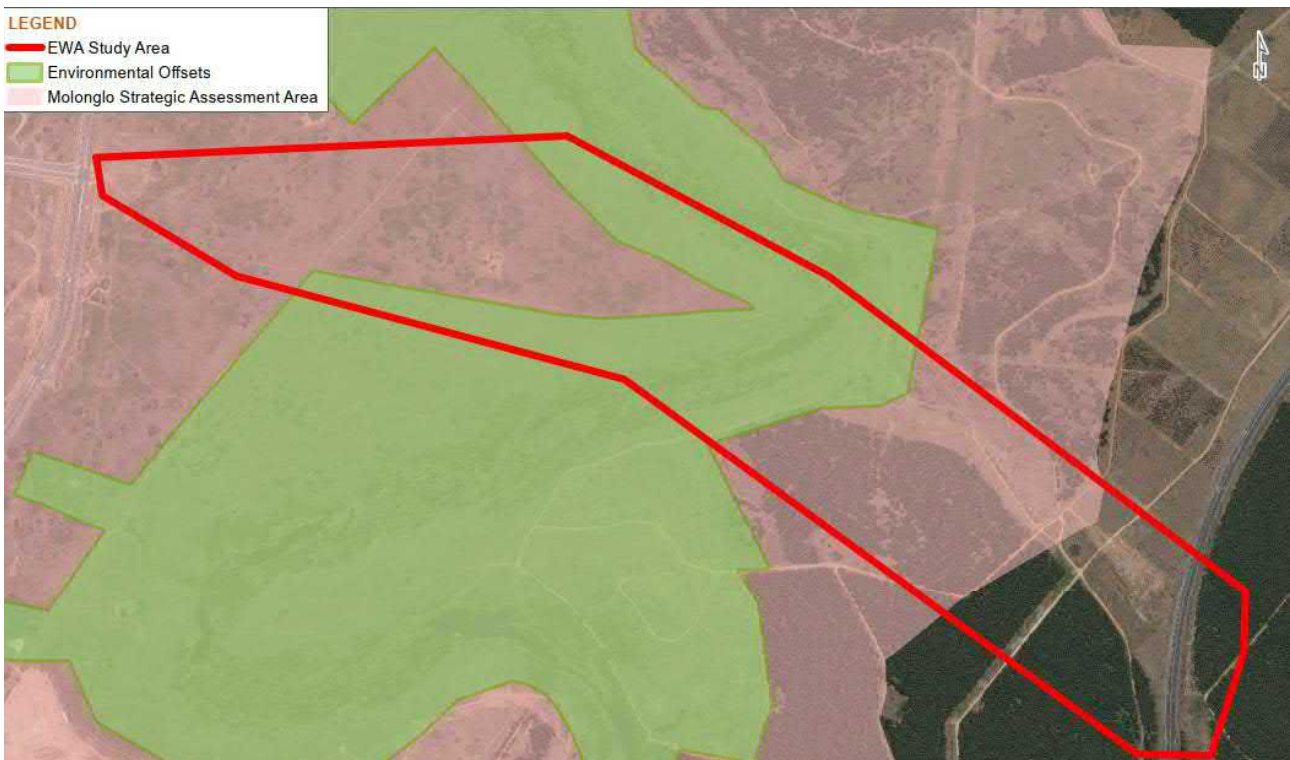
Figure 3-2 The Molonglo Strategic Assessment Area and Molonglo River Reserve, an offset under the NES Plan.

It is noted that land to the east of the Study Area comprises a Designated Area and works in this portion of the site would require NCA Approval under the National Capital Plan. This land is not within the Molonglo Strategic Assessment Area, and as such, the provisions of the EPBC Act would apply to future development. Figure 3-1 provides the extent of the Molonglo Strategic Assessment Area (covered by the NES Plan) and the area of offsets in the Molonglo River Reserve.

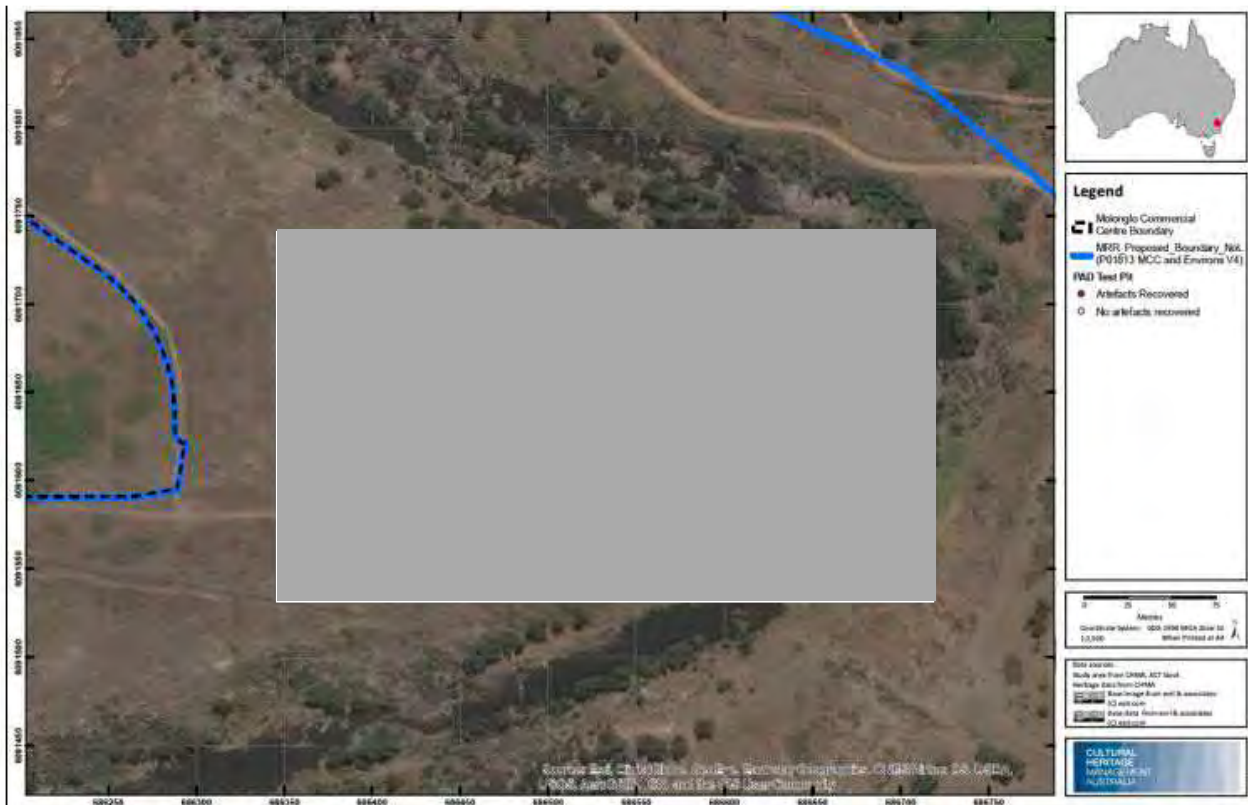
Figure 3-7 Testpit locations within PAD 1 undertaken by CHMA in 2013. Red sites indicate where artefacts were recovered and show a greater density of finds toward the east of PAD 1.

The Site of PAD 1 was originally classified as having high archaeological potential through predicative modelling undertaken by AASC in 2006. A sub-surface testing program was undertaken by BIOSIS in 2010 however did not result in the identification of any cultural heritage material. However, when the site was revisited by CHMA in 2013, the extent of the PAD was enlarged as the modelling undertaken at the time identified “moderate to high densities of artefacts were anticipated resulting in an assessment of high archaeological sensitivity” (CHMA, 2020). A test-pitting program was subsequently undertaken, resulting in [REDACTED]

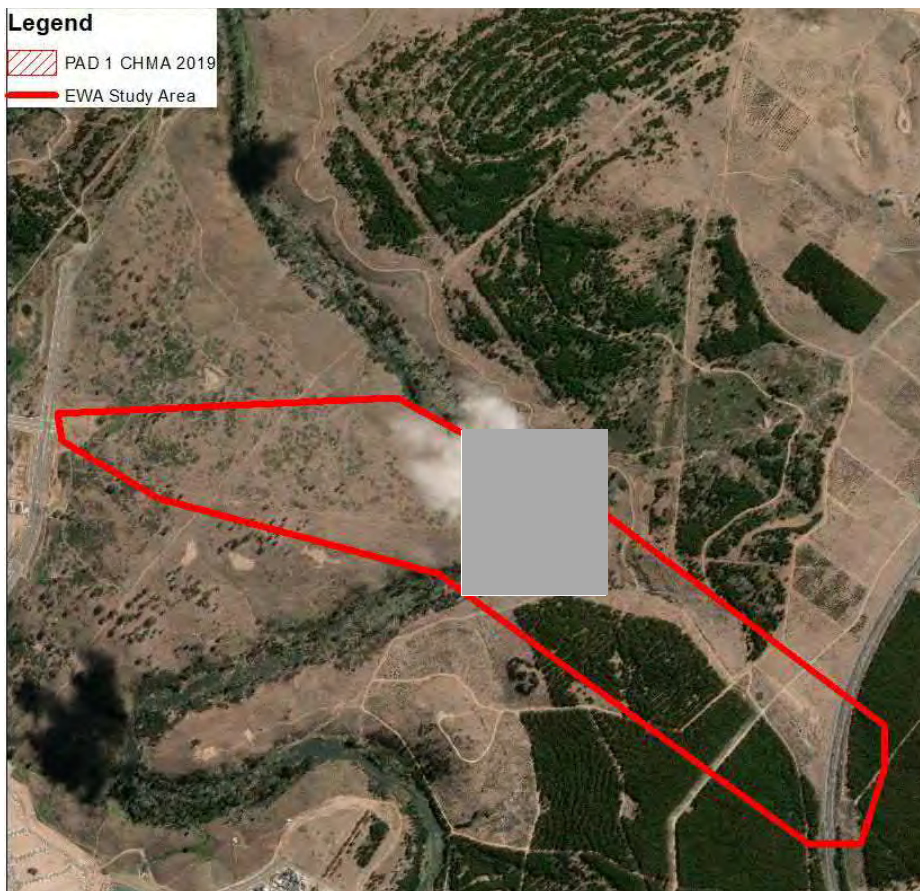
This advice is relevant to the EWA project and the options consideration, as the bridge will likely pass through the registered PAD 1 boundary. In order to ensure the MCA process was as robust as possible, advice was sought from the ACT Heritage Office to confirm the extent of impact to PAD 1 that would be considered acceptable and an approach seeking to avoid and minimise impacts on the most-dense areas of artefacts was adopted. Figure 3-8 provides the registered extent of PAD 1 relative to the EWA Study Area.

Figure 3-8 PAD 1 relative to the study area of the East West Arterial
