C12176.1 - River Pump
 Option 1

BUSHFIRE RISK ASSESSMENT

Figure 1 – Tharwa Infrastructure Capacity Study Area.

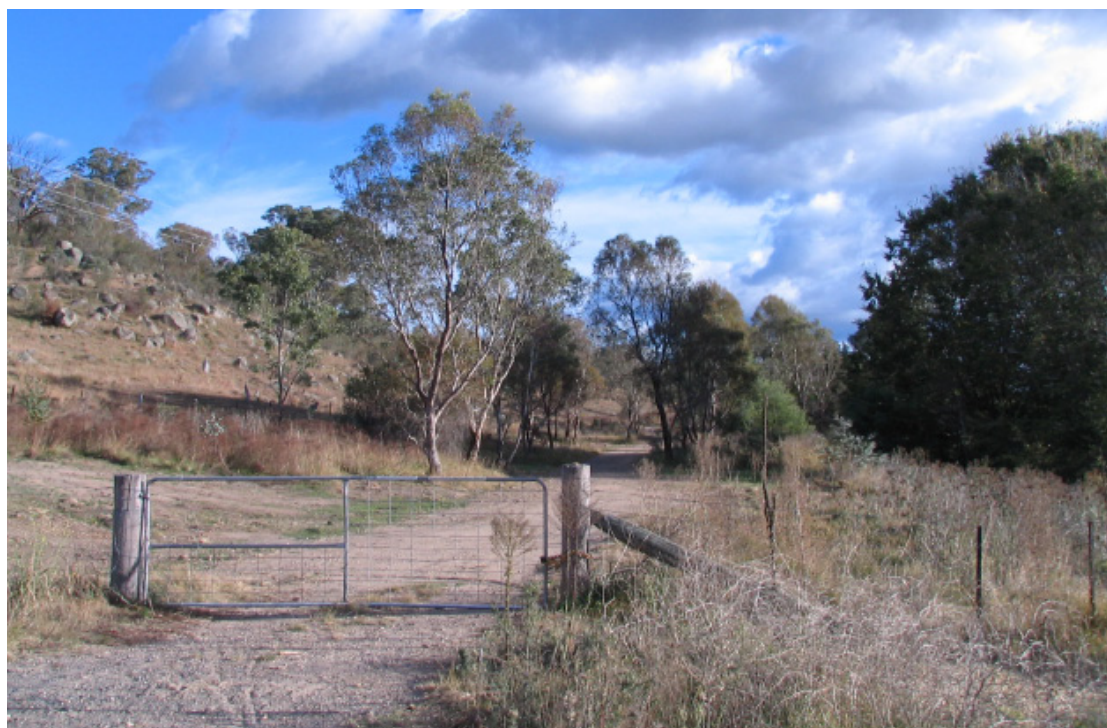
Photograph No. 1 – Looking to the northwest from the north-western edge of the Tharwa Village precinct showing the access track and vegetation along the south-western side of the Murrumbidgee River.

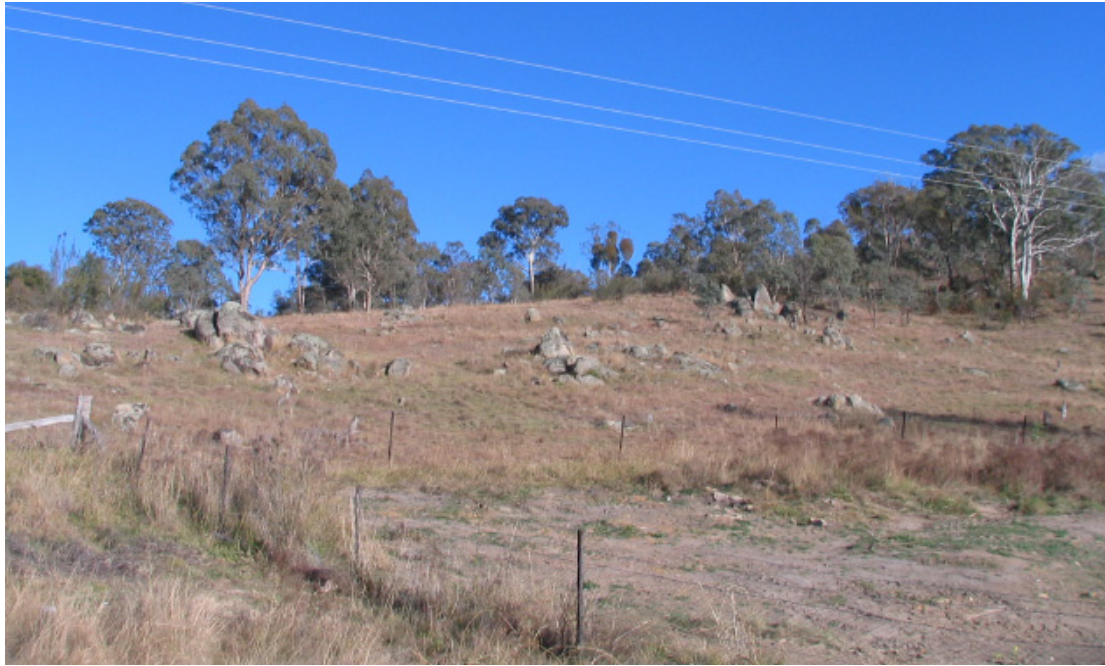
Photograph No. 2 – Looking west from the previous photographs’ location showing the land and vegetation to the northwest of the Village.

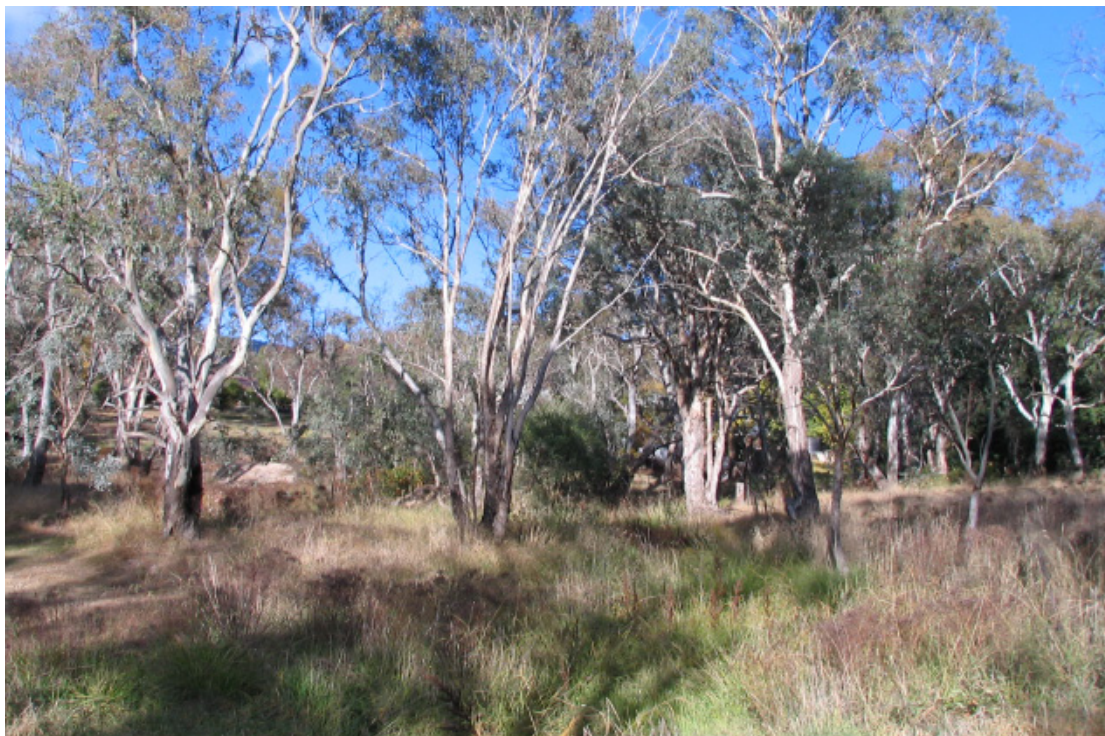
Photograph No. 3 – Looking southwest from the previous photographs’ location showing the unmanaged vegetation within the northern portion of the Village.

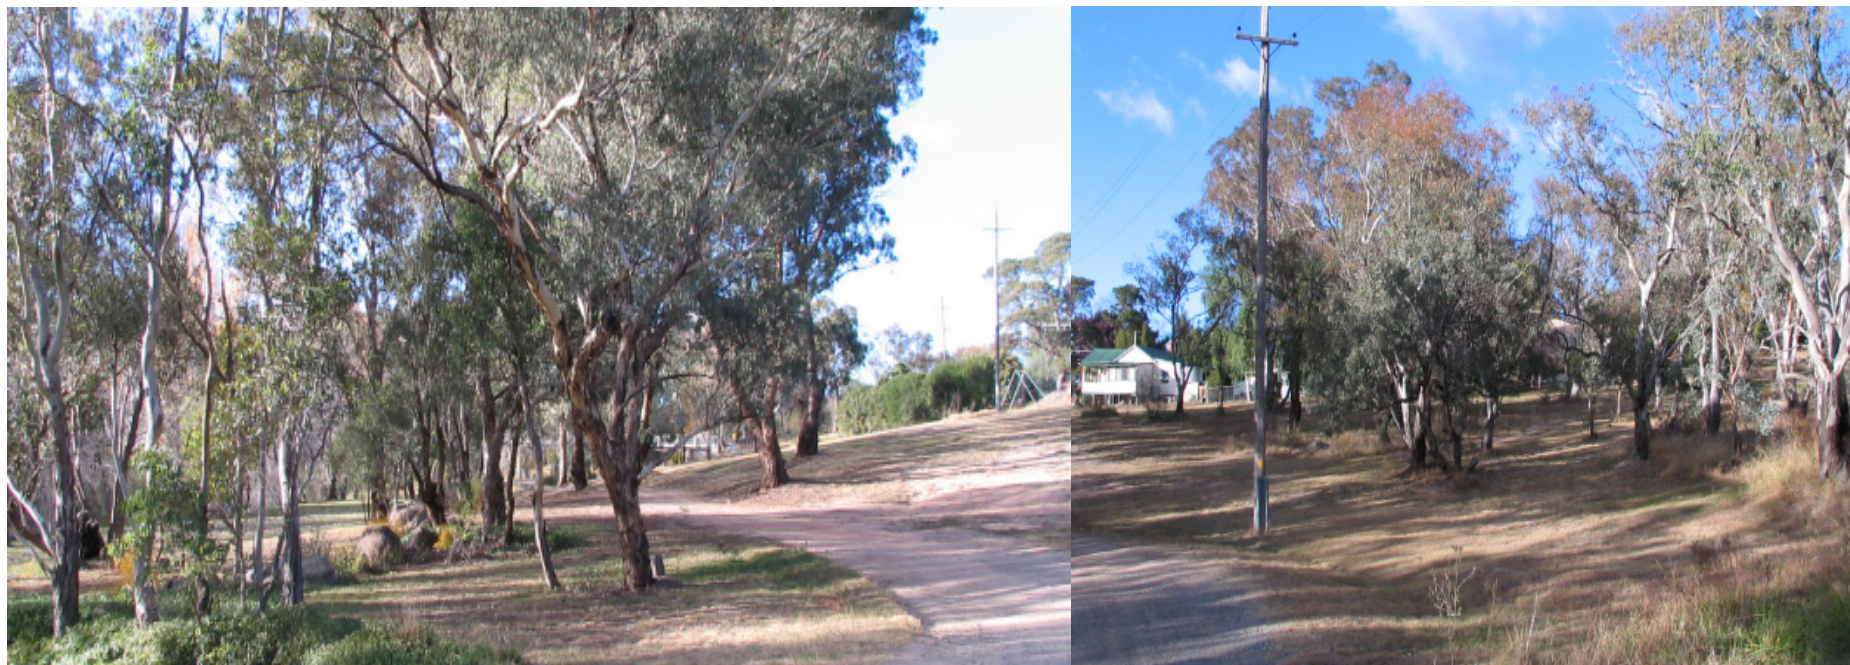
Photograph No. 3 – Looking southeast to the dwelling/s on North Street showing the managed river corridor to the northwest of the Tharwa Bridge.

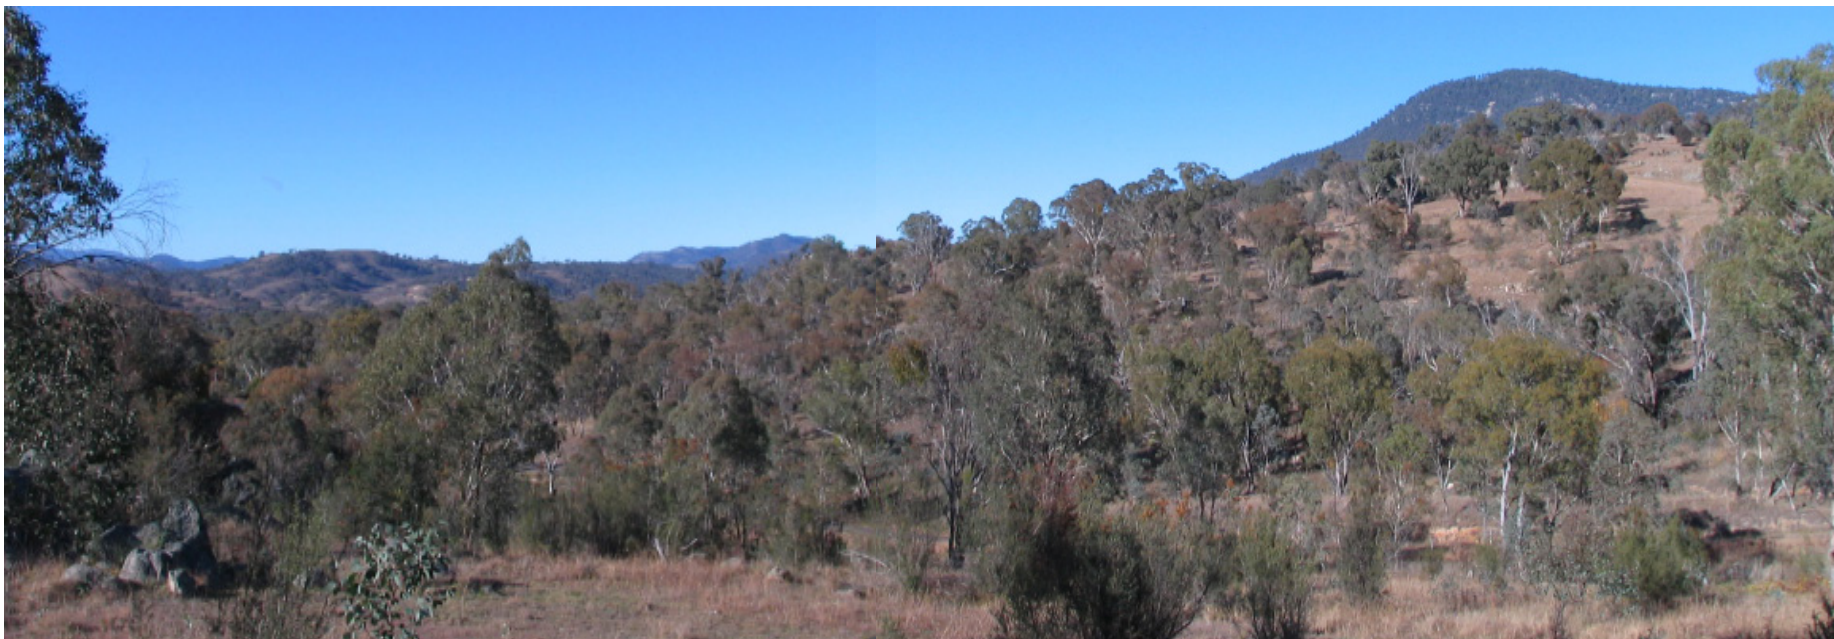
Photograph No. 4 – Looking southeast from Tidbinbilla Road, northwest of the Tharwa Village precinct showing the landform and vegetation on the land to the southwest of the Village precinct.

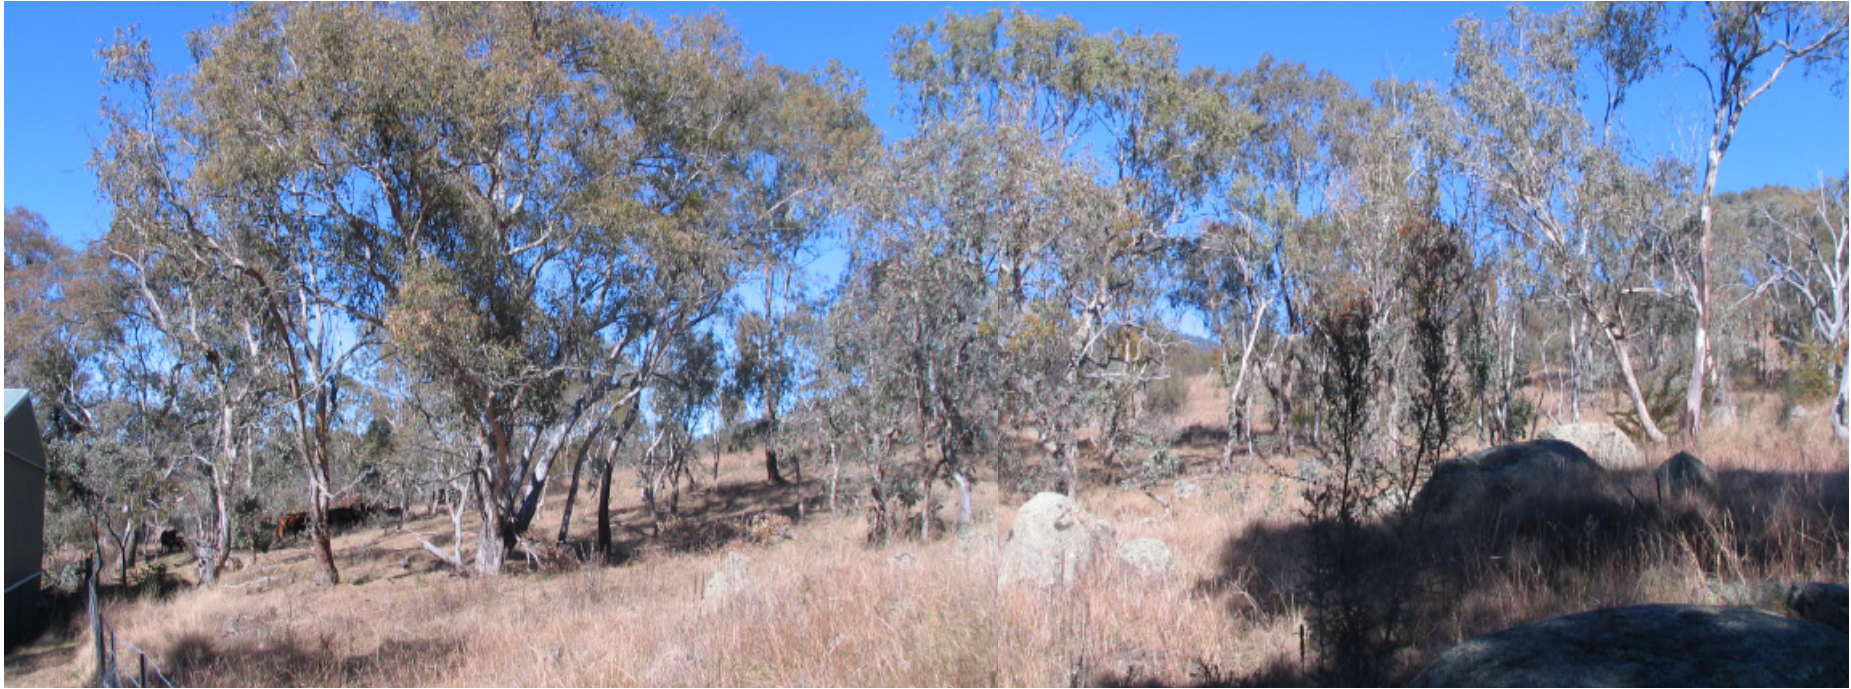
Photograph No. 5 – Looking to the southeast along the south-western edge of the north-western portion of the Village Precinct showing the land form and vegetation – note the RFS Fire Station is the building on the left.

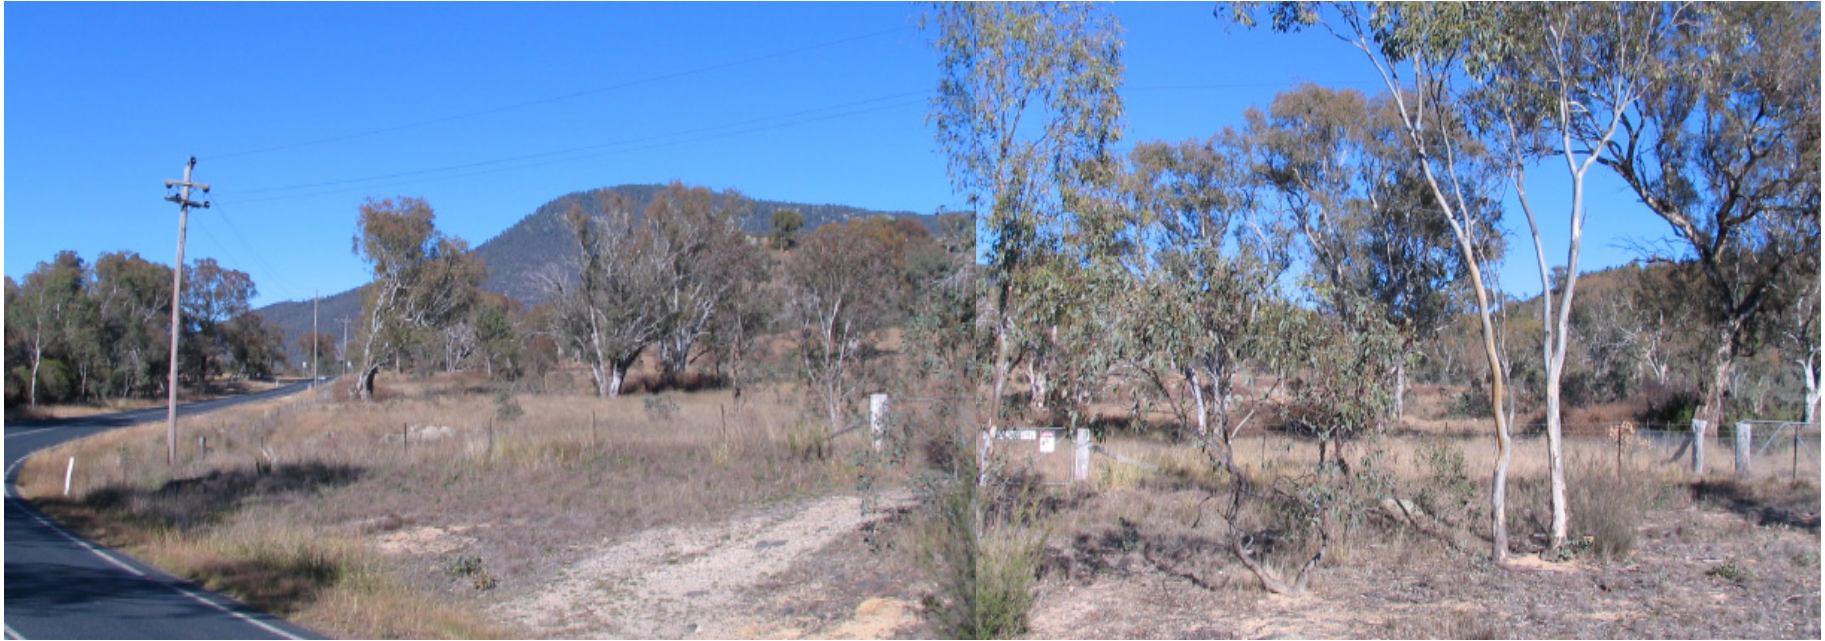
Photograph No. 6 – Looking to the south along Nass Road showing the land form and vegetation to the southwest of Cuppacumbalong Station and the Outward Bound facility.

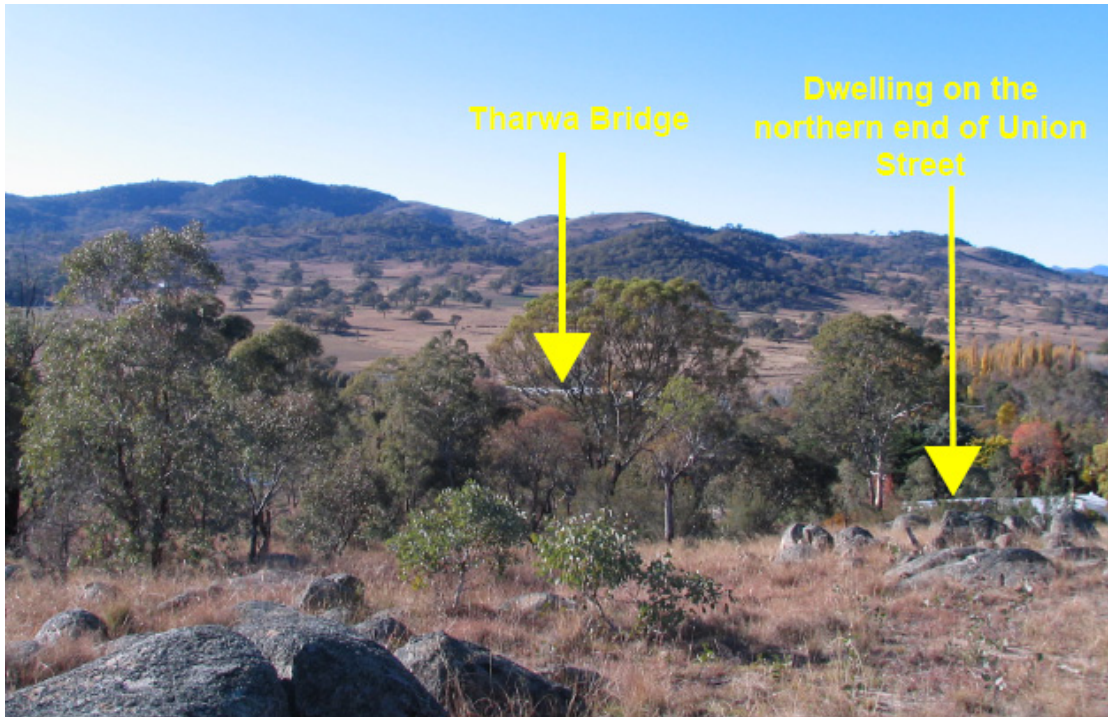
Photograph No. 7 – Looking to the east from Tidbinbilla Road showing the landform and vegetation on the land to the northwest of Union Street.

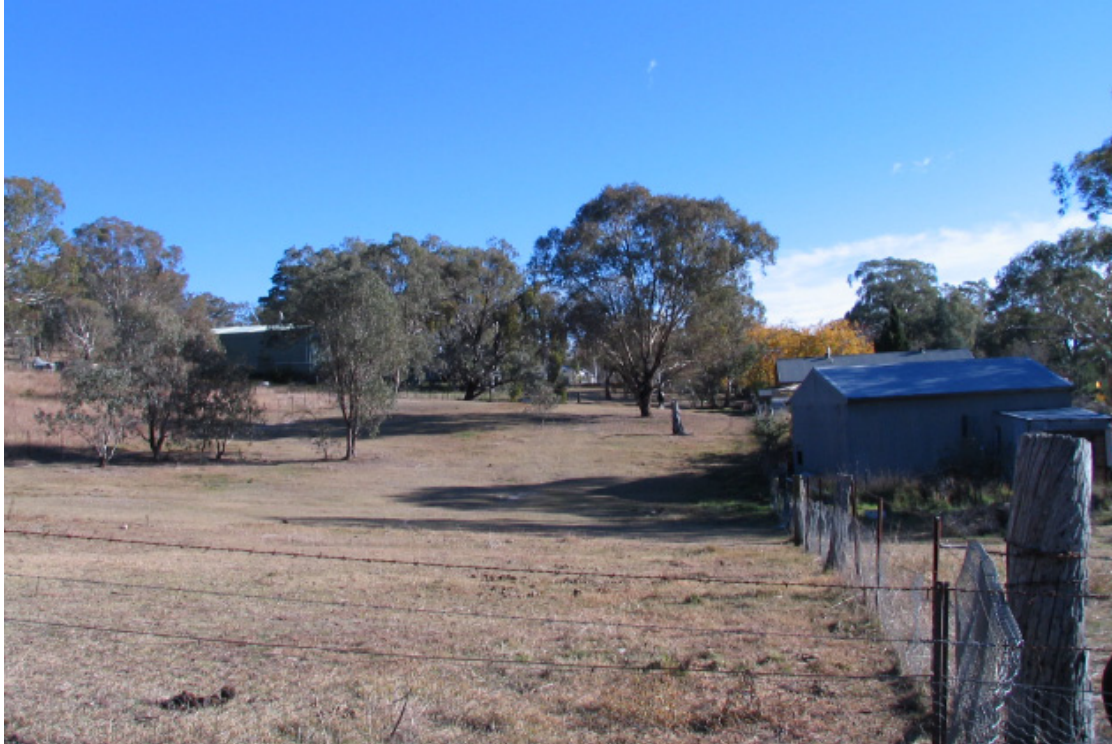
Photograph No. 9 – Looking to the northwest showing the managed land within Section 11 at the rear of the blocks on the south-western side of Clarrie Lane.

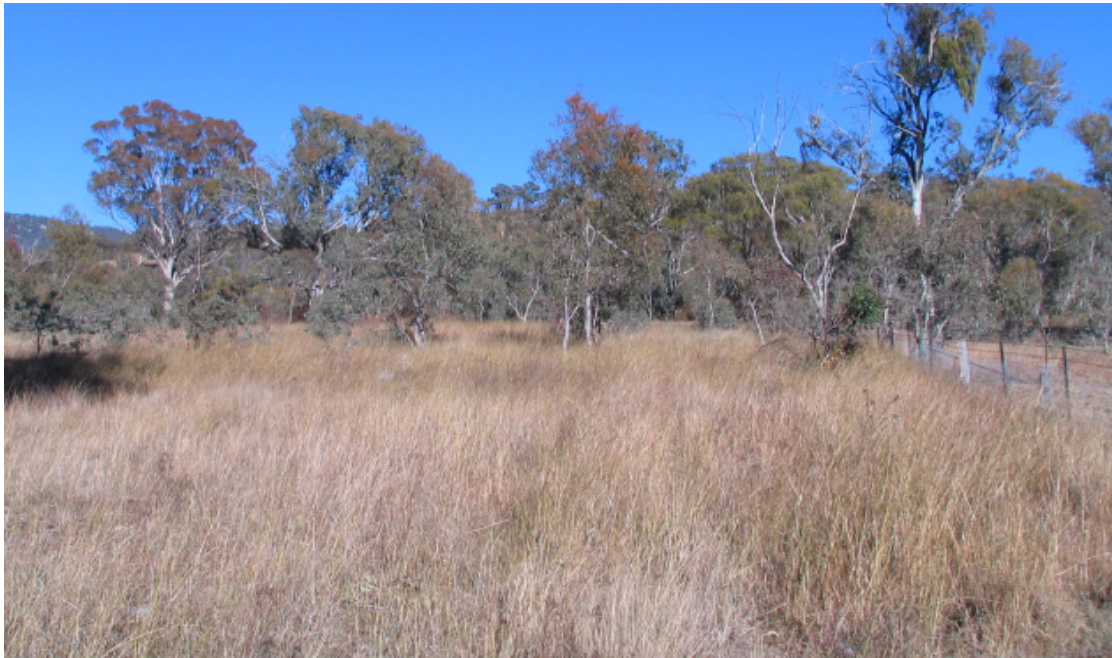
Photograph No. 10 – Looking to the southwest showing the unmanaged vegetation on the land within Block 8 Section 13, to the west and southwest of the Village.

The Overall Fuel Hazard for unmanaged grassy woodland vegetation on the land to the northwest, west and southwest of the Tharwa Village is very high.

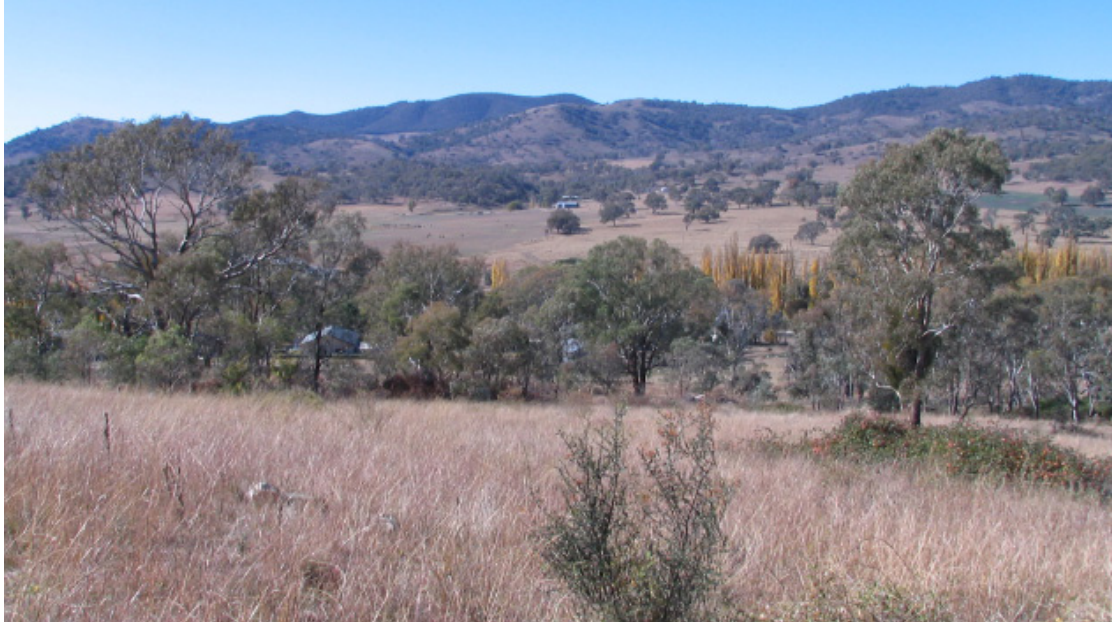
Photograph No. 11 – Looking to the east from the ridgeline to the southwest of the Village – dwellings are located on Clarrie Lane and Poplar Trees are on the south-western bank of the Murrumbidgee River.

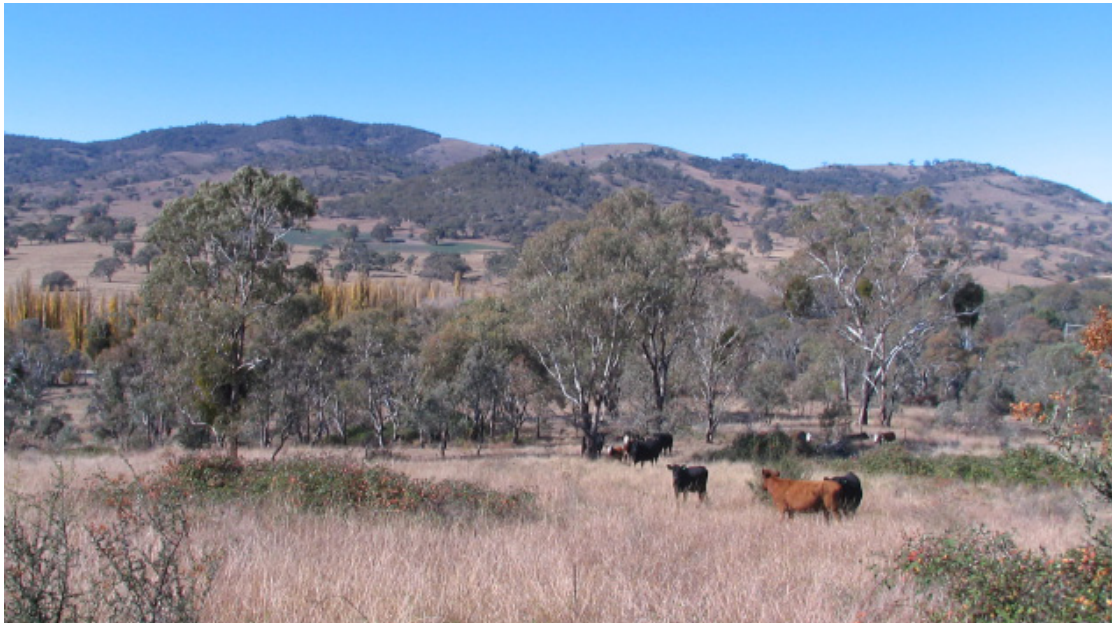
Photograph No. 12 – Looking to the east from the ridgeline to the southwest of the Village – Cuppacumbalong Station is in the centre of the photograph, on the right.

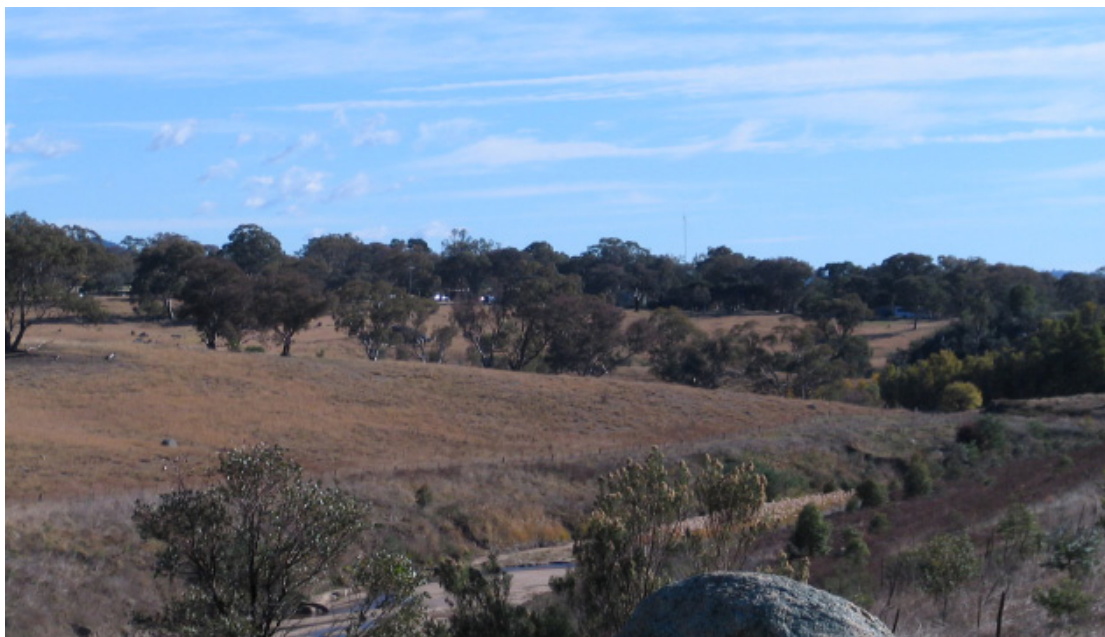
Photograph No. 13 – Looking to the northwest from Smiths Road showing the land to the southeast of the Outward Bound facility – the Cudgenby River is in the foreground.

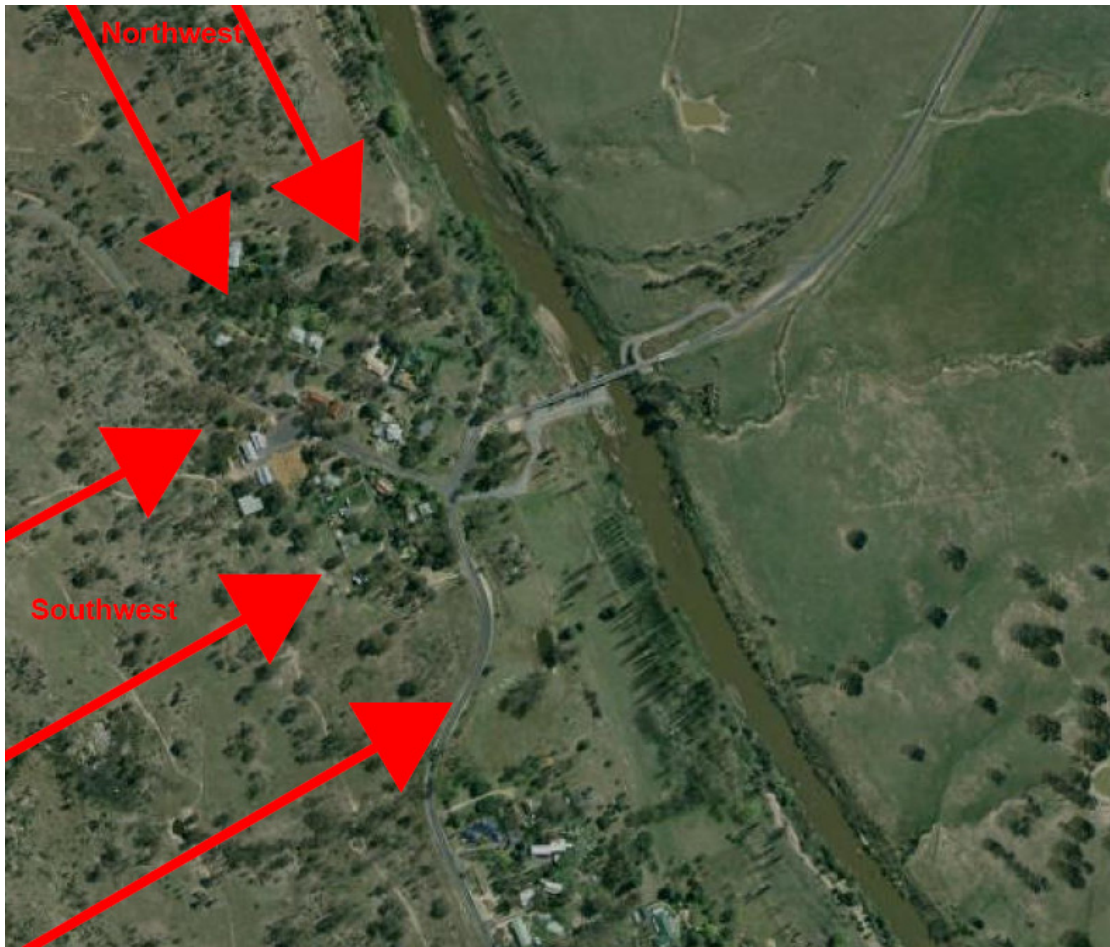
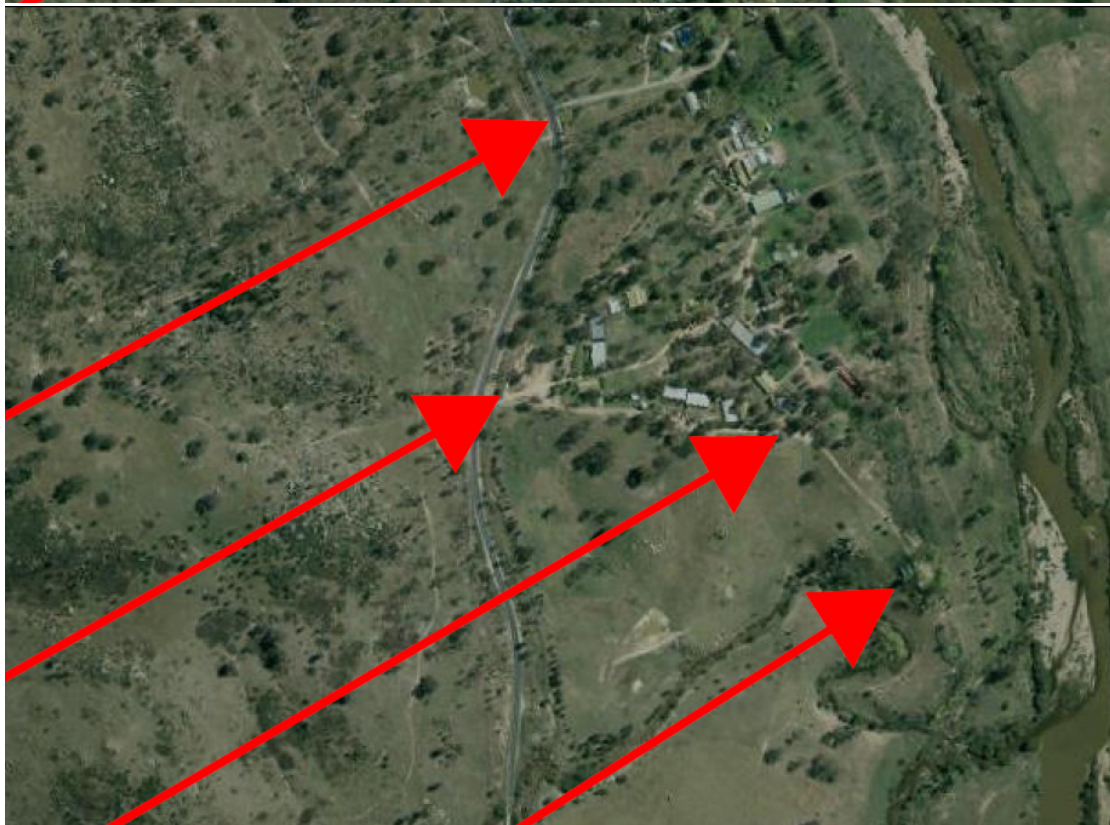
Figure 6 – Fire Paths – Northwest & Southwest.

Figures 6 & 7 below provide a graphical representation of the potential fire paths likely to impact upon the Village. These figures do not predict the effect of likely wind turbulence similar to that which occurred during the 2003 bushfires.

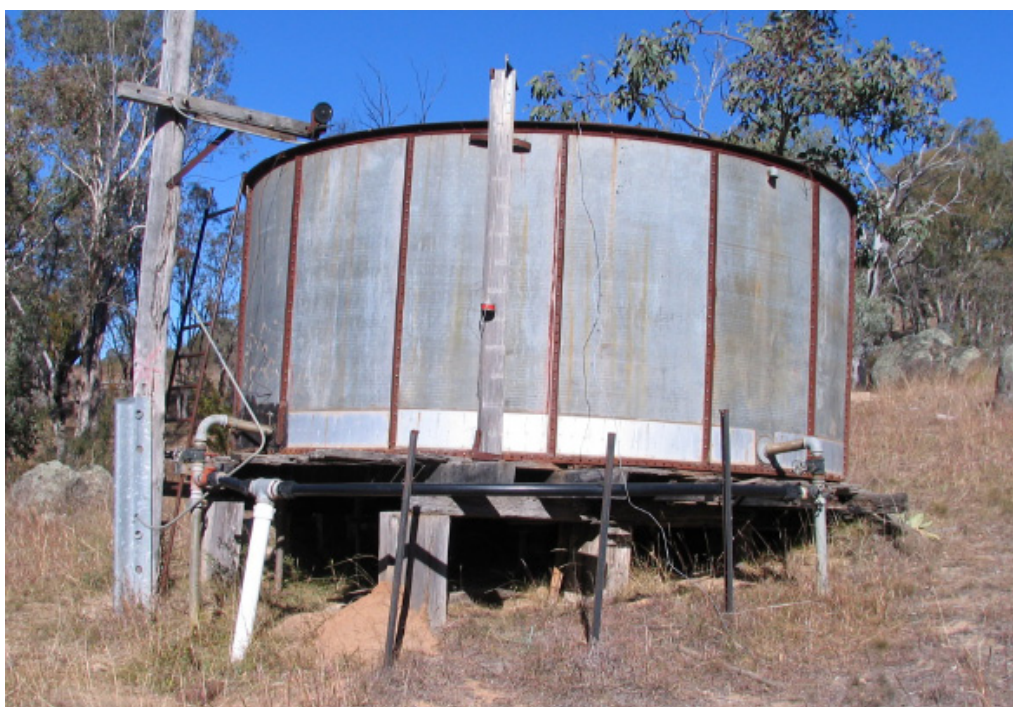
Photograph No. 14 – [REDACTED] Water Storage Tank.

The static water supply tank shall be fitted with a 65mm supply line with an outlet, complete with 65mm ball valve, Stortz Coupling and Cap, located outside the boundary fence so as to facilitate easy access for refilling fire appliances.

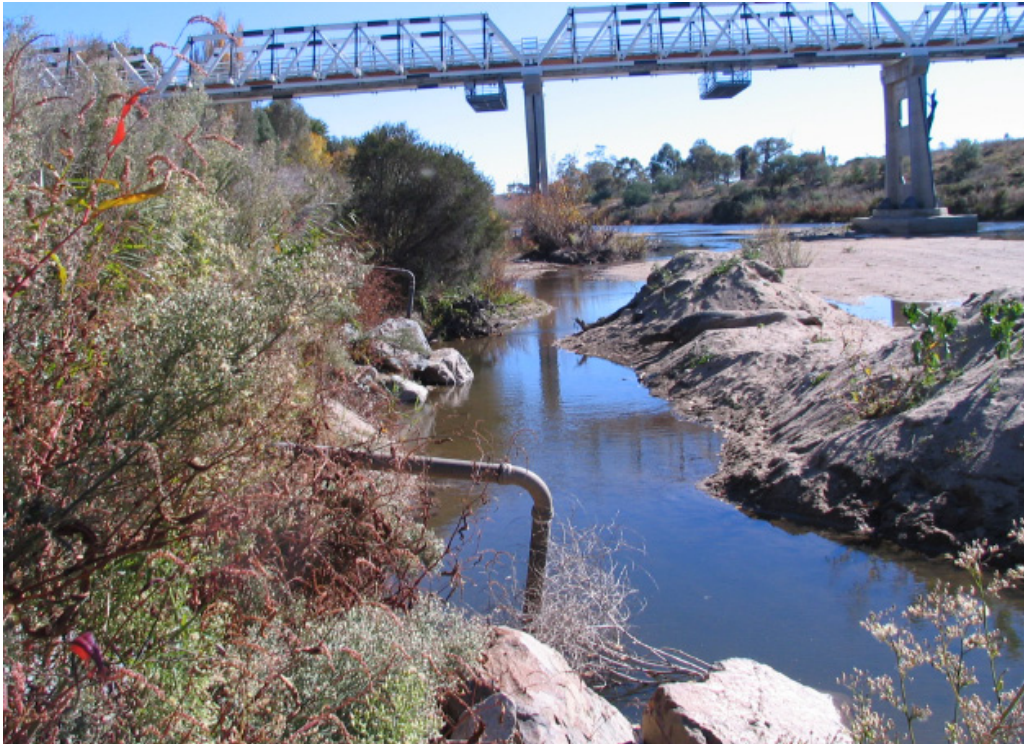
Photograph No. 15 – Supply points in the Murrumbidgee River - [redacted] and School system

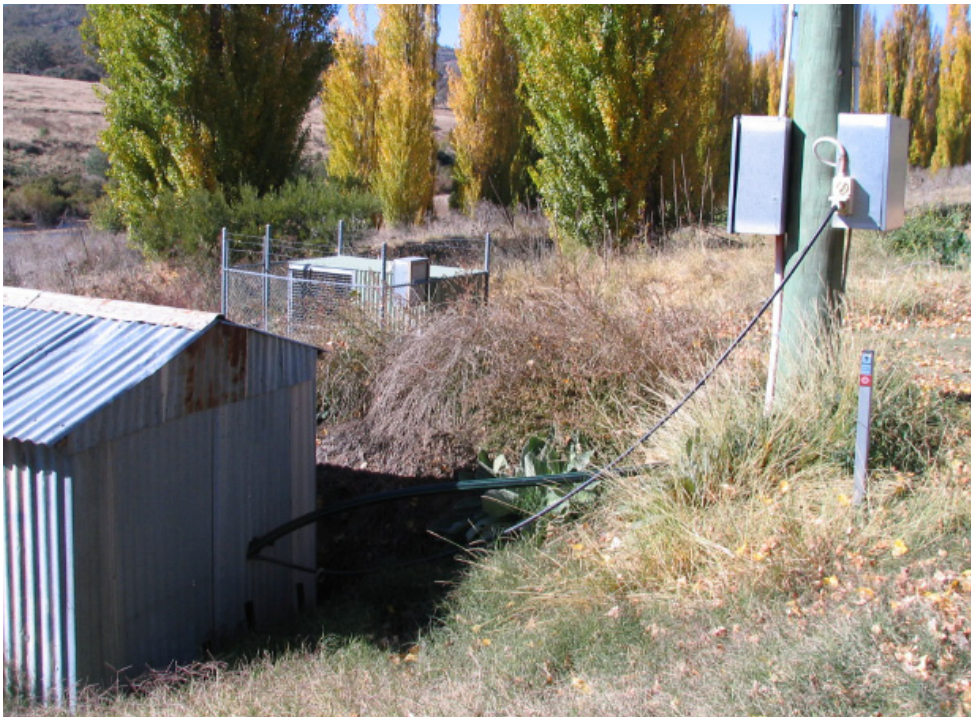
All of the non-potable water supply systems have exposed poly pipes which are subject to damage from ember attack.

Photograph No. 16 – Pump Sheds on the bank of the Murrumbidgee River - [redacted] on the left and School system on the right – note electrical connection and exposed poly pipe and bushfire fuels

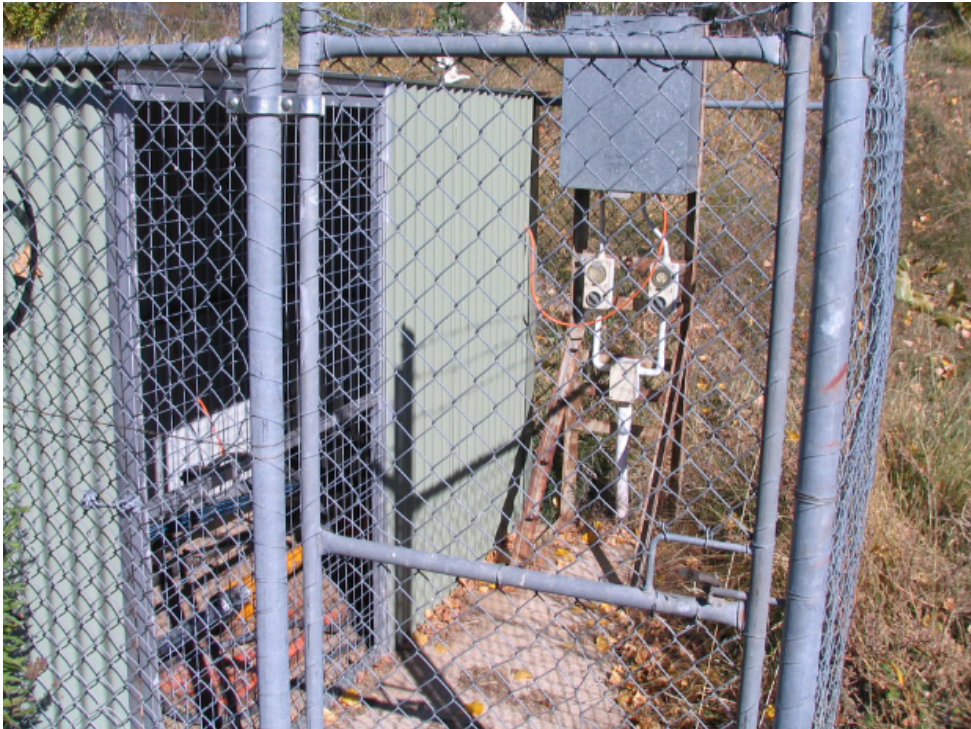
Photograph No. 16 – School Pump enclosure showing exposed pipe work with no protection against ember attack.

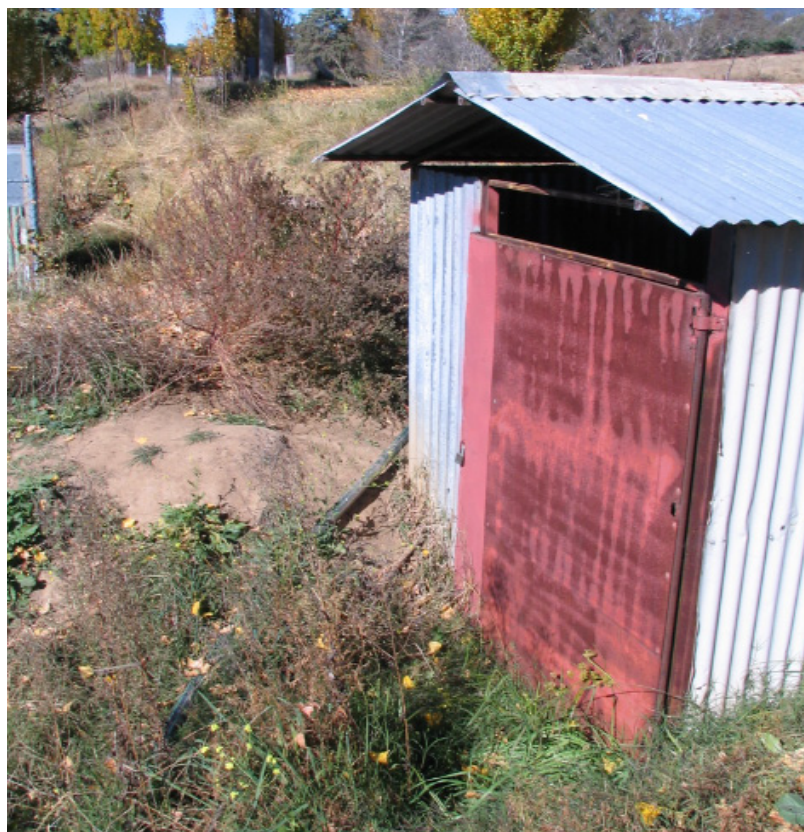
Photograph No. 17 – [REDACTED] Pump enclosure showing exposed pipe work with no protection against ember attack.
