ACT Heritage Council

BACKGROUND INFORMATION

Kallenia Woolshed

(Block 16, Molonglo)

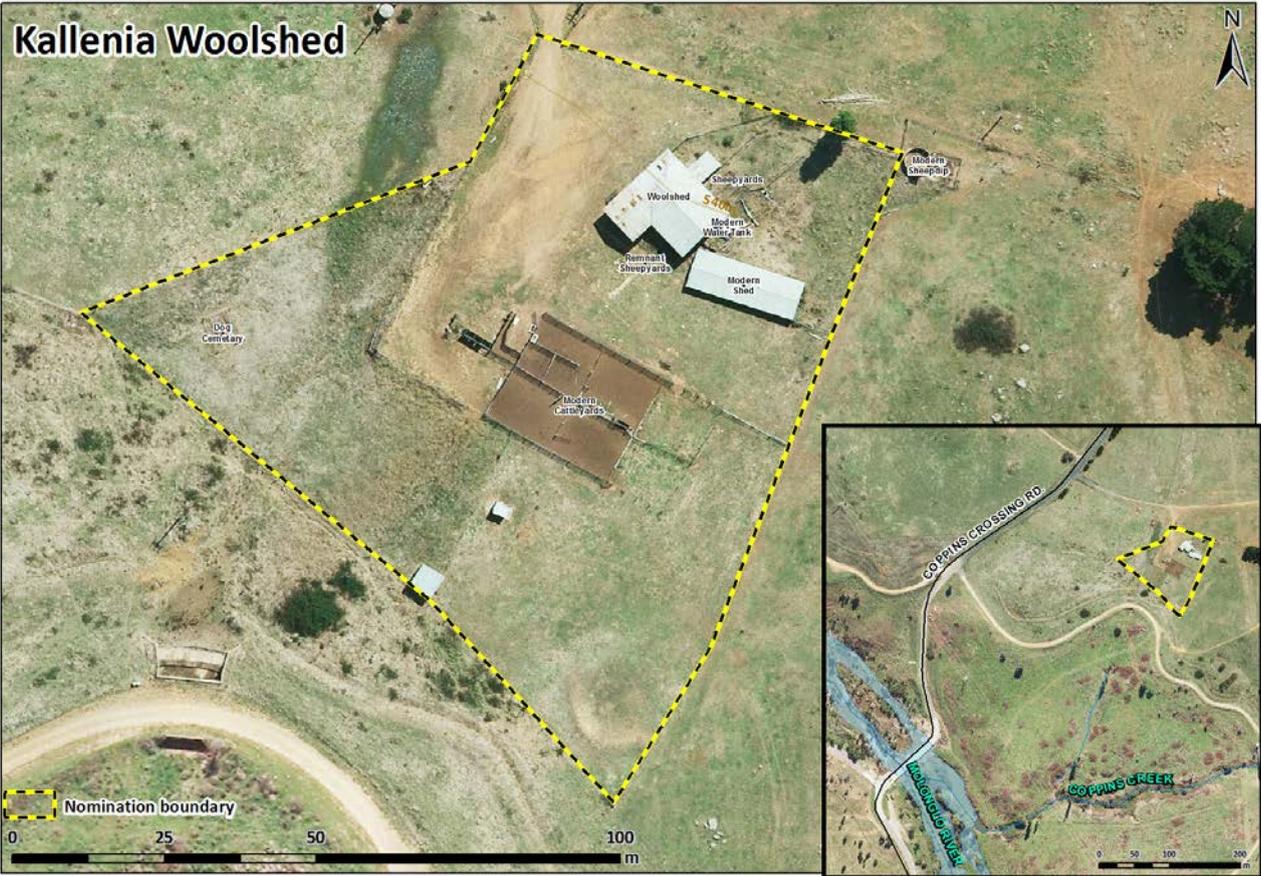
Figure 4 Kallenia Woolshed nomination boundary and features

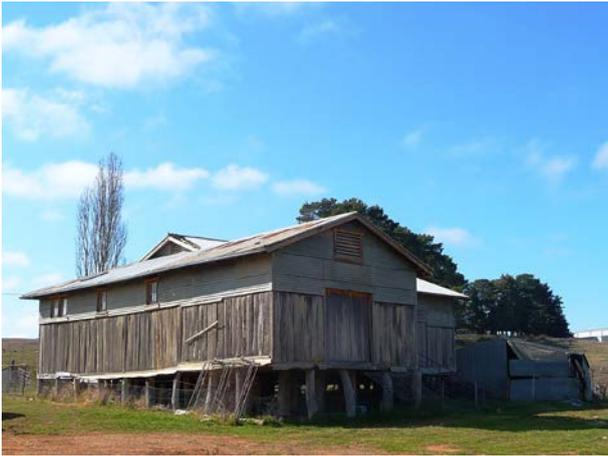
Figure 5 Kallenia Woolshed facing northeast (ACT Heritage 2015)

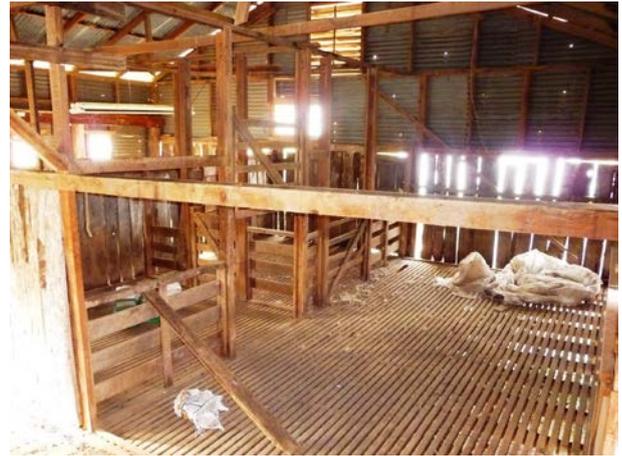
The catching pens: The floor consists of battened boards that allow sheep droppings to fall through. The first pen is an open area of ~3x6.5m just inside the doors for the ramp. From here the sheep would be divided into the two smaller catching pens of ~2.5x3.2m via vertical slide gates in machined timber fences. The machined timber fences are low with horizontal palings spaced apart. The fence around the pens is made of high timber slabs with no spaces

Figure 8 Kallenia Woolshed catching pens (ACT Heritage 2015)

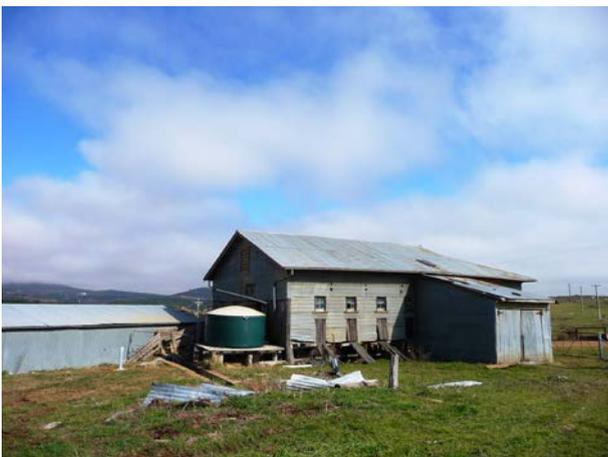
Figure 6 Kallenia Woolshed facing southwest (ACT Heritage 2015)

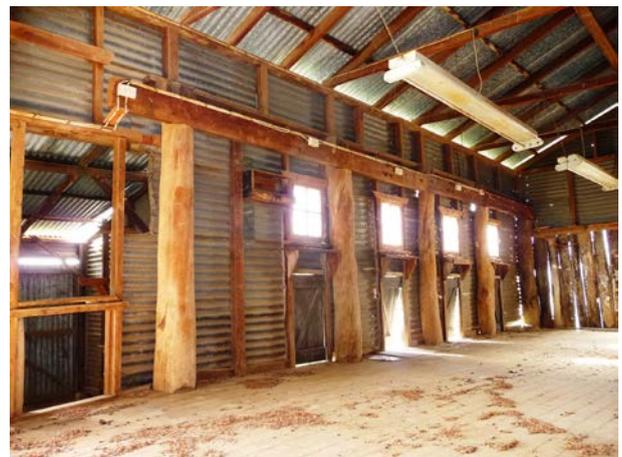
The shearing floor or board is a long open area between the catching pens and the north-northeast wall. The floor is machined tongue and groove floorboards. Opposite the catching pens are four chutes with wood flaps and a small four-pane window and a small shelf above each. The wall has a sturdy frame of tall stumps that also form part of the footings, across the top of these is a large hardwood beam that would have supported the original machine shearing mechanism, that was removed and electrical power sockets installed instead. There are two latter addition large fluorescent light troughs suspended from the ceiling above the shearing floor.

Figure 9 Kallenia Woolshed shearing floor (ACT Heritage 2015)

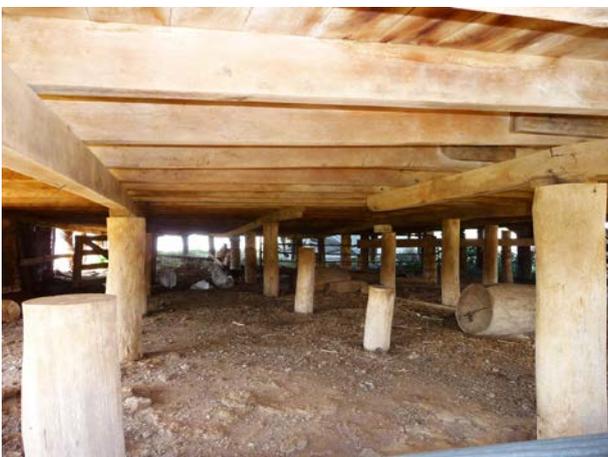
The woolshed is considered to be in poor physical condition due to several of the timber stump footings sinking and the resulting damage to the frame caused by the extra strain then placed on the bearers that have warped, cracked or fallen off.

Figure 7 Underneath Kallenia Woolshed - sweating pens, sunken stumps and missing and broken bearers (ACT Heritage 2015)

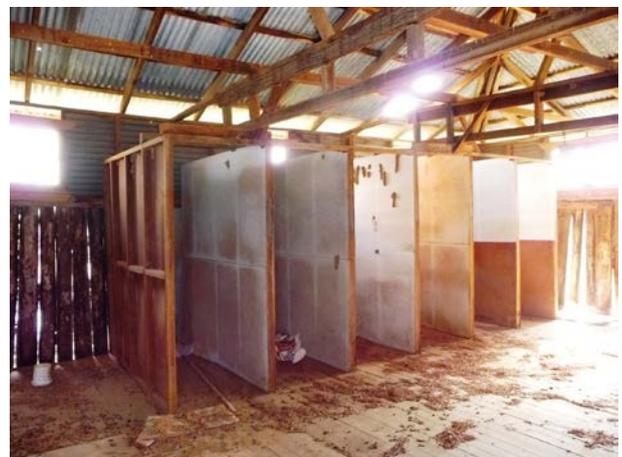
The sorting area is an open area with a later addition of seven timber frame and cement sheeting walls in the northern corner along the west-northwest wall, creating six sorting bins. The sorting bins partially obscure the three windows along the wall.

Figure 10 Kallenia Woolshed wool bins and sorting area (ACT Heritage 2015)

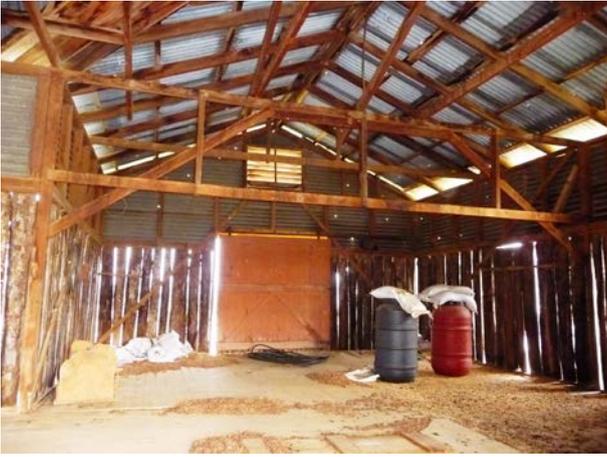
The baling and storage area may be a later addition, creating a small south-southwest wing as indicated by the changes in the design of framing and the floorboards, however there is also a continuation of materials that may indicate that it was a part of the original design.

Figure 11 Kallenia Woolshed bailing and storage area (ACT Heritage 2015)

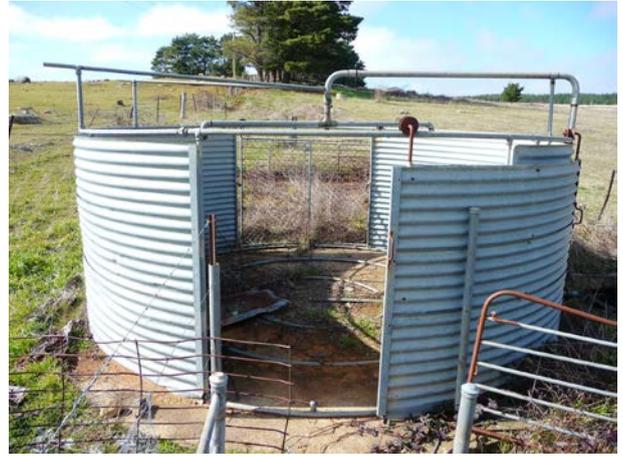
Figure 14 Kallenia Woolshed spray sheep dip (ACT Heritage 2015)

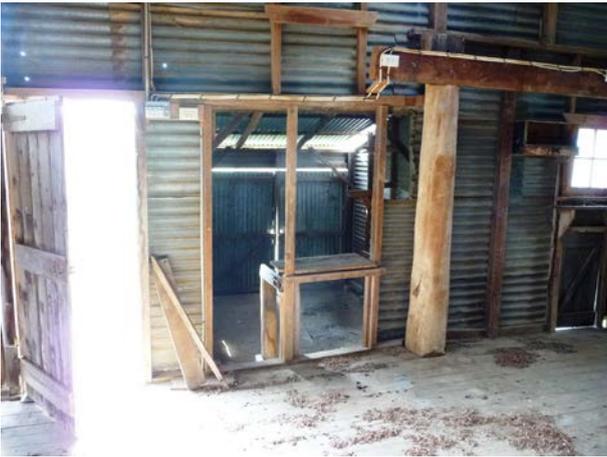
Figure 12 Kallenia Woolshed engine room entrance (ACT Heritage 2015)

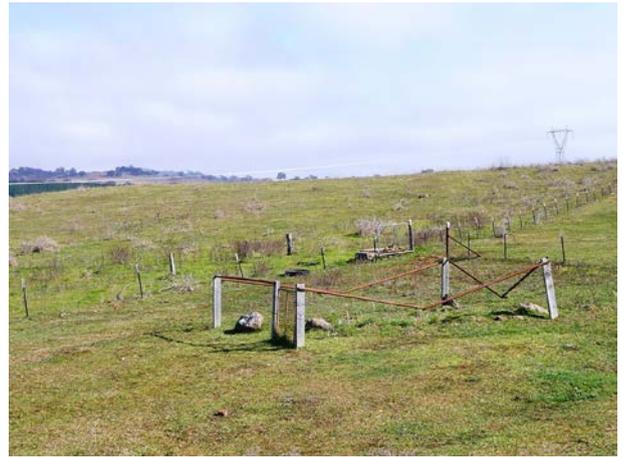
The pet cemetery is located ~65m to the southwest of the woolshed. It is marked out by four machined wood corner posts with an extra post used to hold a metal gate in place. The corner posts are joined by three strands of loose barbed wire with a top rail of metal pipe bolted on to the wood. The rail on the gate side is a single piece, but the other three are constructed from two pipes joined in the middle, however the join has failed on all of them and they are bowed in the middle, forming a 'v' shape.

Figure 15 Kallenia Woolshed pet cemetery (ACT Heritage 2015)

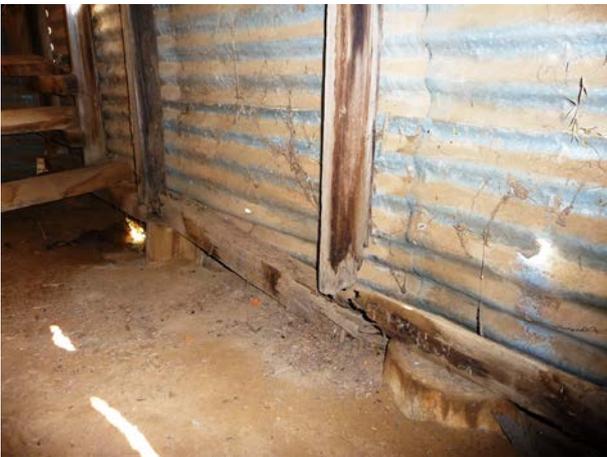
The engine room is a later addition. It has short wood stump footings, a machined timber frame with some bush pole sections and a concrete floor poured directly on to the ground surface. There is considerable termite damage to the lower frame. It has a large double door to the outside and a regular door-sized opening into the woolshed adjacent to some smaller openings that would have accommodated the connection of the shearing equipment to the engine.

There is also considerable termite damage in the timber frame of the engine room, but the extent of the termite infestation and the damage caused has not been assessed.

Figure 13 Kallenia Woolshed engine room termite damage (ACT Heritage 2015)
