ACT Heritage Council

BACKGROUND INFORMATION

Site B (Shores of Yerrabi Pond)

(Block 1 Section 105, Amaroo)

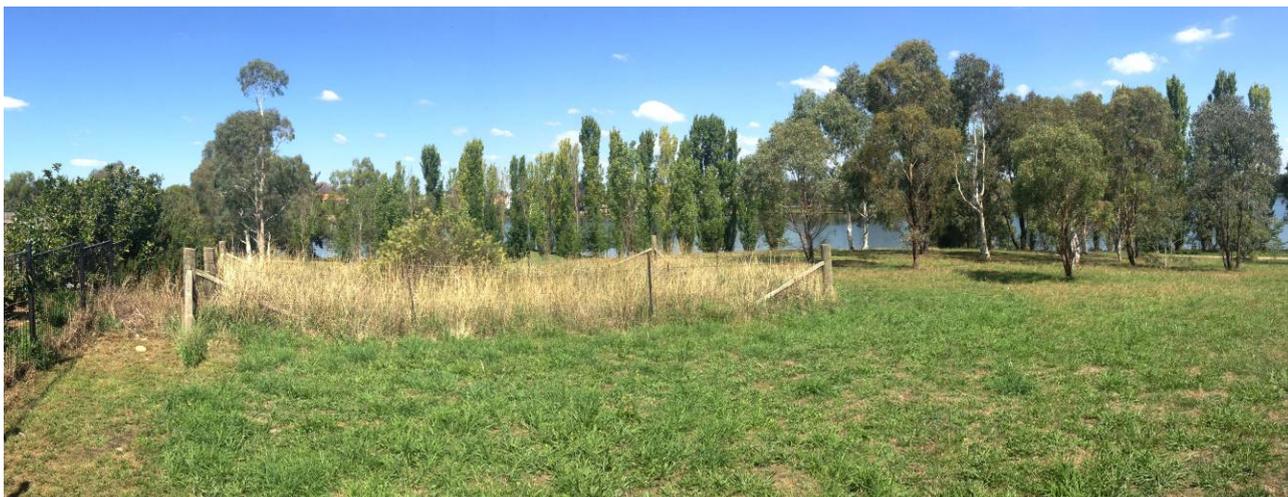
The site is enclosed in an 8x11m galvanised wire fence with treated pine corner posts. The extent of the house remains are fully enclosed within this fence and have been covered over with an orange-red crushed granite. The only part of the original structure visible is the outline of the hearth, which has been reconsolidated with concrete. There is a small concrete plinth with a plaque noting the history of the place.

Image 2 Overview of the Site B, facing east with Yerrabi Pond in the background (ACT Heritage, 2016)

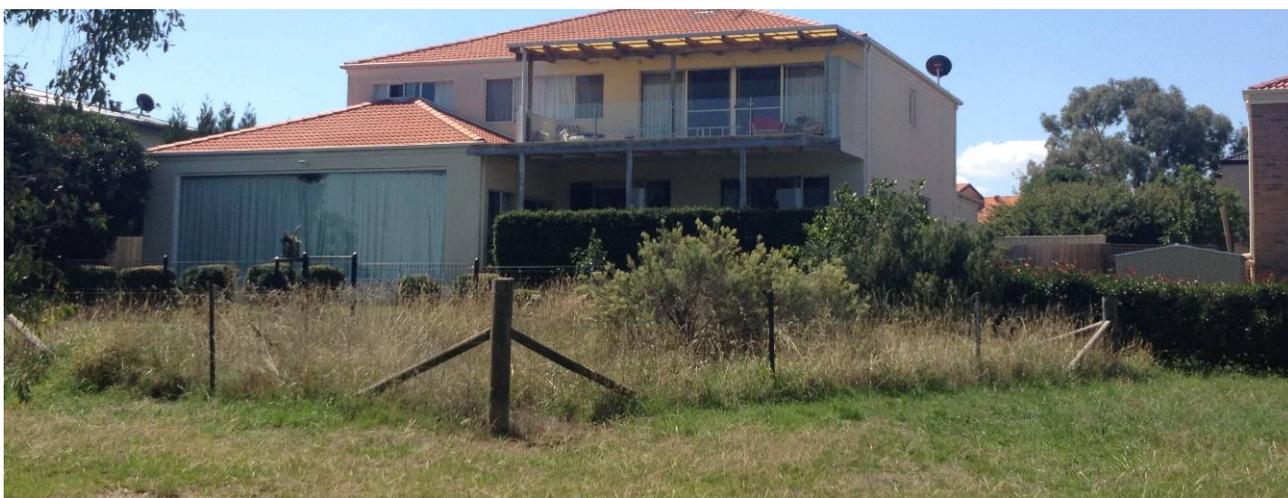
Image 3 Overview of the site facing north with Block 3 Section 78 Amaroo in the background (ACT Heritage, 2016)

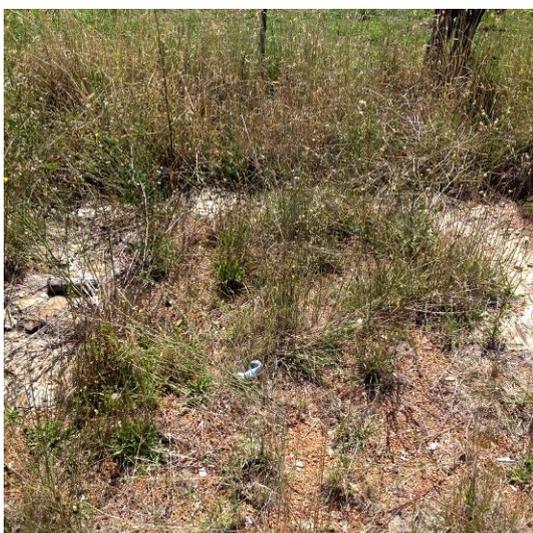
The site has been thoroughly excavated and it is unlikely that any artefactual material remains in-situ. The remains of the footings of the place remain covered by the crushed granite and the small section of the hearth that sits above ground level has been reconsolidated with cement.

Image 4 Closeup of the reconsolidated hearth (ACT Heritage, 2016)

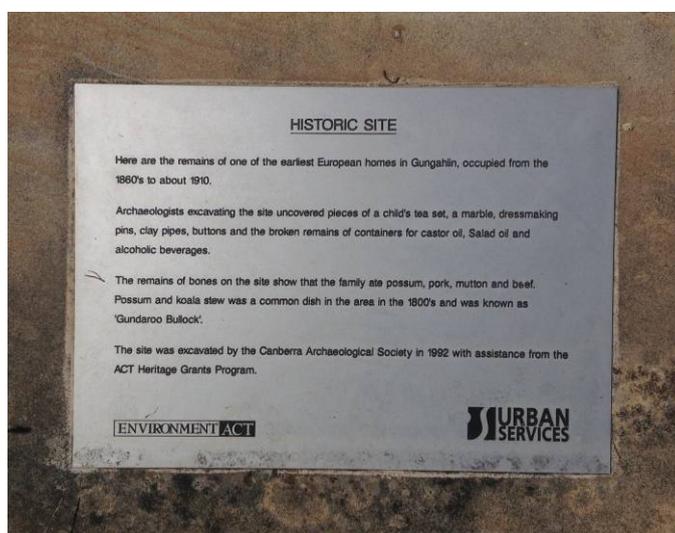
Image 5 Closeup of the plaque (ACT Heritage, 2016)
