## **Loose Fill Asbestos – Site Soil Validation Report**

**KAMBAH, Block 6, Section 352:**

**6 Lawrence Crescent, Kambah, ACT, 2902, Australia**

**Prepared by: WSP Australia Pty Limited**

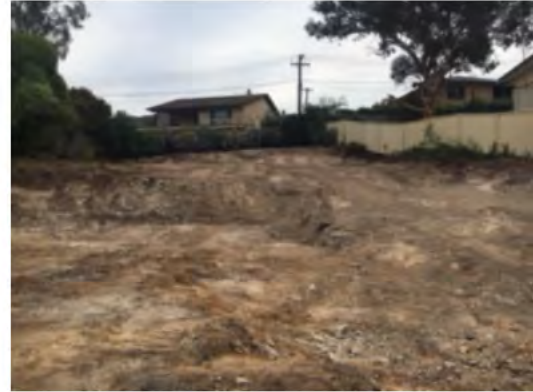
Cleared area of the demolition zone

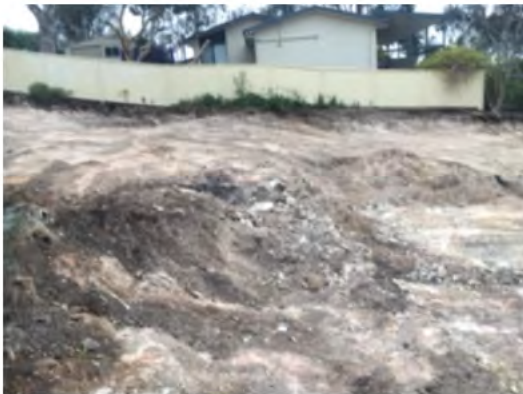
Cleared area of the demolition zone

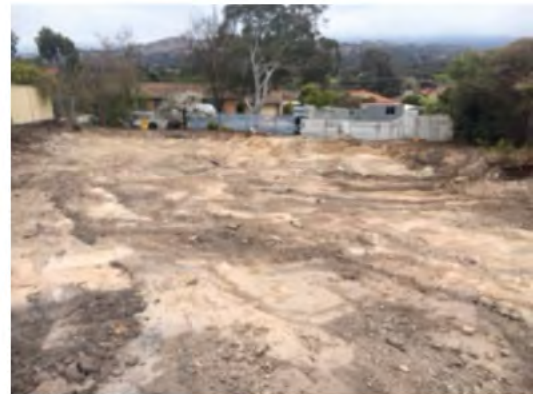
Cleared area of the demolition zone

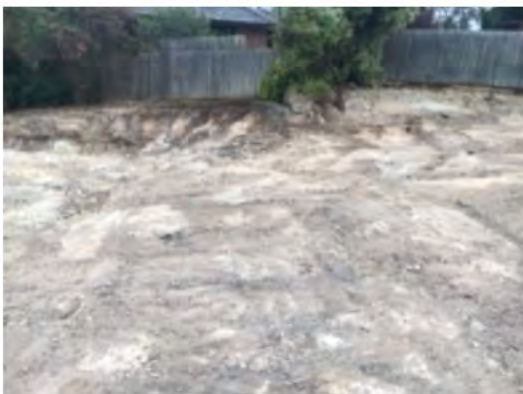
Cleared area of the demolition zone

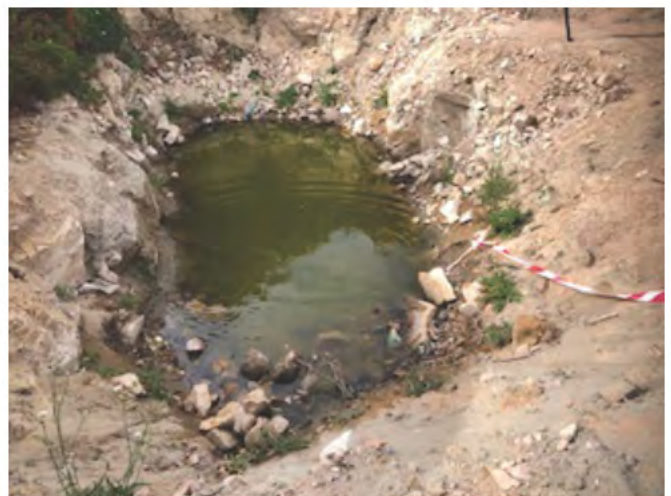
A thorough a visual inspection after completion of the above scope of works at the site location stated above and found no visible asbestos residue from asbestos removal work in the area, or in the vicinity of the area, where the work was carried out. Note: The excavation adjacent the asbestos sheet removal area is filled with water and could not be inspected.

*Pool excavation with water ingress*

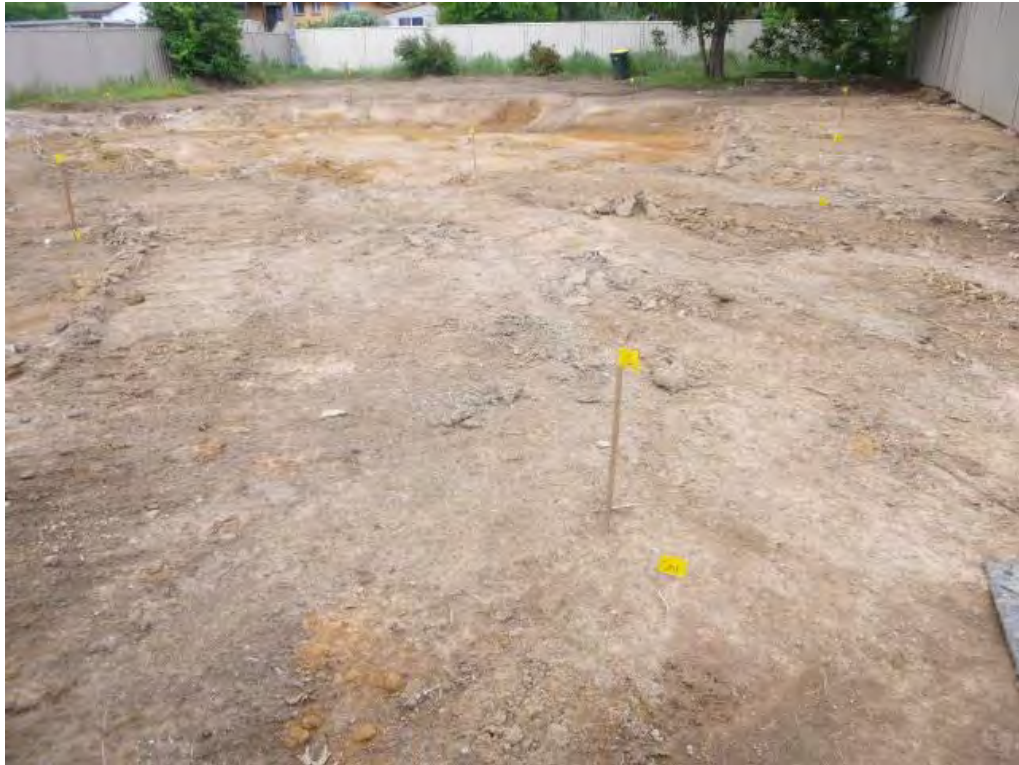
**Figure 3** Soil validation sample location/s (from the left) view from the south-eastern boundary to the northern boundary: S02, S10, S12, S09, S08, S04, S07, S01, S06, S05 and S03.

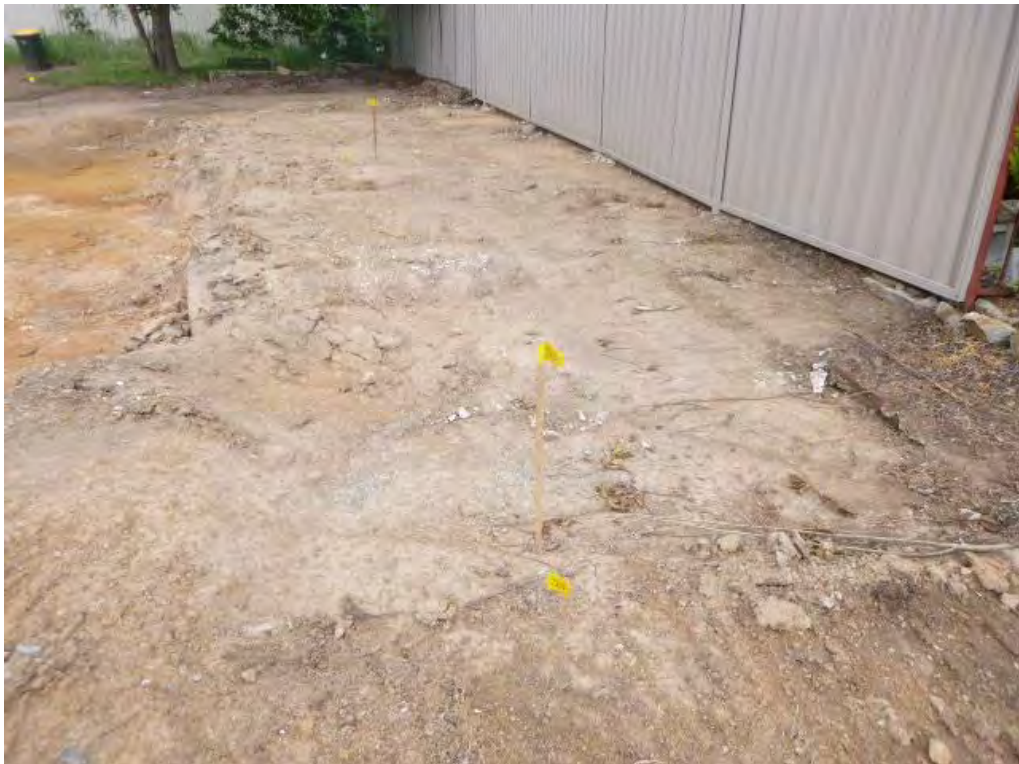
**Figure 4** Soil validation sample location/s (from the left) view from the south-eastern corner of the demolition area to the eastern boundary: S06, S05, S03 and S01. Note colour-bond fence to the left of the photograph.

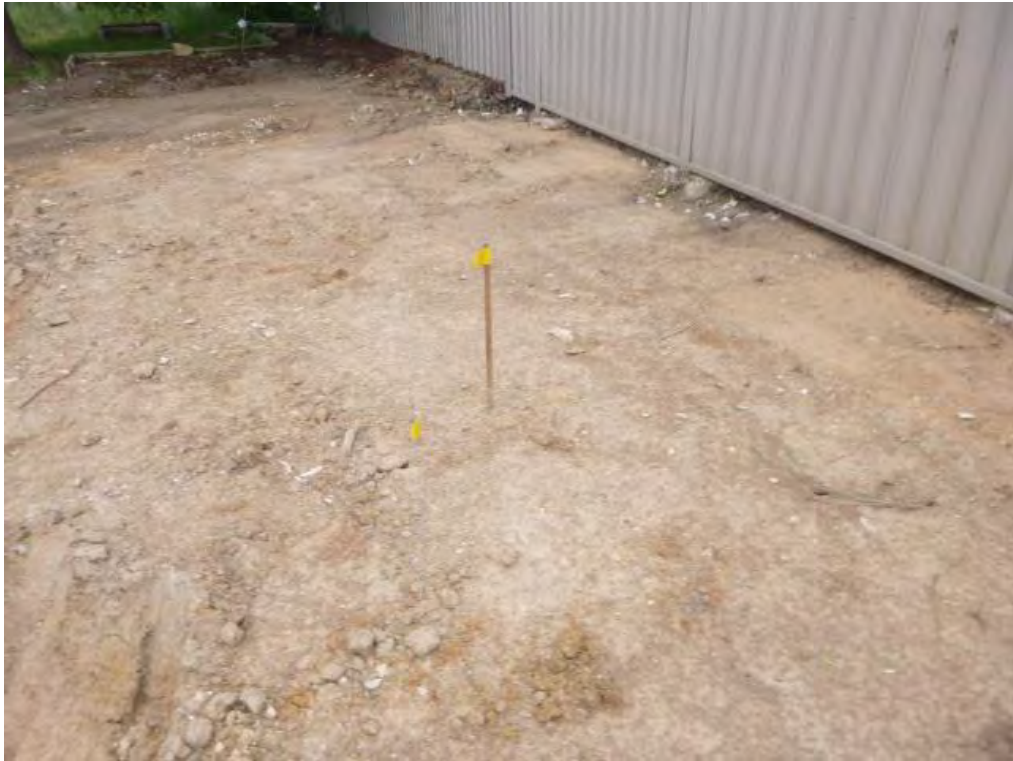
**Figure 5 Soil validation sample location/s (from the left) view from the eastern boundary of the demolition area to the eastern boundary: S05.**

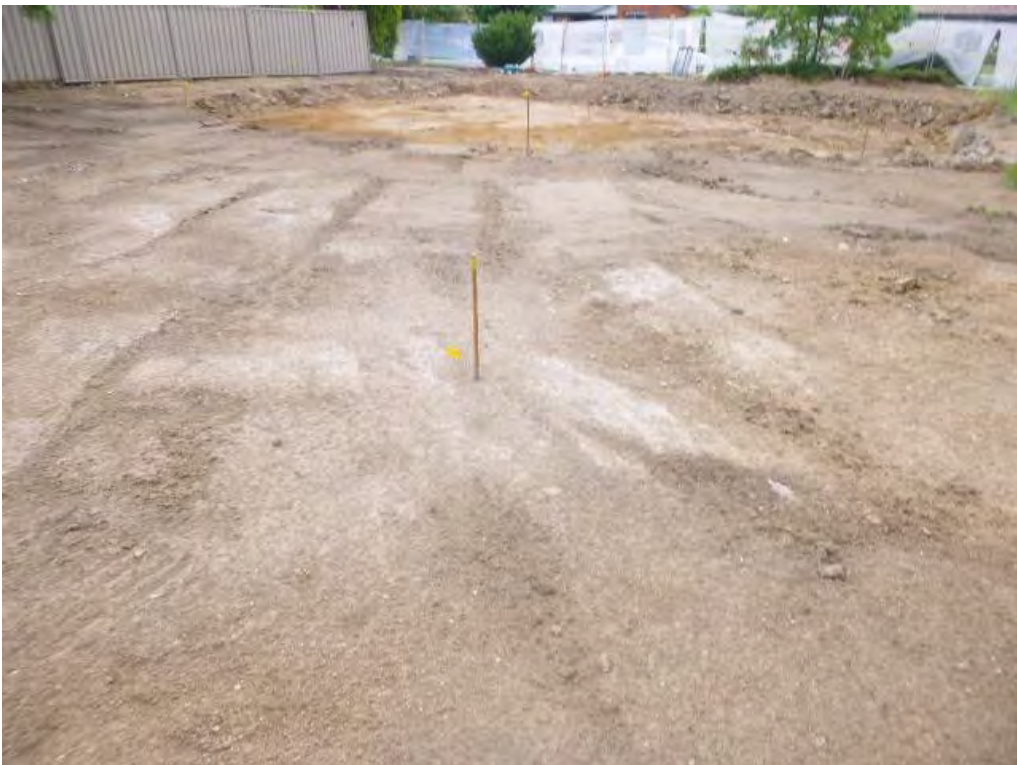
**Figure 6 Soil validation sample location/s (from the left) view from the north-western corner of the demolition area to the south-eastern boundary/demolition corner: S05, S06, S03, S04, S01, S02, S09, S12 and S11.**

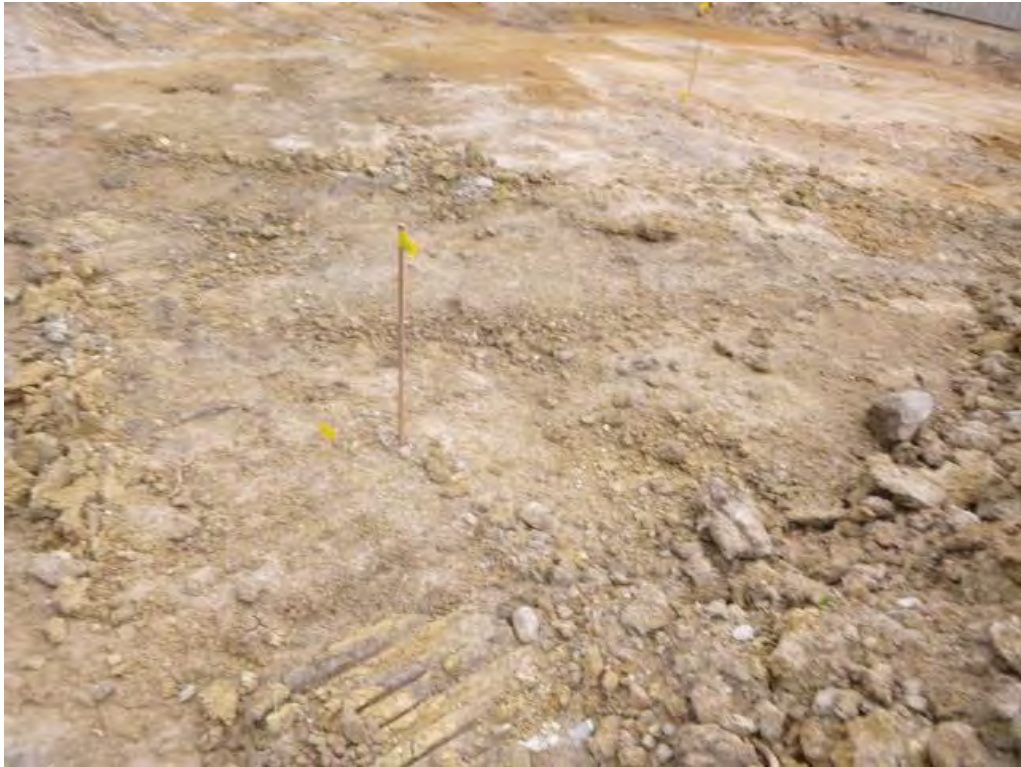
Figure 7 Soil validation sample location/s (from the left) view from the south-western corner of the demolition area to the eastern boundary: S11 and S12.

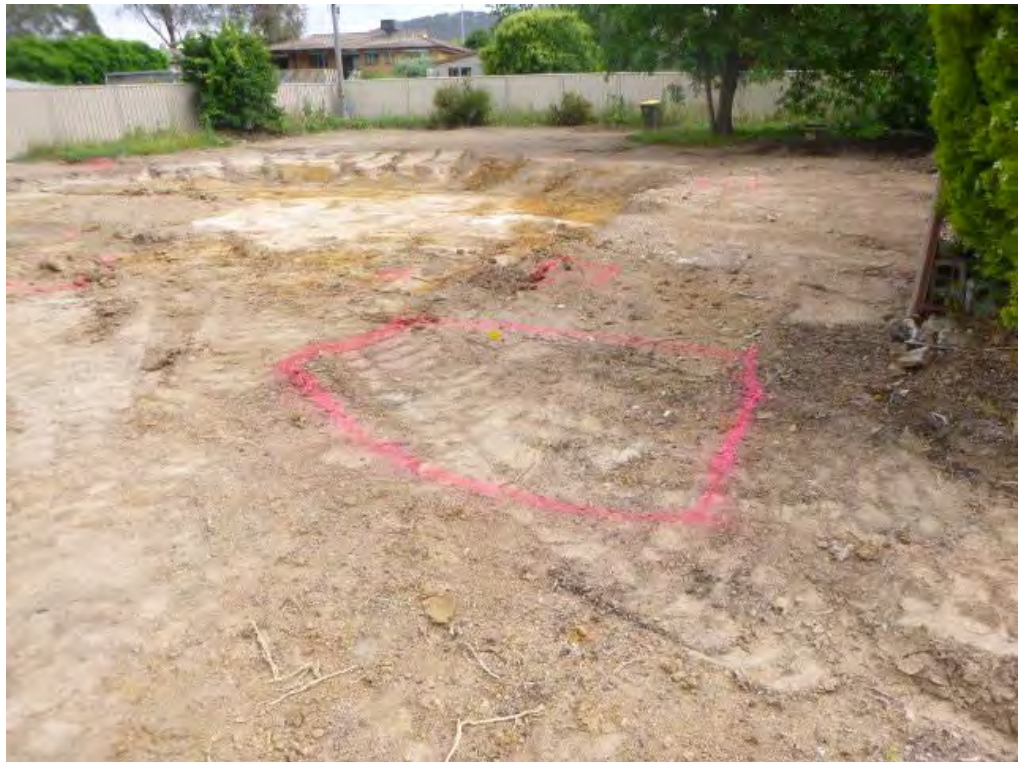
Figure 8 View from the south-eastern corner of the demolition area to the northern boundary. Photograph taken after soil scrape - painted areas are visual fibre cement sheet.

The 1st Hot spot samples were tested and additional chrysotile and amosite asbestos fibres were detected at H/S-7508-S01 and H/S-7508-S04. It was also noted during the inspection that visual fibre cement sheet fragments were visible on the surface of the site, particularly near the eastern boundary (colour bond fence).

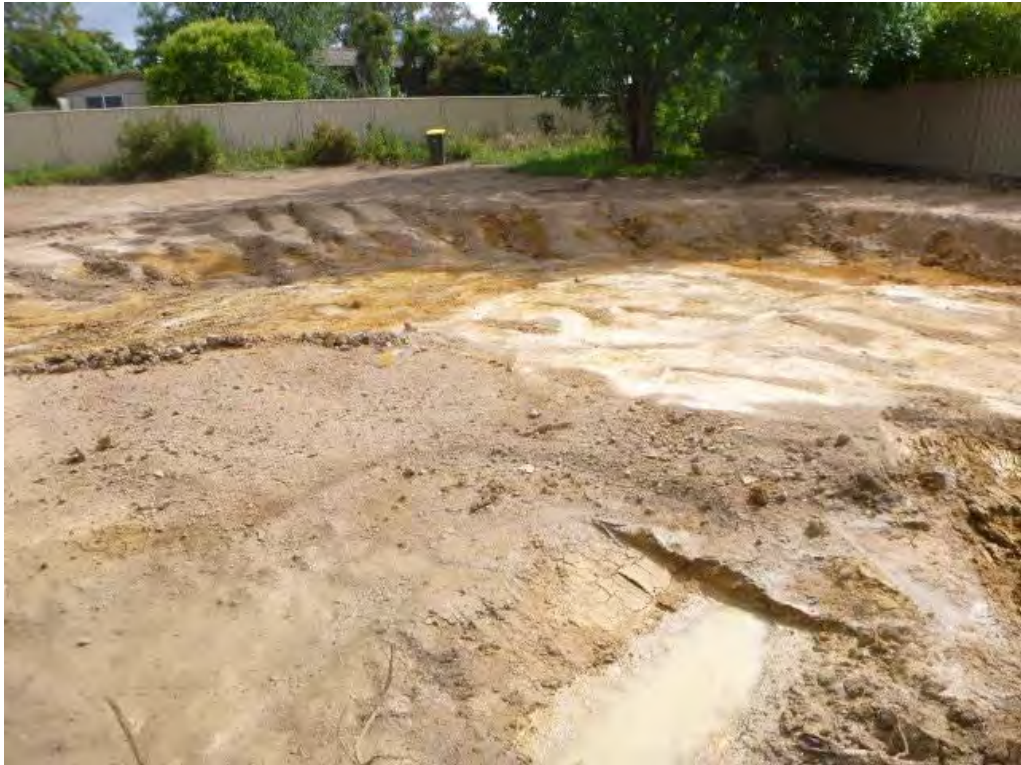
Figure 9 Overview of the first Hot Spot scrape.

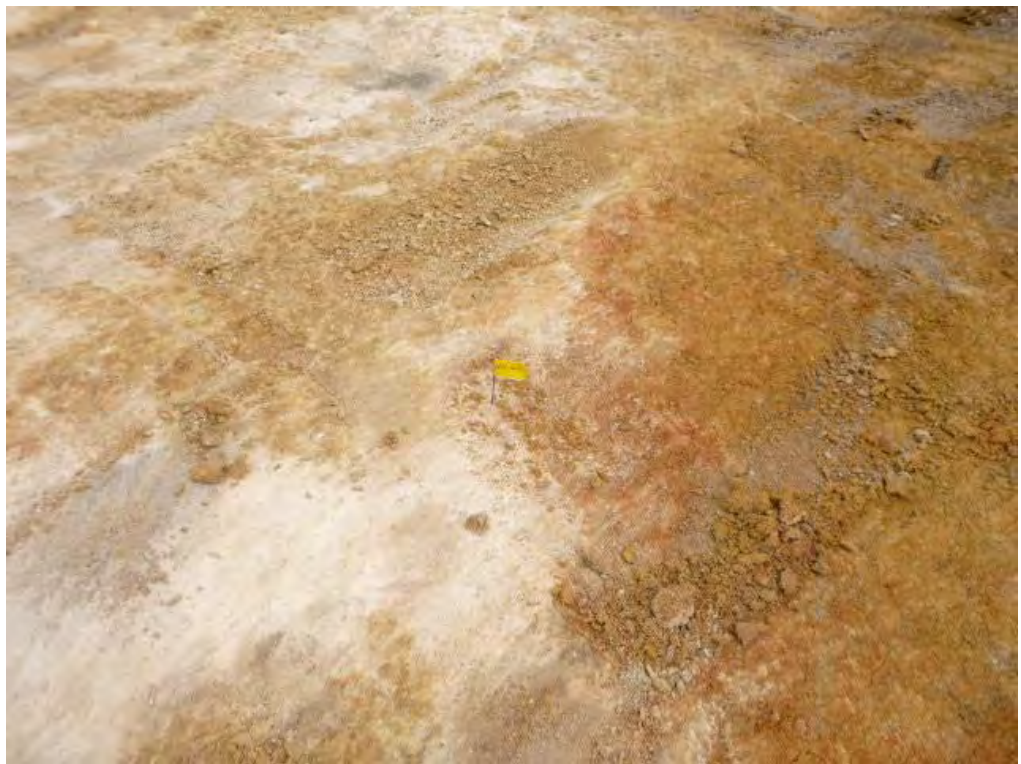
Figure 10 Final Hot Spot Soil validation sample location: H/S-7508-S01.

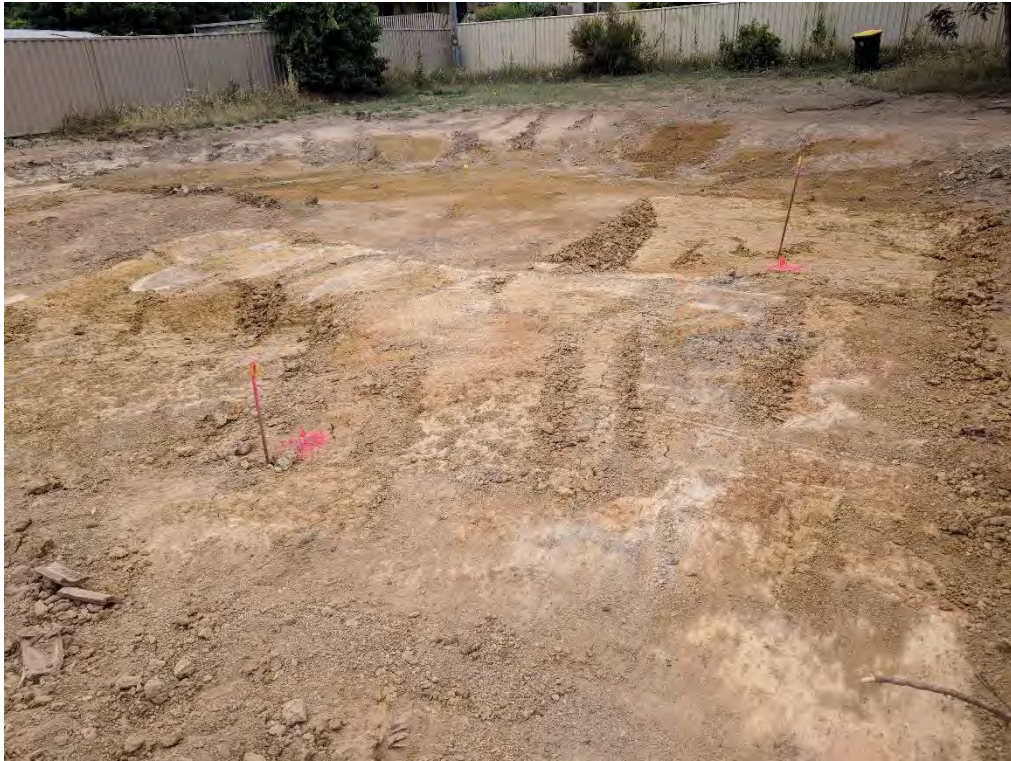
**Figure 11 Final Hot Spot Soil validation sample location/s (view from the left) view from the south-eastern corner of the demolition area to the northern boundary: H/S2-7508-S01 and H/S2-7508-S04.**

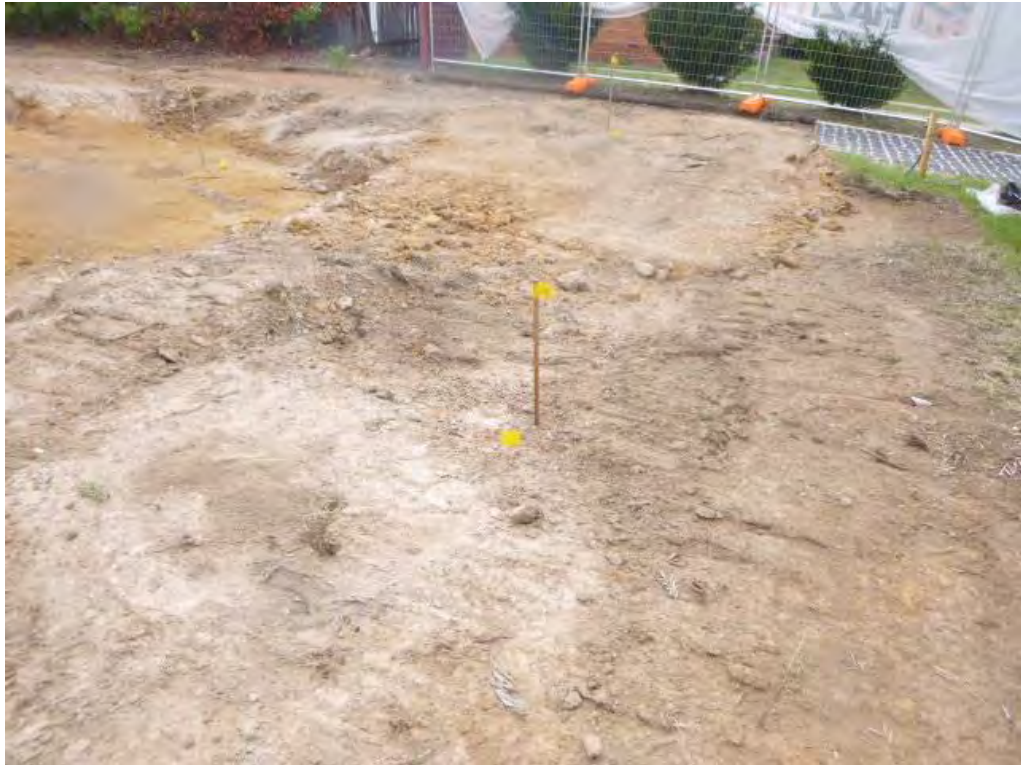
Figure 3 Soil validation sample location/s (from the left) view from the southern elevation of the demolition area to the eastern boundary: S11, S02 and S12.

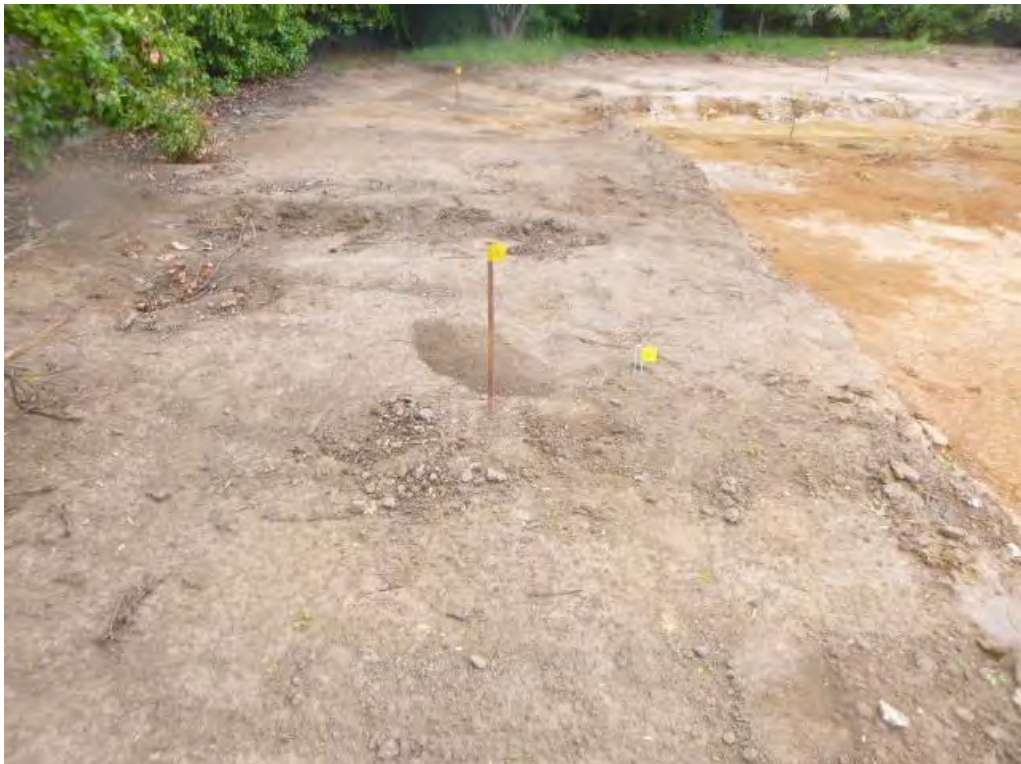
Figure 4 Soil validation sample location/s (from the left) view from the western elevation of the demolition area to the northern boundary: S04, S05, S06, S07 and S09.

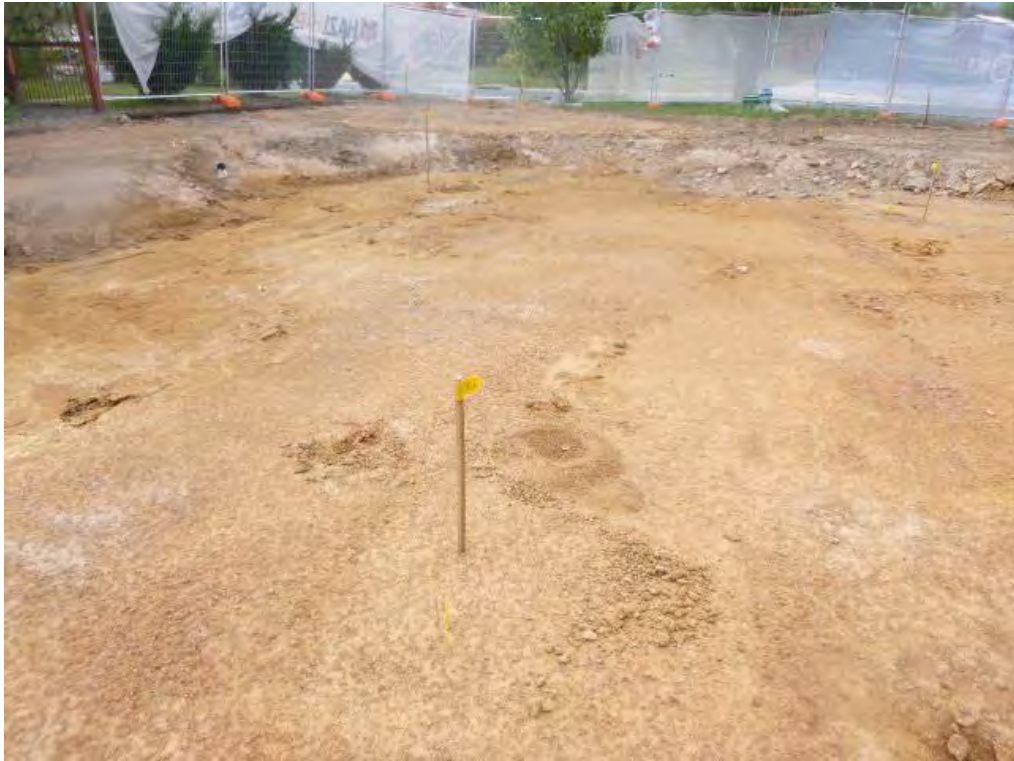
**Figure 5 Soil validation sample location/s (from the left) view from the southern centre of the housing footprint to the southern boundary: S12, S11, S06, S02 and S03.**

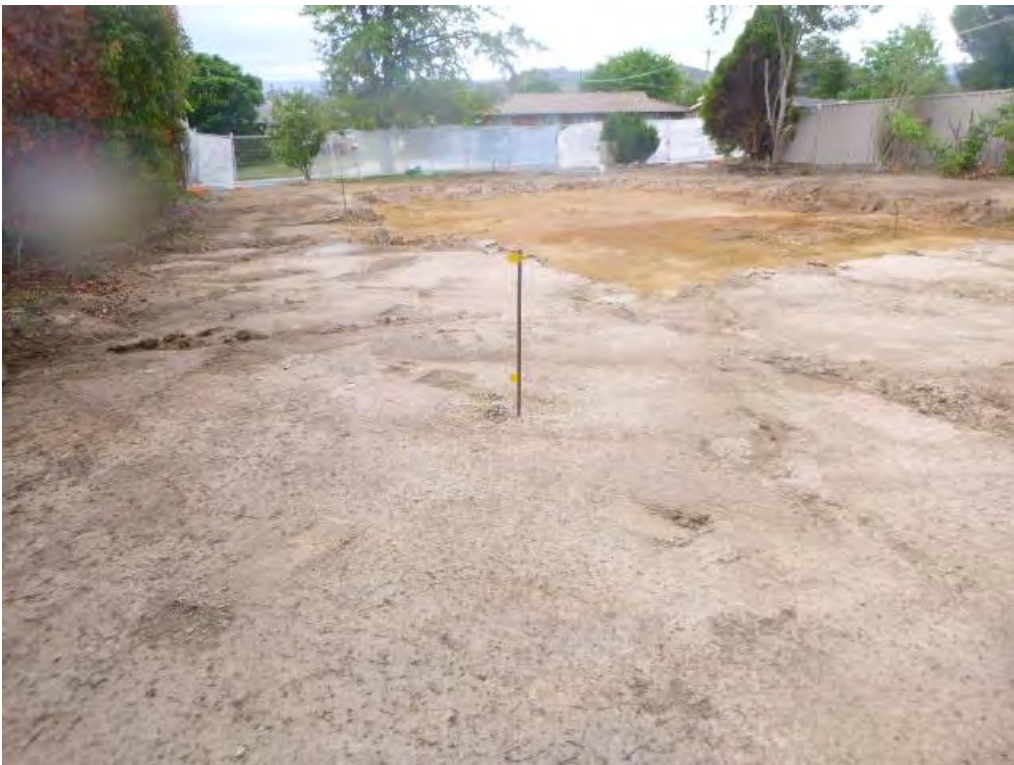
**Figure 6 Soil validation sample location/s (from the left) view from the north-eastern corner of the demolition area to the southern boundary/demolition corner: S12, S10, S11, S02, S09, S06, S01, S04 and S05.**

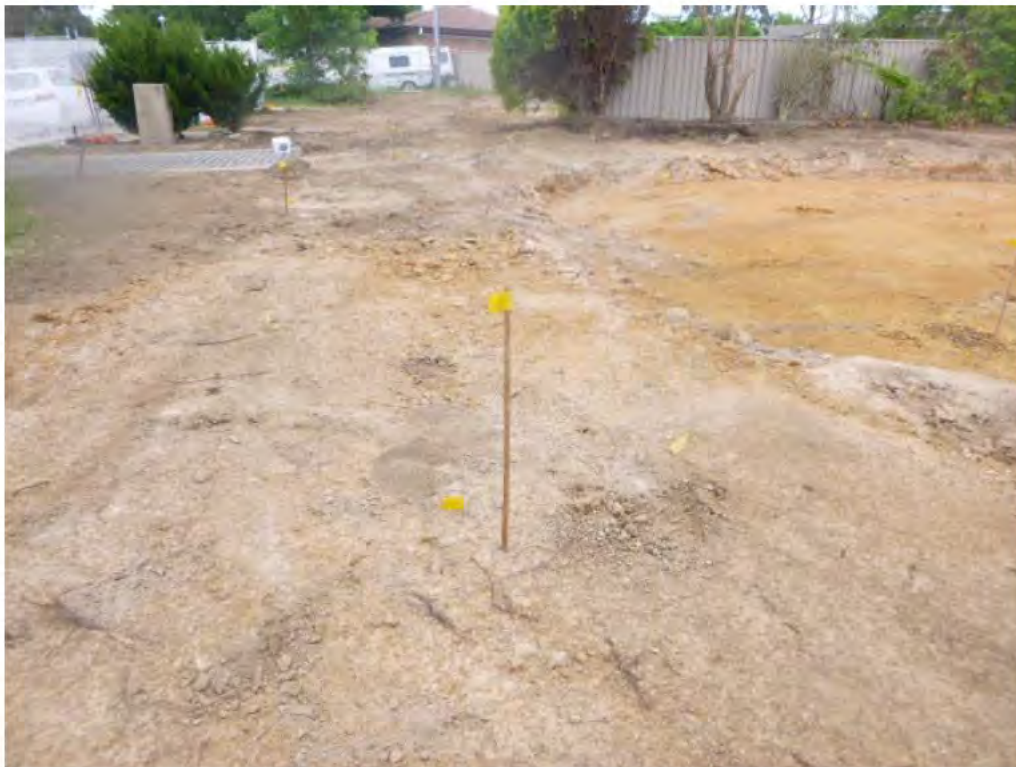
Figure 7 Soil validation sample location/s (from the left) view from the southern corner of the housing footprint to the western boundary: S01, S02, S12, S03, S04 and S11. Note remaining colour bond fence separating 45 and 46 McDermott Street, Kambah.

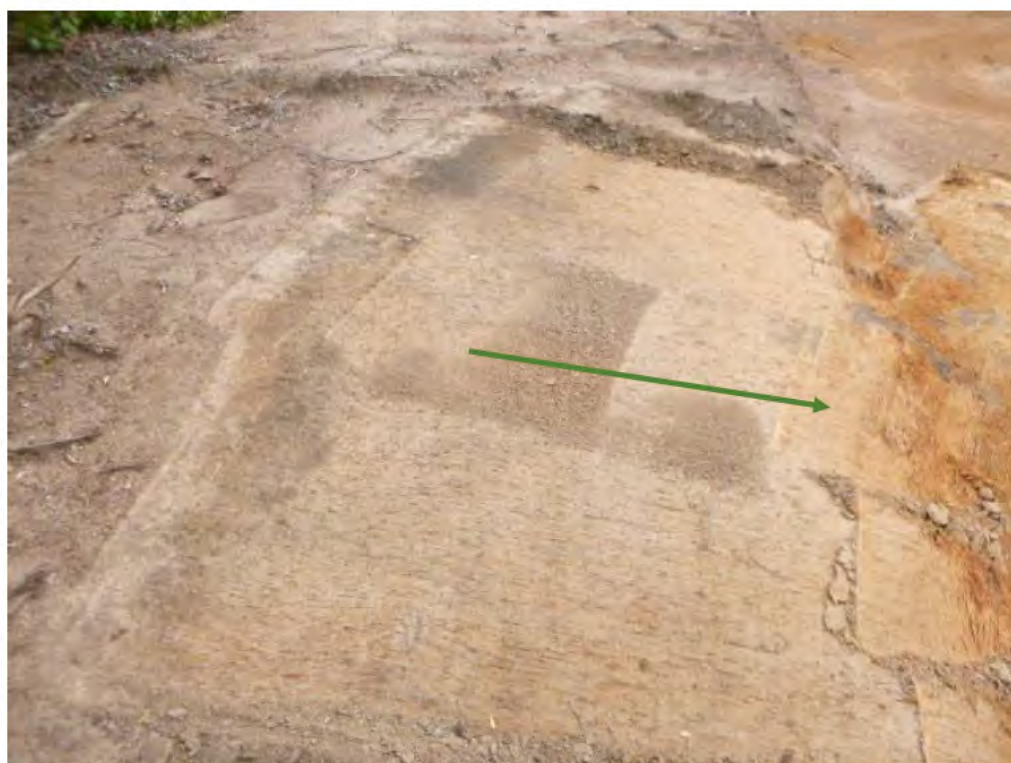
Figure 8 First Hot Spot Soil validation sample location (14/12/2017): H/S-7508-S01.

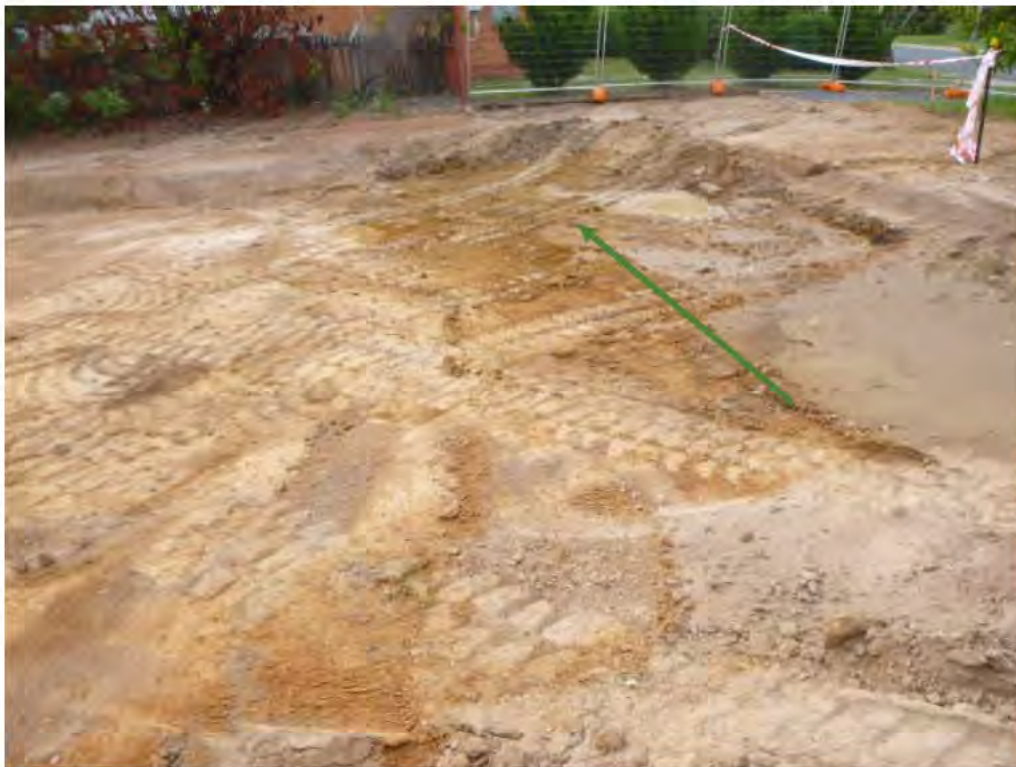
Figure 9 First Hot Spot Soil validation sample location (14/12/2017): H/S-7508-S02.

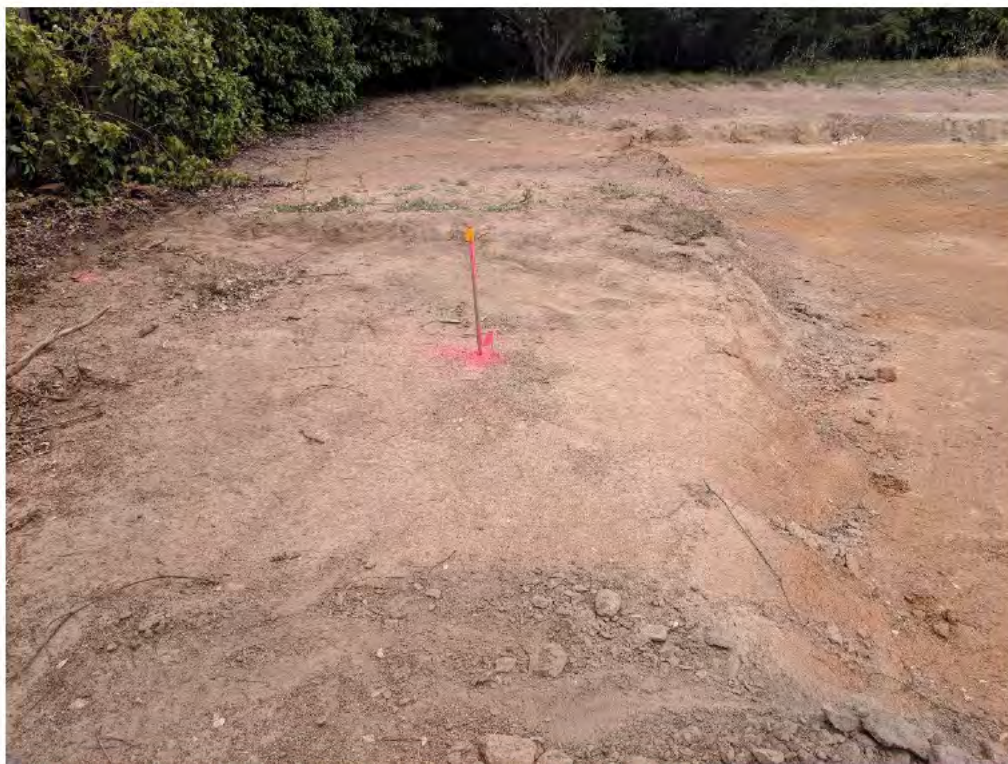
Figure 10 Final Hot Spot Soil validation sample location (22/01/2018): H/S2-7508-S01.

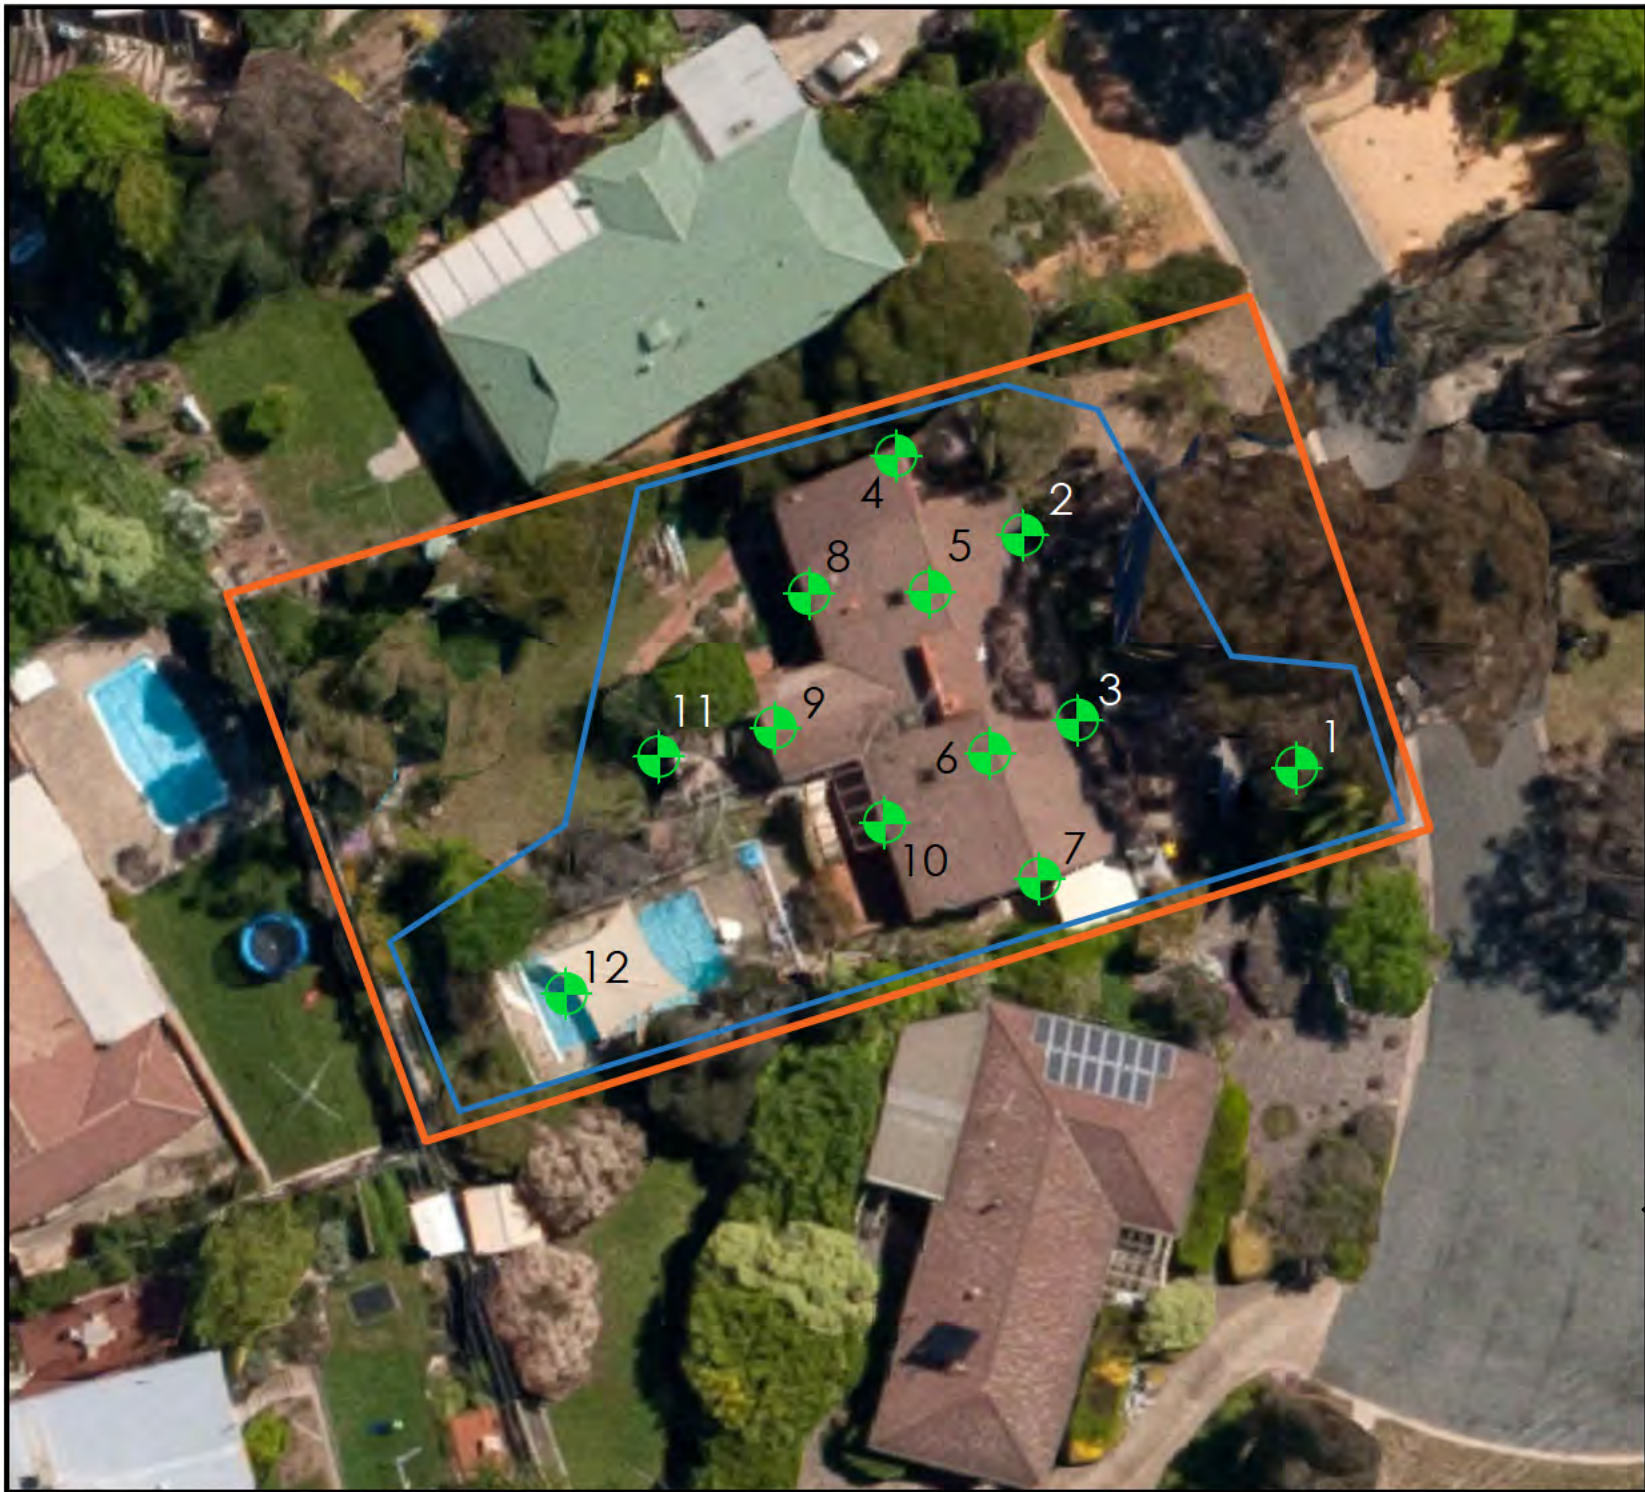
ATTACHMENT A  
Site Sample Plan

**SITE DETAILS**  
Block 5, Section 49  
12 Hamersley Pl  
Fisher, ACT
