Draft 3

Historic Huts in Namadgi affected by Bushfire

Demandering Hut

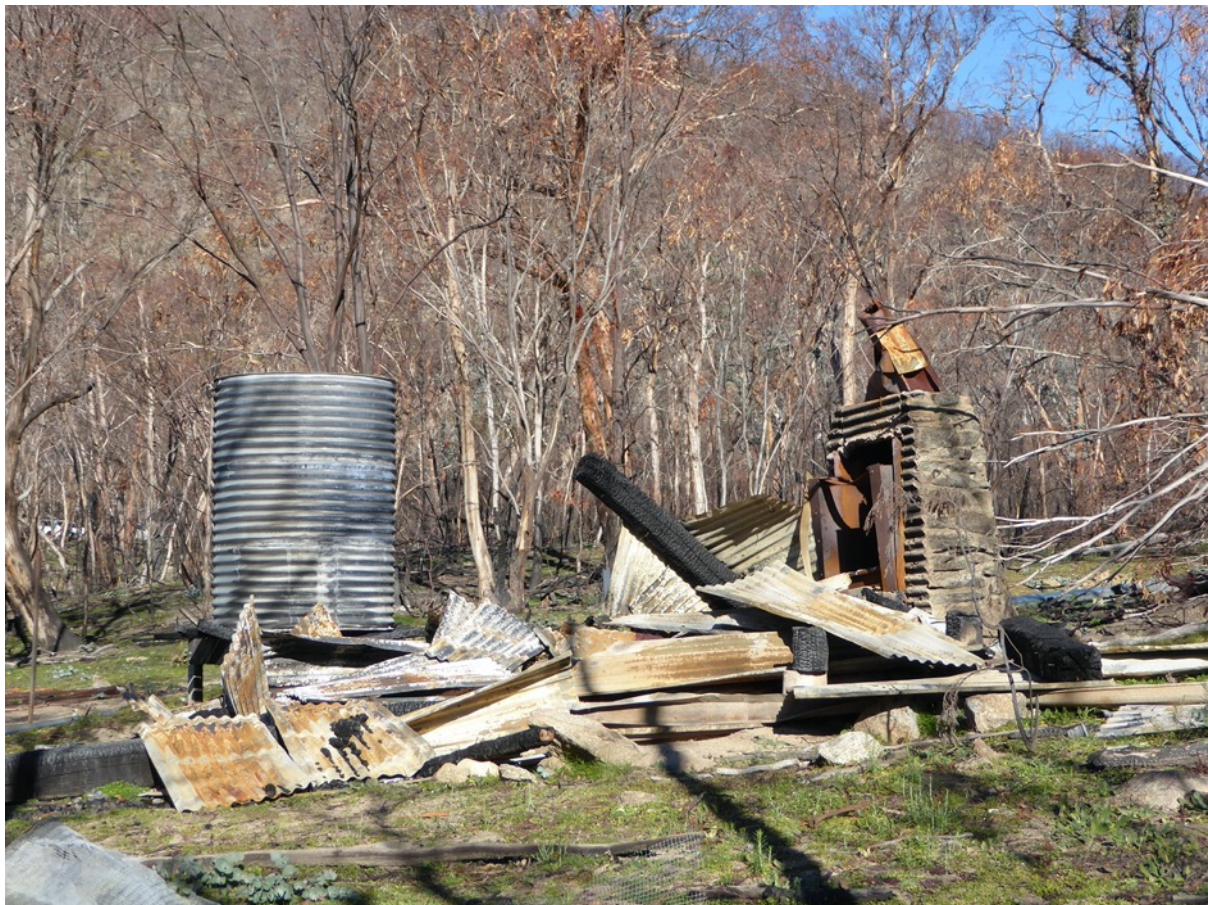
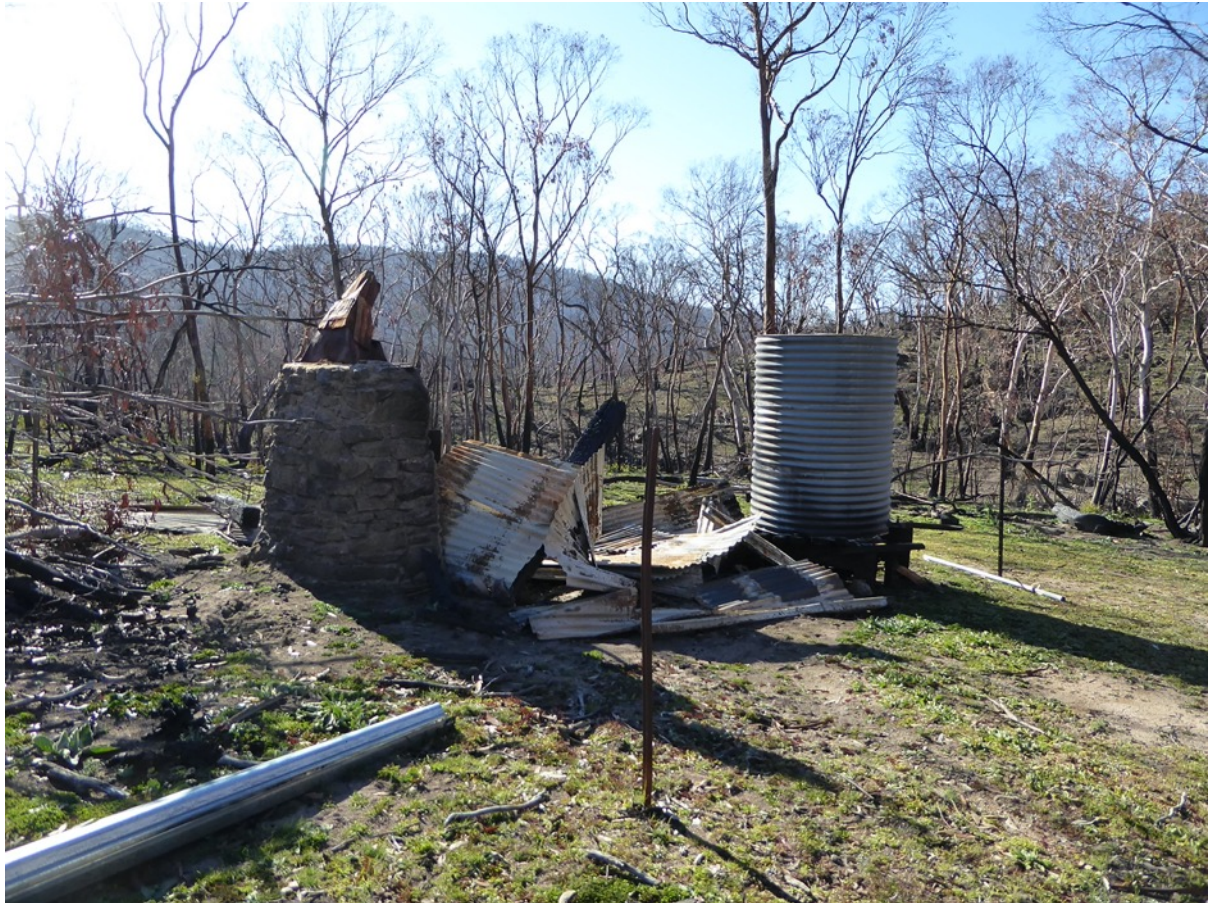
The hut has substantially collapsed. There are modern circular concrete footings, the concrete collar for a former timber post, circular stump footings, the charred remnants of collapsed massive sawn timber posts (more in the character of bridge timbers), some bush pole timber framing, collapsed corrugated galvanised iron walls and roof, a stone and concrete fireplace and chimney, a corrugated metal rainwater tank, now burst at the base, set on a modern timber stand which is part burnt and collapsed.

Given this context, and noting the discussion of options presented in the previous sections, ***it is recommended the two huts be fully restored/reconstructed, re-using as much of the original material as possible*** (eg. corrugated iron). This should be undertaken after the careful recording, deconstruction and salvage of the hut sites, possibly with the assistance of an historical archaeologist.

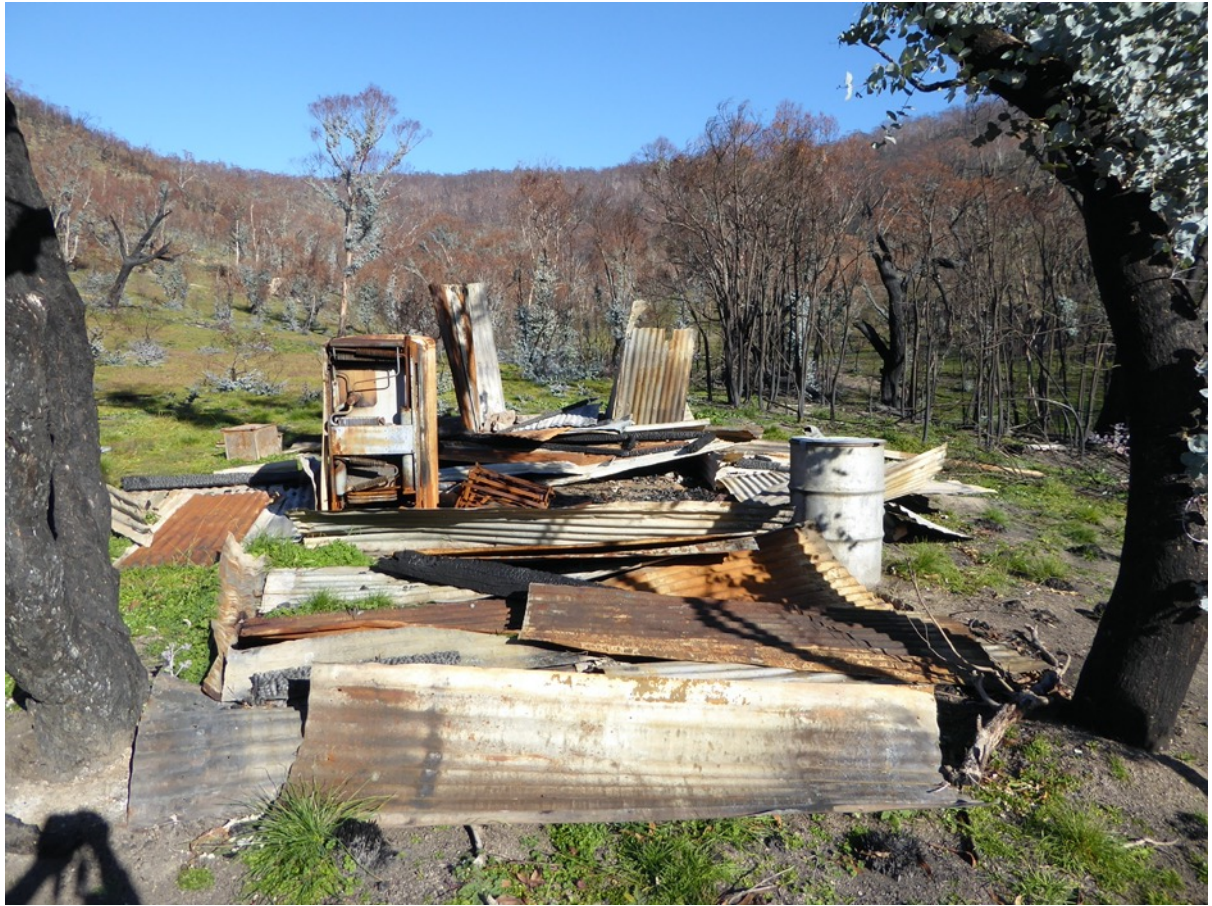
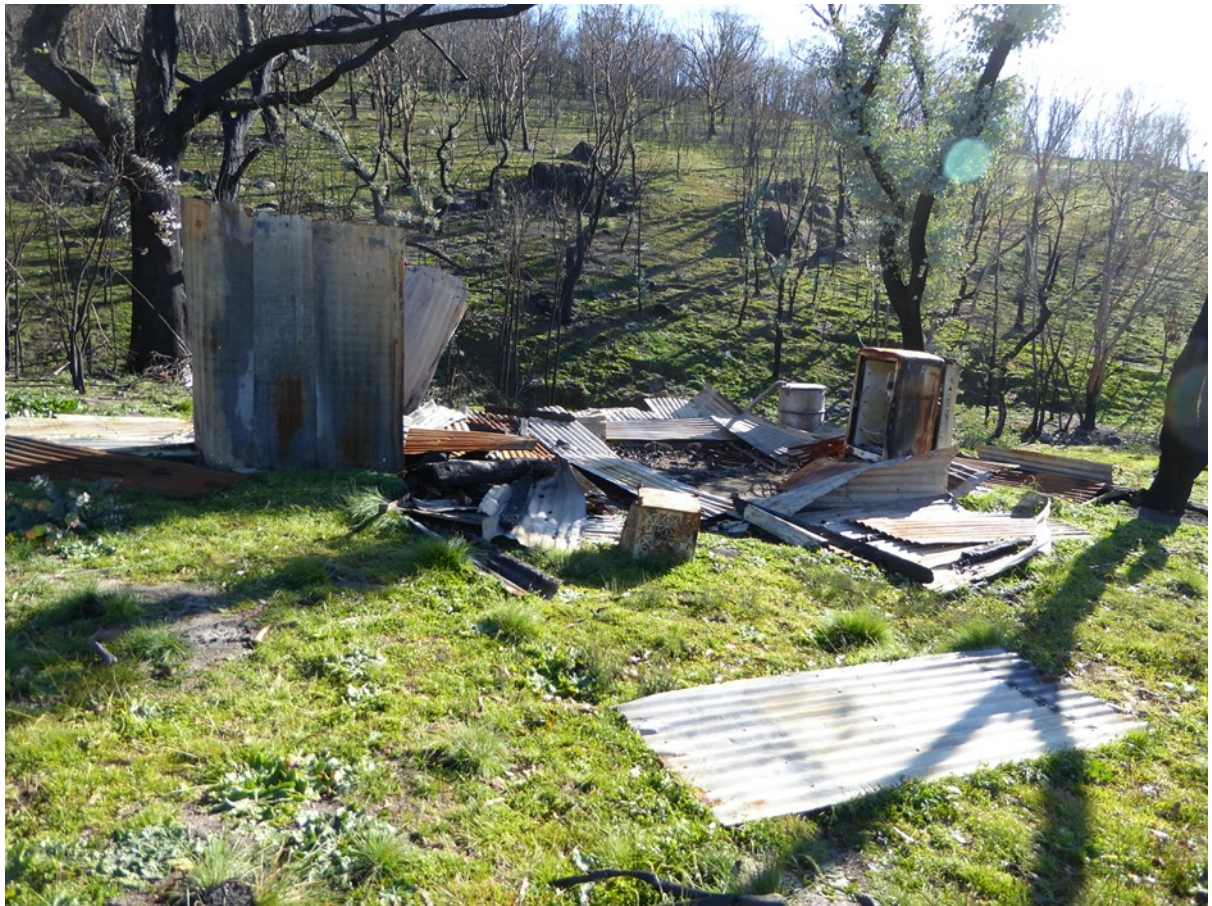
The hut has substantially collapsed. This was a timber framed and corrugated galvanised iron wall and roof structure. The remnant timber members are charred and no sound timbers appear to survive, along with the collapsed corrugated iron wall and roof sheeting. Fixings are wire, nails and modern power driven screws. Part of the corrugated iron fireplace surround remains standing. The fireplace stones remain largely in place. Features on site include a former fridge, a rainwater drum with downpipe, remnant metal bed and chairs.

The former fridge door, at least, contains an insulation material which, given the age of the fridge, may contain asbestos. The insulation is visible. The potential for hazardous material should be formally assessed.

- a check should be made as soon as possible for any hazardous materials which might exist on the hut sites (eg. in the case of the refrigerator at Max and Bert Oldfield's Hut);
