**Phase 1 and 2 Contamination Assessment**

Block 2, Section 28, Greenway, ACT

18 February 2015

Preliminary Geotechnical Investigation

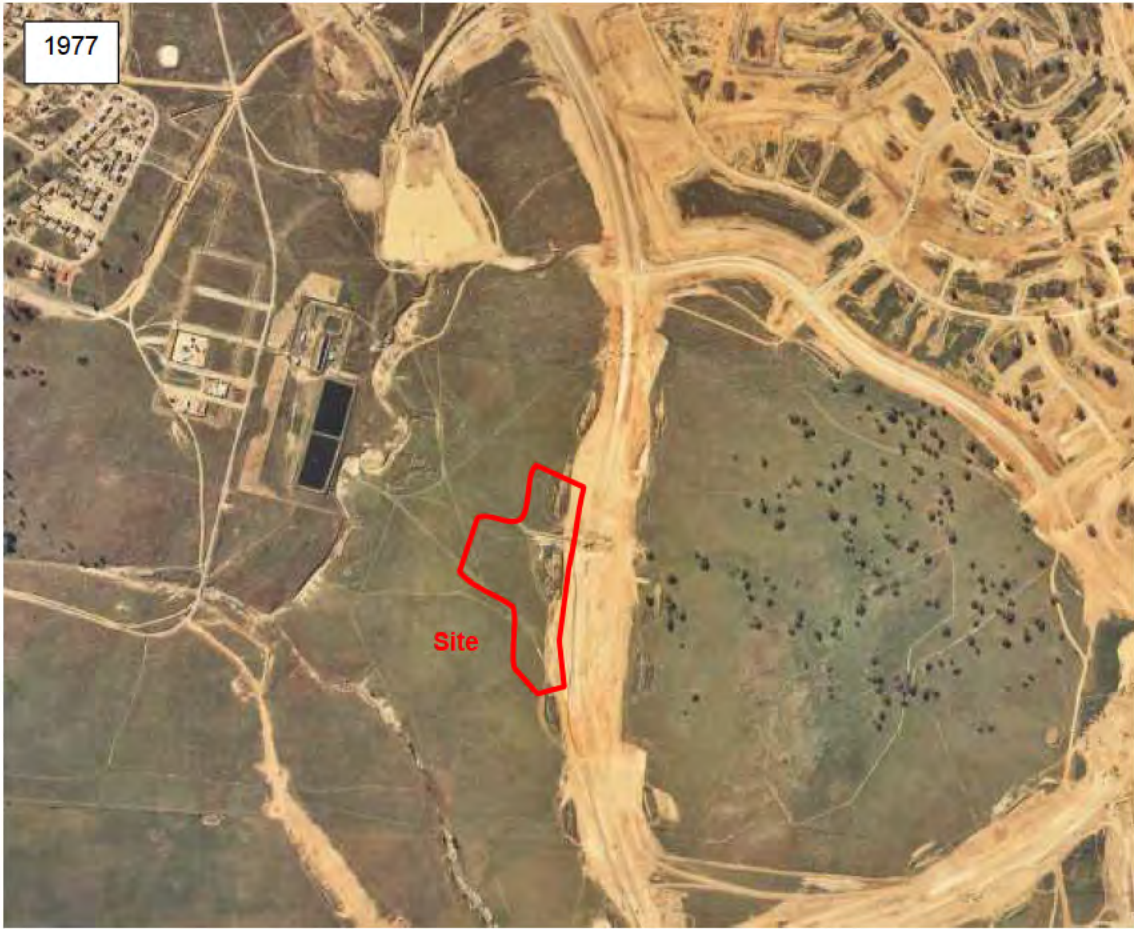
1984 (colour)	<p>The majority of the site appears grassed and is similar to the previous aerial photograph. The trench visible in the previous aerial photograph appears as a culvert or walkway. An irregular patch of land partially covers the walkway in the centre of the site. The existing tracks are not visible, and appear to have been replaced with more lineal pathways across the site.</p> <p>The northbound lane of Drakeford Drive is visible, and there appears to be redevelopment earthworks to the east of Drakeford Drive. The treatment ponds to the west of the site appear to be infilled. The surrounding land use appears similar to the previous aerial photograph.</p>

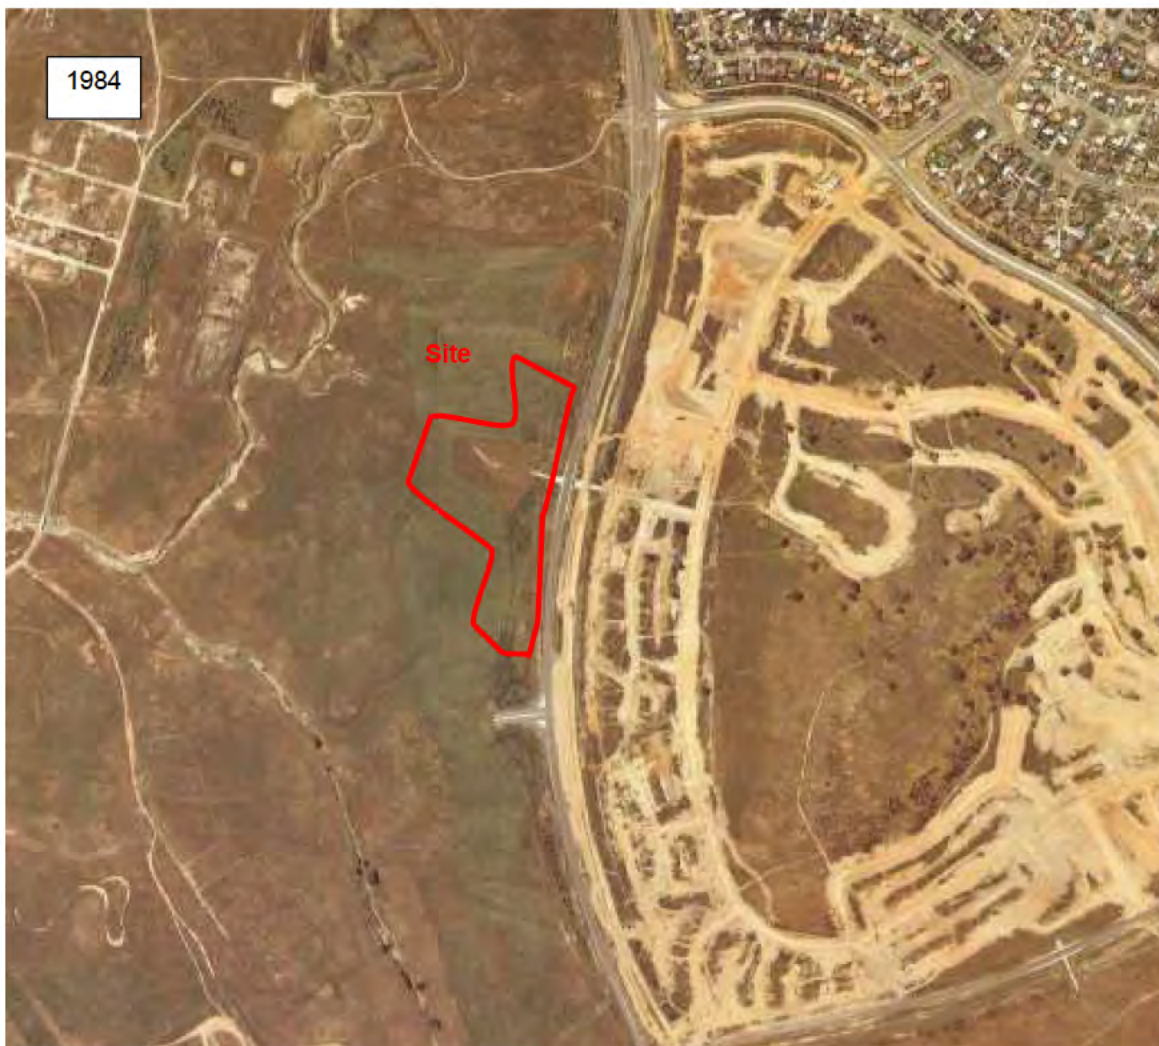
Site

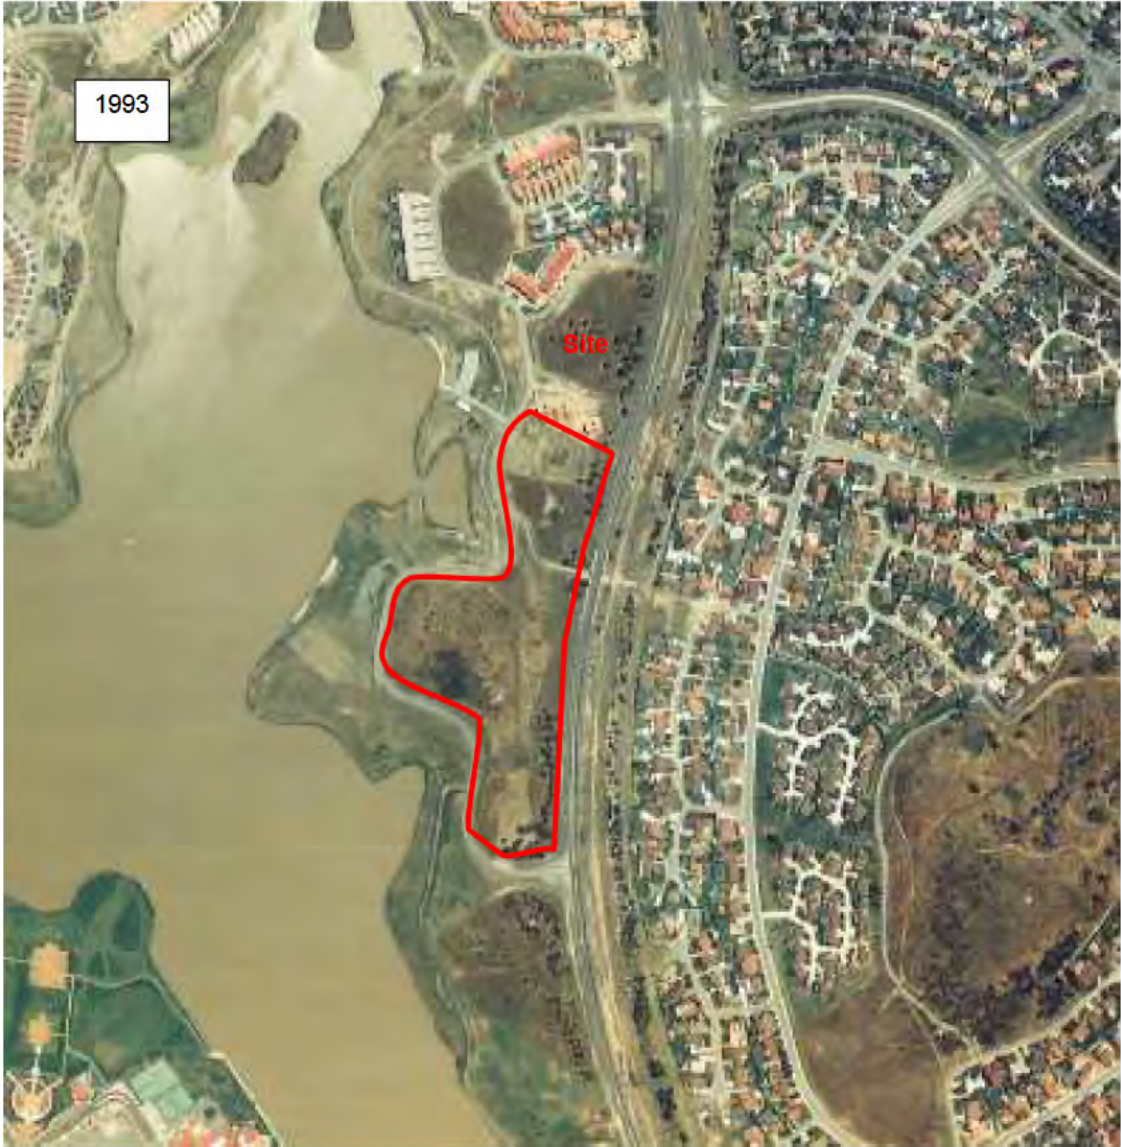
Image Date	Observations
1993 (colour)	<p>The walkway appears to extend westwards towards Mortimer Lewis Drive, which is visible along the western site boundary. Two areas of the site (in the north and west) appear a deeper shade of green, possibly indicating that these are areas of higher moisture than surrounding areas.</p> <p>Lake Tuggeranong is visible, and is of a similar orientation as present. The Lake footprint covers the former treatment ponds. Residential properties are visible to the east of Drakeford Drive, and earthworks activities are occurring in areas to the north of the site. The remainder of the surrounding site use appears similar to the previous aerial photograph.</p>
22/12/2002 (Google Earth Image™)	<p>The greener area in the north and west of the site appears to be of a duller shade of green and appears similar to surrounding land. The area where the current depression in the southern area of the site is distinguishable from the darker green colour in this photograph. There is a dirt track transecting the western area of the site. The remainder of the site appears similar to the previous aerial photograph.</p> <p>Additional residential development is being constructed to the north of the site, and the southbound land of Drakeford Drive is visible. The surrounding site use appears similar to the previous aerial photograph.</p>

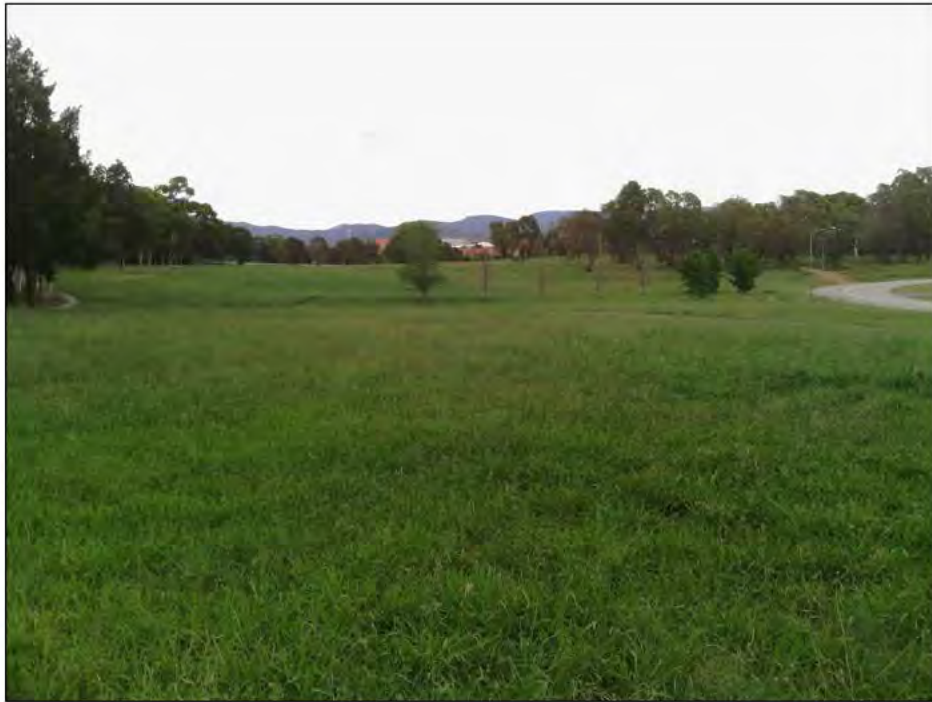
Photograph 1: Looking south from the northern area of the site.

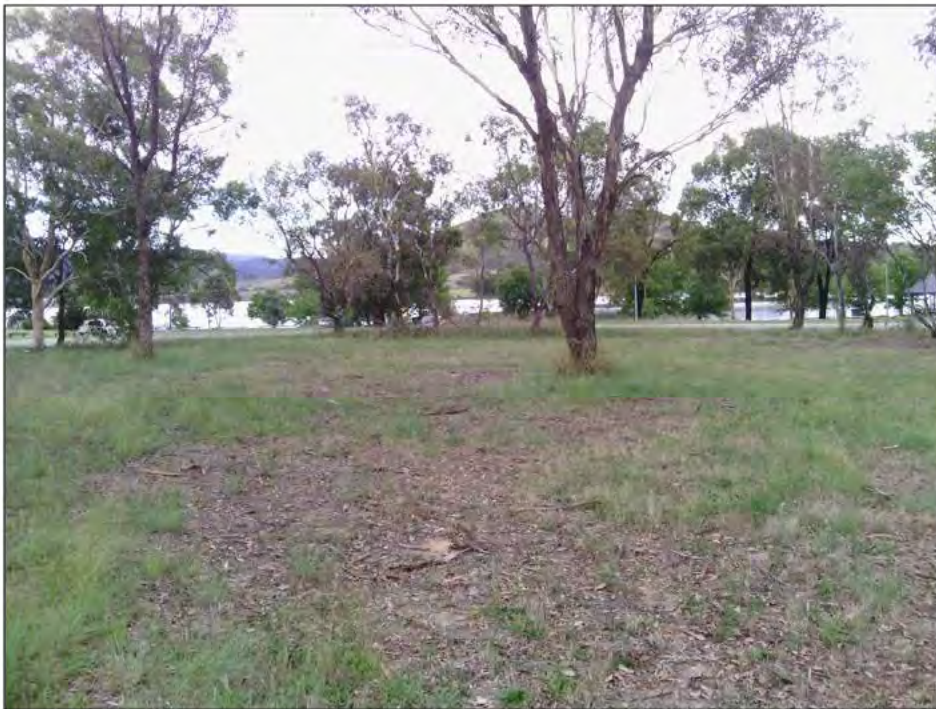
Photograph 2: Looking east towards Lewis Mortimer Drive and Lake Tuggeranong from the eastern area of the site

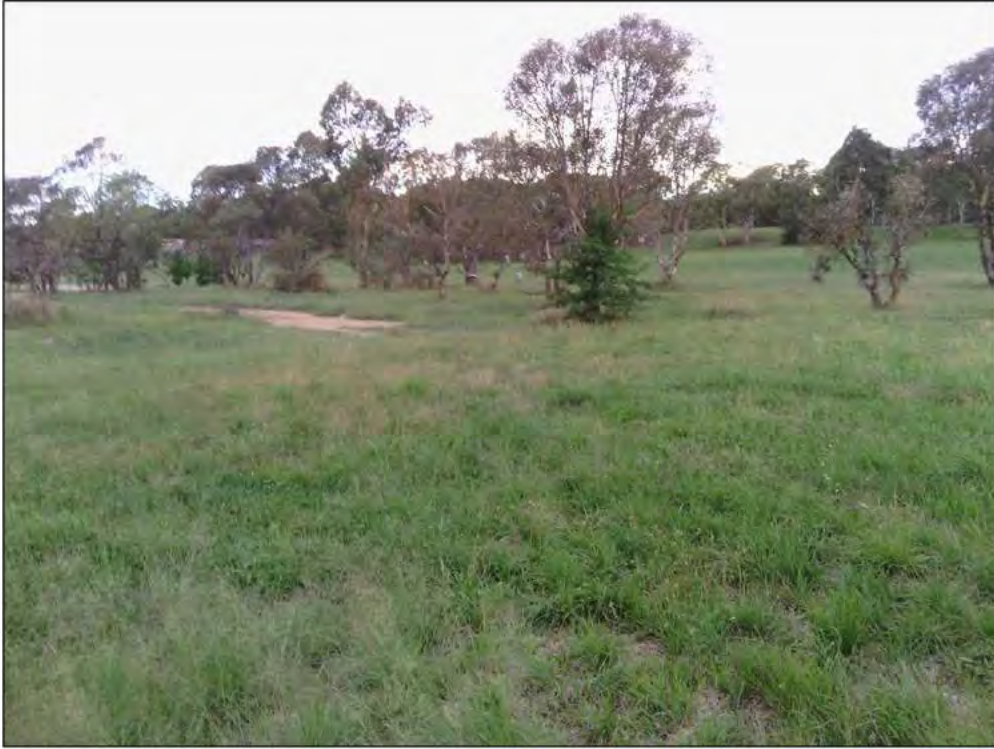
- A dirt track transects the eastern portion of the site from the north. Patches of exposed soil were observed in this area, and a small mound ( $<1\text{m}^3$ ) of mulch was also observed.

Photograph 3: Looking northeast towards the centre of the site from the eastern portion of the site. The dirt track is visible in the left of the photograph.

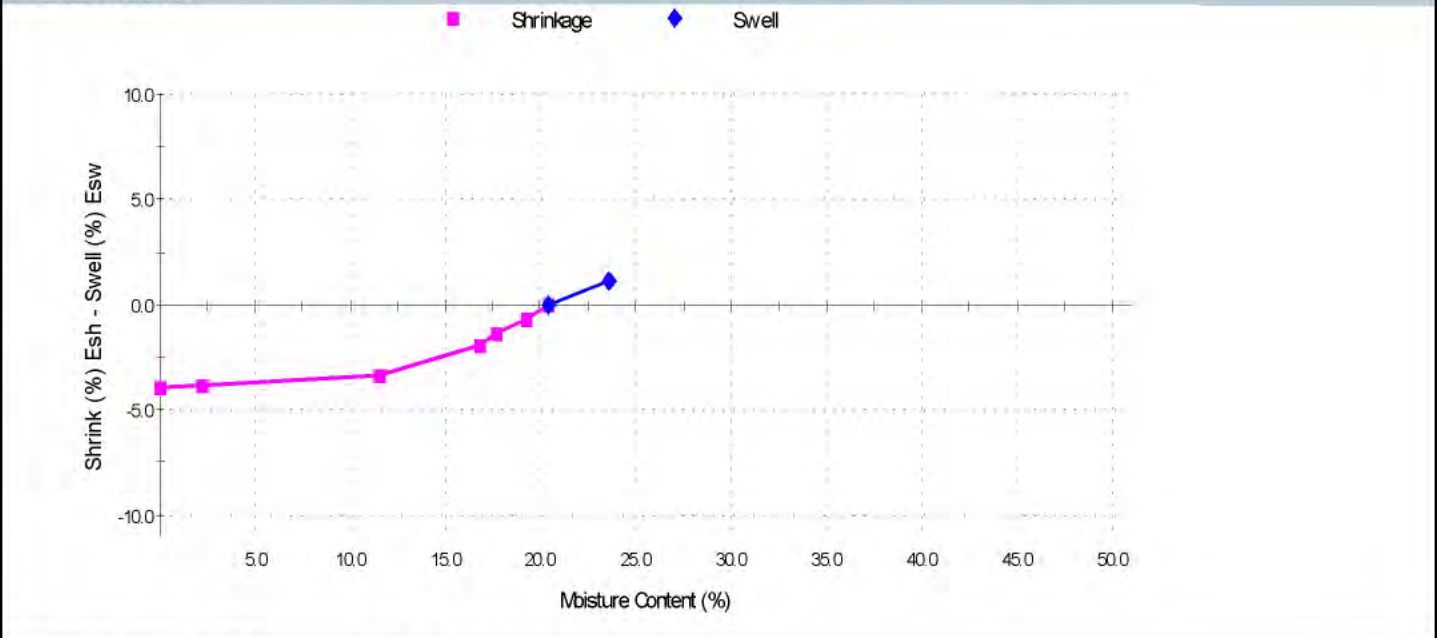
## Shrink Swell

Swell Test AS 1289.7.1.1		Shrink Test AS 1289.7.1.1	
Swell on Saturation (%):	1.1	Shrink on drying (%):	3.9
Moisture Content before (%):	20.4	Shrinkage Moisture Content (%):	20.4
Moisture Content after (%):	23.6	Est. inert material (%):	<5
Est. Unc. Comp. Strength before (kPa):	>500	Crumbling during shrinkage:	Very Slight
Est. Unc. Comp. Strength after (kPa):	300	Cracking during shrinkage:	Very Slight

Shrink Swell Index - Iss (%): 2.5
