FEASIBILITY STUDY

EAST LAKE

SITE PREPARATION

Prepared for **Environment and Sustainable Development Directorate**

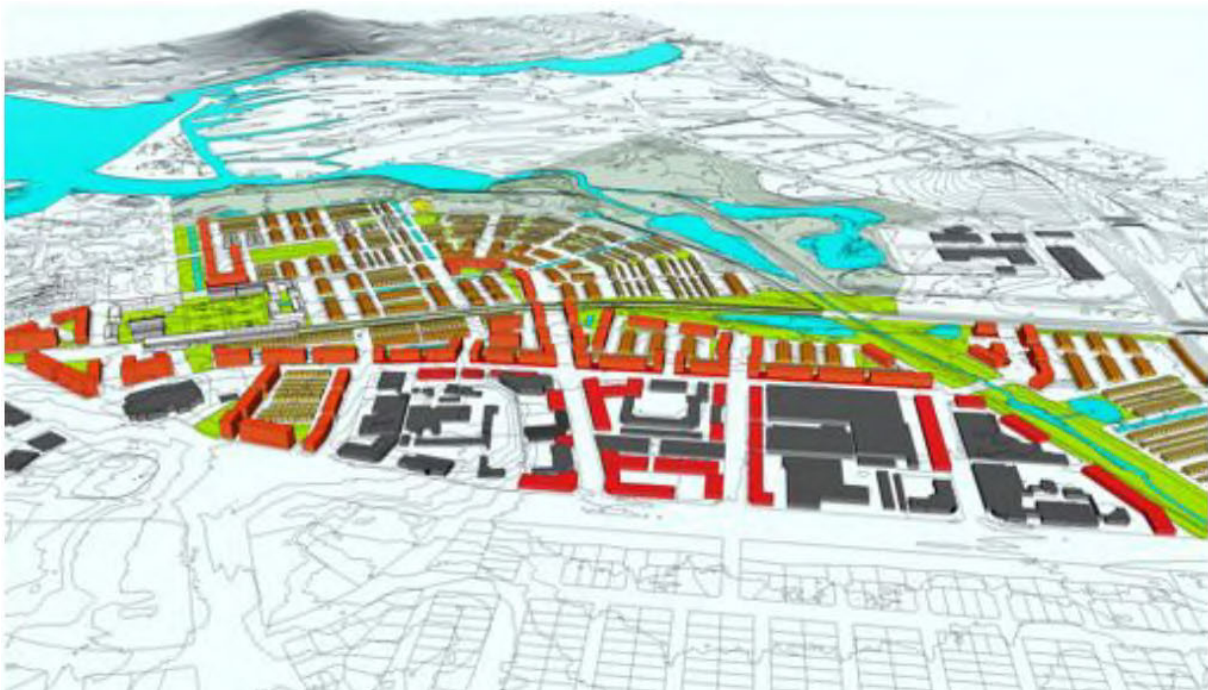
Figure 2 Project Concept (Source Simpson and Wilson 2011)

The 2004 Canberra Spatial Plan, the subsequent Act Planning Strategy (2012) and the revised 2011 Draft Planning and Design Framework (Simpson and Wilson 2011) identifies East Lake as a potential area for urban renewal (Figure 2).

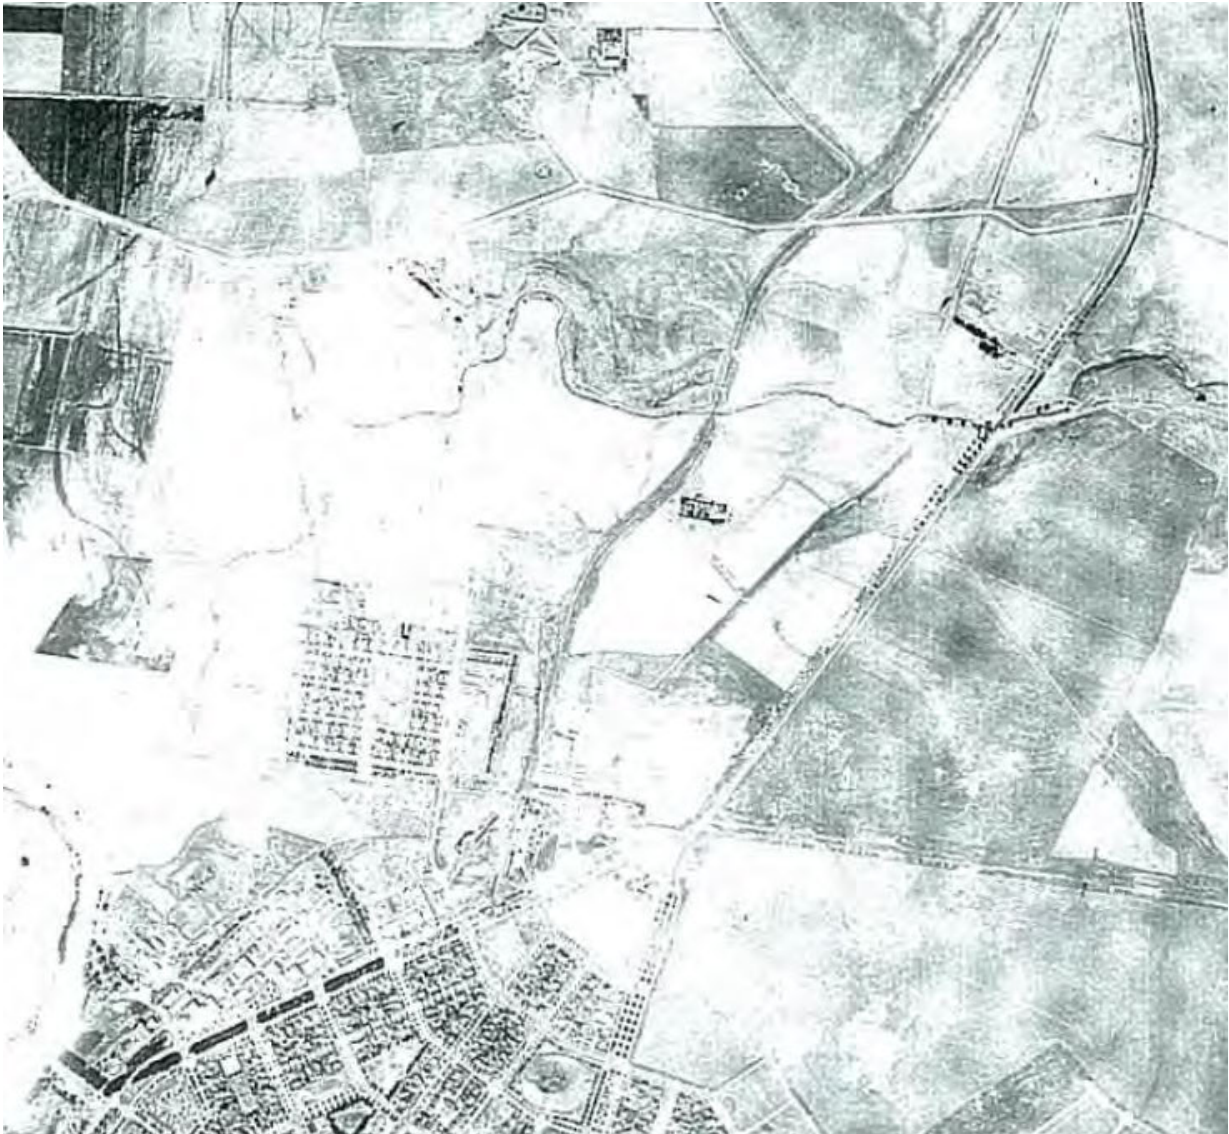
Figure 3 Historical Aerial Photograph – 1944

In 1944 the Site was mostly undeveloped or possibly used for grazing, with a train line running through the area. In addition to undeveloped or agricultural land, land uses included some residential development to the west of the Site.

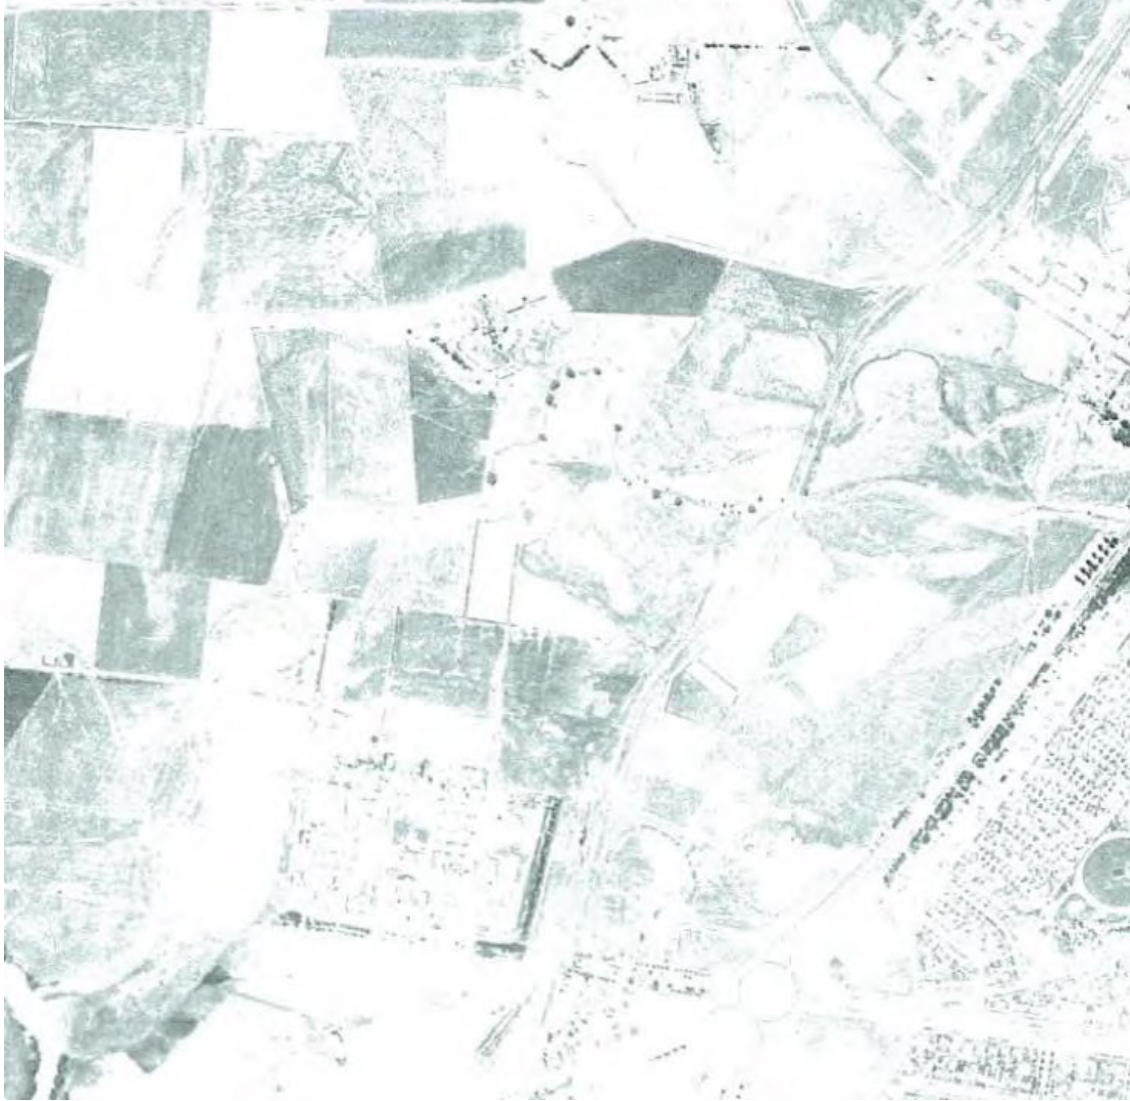
Figure 4 Historical Aerial Photograph – 1961

By 1961, a dairy farm was established along Dairy Road, and by 1968 the majority of the site was cleared, with the exception of areas along the creek. Commercial development is progressing to the south-west and east of the site, urbanisation is increased to the west, and large water ponds have been established to the east of Dairy Road.

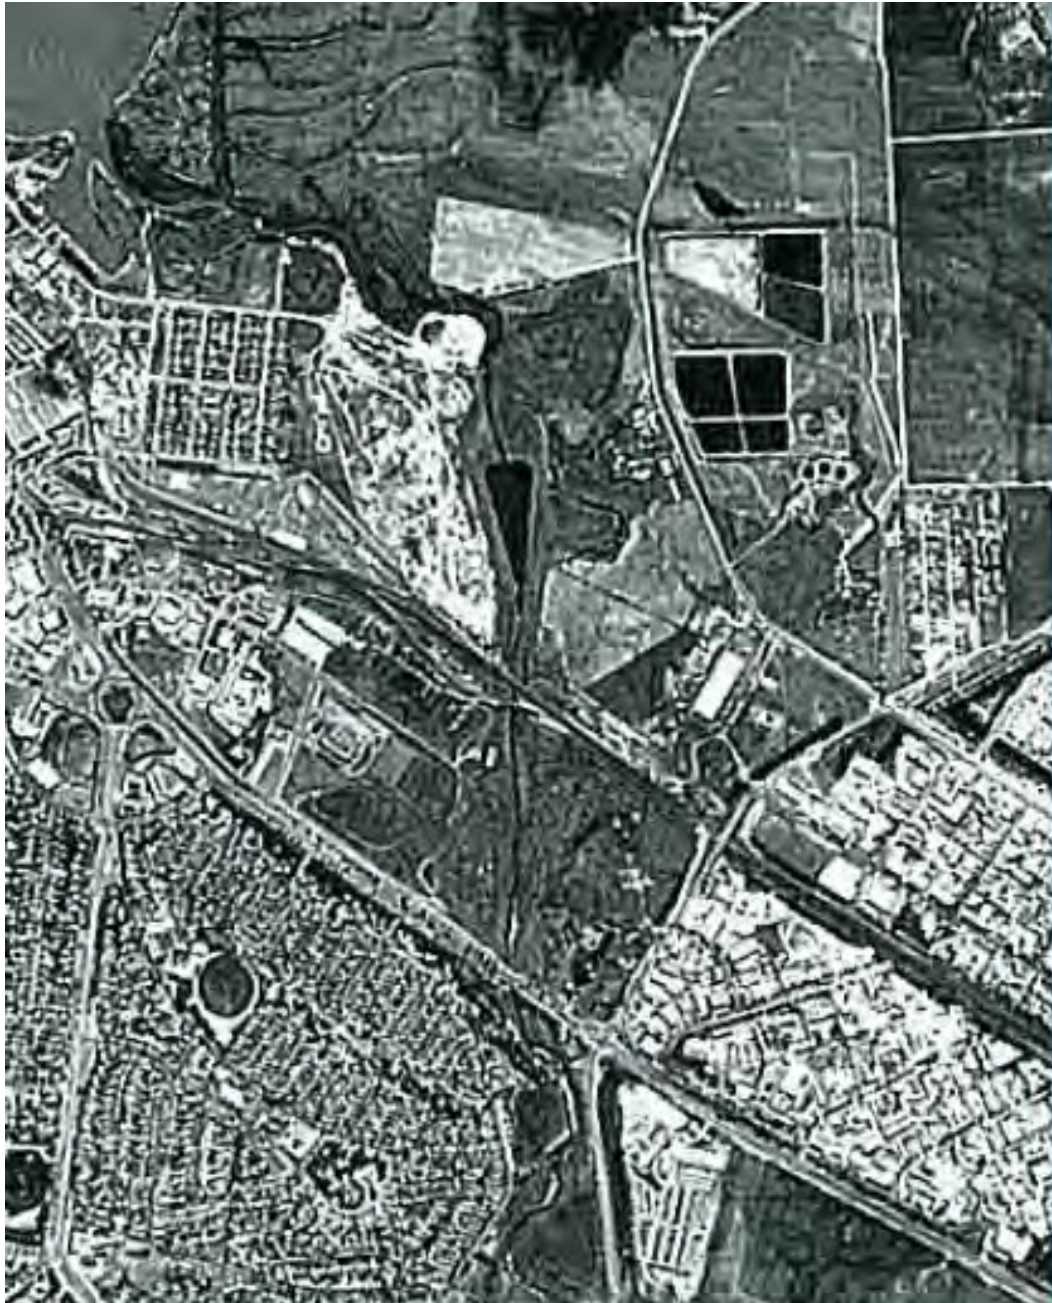
Figure 5 Historical Aerial Photograph --1968

By 1968 Jerrabomberra Creek has been straightened and partly channelled. The central area of the Site as well as the area along the northern site boundary has been extensively filled, and fill has been deposited along the eastern site boundary. By this time Lake Burley Griffin has filled and the railway station and refuelling facility have also been constructed. Further commercial development has also occurred.

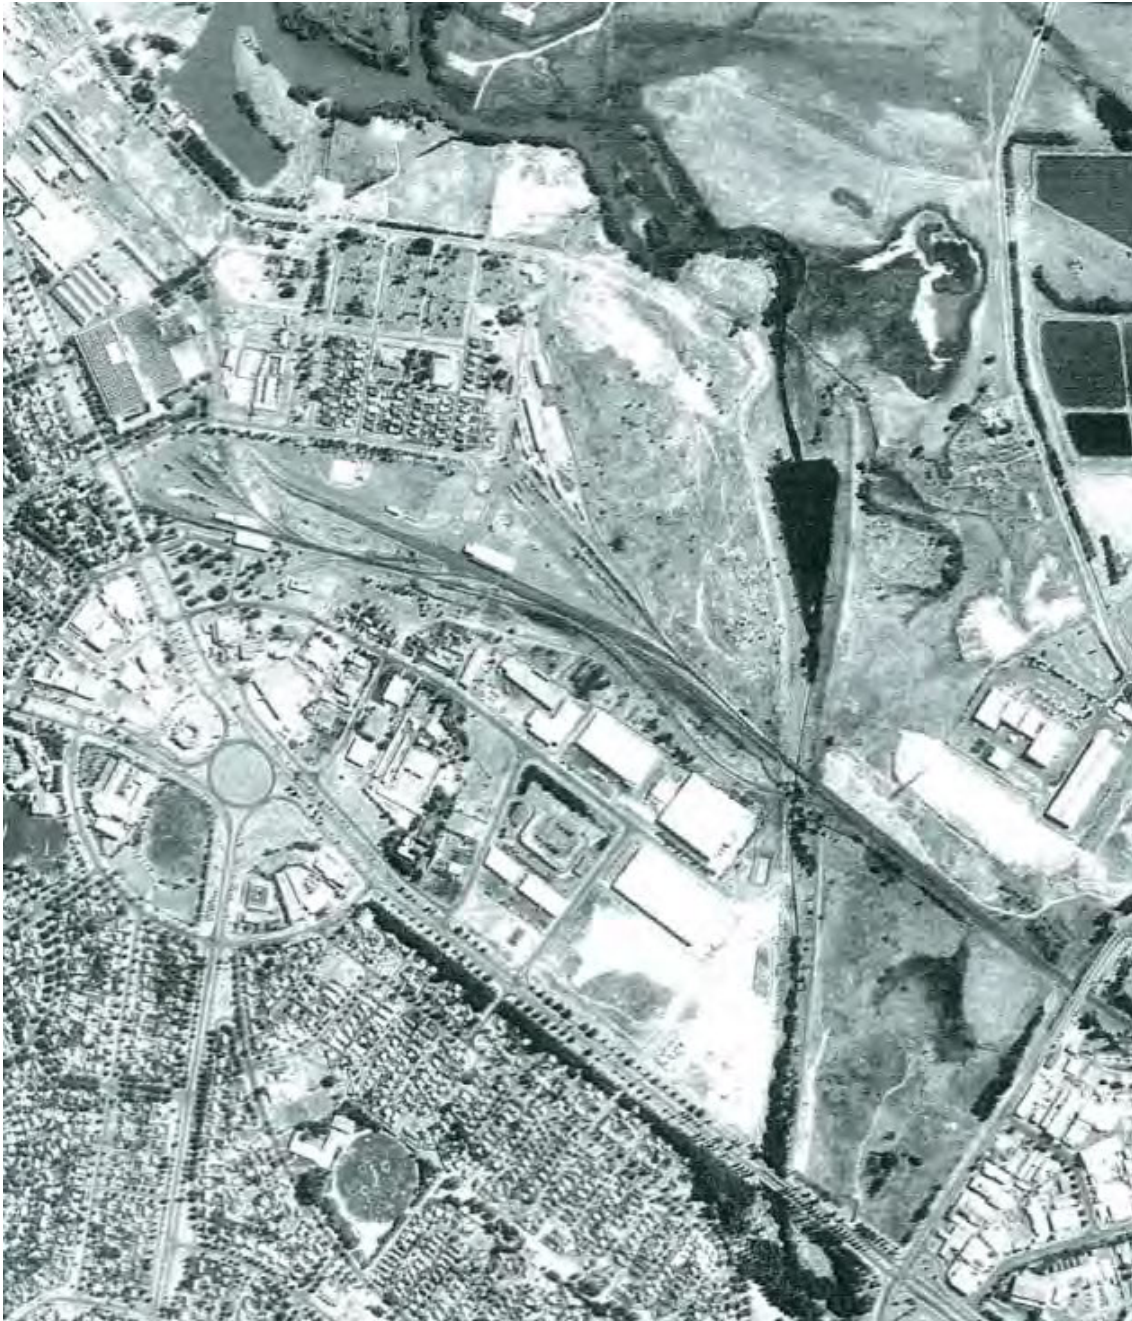
Figure 6 Historical Aerial Photograph -- 1985

By 1985 the north-eastern corner of the Site has become a wetland. The central landfill is predominantly grassed and additional areas have been filled, and urbanisation further increased. All buildings currently present have been built.

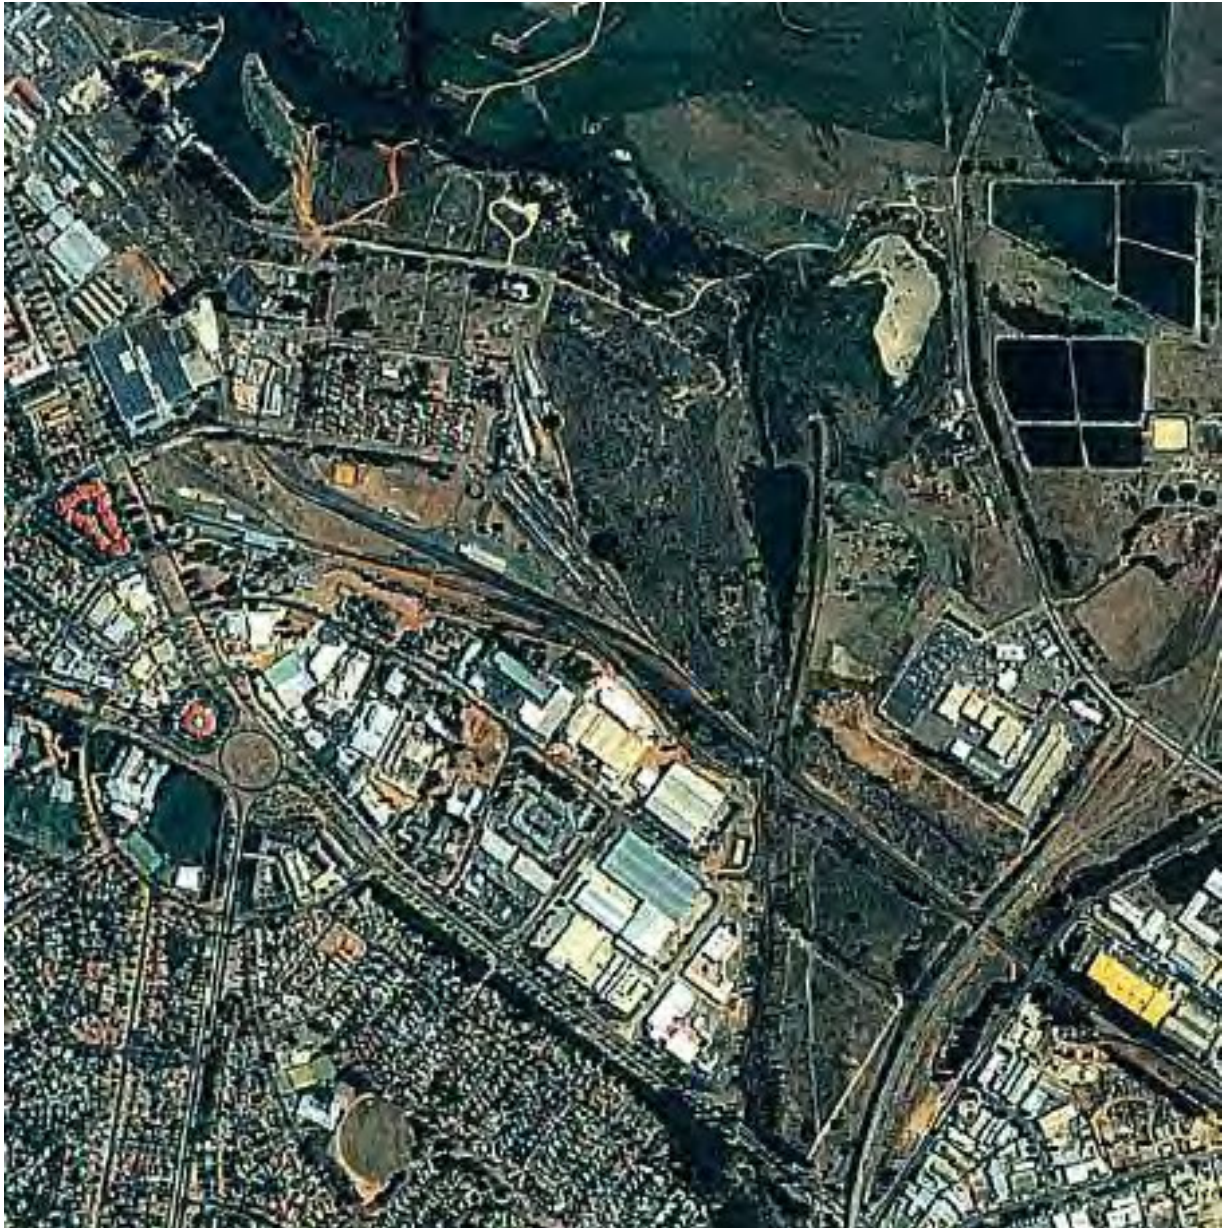
Figure 7 Historical Aerial Photograph ---1998

By 1998 no significant changes to the Site or surround land uses occurred, however there was extensive vegetation growth across the Site.

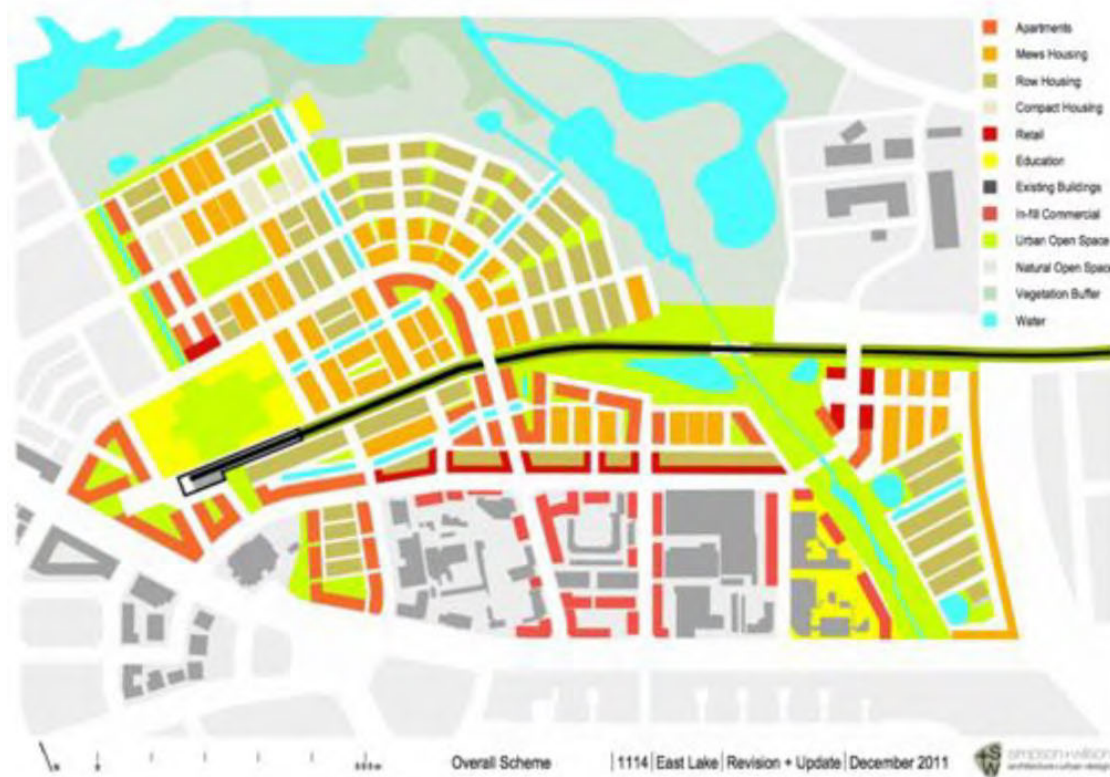
Figure 8 Planning Design Framework (Source Simpson and Wilson 2011)

Details of the proposed layout and location of various planned land uses are presented below within Figure 8.

Based on the December 2011 revised draft PDF the following plan elements and development statistics (Table 2 and Table 3 respectively) were identified:

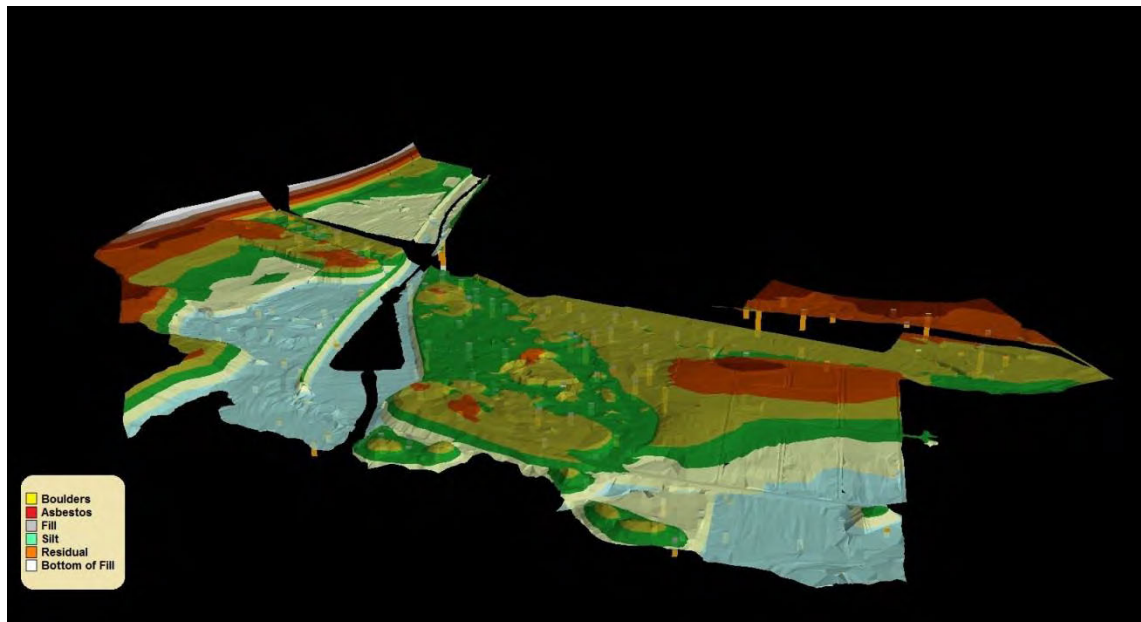
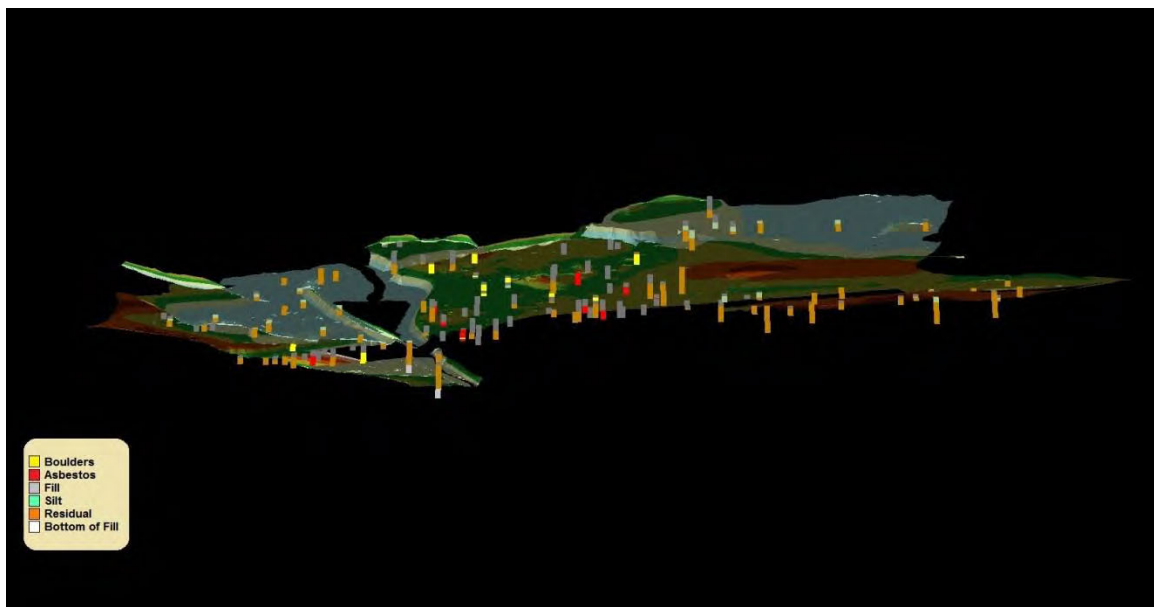
Figure 10 Fill Volume Modelling

Upon completion of fill modelling works, the revised total fill volume calculated within the Site was approximately 990,000m³.

Following completion of the Site survey, AECOM reviewed the total fill volumes reported by PB (2010).

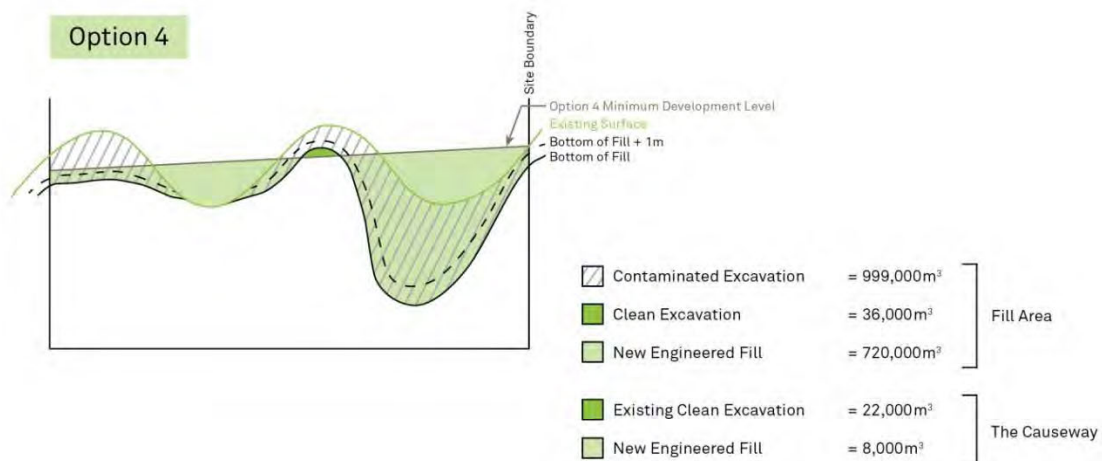
Figure 30 Site Preparation Option 4 Excavation Depth and Volume

Option 4 involves the excavation of clean fill material from the South Eastern portion of the Site and excavation of contaminated and geotechnically unsuitable fill material from the central portion of the Site.

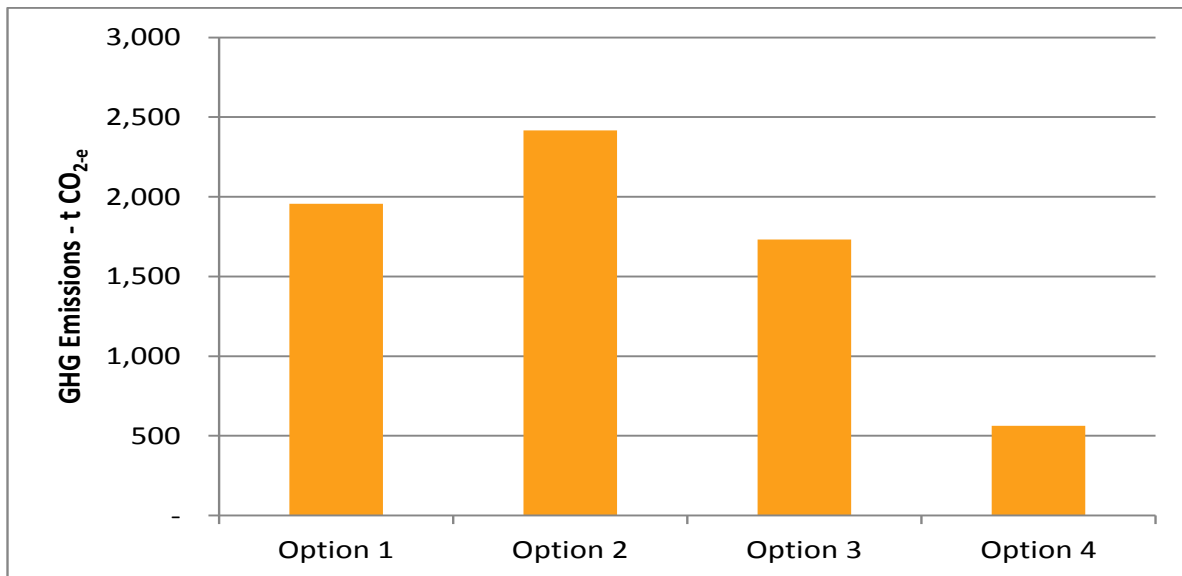
Figure 37 GHG emissions associated with fill transport

Option 4 has lower GHG emissions due to the significantly less amount of fill transported to and from the East Lake site.

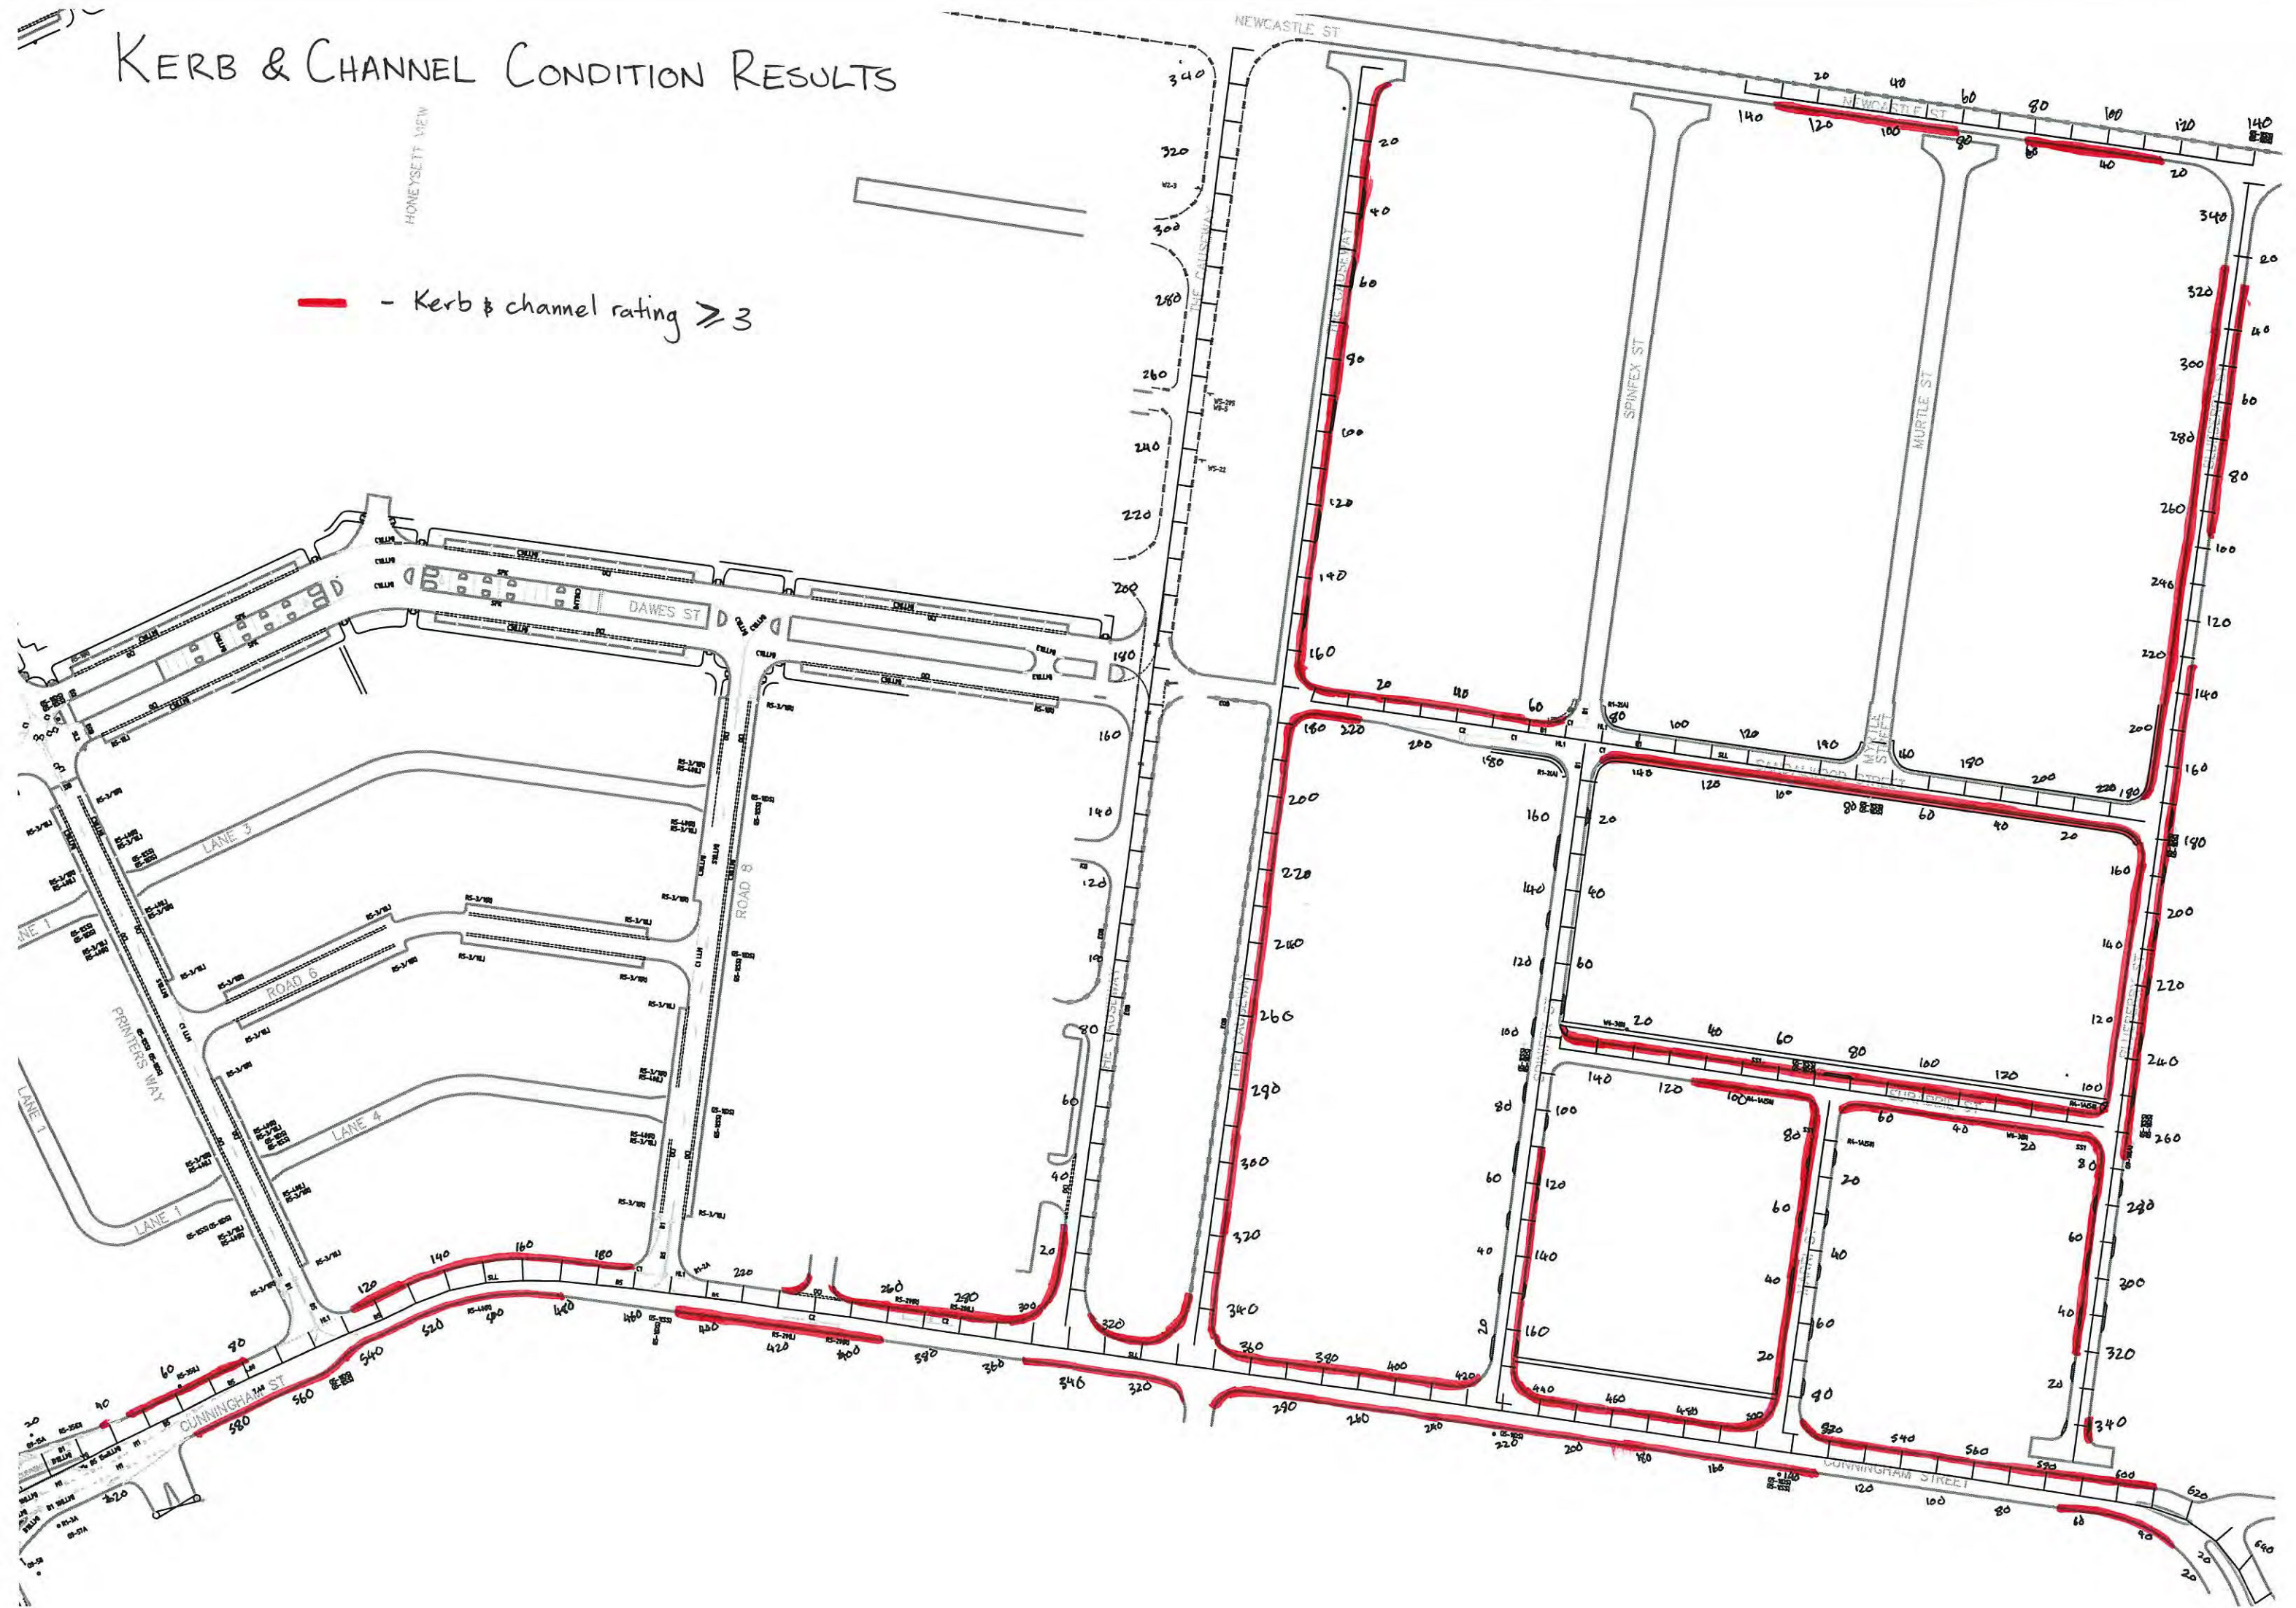
KERB & CHANNEL CONDITION RESULTS

— - Kerb & channel rating ≥ 3
