ACT Heritage Council

BACKGROUND INFORMATION YARRALUMLA WOOLSHED AND OUTBUILDINGS (Blocks 1144 and 1201 Weston Creek)

At its meeting of 19 November 2015, the ACT Heritage Council decided that the Yarralumla Woolshed and Outbuildings was eligible for registration.

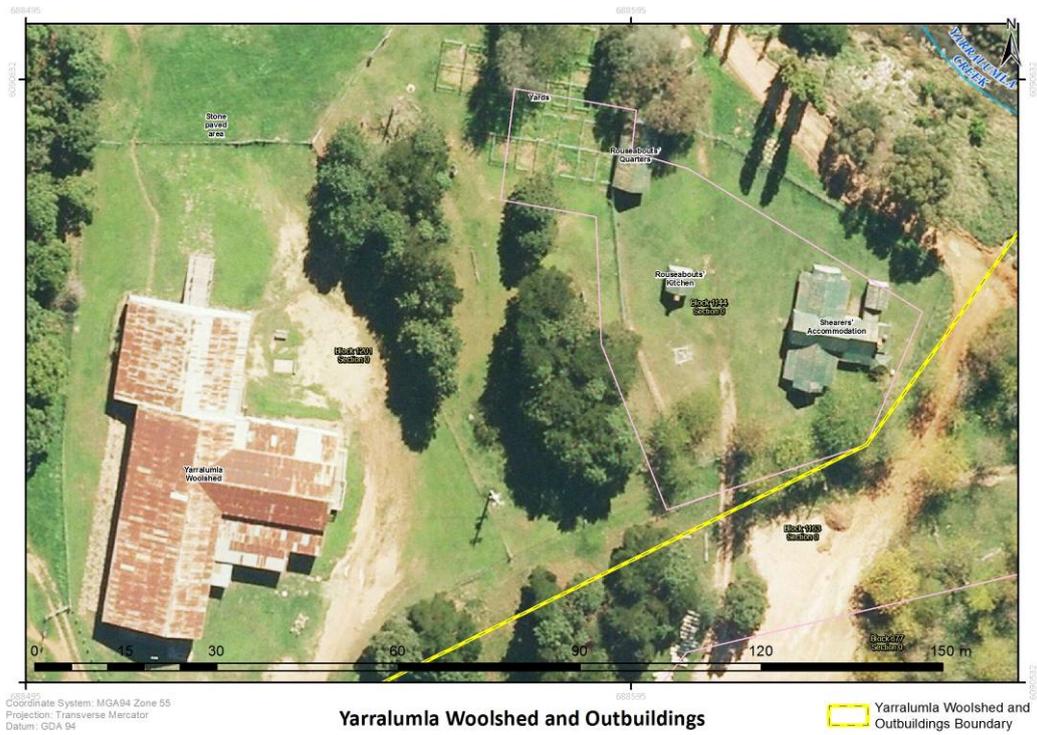
Figure 2 Yarralumla Woolshed (left) and Outbuildings building (right).

The place (Blocks 1144 and 1201, Weston Creek) consists of the Woolshed, the Outbuildings (Shearers' Quarters, Rouseabouts' Quarters and the Rouseabouts' Kitchen) and the surrounding landscape (see Figure 1 and Figure 2).

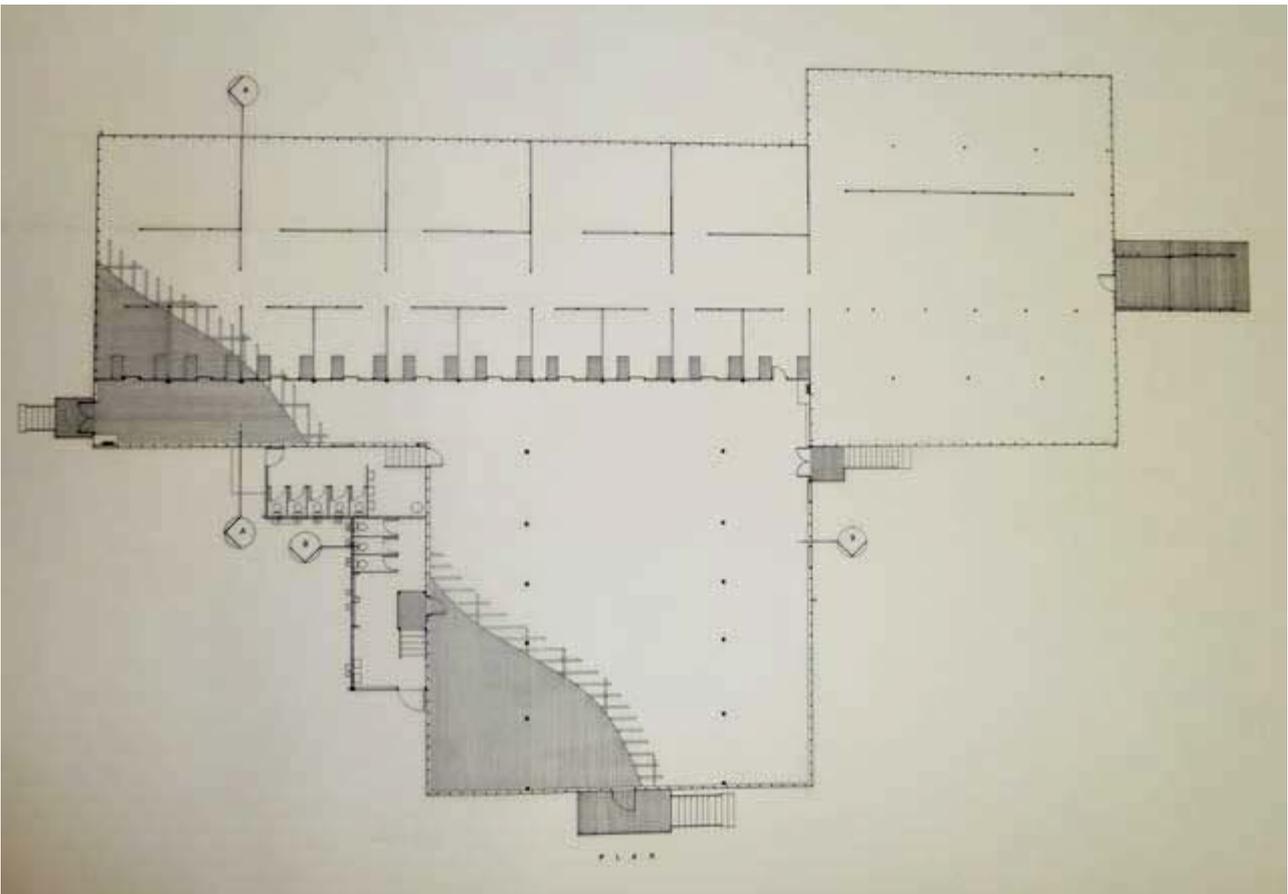
Figure 5 Floor Plan – 1989 (John Morris & Wong Sing Hijang, Marion Mahony Griffin Measured Drawing Competition, courtesy ACT Heritage Library) (from Marshall et al 2014, p.14)

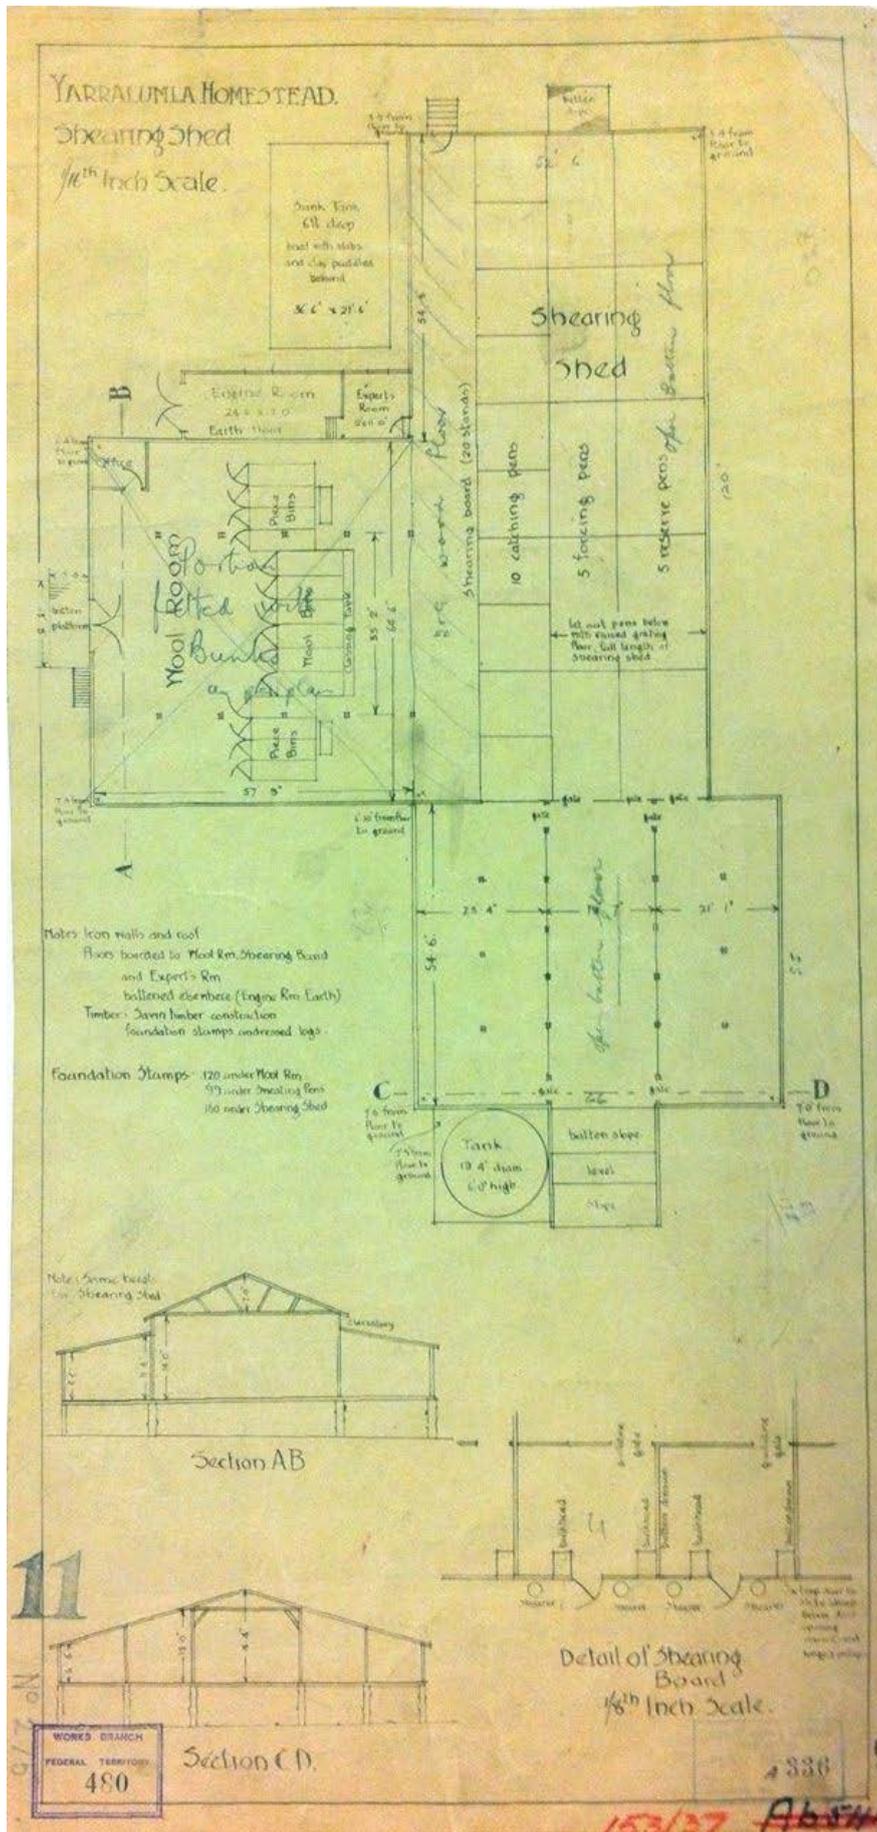
Figure 6 Yarralumla Shearing Shed Plan and Sections, 1925-30, Federal Capital Commission Source: National Archives of Australia, A2502, AB544 (from Marshall et al 2014, p.30)

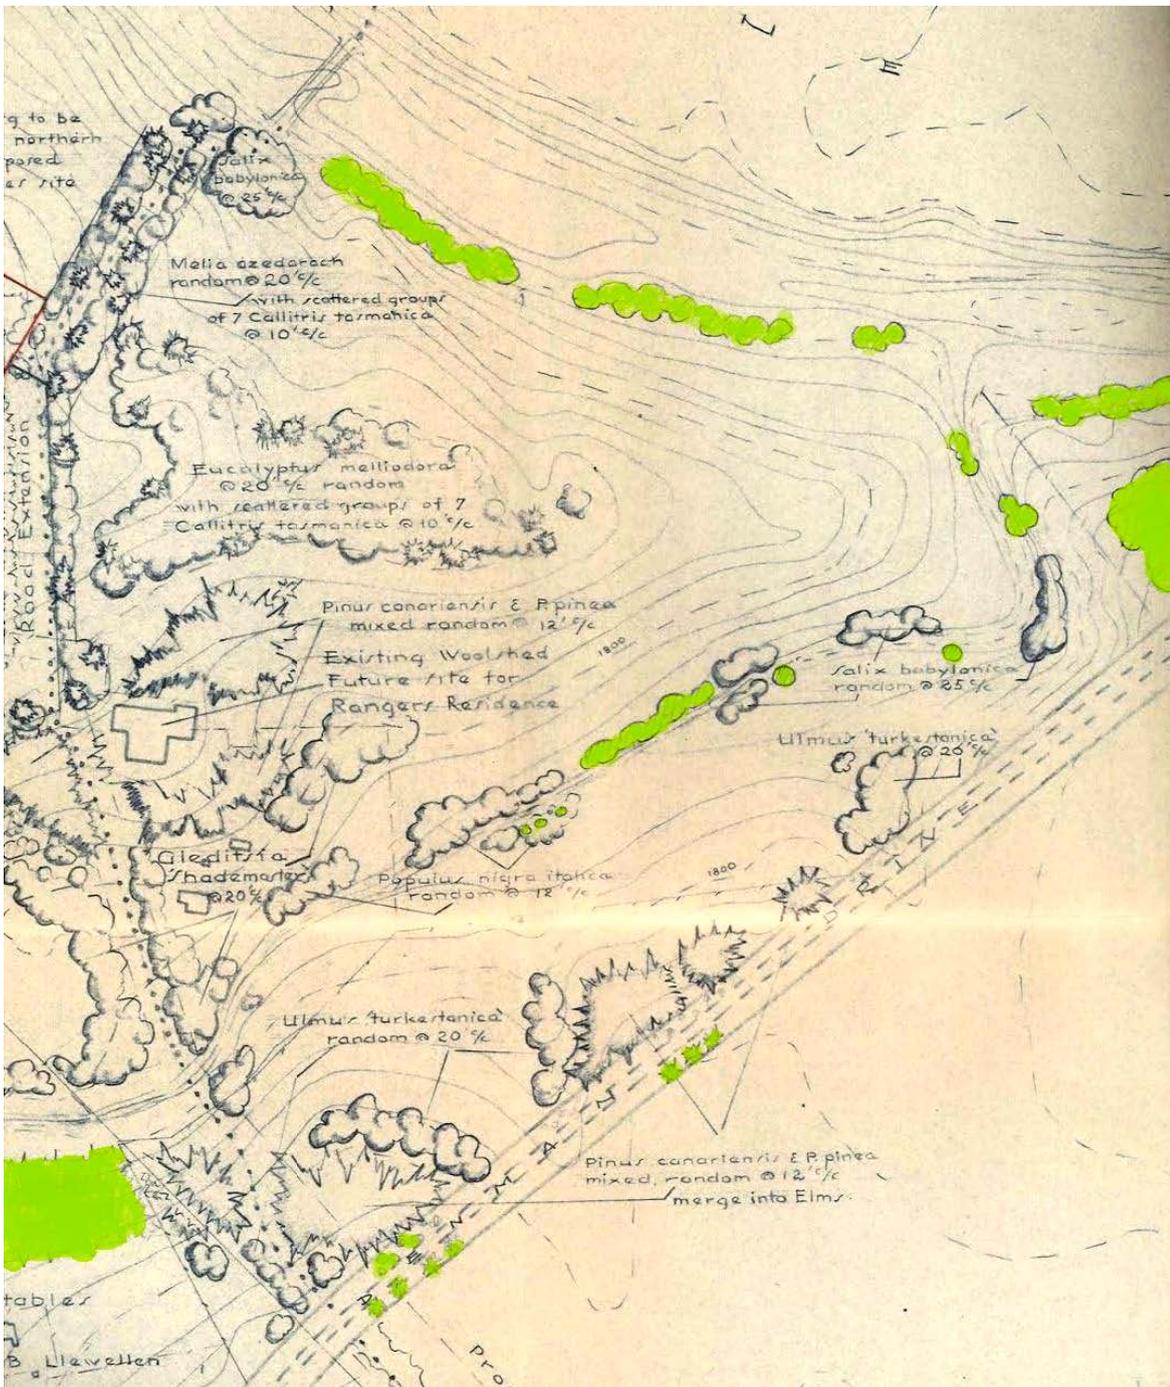
Figure 7 Extract from Plan L.103/68 drawn by Alan Wilson for the NCDC proposed landscaping for the equestrian park. Note the existing plantings highlight in green. (extracted from Marshall et al, 2014:36)

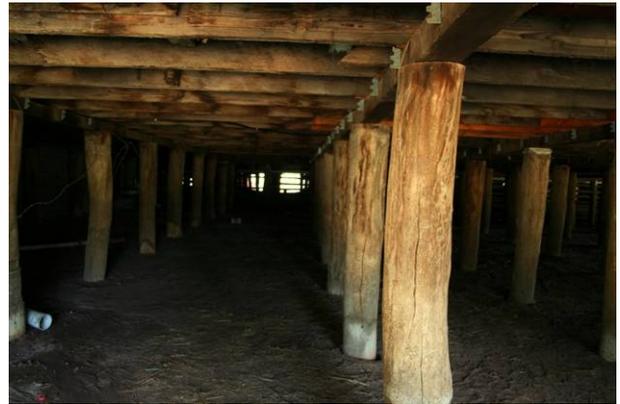
Figure 18 Yarralumla Woolshed under floor area of east wing (ACT Heritage, 2015)

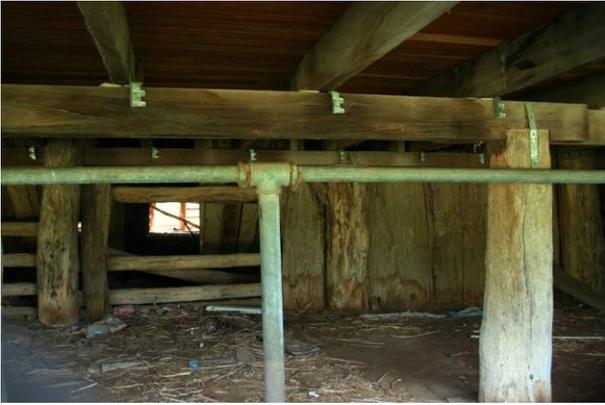
Figure 19 Yarralumla Woolshed under floor area of south wing showing bark partitions on eastern side (ACT Heritage, 2015)

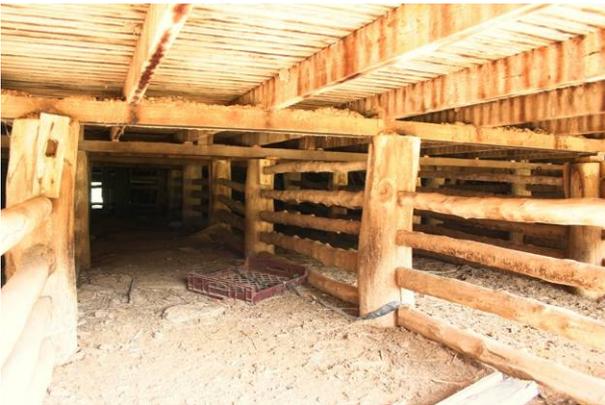
Figure 20 Yarralumla Woolshed under floor area showing separation into pens under south wing (ACT Heritage, 2015)

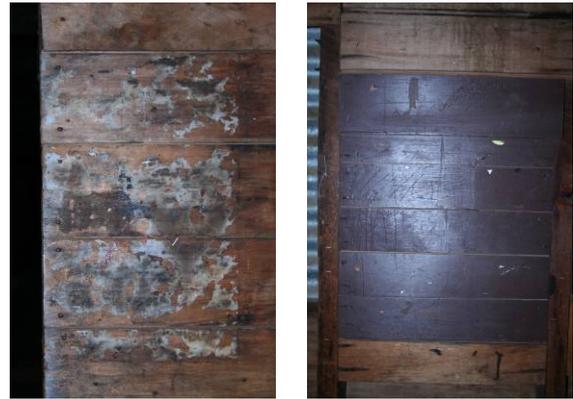
Figure 23 Yarralumla Woolshed interior detail of remnant wall cladding along the board (ACT Heritage, 2015)

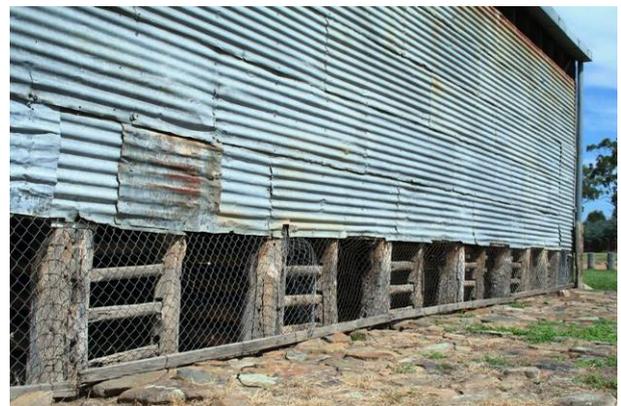
Figure 24 Yarralumla Woolshed under floor counting pens visible on the west elevation of the south wing (ACT Heritage, 2015)
