## Loose Fill Asbestos Site Soil Validation Report

DOWNER Block # 13, Section # 53,  
32 Phillip Avenue, Downer ACT 2602

**Prepared by:** OCTIEF Pty Ltd

**ACT Asbestos Response Taskforce**

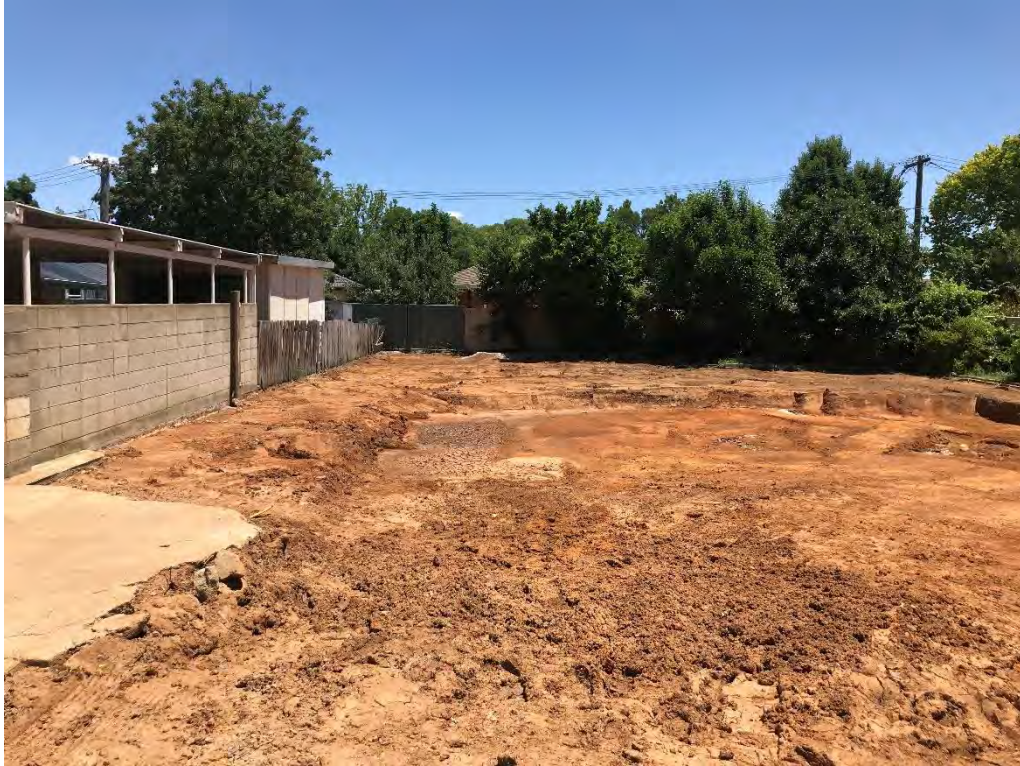
Figure 1 Site overview of demolition footprint.

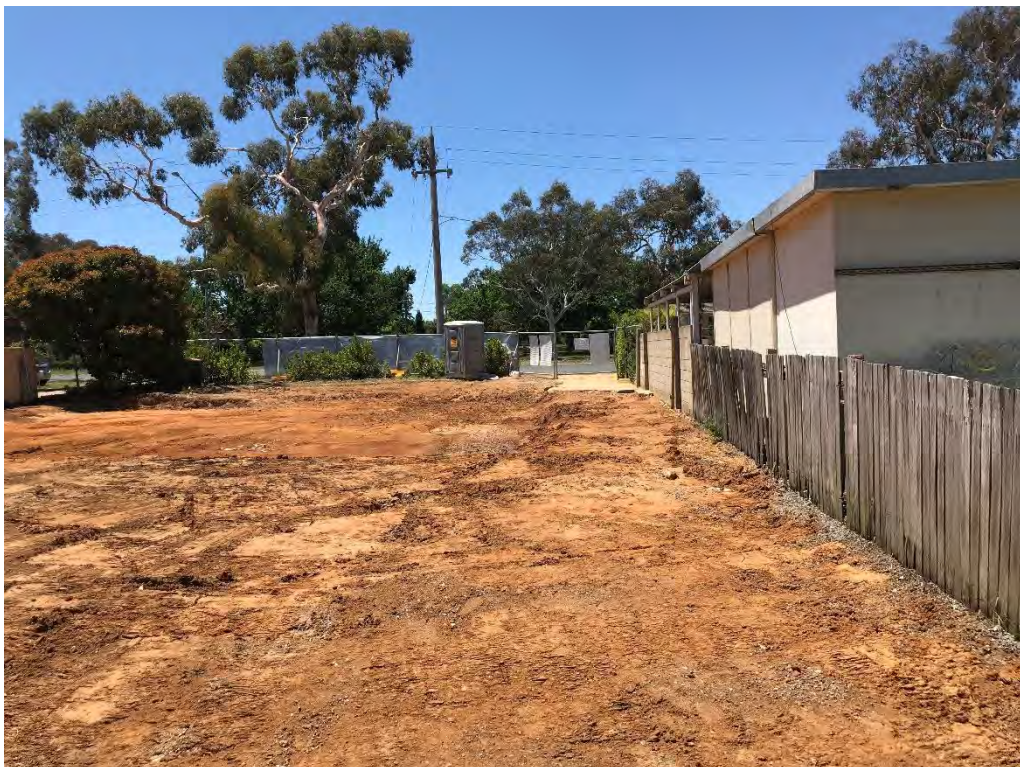
Figure 2 Site overview of demolition footprint.

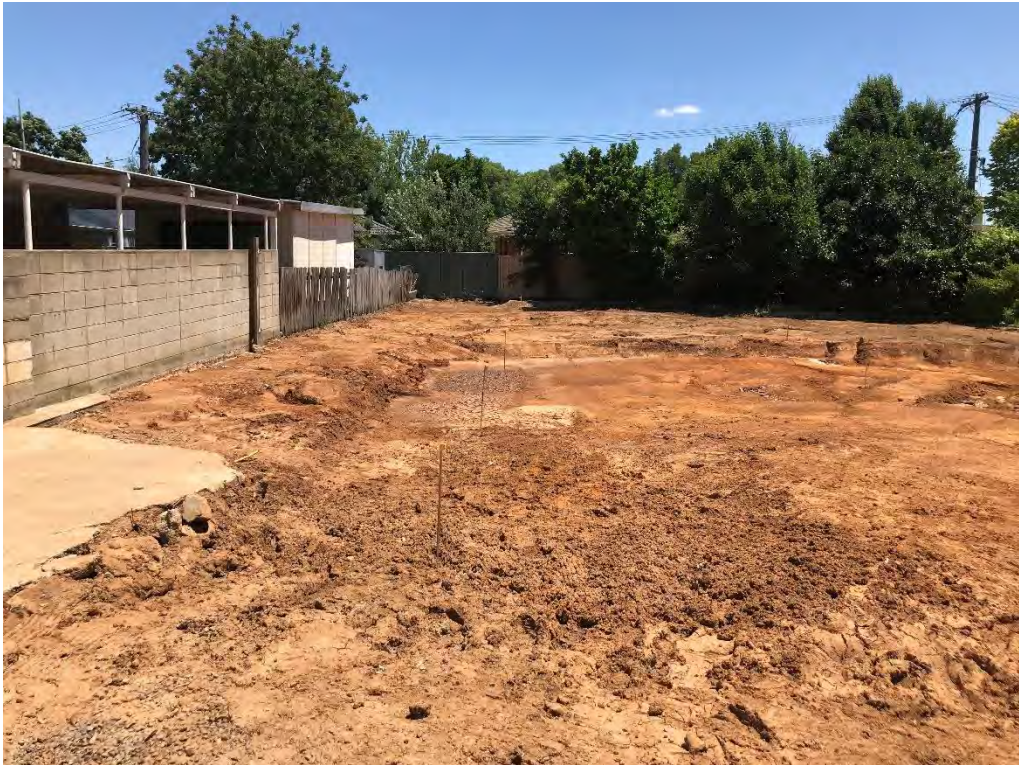
**Figure 3 Soil validation sample location/s (from the left) view from the north-eastern corner of the housing footprint to the southern boundary corner: S01, S02, S03, S04, S05, S06, S07 and S10.**

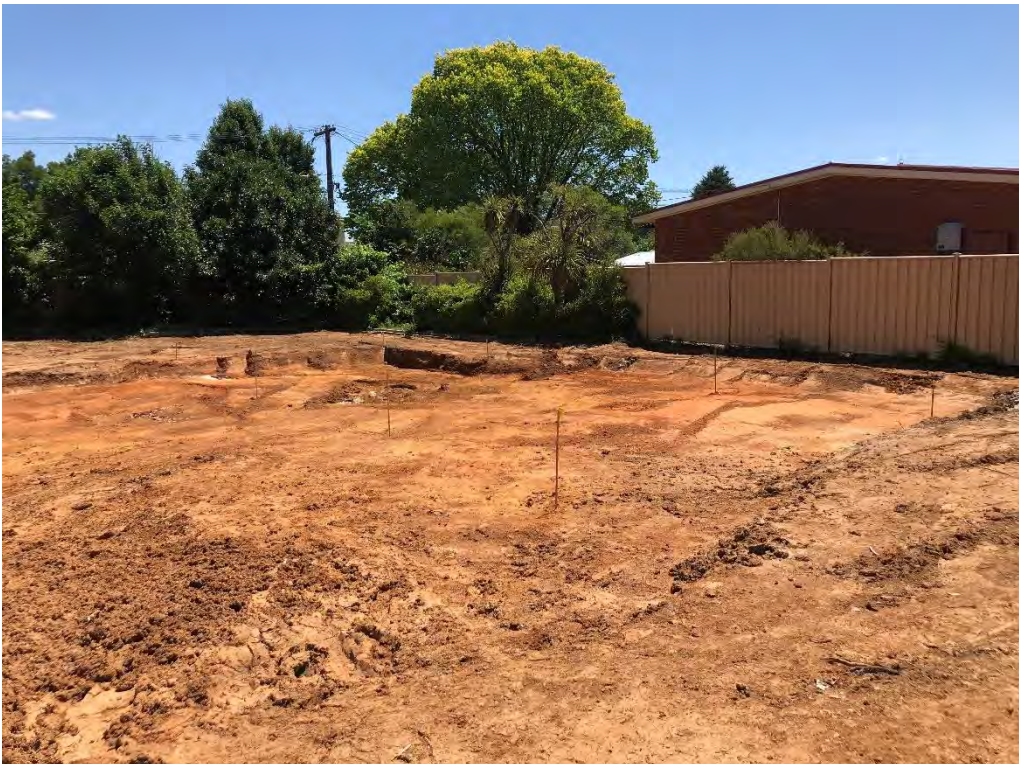
**Figure 4 Soil validation sample location/s (from the left) view from the northern elevation of the housing footprint to the western boundary/demolition corner: S05, S06, S12, S07, S11, S07, S08, S10 and S09.**

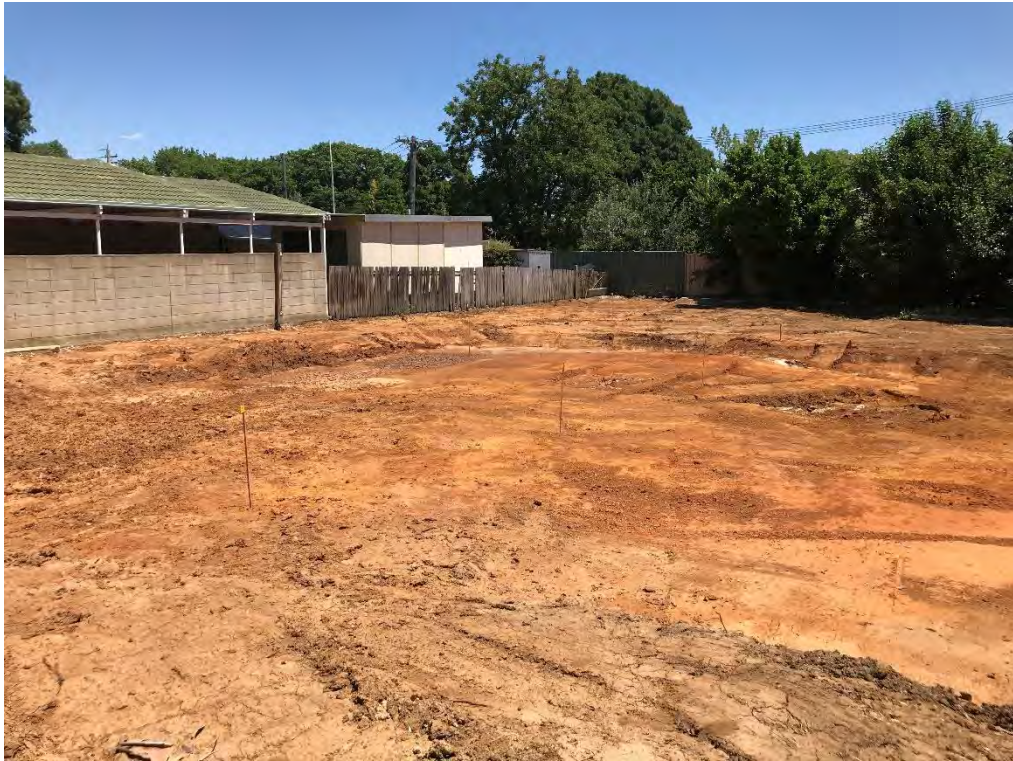
**Figure 5** Soil validation sample location/s (from the left) view from the northern elevation of the housing footprint to the southern boundary/demolition corner: S08, S01, S02, S07, S03, S06 and S05.

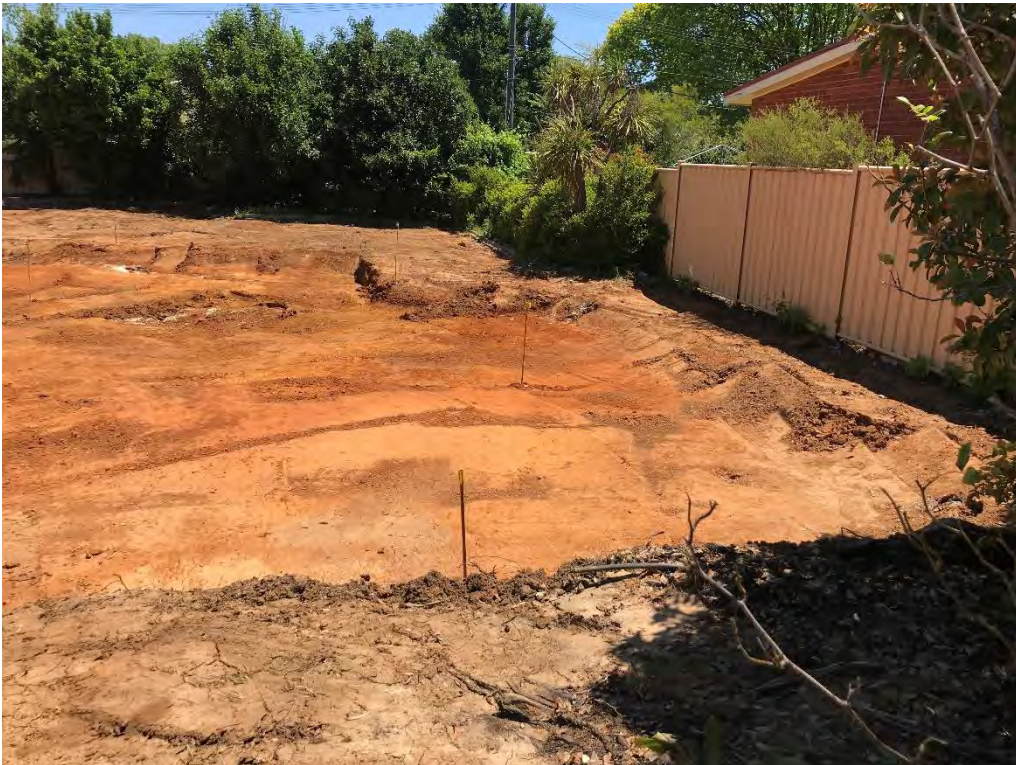
**Figure 6** Soil validation sample location/s (from the left) view from the northern elevation of the housing footprint to the western boundary/demolition corner: S06, S05, S12, S11, S10 and S09.

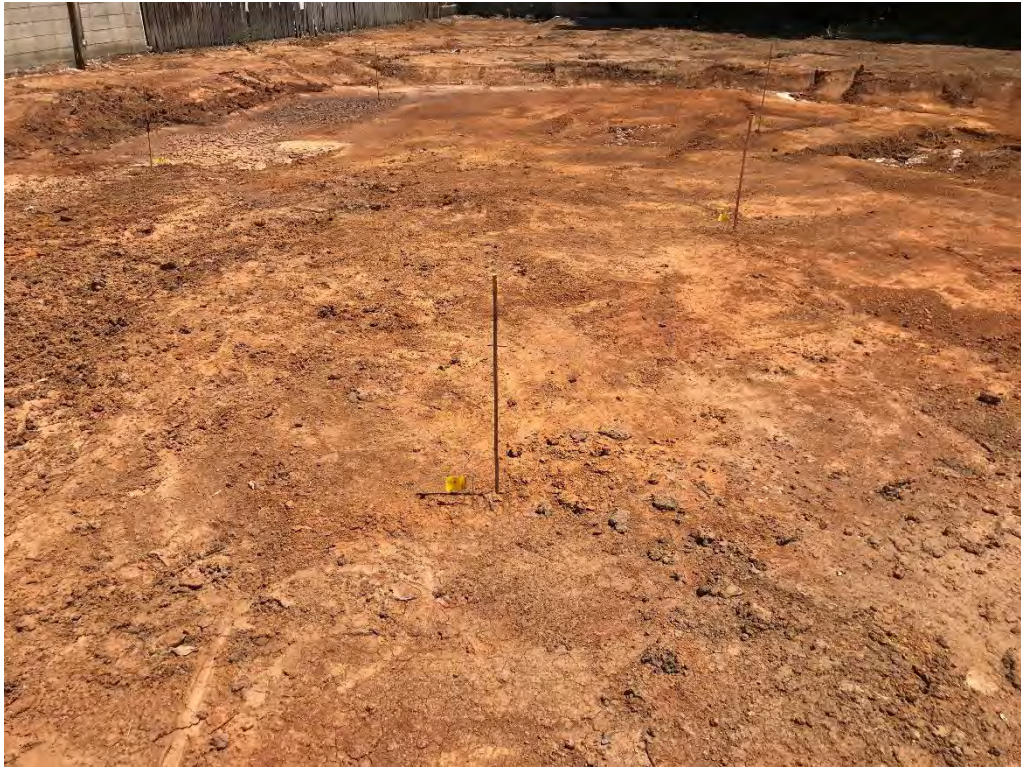
**Figure 7** Soil validation sample location/s (from the left) view from the centre of the housing footprint to the southern boundary/demolition corner: S02, S03, S08, S04, S07, S06 and S05.

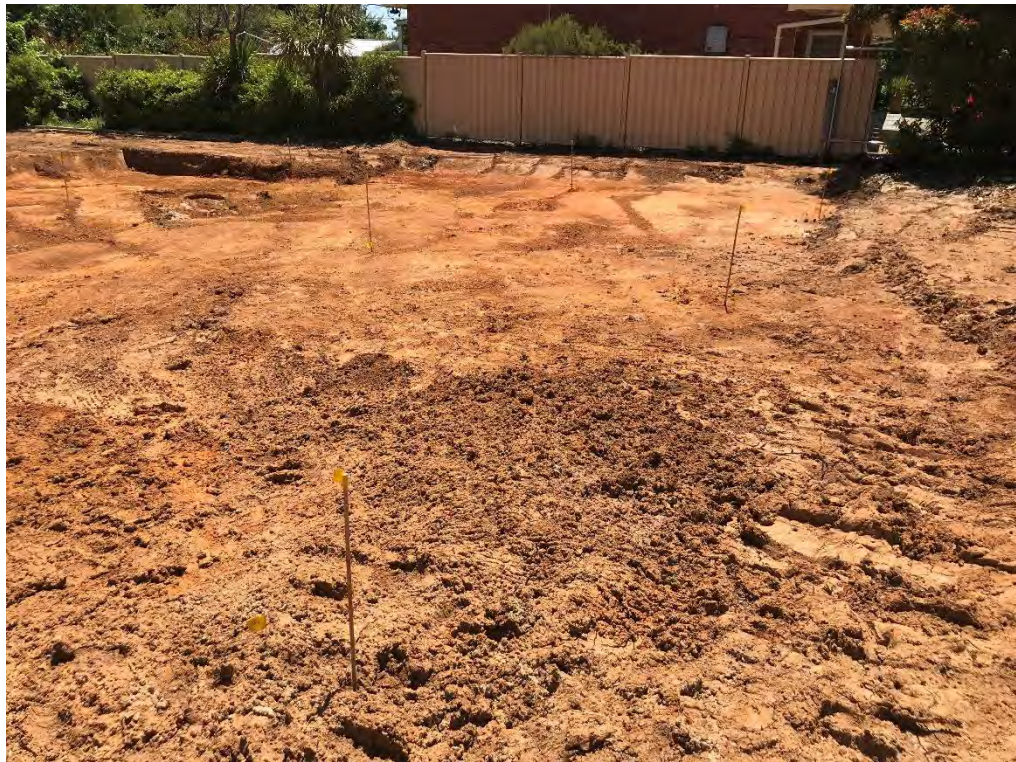
**Figure 8** Soil validation sample location/s (from the left) view from the eastern boundary corner of the housing footprint to the northern boundary: S05, S12, S11, S10, S01, S06, S07 and S09.

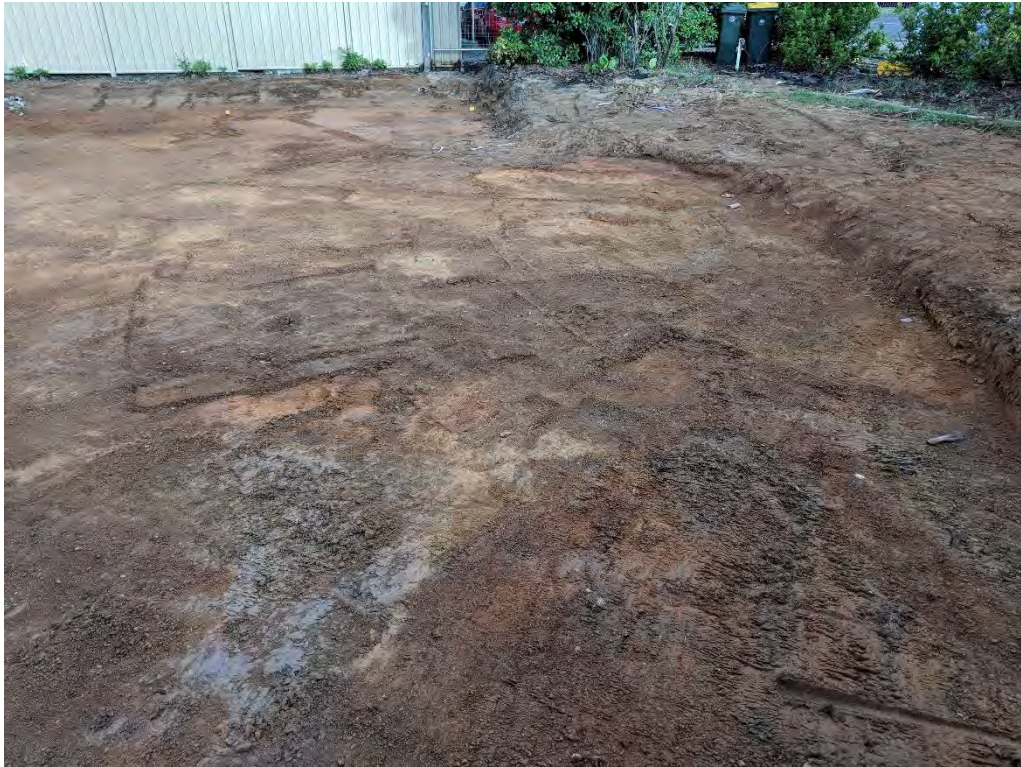
Figure 9 Overview of the Hot Spot Soil Validation sample location.

A hot spot was identified in the initial soil validation. The contractor was advised to remove soil in the vicinity of the sampling point where Chrysotile asbestos fibres were detected (7657-S01), out to the next clean sample grid square. Soil removed from site during 'hot spot treatments' was advised to be transported in a damp condition in a covered vehicle (to control dust) to West Belconnen Resource Management Centre for disposal. Refer to Figure 1 for sample locations and the area removed.

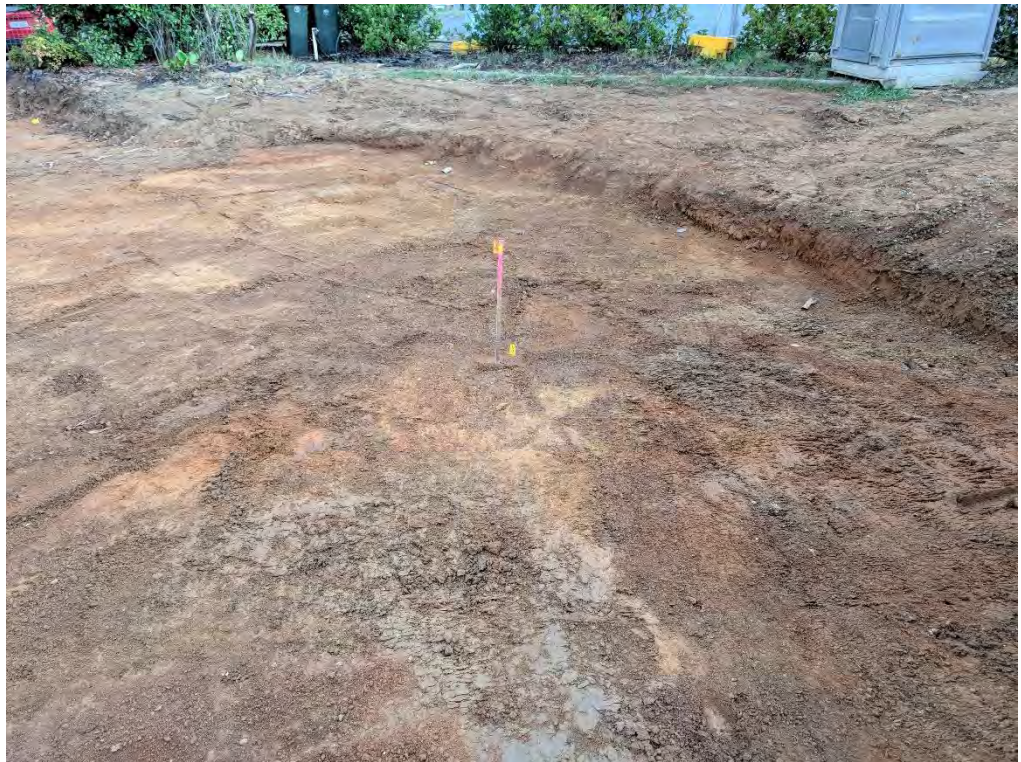
No further Asbestos Fibres were detected in the hot spot sample H-S 7657-S01 at 32 Phillip Avenue, Downer ACT 2602.

Figure 10 Hot Spot Soil Validation sample location: H/S 7657-S01.

Following confirmation that the contractor had completed the required hot spot soil scrape; Octief revisited on the 21<sup>st</sup> of December 2017 and collected a hot spot soil validation sample from the treated area (Refer to Figure 1).

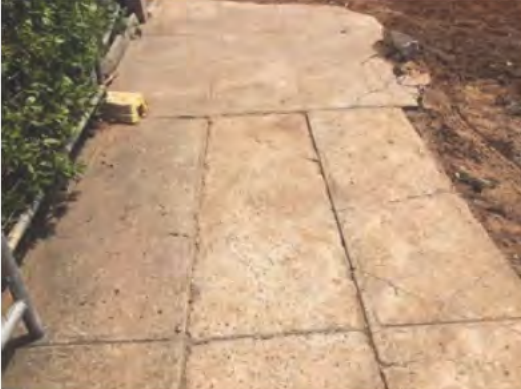
Driveway outside the demolition zone

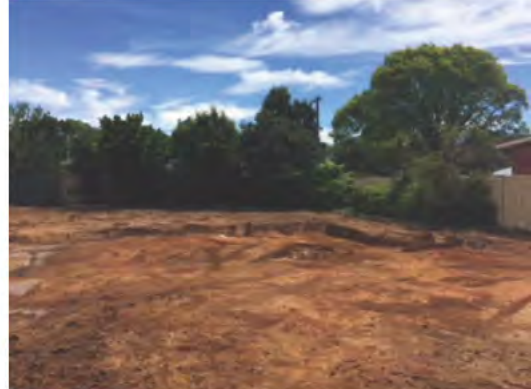
Cleared area of the demolition zone

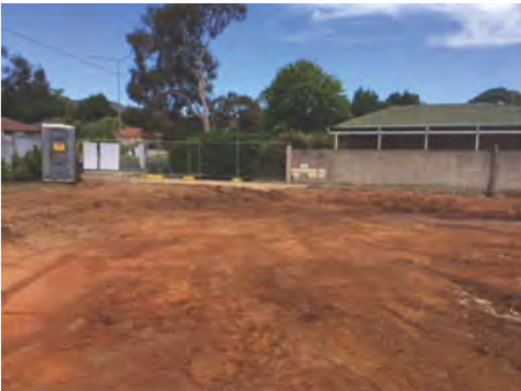
Cleared area of the demolition zone

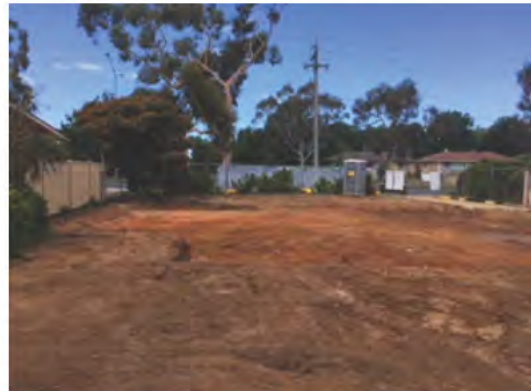
Cleared area of the demolition zone

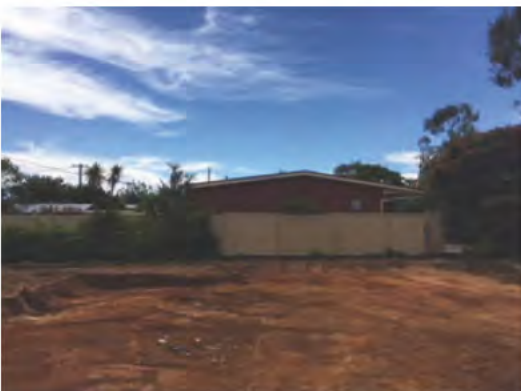
Cleared area of the demolition zone

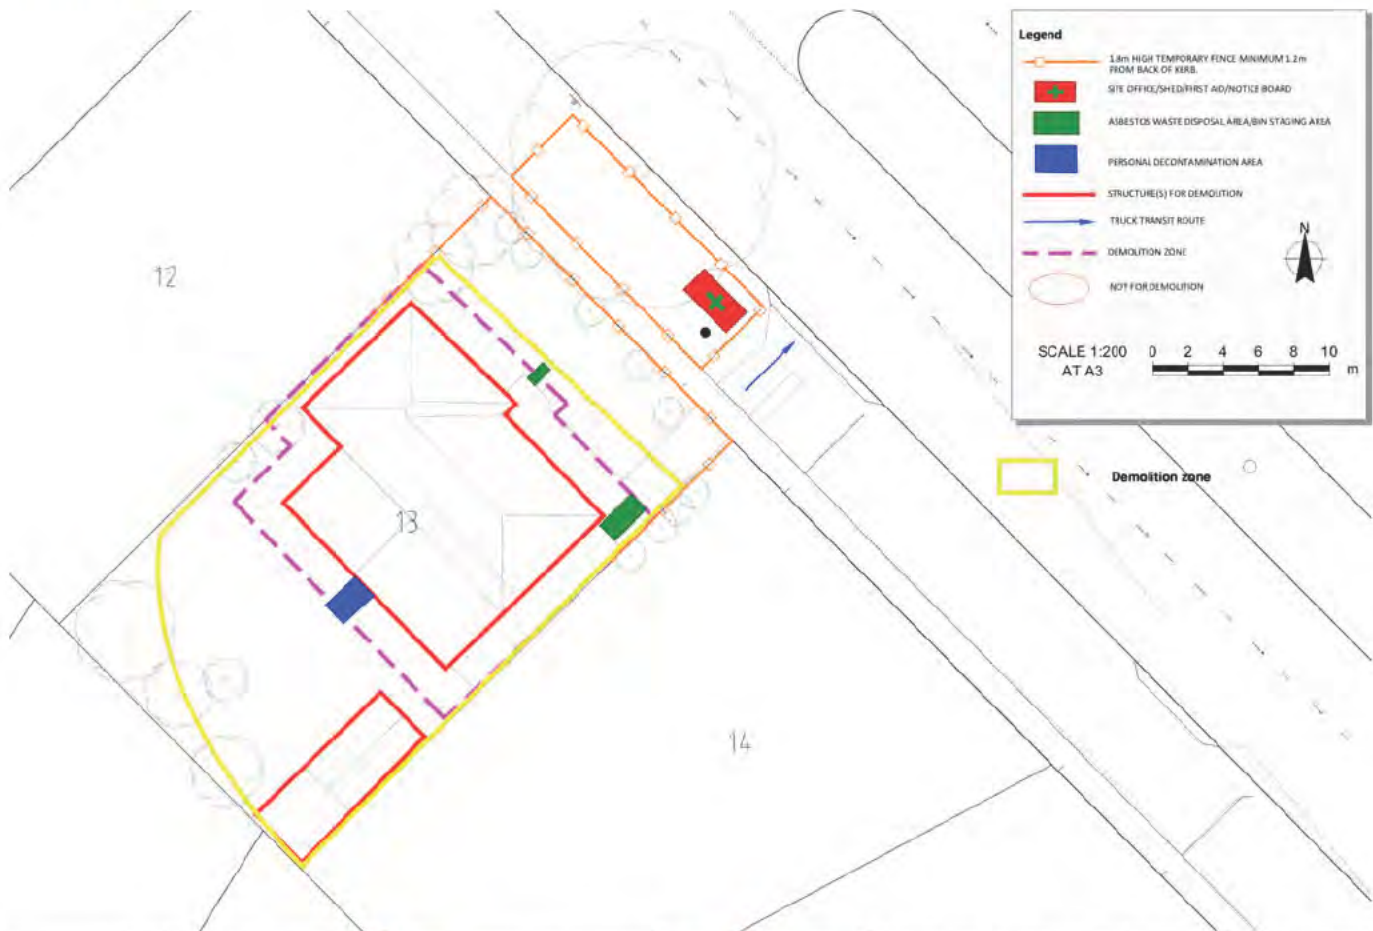
Site Plan

**Note:** Asbestos material may be present within the soil at depth or outside the demolition zone. The site infrastructure on the block associated with the property, including the concrete paths/driveways, retaining walls, concrete slabs and subterranean pipework remain onsite. See attached site plan showing the demolition zone.
