ACT Heritage Council

BACKGROUND INFORMATION LUTONS CRUTCHING SHED (BLOCK 39, MOUNT CLEAR)

At its meeting of 30 May 2019 the ACT Heritage Council decided that Lutons Crutching Shed was not eligible for provisional registration.

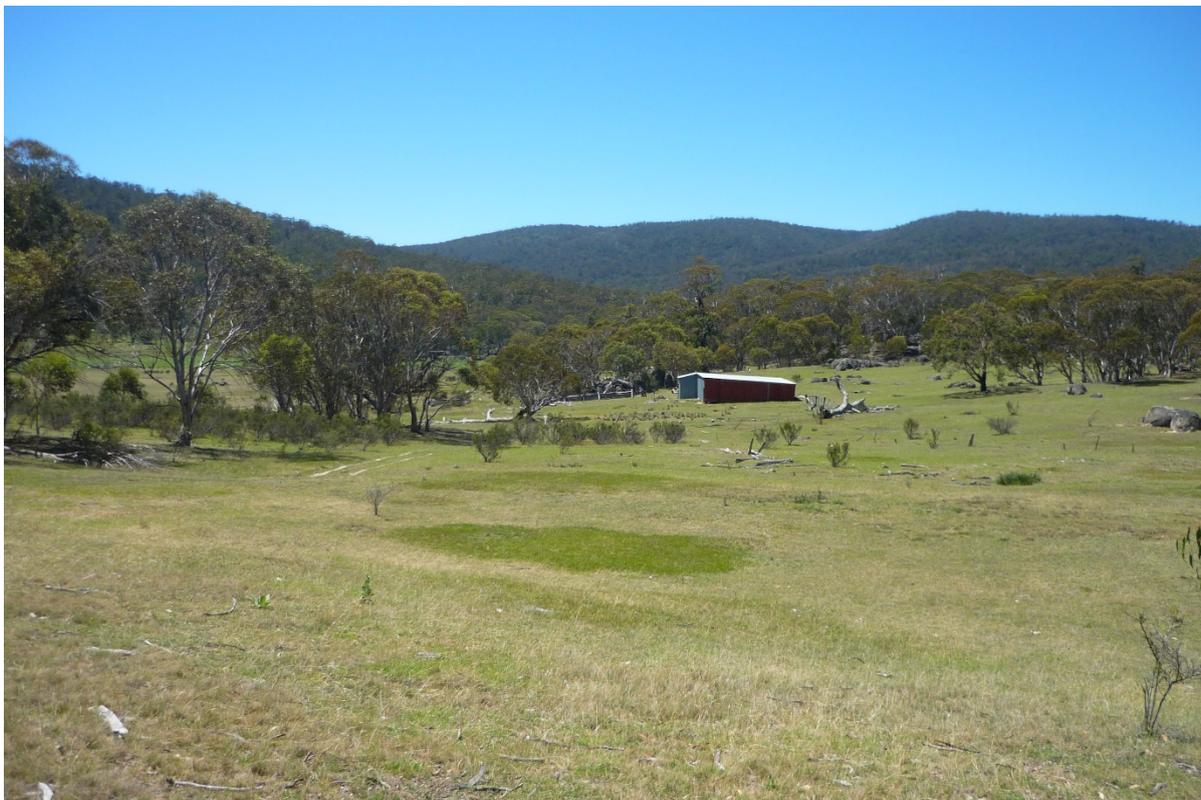
Image 3: Shows Lutons Crutching Shed in its setting. This image is looking to the east, towards the bottom of Bobeyan valley. Image from 10 February 2019 site visit.

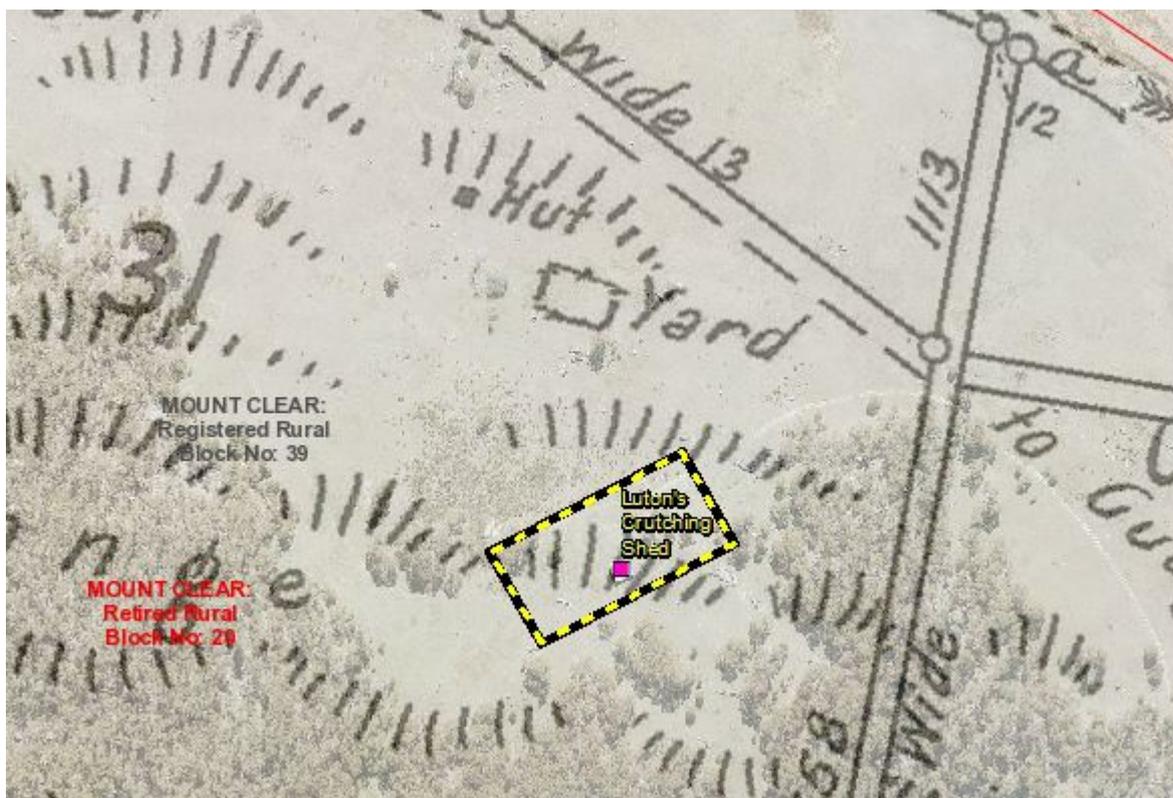
Image 4: This image is a composite of 2017 air photo with 1883 Portion Plan Overlay. It shows yards from the Crawford era not in the vicinity of the yards associated with the crutching shed.

Presumably, many of the fences mentioned by Greg, are those marked on the early portion plans for County of Cowley, Parish of Bobeyan as a variety of fence types, not just 'fork'. From interest, the fences on the portion plans for Bobeyan show many sections of fences variously described as; log, fork, split, brush, pack, drop, stud line, rail & wire, skid, stud, or slab, two or three rail, and finally, fork & wire or slip rail. Portion Plan 31, dated 1883 and owned at that time by Edward Crawford, encompasses the site on which the crutching shed was later built. It shows several fence lines and a fenced garden as well as a yard and hut very close to the crutching shed and yards, as shown in image 4.

The above transcript excerpt illuminates construction of the yards and clarifies that the perimeter fences around the shed were built by the Lutons. Additionally, geo-referencing and overlaying the portion plan with a 2017 air photo does not align the yards from 1883 with the later yards at the crutching shed, as shown in image 4. Further, ACT PCS

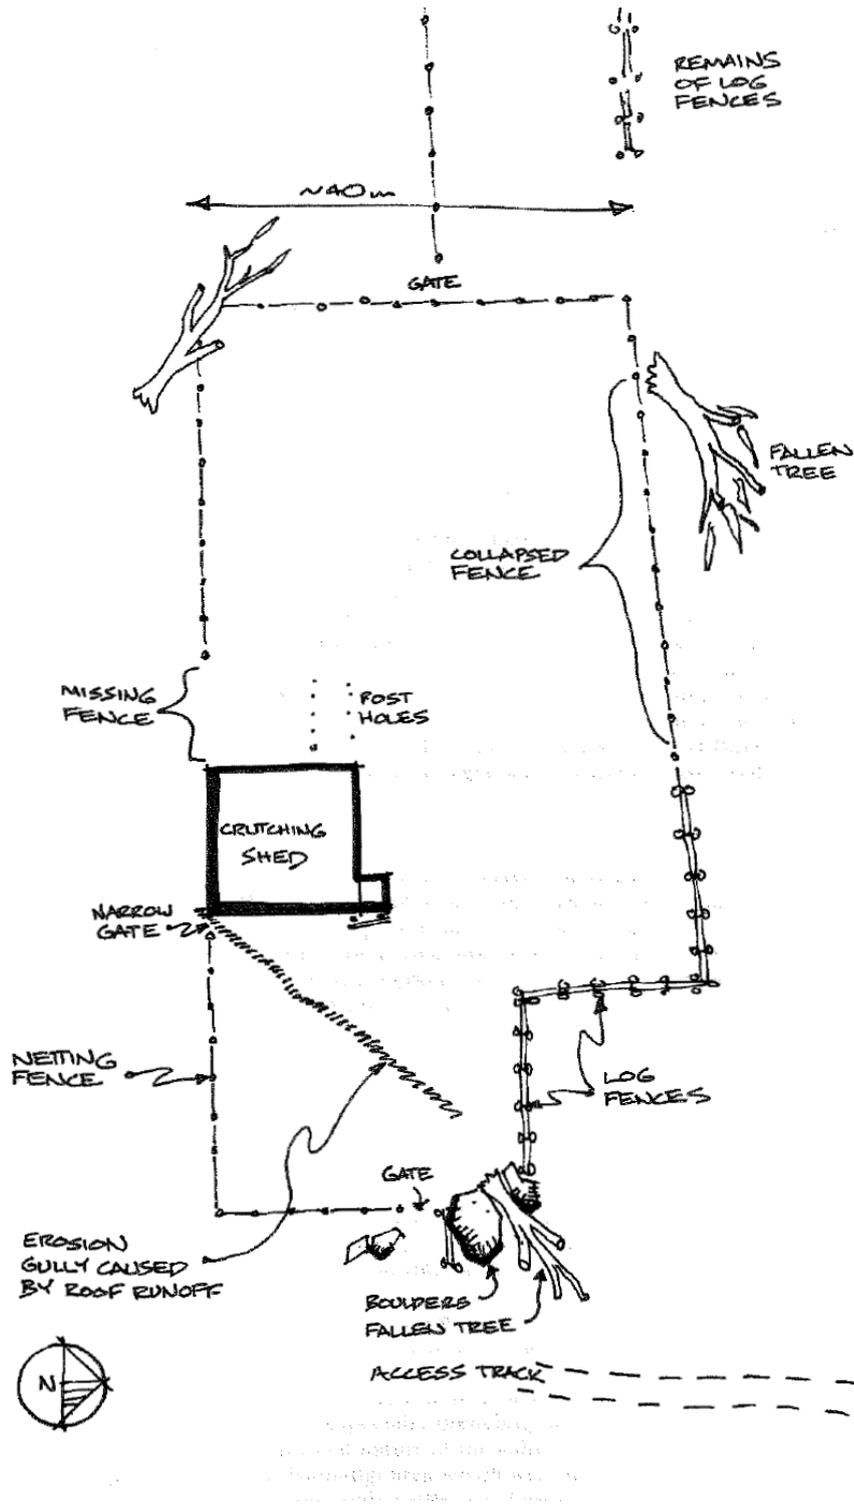
Image 5: Perimeter fence line – this sketch from the 1994 conservation study shows the shed and perimeter fence line. The section labelled 'log fences' is the drop log section considered to form the race and currently under reconstructing by the KHA. Of the fence lines, that labelled 'netting fence' is relatively intact. The remainder are in poor condition or collapsed.

Constructed in 1952 on a site selected as being protected from the weather, and possibly also for the availability of timbers from a previous fence line, the perimeter fence measured 70 meters x 35 meters, and included a drop log section used as a race. At the time of the 1994 conservation study, the perimeter fence and race were not intact and the internal yarding had been removed. The exact details of the perimeter fence, race and internal yards were also unknown in 1994. (Higgins & Scott 1994)

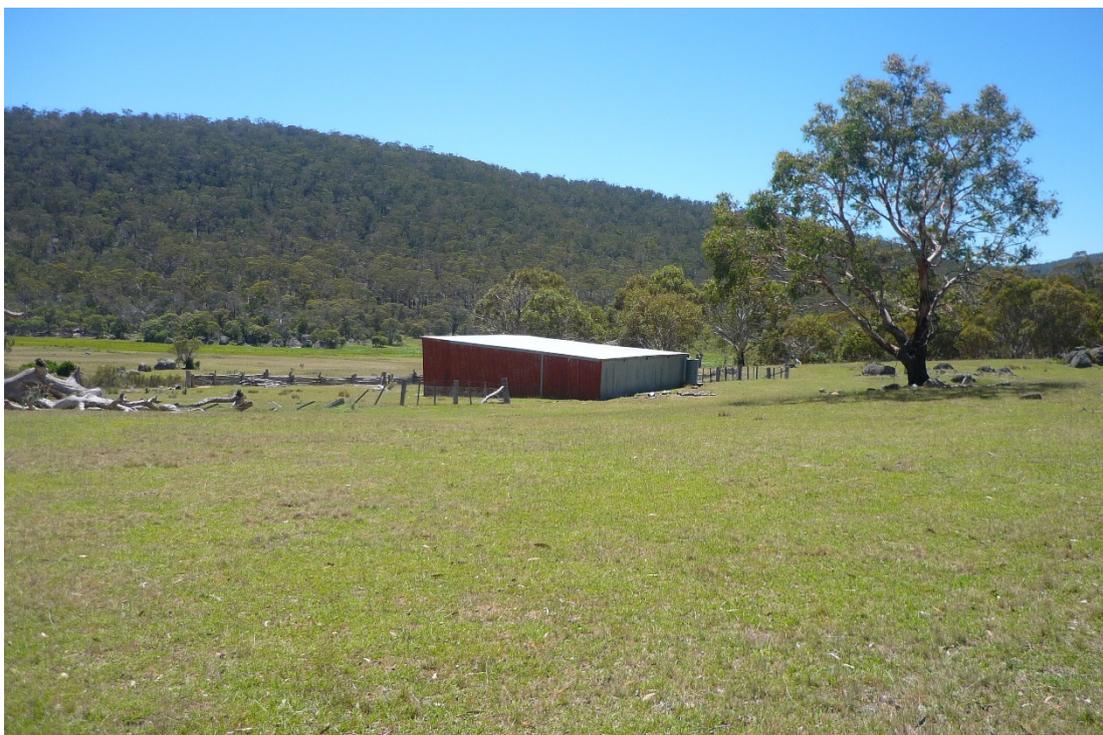
Image 6: Perimeter fence line - looking towards the north-east, this image demonstrates the general lack of intactness of the perimeter fence. On the far side of the shed however, is the relatively intact 'netting fence'. Image from site visit 10 February 2019.

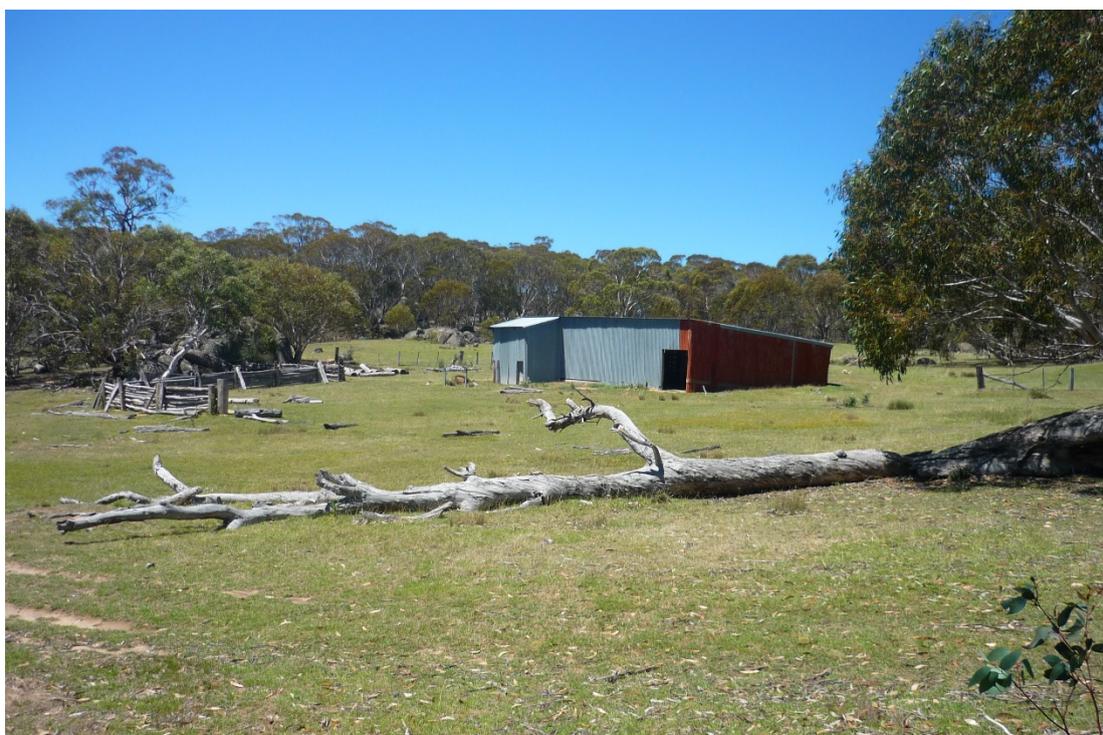
Image 7: Perimeter fence line - looking to the south-east, this image demonstrates the lack of intactness of the perimeter fence and absence of original internal yards. Image from site visit 10 February 2019.

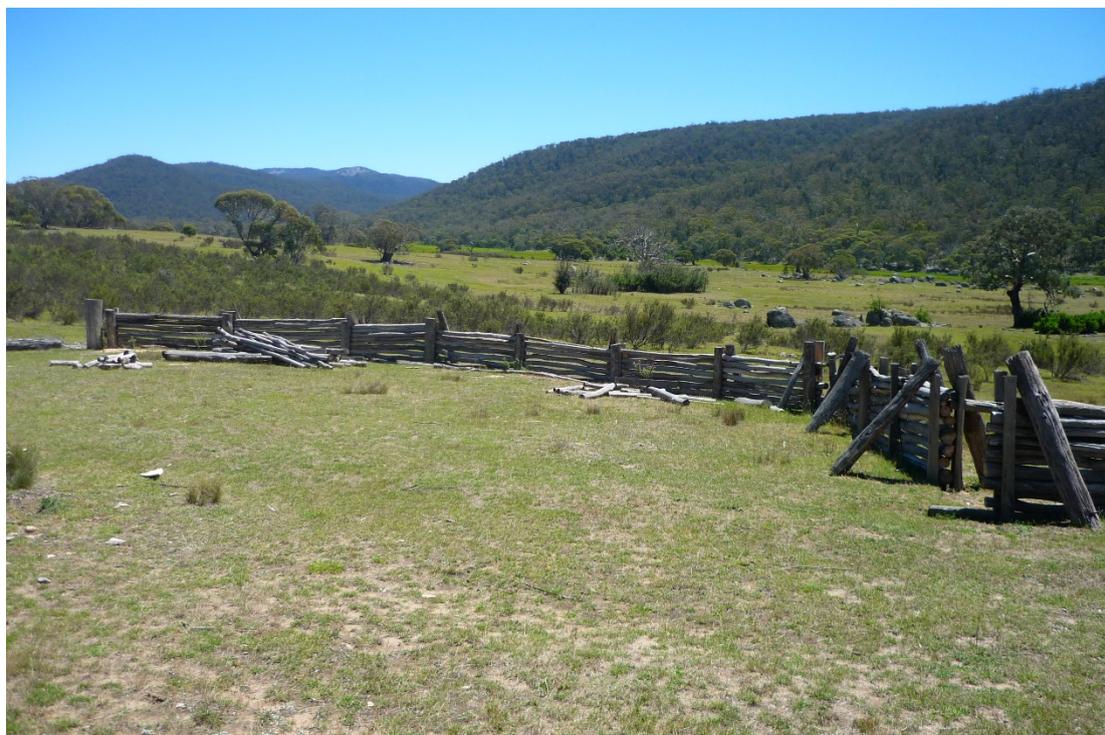
Image 8. Perimeter fence line – this image shows the drop log section of fence reconstructed by the KHA with building materials in the foreground. Comparing this with air photography dated 2017 in image 1 shows the extent of recent fence reconstruction. Image from site visit 10 February 2019.

- 2014: Commence reconstruction of drop log fence, repair netting and wire fencing running from rear of the shed, and affix large corrugated iron sheet,
- 2015: Re-stump / replace / scarf 6 posts, remove and replace damaged battens to catching pens, remove lining and clean up machinery room,
- 2016: Re-stump / repair 8 posts, affix loose corrugated iron, adjust guttering along rear of the shed, and continue reconstruction of drop log fence, and
- 2017 to 2018: Re-stump /repair 6 posts that are part of the roof support, clean-up and wash-down interior affected by roosting starlings, construct new rear door, general clean-up around the shed, reconstruct north

Currently, the main work the KHA is completing is the reconstruction of the drop log race and working with the Luton family to understand the original configuration of the race and internal yarding, with the possible aim of reinstating them. At a site visit on 10 February 2019 it was noted that the crutching shed was well maintained and on the whole is well maintained. The KHA caretaker for Lutons has a reputation for thoughtful work.

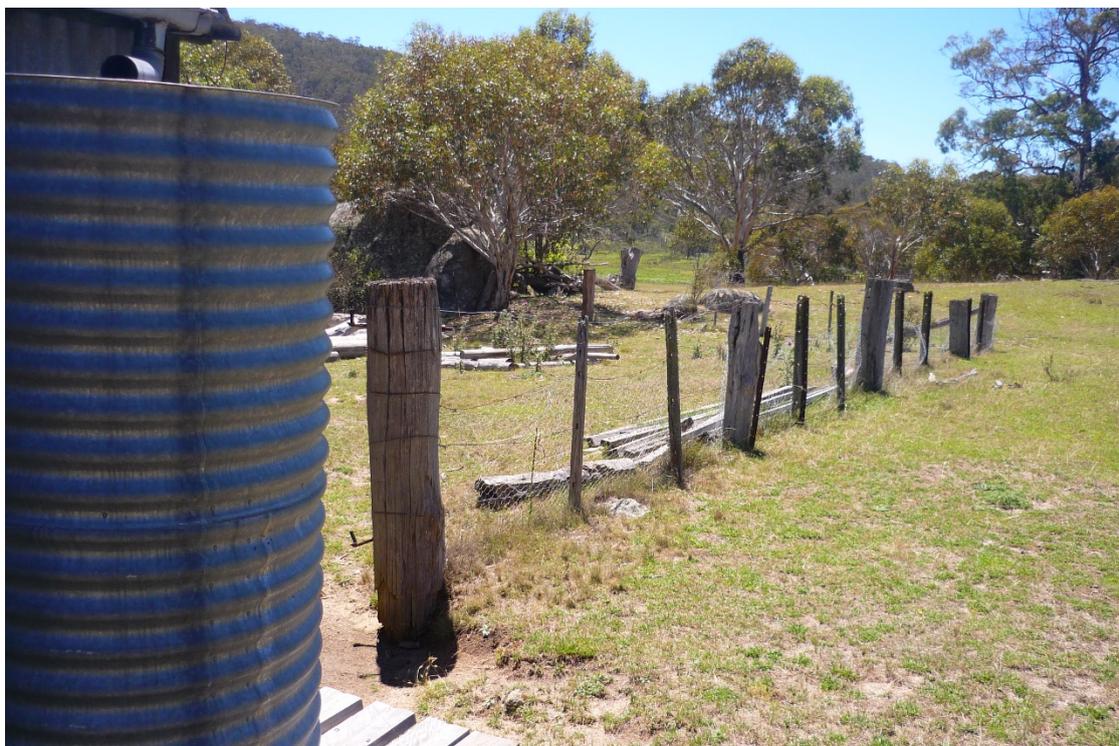
Image 9: Perimeter fence line – shows the relatively intact section of ‘netting fence’ on the eastern side of the crutching shed. Image from site visit 10 February 2019.

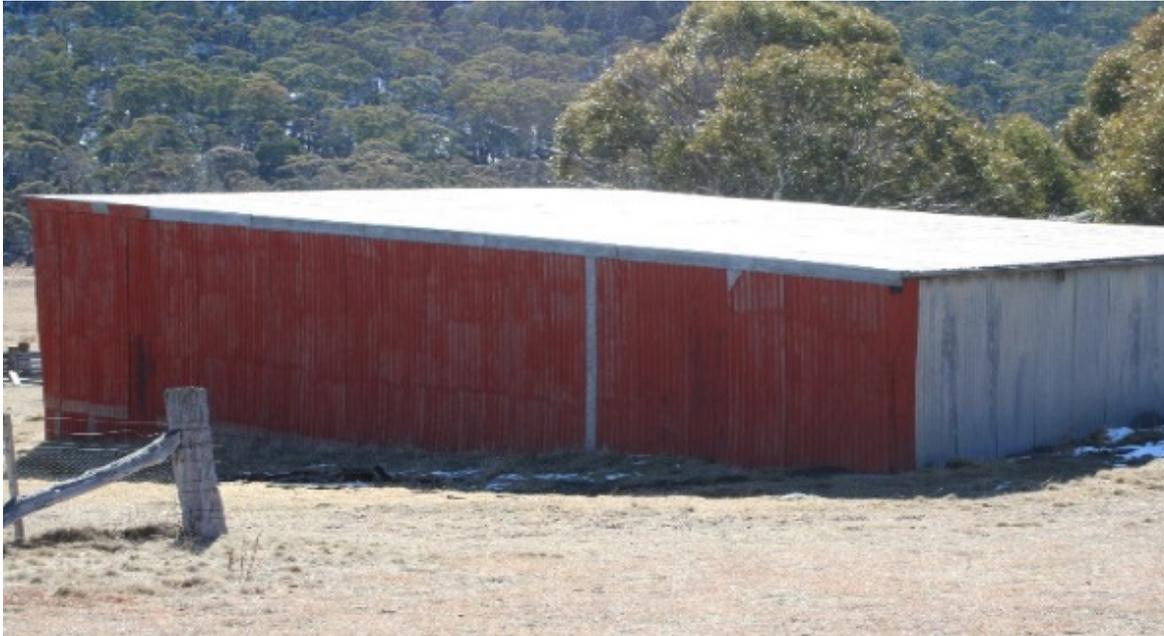
Image 10: Shows the external western wall of the crutching shed. The red iron was originally from the verandah at Muzzelbrook. Image from site visit 9 August 2018.

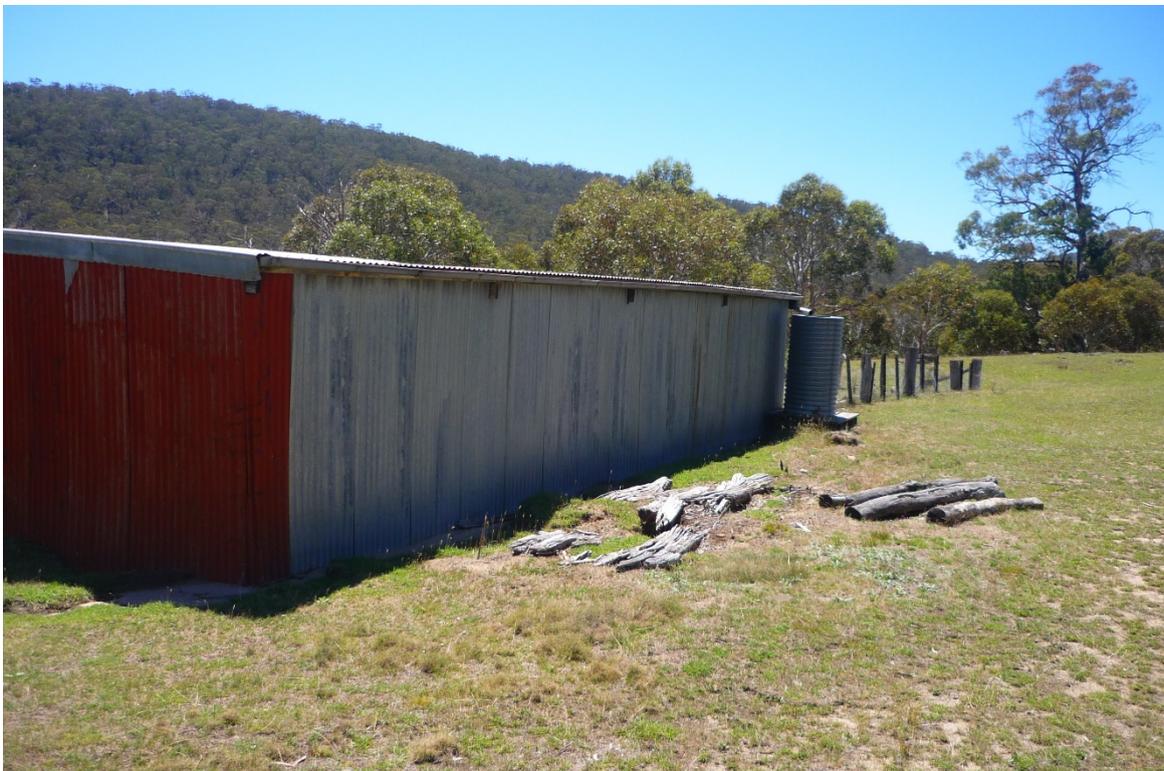
Image 11: Shows the external southern wall of the crutching shed. The guttering and tank were ACT PCS additions from the 1980s. Image from site visit 10 February 2019.

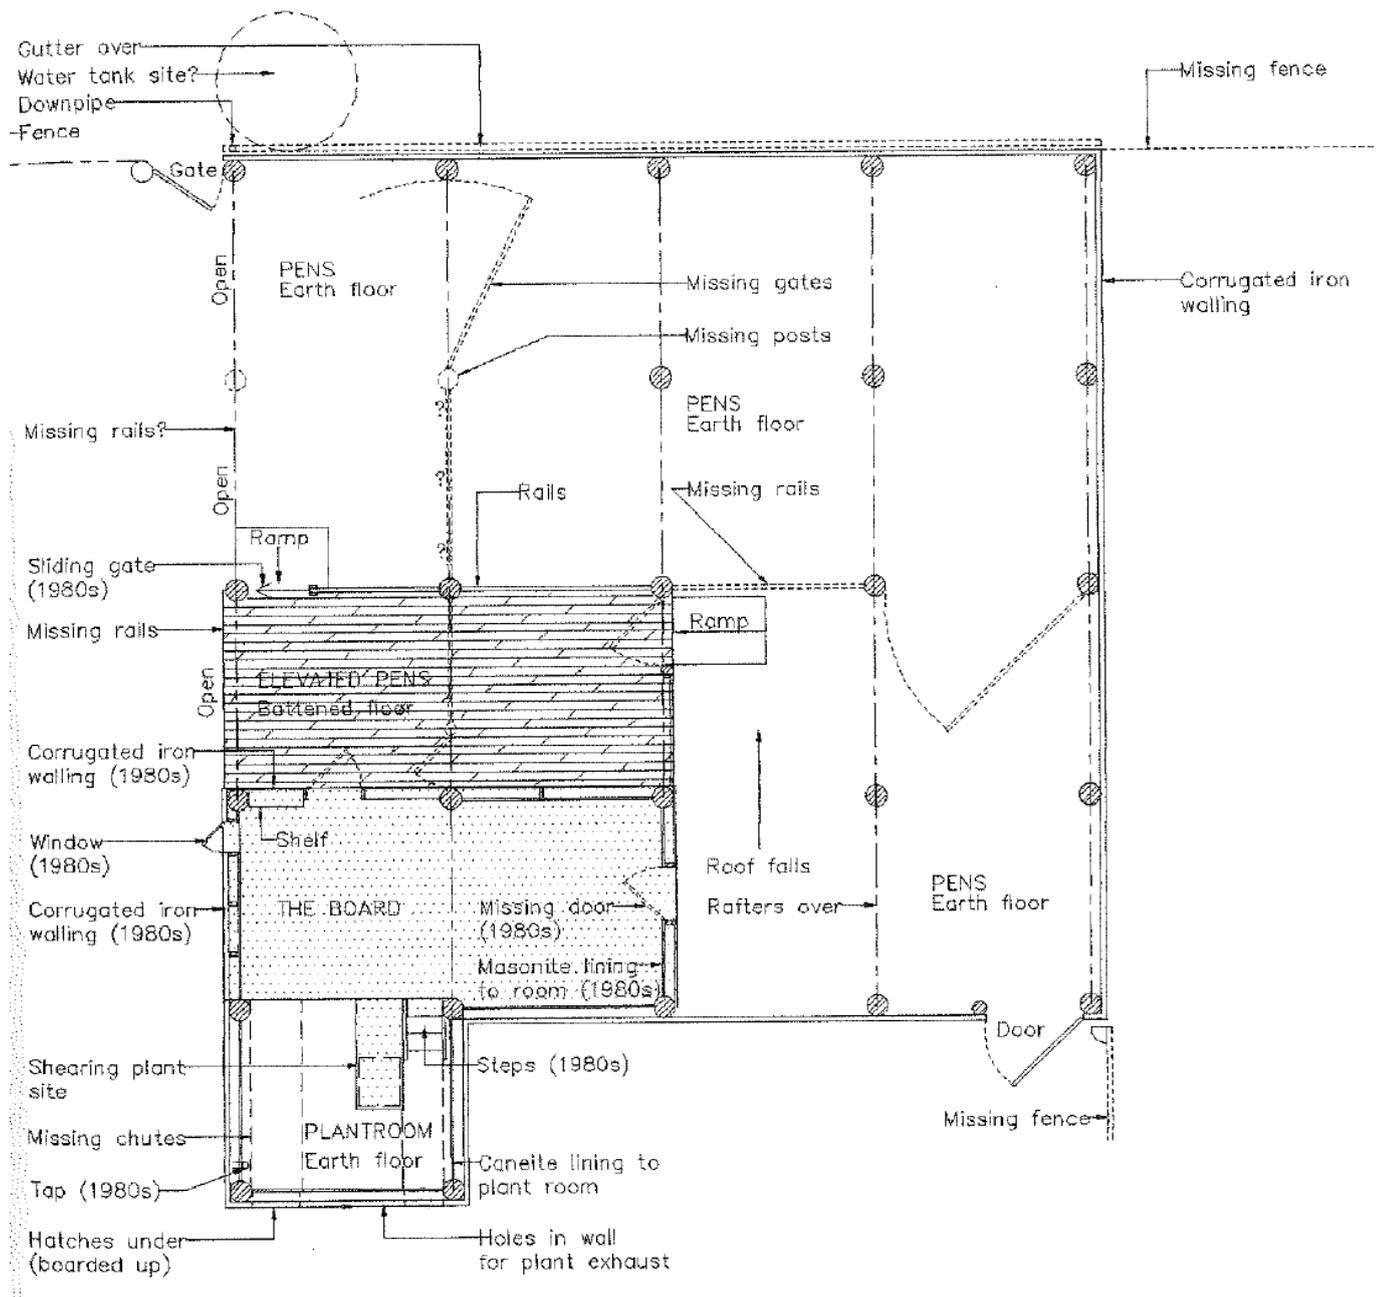
In the crutching shed, the sheep were managed as follows; from the ground floor yards, they were moved up one of two ramps by the roustabout into one of the two battened floor catching pens (the battens allow the passage of sheep waste). From the catching pens the sheep were drawn by the shearer or shearers through swinging gates onto the board for crutching. Once finished crutching a sheep, the shearer pushed it down a chute into yards outside of the shed. See image 12 for a plan drawing of the shed from the 1994 conservation study.

Image 12: Plan drawing from the 1994 conservation study. The drawing shows three quarters of the original shed being earth floor pens. The elevated quarter of the original shed is shown in the bottom left hand side of the drawing; this area is the catching pens (shown in drawing as 'elevated pens') and the shearing board. The 1970s plant room addition is shown beneath the board, it is also at ground level.

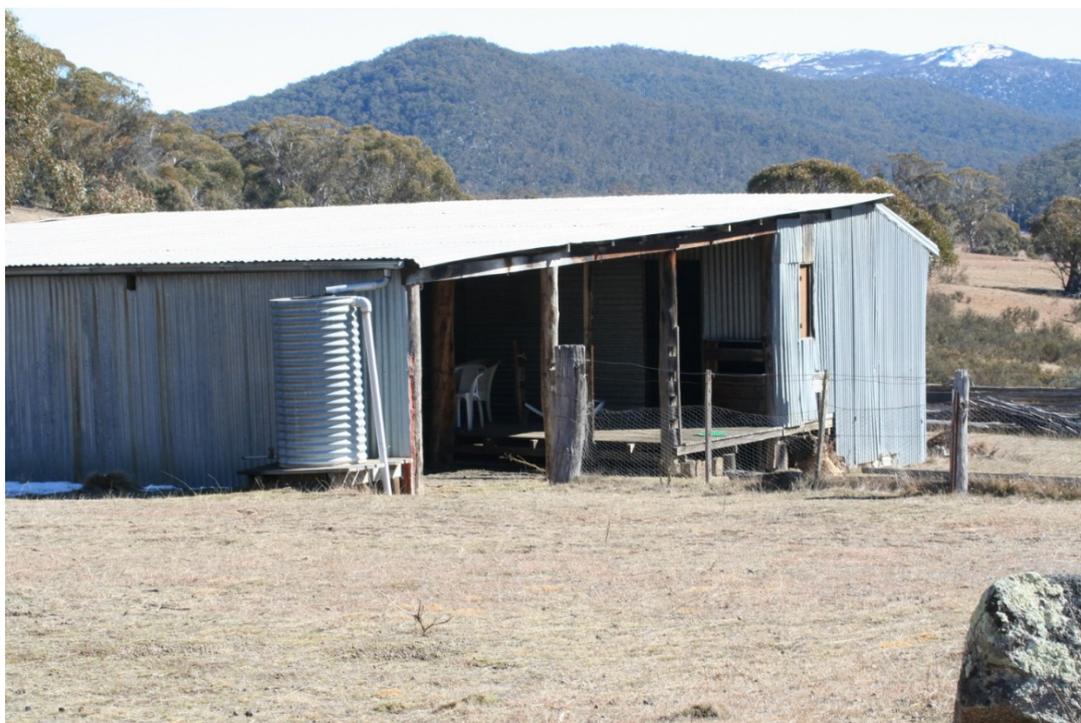
Image 13: This image shows the eastern side of the crutching shed, opening onto the yards. Prior to ACT PCS modifications in the 1980s there were yards and gates separating the covered pens from those outside. Image from site visit 9 August 2018.

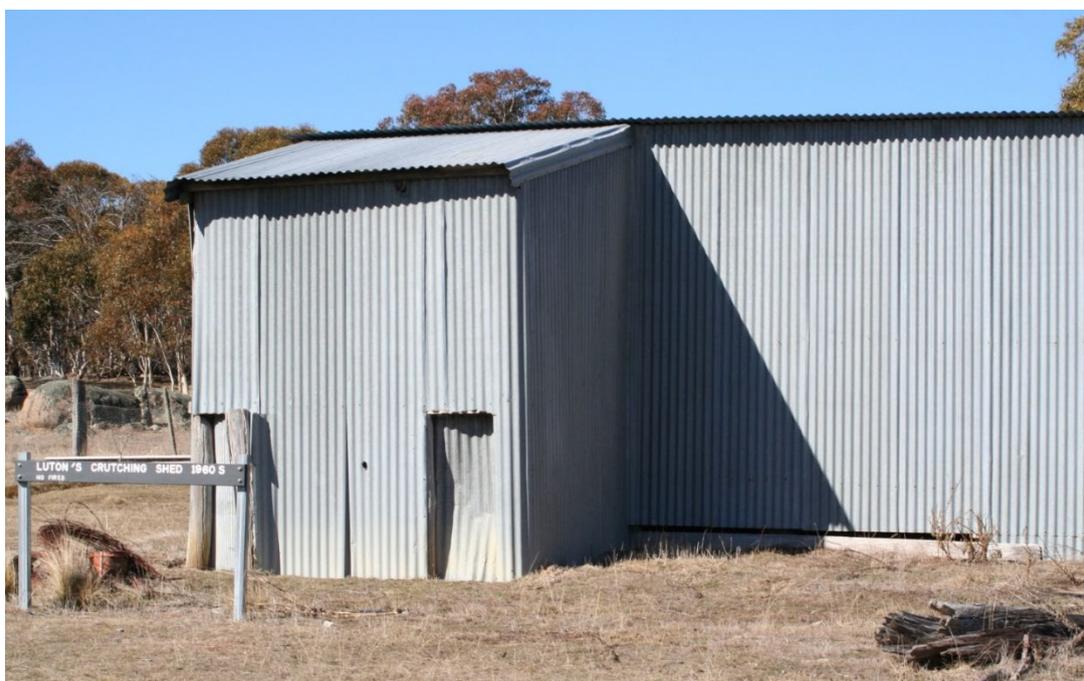
According to Higgins & Scott (1994) the plant room was added for shearing in the 1970s, it measured 3 meters x 2.4 meters and was added to the north-east corner of the building. It was constructed in a day using corner posts that appear similar to the ones used for the original building; it has a skillion roof and is clad in corrugated iron as per the original building. It was built over the sheep chutes from the board. A 'gangway' was built between the sheep chutes, at the same elevation as the shearing board; it was here that the crutching plant was moved, to make more room on the board for shearing. At the time of the conservation study the interior walls of the engine shed had remnants of a wall lining which may have dated from the Luton era or was later added by ACT PCS. (Higgins & Scott 1994)

Image 14: This image shows the 1970s engine shed addition to the northern side of the original building. The two apertures were the chutes from the shearing board, through which sheep were returned to the yards following crutching. The small hole is where the exhaust from the crutching plant was plumbed. Image from site visit 9 August 2018.

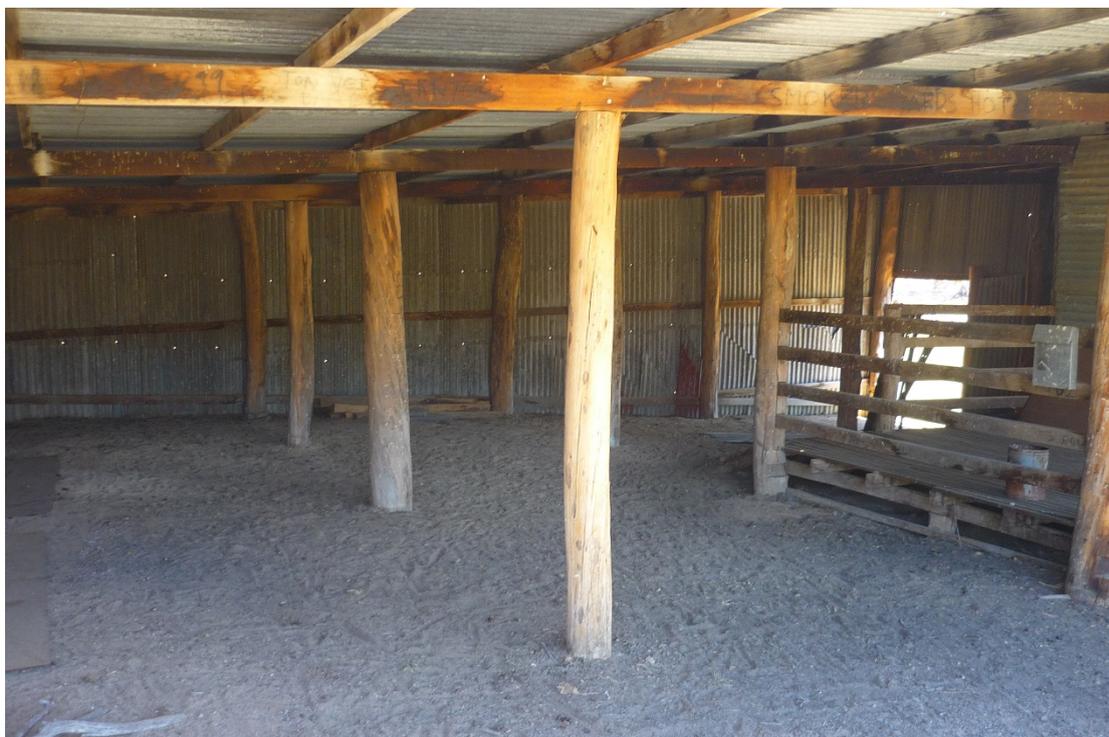
The crutching shed is 12 meters square, it was constructed with a series of white gum posts, cut from the Bobeyan valley, placed at 3 meter intervals. Its roof is framed with sawn timbers of alpine ash from an Adaminaby saw mill, and the roof, plus north, west and south walls are clad with new and reused corrugated iron. The east wall, opening to the outside yards, was open to the yards, but separated from them with yard rails and gates. Some of the rails and / or gates were designed to be removable [possibly the ones at the shearing board] to enable baled wool to be loaded onto a truck with ease. The ground floor area, which forms three quarters of the shed, originally had a series of yards within it. The two catching pens had a battened floor, with an access ramp from ground level leading to each of them. The shearers' board is solid timber and is the same elevation as the catching pens. It had two chutes off it, from where the crutched sheep were pushed by the shearer into the outside yards, following crutching. The elevated floor sections were framed with sawn timbers as per the roof. (Higgins & Scott 1994)

Image 15: This image shows the interior of the shed. On the right hand side are the catching pens. Visible are the timber poles cut from the Bobeyan valley and the sawn timbers used for roof framing from a saw mill at Adaminaby. From site visit 10 February 2019.

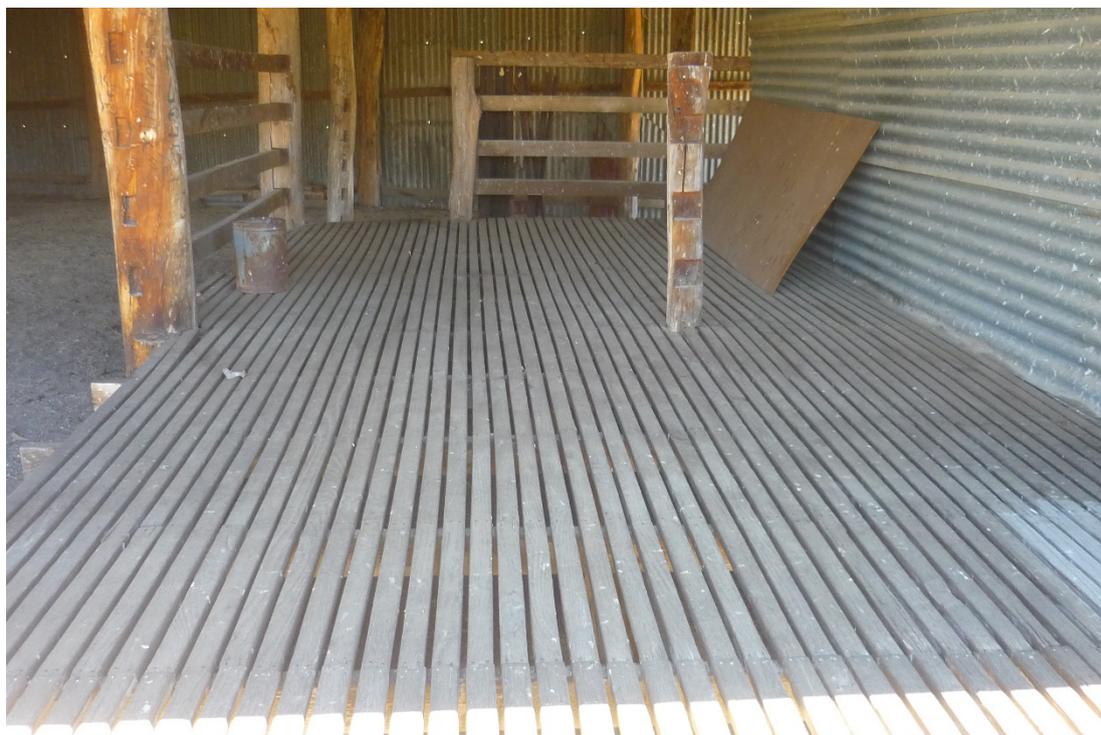
The battened floor of the catching pens and one ramp, the board, and the gangway on which the crutching plant was located are mostly intact but the catching pens and board remain separated by the 1980s stud wall framing, clad with corrugated iron. The lining to the 1980s proposed accommodation area and engine shed has been removed, likely it was in very poor condition.

Some of the railings and all of the gates associated with the catching pens have been removed. All the railings separating catching pens from the board have been removed and replaced with the ACT PCS stud wall. The chutes and associated hatches at the board through which the sheep were passed following crutching no longer exist. The apertures in the engine room wall through which the sheep passed into the external yards remain, but are covered with iron. The holes in the same area, through which the exhaust from the plant was plumbed, also remain. All the ground floor yards within the shed remain absent.

Image 16: This image shows the batten floor of the catching pens and remaining rails. Also visible are the notches in posts showing the location of original rails. From site visit 10 February 2019.

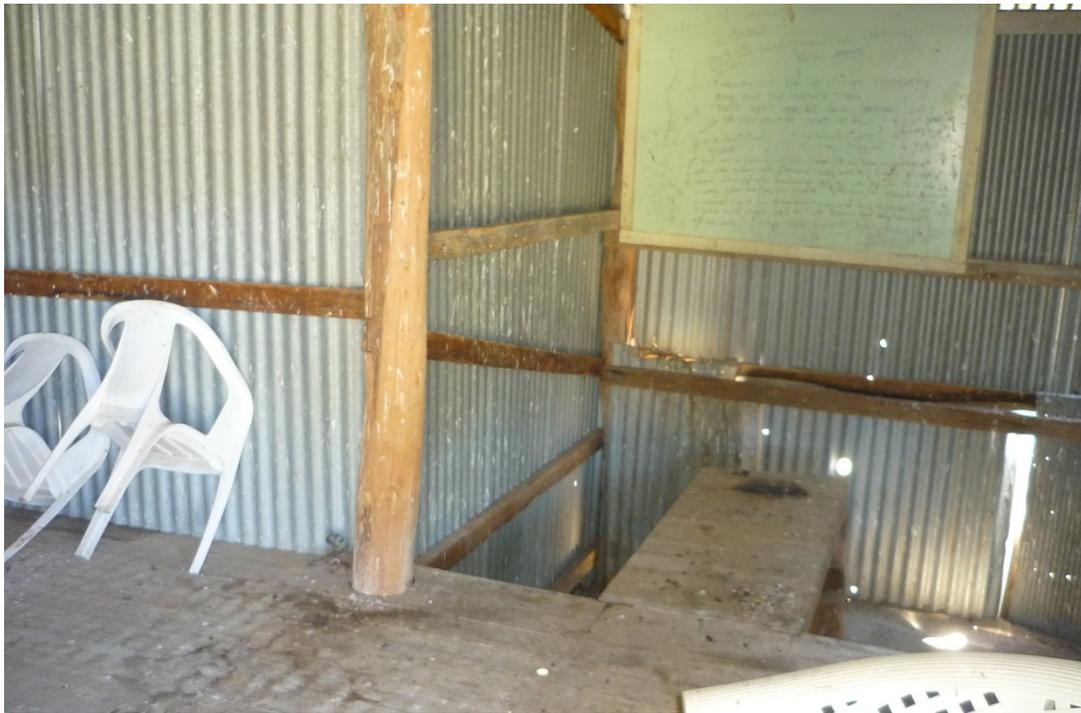
Image 17: The image shows the shearing board at the bottom of the frame and the gangway on which the crutching plant was located. The hole into which the crutching plant exhaust was plumbed is visible, as are oil stains on the floor boards where it was located. From site visit 10 February 2019

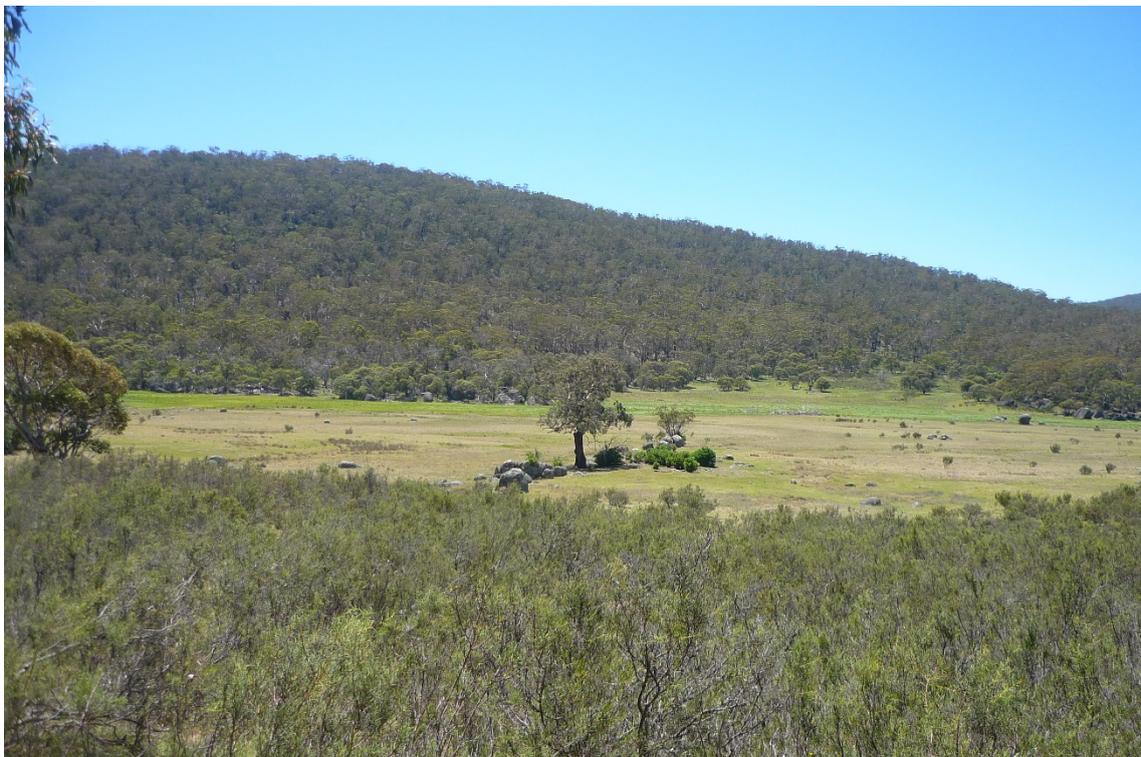
Image 18. This image relates to the next sketch. It shows one of the site identified with exotic trees and possible fire place.
