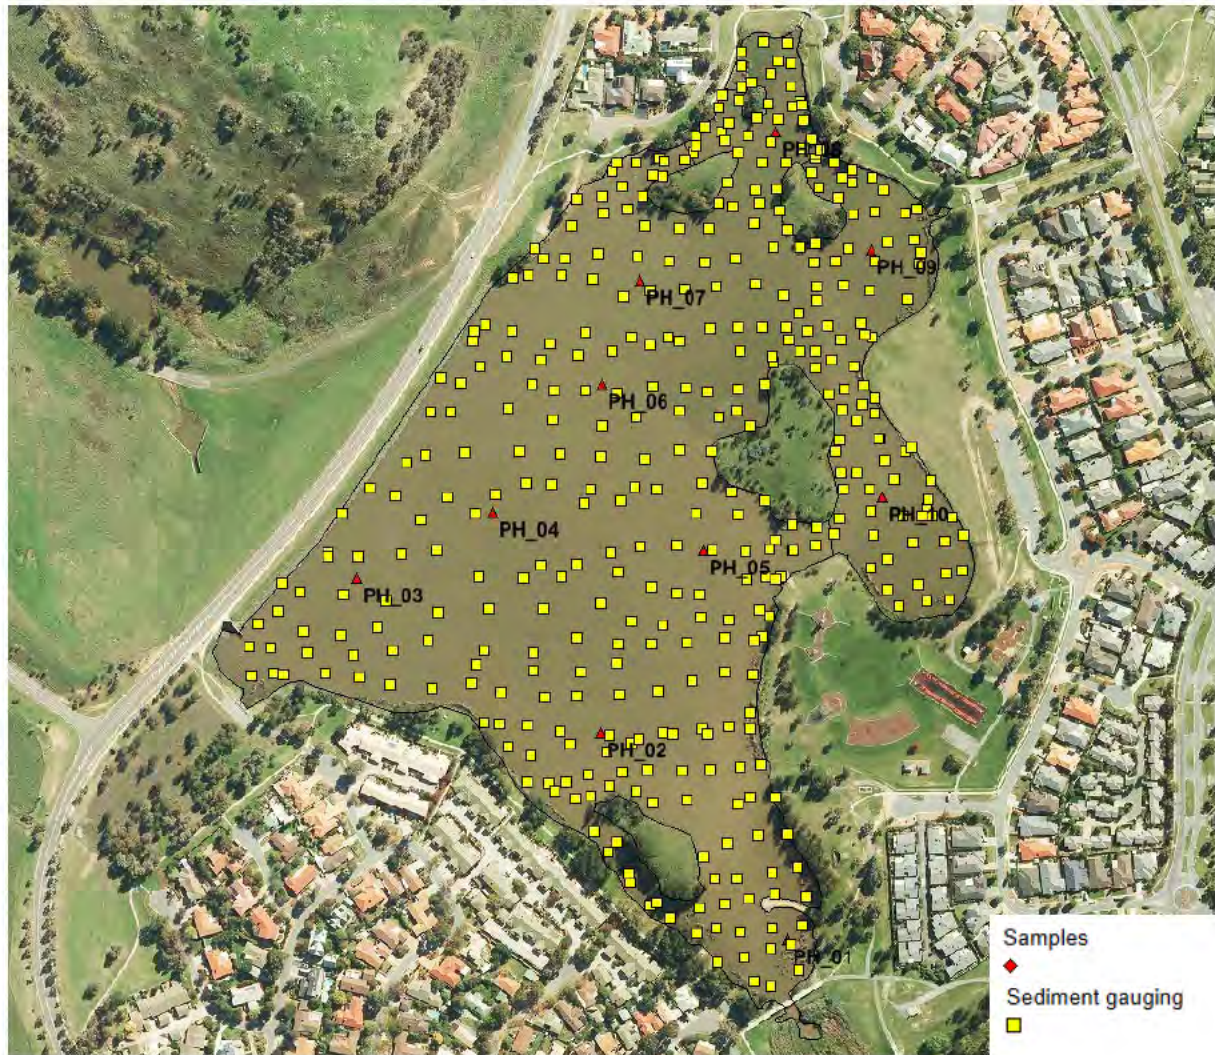
Figure 52. Gauging and sampling locations, Point Hut Pond

A physical survey of the pond was undertaken in April 2015 in order to gauge sediment depth and thickness. A qualitative description of the sediment (or base surface of pond) was also noted. The survey covered the area of the pond with measurements taken at a spacing of approximately 30 m. Survey points are shown in Figure 52.

Ten sediment samples were collected and analysed for total nitrogen, total phosphorus, and heavy metals. Figure 52 above shows locations of these samples. The samples were collected from the top of the sediment layer, which represents the most recently deposited material. Results from laboratory analysis are in Table 38.

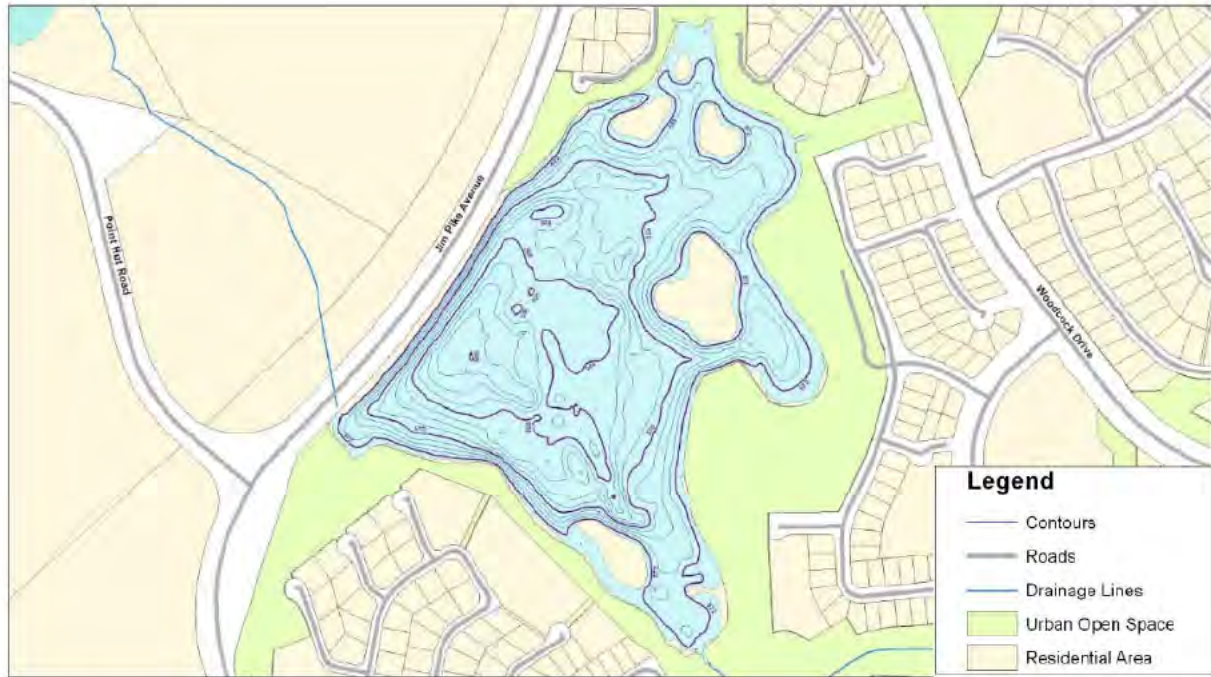
Figure 55. Bathymetric silt survey, Point Hut Pond (Ecowise Environmental 2009b)

Figure 55 below is a plot of the Point Hut Pond silt surface contours taken from Ecowise Environmental's report (2009b). This contour plot is very similar to Figure 54. Therefore the Ecowise (2009b) data helps to support the calculations for sediment volume in Point Hut Pond.

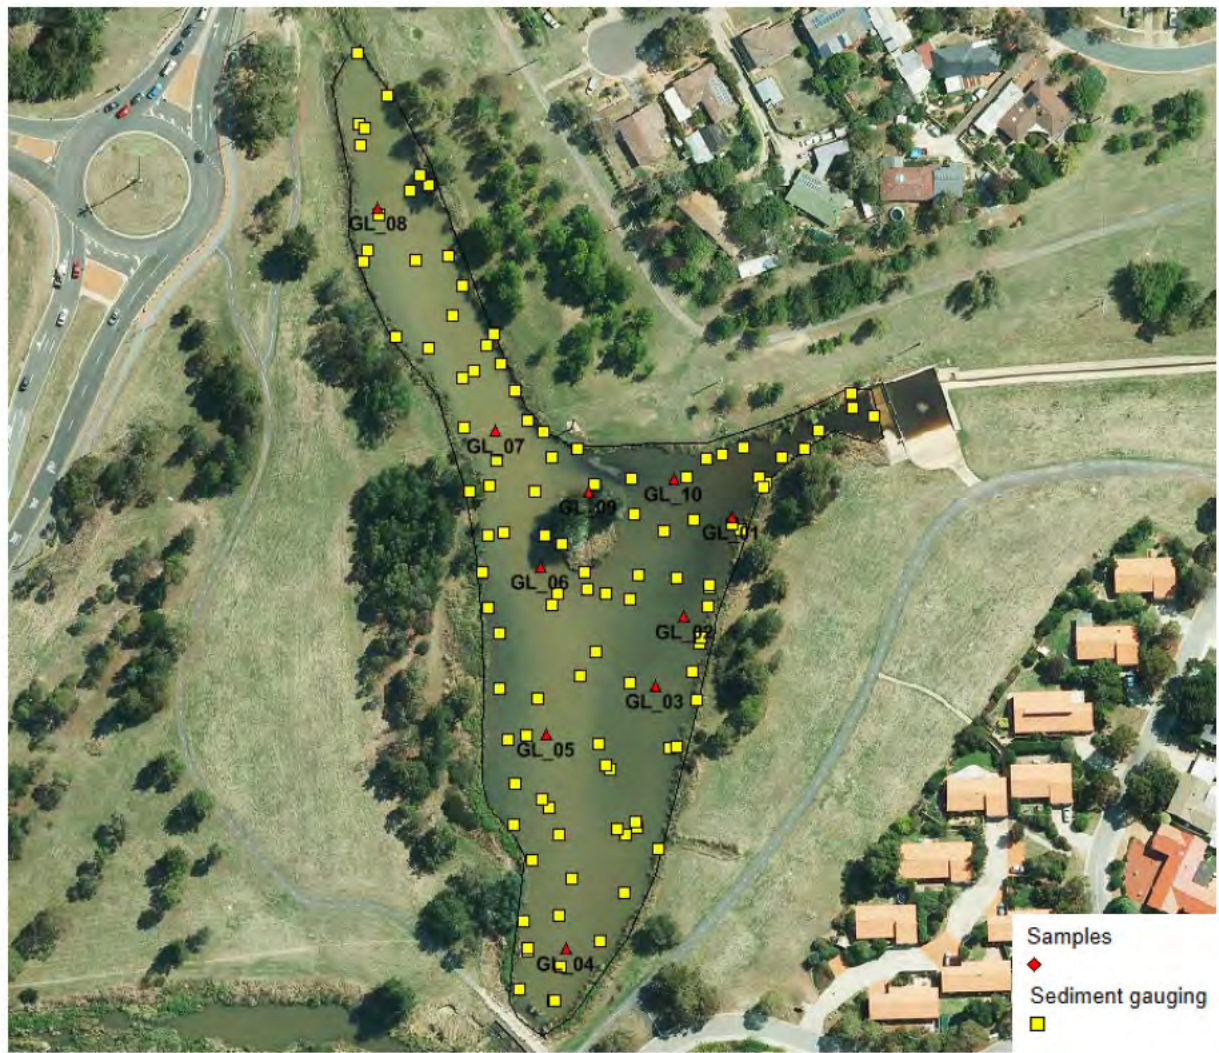
Figure 56. Gauging and sampling locations, Giralang Pond

A physical survey of the pond was undertaken in April 2015 in order to gauge sediment depth and thickness. A qualitative description of the sediment (or base surface of pond) was also noted. The survey covered the area of the pond with measurements taken at a spacing of approximately 15 m. Survey data points are shown in Figure 56.
