Heritage (Decision about Registration of Robertsons' House, Oaks Estate) Notice 2015

Notifiable Instrument NI2015—72

Robertsons' House

Blocks 11-12 Section 7, Oaks Estate

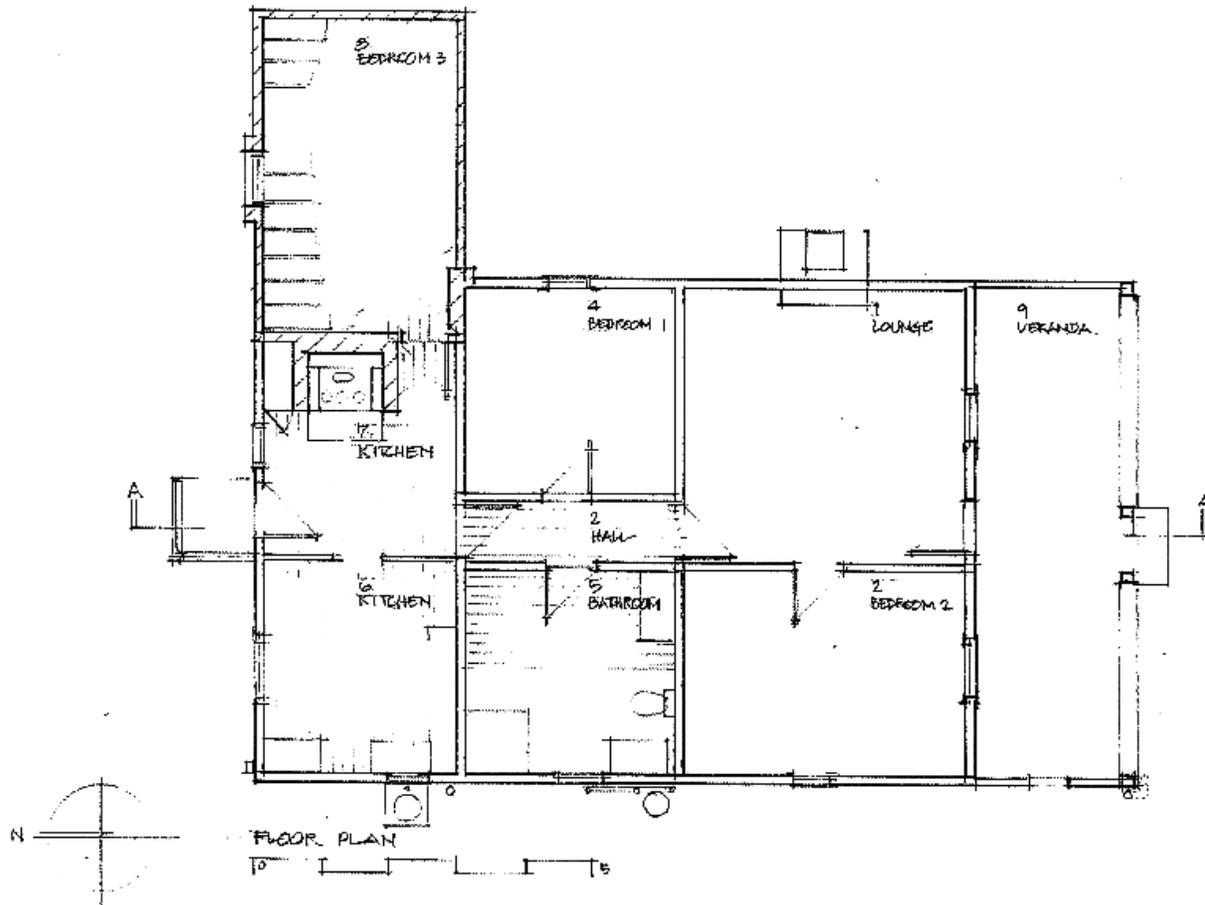
Figure 1 Robertsons' House measured drawing (Philip Leeson Architects, 2007. p.5)

Robertsons' House is a three bedroom L-shaped house with an internal bathroom, a lounge room with a wood fire heater, a kitchen with a partition through the centre and a wood fire stove, a verandah on the southern end, and several outbuildings connected to the house by paths and paving (see Figure 1 for floor plan and room numbers). The main house has been built in several stages with various materials which is evident based on exposed material as well as design, both internally and externally. The house and outbuildings are located on a long parcel of land, ~90m north south by 20m east-west, comprising Blocks 11 and 12 Section 7 (originally they were a single block, Block 7 section G).

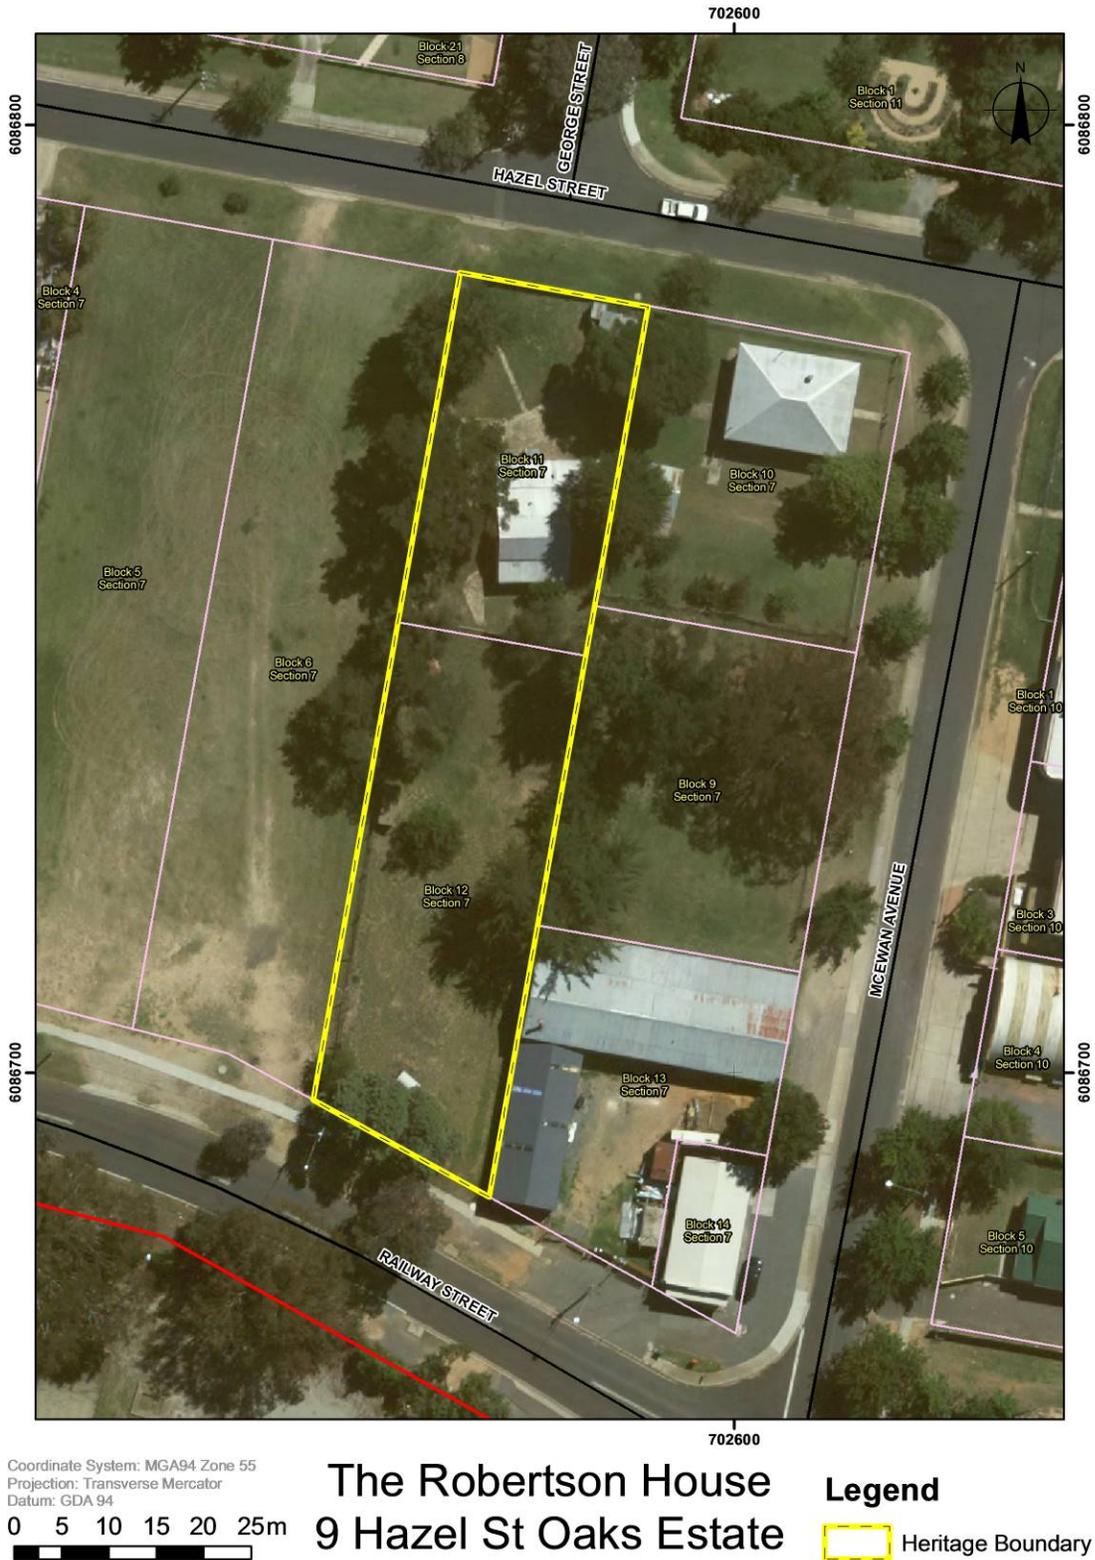
Figure 2 Robertsons' House, registration boundary.

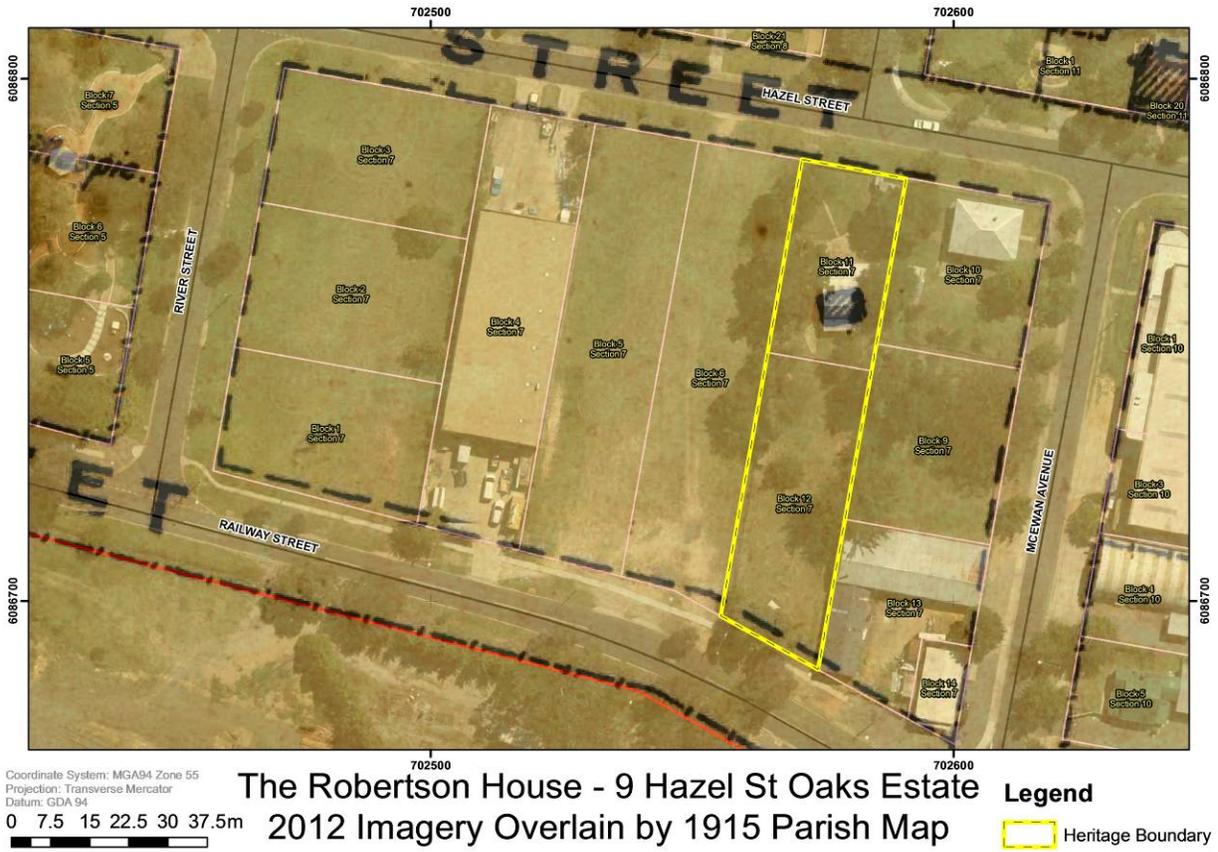
Figure 3 Cadastral map and aerial imagery of the Robertsons' House with 1915 survey overlay

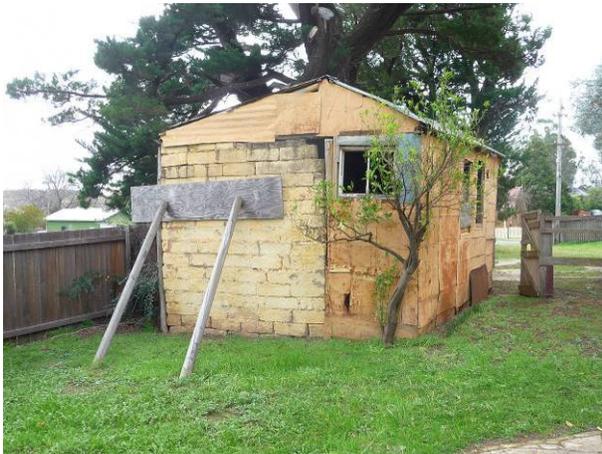
Figure 8 Southern end of western shed and laundry (ACT Heritage, 2014)

A site inspection by ACT Heritage on 11 June 2014 showed the house and grounds to be in good condition, and the outbuildings to be in a stable condition with the exception of the western shed which was in a poor condition. The house has been well maintained after the 2011 conservation works which had consolidated the external walls by replacing materials and painting existing materials which still appear to be in good condition and resistant to weathering, the new guttering and pipes are intact and working well, the interior condition has been stabilised with the flooring of bedroom 3 removed, exposing the raw earth beneath and the brick supports, the floor in bedroom 1 still has moderate movement evident when walking on it, as well as water damage to the wall, where water was entering through the ceiling. The outbuildings have been stabilised by the removal of trees affecting them and the structures repaired or strengthened where needed. The western shed is in the worst condition with the southern concrete brick wall requiring supports to stabilise it (Figure 8 - these appear to be temporary in

nature and detract from the site, although they have been in place for several years) and the western wall has lost most of its cladding with the structure becoming quite weathered and the earth floor spilling out, causing the table and wall to slump outwards. The fowl shed is in moderate condition, but the roofing is deteriorating which will expose the rest of the structure to rain. The boundary fencing installed in 2011 is in good condition and the grounds have been well maintained. The mature pine trees (*Pinus radiata*) along the boundaries are in good condition.

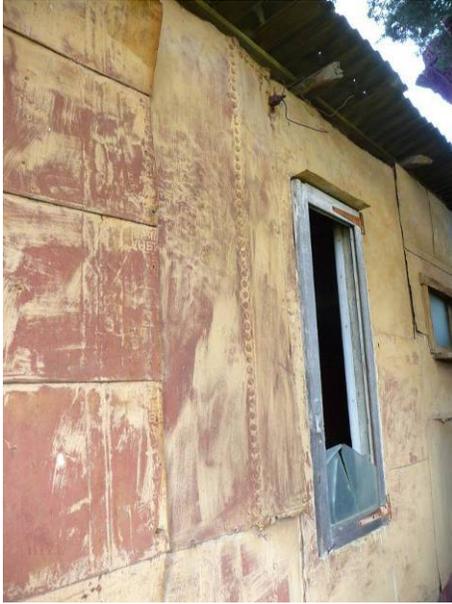
Figure 11 Tin cladding on east laundry facade (ACT Heritage, 2014)

are what appears to be sections of a metal shipping container (Figure 11). The adjoining shed contains tins marked by “B. I. O. Co. Ltd.” (Figure 12 and 13) – the British Imperial Oil Company, which operated as a subsidiary of Shell in Australia between 1905 and 1927, with the designs found at the Robertsons’ House likely to correspond to the later part of this period (Shell, 2001). The tins used in the house are from the Vacuum Oil Company (Figure 13), which had a branch down the road from Robertsons’ House from 1927 and were in Queanbeyan from the start of 1926.

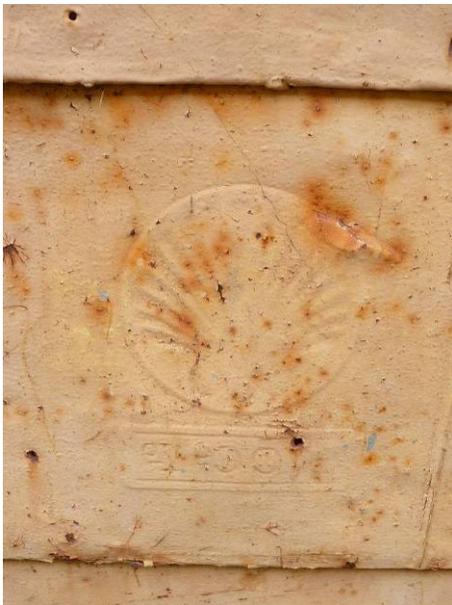
Figure 12 B.I.O. Shell kerosene tin cladding on western shed (ACT Heritage, 2014)

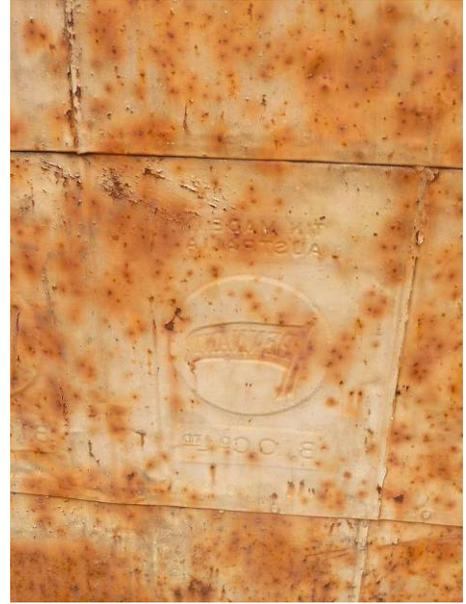
Figure 13 B.I.O. Pennant kerosene tin cladding on western shed (ACT Heritage, 2014)

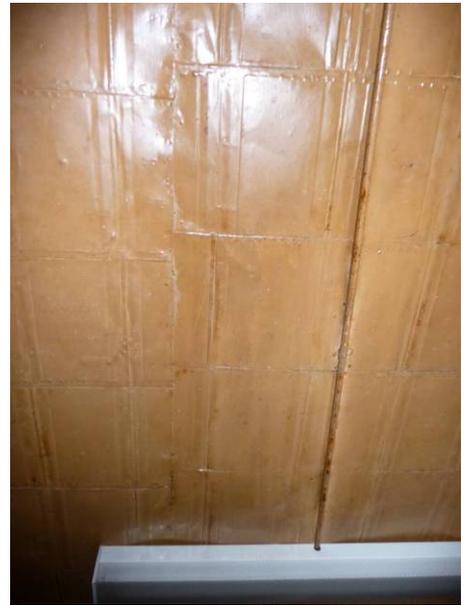
Figure 14 Vacuum Oil Company flattened kerosene tin lining on room 4/bedroom 1 ceiling (ACT Heritage, 2014)

The kerosene tins used to clad the outside and inside of the house and outbuildings come from various sources which are clustered by types in various locations. The earliest materials are located on the laundry building, originally the cookhouse, prior to the kitchen being added to the house, and workshop, and was used as a sleep-out from time to time during the depression years (Williams, 2014). There are several kerosene tins marked out with "The Texas Company. Light of the Age. Best American Kerosene" (Figure 11) and a star symbol which is an early Texaco trademark used between 1903 and 1907 (Chevron, 2014). The kerosene tins cladding the shed on the western boundary and the packing cases used for the flooring of the earliest section of the kitchen in the house were sourced from Dr Blackall who was a Queanbeyan Doctor (Williams, 2014). Also used in this structure

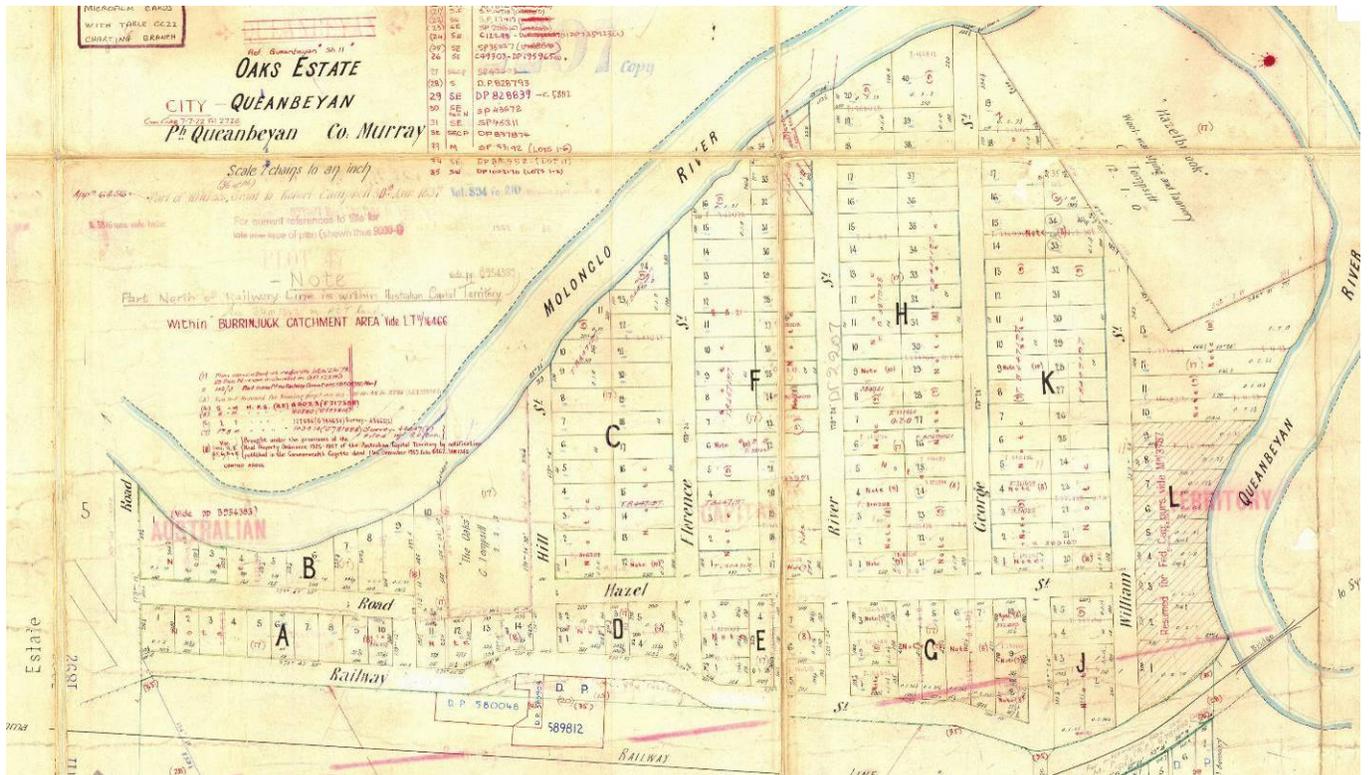
Figure 16 1888 Oaks Estate subdivision Deposited Plan 2207 (NSW Land & Property Information)

The first Robertson house was located at the bottom of George St, close to the river (the historical block layout can be seen in Figure 16 - historical block 40 Section H, today within the Hazelbrook Nursery property blocks 4 and 5 Section 14). The house was washed away in the 1891 floods after which they moved to higher ground at Blocks 8-9 Section 8 (historical Section H) on River St. On Block 9 Section 8 (H) from 1901 is where they slowly built up the family home of Weowna in stages from whatever material was available. Edward (Ned) Robertson acquired the house and land and lived there with his wife until their deaths in 1946 and 1954. Ned was a key figure in the Oaks Estate community and helped to build many of the early houses. Ned also acquired Block 20 Section 6 (F) in 1927 until 1950; Blocks 10-13 Section 8 (H) in 1927 with Blocks 11-13 transferred to William Edward Hopkins in 1957 as a partnership to run a sawmill from the property. Block 10 was retained and a brick house built there, but there is no further information on it. Ned also owned Block 26 Section 8 (H) and had a house built using bricks made by Dick Robertson. It was sold in 1940. Ned had houses built on Block 7 Section 8 (H) and Block 22 Section 6 (F) from bricks made by Dick Robertson at his house on Block 11 Section 7 (previously Block 7 Section G). The roof being a joint venture between Dick and Tom. The builder was Tom Rickman who married Jessie Robertson and the couple lived in the house until 1957. The other house (B7) was occupied by Ivy Robertson who had married Sydney Goggin, who were living with Ned and family while it was being built. (Williams, 1997)
