## CONSERVATION MANAGEMENT PLAN

### THARWA BRIDGE

ROADS ACT

PHILIP LEESON ARCHITECTS PTY LTD

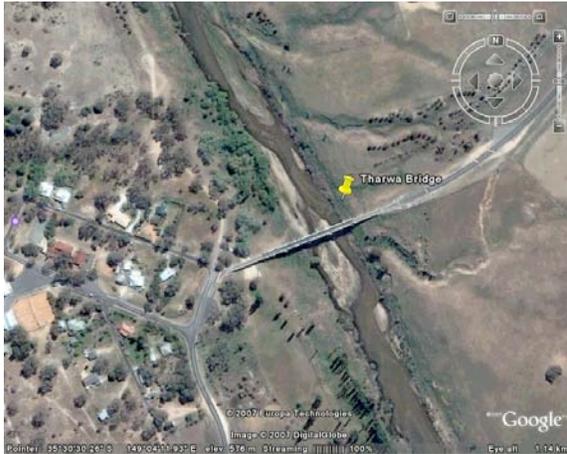
Figure 1. Aerial photo of Tharwa Bridge and surrounding areas.

The Tharwa Bridge spans the Murrumbidgee River to connect Tharwa Drive, Tuggeranong, with the village of Tharwa and is illustrated in Figures 1 and 2 below. It is located approximately 34 km south of Canberra.

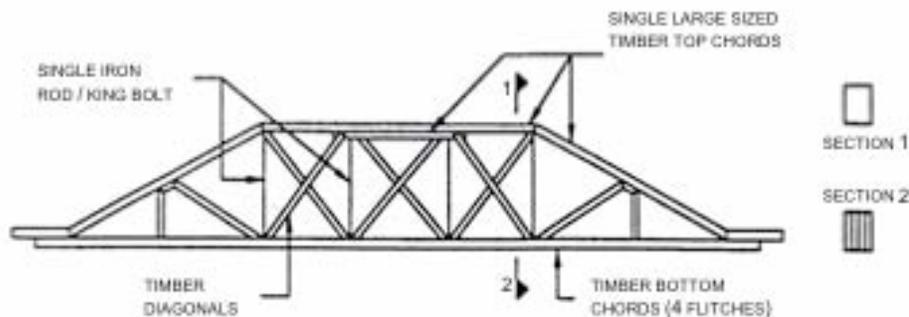
Figure 2.1 Schematic diagram of Old Public Works Department Truss (OPWD), (derived from DMR 1987)

element was attached to the underside of the top chord at mid span above the central diagonals. In essence this member acts as a butting block to assist in transferring forces from the diagonals into the top chord as well as increasing the stiffness in the top chord. Other elements which were omitted from later designs are the additional timber vertical and cross members supporting each end principal of the trusses.

Unique to the Old PWD and its successor, the McDonald truss is the manner in which the butting blocks are placed. The butting blocks are situated on top of the bottom chord at each end of the truss with the end principals abutting them. The butting blocks perform the important function of transferring the load from compression in the principal to tension in the bottom chord. In later designs these forces were transferred through cast iron shoes, which were notched into the timber bottom chords.

Also unique to the Old PWD truss design is the use of a single timber member to form each large end principal. All later designs used double components, known as flitches, separated by a spacer block. The latter required smaller, more readily available sizes and also facilitated replacement of deteriorated or damaged principals under traffic, as the load on the principal could be temporarily transferred to a single member during replacement works.

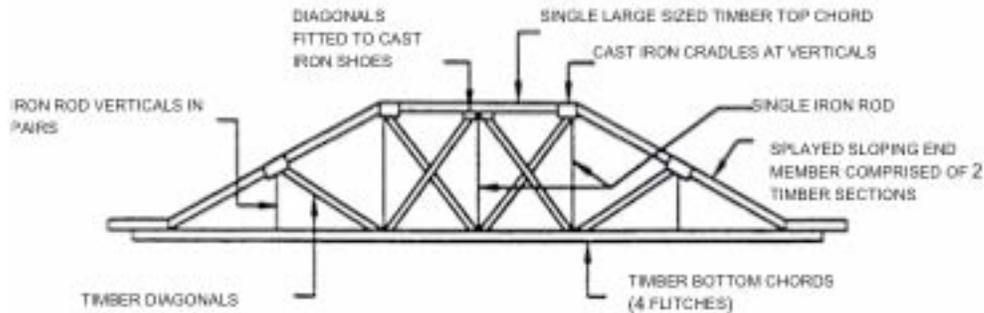
Figure 2.2 Schematic diagram of a McDonald Truss (derived from DMR 1987)

The truss was designed by John A McDonald (an expatriate English engineer) when he joined the PWD in 1879 as Engineer for Bridges. It was designed primarily with the aim of being easier to build and maintain and to support greater loads than the Old PWD truss. This design, much like its predecessor, was influenced by European truss designs. The basic McDonald truss design used a single thickness top chord with double timber principals, which were splayed to provide more stability for the top chord, and double tension rods made from Iron. The vertical rods were placed on the outside of the chord and were connected using cast

iron cradles, thus eliminating the need to drill through the chords. The compression diagonals and bottom chord continued to be made from timber. This design produced a truss that was cheaper to make, able to span a greater distance and easier to maintain. The McDonald truss continued the use of the traditional timber bottom chord; it was not until de Burgh's 1899 truss design that the merits of steel lower chords were realised in practice. McDonald truss bridges were constructed throughout the period 1886 to 1893.

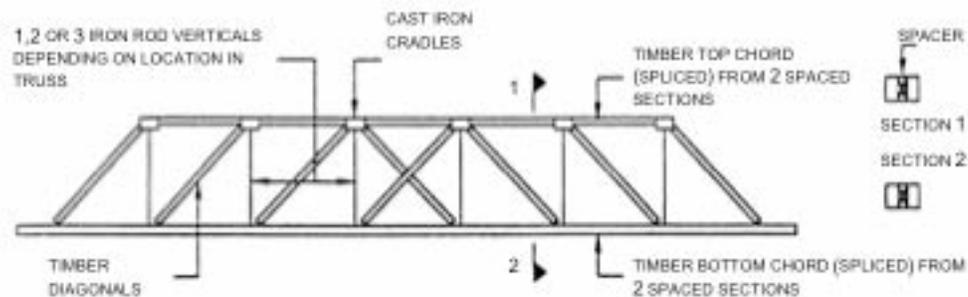
Figure 2.3 Schematic diagram of an Allan Truss (derived from DMR 1987)

- The adoption of open top and bottom chords for easier painting, which also reduced the decay due to the entry of water between the members in a built up chord.

- The absence of overhead cross braces spanning the roadway eliminated a height limitation on loads being carried.
- All joints and surfaces of members left accessible for inspection and maintenance.
- The use of external iron clamps almost eliminated drilling of timbers for the large diameter suspension rods.
- Cross girders placed at panel points to eliminate bending in the bottom chord.
- Well designed splices (a direct result of Warren's earlier program of timber testing) enabling shorter pieces of timber to be used.
- Any member could be renewed without destroying the overall structural integrity of the truss. It was easy to replace half members with minimal disruption to traffic.

Due to Allan, timber truss road bridges were relatively cheap and remained serviceable for longer periods than the earlier designs. The first Allan truss was constructed in 1894 and the last Allan truss bridge was built over Mill Creek near Wisemans Ferry in 1929.

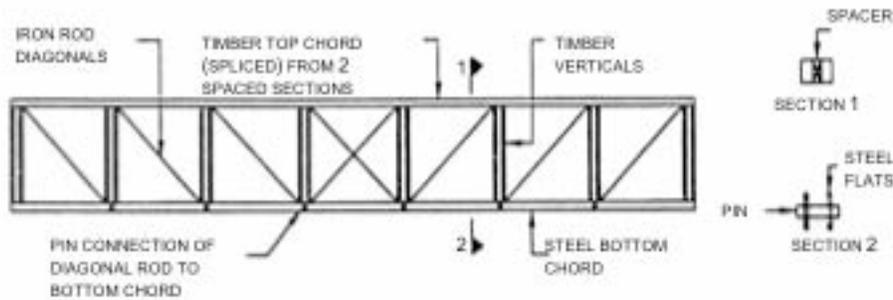
Figure 2.4 Schematic diagram of a de Burgh Truss (derived from DMR 1987)

The de Burgh truss was designed by Ernest McCartney de Burgh, a British expatriate engineer, who had worked in the PWD since 1885. The de Burgh truss was possibly based on the American Pratt style truss but was modified to include steel bottom chords, vertical posts and diagonal tension members. A later modification to the truss was the replacement of the sloping end members with the conventional Pratt truss squared ends. This truss design incorporated features of the Allan truss but changed some details to include a steel bottom chord which resulted overall in a stiffer, more robust truss. However, the pins along the bottom steel chord made replacement and maintenance of this feature difficult. De Burgh truss designs were used for a relatively short length of time between 1900 and 1905.

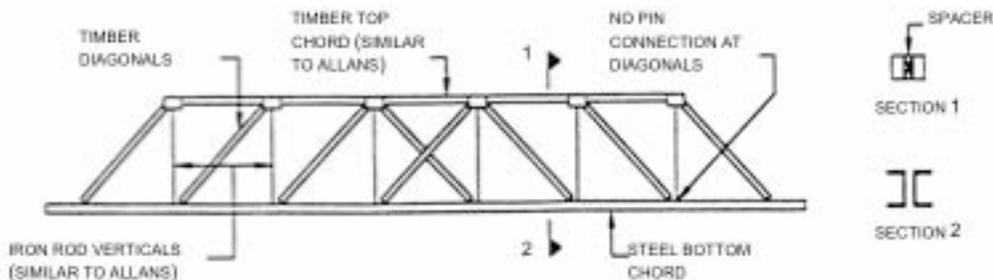
Figure 2.5 Schematic diagram of a Dare Truss (derived from DMR 1987)

The Dare truss was designed by Harvey Dare and was a design used extensively in NSW in the period 1906 to 1935. It is a variation of the Allan truss design, substituting a pair of steel channels for the bottom chord. The Dare truss proved to be a very successful composite truss design, which was relatively simple to maintain.

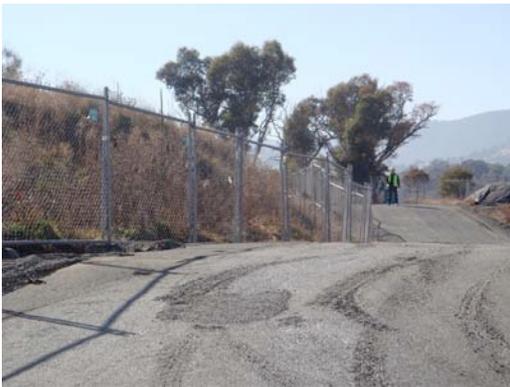
The river ford crossed just downstream of the bridge. The approach track and cutting are still visible on the eastern bank, however since the construction of the Tharwa Bridge, the ford area on the Lanyon side has been highly disturbed. During high water levels and floods, scouring of the bank has occurred which has resulted in the removal of the lower level of the ford where it reaches the riverbed. The ford area is currently covered by low vegetation. The approach track has been used on several occasions since the 1930s to provide access for alterations and repair of the bridge, including the Stage 1 works but its basic form is still apparent.

*Track and cutting to ford on eastern downstream side of bridge during Stage 1 works.*

<b>Physical Assessment Summary</b>
Condition: Fair
Modifications: Road base and fencing provide protection during Stage 1
Integrity: High

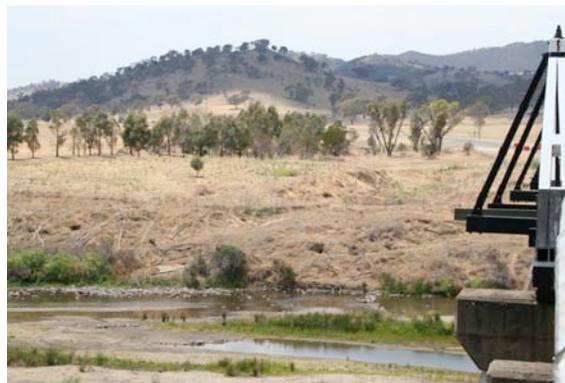
*Track and cutting in natural state.*

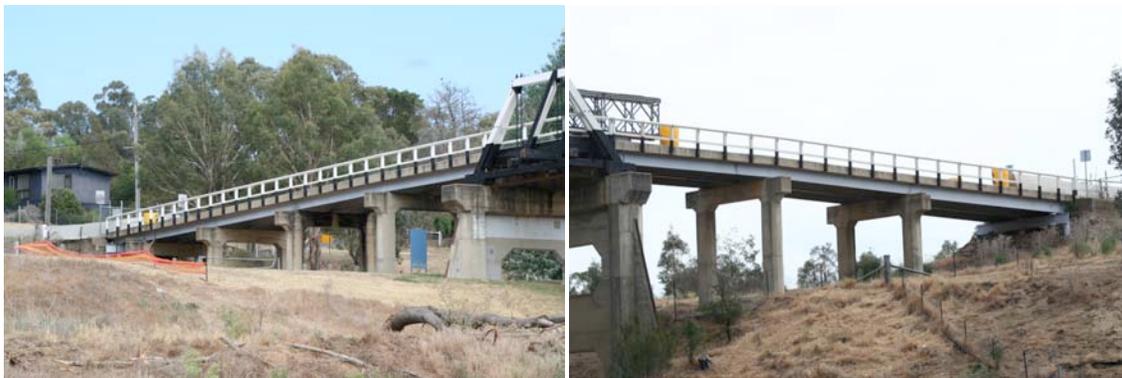
*Western abutment*

*Eastern abutment*

In c.1939-40 the original abutments were replaced with reinforced concrete, of a form and composition typical for its time. At some later time due to subsequent settlement steel channel cross girders were placed adjacent to both abutments supported on 2 steel columns. The end span girder of the upstream eastern approach deck is raised approximately 70mm clear of this cross girder, indicating some movement.

The abutments have settled, are badly cracked and in need of replacement. There is no record of any concrete test cores having been taken from either abutment to determine composition.

Timber gravel boards retain the earth behind the abutments. The existing boards are in poor condition, being either rotten or burnt. As a result loose fill is spilling out over the tops of the abutments and the asphalt road base is sinking relative to the approach decks. Stage 1 works include the replacement of gravel boards with a reinforced concrete wall, and realignment of the road surface on each side.

<b>Physical Assessment Summary</b>
Condition: Poor (to be confirmed)
Modifications: Original timber abutments replaced in c. 1939-40. Age of existing gravel boards unknown
Integrity: Nil

It is recommended that a more detailed condition report be prepared.

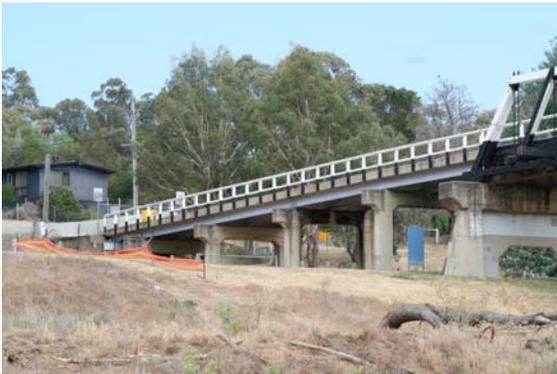
*Western approach piers*

The approach piers supporting the eastern and western approach decks are located at 9.3m intervals typically, with shorter spans at each end.

In c.1939-40 the original timber piers were replaced with reinforced concrete portal frames with spread concrete footings. It is assumed the concrete was bulk mixed and hand placed with only steel rods used to compact it.

The approach piers appear to be in good condition based on visual inspection and display no distress under their loading to date.

<b>Physical Assessment Summary</b>
Condition: Good (To be confirmed)
Modifications: Originals replaced in c.1939-40
Integrity: Nil

It is recommended that a more detailed condition report be prepared.

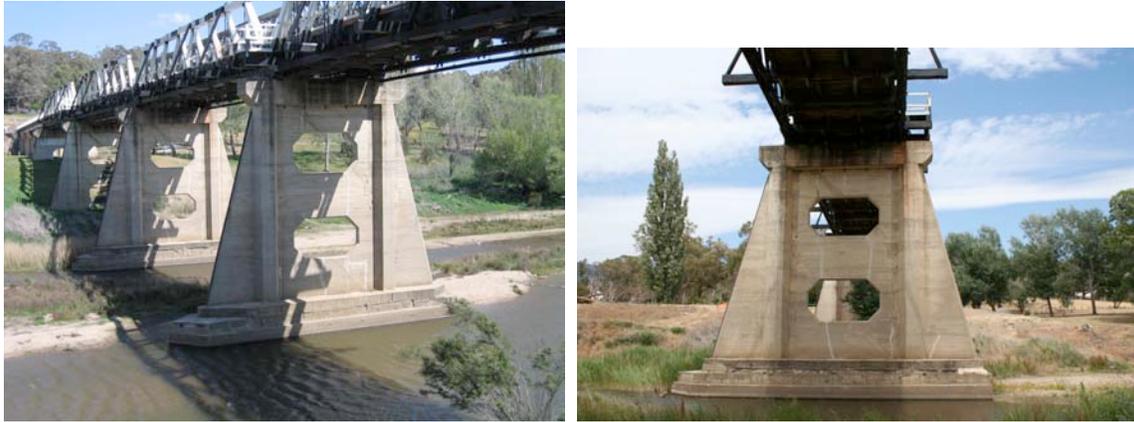
Main piers

The main piers are located at 27.4m intervals supporting the main truss spans. The original piers comprised timber trestles founded on timber piles driven as deep as possible in accordance with typical procedures at the time.

In 1936 three of the five timber trestles were replaced with reinforced concrete webbed wall type piers constructed in the same location as the original piers. The remaining two trestles were replaced in 1939-40. The new piers were founded on both the original timber piles and additional timber piles which were driven on either side, necessitating wider webs than would otherwise have been required. It is noted that the headstocks of the new piers were also wider than necessary, perhaps allowing for future deck widening, or replacement of the original truss spans.

<b>Physical Assessment Summary</b>
Condition: Poor in relation to current loading requirements
Modifications: Originals replaced in 1936, 1939-40
Integrity: Nil

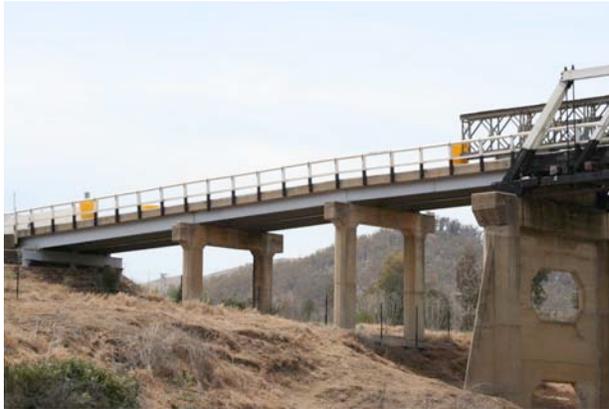
*Approach spans*

The original approach spans comprised c.100mm x 200mm timber planks spanning over 4 timber girders. The centre two girders were trimmed round logs of c. 500mm dia. The edge girders were 300mm x 350mm squared up logs.

In 1939-40 the original spans were replaced with steel girders, 400mm x 200mm generally and 325mm x 125mm for the short spans adjacent to the abutments, spaced at c. 2m, supporting a reinforced concrete deck with a 25mm bituminous road surface.

Connell Wagner report that based on the design loading at the time of construction the concrete deck is possibly under reinforced and the girders inadequate to support a T44 loading. This is the subject of ongoing investigation.

<b>Physical Assessment Summary</b>
Condition: Fair (to be confirmed)
Modifications: Original replaced in 1939-40
Integrity: Nil

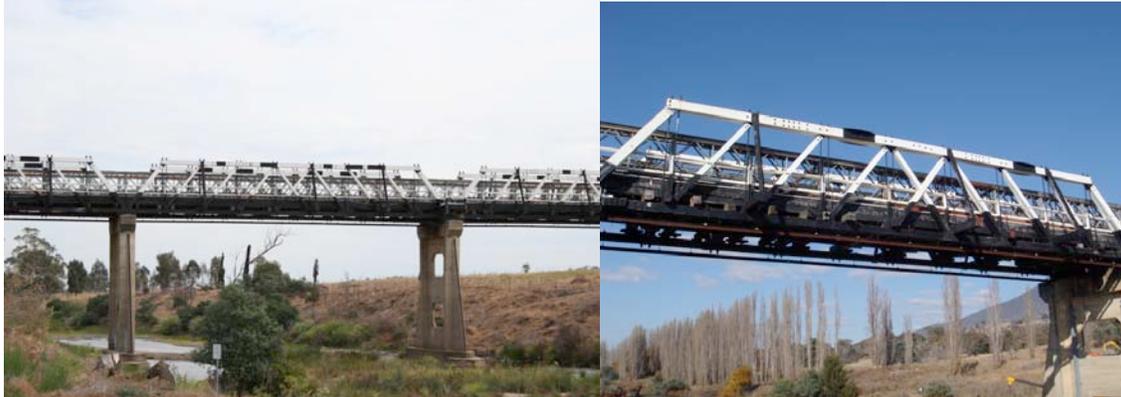
*General view of main truss spans*

*Individual truss span*

The truss spans appear largely as per the original. However it is assumed that most timber members have been replaced over time as per the original design intention.

Connell Wagner Consulting Engineers advise that almost all of the existing timber elements forming the trusses have deteriorated significantly and cannot be reused in replacement trusses. This deterioration is primarily typical timber rot or decay forming on the inside of the timber and then spreading out, gradually reducing the member strength. This form of deterioration is generally not visible from the outside of the member and makes timber strength assessment difficult unless timber boring is undertaken. A recent regular series of timber borings on the bridge have confirmed the unserviceability of the timber truss members and the need for replacement.

<b>Physical Assessment Summary</b>
Condition: Poor
Modifications: Periodic replacement of members. Extent unknown
Integrity: Appearance – High. Fabric - Low

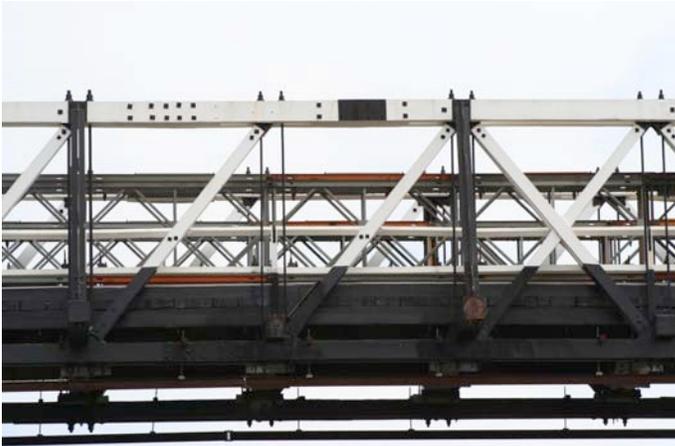
*Hangers*

The hangers are black painted wrought iron rods. These are 50mm diameter towards the ends of each truss (to reduce stress concentrations) and 38mm diameter in the centre. Each rod is supported by wrought iron clamps above the top chord and below the bottom chord with washers and nuts on rolled threads at the ends. There is no record of replacement and it is likely that the originals survive in place.

The hangers are believed to be in a satisfactory condition but nuts may not be able to be moved. They are probably inadequate to support a T44 loading. This is the subject of ongoing investigation.

<b>Physical Assessment Summary</b>
Condition: Fair. May be inadequate for T44 load (to be confirmed)
Modifications: Extent of replacement unknown
Integrity: High. Assume most original members exist

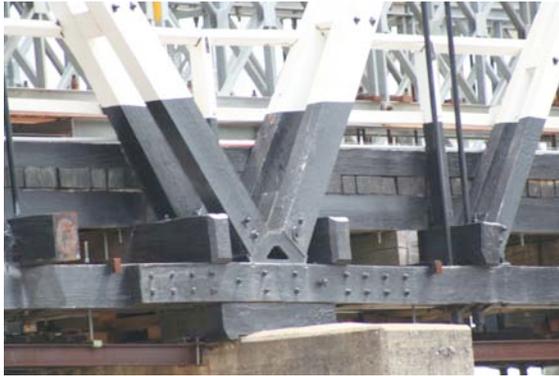
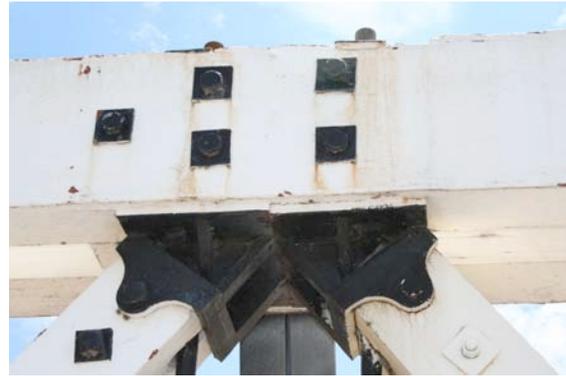
*Bottom shoes*

*Top shoes*

Cast iron shoes are located at the intersection of horizontal and diagonal timber truss members. There is no record of replacement and it is likely that most originals survive in place. Roads ACT report that there is extensive cracking and movement in the shoes, and that they are difficult to access for repairs. Impact loading tends to cause cracking of the cast iron. This was a known source of weakness in the original design.

<b>Physical Assessment Summary</b>
Condition: Poor
Modifications: Periodic strengthening. Extent of replacement unknown
Integrity: High. Assume most original members exist

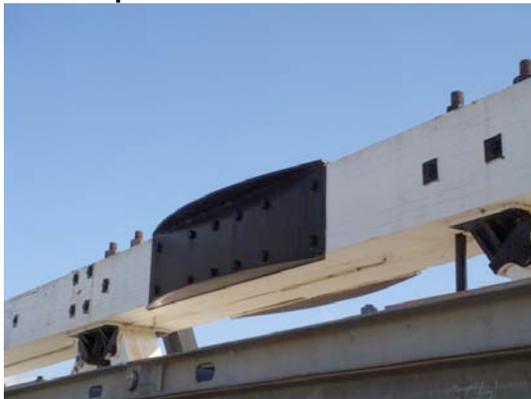
*Flanged plates on top chord*

Splice plates are used to join shorter timber lengths to make up the required length of each truss member. The originals were cast iron. Newer plates are steel. Originally flanged plates were used only on the truss top chords, which are subject to compression. Over time plates have been modified in an ad hoc manner. The use of shorter timbers has required more splice plates, and the convention of flanged plates on top chords is not always followed.

The condition of the plates is unknown. Roads ACT advise that the plates often conceal timber rot.

<b>Physical Assessment Summary</b>
Condition: TBA
Modifications: Extent of replacement unknown.
Integrity: Moderate. Assumed some original members exist

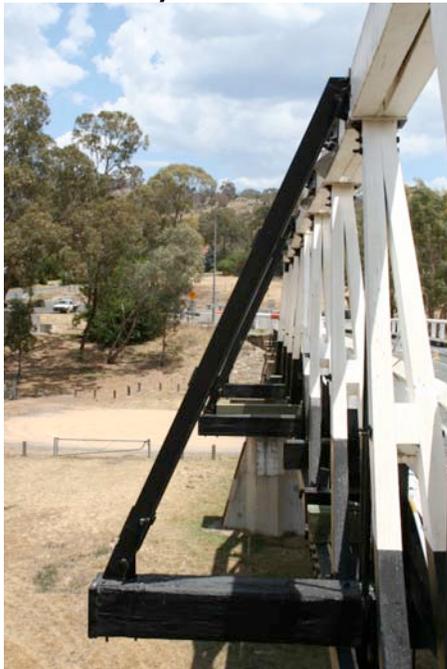
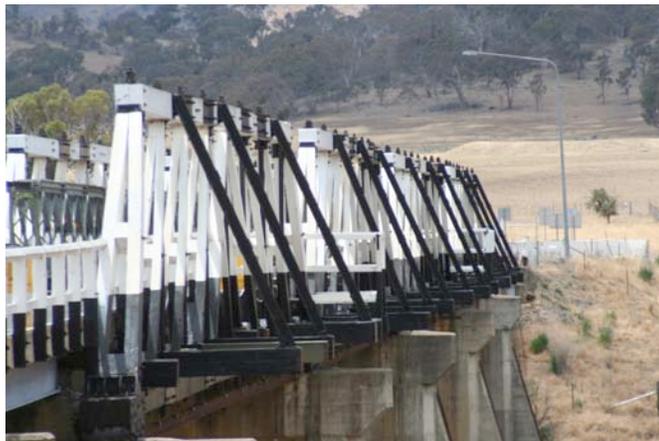
*Sway braces*

External sway braces connect the top chord to the cross girder to prevent lateral deflection. The original braces were fabricated from 100mm x 60mm wrought iron T sections and were located at the first, fourth, fifth and eighth panel points of each nine panel truss.

There is no record of replacement but it appears most if not all braces have been replaced.

There is significant lateral deflection of the top chord suggesting the braces are inadequate. This would be exacerbated under a T44 loading.

<b>Physical Assessment Summary</b>
Condition: Poor. Inadequate for T44 load
Modifications: Extent of replacement unknown. Assumed few original members exist.
Integrity: Low

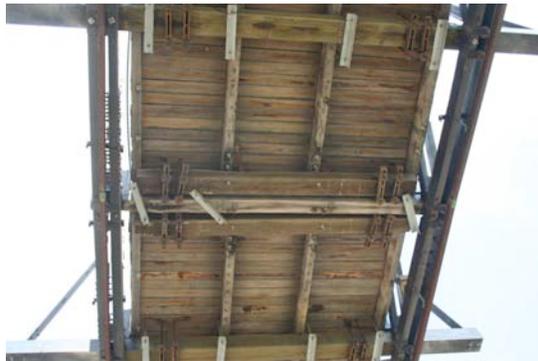
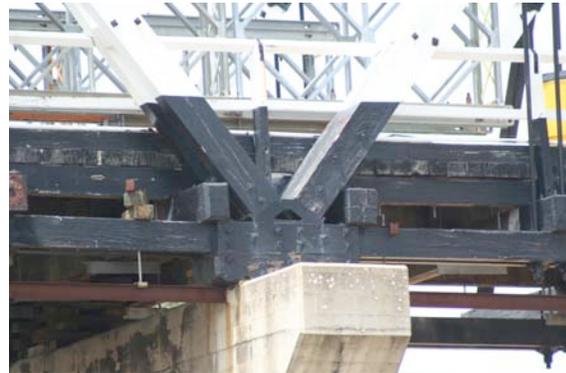
General view cross girders

Close up, showing bottom chord

The main span deck is supported on 250mm x 375mm hardwood cross girders which are bolted to the truss bottom chord.

There is no record of replacement but it is likely that all originals have been replaced over time. Roads ACT report their condition as poor. They are comprehensively rotted due to moisture seeping through the road deck. They are the greatest ongoing maintenance issue on the bridge.

<b>Physical Assessment Summary</b>
Condition: Poor
Modifications: Periodically replaced
Integrity: Low. Assume no original members exist

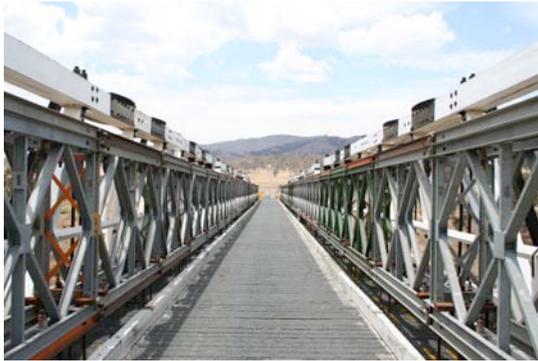
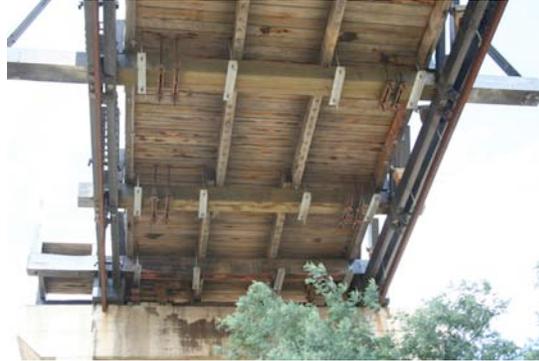
*Main deck top view*

*View from underside*

The main deck consists of closely spaced transverse planks, each 200mm wide and 100m deep, spiked into longitudinal hardwood stringers bolted to the cross girders. The stringers are c. 150mm wide and are nominally 275mm deep, varying slightly to provide deck camber.

Transverse deck planks shrink, become loose and allow moisture through, which causes deterioration and rot of lower timber members. The effect of the rough ride caused by worn transverse planks increases the dynamic impact from vehicles.

The condition of the deck planks is fair. They have suffered heavy wear due to vibration and have rotted due to moisture on the road surface. They are due for replacement.

<b>Physical Assessment Summary</b>
Condition: Fair
Modifications: All members have been periodically replaced
Integrity: Nil

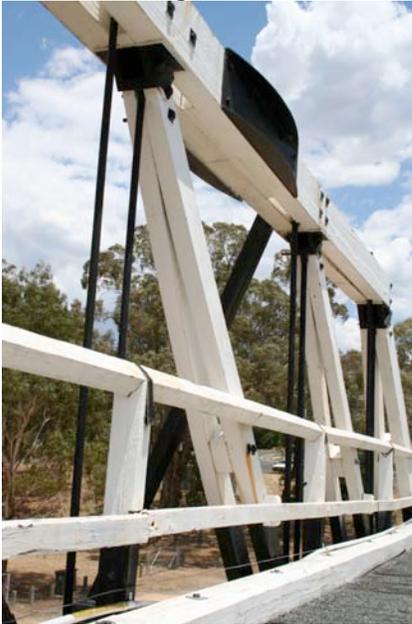
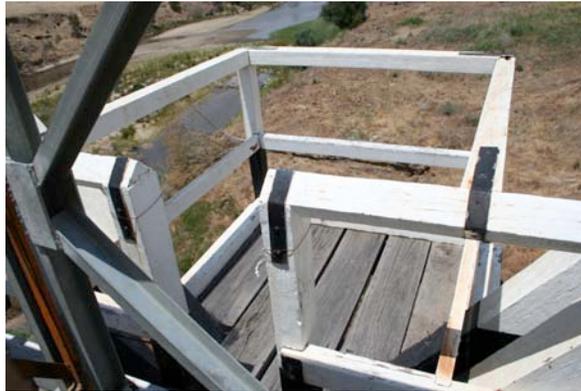
General view of railings

Refuge

The railings are traditional timber ordnance rails approximately 1200mm high above the main deck level. They consist of timber posts 150mm x 100mm, a kerb rail 200mm x 200 mm, a midrail 100mm x 75mm checked into the posts and a top rail 100mm x 100 mm set at 45 degrees. The posts are spaced at c. 2.4m on the main spans and 1.8m on the approaches.

The railing retains its original form, although the extent of member replacement is unknown.

<b>Physical Assessment Summary</b>
Condition: Poor. Does not comply with current safety barrier regulations
Modifications: Members have been periodically replaced
Integrity: Moderate. Assume no original members exist.

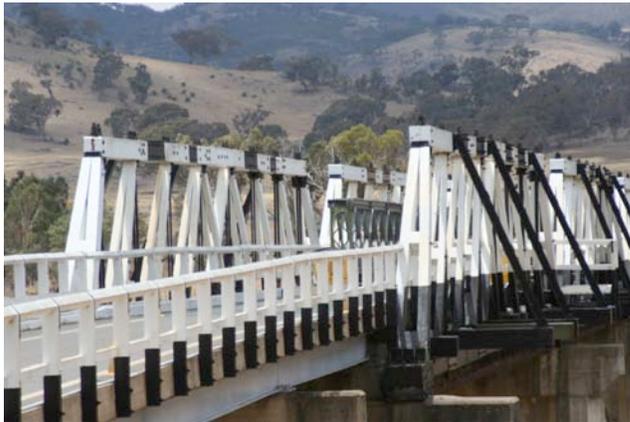
*Current colour hierarchy*

Early photographs suggest the original bridge had all timbers painted white and all iron/steel elements black.

<b>Physical Assessment Summary</b>
Condition: Poor
Modifications: Departs from original colour hierarchy in some respects
Integrity: Moderate.

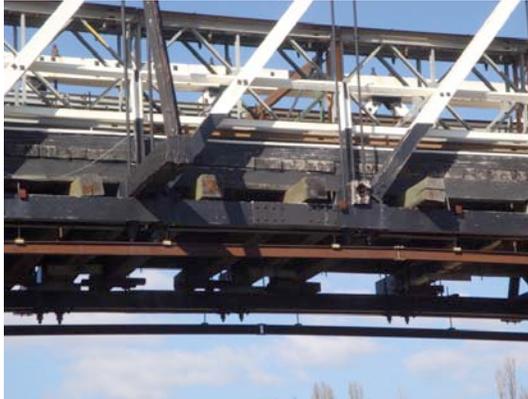
*Maintenance rail at bottom*

A rolled steel joist is suspended from the truss bottom chords on each side of the main span. This is not original. It was installed in c. 2001 to provide support for a maintenance gantry. The beam is not sufficiently rigid for its purpose due to deterioration of the timber bottom chord.

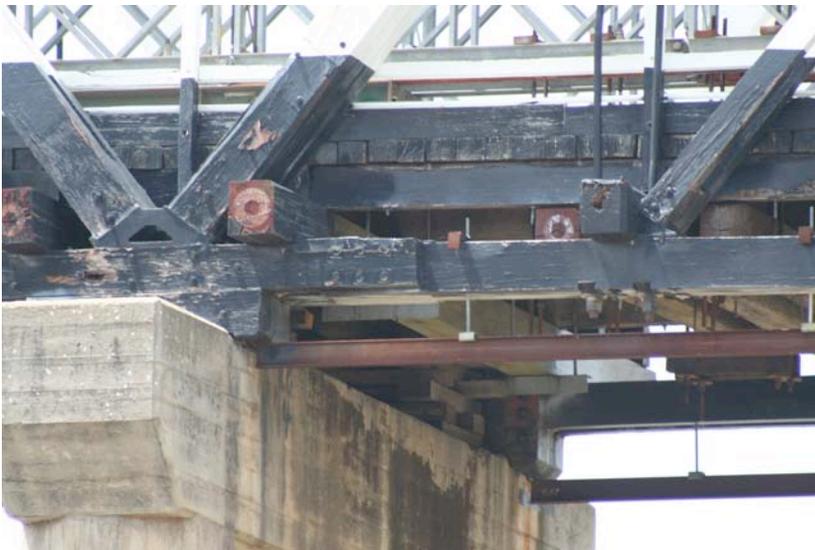
The Tharwa Bridge is in a severely deteriorated condition. The bridge is closed to all vehicles and pedestrians. The condition of most elements is the subject of continuing analysis by Connell Wagner. Initial indications are:

- The abutments are in poor condition and will require replacement
- The approach piers and spans may require replacement, depending on analysis of load carrying capacity.
- The main piers may require strengthening or replacement depending on analysis of load carrying capacity.
- The main truss timbers and cross girders are extensively rotted and require replacement.
- Iron and steel elements are in fair to poor condition. They will be difficult to remove intact and there is doubt as to their adequacy to support the increased load requirement.
- The main deck is in poor condition and requires replacement
- The railings are poor condition and require replacement to comply with current safety standards
- The maintenance rails require replacement to comply with current safety standards and operational requirements.

*General deterioration*
