# ACT Water Report

2010–11

Environment and  
Sustainable Development

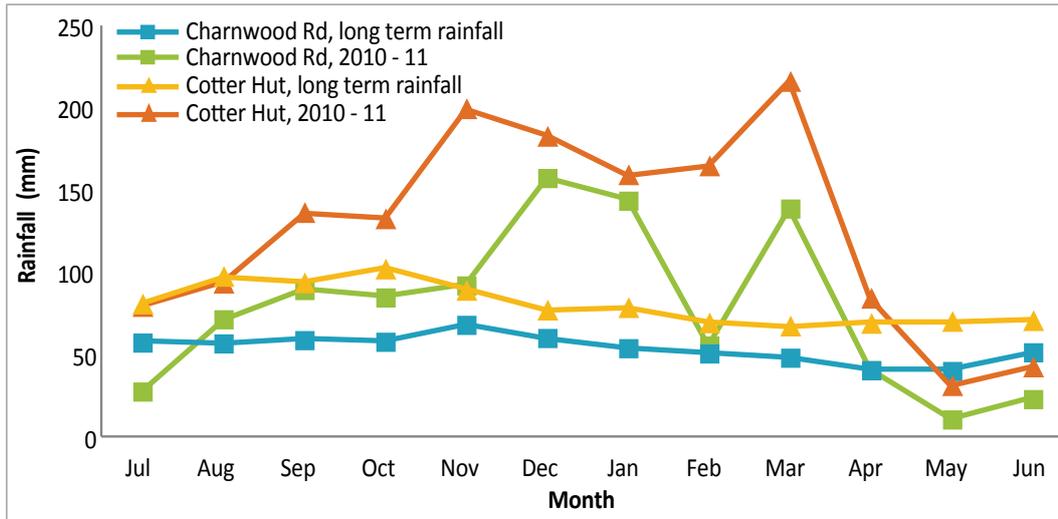
**Figure 3: Comparison of 2010–11 monthly rainfalls in Belconnen near Charnwood Road and Cotter Hut in the Corin Reservoir Catchment with the long term average monthly rainfall**

Rainfall in an urban area (Charnwood Road in Belconnen) and in a water supply catchment area (Cotter Hut, above Corin Reservoir) is depicted in Figure 3. These two sites, where rainfall measured is directly correlated with stream flow in the ACT, demonstrate the rainfall and landform interaction. Both the long-term average monthly rainfall from data collected since 1990, and the monthly rainfall for the 2010–11 reporting period are presented.

Rainfall at both the Cotter Hut and Charnwood Road stations was well above average for all but three months in 2010–11. Annual rainfall at the Charnwood Road site in Belconnen was 936 mm, 145% of long term annual rainfall. This was more than 200mm greater than 2009–10, with good falls in the spring, summer and March. The 1522 mm of rain recorded at Cotter Hut was 158% above average rainfall with above average rain from September to April and 200mm or more in November and March. The water supply reservoirs received good flows throughout the year and were above capacity by December 2010. They have remained at better than 95% capacity to the present.

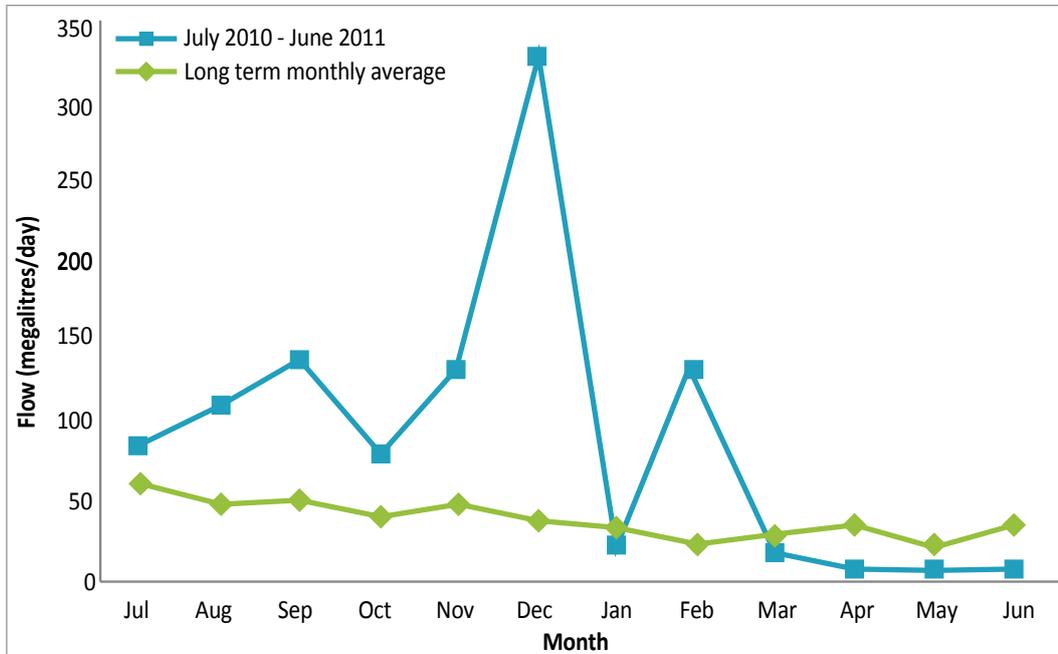
**Figure 4: Average monthly flow July 2010 to June 2011 in Ginninderra Creek (410750) upstream of Charnwood Road compared with the long-term average monthly flow for that site**

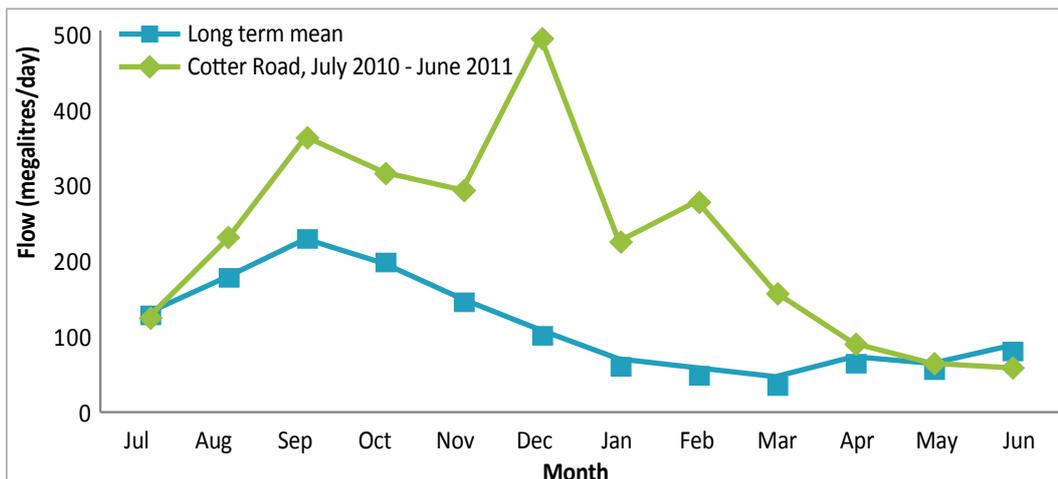
**Figure 5: A comparison of the average monthly flow (July 2010–June 2011) to the long-term average monthly flow in the Cotter River for a site upstream of Corin Reservoir**

The pattern for the Cotter River shows high peaks that coincide with the wet periods of September, December and February. This led to both Corin and Bendora reservoirs being at or over capacity for most of the year (Figure 5).

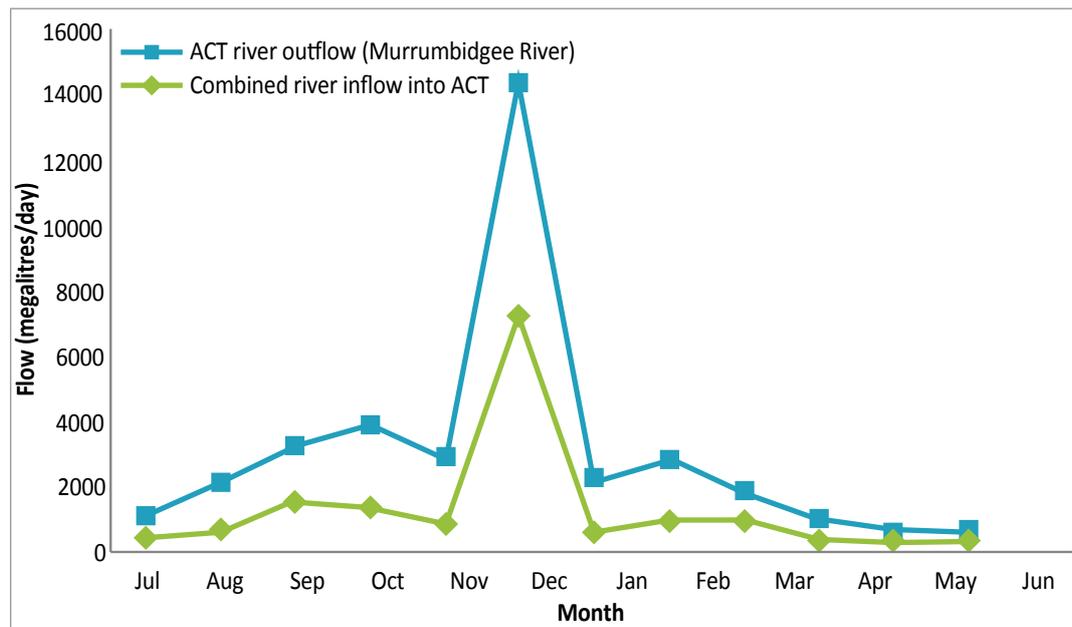
**Figure 6: A comparison of the average monthly inflows into the ACT (combined monthly data for the Murrumbidgee, Molonglo and Queanbeyan rivers) with the average monthly outflows from the ACT (Murrumbidgee River, just after the downstream exit of the ACT border, at Hall Crossing) for the July 2010–June 2011 period**

The ACT remains a net exporter of water into the Murrumbidgee River. A comparison of the volume of water flowing (including the Queanbeyan River water that collects behind Googong Dam) into the ACT with the volume of water leaving the ACT is shown in Figure 6. The Murrumbidgee River at the Lobbs Hole gauge experienced average daily flows of greater than 200 ML/day in all months, reaching a maximum mean daily flow of 4077 ML/day in December 2010. The Molonglo River at the Burbong bridge gauge contributed more than 40 ML/day on average from July 2010 to March 2011 while the Queanbeyan River at the gauge above Googong reservoir had readings of greater than 150 ML/day between September and March. Flow-based samples covering the percentile bands (Table 4) were taken in 2010–11 in spring and again after the December floods had subsided. Flows in the Murrumbidgee River were supplemented by the returns from sewage treatment and extensive urban area flooding, especially in December. The 6000ML difference between inflow and outflow in December represents urban runoff and water from the lower Cotter catchment.

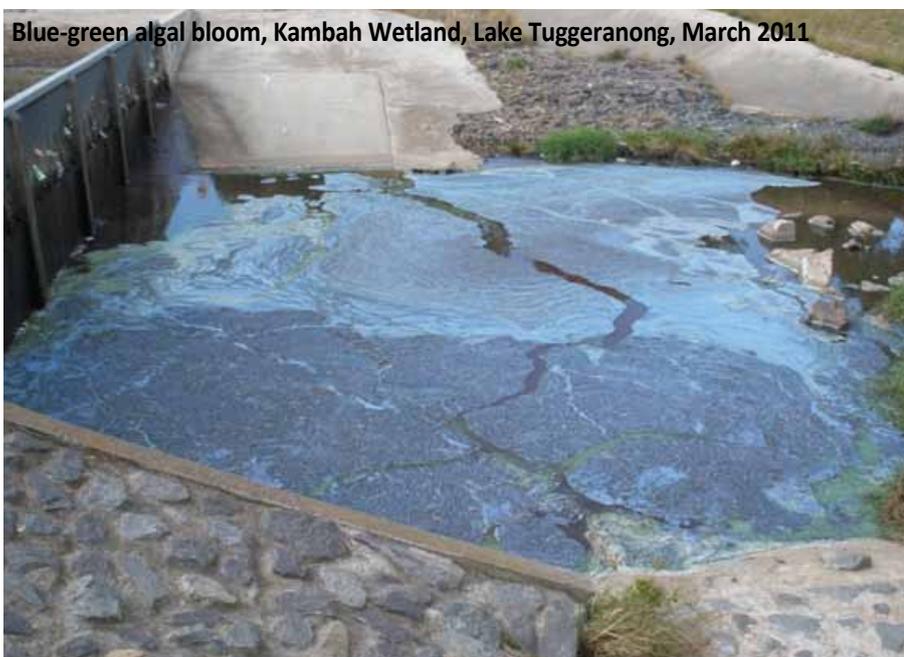
Blue-green algal bloom, Kambah Wetland, Lake Tuggeranong, March 2011

A bloom began in Lake Tuggeranong in January 2011 and was monitored by inspection until mid February when the lake was closed for primary contact sport and recreation. *Microcystis* and *Anabaena* were both detected in large numbers throughout March and April, and precautionary samples were sent for toxicology in April. The results indicated

that saxitoxin, associated in freshwater systems with *Anabaena* blooms, was present in low but significant levels and the closure was upgraded to secondary contact. While the *Anabaena* population had dropped out by late May, traces of *Microcystis* remained until early June. The closure from mid February to early May was the longest experienced for some years. The circumstances leading to this unusual bloom may have been the transport of substantial nutrients and sediments into the lake during spring and summer floods followed by a very dry autumn.
